Aviation Investigation Preliminary Report

Location:	Portland, OR	Accident Number:	DCA24MA063
Date & Time:	January 5, 2024, 17:14 Local	Registration:	N704AL
Aircraft:	Boeing 737-9	Injuries:	177 None
Flight Conducted Under:	Part 121: Air carrier - Scheduled

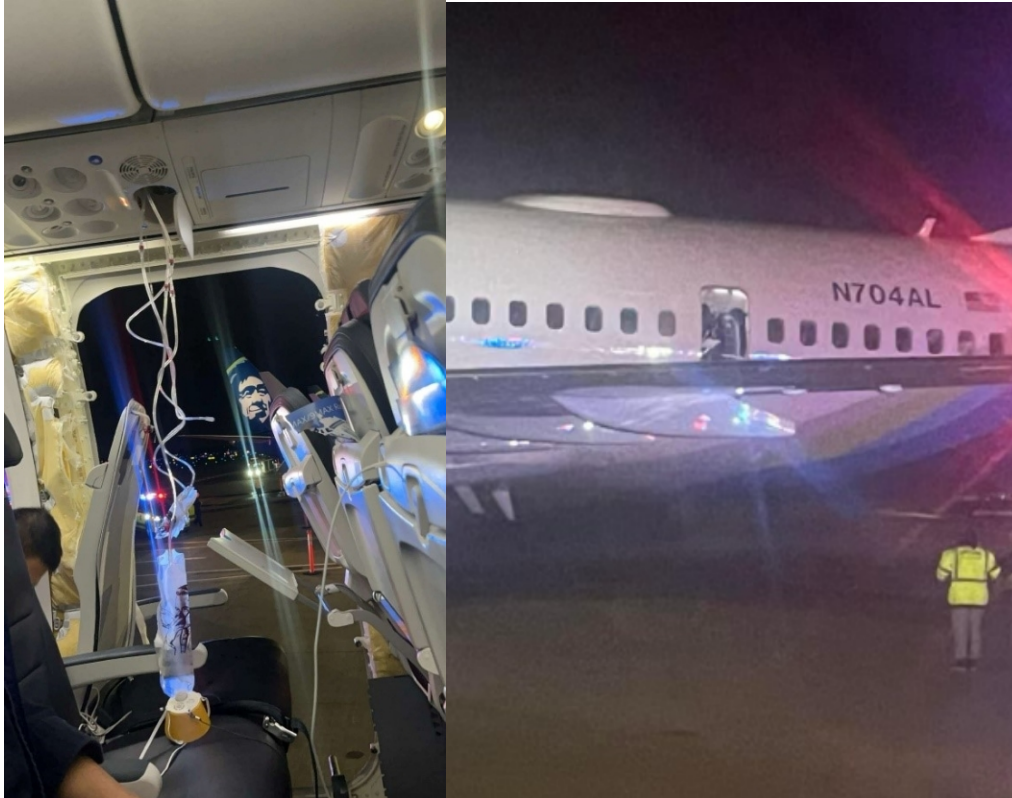
Figure 1 below shows the location of the missing MED plug from inside and outside the airplane. The separation of the MED plug from the airplane adversely affected the pressurization performance of the airplane and the damage to the MED plug adversely affected its structural strength, requiring replacement of the MED plug, resulting in a classification of substantial damage in accordance with Title 49 *CFR* Part 830.

Figure 1. Photos of the location of the missing MED plug. (Source: left photo provided by a passenger. Right photo provided by media.)

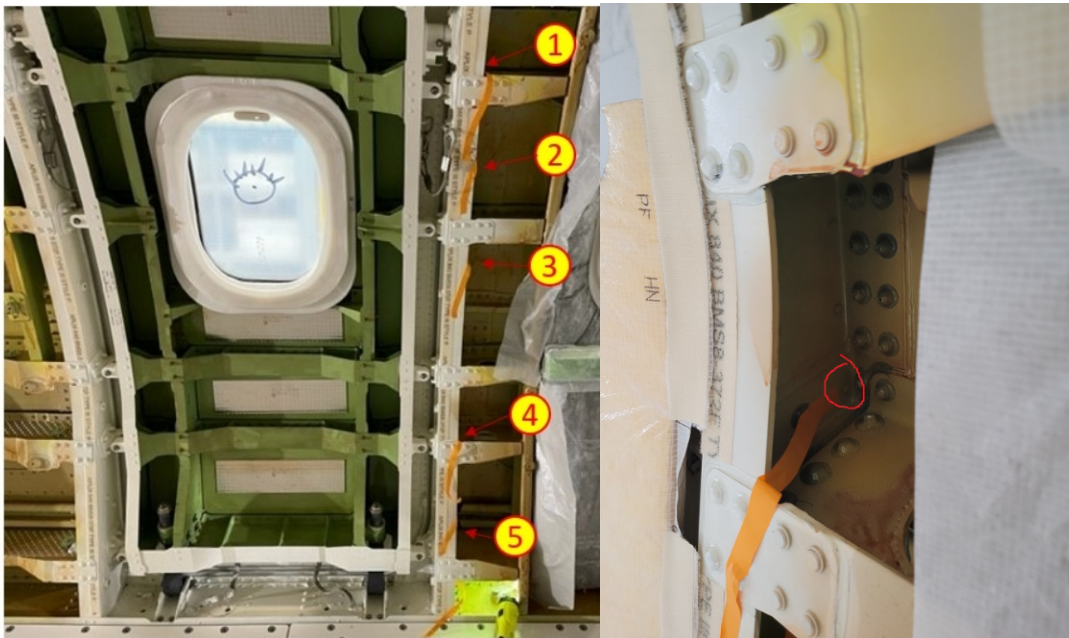
On September 1, 2023, records show that NCR 1450292531 was created noting five damaged rivets on the edge frame forward of the left MED plug. See figure 14 for rivet locations.

Figure 14. Photo on the left shows the five locations of the damaged rivets. Photo on the right is a close-up of a damaged rivet. (Source: Boeing. Image Copyright © Boeing. Reproduced with permission.)

Records show the rivets were replaced per engineering requirements on Non-Conformance (NC) Order 145-8987-RSHK-1296-002NC completed on September 19, 2023, by Spirit AeroSystems personnel. Photo documentation obtained from Boeing shows evidence of the left-hand MED plug closed with no retention hardware (bolts) in the three visible locations (the aft upper guide track is covered with insulation and cannot be seen in the photo). See figure 16. This image was attached to a text message between Boeing team members on September 19, 2023, around 1839 local. These Boeing personnel were discussing interior restoration after the rivet rework was completed during second shift operations that day.

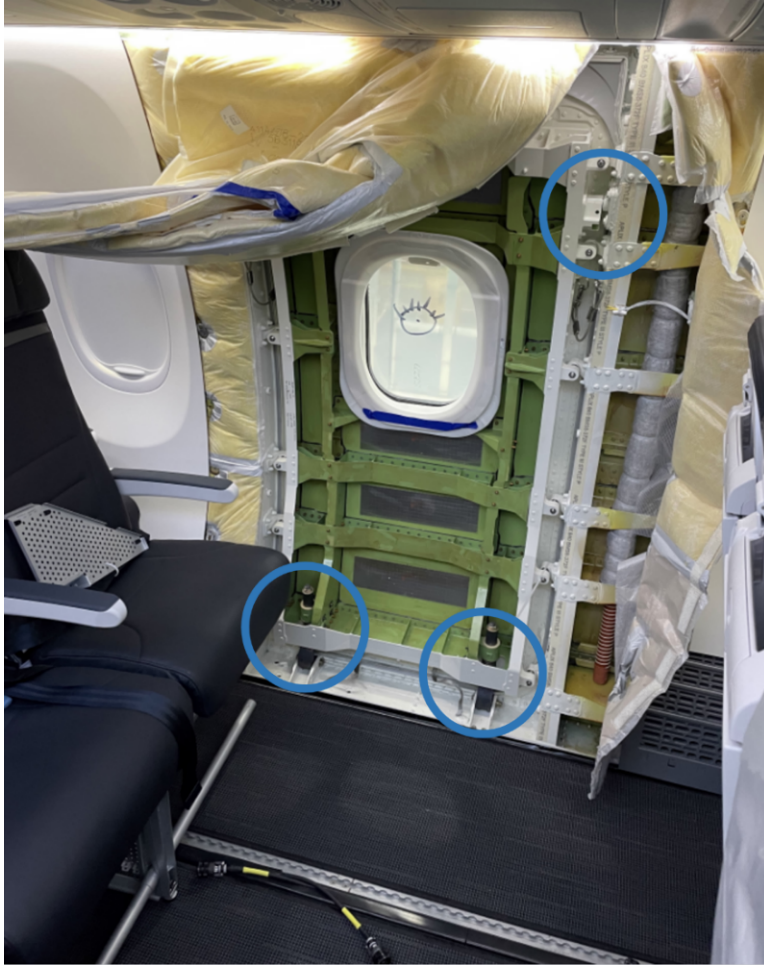
Figure 16. Photo showing the left MED plug immediately before interior restoration and the circles show the three locations without the retaining bolts, two vertical movement arrestor bolts and the forward upper guide track bolt. The aft upper guide track is covered with insulation and cannot be seen in the photo. (Source: Boeing. Image Copyright © Boeing. Reproduced with permission.)
