# JLL Valuation Advisory Property Condition Assessment

Property: 7800 Ricchi Tower - 7800 North Stemmons Freeway, Dallas, Texas 75247

Report Date: July 21, 2022

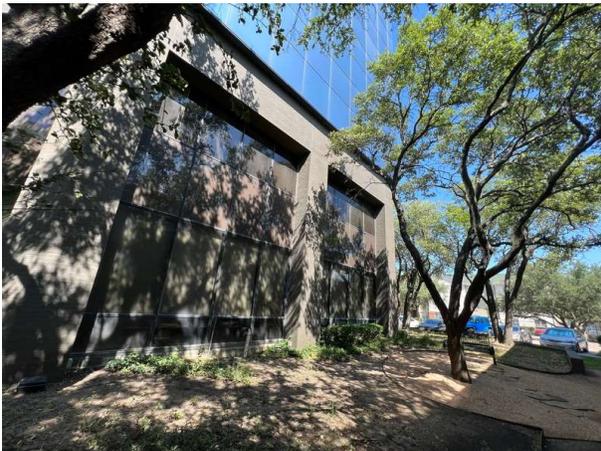
However, bared areas with no grass, distressed plantings and a general poor landscape appearance was observed. JLL VA recommends installing and maintaining the landscape around the Property. An opinion of costs is included in the cost tables.

Landscaping condition

Cost Recommendation	EUL	EFF AGE	RUL	Year	Cost
Landscaping installation and maintenance	-	-	-	Immediate	\$15,000
Total					\$15,000

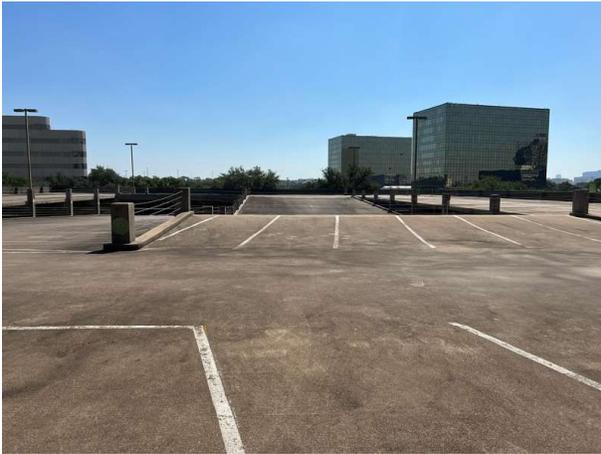
In addition, based on the observed condition and EUL, JLL VA recommends budgeting for sealing and cleaning the parking garage every 5 years to avoid water penetrating the structural system. An opinion of cost is included in the tables.

Parking garage concrete structure

Cost Recommendation	EUL	EFF AGE	RUL	Year	Cost
Concrete pavement striping	5	5	0	Immediate	\$13,660
				5	\$13,660
				10	\$13,660
Parking garage sealing and maintenance	5	5	0	Immediate	\$20,000
				5	\$20,000
				10	\$20,000
<b>Total</b>					<b>\$100,980</b>

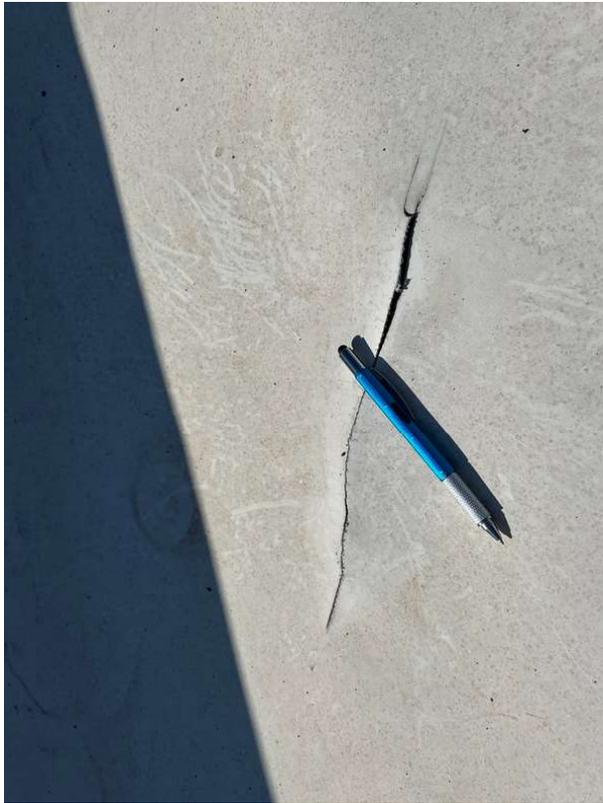
Roofing appeared to be in overall good condition. However, JLL VA noted that the membrane appears to be delaminating at some of the sections, and a 12 inch tear was observed at the southeast corner of the building. JLL VA recommends repairing these issues at this time. An opinion of cost is included in the tables.

Roof tear

Cost Recommendation	EUL	EFF AGE	RUL	Year	Cost
Roof repairs	-	-	-	Immediate	\$10,000
Roof replacement	15	6	9	9	\$315,000
Total					\$325,000

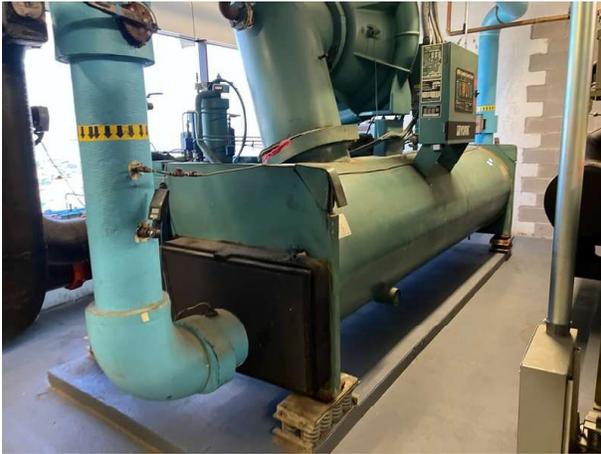
The chillers are in good to fair condition. air-cooled chillers are located at the lower level. They were manufactured by Trane and York. One chiller was replaced in 2015, and the other one is from original construction. Based on the EUL, replacement of the original chiller is recommended. An opinion of cost for this work is included in the cost tables.

Chiller

Cost Recommendation	EUL	EFF AGE	RUL	Year	Cost
HVAC: central AHU overhaul	25	20	5	2	\$30,000
				4	\$30,000
				6	\$30,000
HVAC: chiller unit replacement, original unit	40	35	5	5	\$250,000
HVAC: fan boxes overhaul, allowance	25	20	5	1	\$8,000
				2	\$8,000
				3	\$8,000
				4	\$8,000
				5	\$8,000
				6	\$8,000
				7	\$8,000
				8	\$8,000
				9	\$8,000
				10	\$8,000
				11	\$8,000
				12	\$8,000
<b>Total</b>					<b>\$436,000</b>

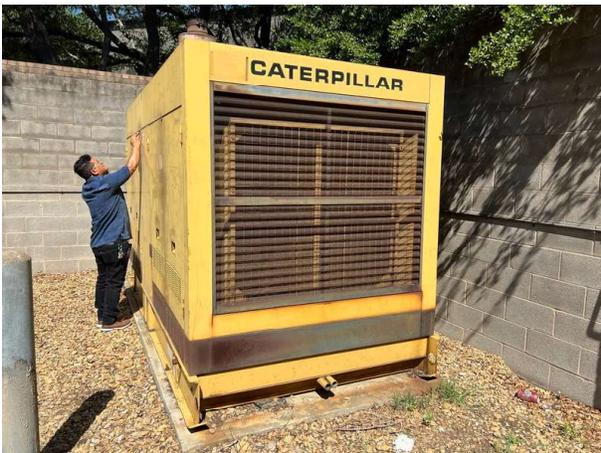
Item	Description	Action
GFCI	GFCI outlets were noted at appropriate locations.	
Transformers	Transformers are pad-mounted, and are the property of the electric utility.	
Generator	A generator, manufactured by Caterpillar, is located at in a CMU block enclosure on the ground level, and provides power to the building in case of a power outage. The generator is diesel powered, and has a 500 gallon capacity. The generator is exercised regularly. The generator is original.	RR

Emergency generator

Cost Recommendation	EUL	EFF AGE	RUL	Year	Cost
Electrical generator replacement	40	37	3	3	\$60,000
Total					\$60,000

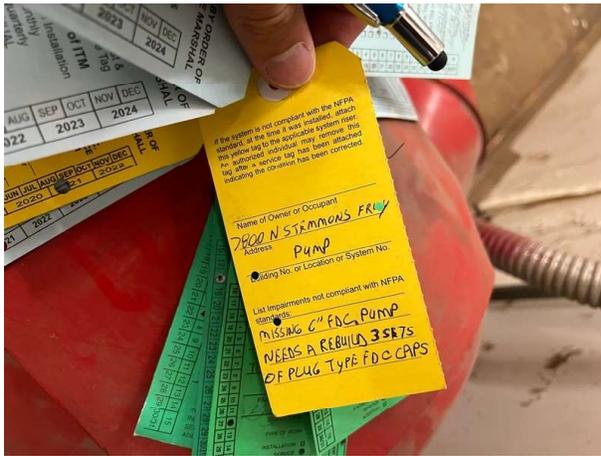
Yellow tags at fire sprinkler system

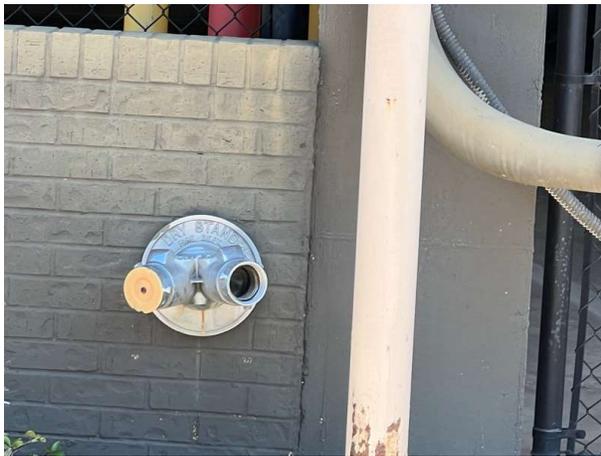
Missing FDC caps

Cost Recommendation	EUL	EFF AGE	RUL	Year	Cost
FDC caps are missing	-	-	-	Immediate	\$5,500
Total					\$5,500

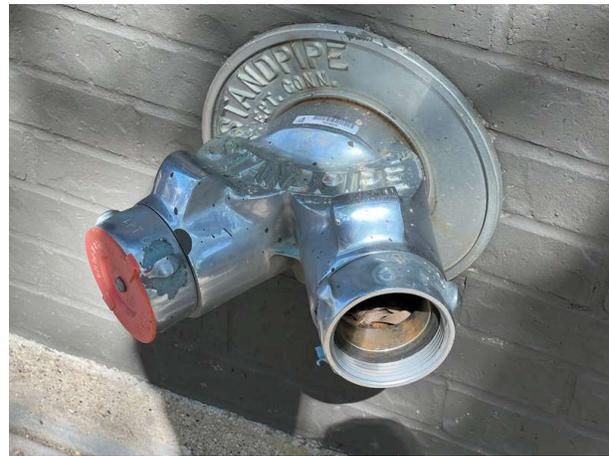
Missing FDC caps

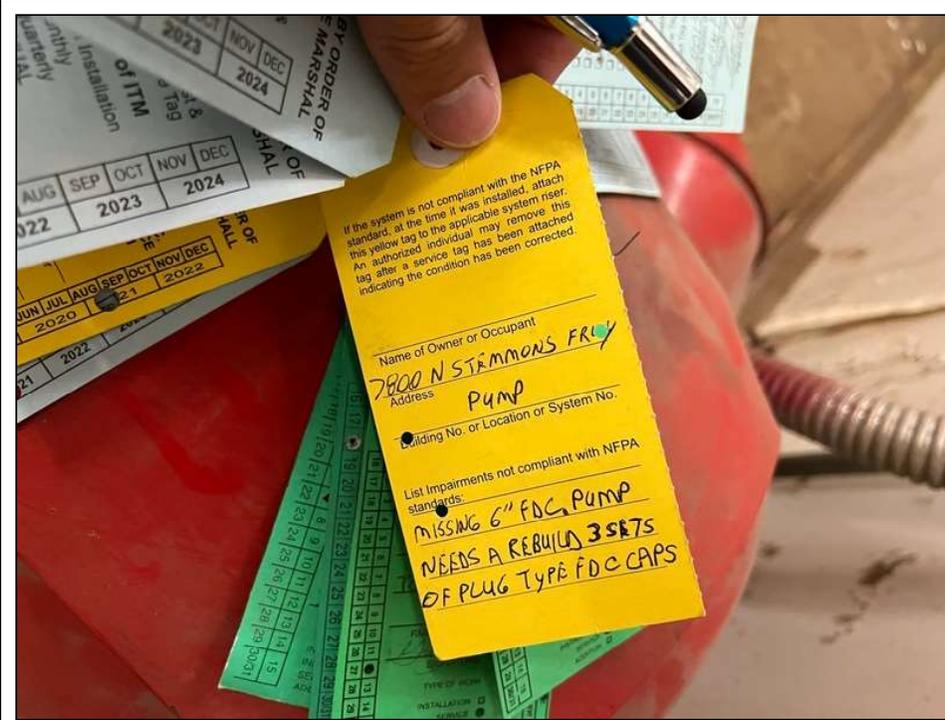
79. Yellow tags at fire sprinkler system

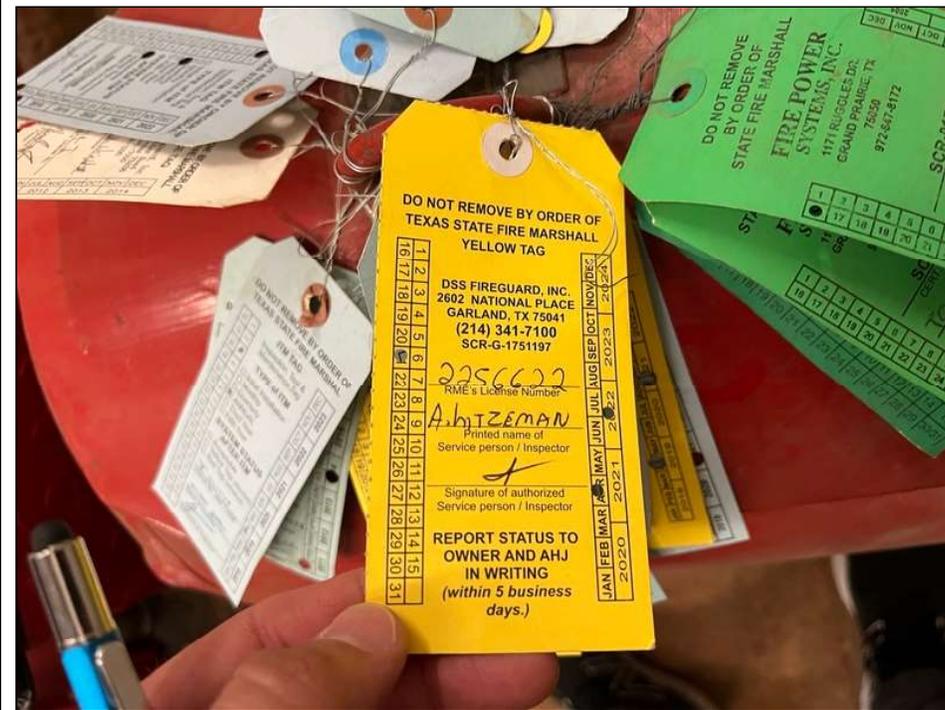
80. Yellow tags at fire sprinkler system

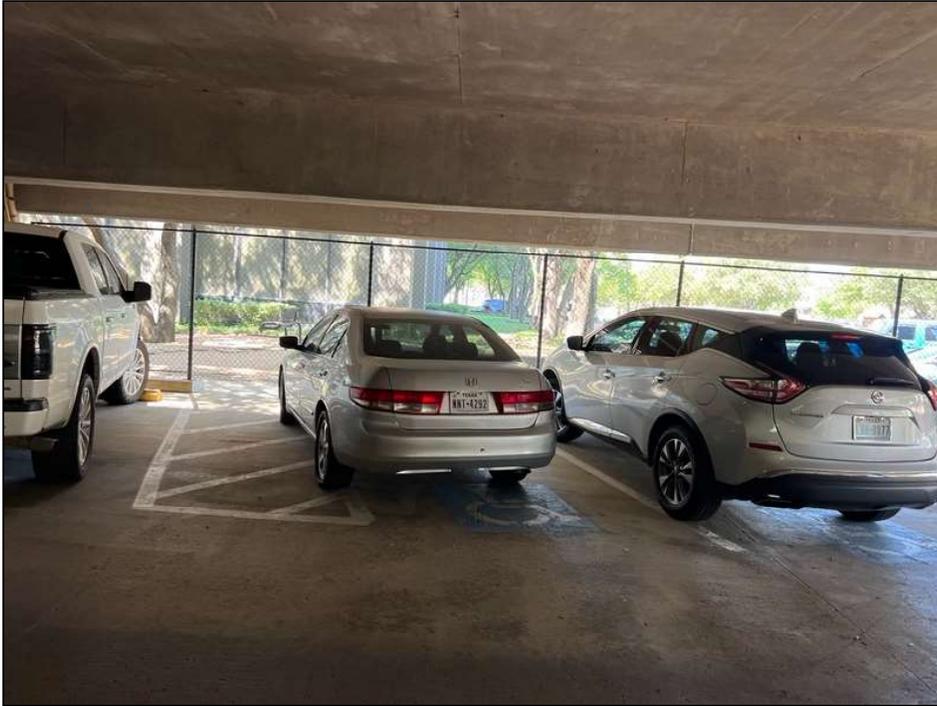
81. Missing accessible parking signs

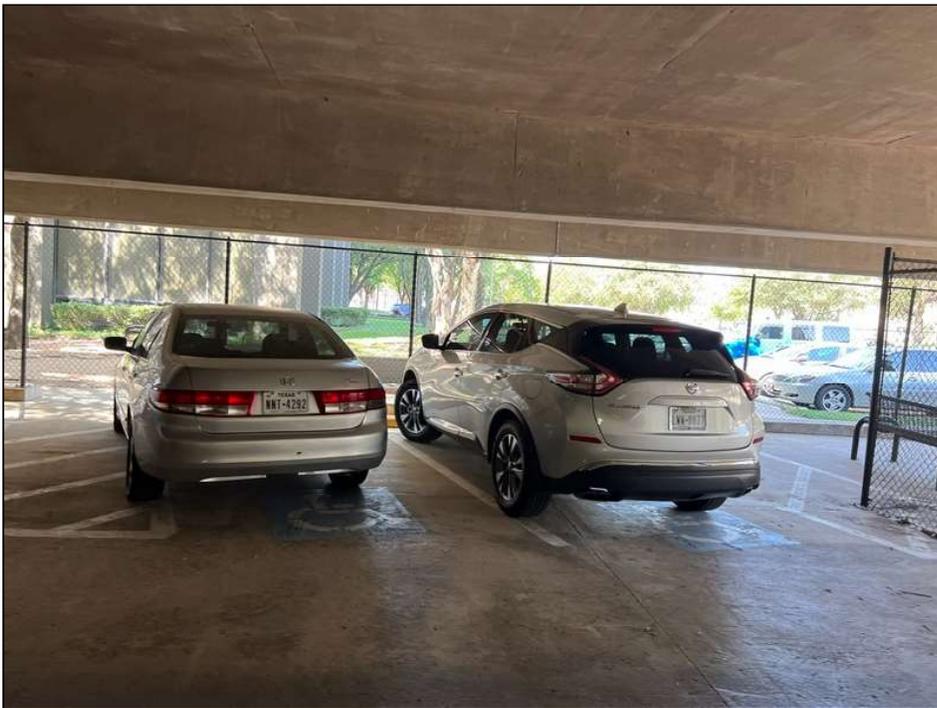
82. Missing accessible parking signs

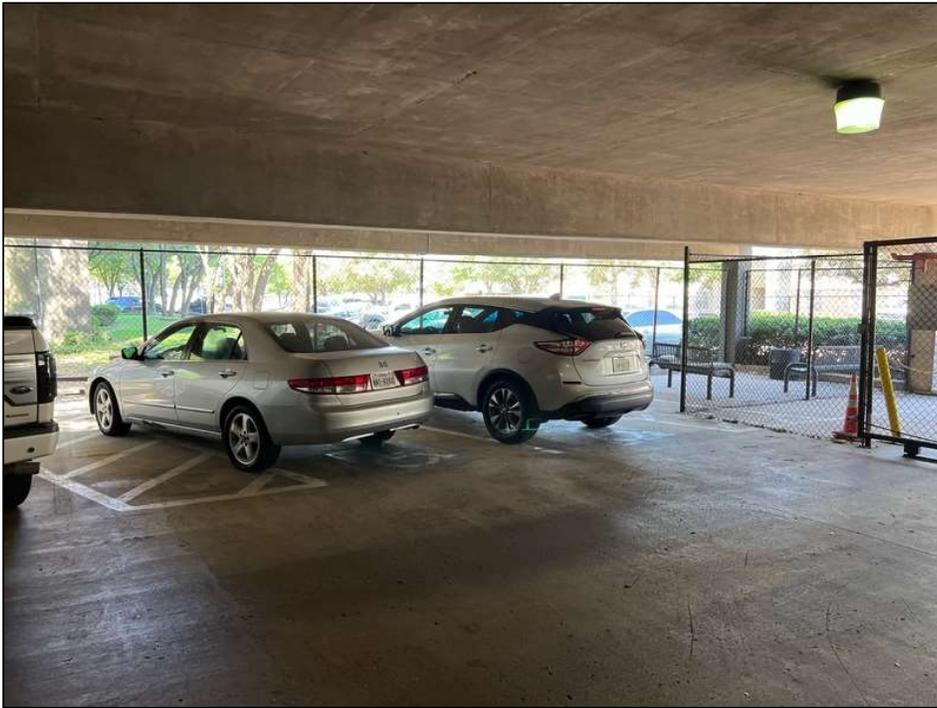
83. Missing accessible parking signs

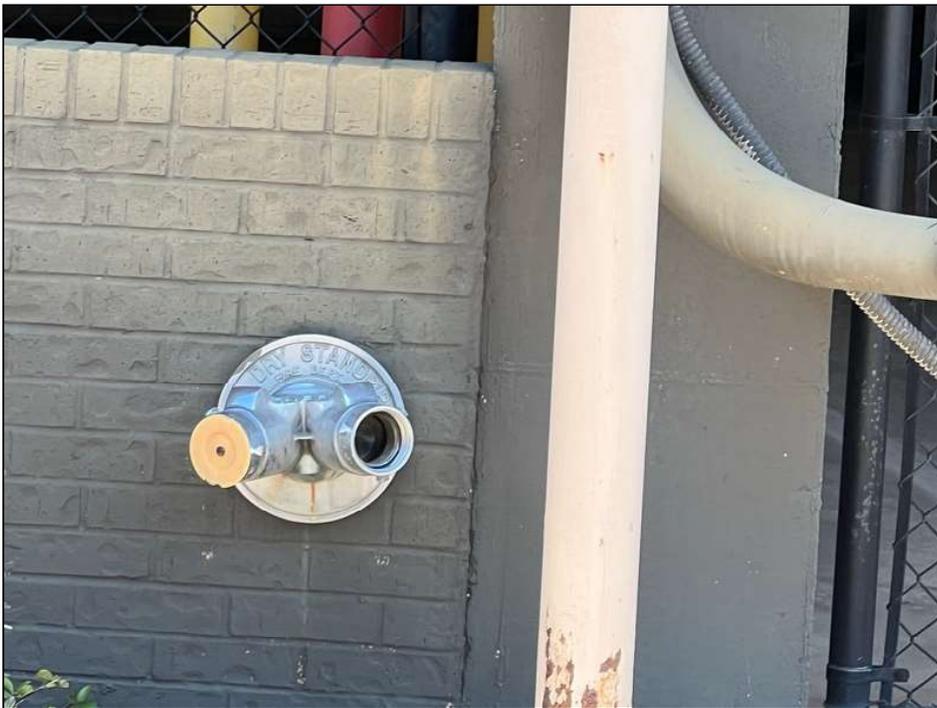
84. Missing FDC caps

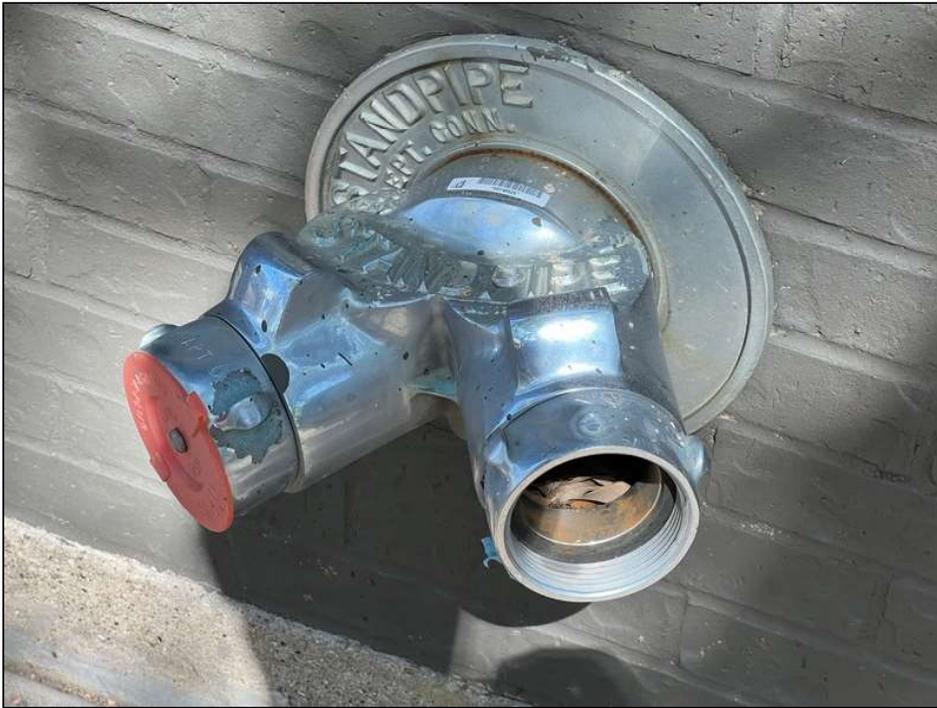
85. Missing FDC caps

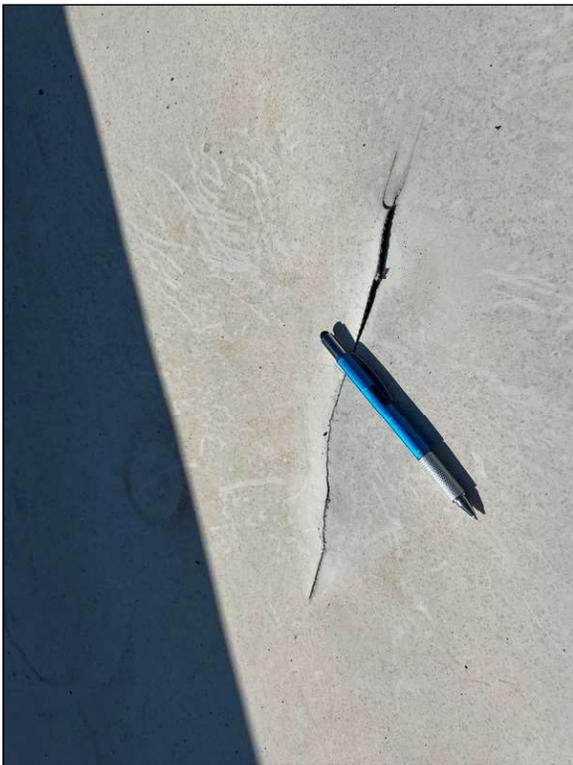
86. Roof tear

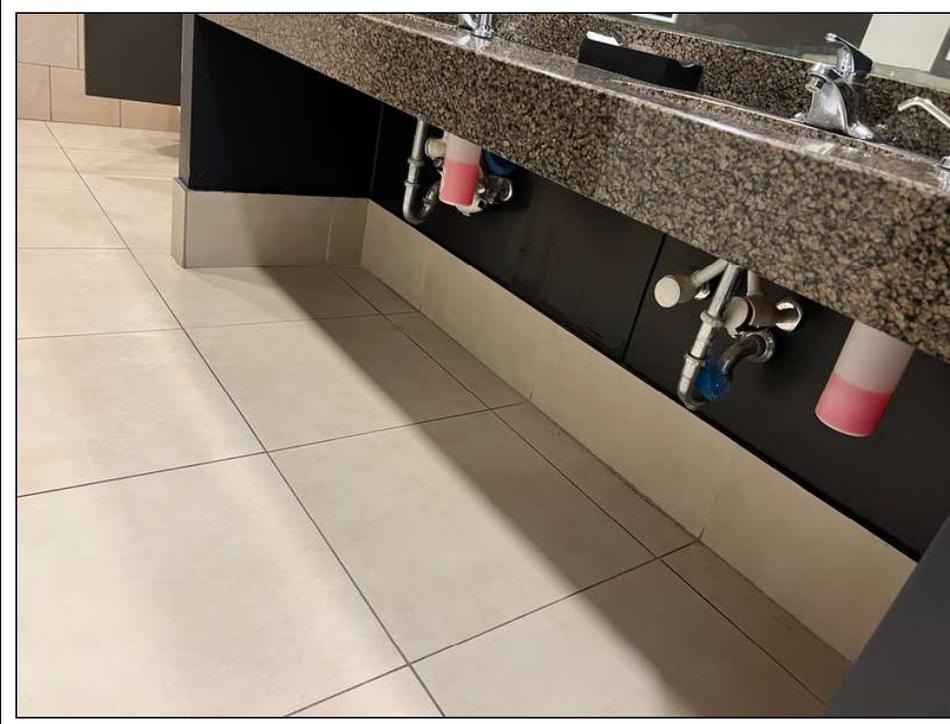
89. Sink pipe protection is needed
