ANALYSIS REPORT

TPA No. 1114

Object 21 Star U. S. Nat'l.

Cat. No. ZFC 0422

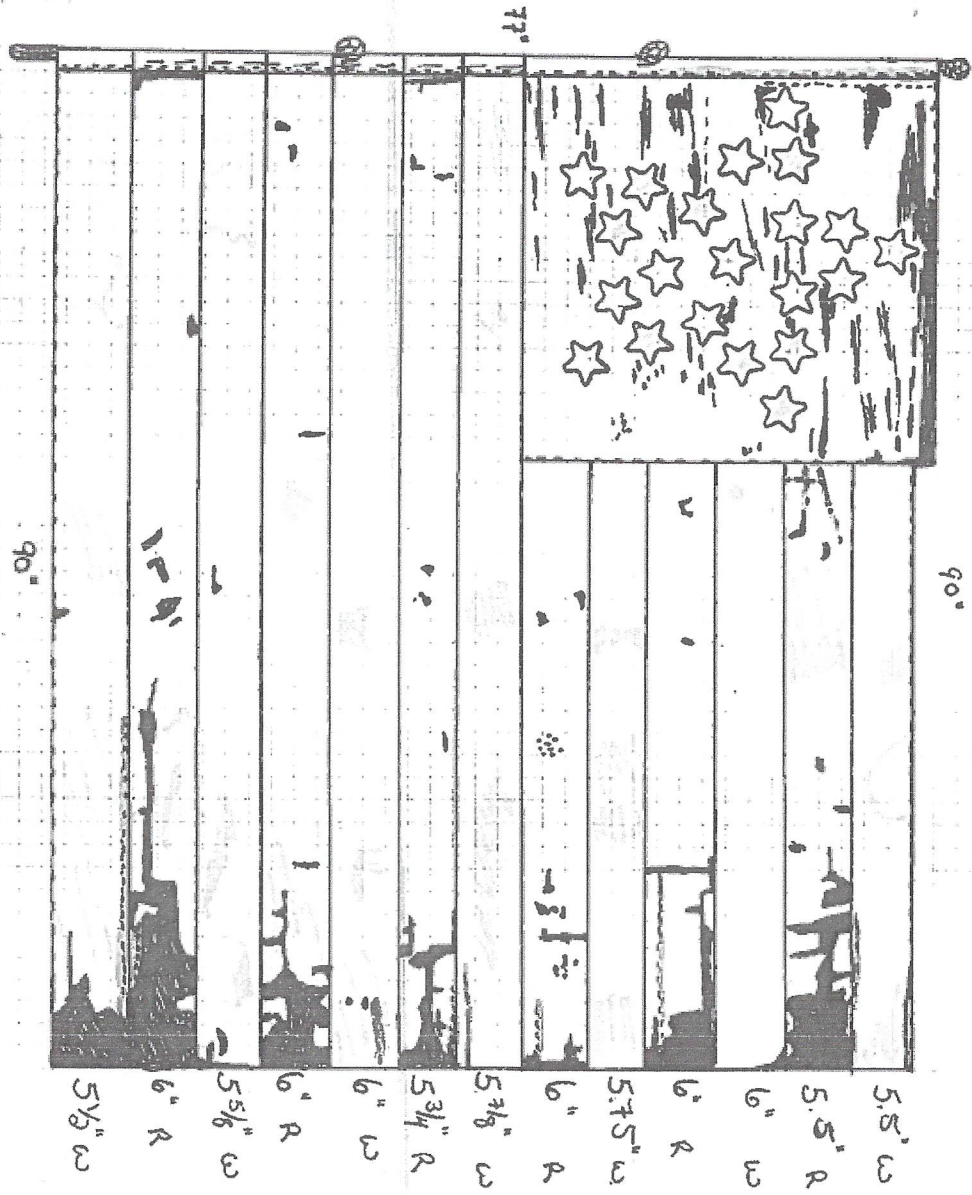
Drawing No: 3
Condition

The flag is severely damaged with the majority of the damage occurring in the canton and along the fly end. The canton fabric is severely degraded with numerous horizontal splits and missing fabric, primarily across the top. The red stripes on the fly end are more severely damaged with greater losses than the white stripes. Only the bottom white stripe has major losses. The flag is stained and soiled and has numerous repairs both hand and lockstitch machine stitching (see condition drawing). There are minor holes throughout the fly and numerous areas of staining.
