REINFORCED AUTOCLAVED AERATED CONCRETE (RAAC) ROOF PANEL ASSESSMENT

Ontario Science Centre Building A – B14175
770 Don Mills Road, North York, ON

Infrastructure Ontario and Ministry of Infrastructure
June 18, 2024

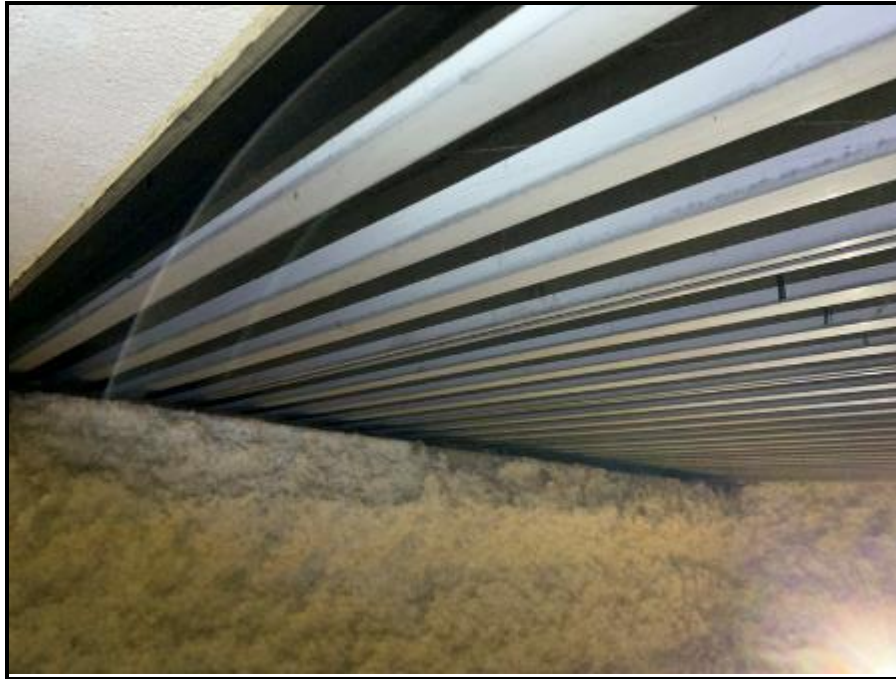
Photograph 1
Roof Area A1 – RAAC replacement with steel deck

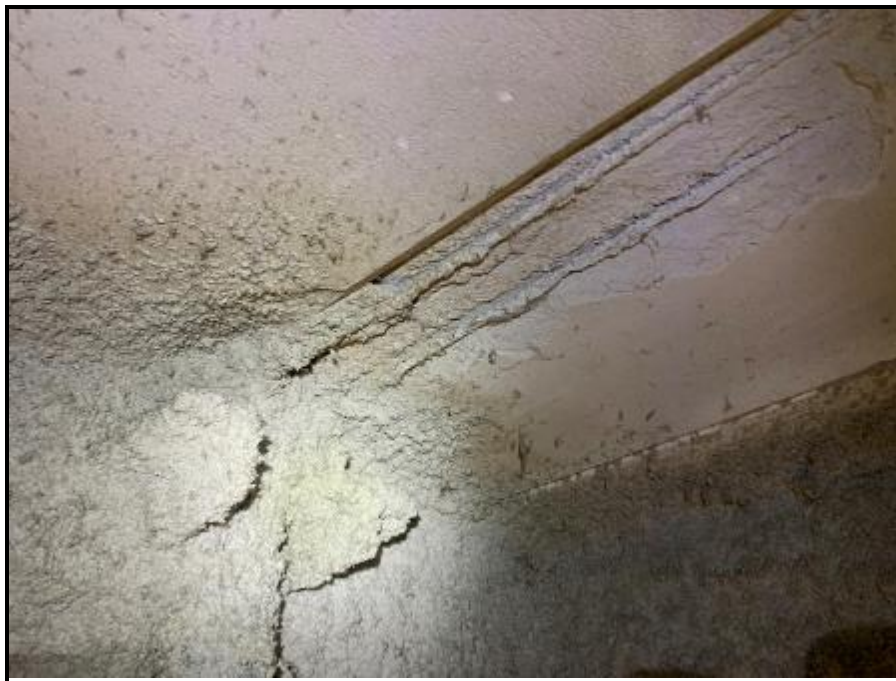
Photograph 2
Repair Location A1.1 – Spalling and exposed reinforcing bars

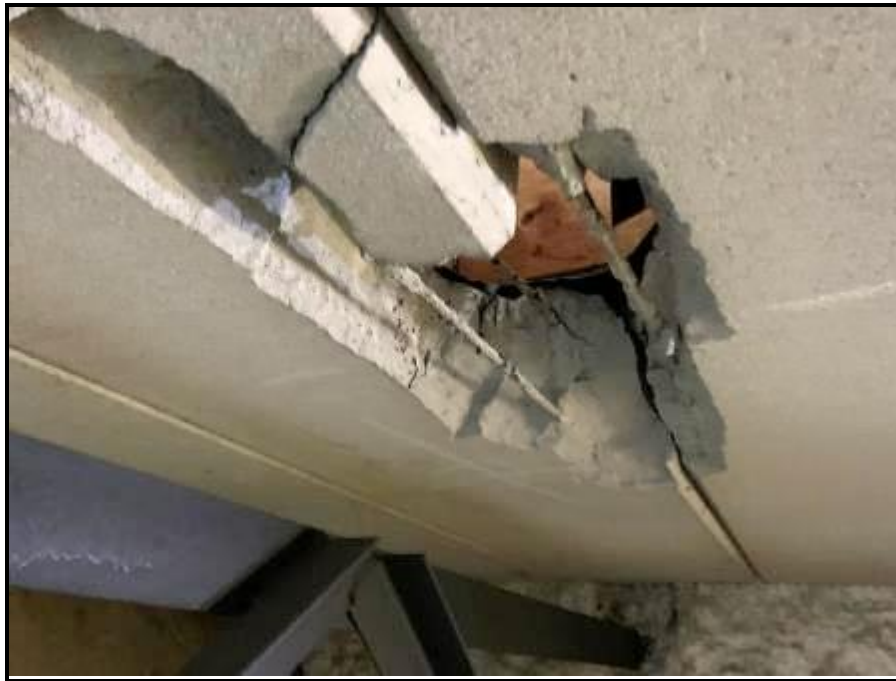
Photograph 3
Repair Location A1.2 – Unreinforced field modification

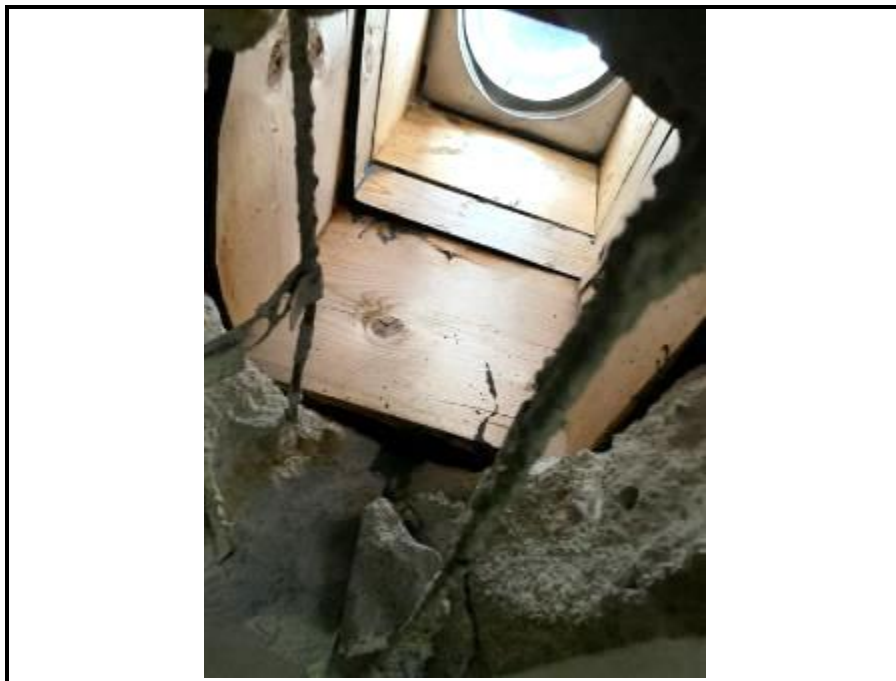
Photograph 4
Repair Location A1.4 – Unreinforced field modification

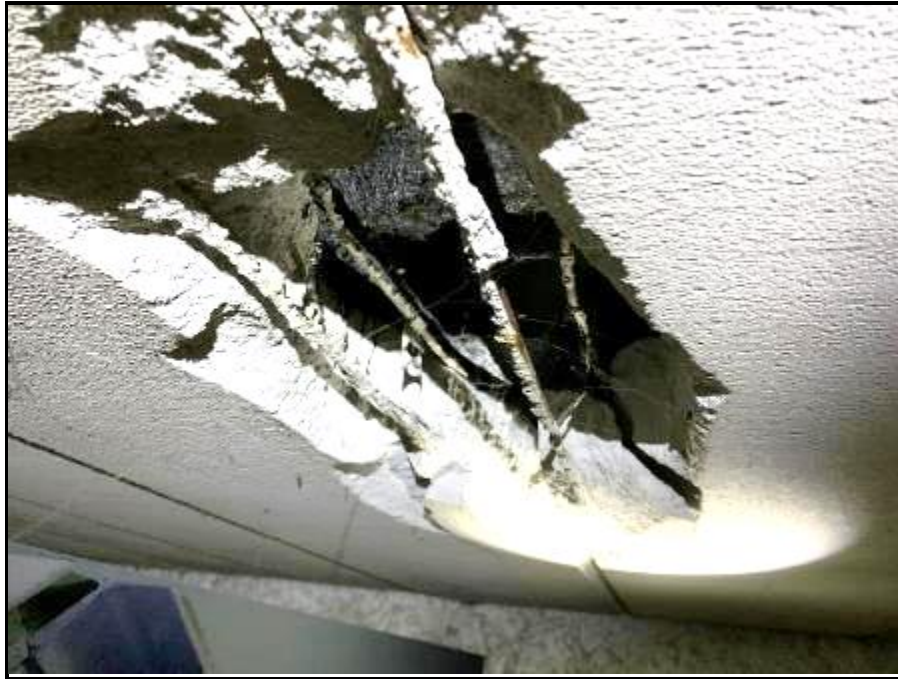
Roof Area	Observations
A1	<p>General</p> <ul style="list-style-type: none"> - RAAC panels in good to fair overall condition - Some panels fall within the yellow and amber risk categories - Observed anomalies include moderate to excessive moisture staining; spalling and exposed reinforcement bars; unreinforced field modifications - Approximately 20 RAAC panels in total had been replaced with steel decking at two locations (Photograph 1)
A1	<p>Repair Location A1.1</p> <ul style="list-style-type: none"> - Spalling and exposed reinforcing bars close to support (Photograph 2)
A1	<p>Repair Location A1.2; A1.4</p> <ul style="list-style-type: none"> - Unreinforced field modifications at roof canopy vent locations (Photographs 3 & 4)
A1	<p>Repair Location A1.3</p> <ul style="list-style-type: none"> - Excessive moisture staining
A1	<p>Repair Location A1.5</p> <ul style="list-style-type: none"> - Unreinforced field modification (Photograph 5)

Photograph 5
Repair Location A1.5 – Unreinforced field modification

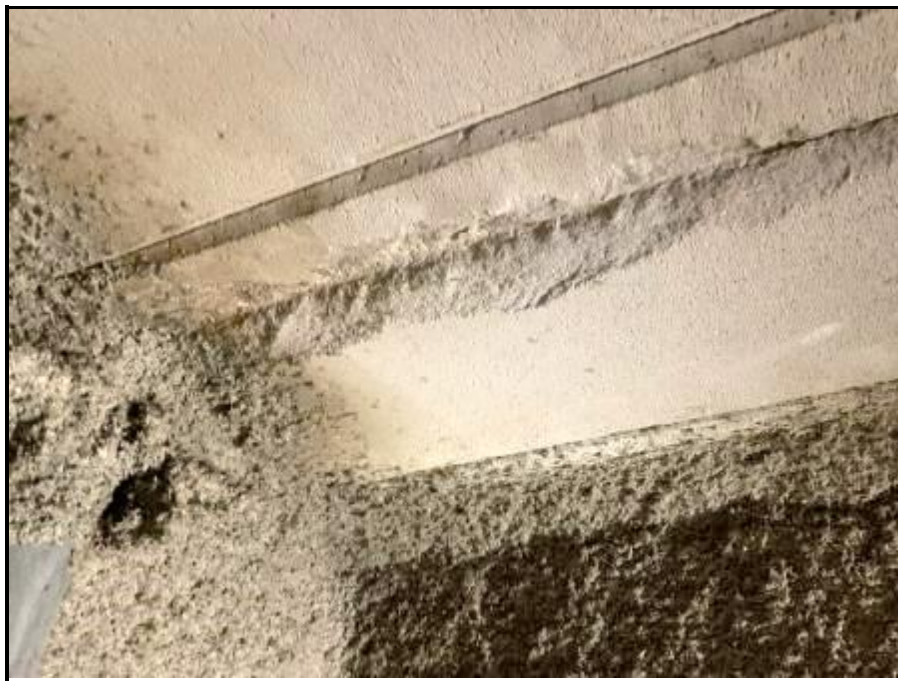
Photograph 6
Roof Area A2 – Spalling and exposed reinforcing bars

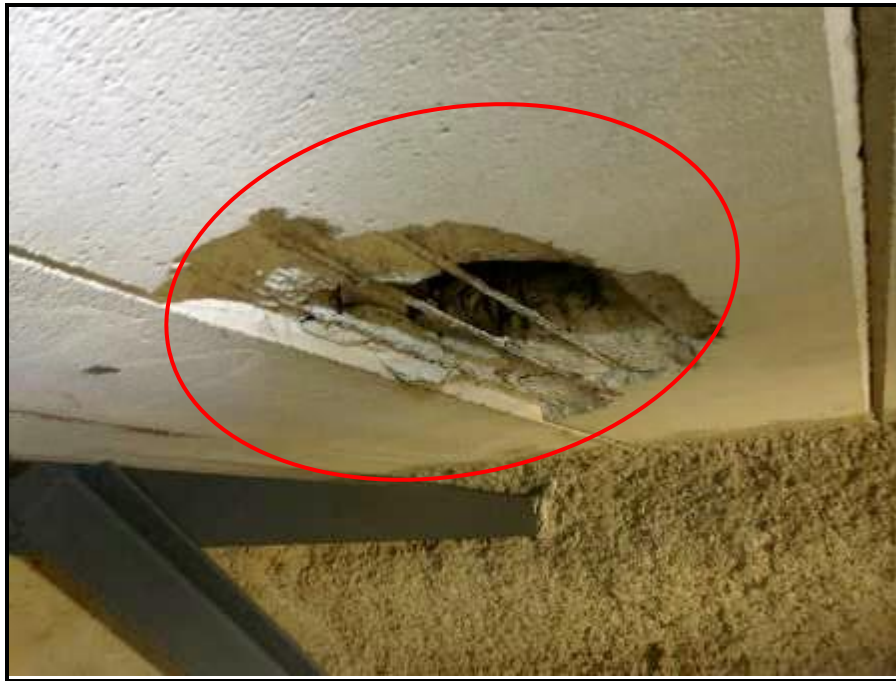
Photograph 7
Roof area A2 – Unreinforced field modification

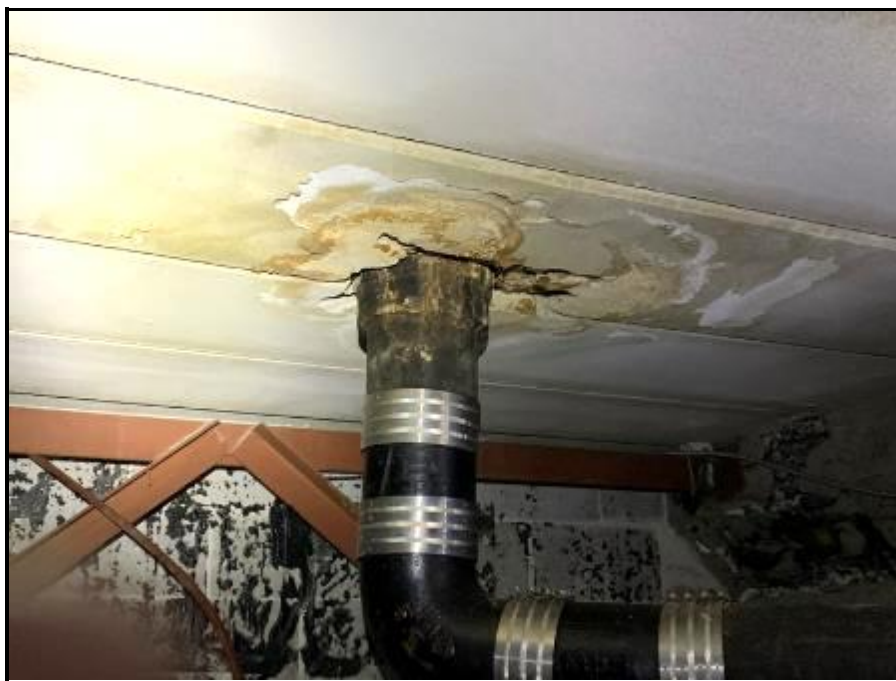
Photograph 8
Roof Area A2 – Excessive water staining and field modification

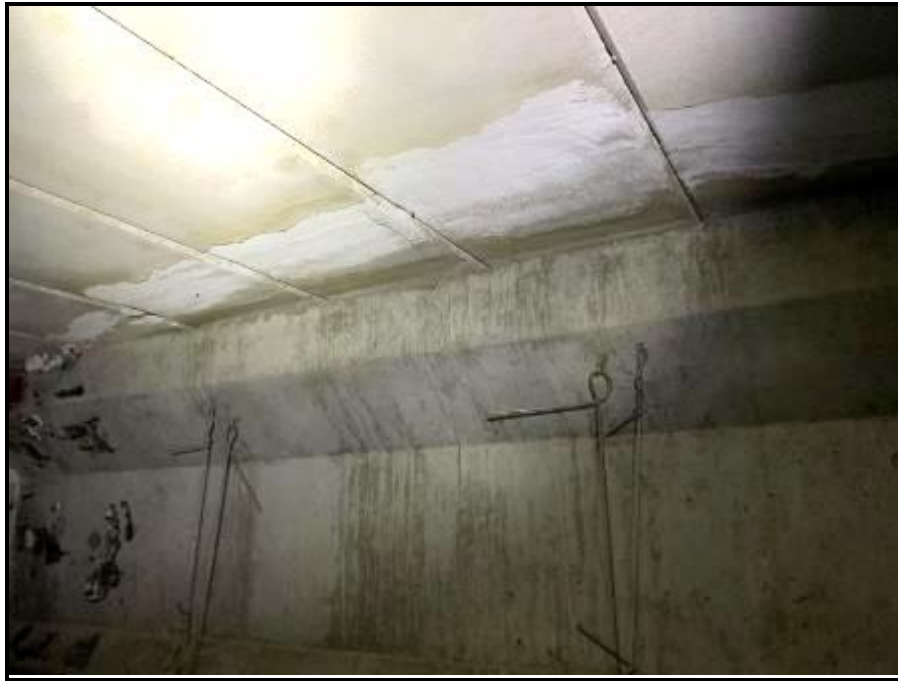
Photograph 9

Repair Area A2 – Water staining at supporting concrete beam

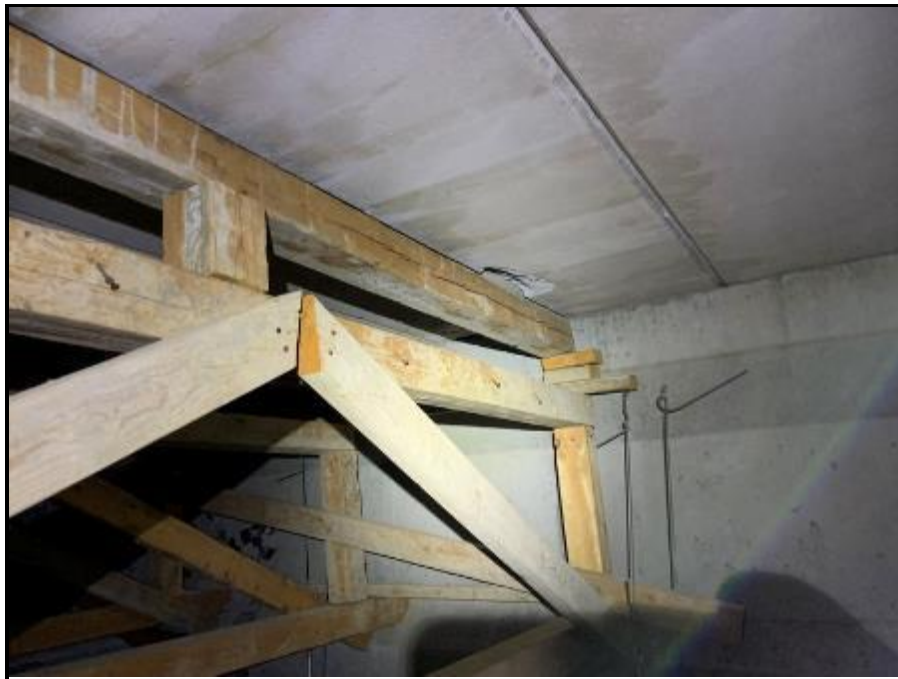
Photograph 10

Roof Area A2 – Existing wood framing intended for distressed RAAC panel support

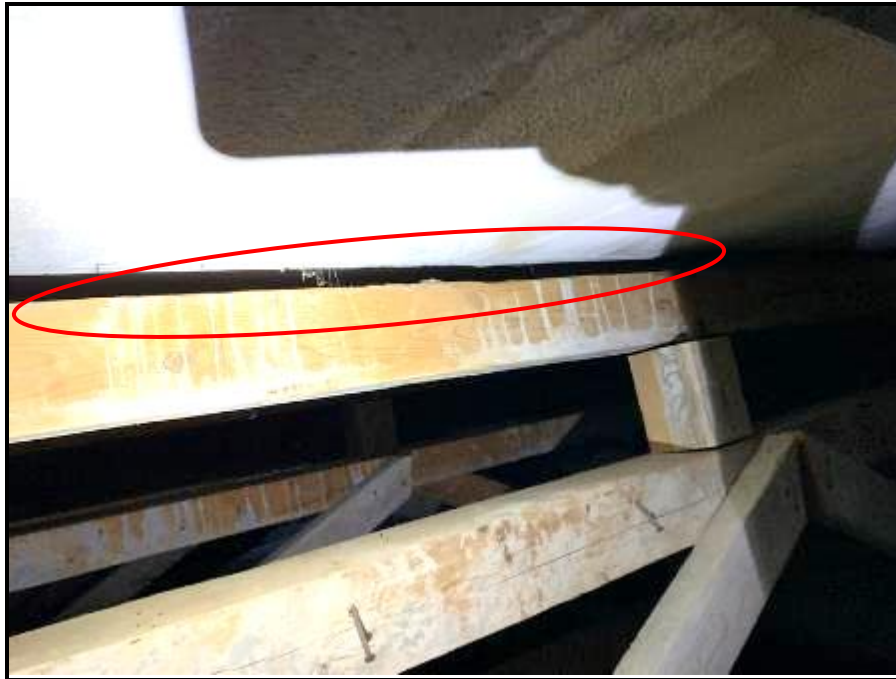
Photograph 11

Roof Area A2 – Gap observed between wood framing support and underside of distressed RAAC panel

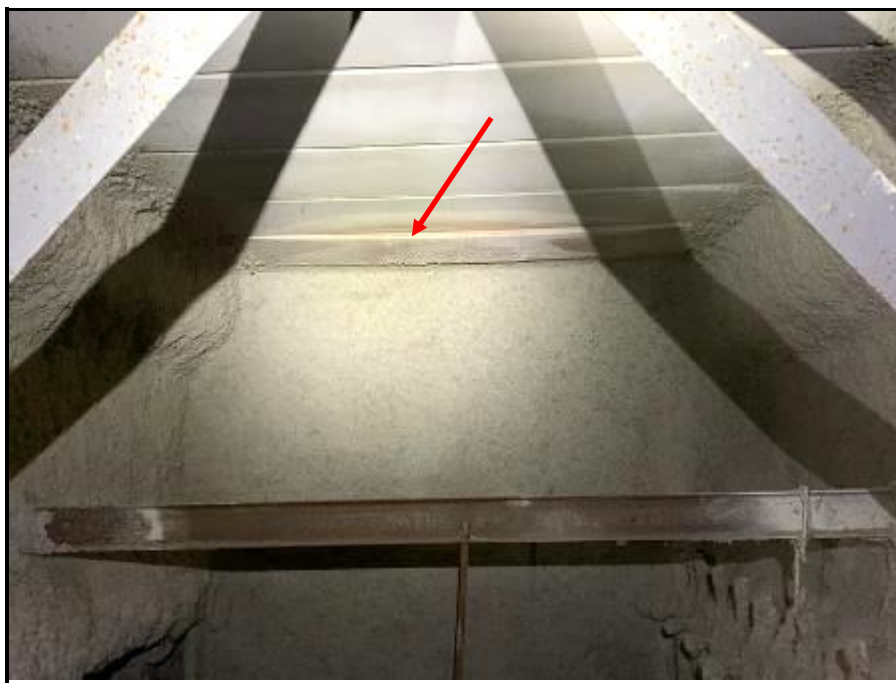
Photograph 12

Roof Area A3 – Visibly deflected RAAC panel relative to adjacent panels

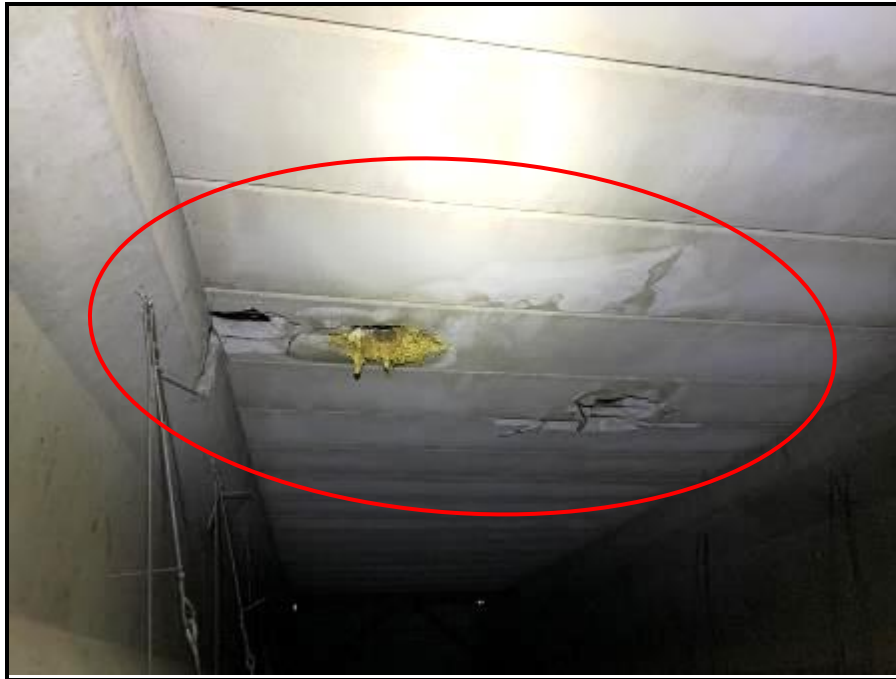
Photograph 13

Roof Location A3 – Unreinforced field modifications, spalling and moisture staining

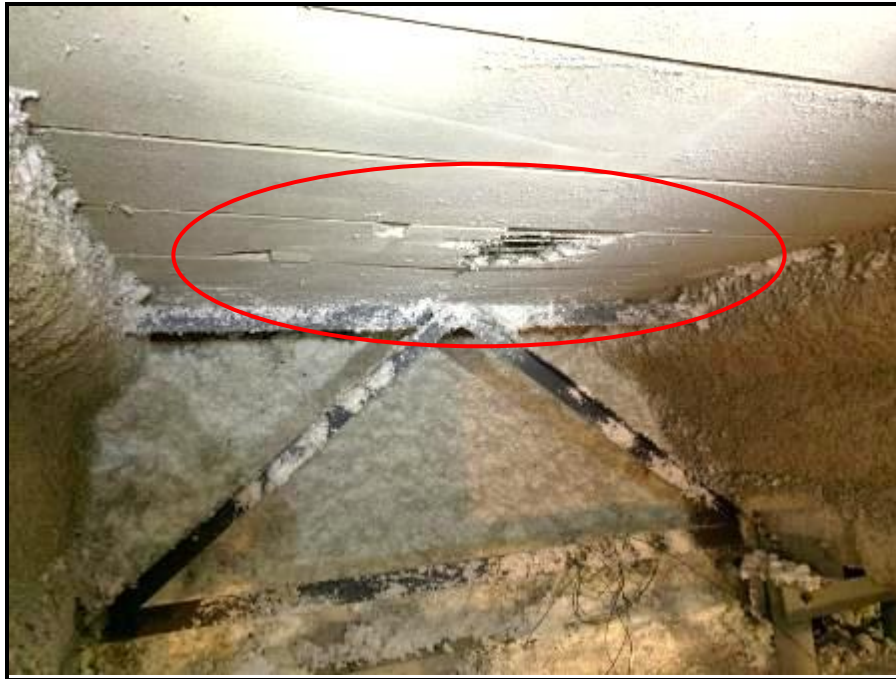
Photograph 15

Roof Area	Observations
A7	Repair Location A7.2 & A7.4 <ul style="list-style-type: none"> - Excessive moisture staining
A7	Repair Location A7.3 <ul style="list-style-type: none"> - Spalling and visible deflection relative to adjacent panels, noted at unreinforced field modification for canopy vent (Photographs 15 & 16)
A7	Repair Location A7.5 <ul style="list-style-type: none"> - Unreinforced field modification (Photograph 17)

Repair location A7.3 – Spalling and visible deflection at unreinforced field modification

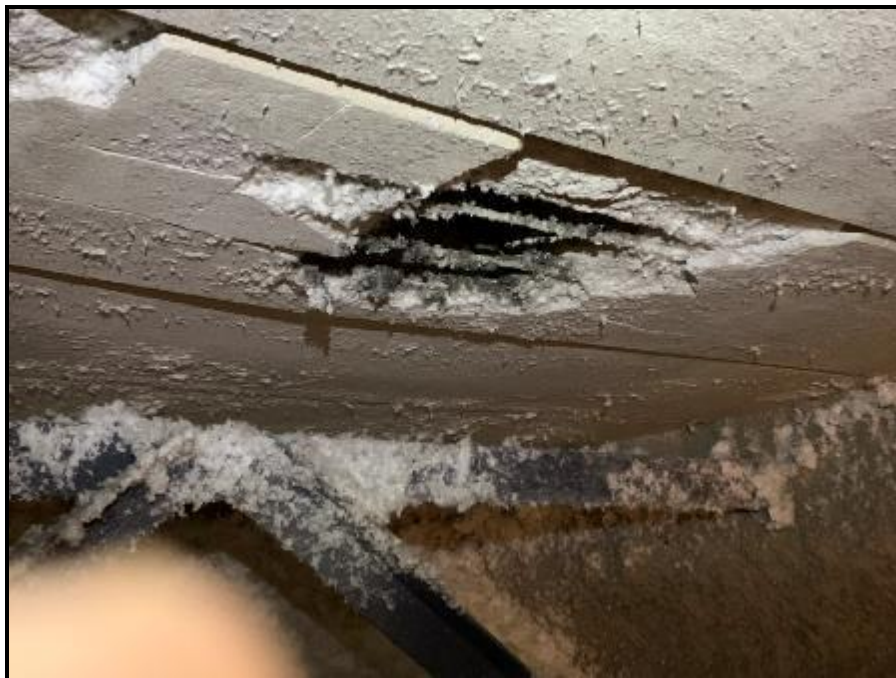
Photograph 16

Repair location A7.3 – Close up view of distressed panel at mid-span

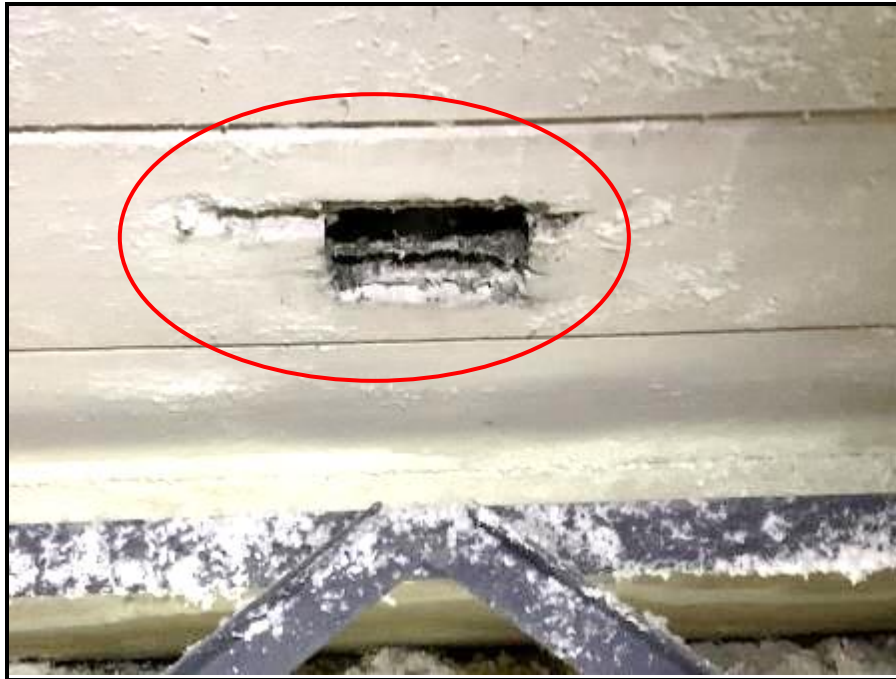
Photograph 17
Repair Location A7.5 – Unreinforced field modification

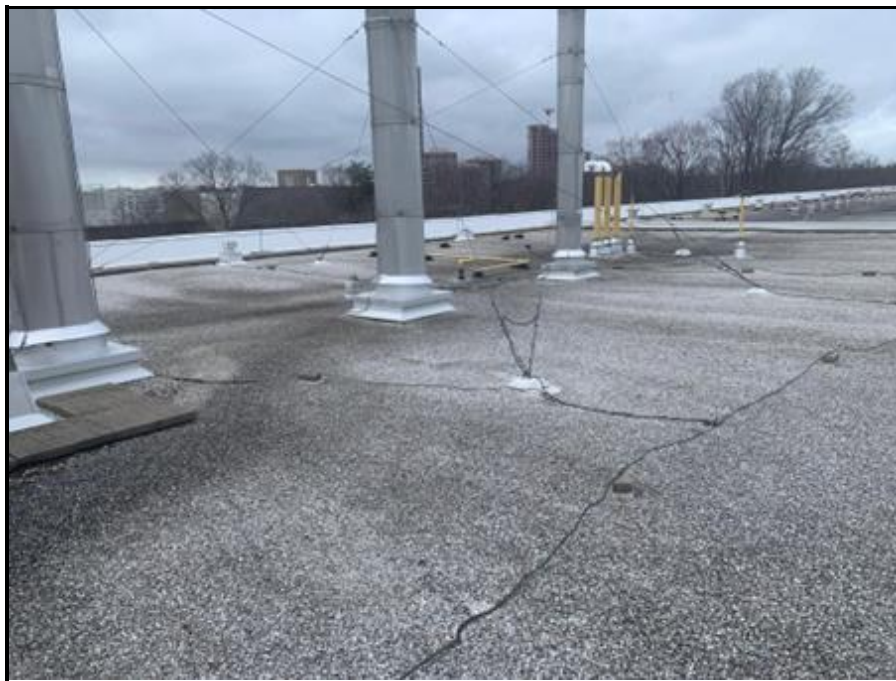
Photograph 18
Roof Area A1

Roof Area	Observations
A1	General <ul style="list-style-type: none"> - The existing roofing assembly is considered to be in fair condition. With an expected serviceable life of 5 to 10 years (Photograph 18) - minor sealant deficiency at stack supports and wall flashings was noted. - Exposed opening at the top of the spun aluminum tall cones for exhaust stacks. Possible water migration into the roof system
A1	Repair Location A1 <ul style="list-style-type: none"> - Sealant deficiency at stack supports (Photograph 19) - Opening at the top of the spun aluminum tall cones (Photograph 20)
A2	General <ul style="list-style-type: none"> - The existing roofing assembly is considered to be in fair condition. With an expected serviceable life of 5 to 10 years. (Photograph 21) - Broken gas line support on the north end of Roof area A2 - Ponding water observed close to the centre of a roof area A2 - Excessive algae growth was observed on the north end of roof area A2 - The existing roof drain at the north end of roof area A2 is partially plugged with organic debris - Large amount of organic debris gathered at the expansion joint between roof areas A2 and A3

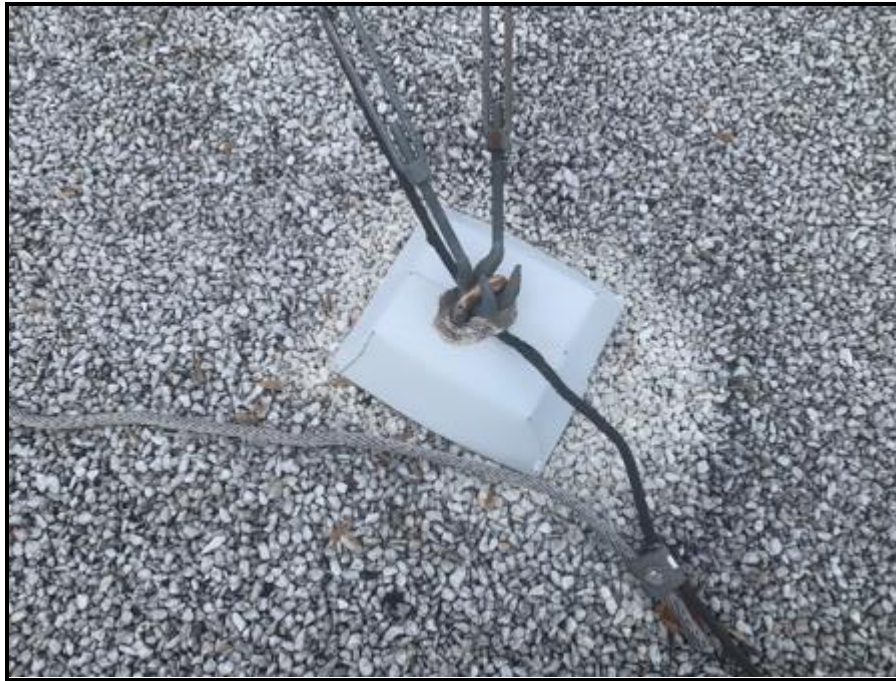
Photograph 19
Repair Area A1 - Sealant deficiency at stack supports

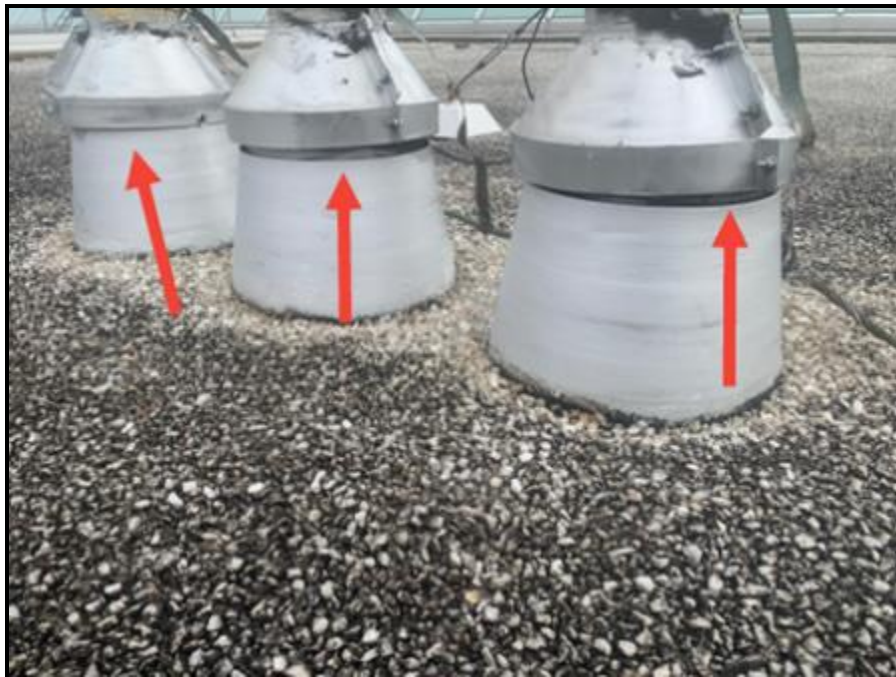
Photograph 20
Repair Area A1 - Opening at the top of the spun aluminum tall cones

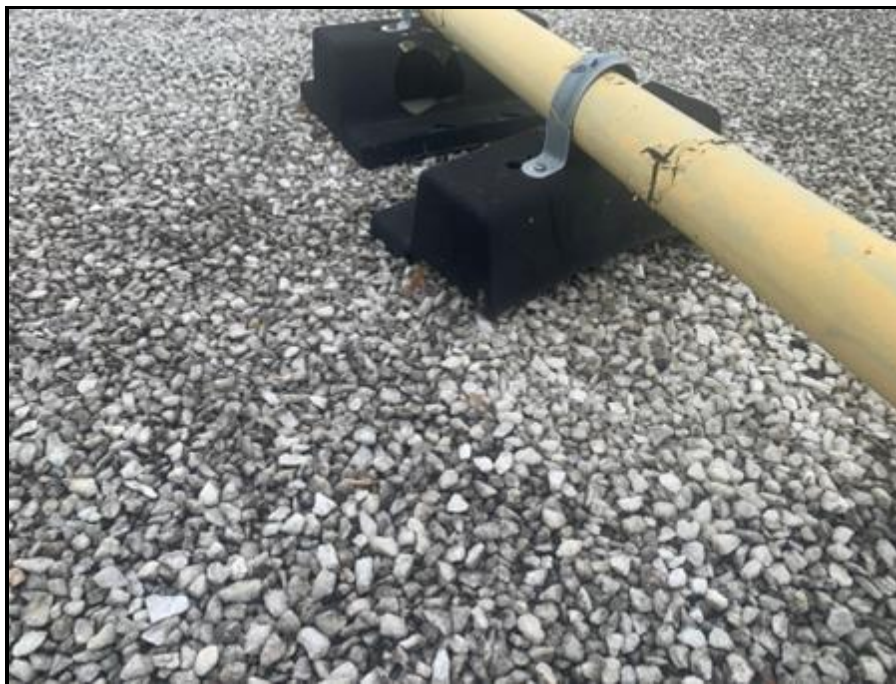
Photograph 22
Repair Area A2 - Repair broken gas line support

Roof Area	Observations
A2	<p>Repair Location A2</p> <ul style="list-style-type: none"> - Repair broken gas line support on the north end of Roof area A2 (Photograph 22) - Remove excessive algae growth on the north end of roof area. (Photograph 23) - Remove organic debris from roof drain at the north end of roof area A2. (Photograph 24) - Remove organic debris from expansion joint between roof areas A2 and A3. (Photograph 25)
A3	<p>General</p> <ul style="list-style-type: none"> - The existing roofing assembly is considered to be in fair condition. With an expected serviceable life of 5 to 10 years (Photograph 26) - Very low termination at the louvered grate located on the north end of Roof area A3, possibility for water migration into the existing roof system - Organic debris observed at the north end of roof area A3 - Minor algae accumulation at the north end of Roof area A3 - Area of deteriorated sealant, possibility of water migration into the existing roof system at the north end of roof area A3

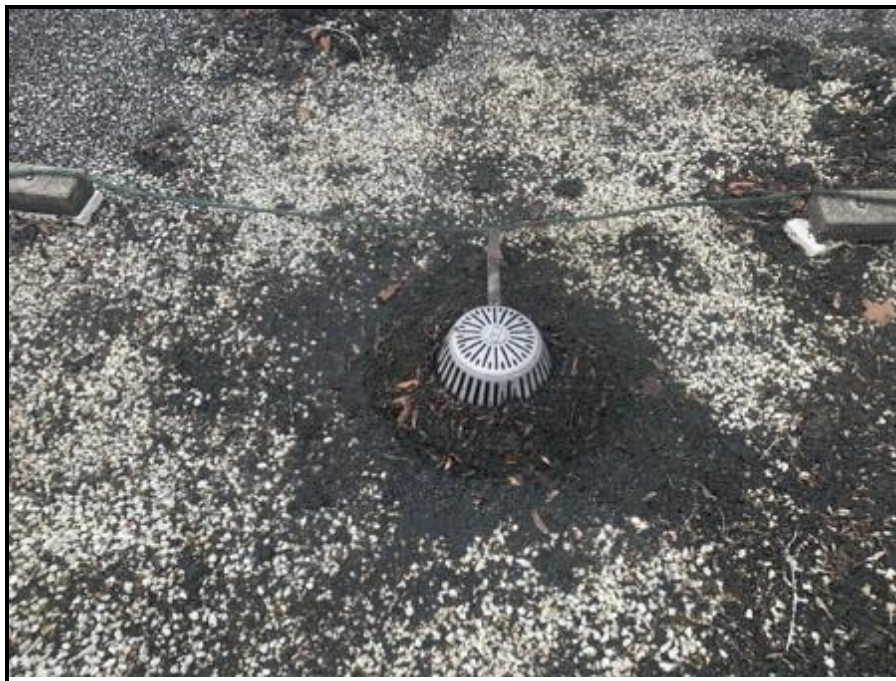
Photograph 24

Repair Area A2 - Remove organic debris from roof drain at the north end of roof area A2

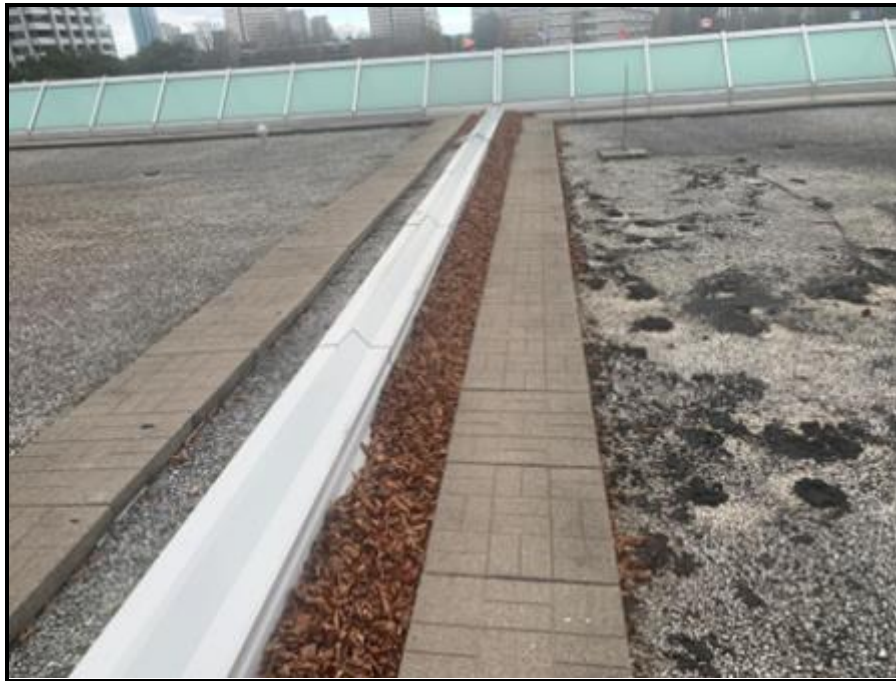
Photograph 25

Repair Area A2 - Remove organic debris from expansion joint between roof areas A2 and A3

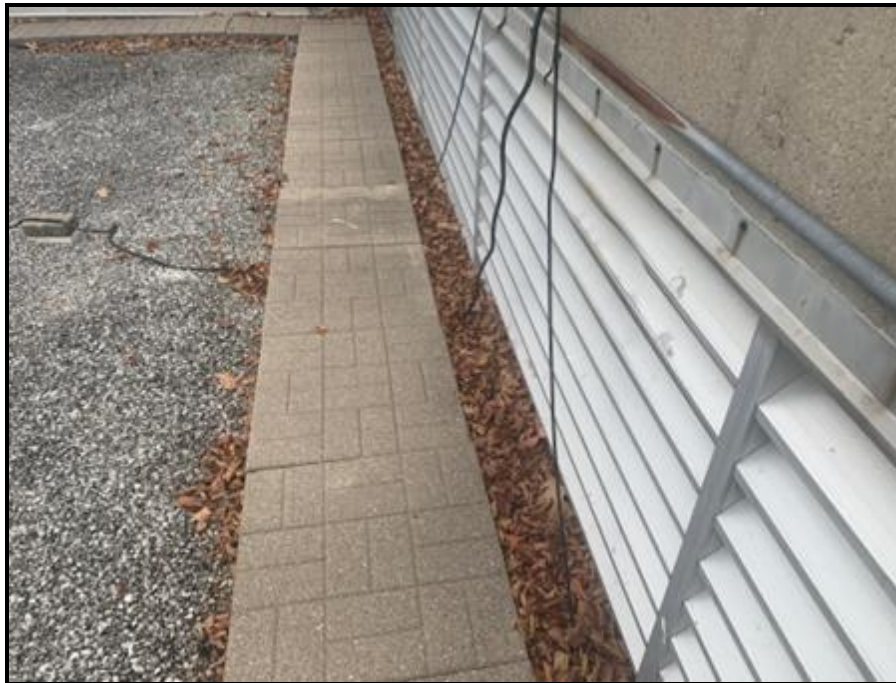
Photograph 27

Repair Area A3 - Remove organic debris observed at the north end of roof area A3

A3	<p>Repair Location A3</p> <ul style="list-style-type: none"> - Remove organic debris observed at the north end of roof area A3. (Photograph 27) - Remove minor algae accumulation at the north end of Roof area A3 (Photograph 28) - Remove and replace area of deteriorated sealant at the north end of roof area A3 (Photograph 29)
A4	<p>General</p> <ul style="list-style-type: none"> - The existing roofing assembly is considered to be in fair condition. With an expected serviceable life of 5 to 10 years. (Photograph 30) - Sealant deficiency at reglet possible source of water migration into roof system - Minor organic debris accumulated at the existing roof drain
A4	<p>Repair Location A4</p> <ul style="list-style-type: none"> - Remove and replace Sealant deficiency at reglet (Photograph 31) - Remove minor organic debris accumulated at the existing roof drain (Photograph 32)

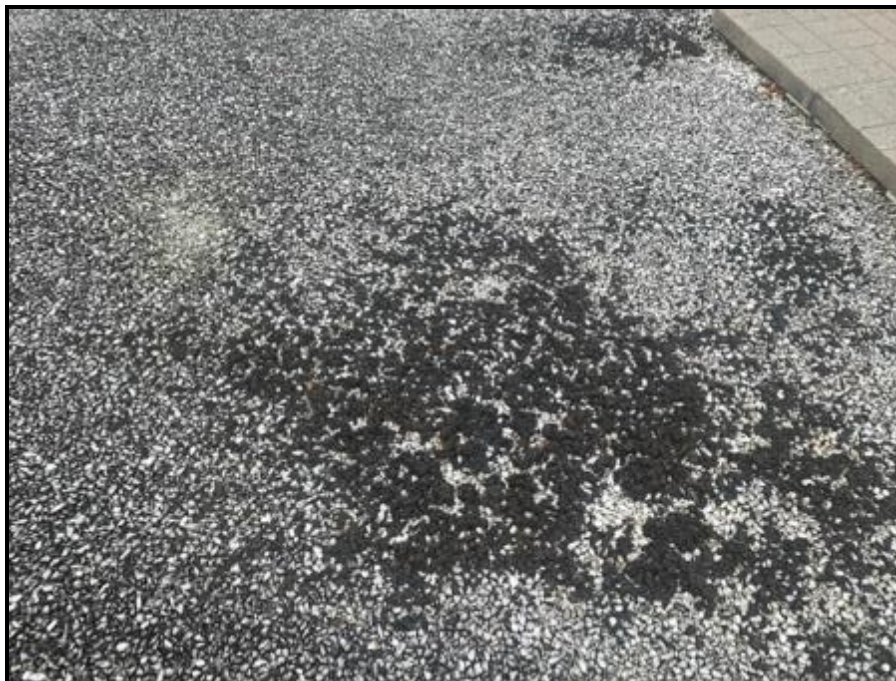
Photograph 28

Repair Area A3 - Remove minor algae accumulation at the north end of Roof area A3

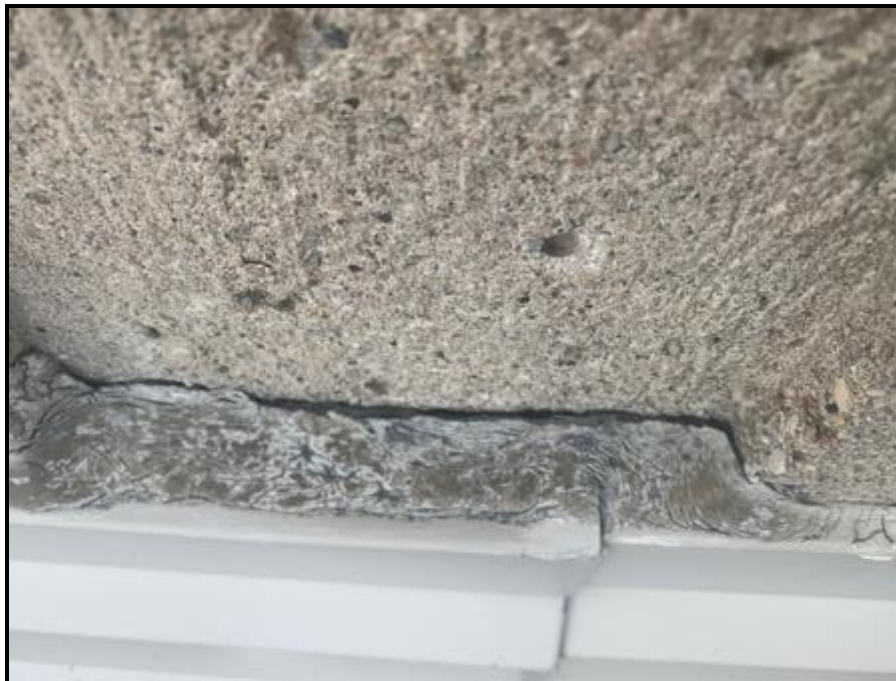
Photograph 29

Repair Location A3 - Remove and replace area of deteriorated sealant at the north end of roof area A3

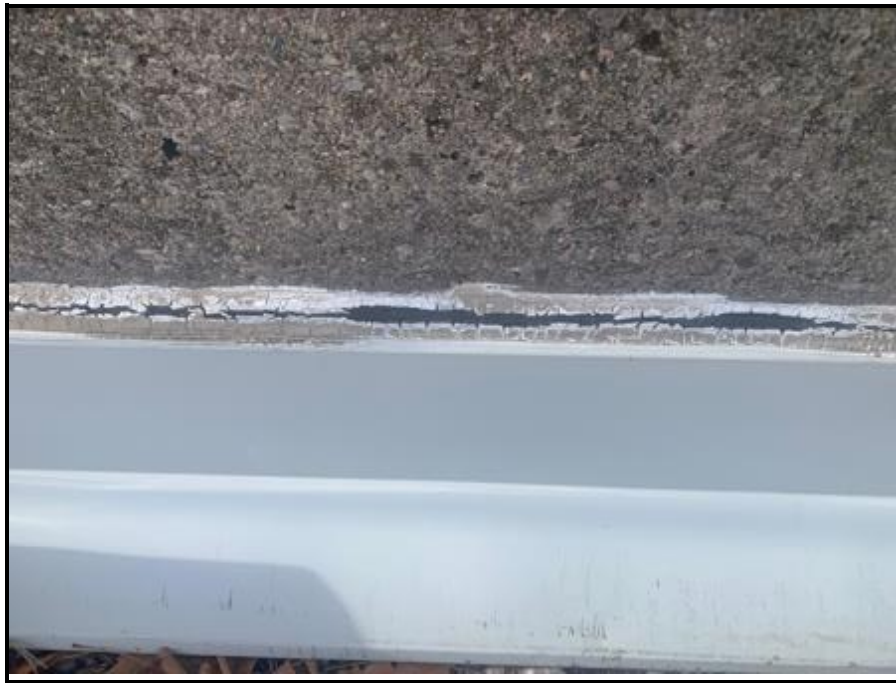
Photograph 31

Repair Area A4 - Remove and replace Sealant deficiency at reglet

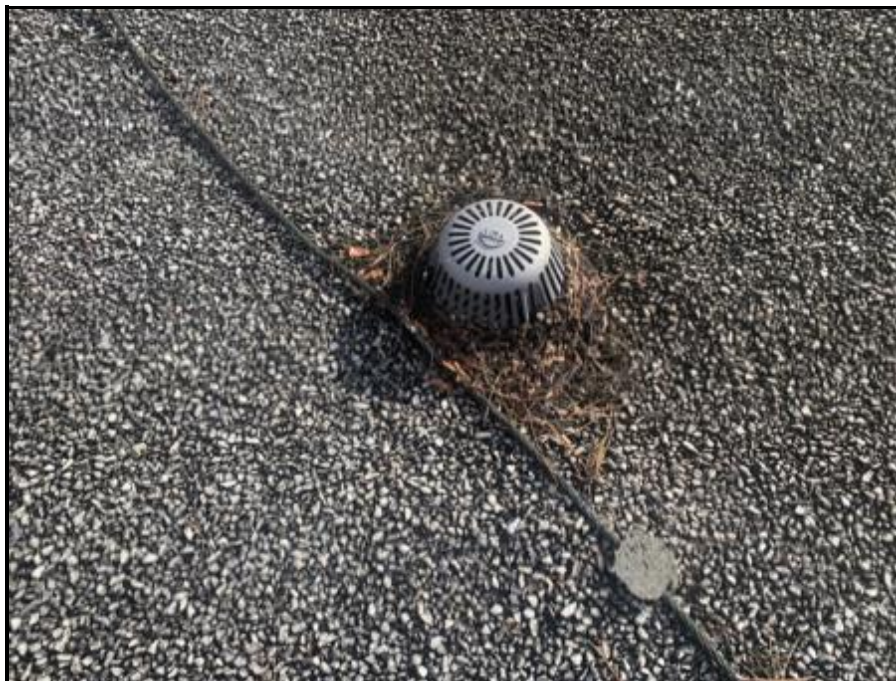
Photograph 32

Repair Area A4 - Remove minor organic debris accumulated at the existing roof drain

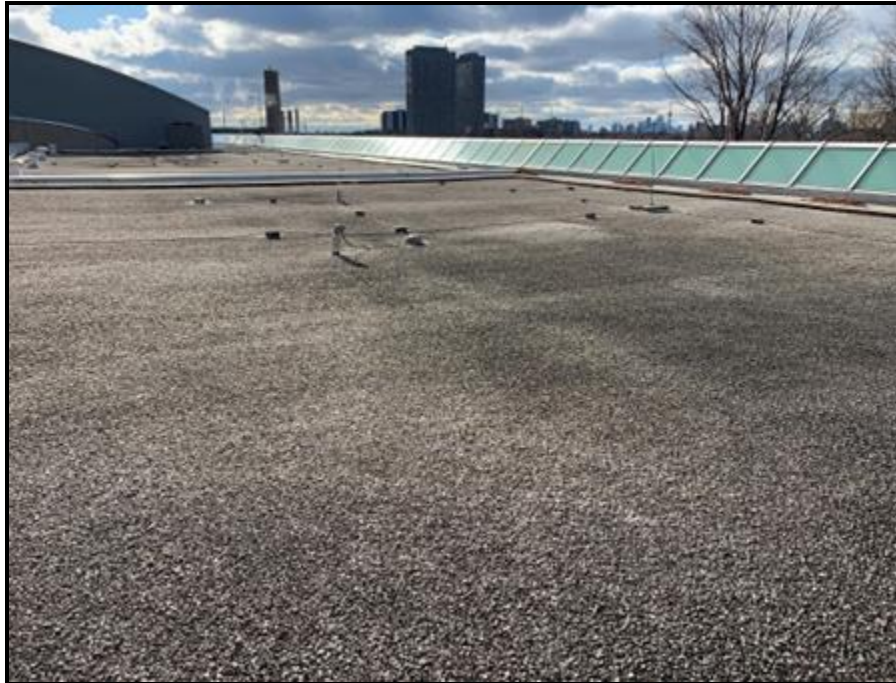
Photograph 33
Roof Area A5

Roof Area	Observations
A5	<p>General</p> <ul style="list-style-type: none"> - The existing roofing assembly is considered to be in fair condition. With an expected serviceable life of 5 to 10 years (Photograph 33) - Questionable termination of the existing roof membrane occurring under the poured in place concrete wall on the north end of Roof area A5 - Poured in place concrete wall at the north end of Roof area A5 requires further structural review - Minor accumulation of organic debris at roof drain located on the north end of roof area A5 - Minor bare Felts, located at the roof drain in the centre of roof area A5 - Accumulation of organic debris between the skylight and concrete paver walkway also observed minor growth of moss at the skylight transition
A5	<p>Repair Location A5</p> <ul style="list-style-type: none"> - Remove minor accumulation of organic debris at roof drain located on the north end of roof area A5 (Photograph 34) - Repair minor bare felts, located at the roof drain in the centre of roof area A5. (Photograph 35) - Remove accumulation of organic debris between the skylight and concrete paver walkway (Photograph 36)

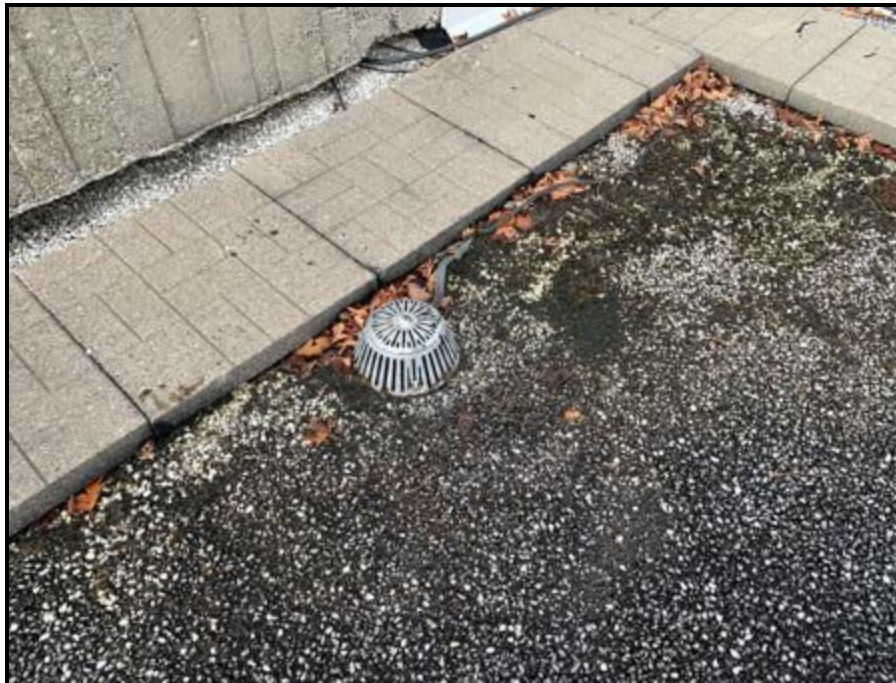
Photograph 34
Repair Area A5 - Remove minor accumulation of organic debris at roof drain located on the north end of roof area A5

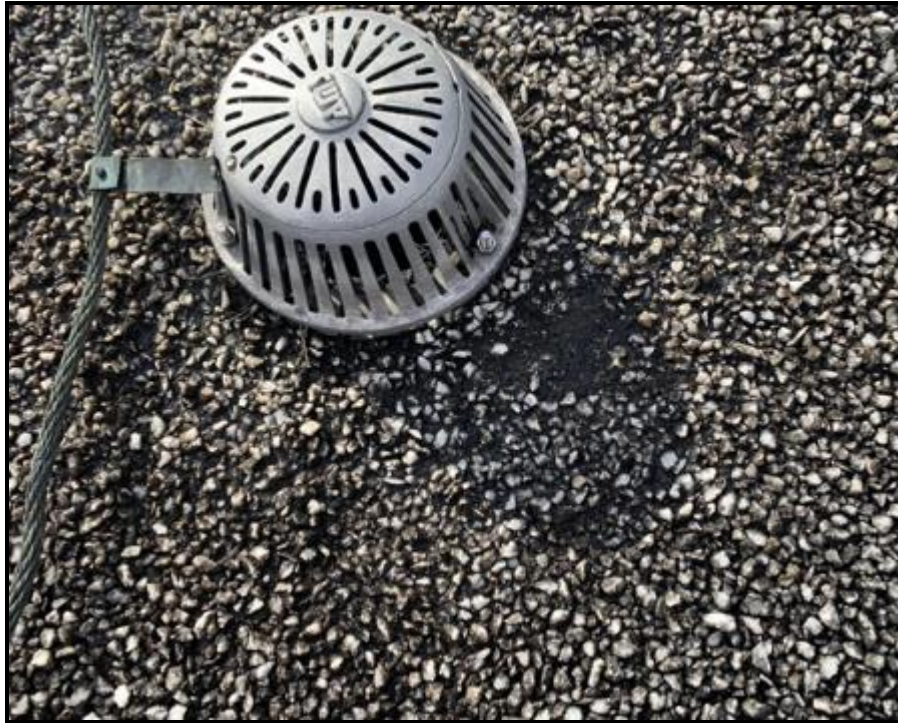
Photograph 35

Repair Area A5 - Repair minor bare felts, located at the roof drain in the centre of roof area A5

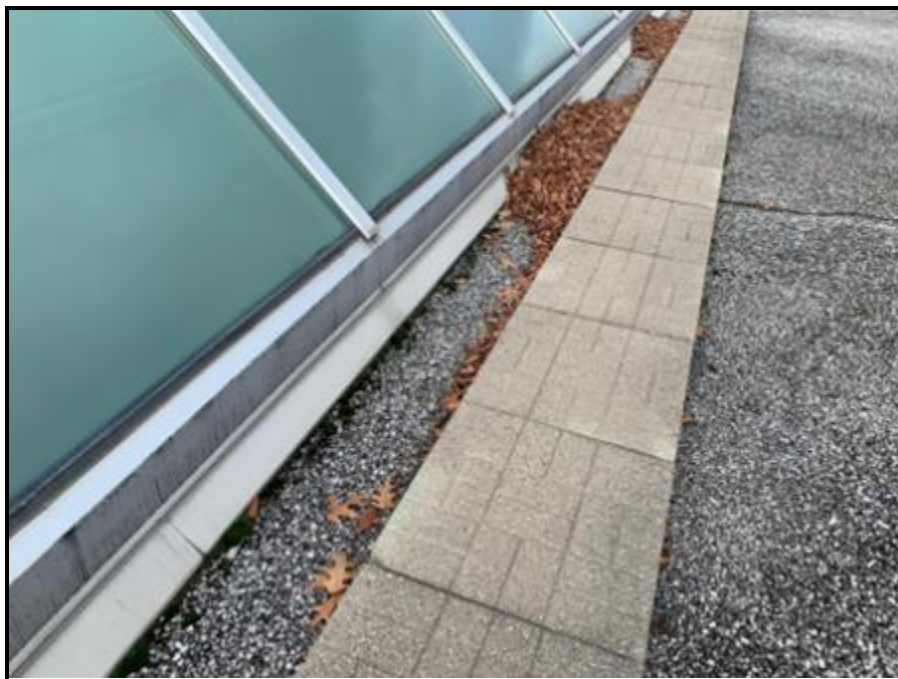
Photograph 36

Repair Area A5 - Remove accumulation of organic debris between the skylight and concrete paver walkway

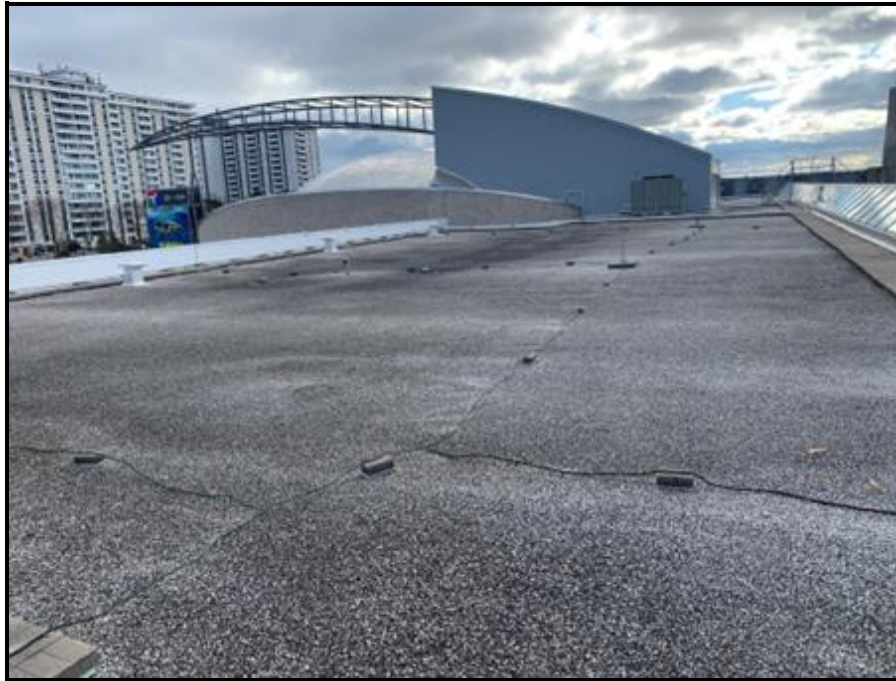
Photograph 37
Roof Area A6

A6	<p>General</p> <ul style="list-style-type: none"> - The existing roofing assembly is considered to be in fair condition. With an expected serviceable life of 5 to 10 years (Photograph 37) - Areas of ponding water were observed on the south end of Roof area A6
A6a	<p>General</p> <ul style="list-style-type: none"> - The existing roofing assembly is considered to be in fair condition. With an expected serviceable life of 5 to 10 years (Photograph 38) - Minor depression in the existing membrane at the entrance to the mechanical room - Patio stone on roof area A6a appears to have been left on the roof area. No existing membrane protection under the existing patio stone - Exposed Felts directly west of the mechanical room - Openings in metal cladding on the southside wall of roof area A6A.
A6a	<p>Repair Location A6a</p> <ul style="list-style-type: none"> - Repair minor depression in the existing membrane at the entrance to the mechanical room. Install membrane protection under the existing patio stone (Photograph 39) - Repair area of exposed felt directly west of the mechanical room (Photograph 40) - Repair openings in metal cladding on the southside wall of roof area A6A (Photograph 41)

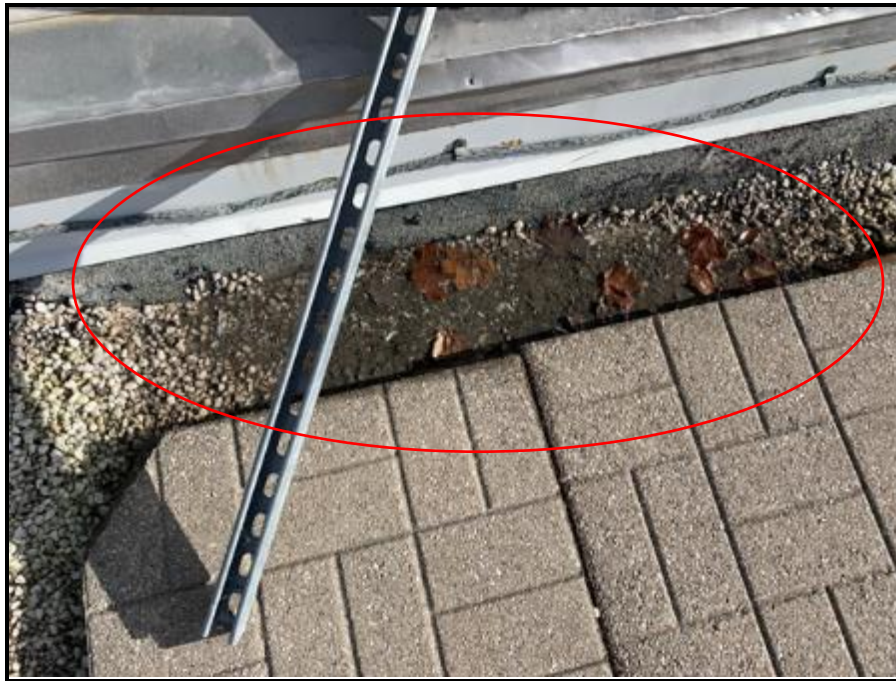
Photograph 39

Repair Area A6a - Repair minor depression in the existing membrane at the entrance to the mechanical room. Install membrane protection under the existing patio stone
