REINFORCED AUTOCLAVED AERATED CONCRETE (RAAC) ROOF PANEL ASSESSMENT

Ontario Science Centre Building A – B14175
770 Don Mills Road, North York, ON

Infrastructure Ontario and Ministry of Infrastructure
June 18, 2024

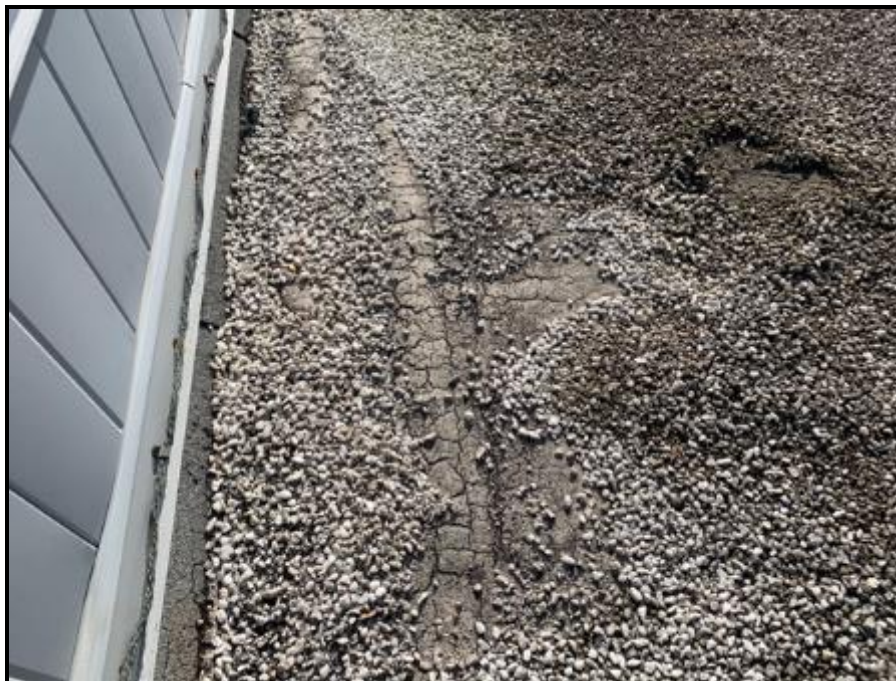
Photograph 40

Repair Area A6a - Repair area of exposed felt directly west of the mechanical room

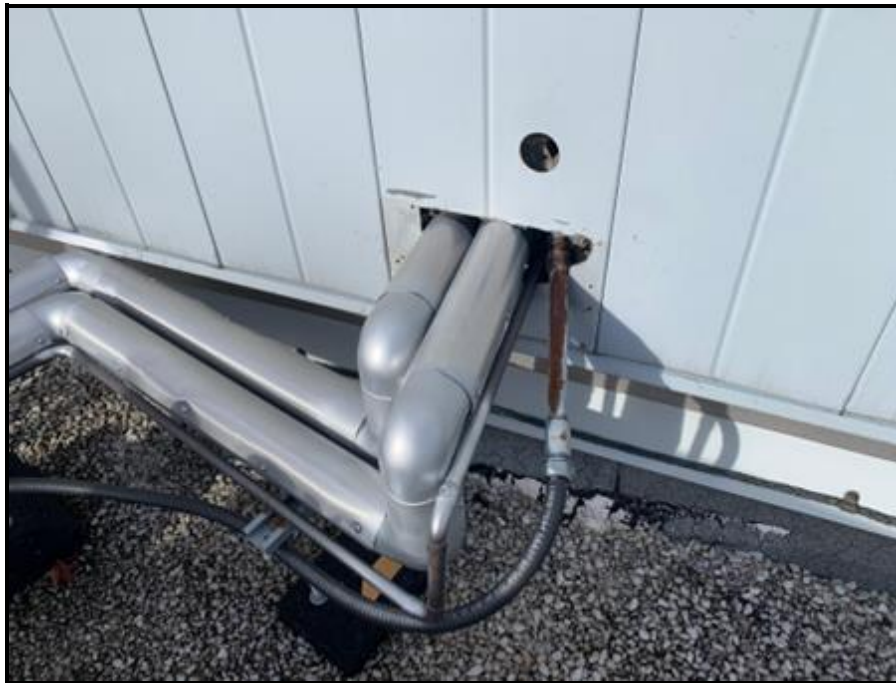
Photograph 41

Repair Area A6a - Repair openings in metal cladding on the southside wall of roof area A6A

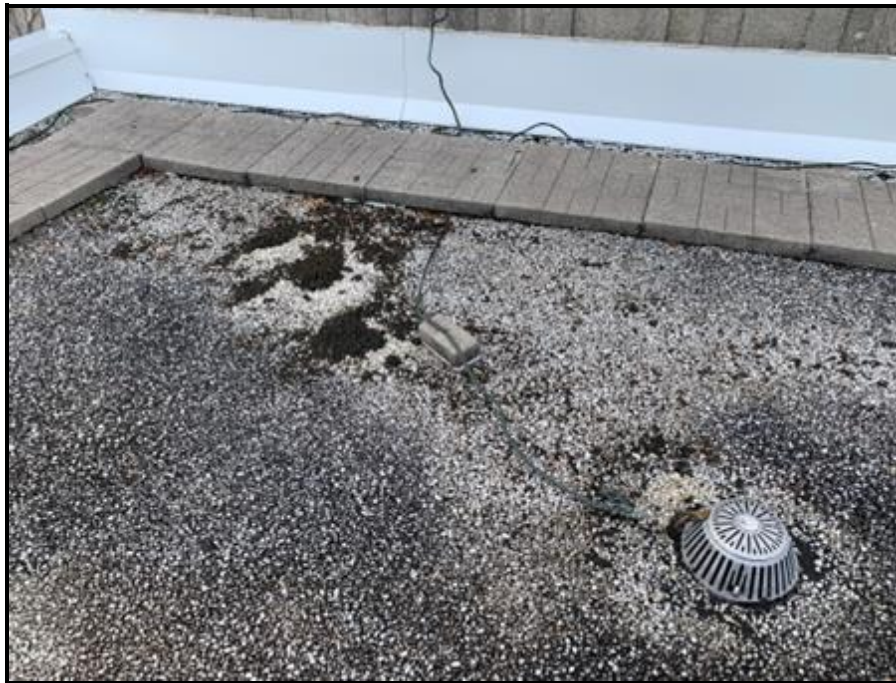
Photograph 43

Repair Area A7 - Remove minor algae accumulation located at the south drain

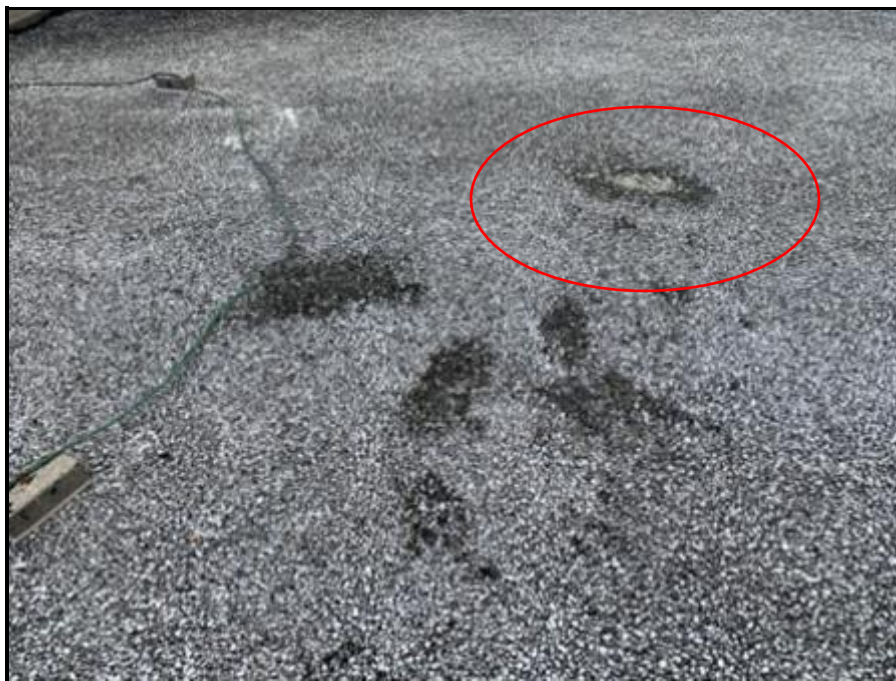
Photograph 43

Repair Area A7 - Repair minor blister located at the south A7

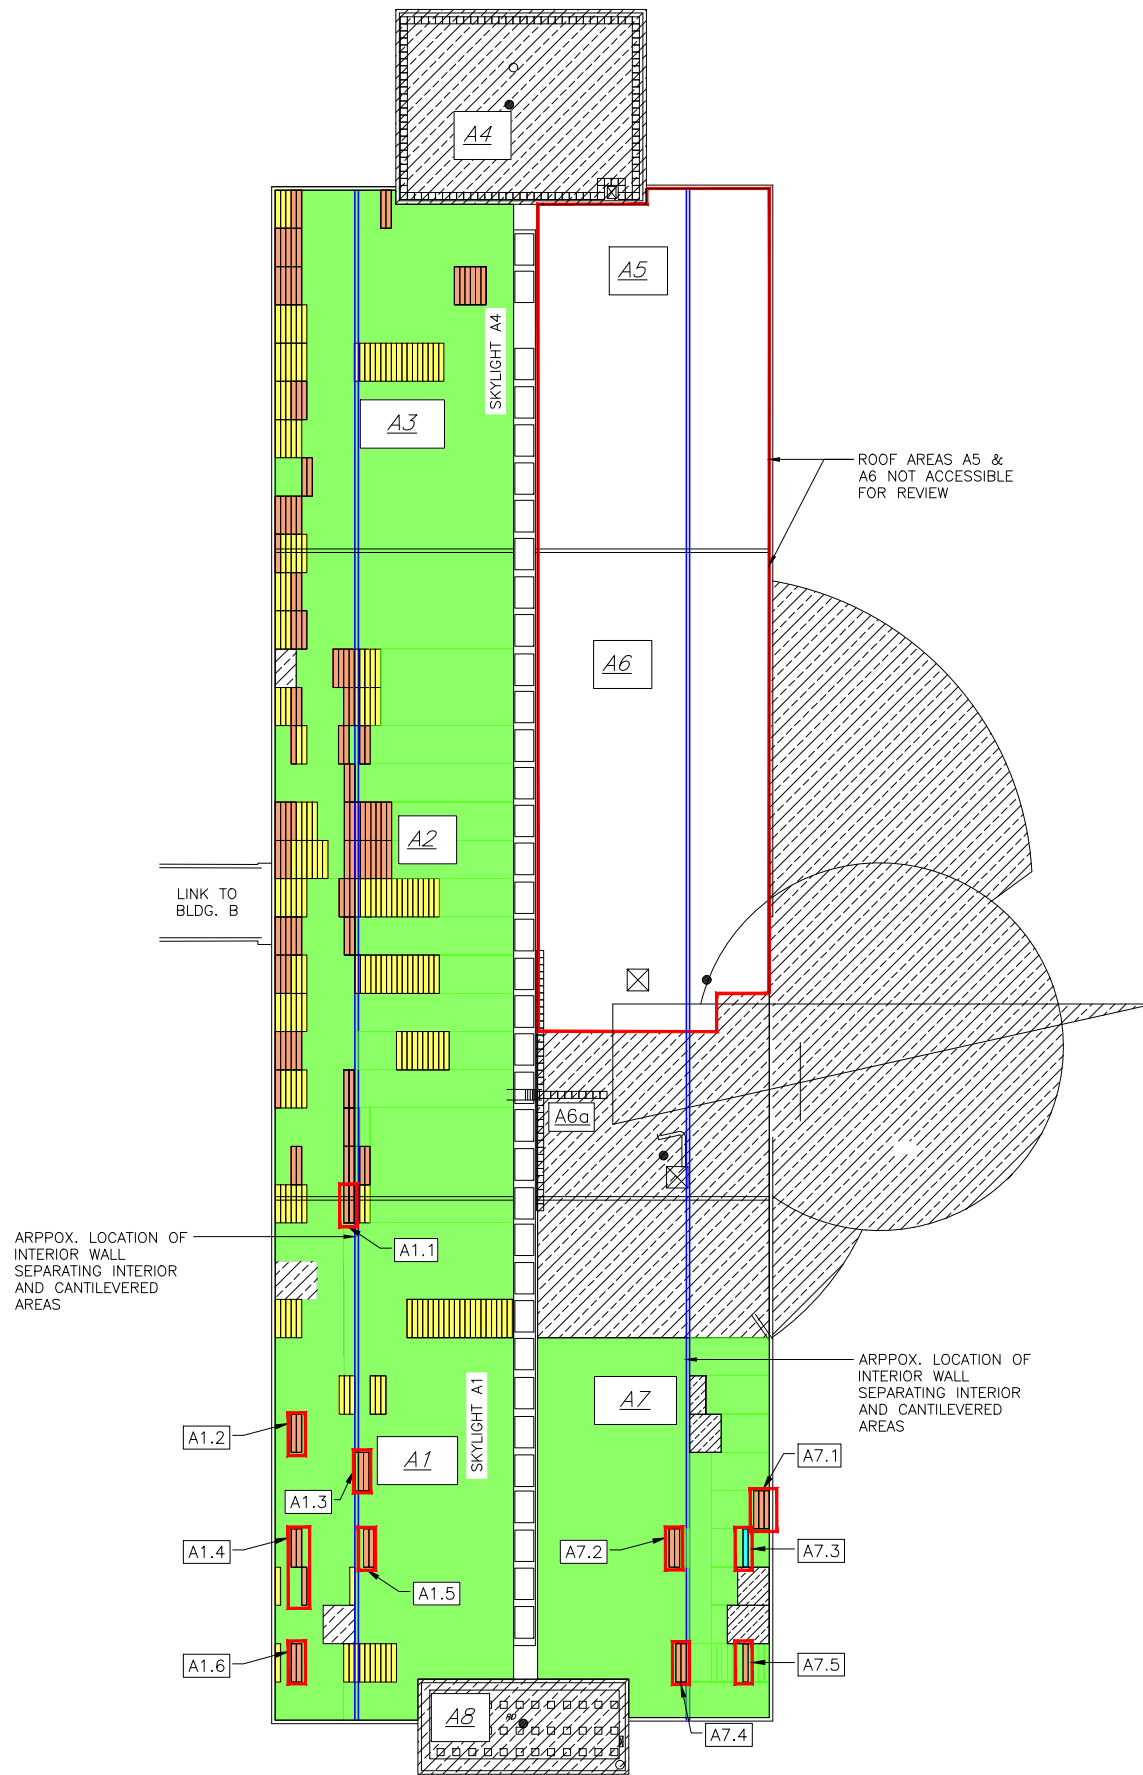
ATTACHMENT B: ROOF PLAN DRAWING

APPROX. TOTAL ROOF AREA = 66,432 sq.ft
 APPROX. ROOF AREA CHECKED = 53,476 sq.ft (80% OF TOTAL ROOF AREA)
 TOTAL ROOF AREA CONTAINING RAAC = 46,085 sq.ft (69% OF TOTAL ROOF AREA)
 AREA OF RAAC NOT YET INSPECTED = 12,971 sq.ft (28% OF TOTAL RAAC AREA)

RAAC PANEL ASSESSMENT TABLE			
ASSESSMENT CATEGORY	RISK CATEGORY	COMMENTS AND REMEDIAL ACTION	PERCENTAGE BY AREA OF RAAC REVIEWED TO DATE
GREEN	LOW	NO VISUAL DISTRESS OBSERVED. REQUIRED PERIODIC ASSESSMENTS AT THREE-YEAR INTERVALS.	84%
YELLOW	MEDIUM	MINOR ANOMALIES OR VISUAL DISTRESS OBSERVED. REQUIRES ANNUAL ASSESSMENT.	9%
AMBER	HIGH	MODERATE ANOMALIES OR VISUAL DISTRESS OBSERVED. REQUIRES ADDITIONAL SUPPORTS OR REPLACEMENT BY OCT 31, 2024	6%
BLUE	CRITICAL	SIGNIFICANT ANOMALIES OR VISUAL DISTRESS OBSERVED. REQUIRES IMMEDIATE SHORING OR CORDONING OF FLOOR SPACES, FOLLOWED BY INSTALLATION OF ADDITIONAL SUPPORTS OR REPLACEMENT.	<1%
