**UNITED STATES AIR FORCE**  
**AIRCRAFT ACCIDENT INVESTIGATION**  
**BOARD REPORT**

**CV-22B, T/N 10-0054**

**LOCATION: YAKUSHIMA ISLAND, JAPAN**

**DATE OF ACCIDENT: 29 NOVEMBER 2023**

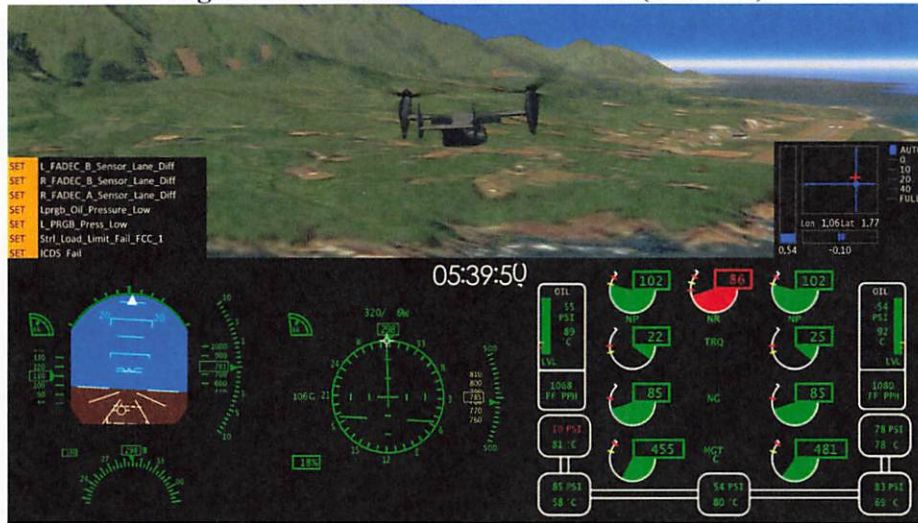
Figure 13. Animation at 14:39:50L (Tab Z-9)

Within the last six seconds of data, cascading failures in short succession were recorded by the KVADR (Tab DD-49). Audible engine surges could be heard in the ambient recording from the cockpit microphone, followed by an auditory master caution tone (Tab DD-49). Left-hand PRGB oil pressure rapidly dropped with an associated, “L PRGB OIL PRESS LOW” caution, followed by a voice warning, “DRIVESHAFT FAILURE, DRIVESHAFT” (Tabs DD-49, and II-64).

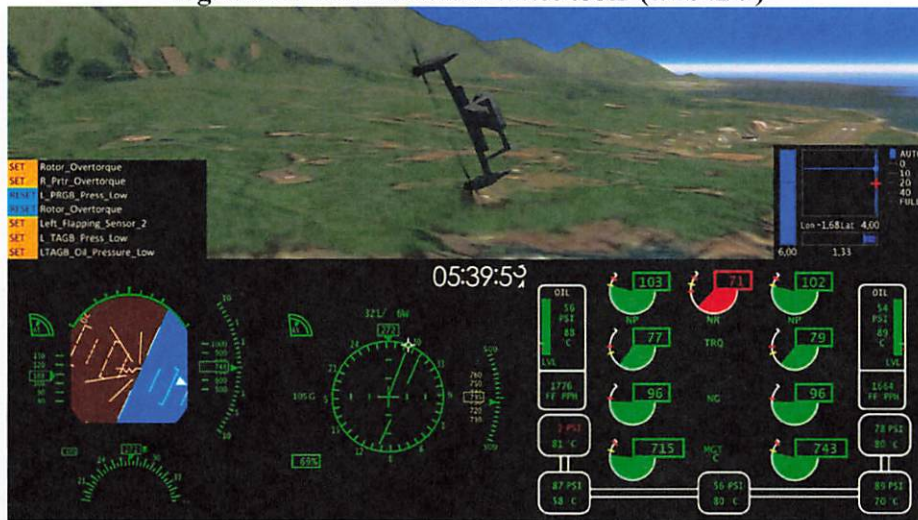
Figure 14. Animation at 14:39:53L (Tab Z-9)

Approximately one-half mile from the approach end of runway 32, the MA was at 785 feet, 106 knots ground speed, with nacelles at 66 degrees, flaps set to auto, and the landing gear retracted, as shown in Figure 15 (Tab DD-49 to DD-50). Every step of the Before Landing Checklist was completed except the extension of the landing gear (Tab II-58). At 14:39:53L (5:39:53Z), 49 minutes after the first left-hand PRGB CHIP BURN advisory posted, the MA abruptly rolled left and rapidly exceeded 90 degrees angle of bank (Tab DD-50). The KVADR's last record was at 5:39:53Z (14:39:53L) depicted in Figure 16 below (Tab Z-9). The thrust control lever was all the way forward at full power (Tab DD-50). The cyclic was 1.6 inches forward of center and full right, the rudder was 1.3 inches right (Tab DD-50). The MA rolled inverted and continued to roll to the left, the left nacelle caught on fire, and an object separated from the MA and fell to the water to the right of the aircraft flight path (Tab DD-50). The MA disappeared from radar at 14:40L (5:40Z) (Tab EE-9). The MA impacted the water upright, nose down, and rolling left (Tab DD-50).

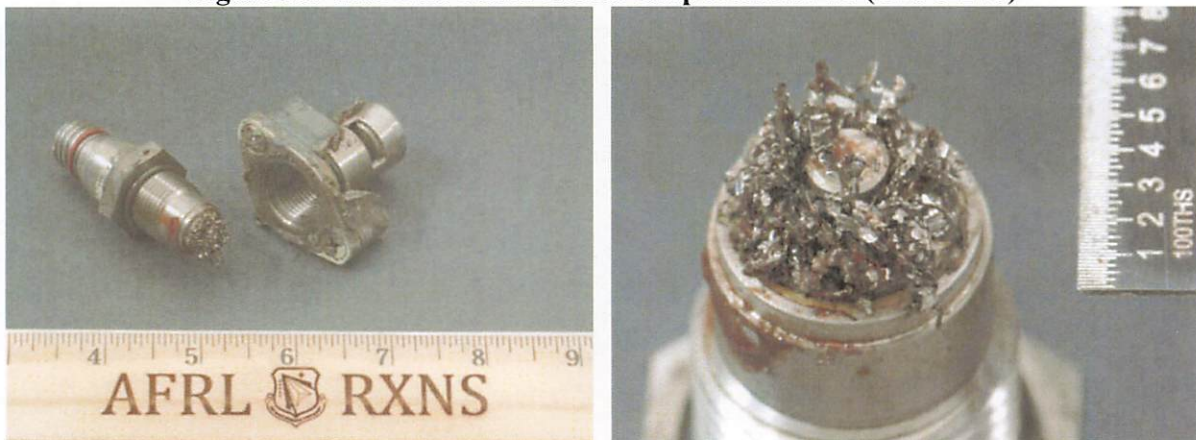
**Figure 15. MA Left-Hand PRGB Chip Detector #1 (Tab J-240)**

When tested with debris present, as seen in figures 17, 18, and 19 low resistance was measured across the left-hand #1, left-hand #2, and left-hand #3 detector electrodes (Tab J-231). After the debris was removed, nominal resistances were measured (Tab J-231). The change in resistance after the debris was removed confirms that the debris sensors were correctly reporting to the monitoring systems (Tab J-231). Fracture of the right-hand #3 detector housing is consistent with impact damage (Tab J-231). Excess signal leakage current and galvanic voltage noted on the left-hand #2 detector are consistent with intrusion of ionic fluid, such as saltwater (Tab J-231).

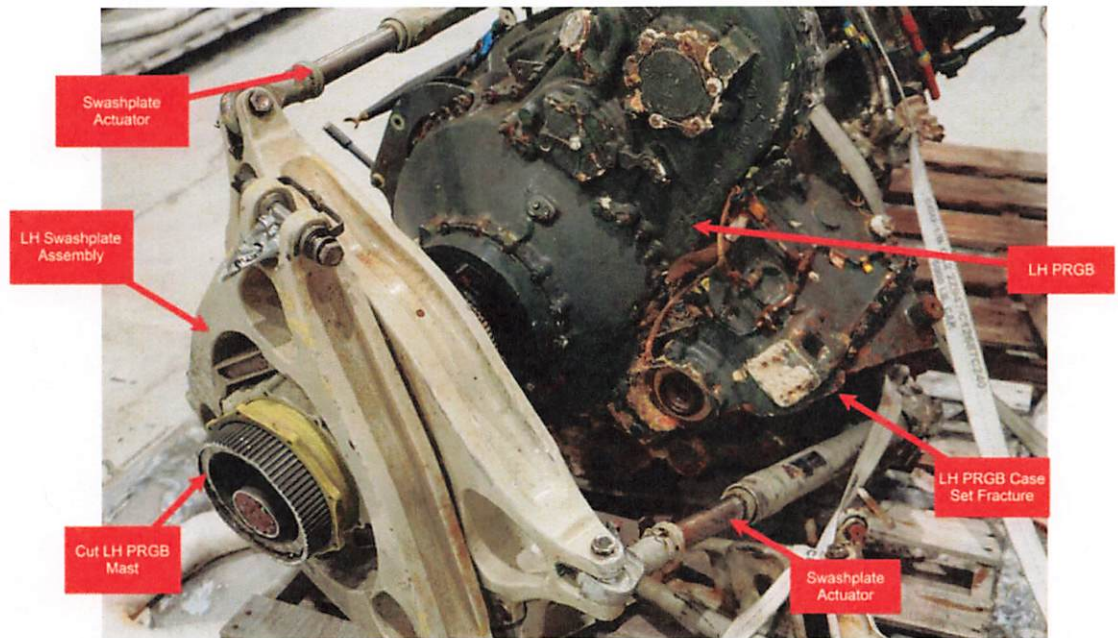
**Figure 18. MA Left-Hand PRGB Barrel Section As-Received (Tab J-379)**

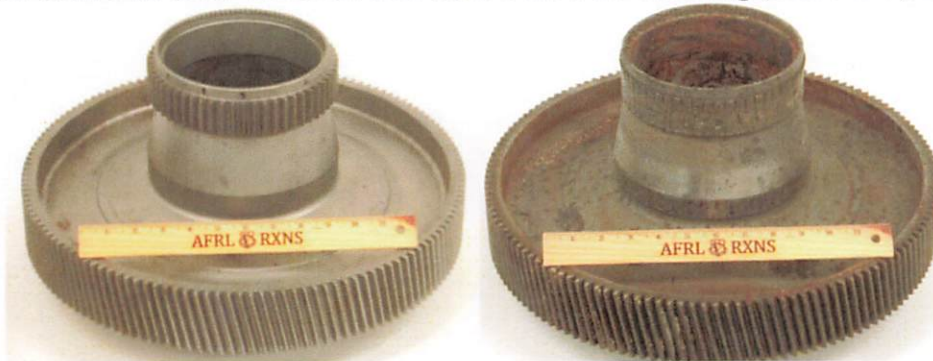
**Figure 19. New Bull Gear vs. Recovered Bull Gear Post Cleaning (Tab J-122, and J-429)**

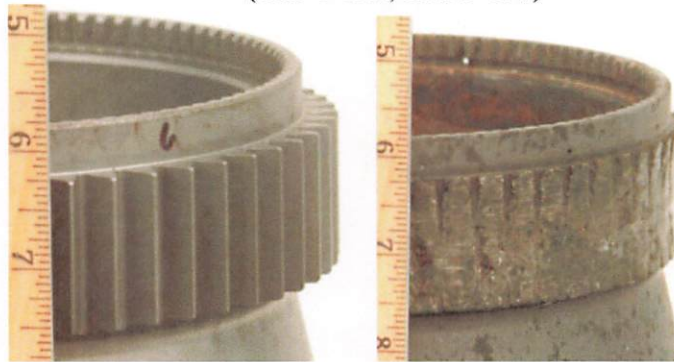
**Figure 20. New vs. MA Left-Hand PRGB Bull Gear – HS Sun Gear Teeth Post Cleaning (Tab J-122, and J-430)**

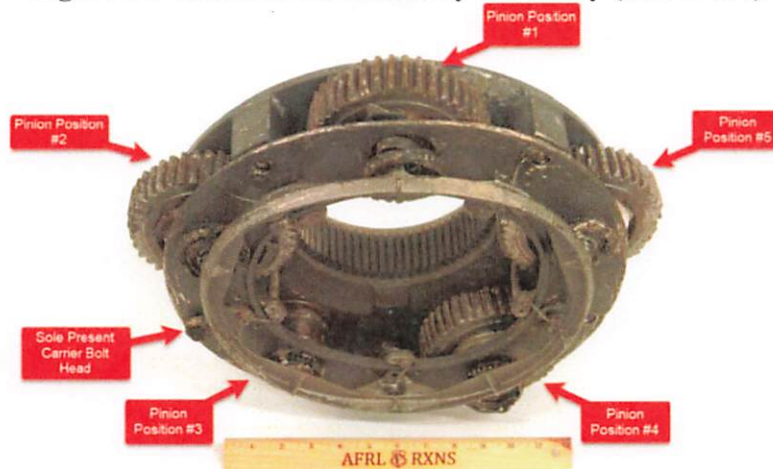
**Figure 21. Cleaned HS Planetary Assembly (Tab J-427)**

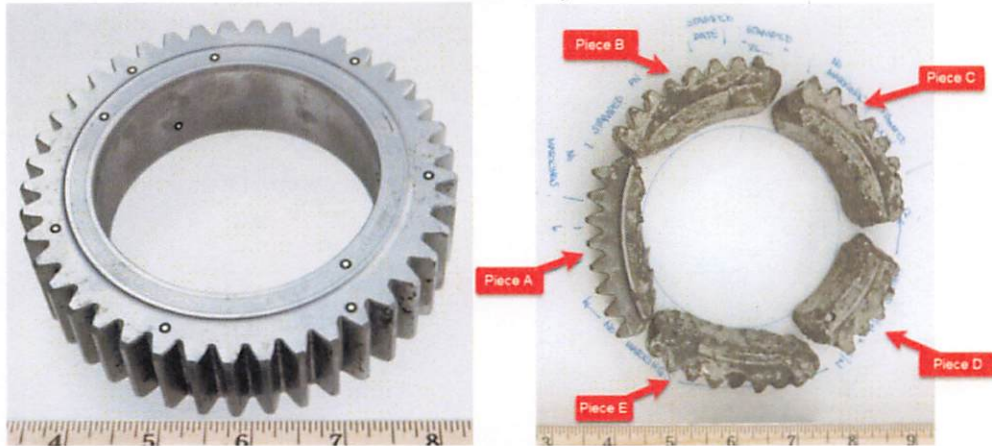
**Figure 22. New vs. Five Pieces of Broken High-Speed Planetary Gear Pinion (Tab J-172, and J-421)**
