UNITED STATES AIR FORCE
AIRCRAFT ACCIDENT INVESTIGATION
BOARD REPORT

CV-22B, T/N 10-0054

21st SPECIAL OPERATIONS SQUADRON
353rd SPECIAL OPERATIONS WING
YOKOTA AIR BASE, JAPAN

DATE OF ACCIDENT: 29 NOVEMBER 2023

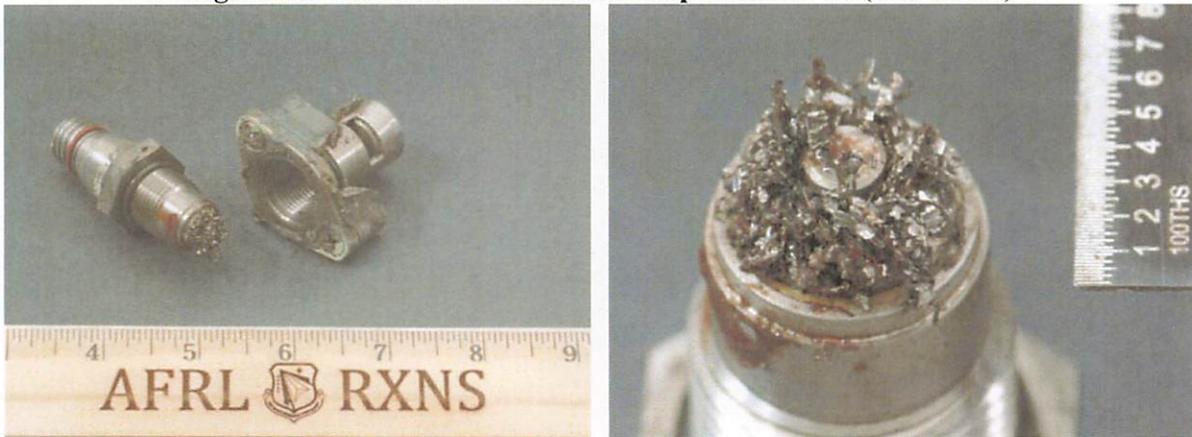
Figure 15. MA Left-Hand PRGB Chip Detector #1 (Tab J-240)

When tested with debris present, as seen in figures 17, 18, and 19 low resistance was measured across the left-hand #1, left-hand #2, and left-hand #3 detector electrodes (Tab J-231). After the debris was removed, nominal resistances were measured (Tab J-231). The change in resistance after the debris was removed confirms that the debris sensors were correctly reporting to the monitoring systems (Tab J-231). Fracture of the right-hand #3 detector housing is consistent with impact damage (Tab J-231). Excess signal leakage current and galvanic voltage noted on the left-hand #2 detector are consistent with intrusion of ionic fluid, such as saltwater (Tab J-231).

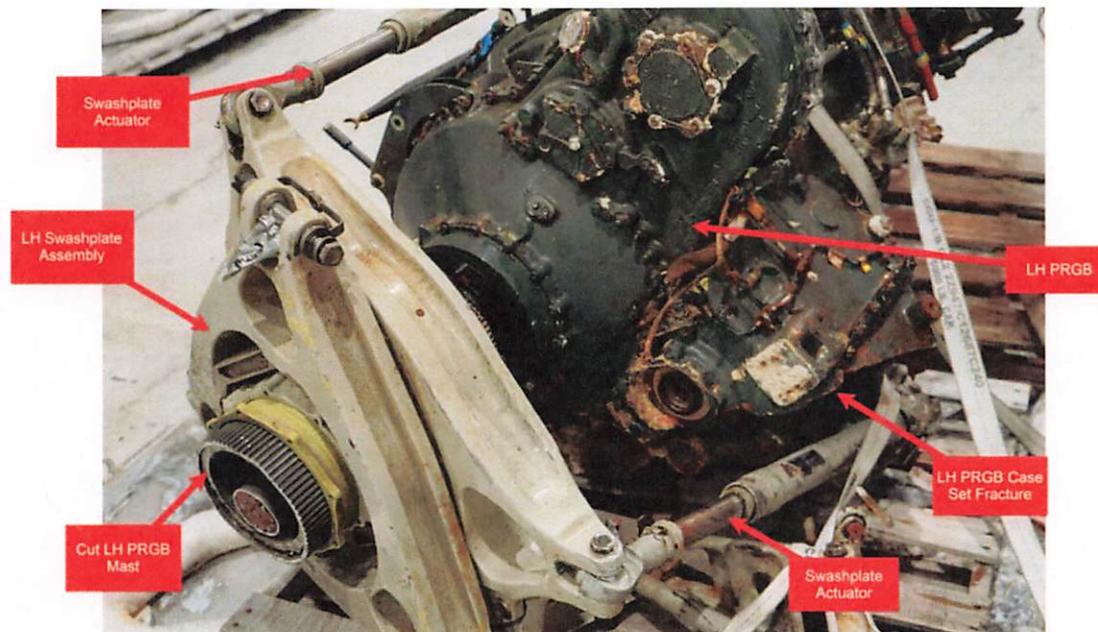
Figure 18. MA Left-Hand PRGB Barrel Section As-Received (Tab J-379)

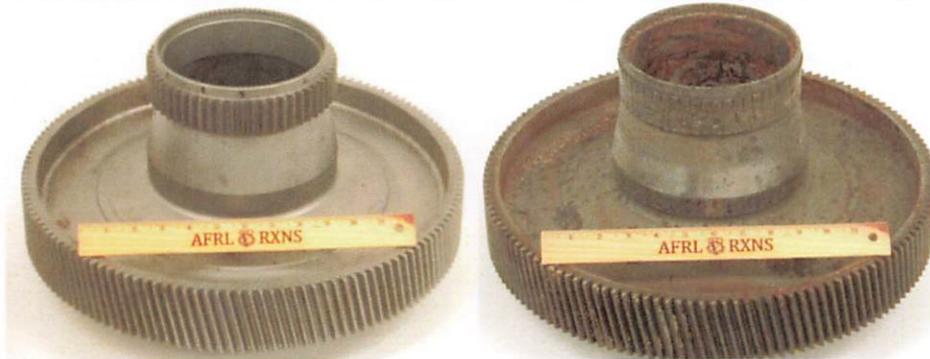
Figure 19. New Bull Gear vs. Recovered Bull Gear Post Cleaning (Tab J-122, and J-429)

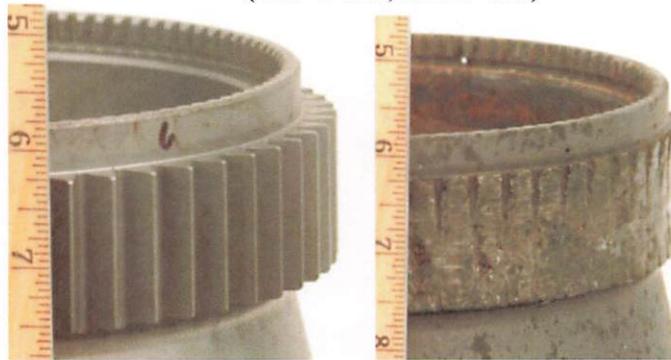
Figure 20. New vs. MA Left-Hand PRGB Bull Gear – HS Sun Gear Teeth Post Cleaning (Tab J-122, and J-430)

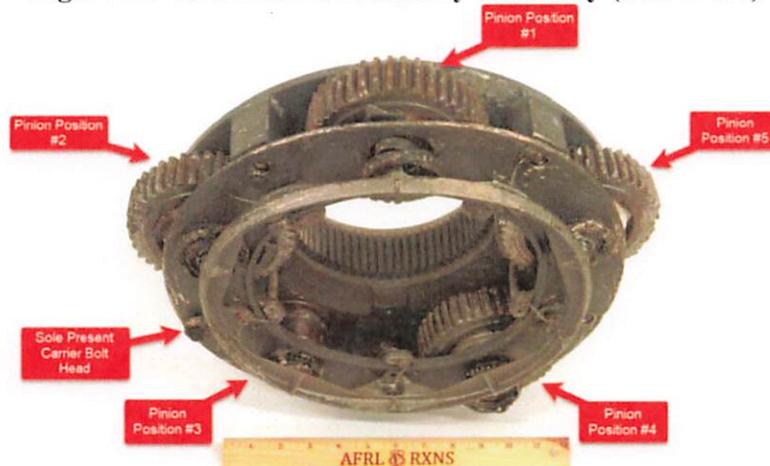
Figure 21. Cleaned HS Planetary Assembly (Tab J-427)

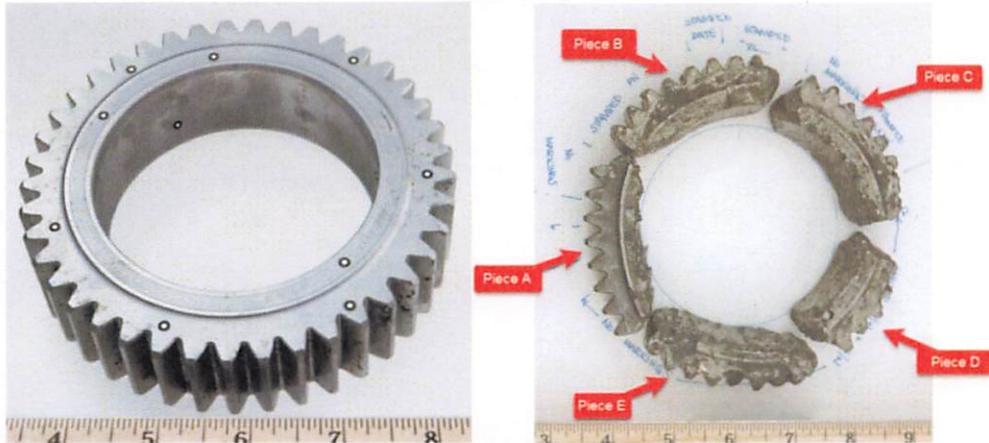
Figure 22. New vs. Five Pieces of Broken High-Speed Planetary Gear Pinion (Tab J-172, and J-421)
