Aviation Investigation Preliminary Report

Location:	McGrath, AK	Accident Number:	ANC24FA085
Date & Time:	August 31, 2024, 10:00 Local	Registration:	N7154Z
Aircraft:	Piper PA-18-150	Injuries:	
Flight Conducted Under:	Part 91: General aviation - Business

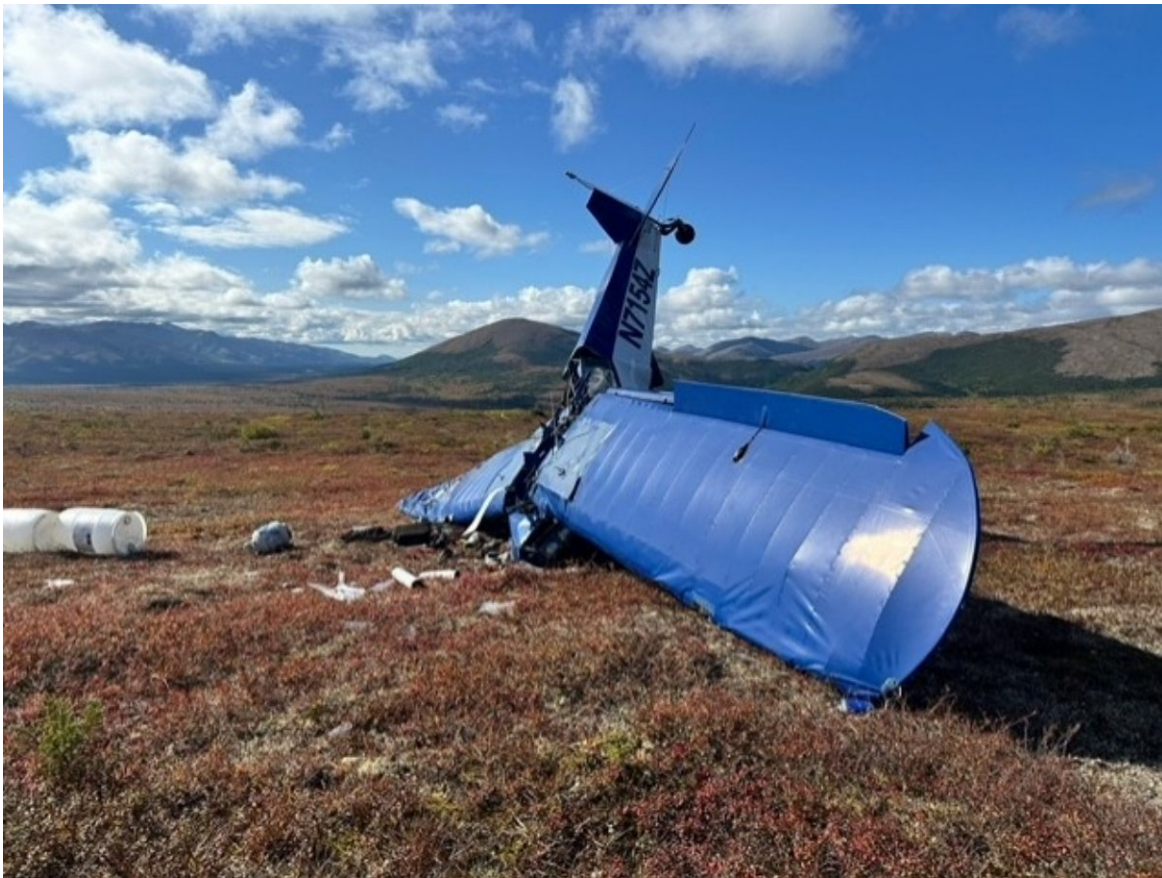
The National Transportation Safety Board investigator-in-charge traveled with the Alaska State Troopers to the remote crash site on September 1. The airplane was found nosed down, in a near vertical attitude, on a northeast heading on the south side of the ridge. The wings remained partially attached and the tail was bent slightly to the right. See figure 1

Figure 1. Wreckage of N7154Z at accident site. (NTSB Photo)

Control cable continuity from the ailerons, flaps and rudder were intact to the fuselage, and fuel was present in the fuel lines.
