Lahaina Fire Incident Analysis Report

Steve Kerber
Derek Alkonis

September 13, 2024
Columbia, MD

This document is the second in a series of three (3) reports commissioned by the Hawai'i Department of the Attorney General (DOAG) to provide an independent review of the tragic fire that destroyed much of Lahaina, Hawai'i, on August 8-9, 2023.

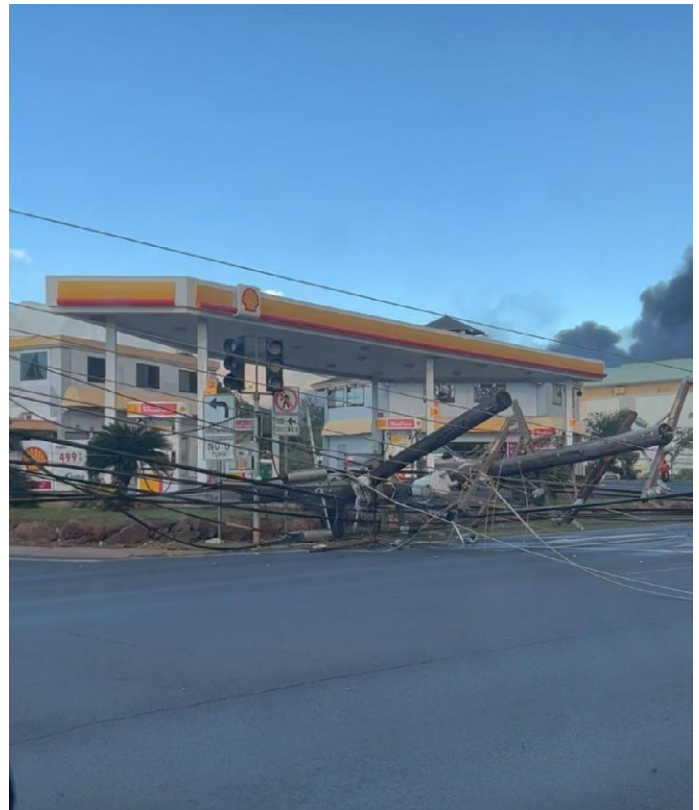
Figure 3.8.2.1 Several downed utility poles and powerlines in the northbound lane of Hwy-30 and Kapunakea Street. Photo taken August 8, 2023, at 16:52. Inset: Viewpoint of photo of downed utility poles and electrical lines at Hwy-30 and Kapunakea Street.

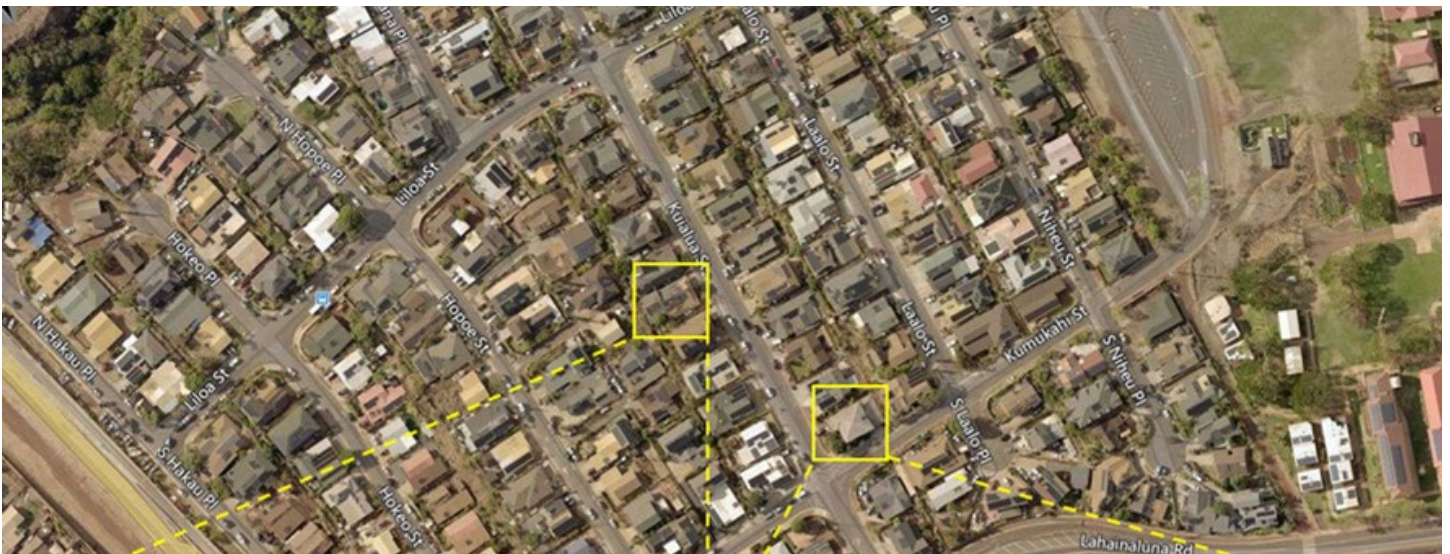
Figure 4.3.3.2.3 Example of wind damage in the Kelaweā Mauka III subdivision—(bottom left) damaged roof sheathing and (bottom right) loss of roof covering.

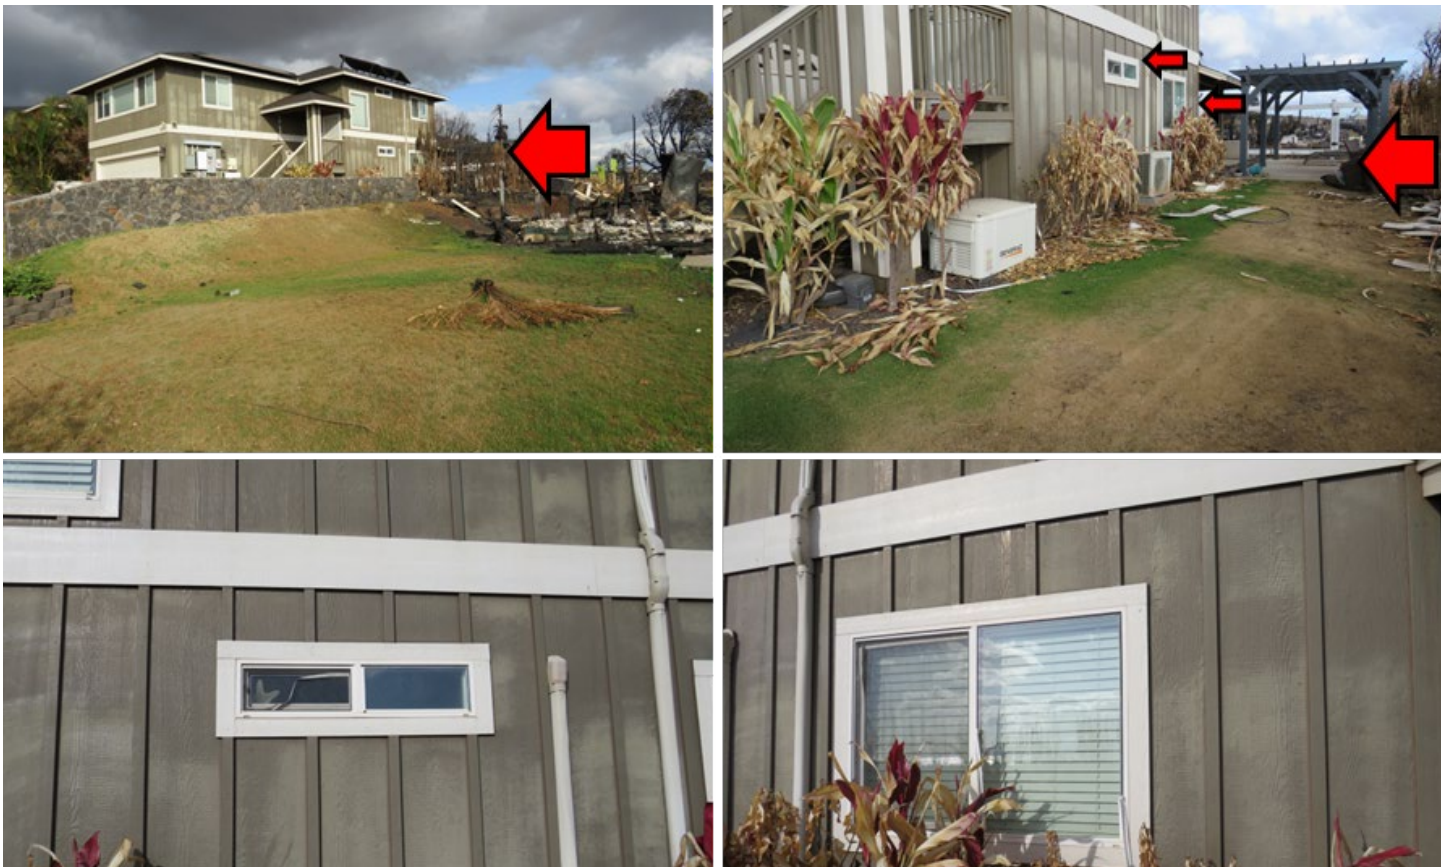
Figure 4.3.3.3.3 Damage classification assessment map to 3█ Komo Mai Street from (destroyed) 3█ Komo Mai Street; approximately 24 foot separation distance. Top left image shows both addresses, top right indicates the radiant heat vector in the generally opposite direction of fire spread. Bottom images show discoloration of fiber cement siding and deformation of vinyl window frames.

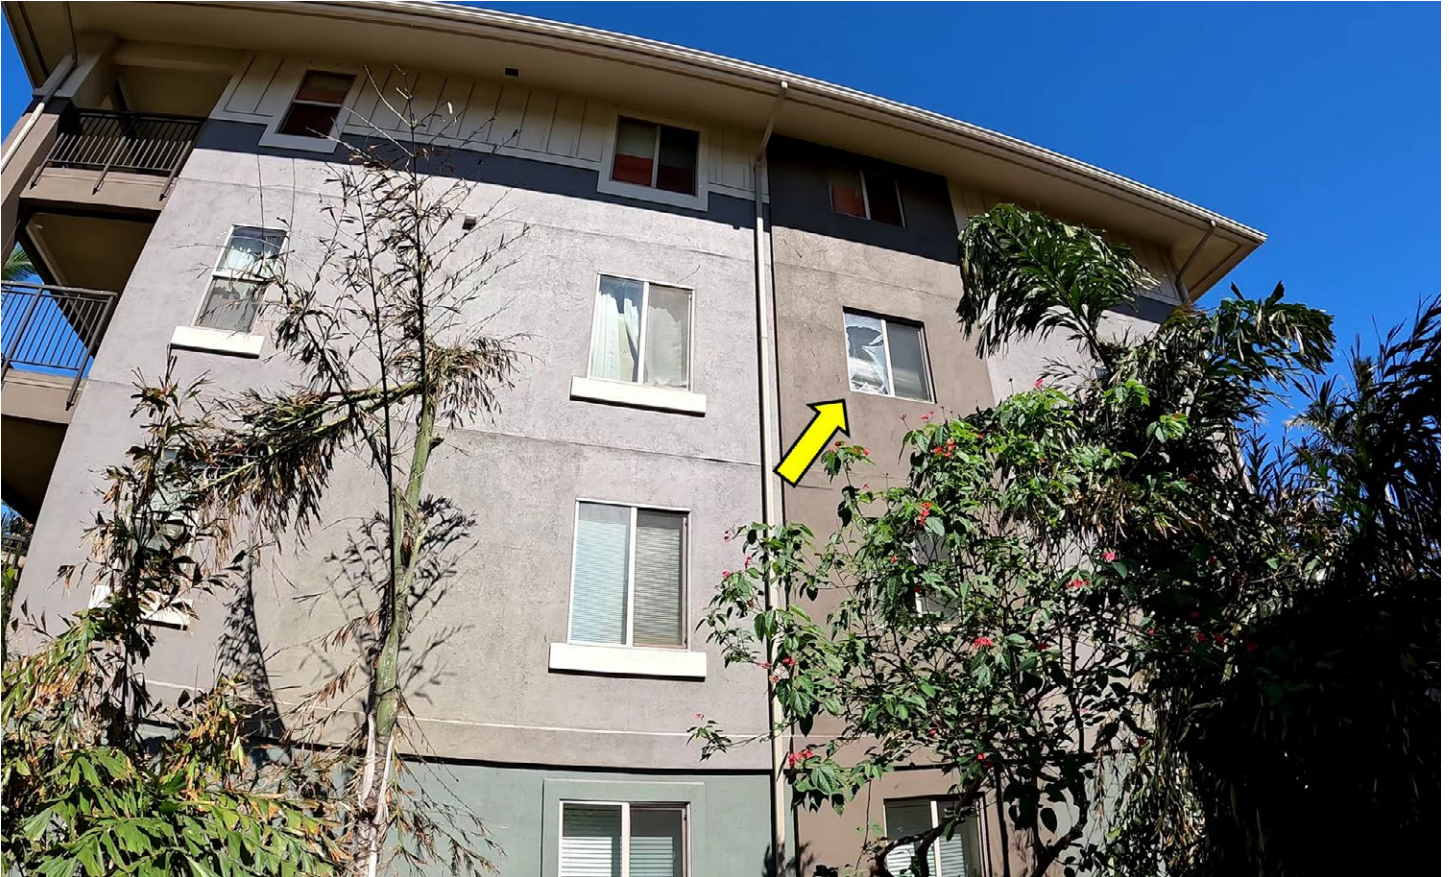
Figure 4.3.3.4.6 Broken window on third floor of eastern (mauka) side of apartment building, likely caused by windborne debris.

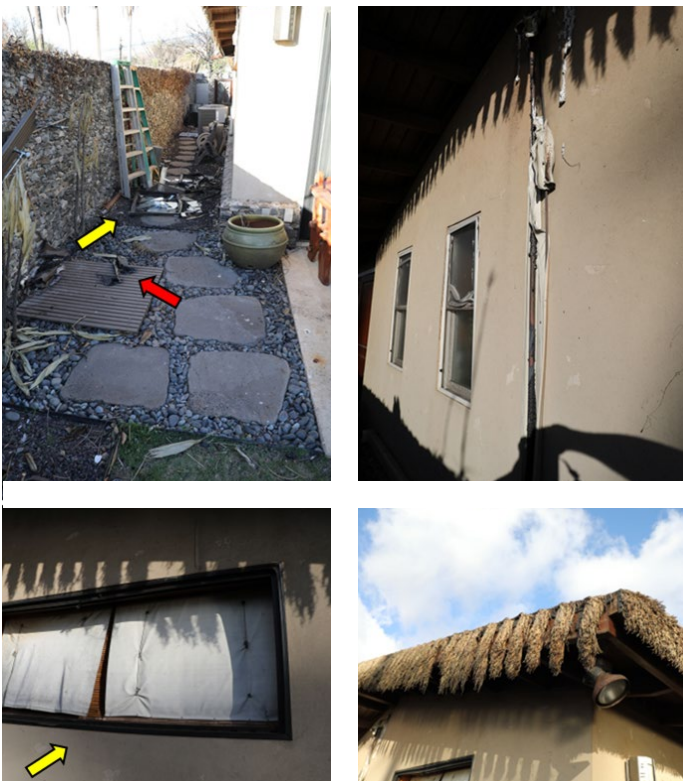
Figure 4.3.3.6.9 Close-up images of the structure at 1■ Kamaka Circle, showing that the extent of damage varied by multiple factors. Yellow arrow indicates the vinyl window frame that was impacted by radiant heat and fell out. Red arrow indicates ember ignition of wooden deck for what appears to be an outdoor shower.

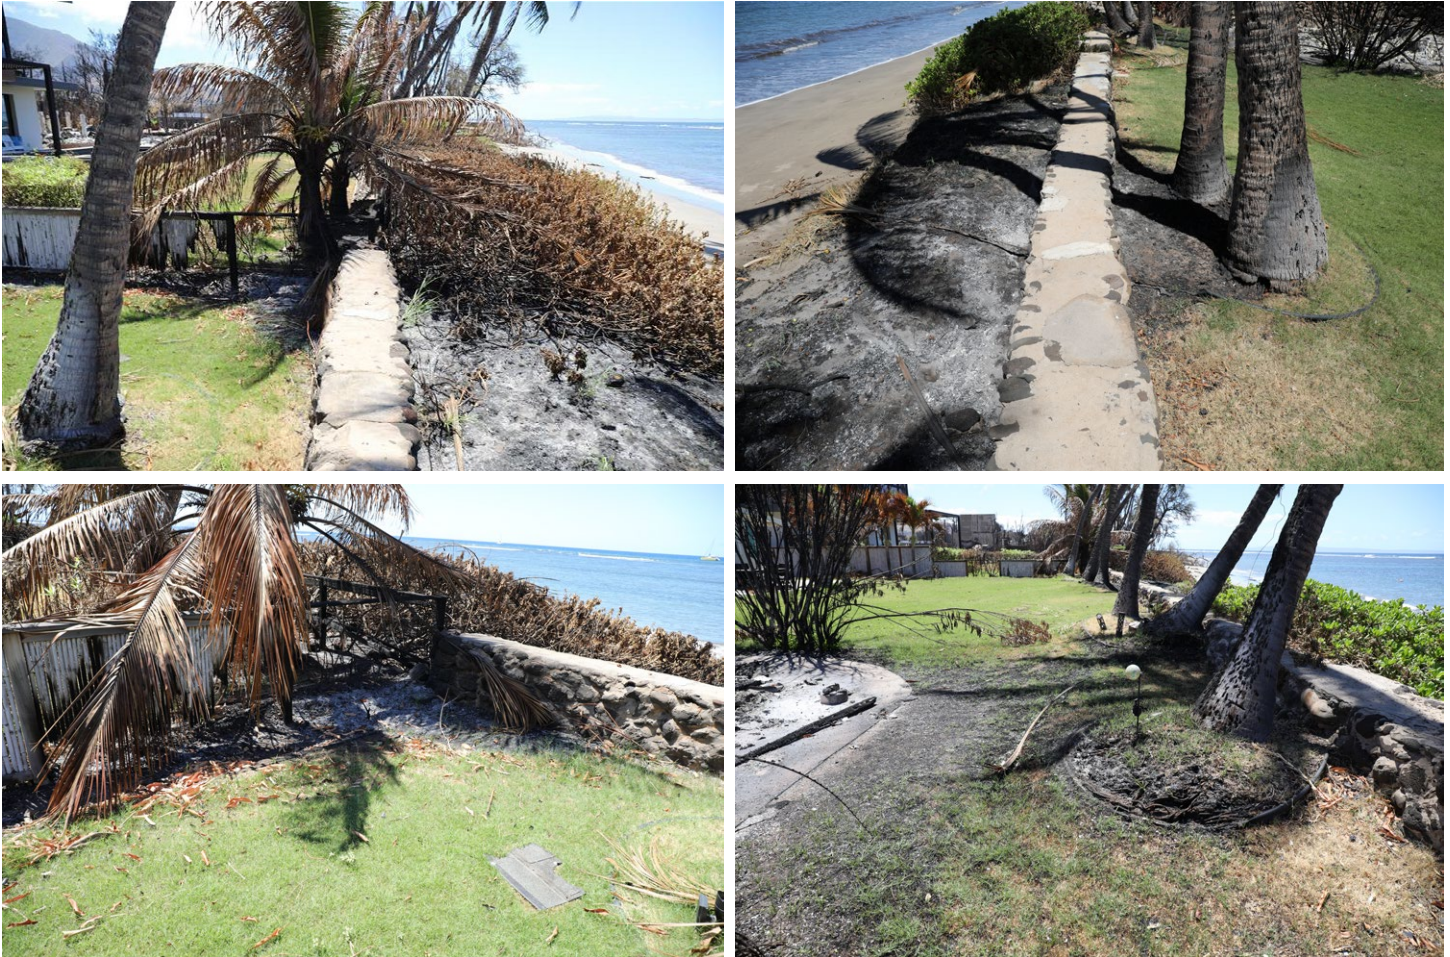
Figure 4.3.4.1.16 Vegetation fire west (makai) of the property line for 4█ Front Street appears to cross into the backyard at the 4█-4█ Front Street property fence line and near large trees proximate to the wall. Note destroyed accessory structure to the left of the bottom, right image.

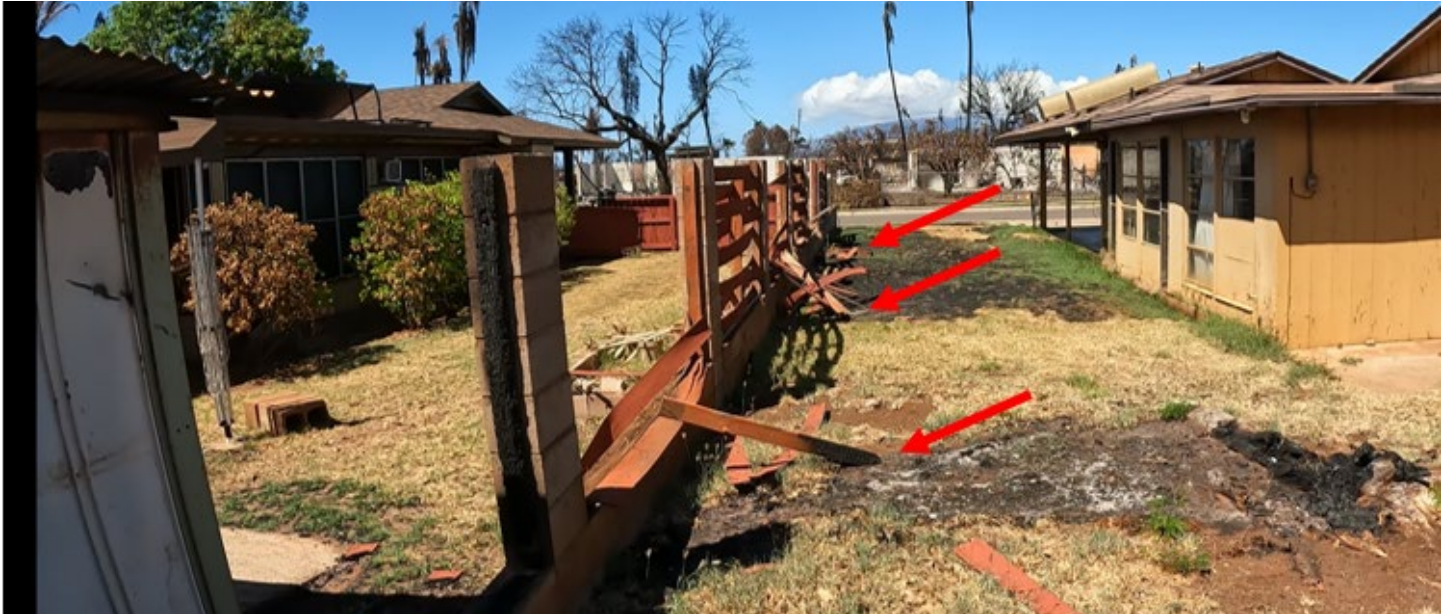
Figure 4.3.4.2.6 Grass fire to the south of 4th 'Ālī'ō Street appears to have ignited in multiple locations where charred sections of the fence from the 4th-4th 'Ālī'ō Street property line landed in dry grass. While it propagated near the wooden structure on the southside of 4th 'Ālī'ō Street, it did not transition to the structure.

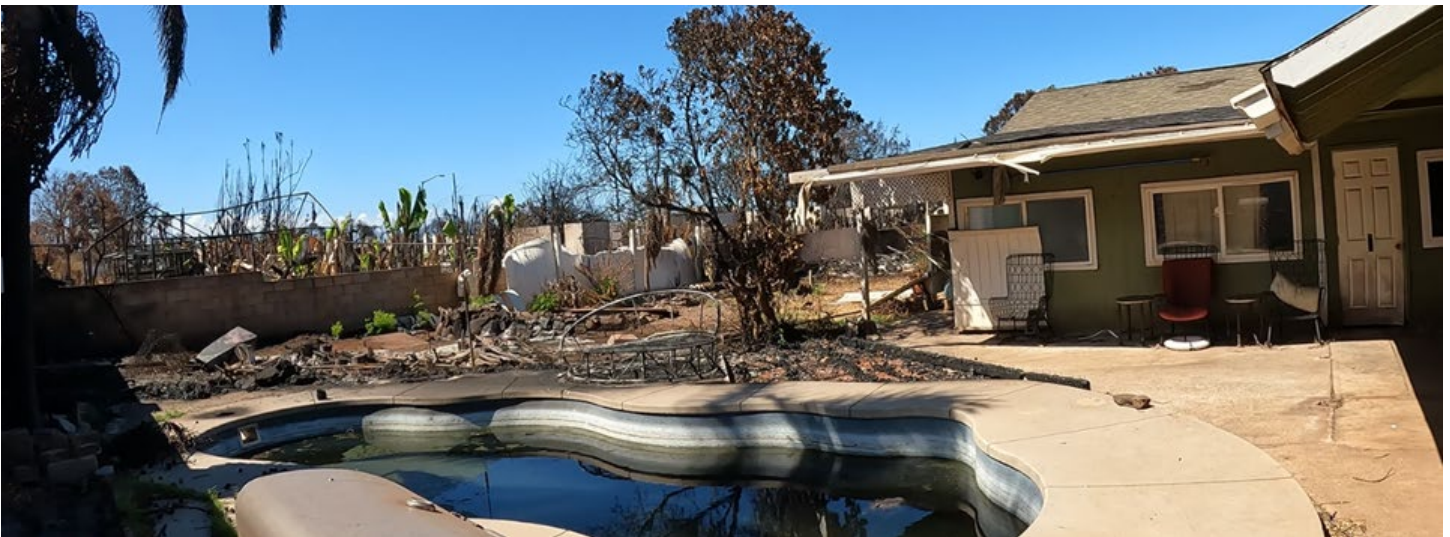
Figure 4.3.4.2.13 Exterior fire in the south yard of 7 Kāua'ula Road destroyed outdoor furnishings and structures up to the corner of the main residential structure. However, these fires did not spread to the south of the residence and appeared to result only in damage to the plastic gutter in the southwest corner.

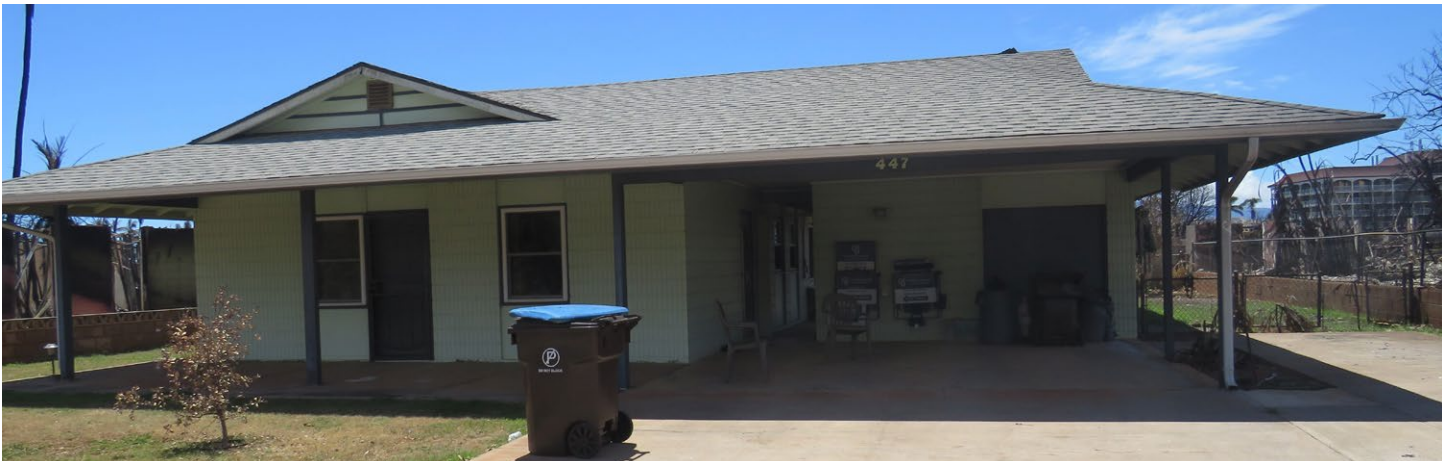
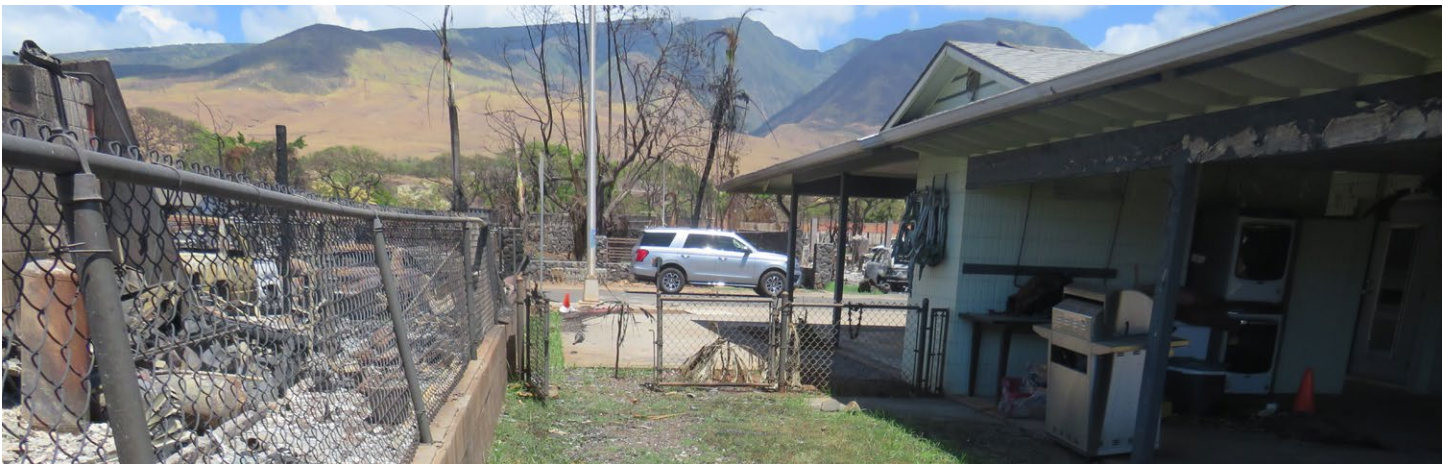
Figure 4.3.4.2.18 Radiant heat damage to the structure and household belongings at 447 'Āli'ō Street was noted primarily on the north side.

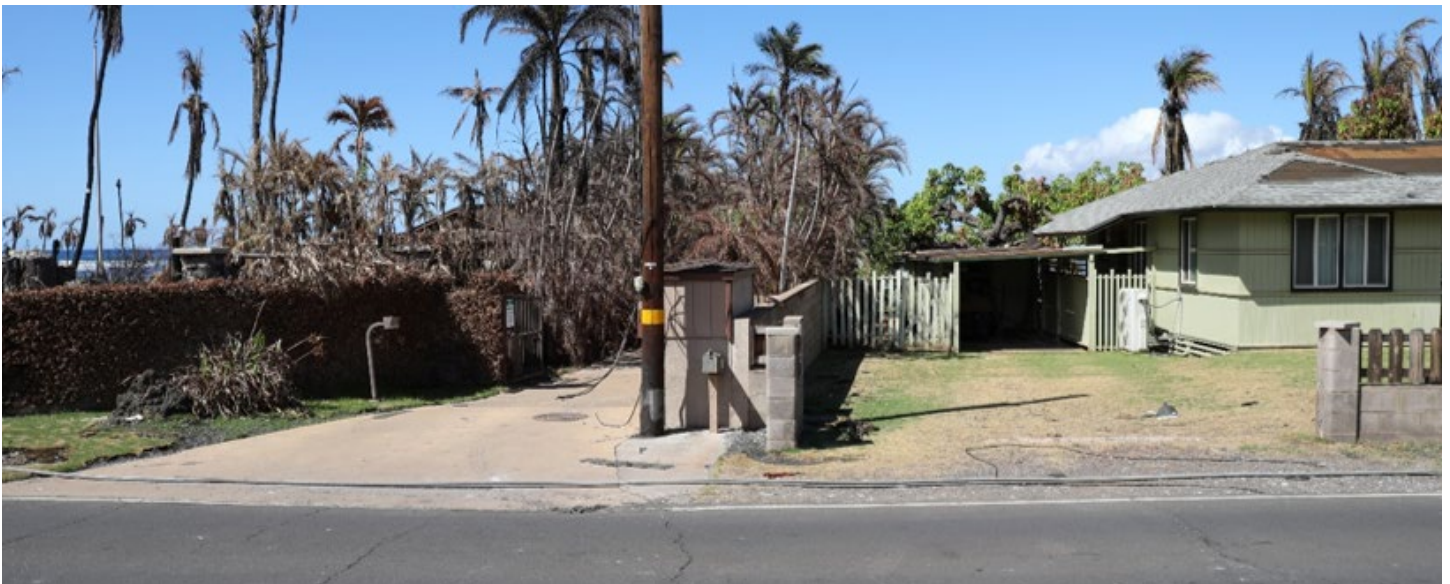
Figure 4.3.4.3.4 Tall, lush vegetation was planted along block walls on either side of the driveway to 3█ Front Street, which may have provided protection to the 3█ and 3█ Front Street lots. The block wall south of 385 Front Street also influenced the ember movement. Note pile up in corner of wall (bottom left) and wind driven burn scar in grass around the wall toward the front of the structure showing the likely path of ground based embers deflected towards the north and away from the open garage (bottom right).

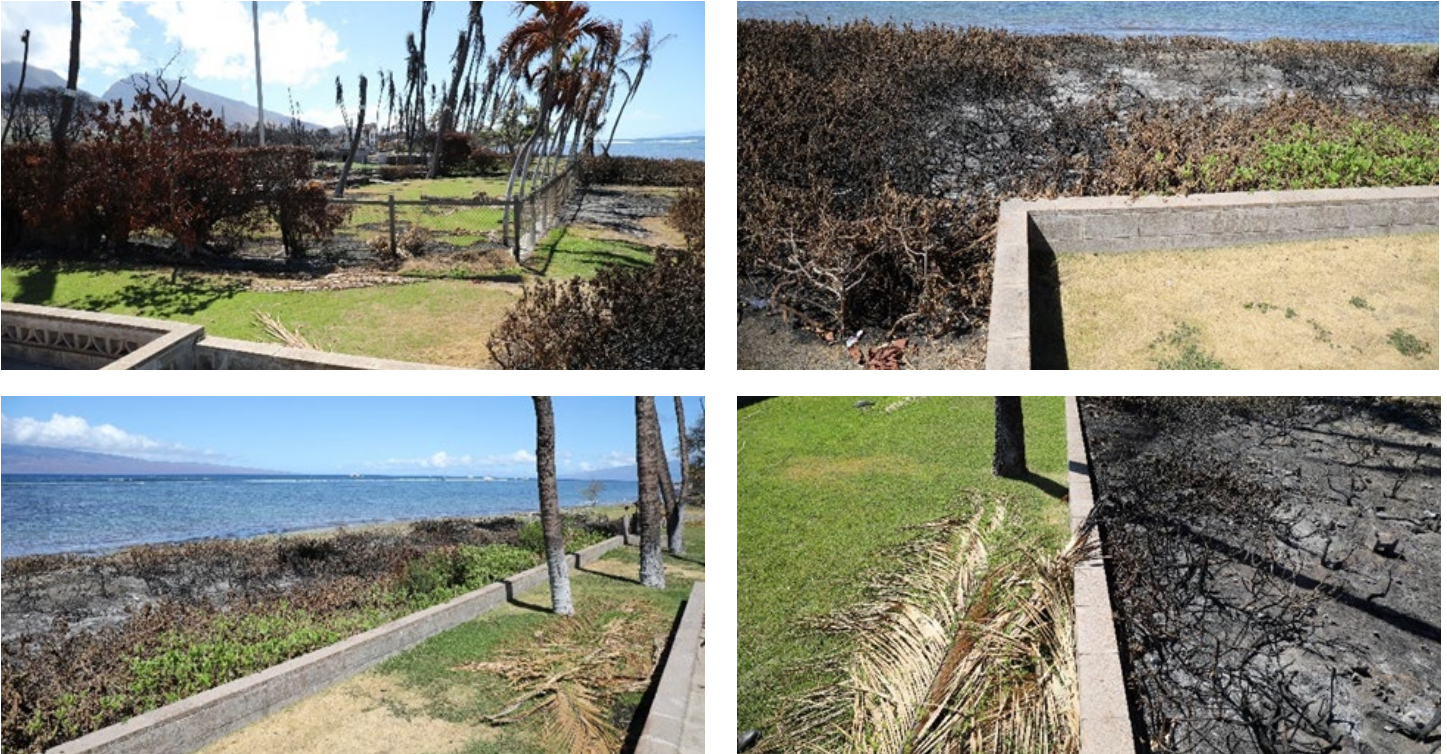
Figure 4.3.4.3.11 Vegetation fire to the west (makai) of 3█ Front, largely confined west (makai) of the low block wall at the edge of the grass yard.

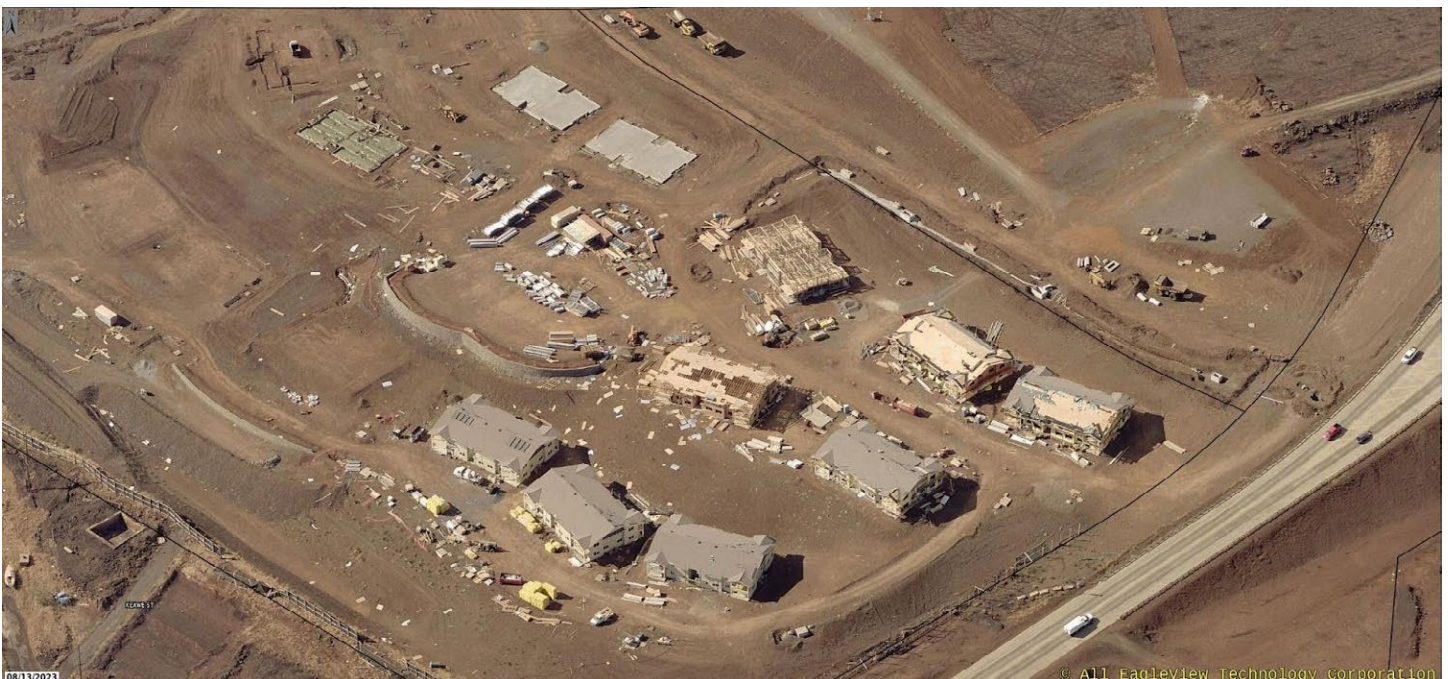
Figure 4.3.5.2.3 Wind damaged apartments at the construction site.

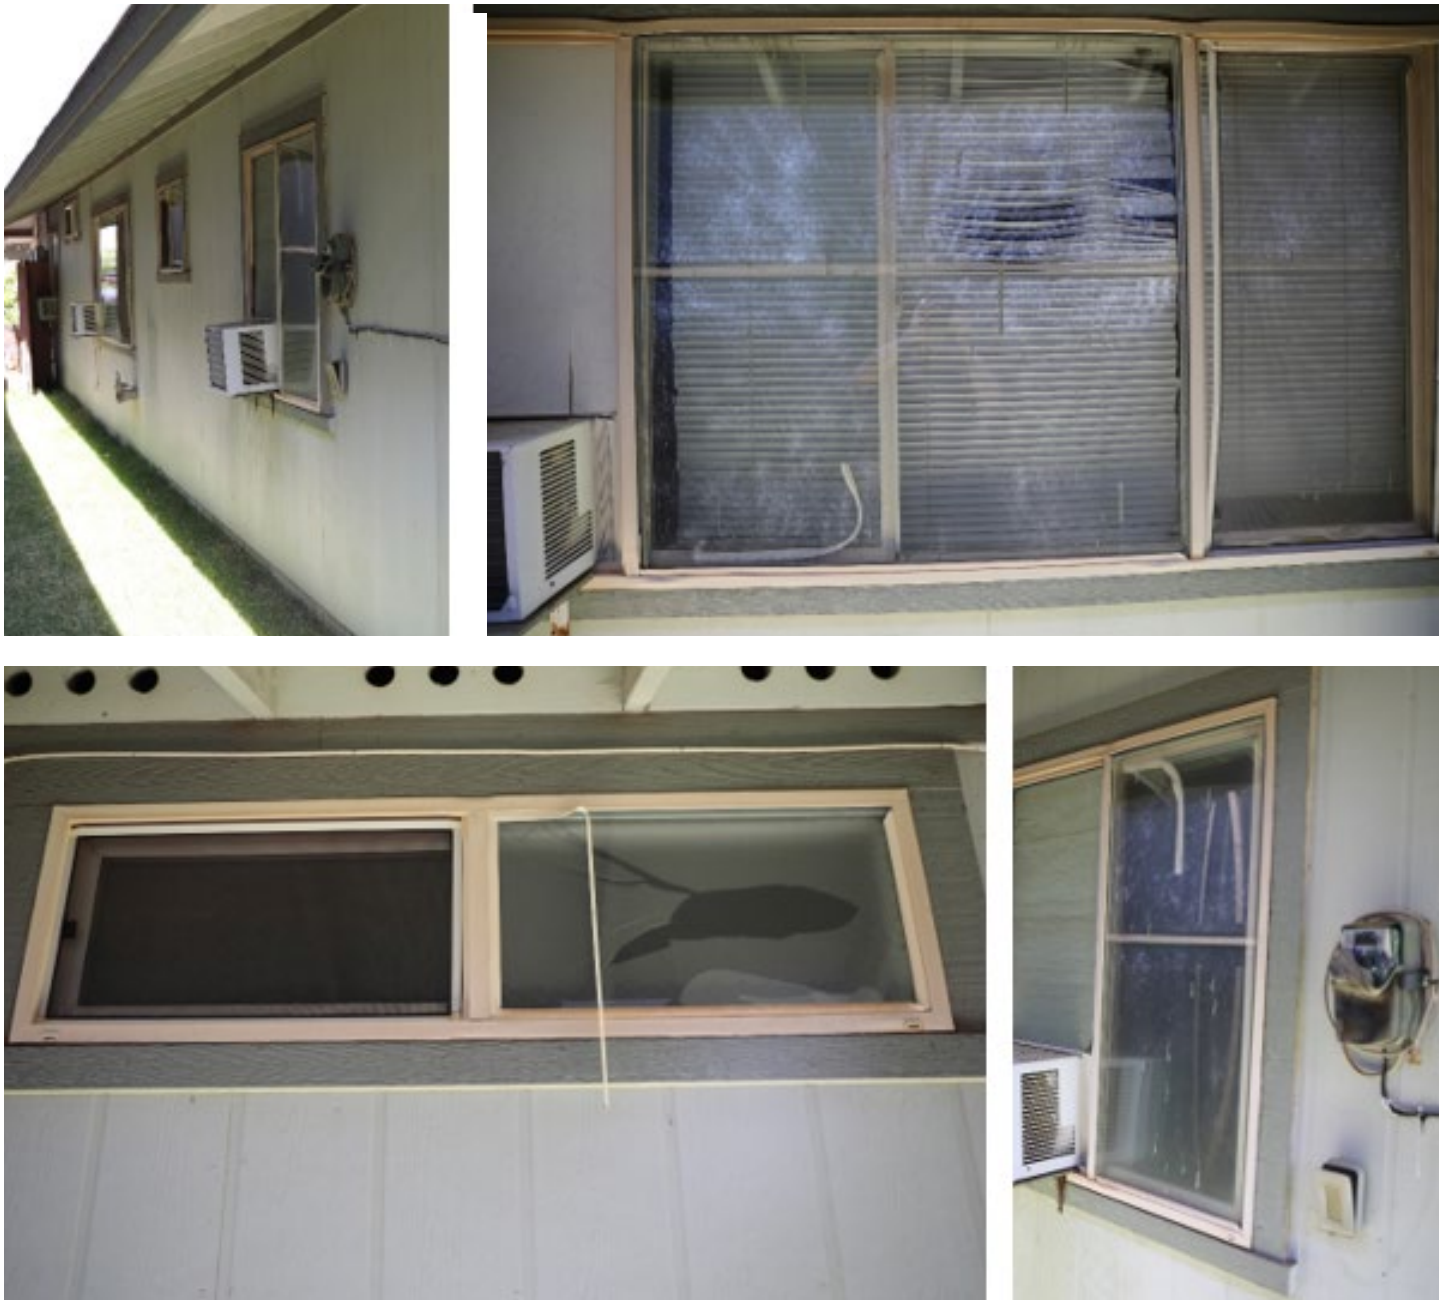
Figure 4.3.5.3.15 West side (makai) of 1█ 'Aipuni showing melted plastic components, damaged/broken window assemblies, and deformed window blinds likely caused by radiant heat transfer.
