Aviation Investigation Preliminary Report

Location:	Saint Mary's, AK	Accident Number:	ANC24FA094
Date & Time:	September 15, 2024, 22:04 Local	Registration:	N90193
Aircraft:	Cessna 207	Injuries:	4 Fatal
Flight Conducted Under:	Part 91: General aviation - Personal

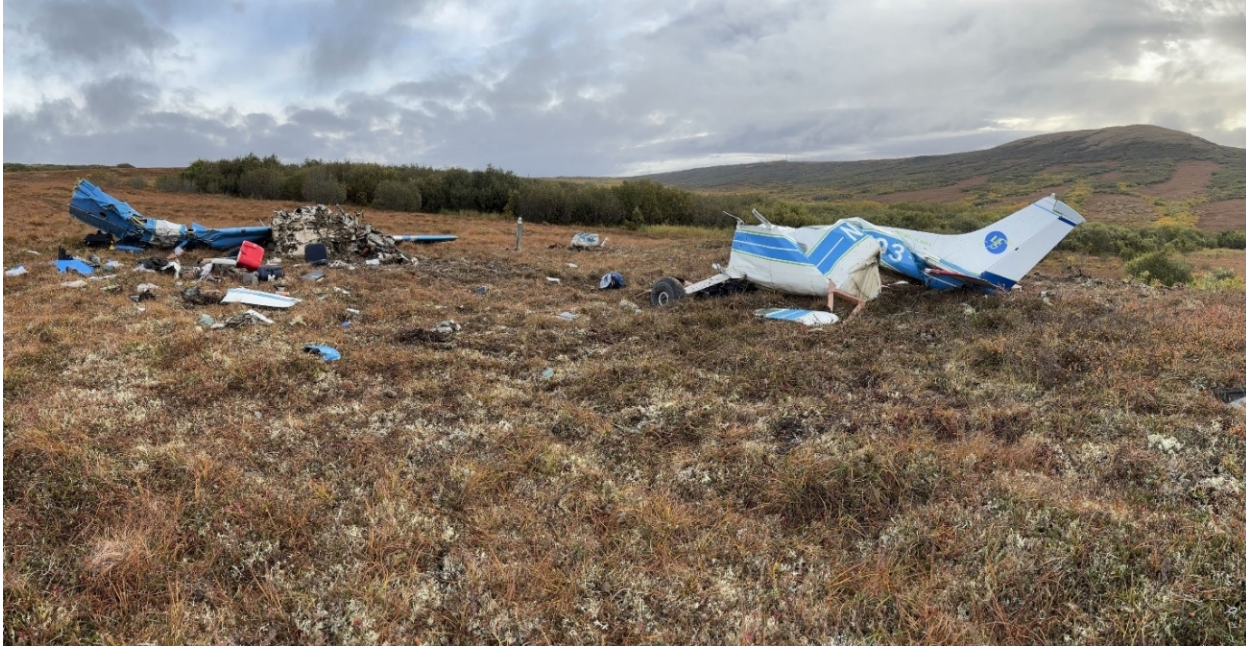
The NTSB on-scene wreckage examination revealed that the airplane impacted rising terrain in a right wing low and nose low attitude on a northwest heading. The highly fragmented debris path was about 150 ft long and contained all major components of the airplane (See figure 2).

Figure 2. A view of the airplane wreckage at the accident site facing north (Courtesy of FAA). The airplane wreckage was recovered for the accident site and transported to Wasilla, Alaska, and a detailed NTSB examination is pending.
