Aviation Investigation Preliminary Report

| Location: | Ninilchik, AK | Accident Number: | ANC24FA091 |
| Date & Time: | September 13, 2024, 08:03 Local | Registration: | N8CK |
| Aircraft: | Champion 7GCBC | Injuries: | 2 Fatal |

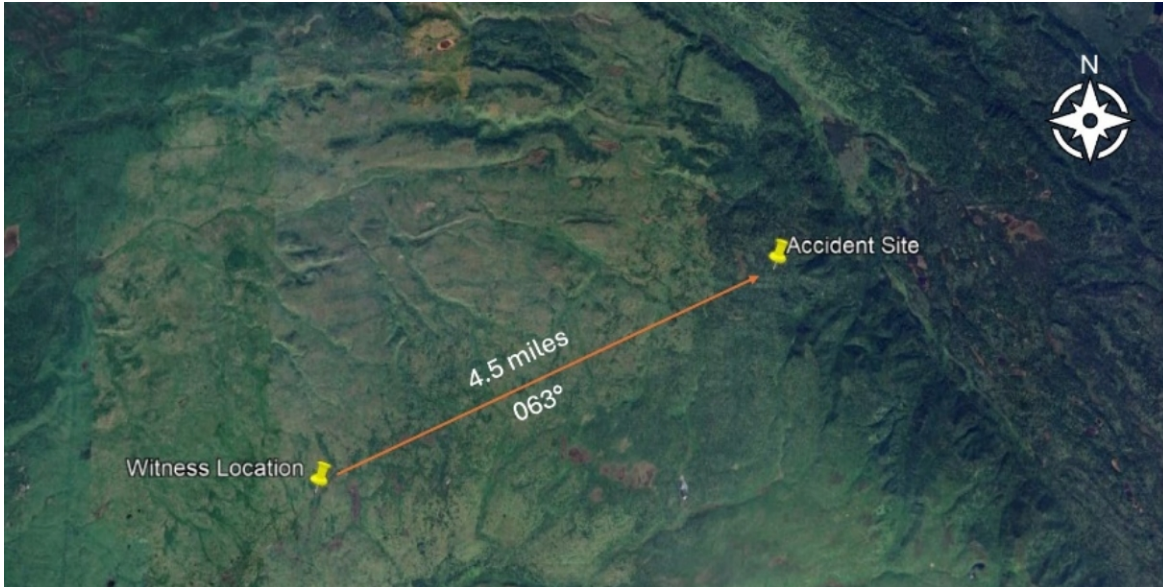
Figure 1: Chart depicting witness location relative to the accident site

About 0745, a witness, located about 4.5 miles southwest of the accident site, reported seeing the accident airplane flying low overhead, following an off-roading trail, at an altitude between 100-200 ft above ground level (agl) with a crab angle of about 10°. The witness reported that, after passing overhead, the accident airplane flew about 500 ft east of his location, circled a group of four moose that were standing in an open field, then proceeded to fly northbound and out of view. (See figure 1)

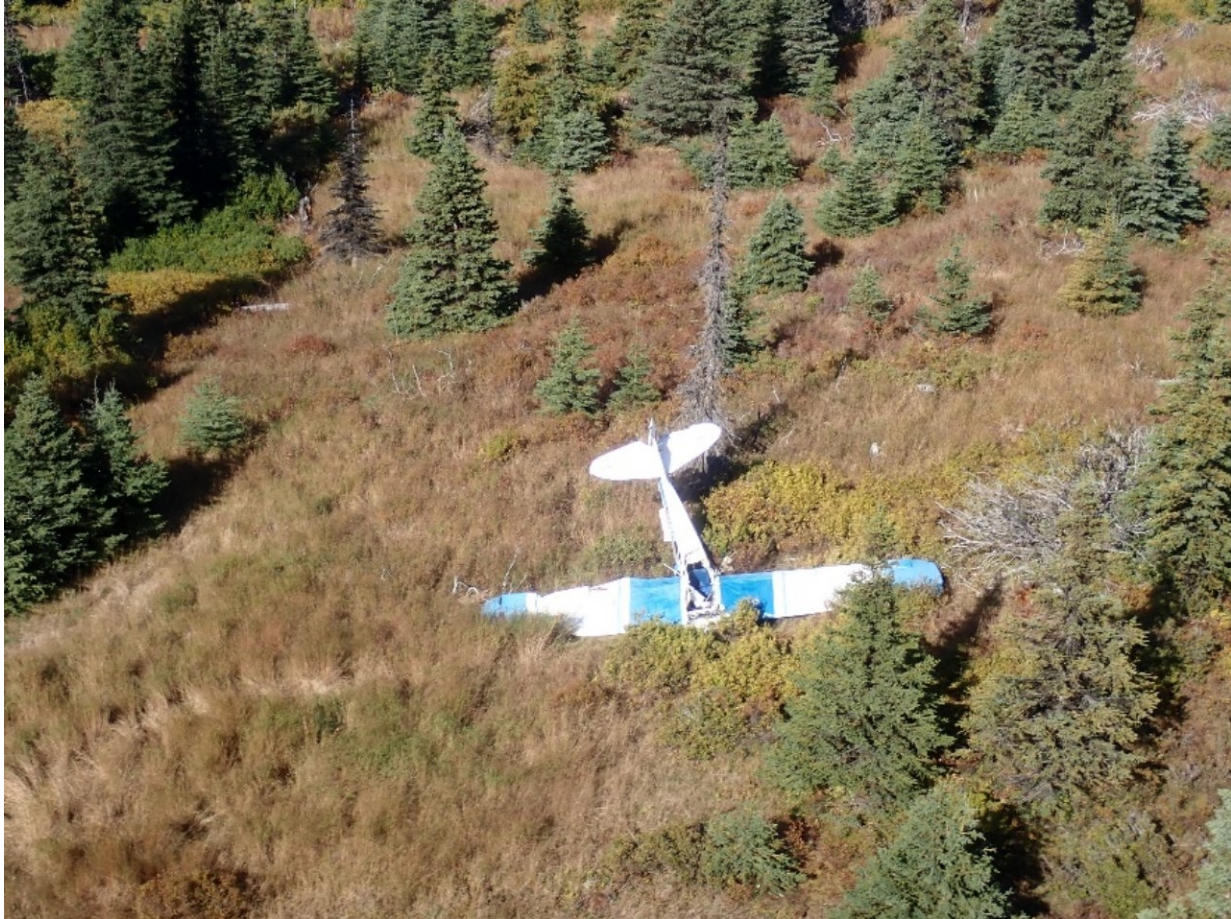
Figure 2: Aerial view of the accident site (NTSB Photo)

About 0803, the Alaska Rescue Coordination Center (RCC) received a 406 Mhz emergency locator transmitter (ELT) signal assigned to the accident airplane from a location Southwest of Tustumena Lake. The RCC contacted the Federal Aviation Administration Kenai Flight Service Station, who routed an airplane over the location of the ELT signal to confirm the presence of a downed airplane. The RCC simultaneously dispatched search and rescue personnel to the accident site. (See figure 2)

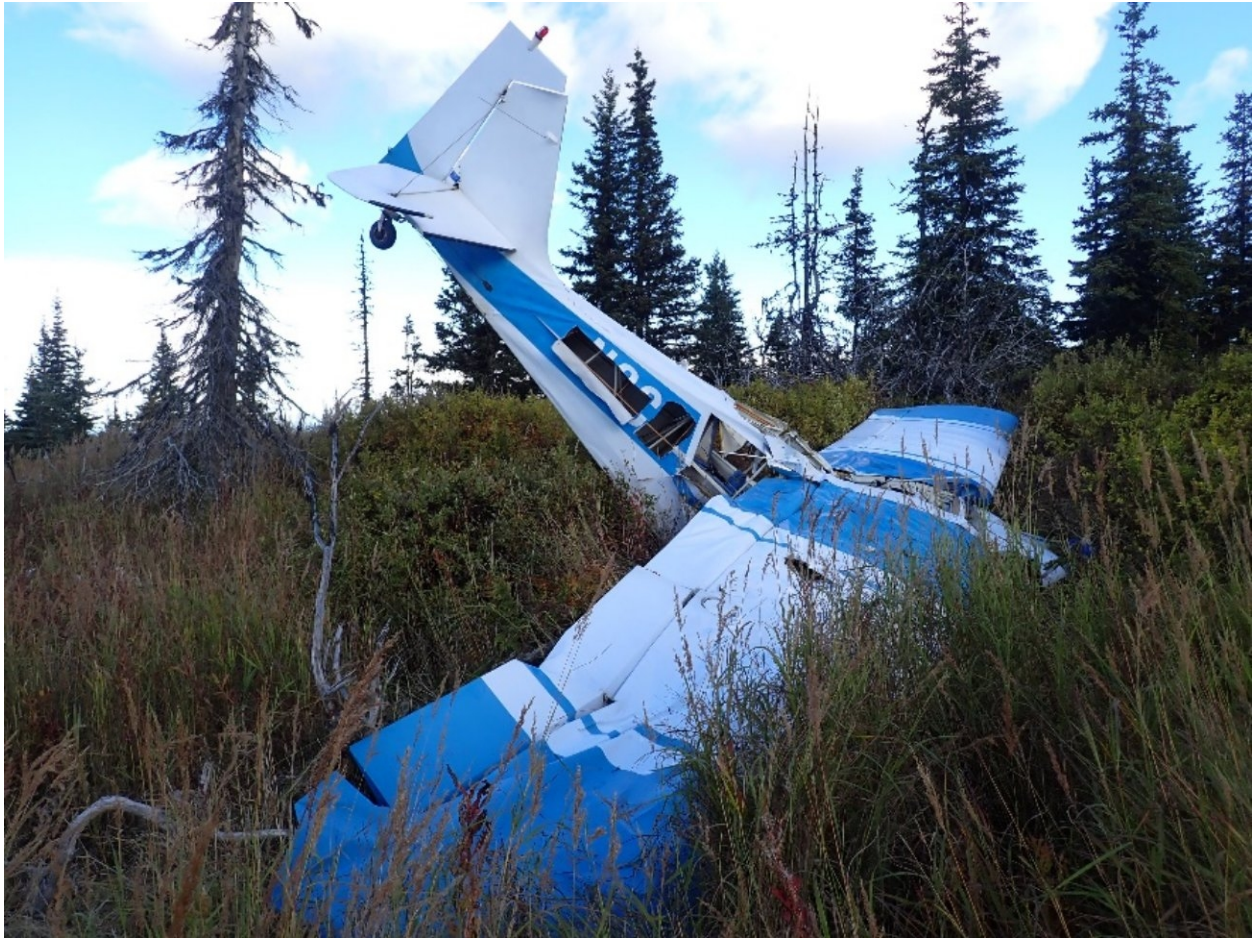
Figure 3: View of the accident at accident site (NTSB Photo)

The airplane came to rest about seven miles southwest of Tustumena Lake in an area of hilly, sparsely forested, tundra-covered terrain. The wreckage exhibited signatures consistent with a high angle, nose down impact. (See figure 3)

All the major structures and components of the airplane were accounted for at the accident site. The engine was partially burrowed into the soft, tundra-covered terrain, leaving only the top deck of the engine visible. The aft section of the fuselage protruded upwards from the point of impact at about a 50° angle with the empennage suspended about 12 ft above the ground. The outboard section of the right wing exhibited impact damage. The inboard, forward section of the left wing exhibited compression damage. The aft section of the fuselage exhibited lateral deformation in the direction of the right wing. No preimpact anomalies were observed with the flight control system at the wreckage site.
