## Flight Safety Investigation Report

**CANADIAN ARMED FORCES  
FLIGHT SAFETY INVESTIGATION REPORT (FSIR)**

**FILE NUMBER:** 1010-CH147F-197571 (DFS 2-5-3)  
**FSIMS IDENTIFICATION NUMBER:** 197571  
**DATE OF REPORT:** 7 October 2024  
**OCCURRENCE CATEGORY:** "A"  
**AIRCRAFT TYPE:** CH147F Chinook  
**AIRCRAFT REGISTRATION NUMBER:** CH147310  
**DATE OF OCCURRENCE:** 20 June 2023  
**TIME OF OCCURRENCE (L):** 0008 (L)  
**LOCATION:** CFB Petawawa, ON  
**OPERATOR:** 450 THS, CFB Petawawa

## SYNOPSIS

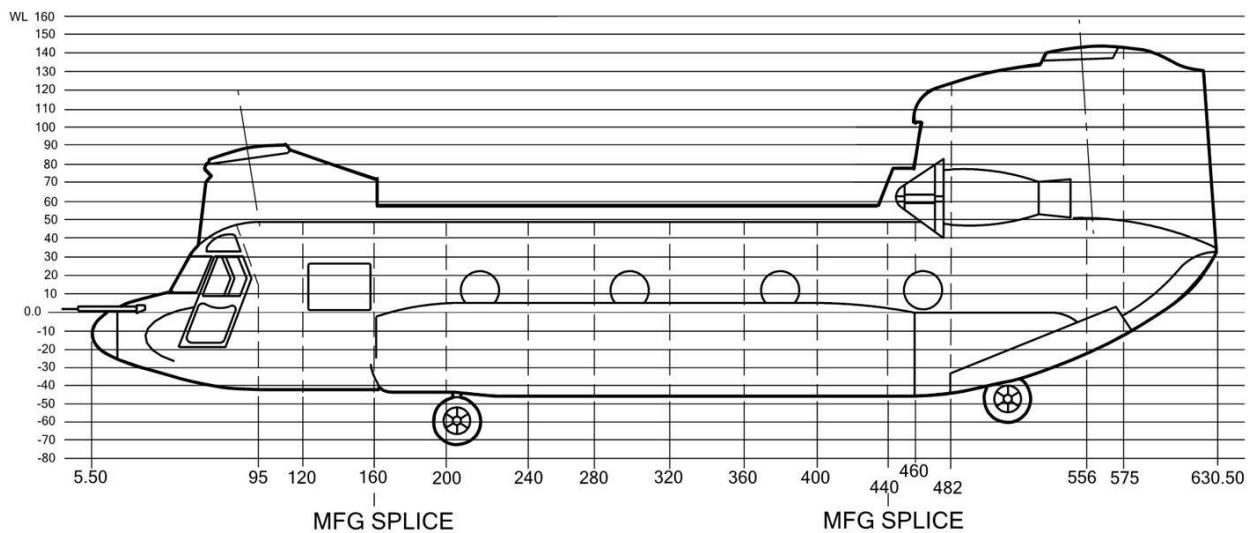
Figure 10 - CH147F Fuselage Stations and Waterlines

1.12.4 The underside of the aircraft sustained significant damage from FS 95 to FS 360, with most of the exterior skin having been ripped off. All bulkhead frames from FS 360 forward were detached, fractured, and displaced rearward.

1.12.5 Multiple cabin floor panels separated from the aircraft structure in numerous areas from FS 120 to FS 420.

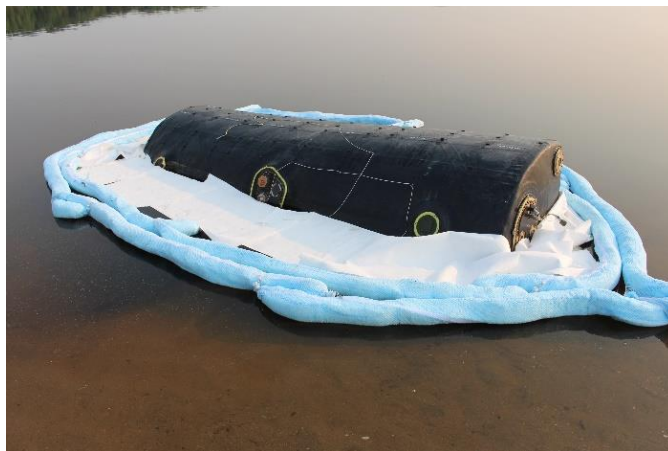
Photo 2 - Right side fuel cell (with POL absorbent material)

1.12.3 The right side fuel cell and pod shell located at Fuselage Station (FS) 275 to FS 440 ([Figure 10](#)) separated from the aircraft at impact (Photo 2). The right-side fuel cell and parts of the pod shell were found floating near the accident site. The left side fuel cell and pod shell remained attached to the aircraft.

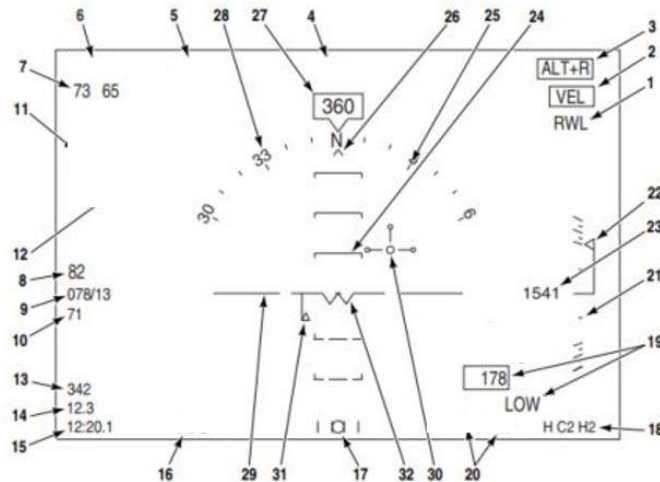
Figure 14 - HUD Display - Hammer 31

1.18.10 Figure 14 is derived from Figure 13 above, edited to show only the elements of the HUD symbology that were selected to be displayed by the pilots of Hammer 31. This is a depiction of what the pilots would have seen through their respective HUD.

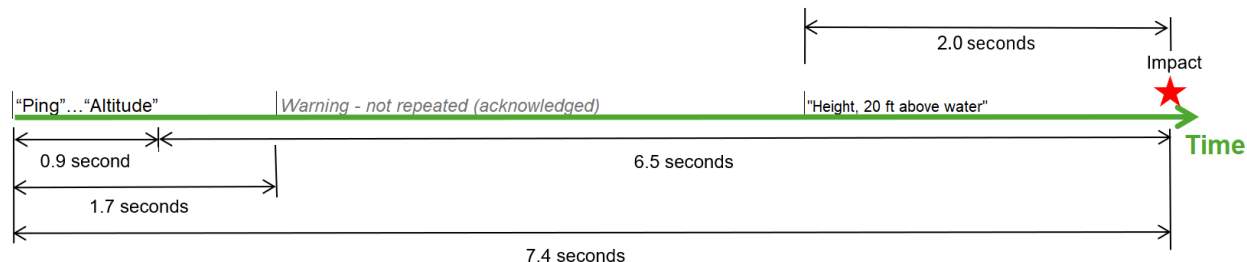
Figure 16: Timeline of select audio elements before impact

2.11.8 Knowing that the RADALT warning sounded 7.4 seconds before impact, there was theoretically sufficient time for the PF to react and avoid impact (7.4 vs 5.0 seconds). The aircraft was not recovered from its descent for three likely reasons: the pilot(s) who heard the alarm (1) did not perceive that they were in a situation that required corrective action, (2) were task saturated preventing further actions, or (3) were still processing the warning at the time of impact, which, if true, would indicate that their response exceeded the best-case scenario used as human Response Time (3.0 seconds). Numerous factors could increase this Response Time (Response Time = Reaction Time and Action Time), such as the number of response options available (requirement for a decision) and stress level, to name a few. (1.13.14). The investigation considers task saturation as the most likely scenario to explain the lack of response following the RADALT warning.

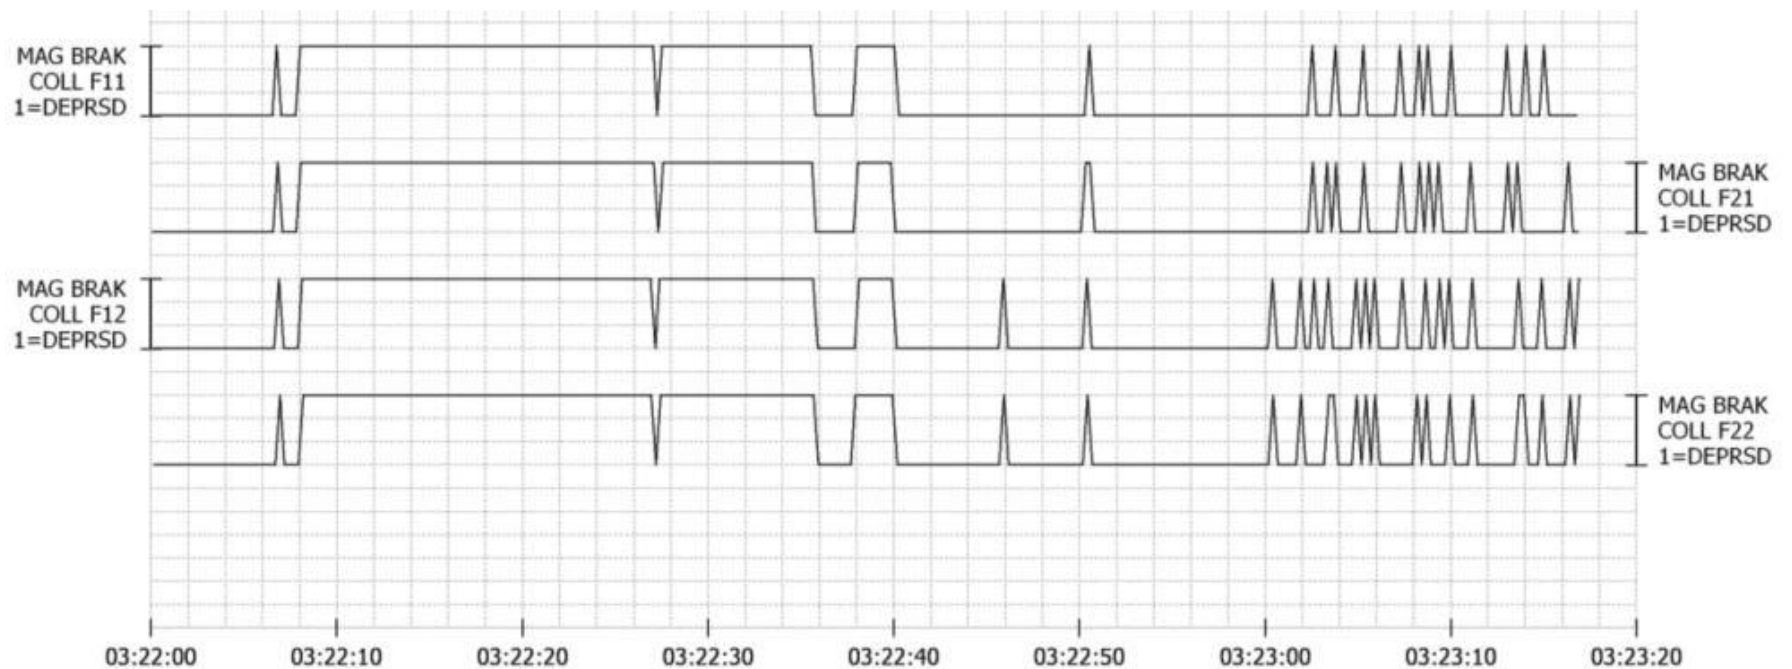
**ANNEX F - FLIGHT DATA (MAG BRAKE ) – CH147310**

1. The following trace is an extract from the CH147310 FDR for the accident flight. It depicts the four channels that record thrust control lever MAG BRAKE activations.

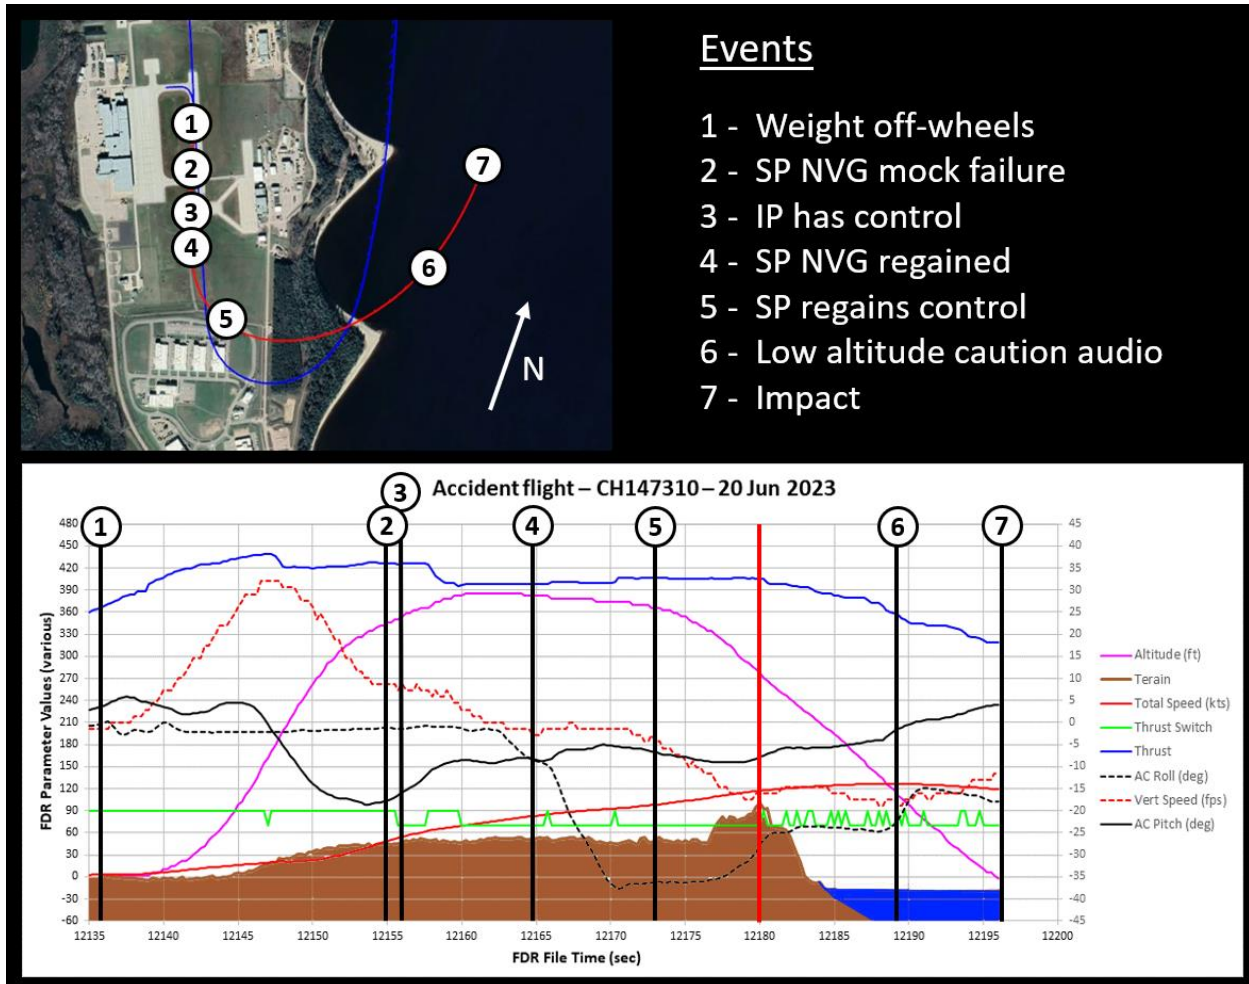
Figure G-3: Flight Path and graph of selected FDR parameters, highlighting specific events.

**NOTE 1:** Tan area represents the approximate ground profile below the flight path, based on RADALT information from FDR; area in blue represents the river.
