# Aviation Investigation Final Report

<b>Location:</b>	Windsor Locks, Connecticut	<b>Accident Number:</b>	ERA23LA135
<b>Date &amp; Time:</b>	March 3, 2023, 16:00 Local	<b>Registration:</b>	N300ER
<b>Aircraft:</b>	BOMBARDIER INC BD-100-1A10	<b>Aircraft Damage:</b>	Minor
<b>Defining Event:</b>	Loss of control in flight	<b>Injuries:</b>	1 Fatal, 4 None
<b>Flight Conducted Under:</b>	Part 91: General aviation - Personal

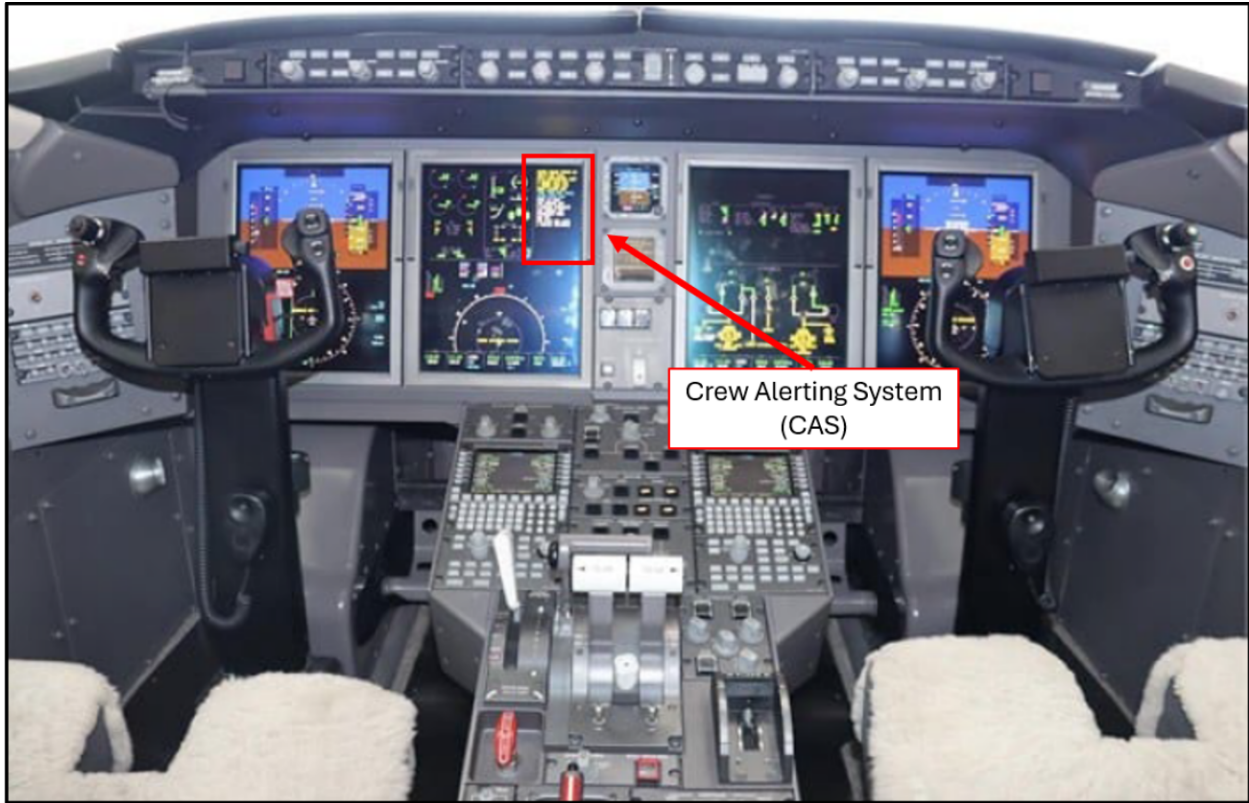
Figure 3: View of the cockpit in the accident airplane with the CAS location annotated (Source of Photo: Aircraft.com)

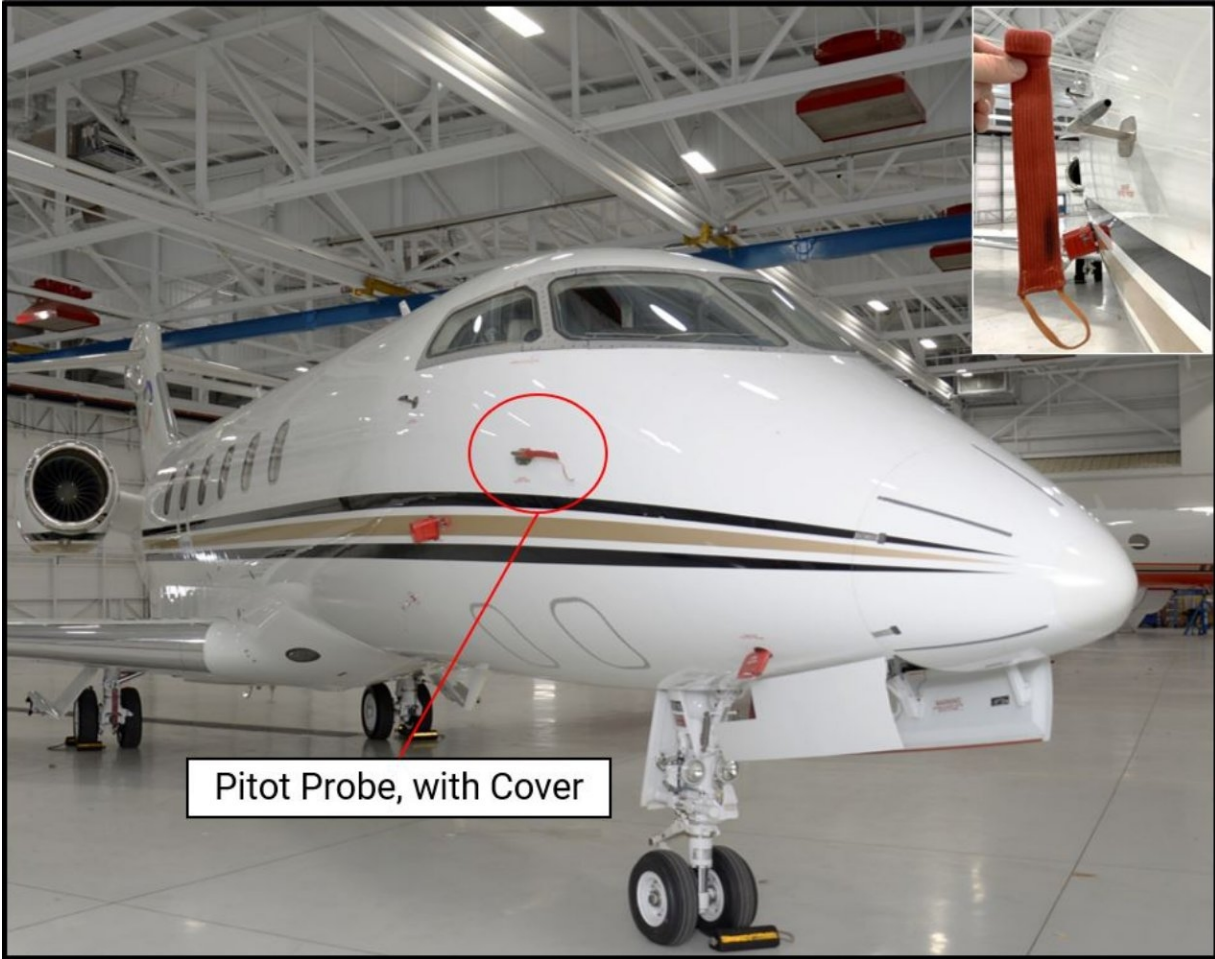
he subsequently observed that the red pitot probe cover remained installed on the right side pitot probe. The SIC removed the cover, did not see any damage to the probe, and returned to the cockpit.

Figure 4 contains photographs that were taken postaccident, which show the right pitot probe cover in place as it would have been on the day of the accident, in addition to a closer view of the red-colored cover.

*Figure 4: View of the right side forward area of the airplane showing the covered pitot probe.*

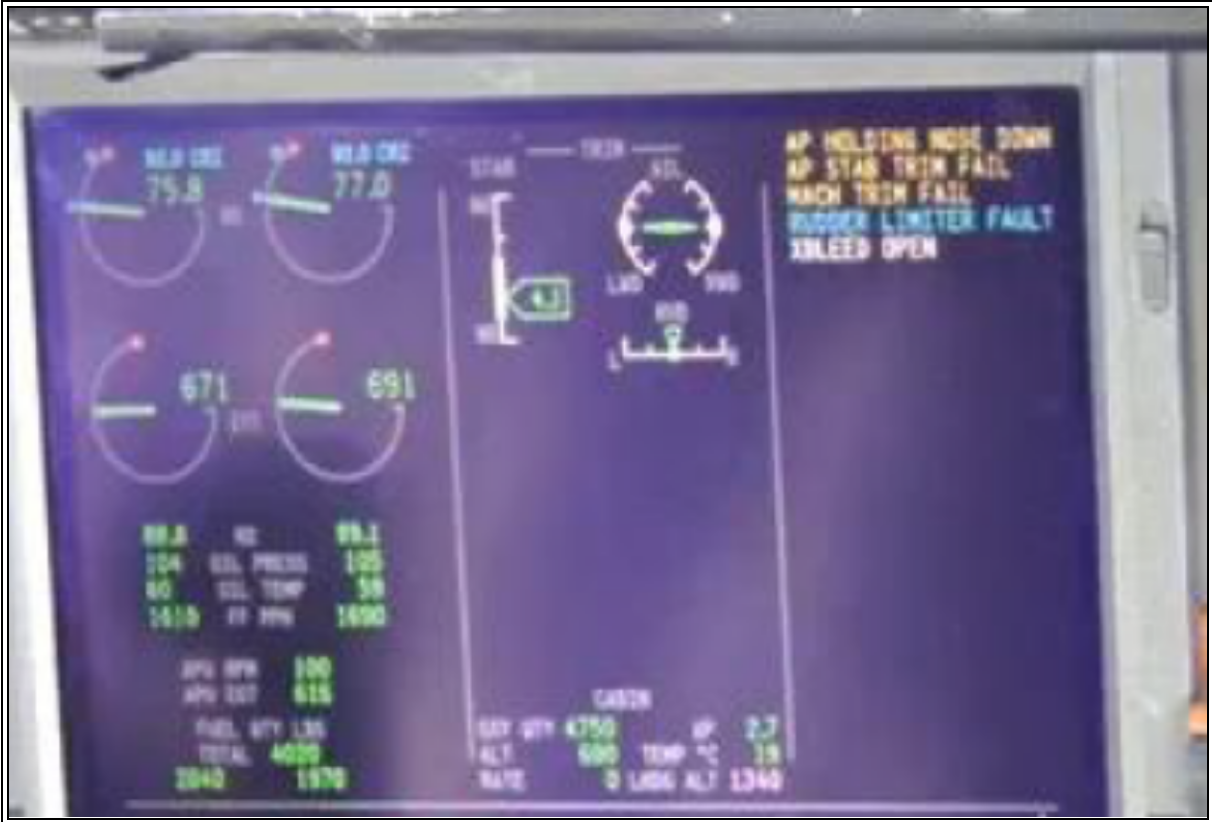
The autopilot was reengaged at 162 kts and 5,750 ft msl. The flight test vehicle was accelerated at a rate of about one knot per second. Upon reaching 182 kts, the "AP HOLDING NOSE DOWN" caution message posted. When speed was reduced below 182 kts, the "AP HOLDING NOSE DOWN" message cleared. The flight test vehicle flight crew subsequently executed the "AP STAB TRIM FAIL" checklist, which included turning the autopilot off, and returned to land without incident. Figure 8 shows the PFD and CAS displaying the series of caution messages observed with the autopilot on and with the airplane having accelerated into an out of trim condition.

Figure 8: View of the flight test vehicle in-flight with the CAS displaying a series of caution messages and advisory messages.
