# Lahaina Fire Incident Analysis Report

**September 13, 2024**  
**Columbia, MD**

This document is the second in a series of three (3) reports commissioned by the Hawai'i Department of the Attorney General (DOAG) to provide an independent review of the tragic fire that destroyed much of Lahaina, Hawai'i, on August 8-9, 2023.

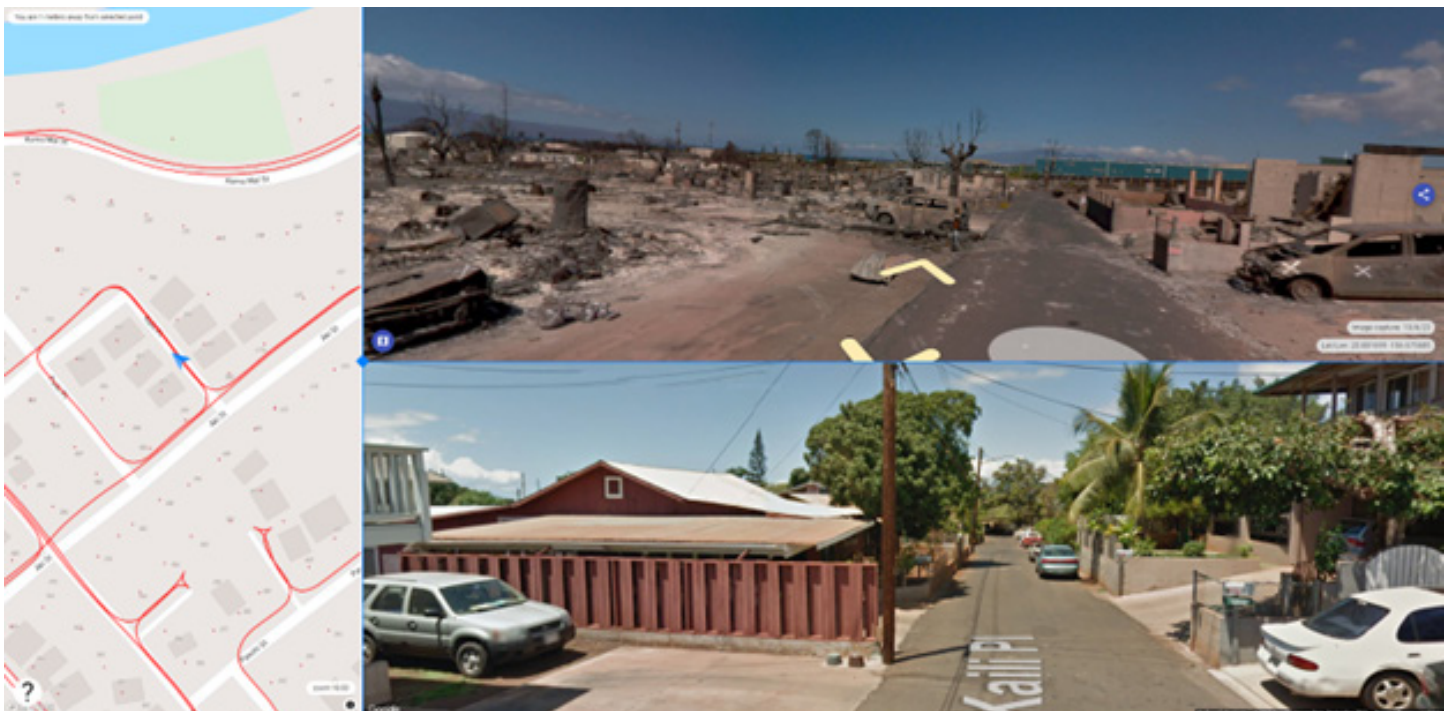
Figure 3.4.2.3.1 Kaili Place showing narrow street and vehicle parking. Pre-fire image taken September 2011 and post-fire image taken October 6, 2023.<sup>132</sup>

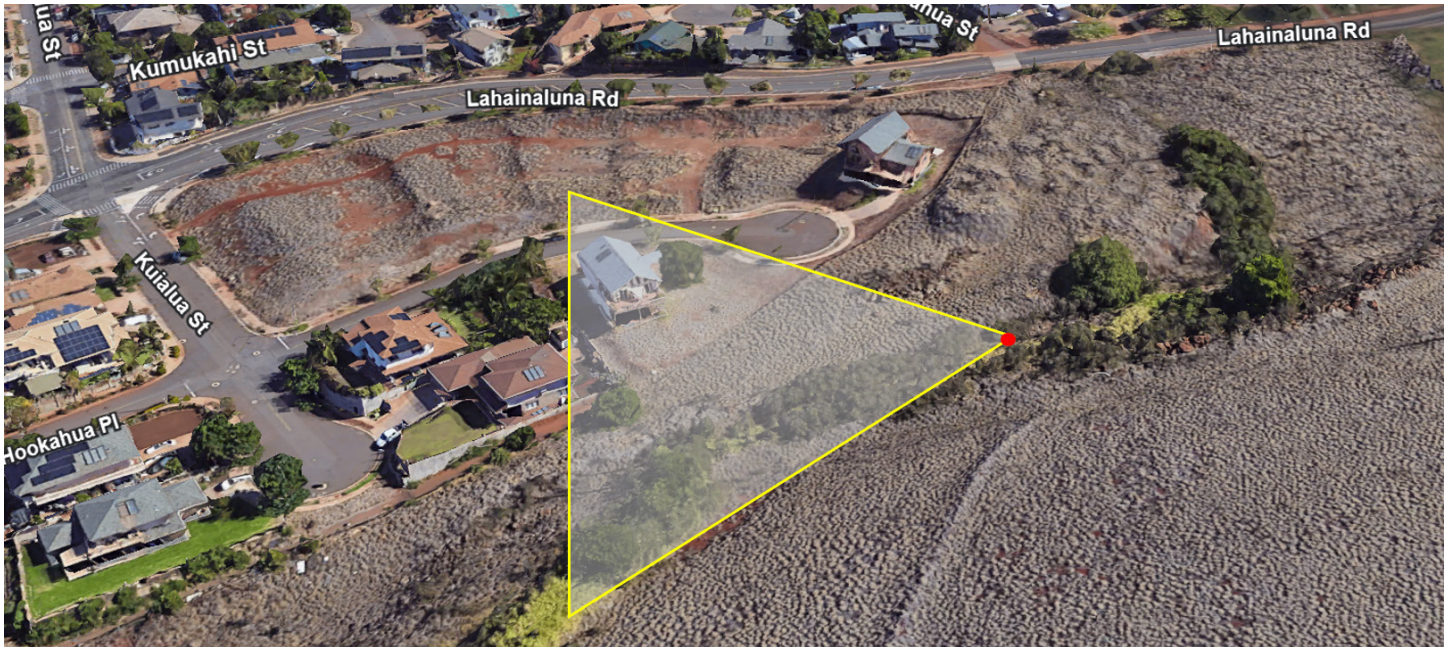
The mid-slope burn area includes a ravine with angled sides made from randomly stacked boulders of various sizes (Figure 3.7.7.3). Small tufts of dry vegetation and combustible human trash filled the voids created between the boulders. The ravine provides natural drainage, running east (mauka-higher elevation) to west (makai-lower elevation) toward the coast.

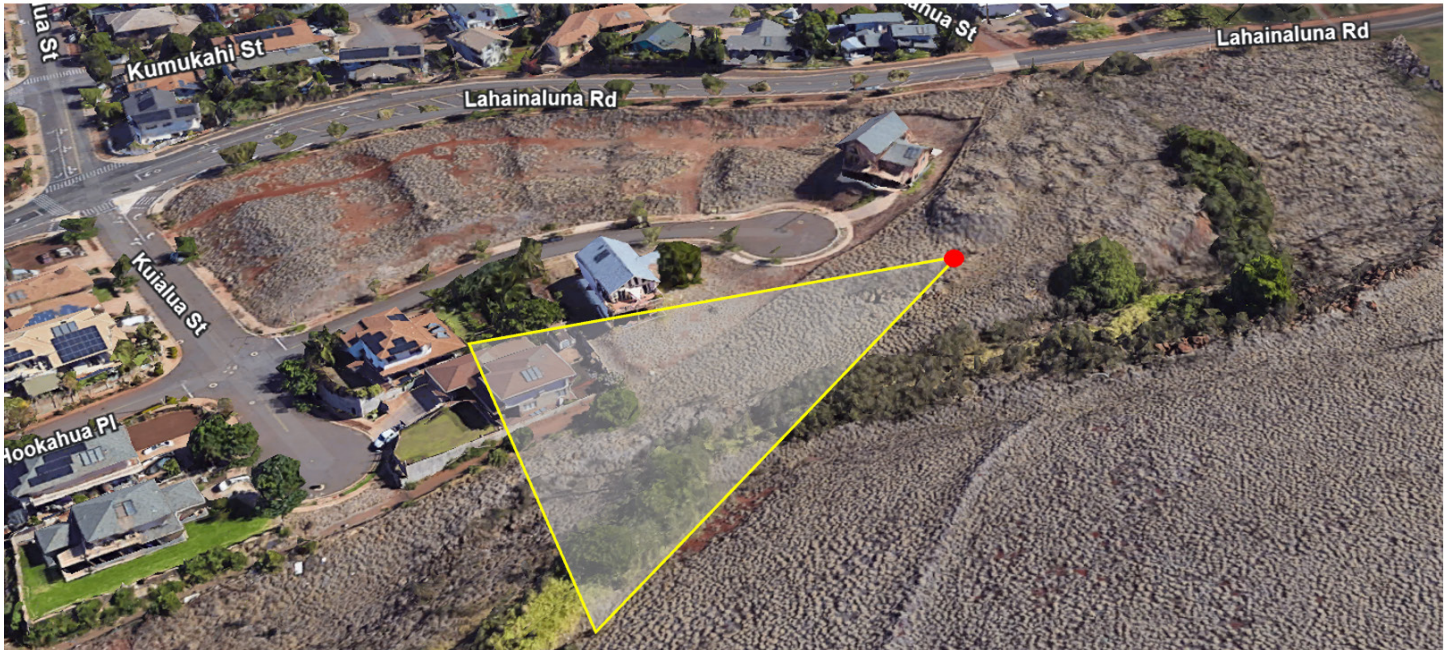
Many overhead electrical transmission lines extended over the area where the Lahaina AM fire burned, and several were directly over the ravine (Figure 3.7.7.4).

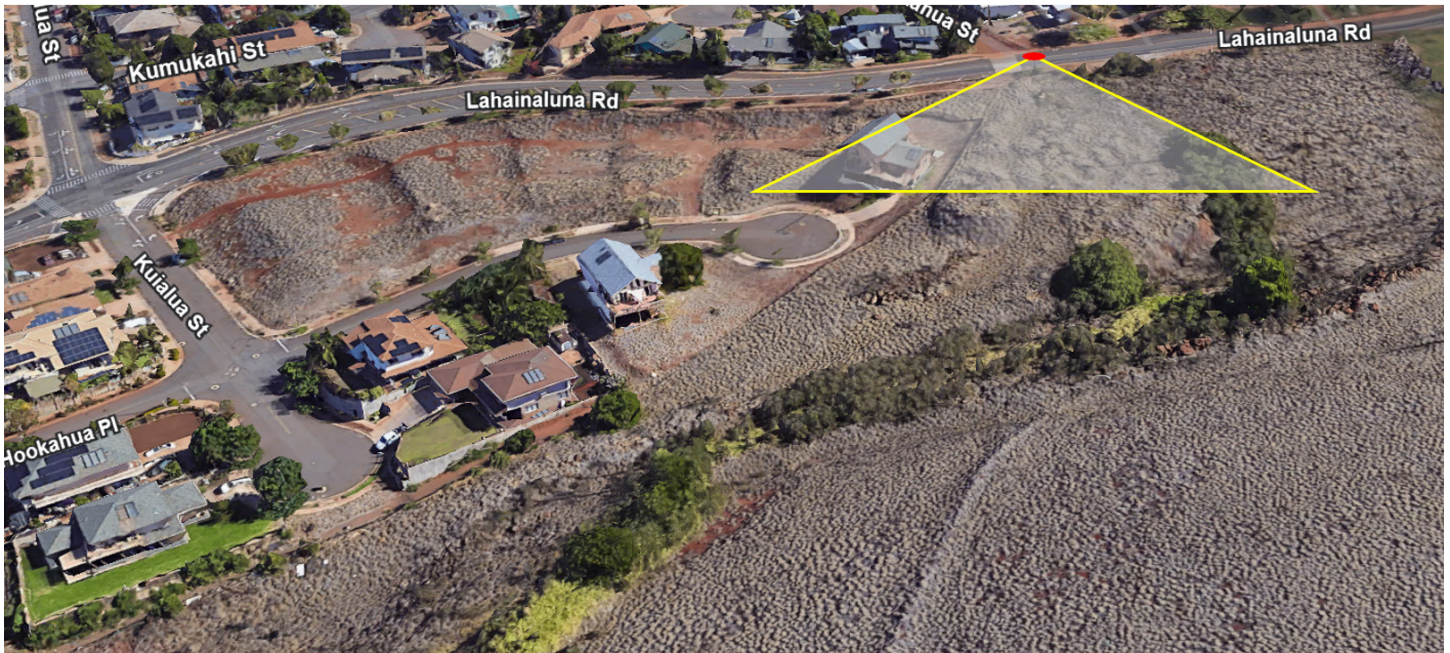
Images from before the August 8, 2023, fire show the highly invasive non-native buffelgrass and haole koa dominating the area just behind the homes off of Ho'okahua Street and on the southside of Lahainaluna Road, across from the intermediate school (Figure 3.7.7.5).

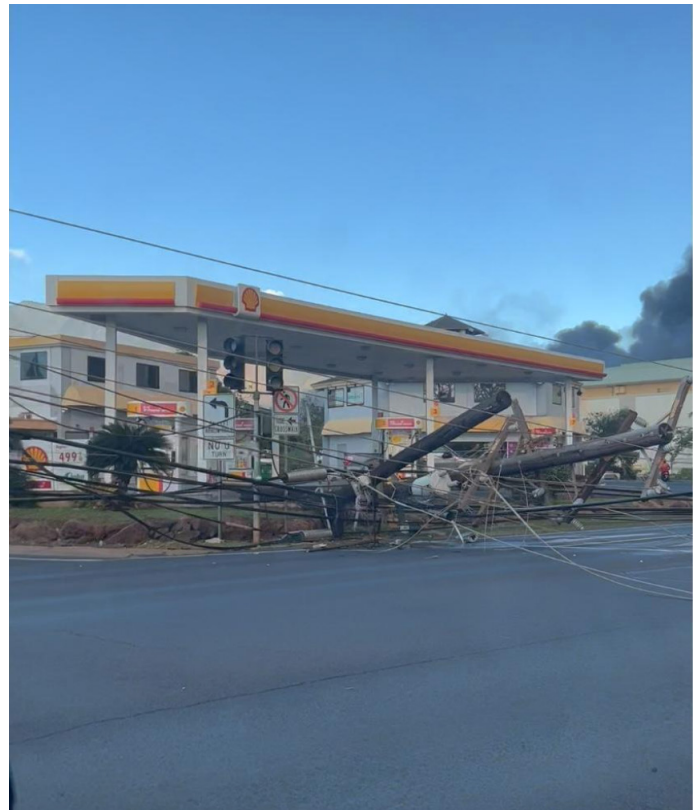
Figure 3.8.2.1 Several downed utility poles and powerlines in the northbound lane of Hwy-30 and Kapunakea Street. Photo taken August 8, 2023, at 16:52. Inset: Viewpoint of photo of downed utility poles and electrical lines at Hwy-30 and Kapunakea Street.

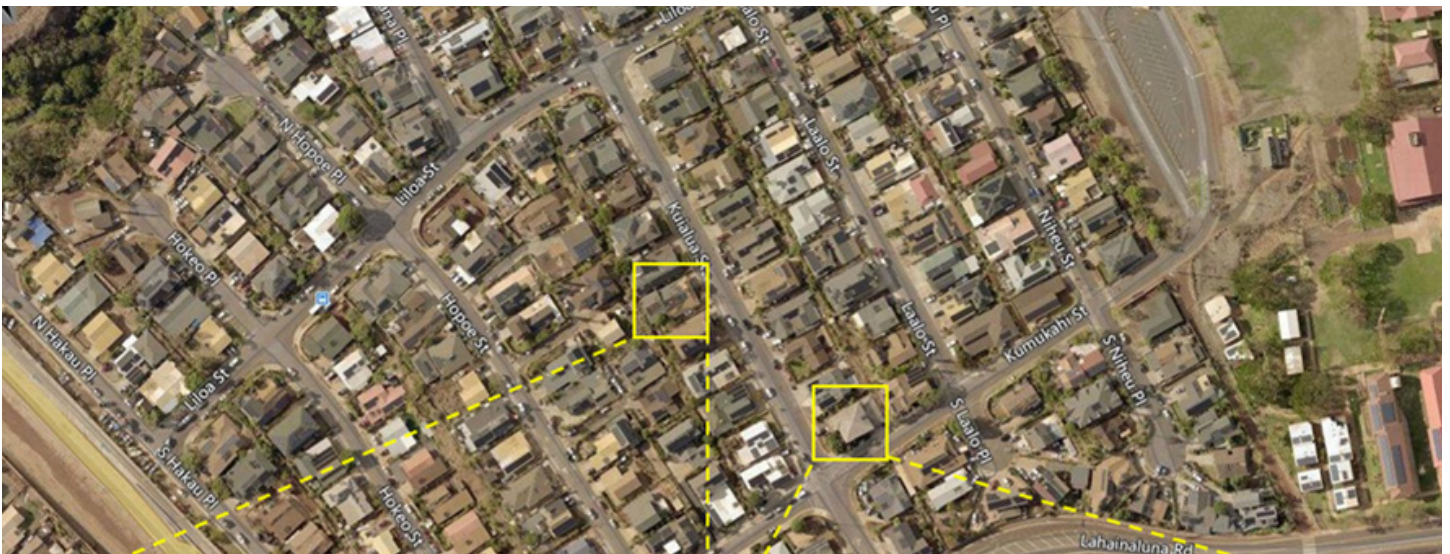
Figure 4.3.3.2.3 Example of wind damage in the Kelaweia Mauka III subdivision—(bottom left) damaged roof sheathing and (bottom right) loss of roof covering.

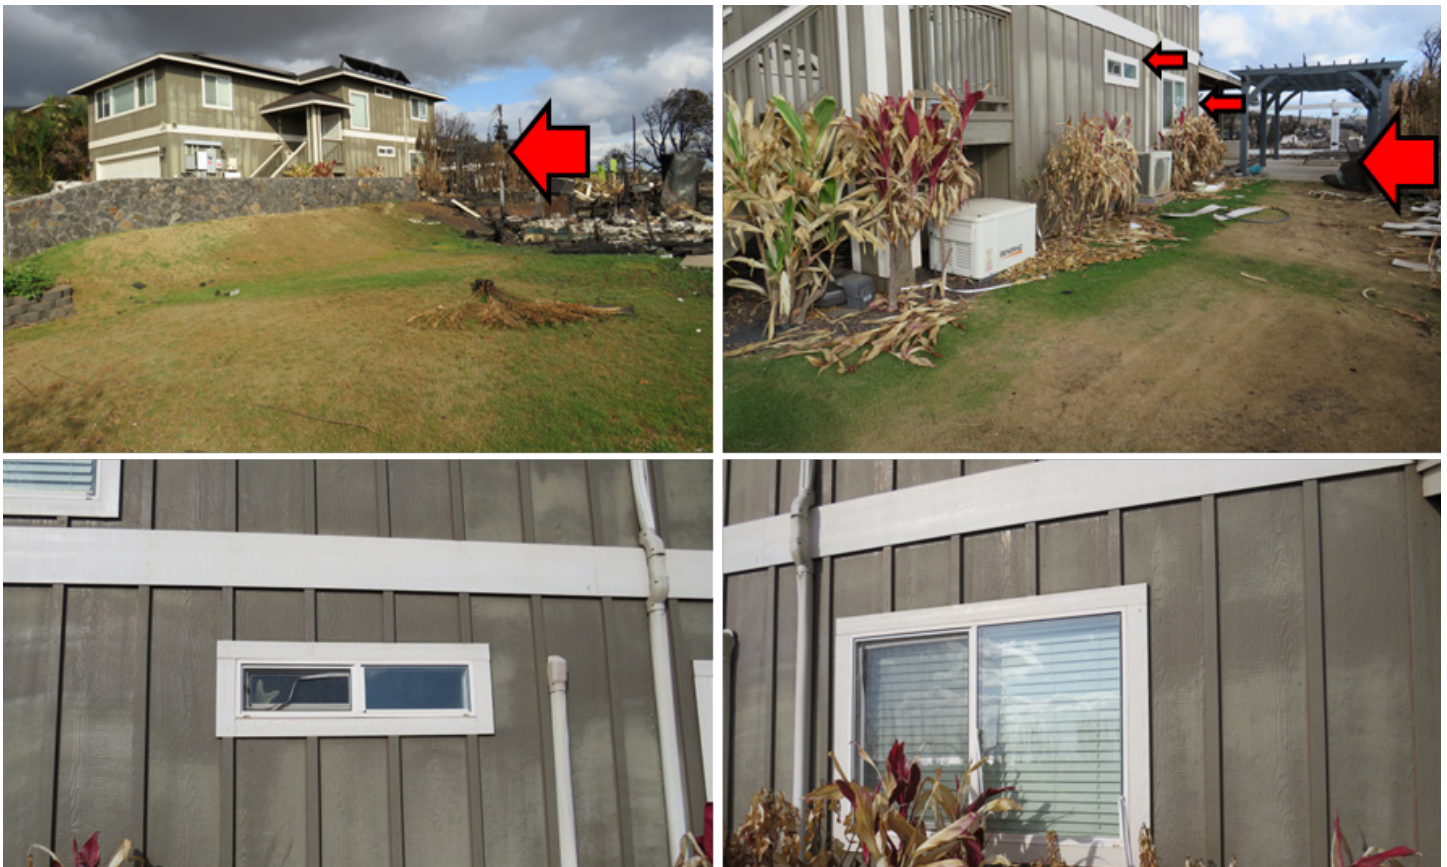
Figure 4.3.3.3.3 Damage classification assessment map to 3█ Komo Mai Street from (destroyed) 3█ Komo Mai Street; approximately 24 foot separation distance. Top left image shows both addresses, top right indicates the radiant heat vector in the generally opposite direction of fire spread. Bottom images show discoloration of fiber cement siding and deformation of vinyl window frames.

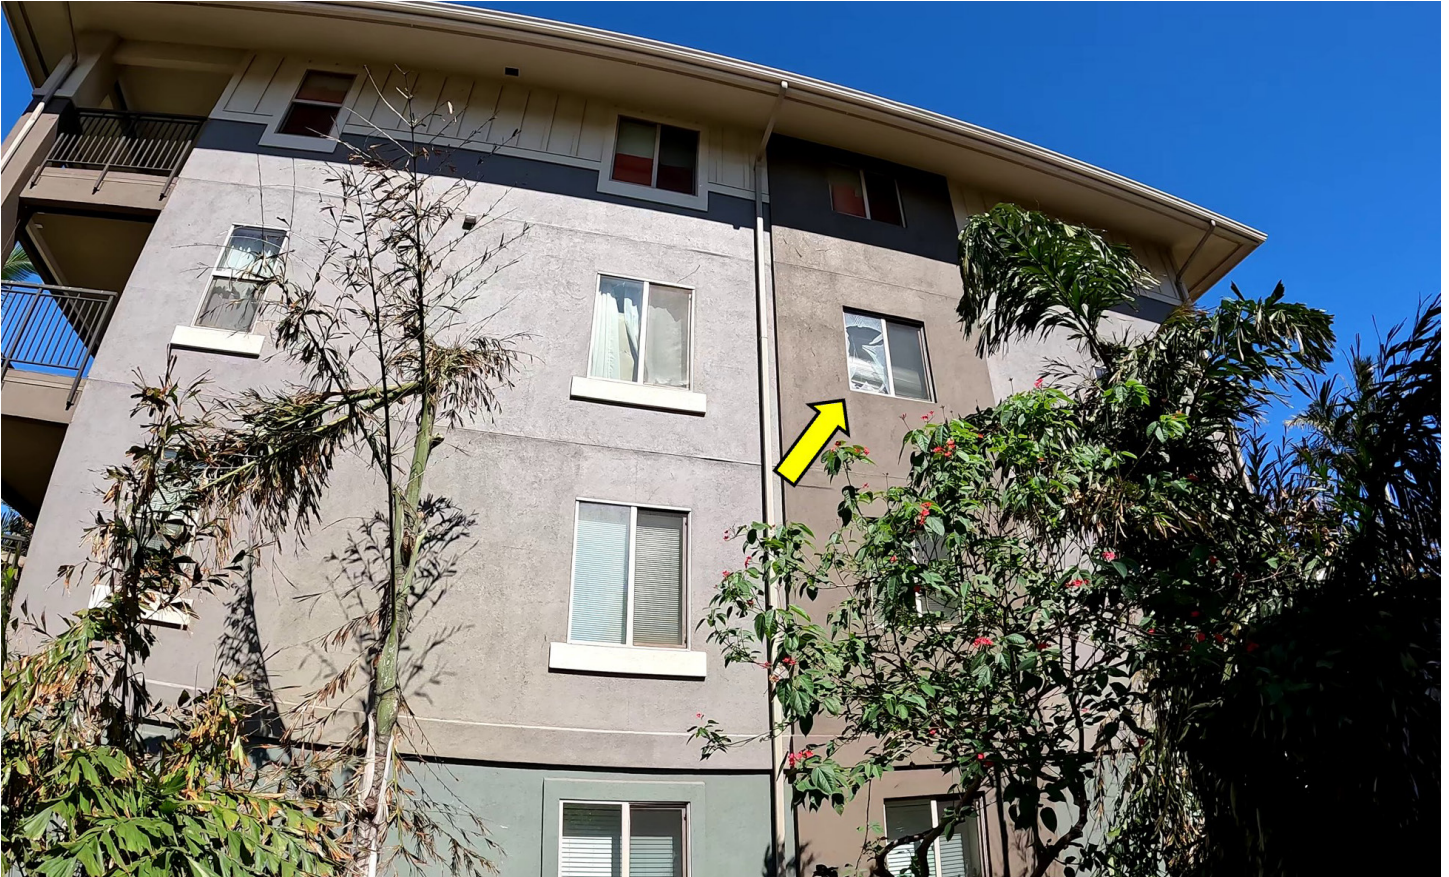
Figure 4.3.3.4.6 Broken window on third floor of eastern (mauka) side of apartment building, likely caused by windborne debris.

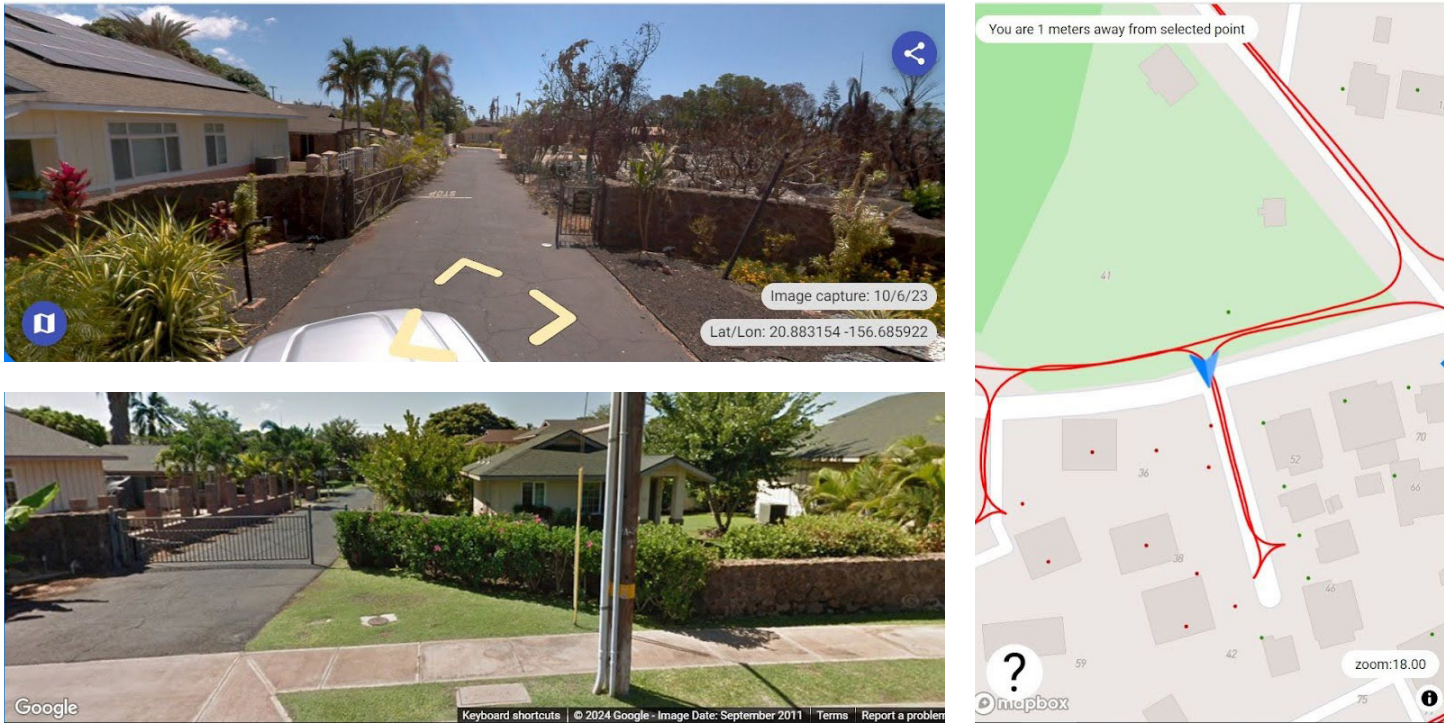
Figure 4.3.3.6.3 Pre- and post-fire Google Street View imagery of Ala Moana Street private driveway. This road is a demarcation of destruction, nearly all of the structures on the ocean (makai) side are destroyed.

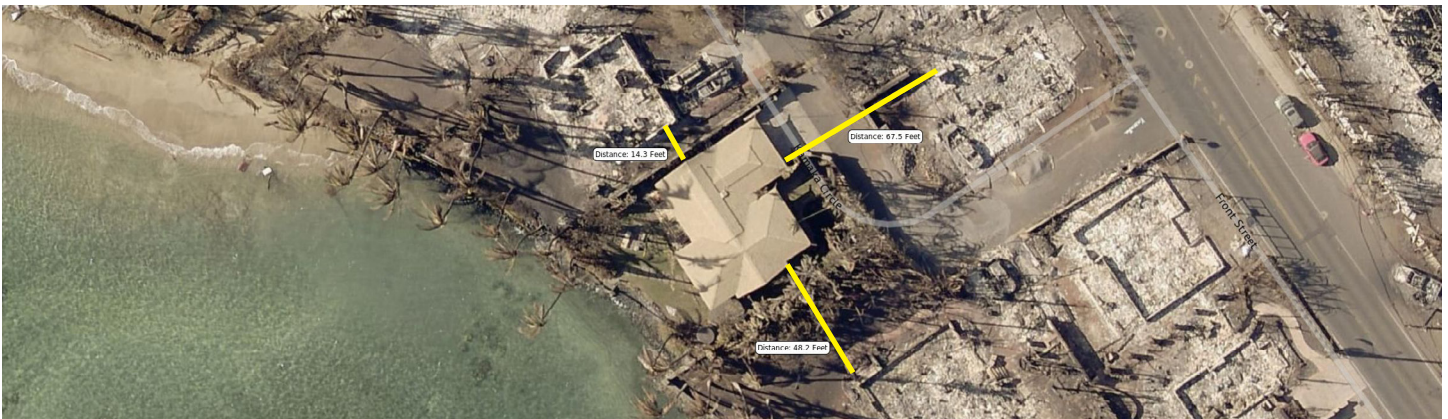
Figure 4.3.3.6.7 Post-fire aerial imagery of 1█ Kamaka Circle (damaged), surrounded by destroyed structures.

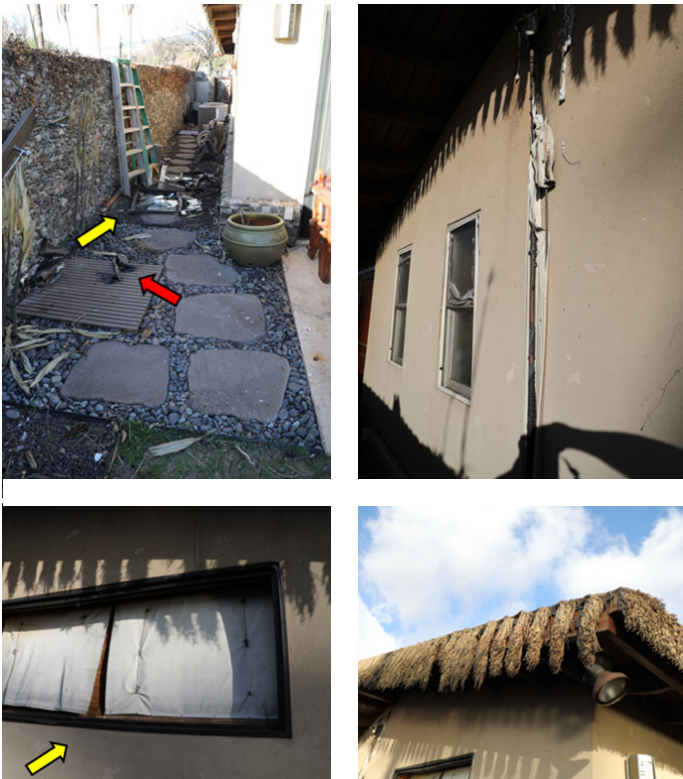
Figure 4.3.3.6.9 Close-up images of the structure at 1■ Kamaka Circle, showing that the extent of damage varied by multiple factors. Yellow arrow indicates the vinyl window frame that was impacted by radiant heat and fell out. Red arrow indicates ember ignition of wooden deck for what appears to be an outdoor shower.

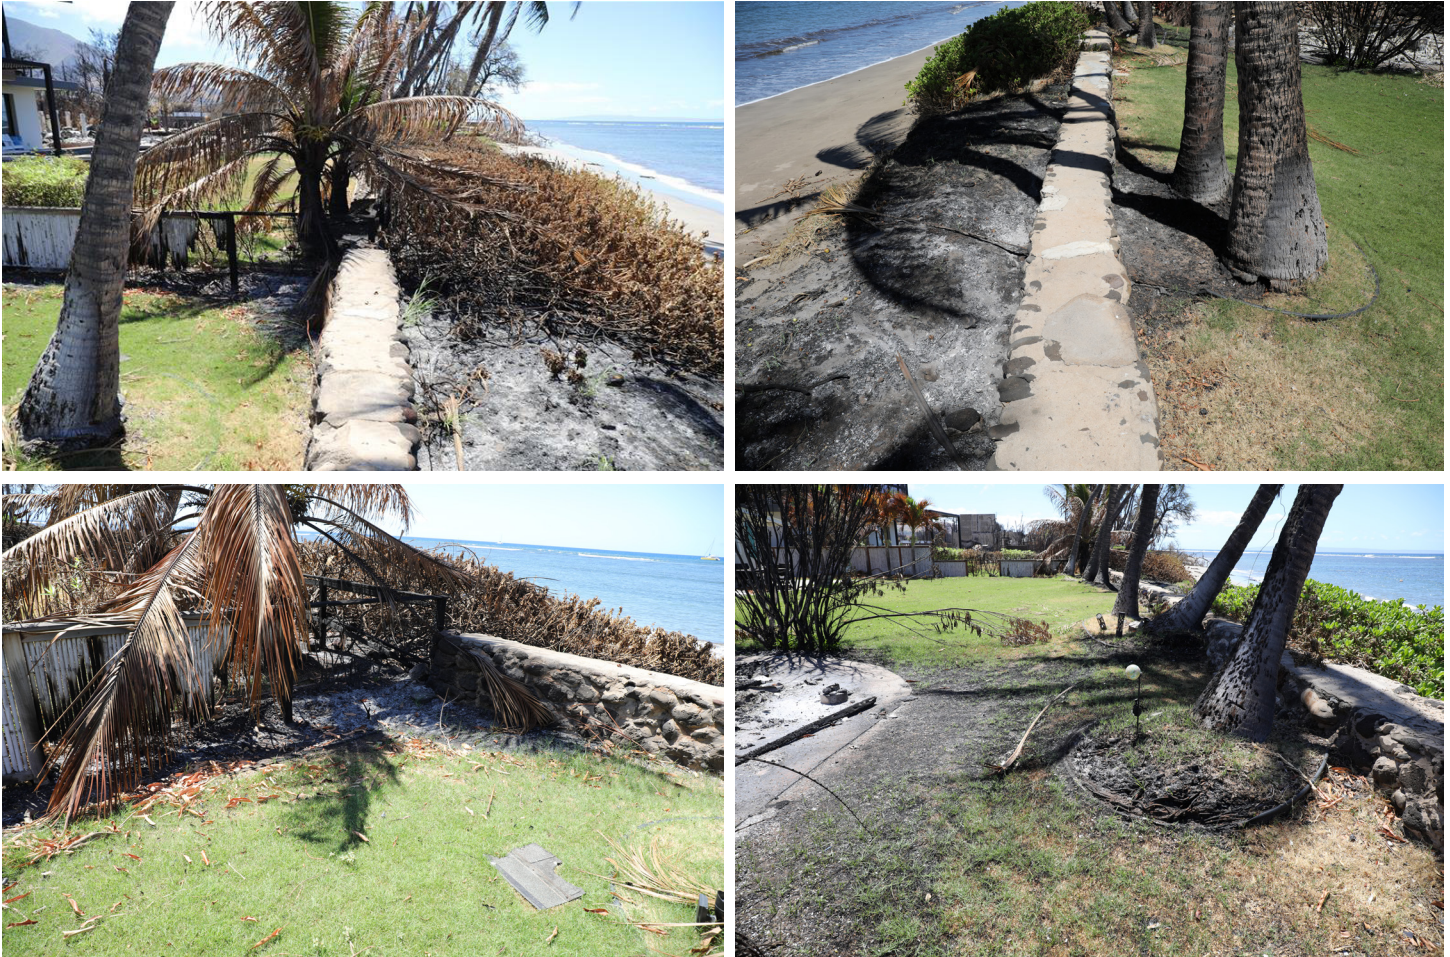
Figure 4.3.4.1.16 Vegetation fire west (makai) of the property line for 4█ Front Street appears to cross into the backyard at the 4█-4█ Front Street property fence line and near large trees proximate to the wall. Note destroyed accessory structure to the left of the bottom, right image.

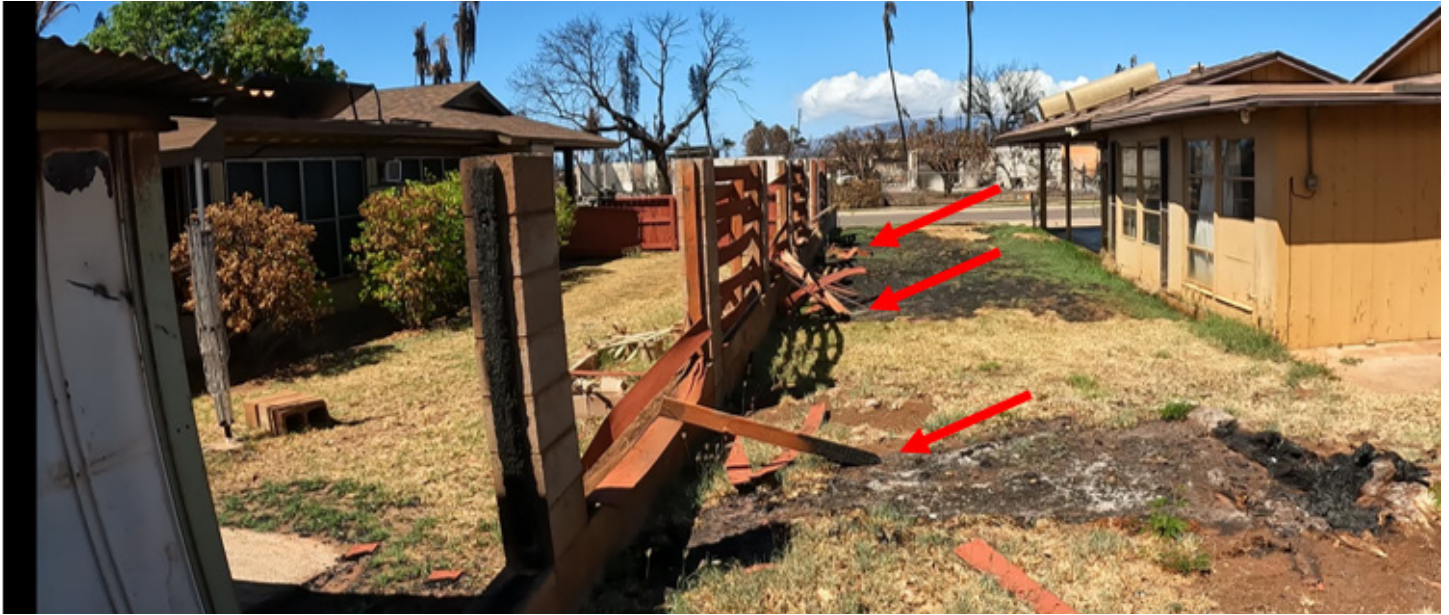
Figure 4.3.4.2.6 Grass fire to the south of 4<sup>th</sup> 'Ālī'ō Street appears to have ignited in multiple locations where charred sections of the fence from the 4<sup>th</sup>-4<sup>th</sup> 'Ālī'ō Street property line landed in dry grass. While it propagated near the wooden structure on the southside of 4<sup>th</sup> 'Ālī'ō Street, it did not transition to the structure.

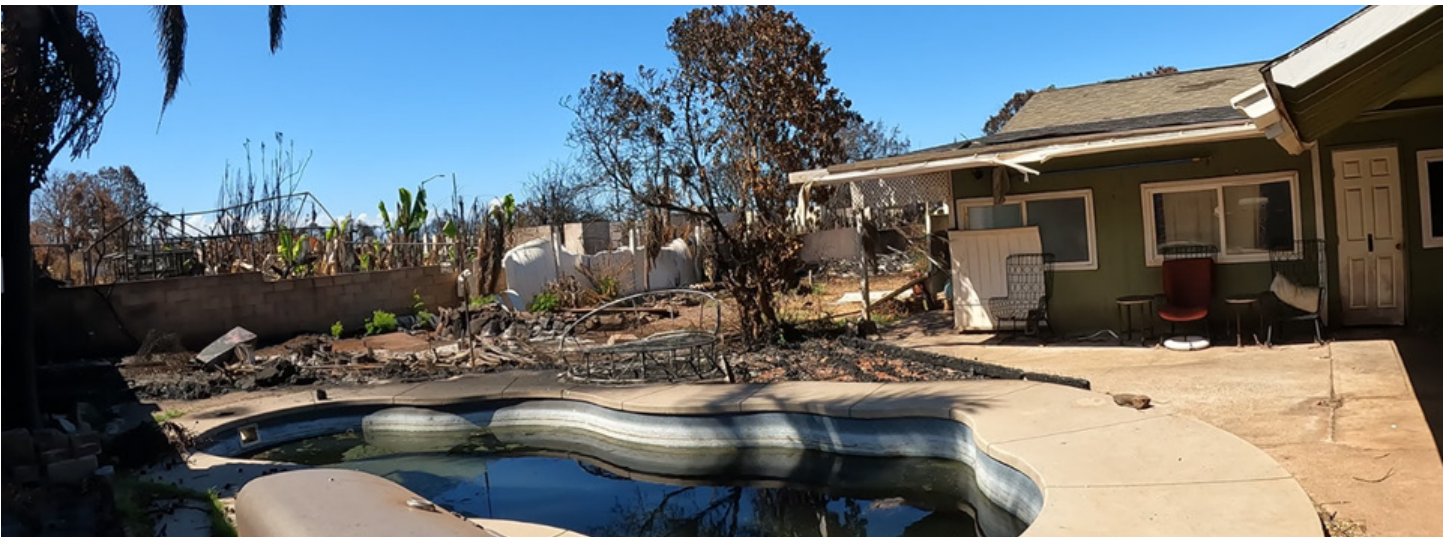
Figure 4.3.4.2.13 Exterior fire in the south yard of 7 Kāua'ula Road destroyed outdoor furnishings and structures up to the corner of the main residential structure. However, these fires did not spread to the south of the residence and appeared to result only in damage to the plastic gutter in the southwest corner.

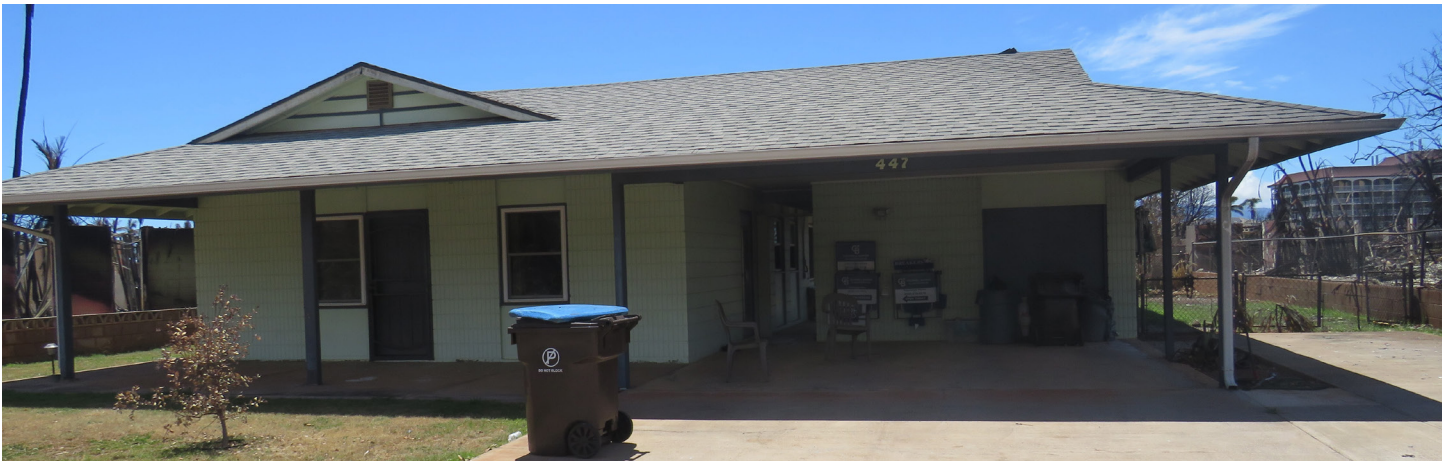
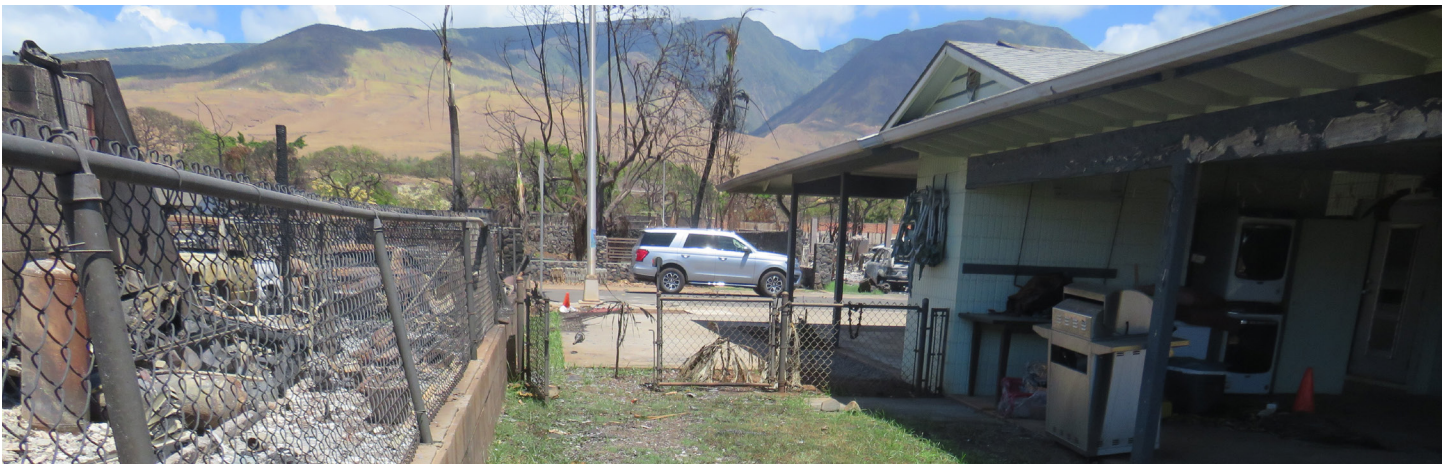
Figure 4.3.4.2.18 Radiant heat damage to the structure and household belongings at 447 Ālīō Street was noted primarily on the north side.

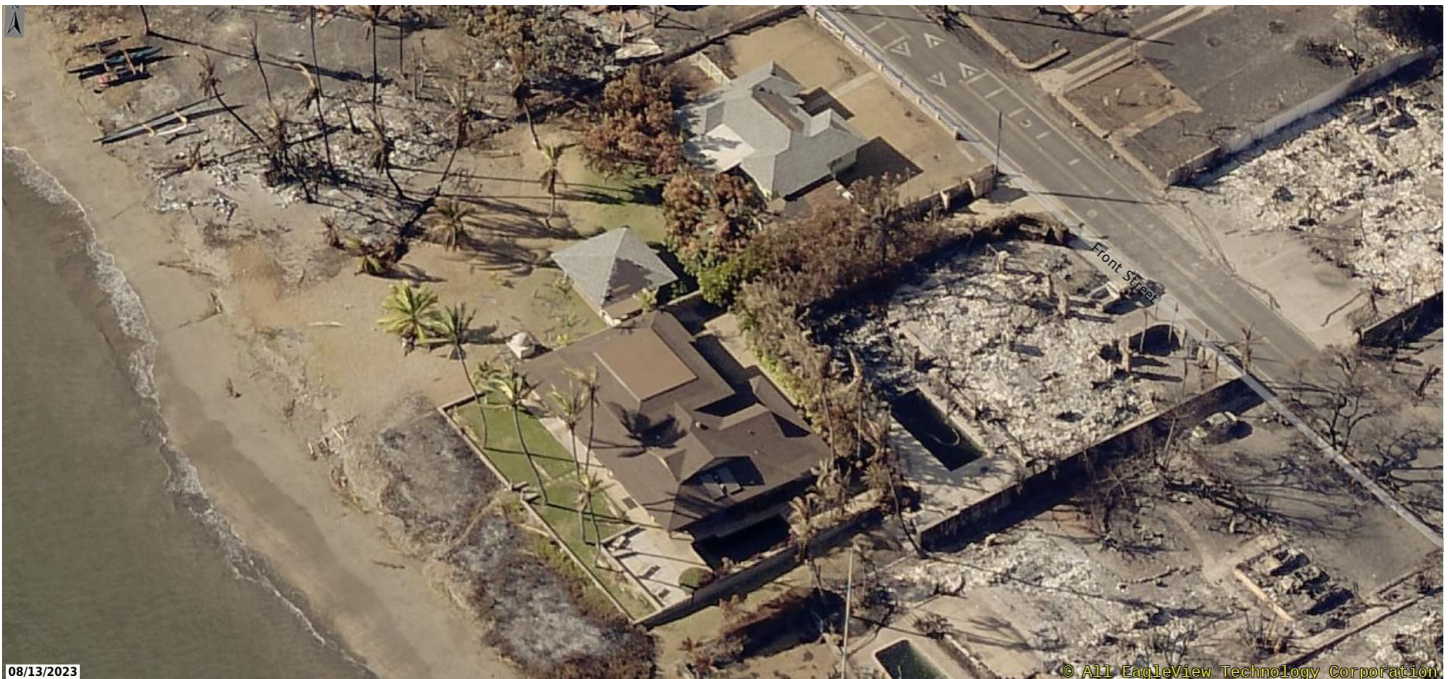
Figure 4.3.4.2.20 Examples of open/broken windows and/or screens in this cluster of surviving homes. (Figure 4.3.4.3.1 continues on page 254.)

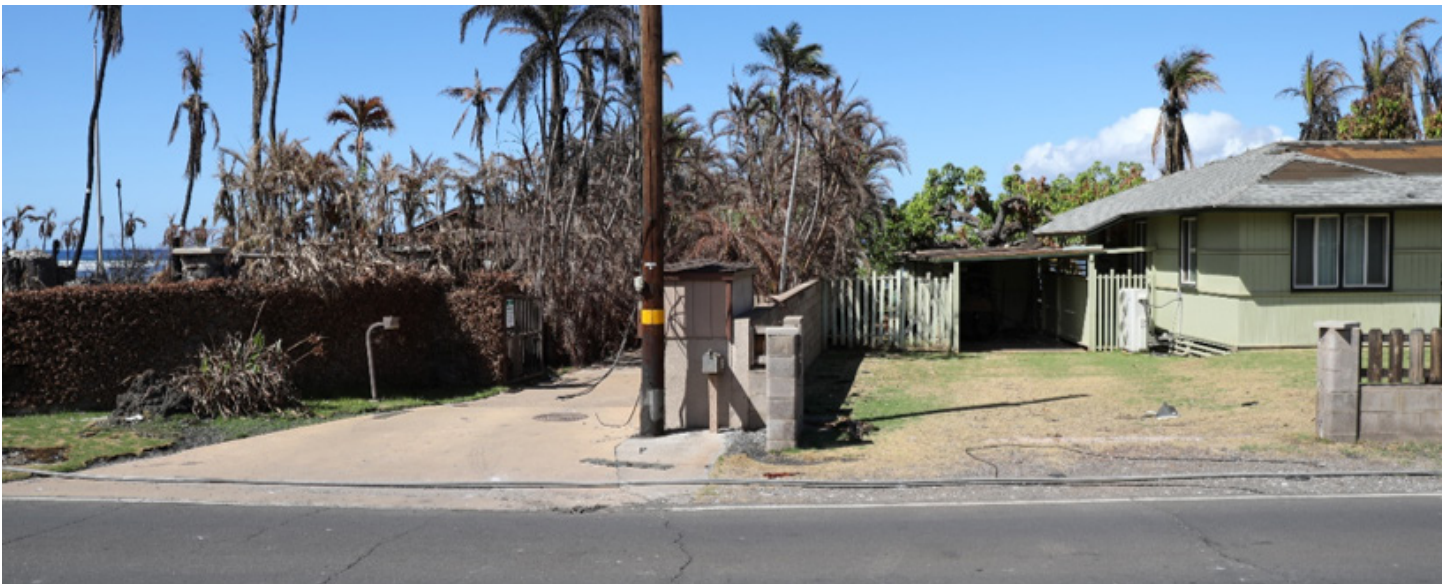
Figure 4.3.4.3.4 Tall, lush vegetation was planted along block walls on either side of the driveway to 3█ Front Street, which may have provided protection to the 3█ and 3█ Front Street lots. The block wall south of 3█ Front Street also influenced the ember movement. Note pile up in corner of wall (bottom left) and wind driven burn scar in grass around the wall toward the front of the structure showing the likely path of ground based embers deflected towards the north and away from the open garage (bottom right).

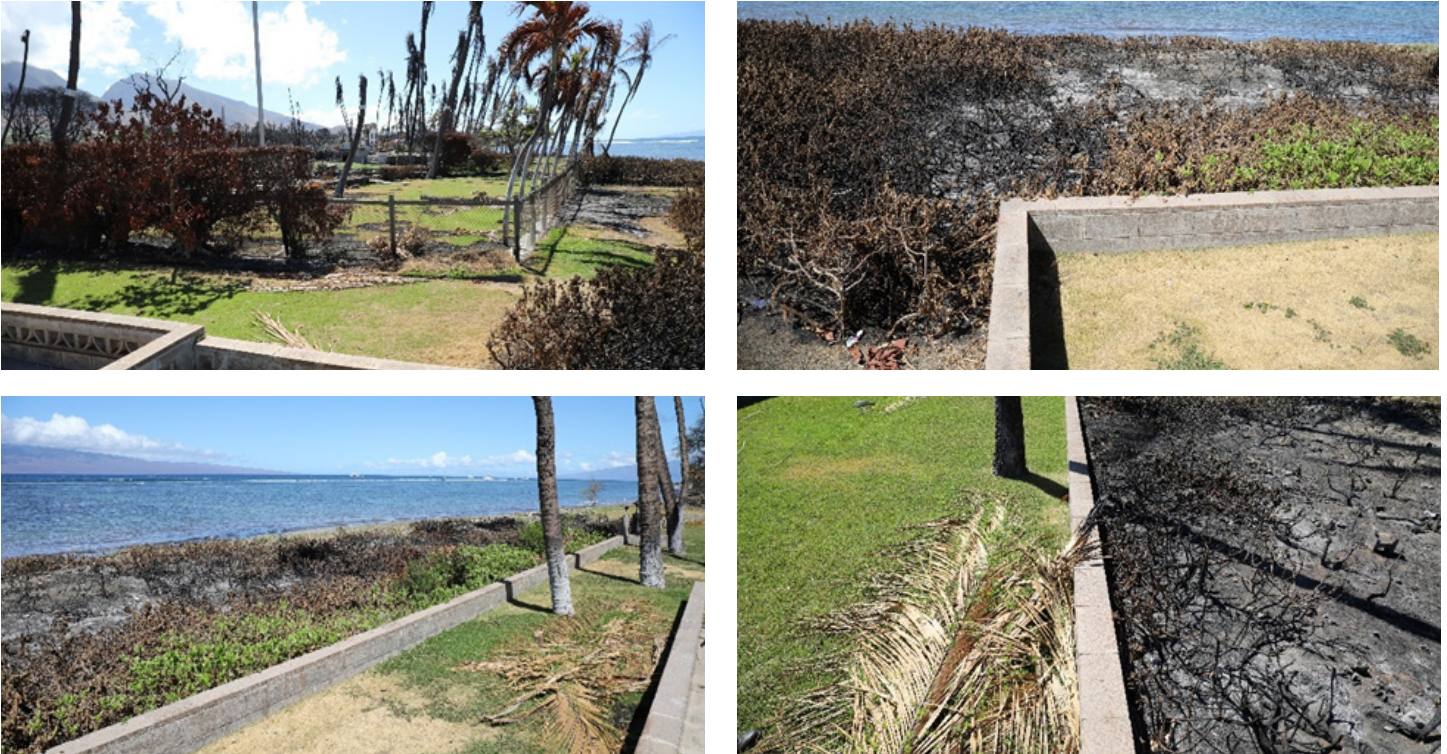
Figure 4.3.4.3.11 Vegetation fire to the west (makai) of 3█ Front, largely confined west (makai) of the low block wall at the edge of the grass yard.

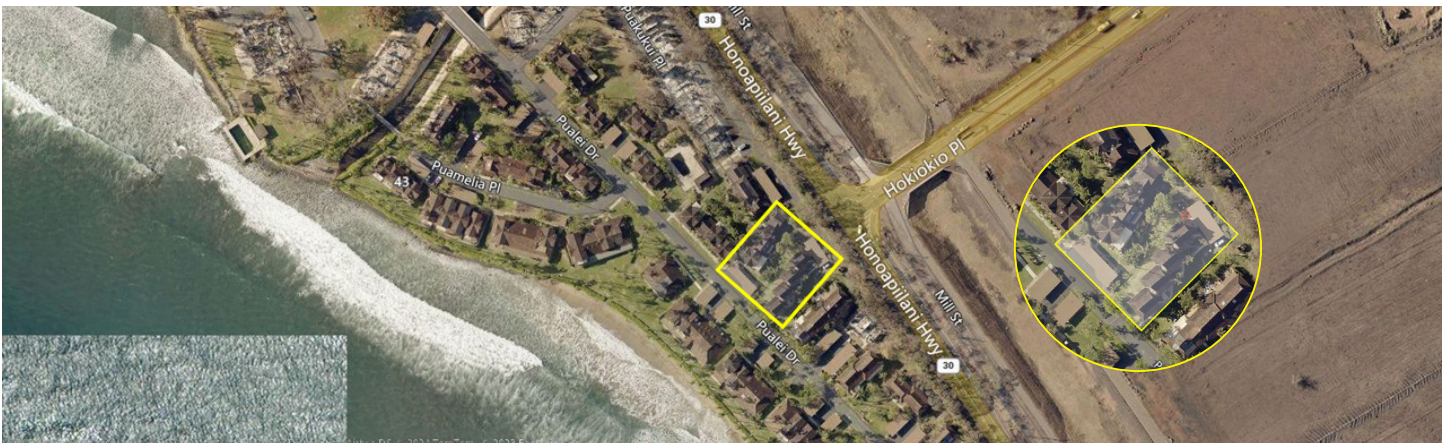
Figure 4.3.4.4.11 Spotting across Puakukui Place in front of structures (top left) 1 and (top right) 1. Embers found a receptive fuel bed to ignite, but not sustain burning through the green grass. Inset: Viewpoint showing above images.

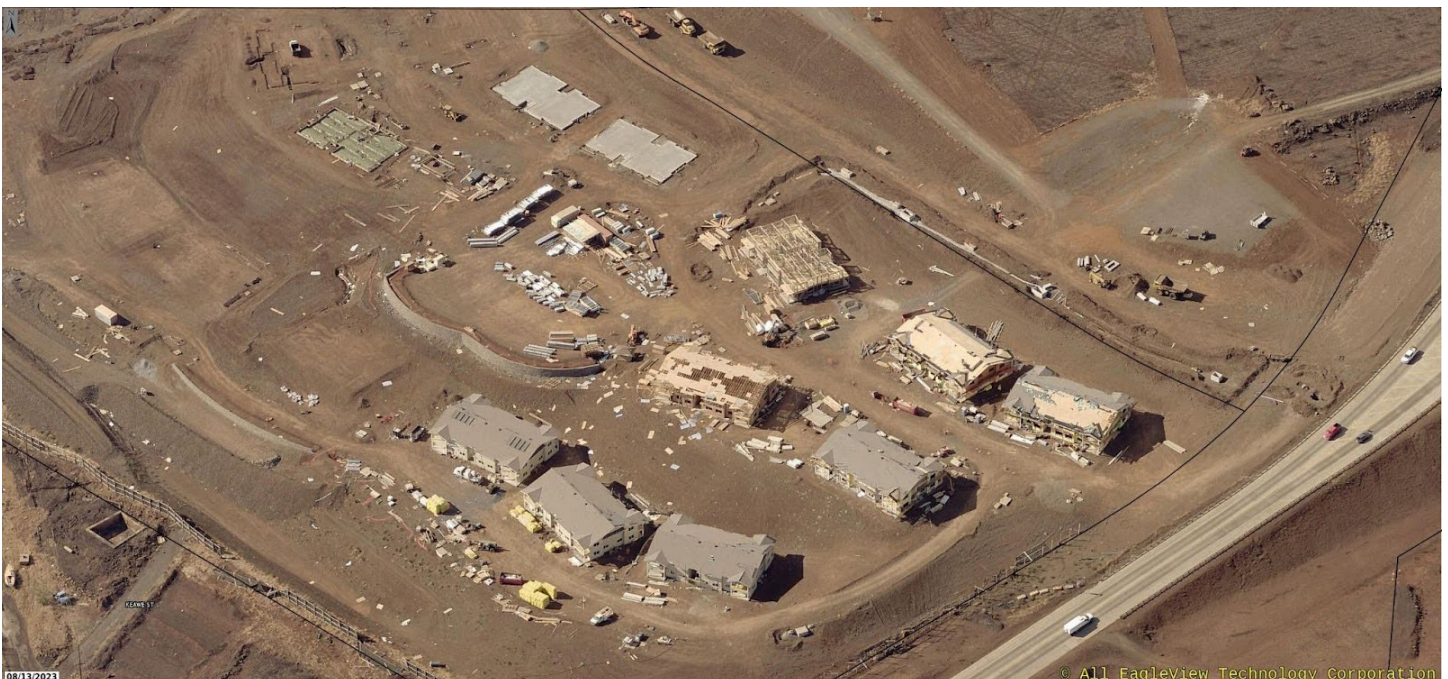
Figure 4.3.5.2.3 Wind damaged apartments at the construction site.

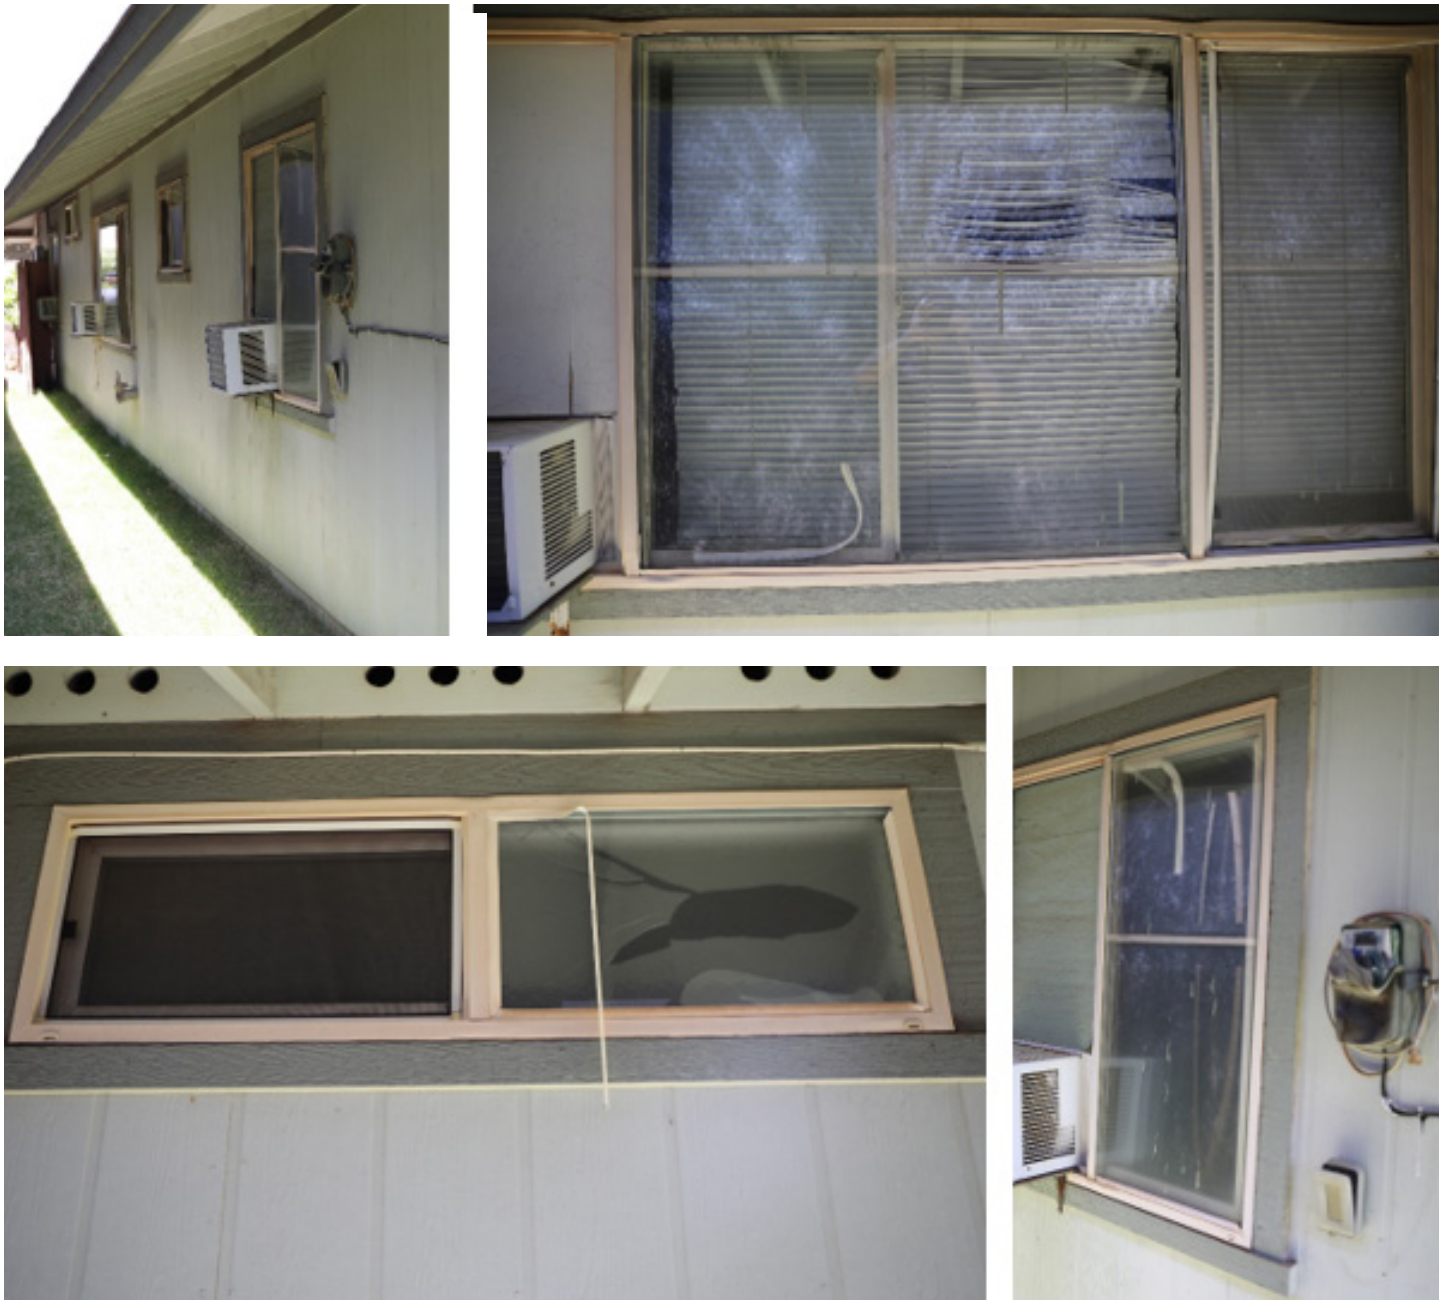
Figure 4.3.5.3.15 West side (makai) of 1█ 'Aipuni showing melted plastic components, damaged/broken window assemblies, and deformed window blinds likely caused by radiant heat transfer.
