**WEST VIRGINIA DEPARTMENT OF ENVIRONMENTAL PROTECTION
WV OIL AND GAS CONSTRUCTION STORMWATER PERMIT**

FACILITY NAME:	Mountain Valley Pipeline Project		REG. #	EXPIRE DATE:
PERMITTEE	MOUNTAIN VALLEY PIPELINE, LLC		WVR310667	5/13/2018 Extended: 12/31/2018
ADDRESS/PHONE:	Attn: MATTHEW HOOVER 625 LIBERTY AVE, ST 1700 PITTSBURG, PA 15222 7248733645			
LOCATION:	39° 33' 45" N, 80° 32' 34" W		Entry Date/Time:	5/9/2018 1545
COUNTY:	Wetzel		Exit Date/Time:	5/9/2018 1800
Site Representative /Phone	Percy Jones/ 304-362-2797		PHOTOS <input checked="" type="checkbox"/>	
CO-PERMITTEE:		ADDRESS:		
SITE OPERATOR:	Trinity Energy Services		ADDRESS:	200 Highland Circle, Argyle, TX 76226
PERMITTED ACREAGE	4311	WEATHER:	Clear	LAST INSPECTION: 5/2/2018
RECEIVING STREAM(S)	Mobley Rn/ North Fk/ Fishing Ck/ Ohio Rv			NOV: 1
Regular Mail <input type="checkbox"/> Certified Mail <input checked="" type="checkbox"/>	Tracking #			
OVERALL FACILITY RATING:	Unsatisfactory	COMPLIANCE OUTCOME	Not Immediately Corrected

STATE OF WEST VIRGINIA
Department of Environmental Protection
Environmental Enforcement
NOTICE OF VIOLATION

Violation No W18-52-001-CP

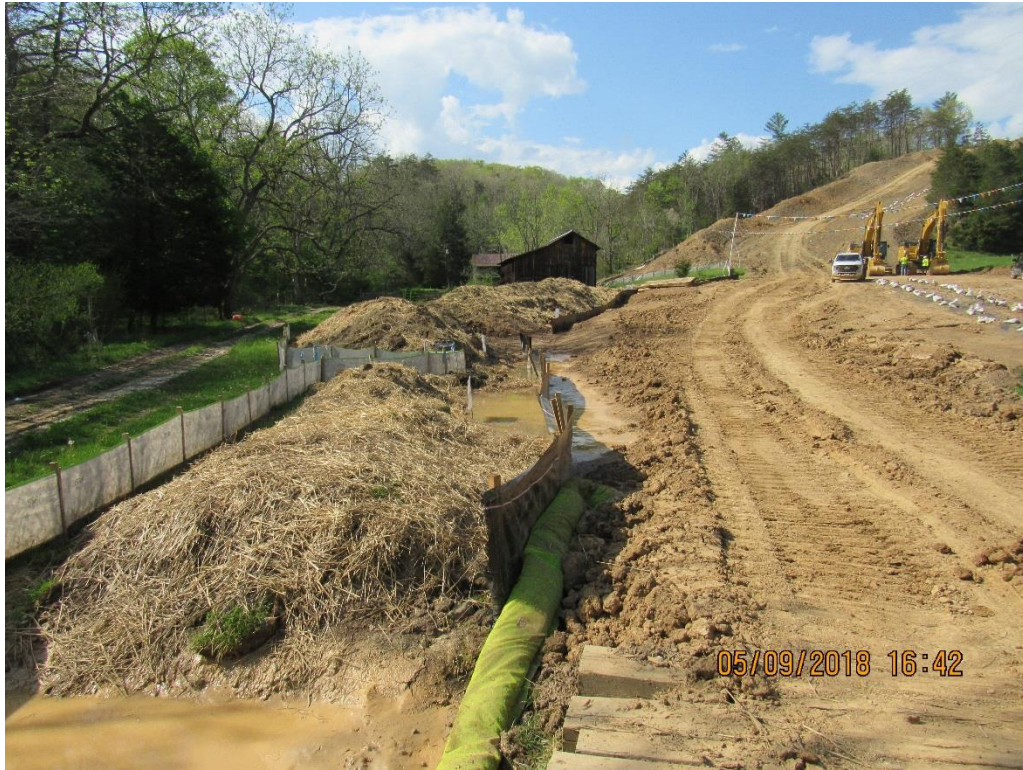
- Slate Run Road (station 9624+00, sheet 9.17)- Black silt fence delineates topsoil stockpiles and was overtopped, and water run running in front of black silt fence. Sump is located downslope of topsoil stockpiles, perimeter fencing is downslope of sump, as well as a vegetative buffer. No indication of sediment laden water leaving the site at this area. (Photo 1 & 2)

Photo 1: Delineation of topsoil stockpiles from subsoil with black silt fence and path to sump prior to stream.

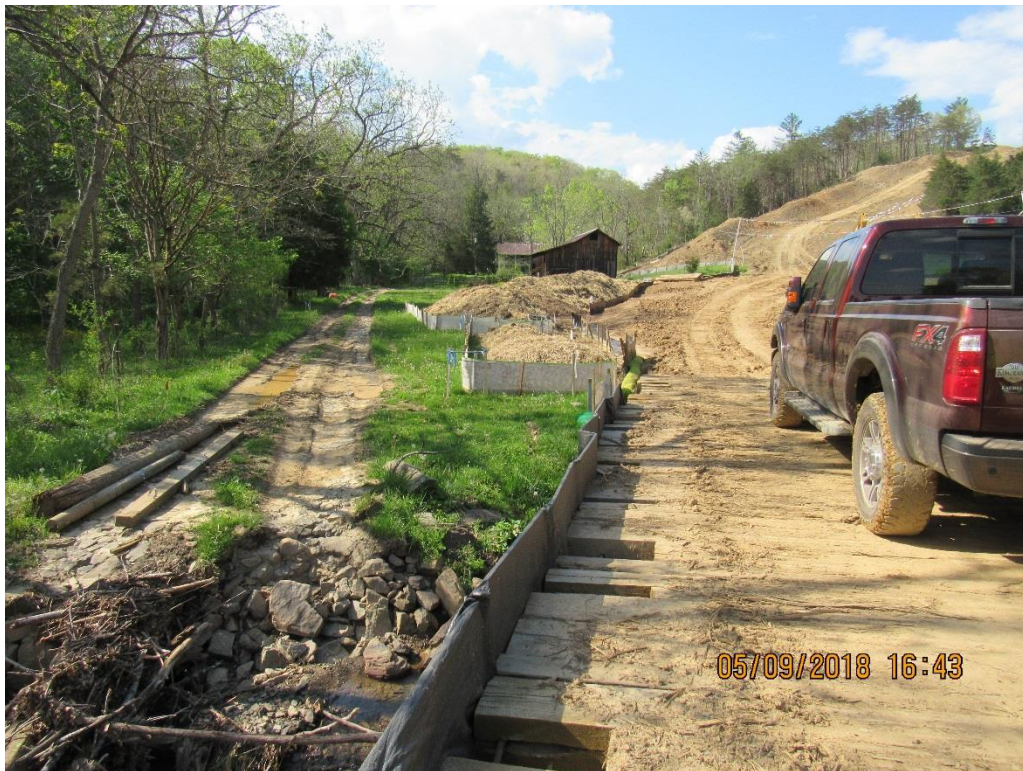
Photo 2: Topsoil delineation, sump, perimeter fencing and vegetative buffer prior to stream.

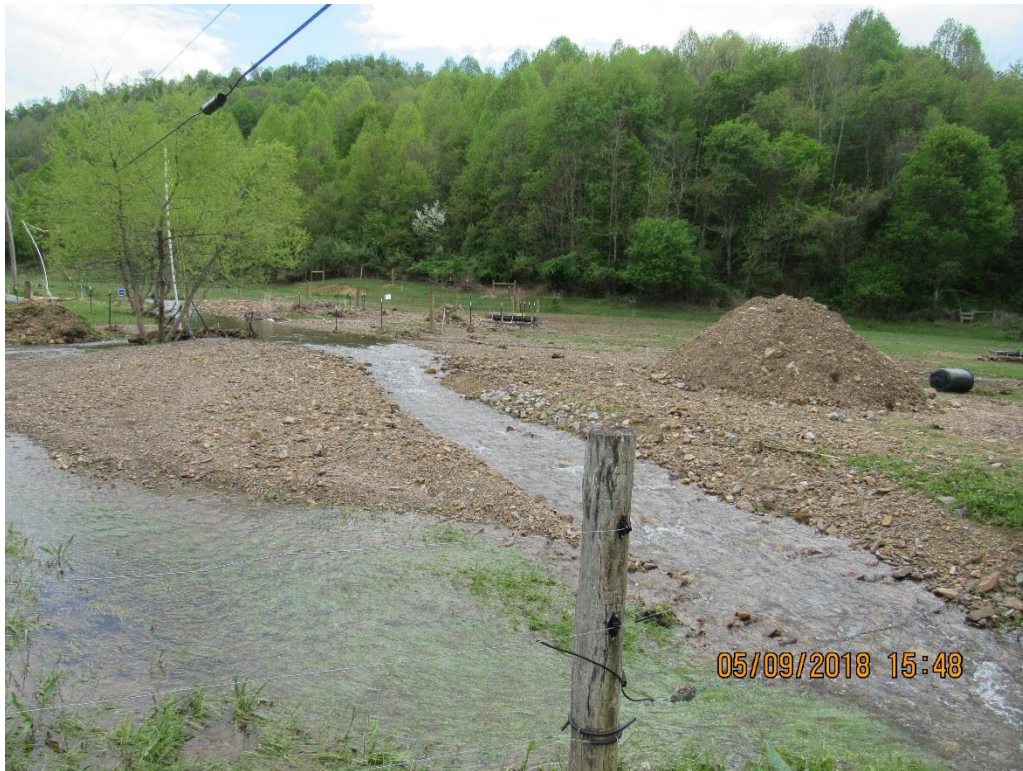
- Mr. Laws field (station 10146+32, sheet 9.35)- Site is a known flood plain. Soil/rock piles were from landowner returning the stream to original channel from earlier flooding. (Photo 3)

Photo 3: Mr. Laws field (station 10146+32, sheet 9.35)- stream has been partially returned to channel. Rock/soil pile from landowner removing debris to restore to channel.

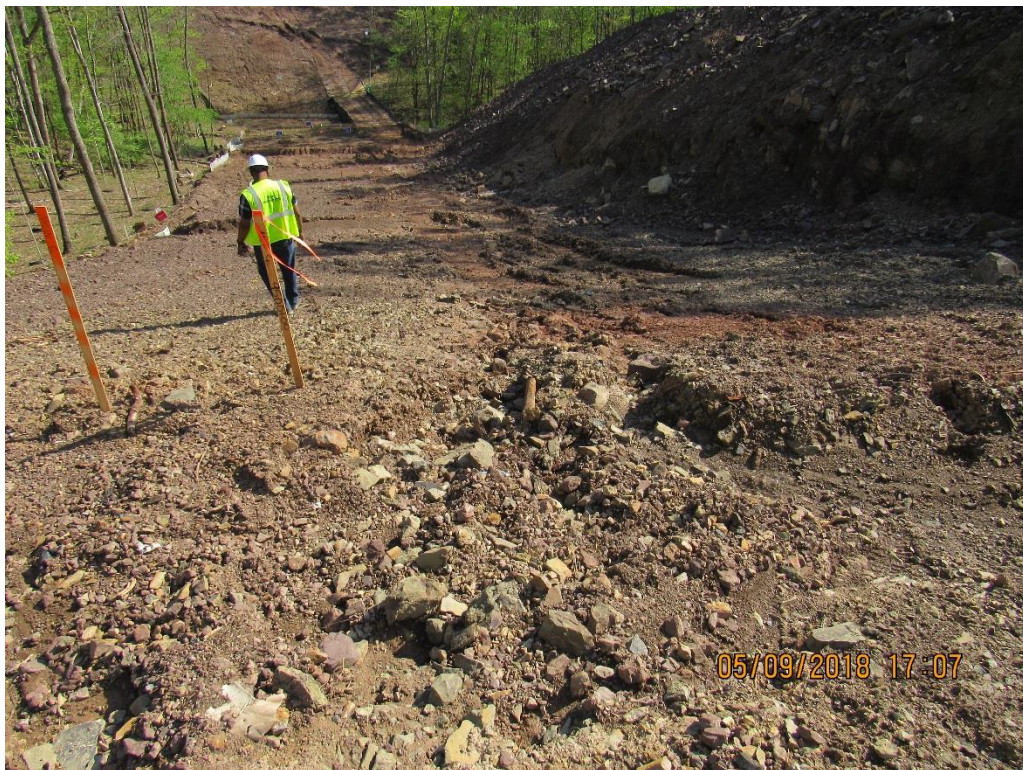
- Rt. 219 crossing (station 10106+00, sheet 9.34)- silt fence was not installed for sediment control and has since been removed.
- War Ridge Road (station 9498.53, sheet 9.12)- controls at stream crossing at S-IJ64 (station 9492+92.85, sheet 9.12) failed and were breached allowing sediment laden water to enter stream. Bridge matting failed contributing to sediment laden water. Additional controls (i.e. additional water bars, deeper sumps at bars, larger silt socks were applied to site until bridge could be re-

built, scheduled for next day. Sediment deposits were observed in stream causing conditions not allowable. (Photos 4-8)

Photo 4: Downslope view of site of sediment laden water left site- erosion gullies observed on slope. (view south)

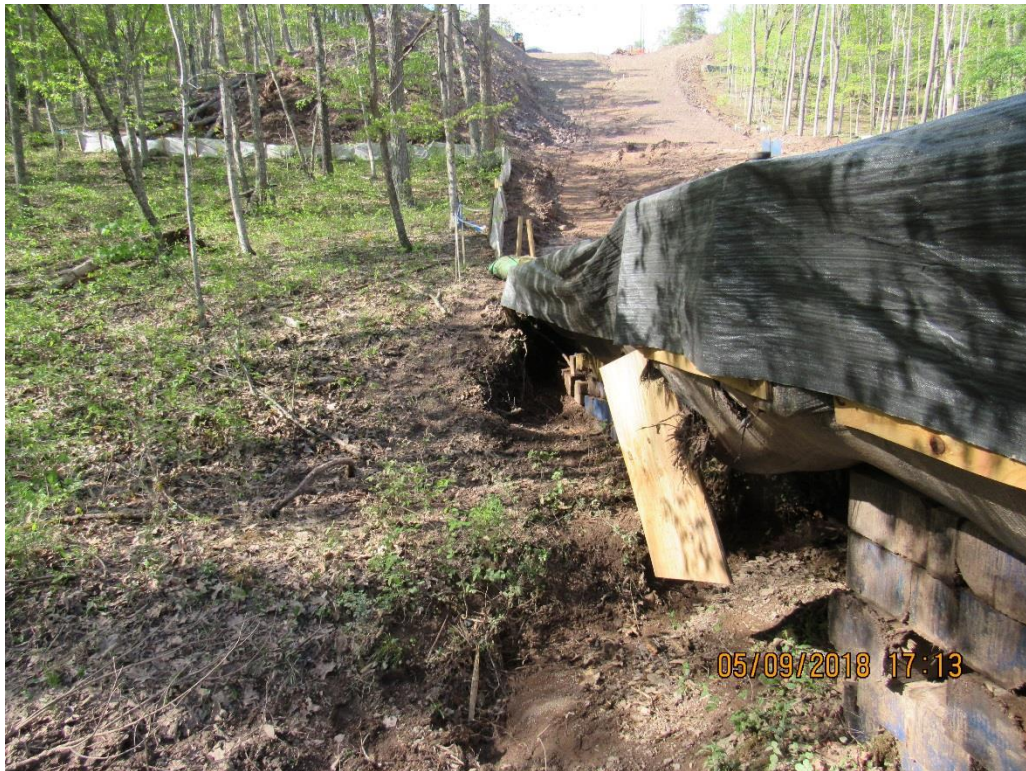
- Section G.4.e.2. - Permittee has failed to implement appropriate controls which allowed a failure of controls at station 9492+92.85 allowed sediment laden water to leave site without going through an appropriate device.
- Section G.4.e.2.A.ii.j - Permittee has failed to prevent sediment-laden water from leaving the site without going through an appropriate device.

Photo 5: Stream crossing where sediment laden water left site after controls failed at stream S-IJ65 (view north). Additional controls added prior to re-building of bridge.

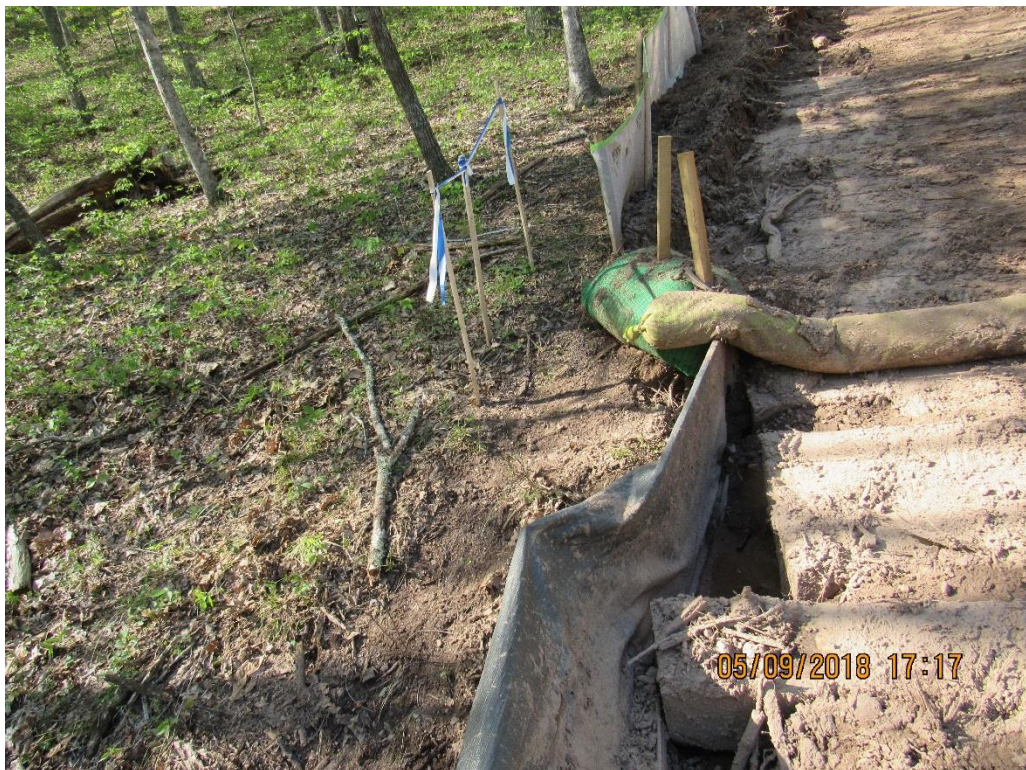
Photo 6: Location of control failure and breach allowing sediment laden water to leave site. Additional control (larger silt sock) added prior to bridge re-build.

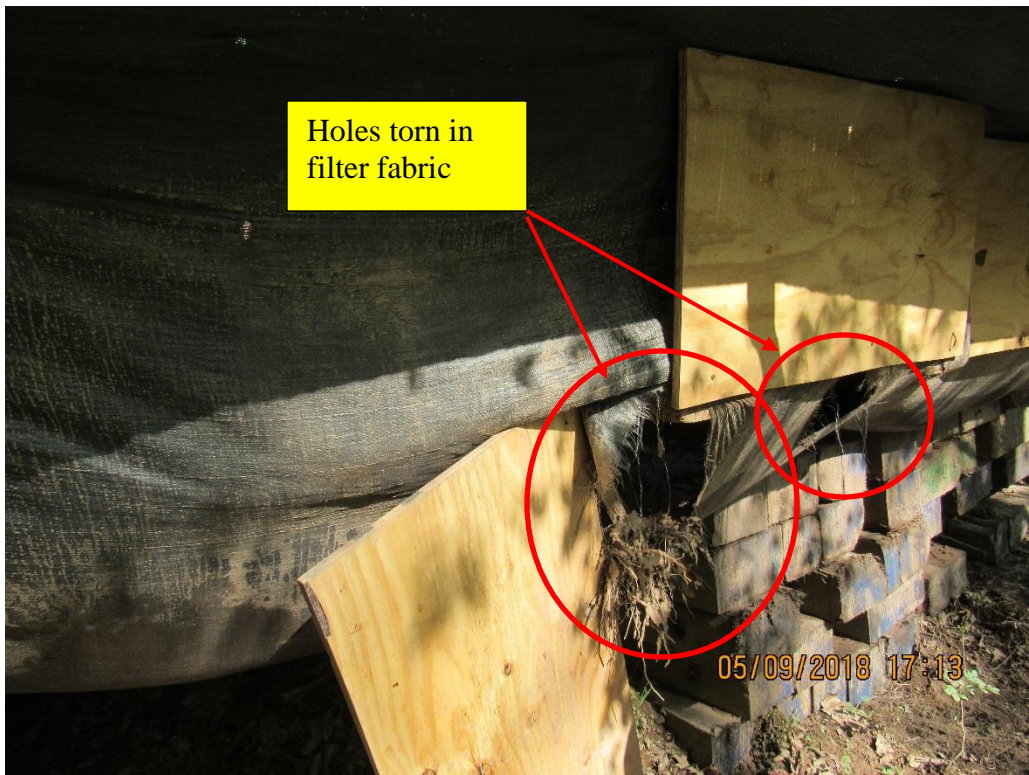
Photo 7: Tears in bridge filter fabric contributing to sediment laden water leaving site.

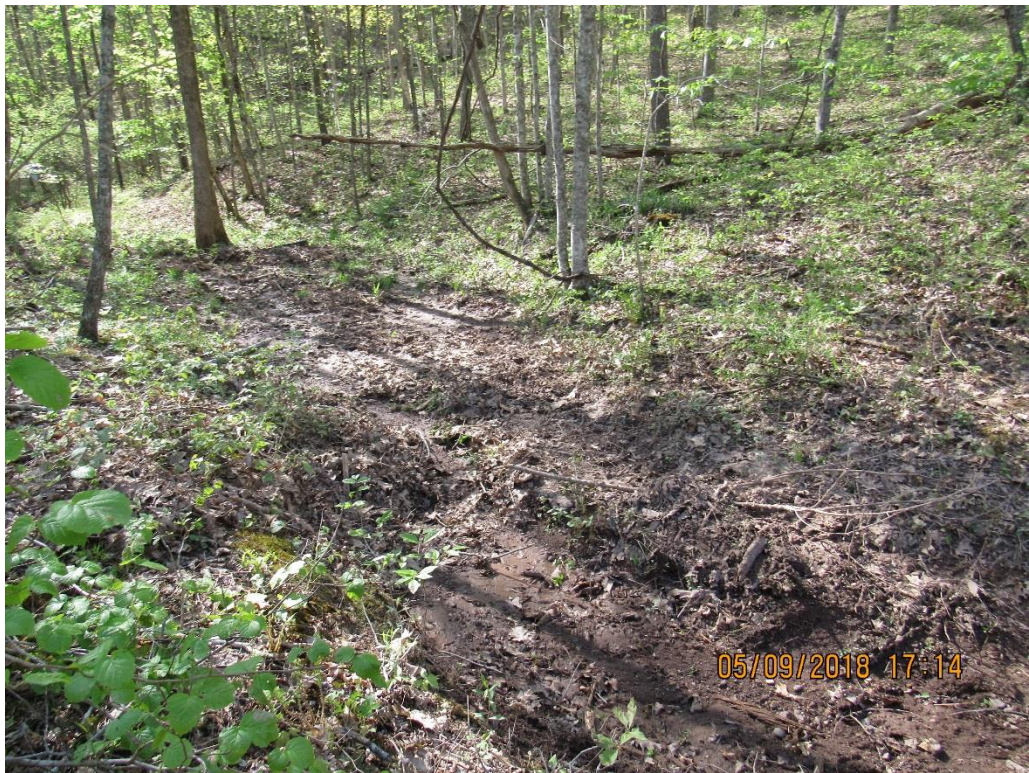
Have violated the following WV Legislative Rules (Requirements Governing Water Quality Standards): Title 47, Series 2, Section 3.2.b.-Section 3.2.b. - Permittee has caused conditions not allowable in waters of the State by allowing sediment deposits on the bottom of the stream.

Photo 8: Downstream view of sediment deposits in stream S-IJ65 creating conditions not allowable. (view west)
