**WEST VIRGINIA DEPARTMENT OF ENVIRONMENTAL PROTECTION  
WV OIL AND GAS CONSTRUCTION STORMWATER PERMIT**

<b>FACILITY NAME:</b>	Mountain Valley Pipeline Project		<b>REG. #</b>	<b>EXPIRE DATE:</b>
<b>PERMITTEE</b>	MOUNTAIN VALLEY PIPELINE, LLC		WVR310667	5/13/2018 Extended: 12/31/2018
<b>ADDRESS/PHONE:</b>	Attn: MATTHEW HOOVER 625 LIBERTY AVE, ST 1700 PITTSBURG, PA 15222 7248733645			
<b>LOCATION:</b>	Leivasy		<b>Entry Date/Time:</b>	6/6/2018 1000
<b>COUNTY:</b>	Nicholas/Greenbrier/Fayette		<b>Exit Date/Time:</b>	6/6/2018 1700
<b>Site Representative /Phone</b>	Cary "Muggs" Cheek/ 318-669-6999 (Lead EI) & Adam Ledbetter (EI)		<b>PHOTOS</b> <input checked="" type="checkbox"/>	
<b>CO-PERMITTEE:</b>		<b>ADDRESS:</b>		
<b>SITE OPERATOR:</b>	Price Gregory		<b>ADDRESS:</b>	920 Memorial City Way, Suite 600, Houston, TX 77024
<b>PERMITTED ACREAGE</b>	4311	<b>WEATHER:</b>	Clear	<b>LAST INSPECTION:</b> n/a
<b>RECEIVING STREAM(S)</b>	UTs/Gauley River/New River/Kanawha River			<b>NOV: 1</b>
<b>Regular Mail</b> <input type="checkbox"/> <b>Certified Mail</b> <input checked="" type="checkbox"/>	<b>Tracking #</b>

STATE OF WEST VIRGINIA  
Department of Environmental Protection  
Environmental Enforc

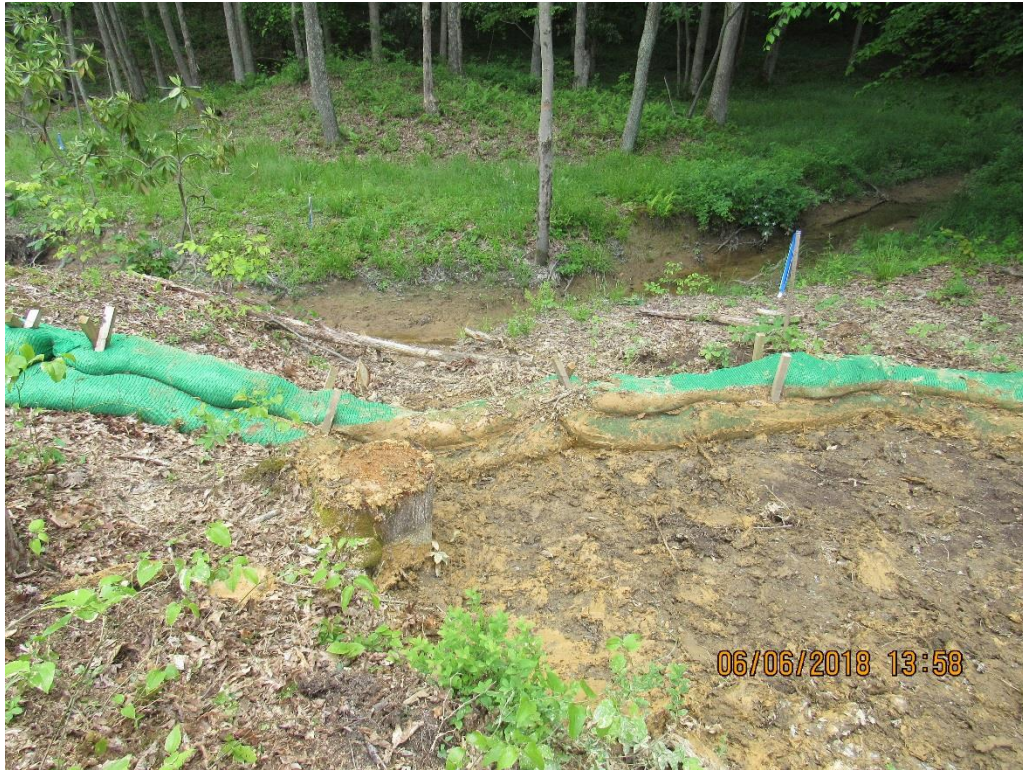
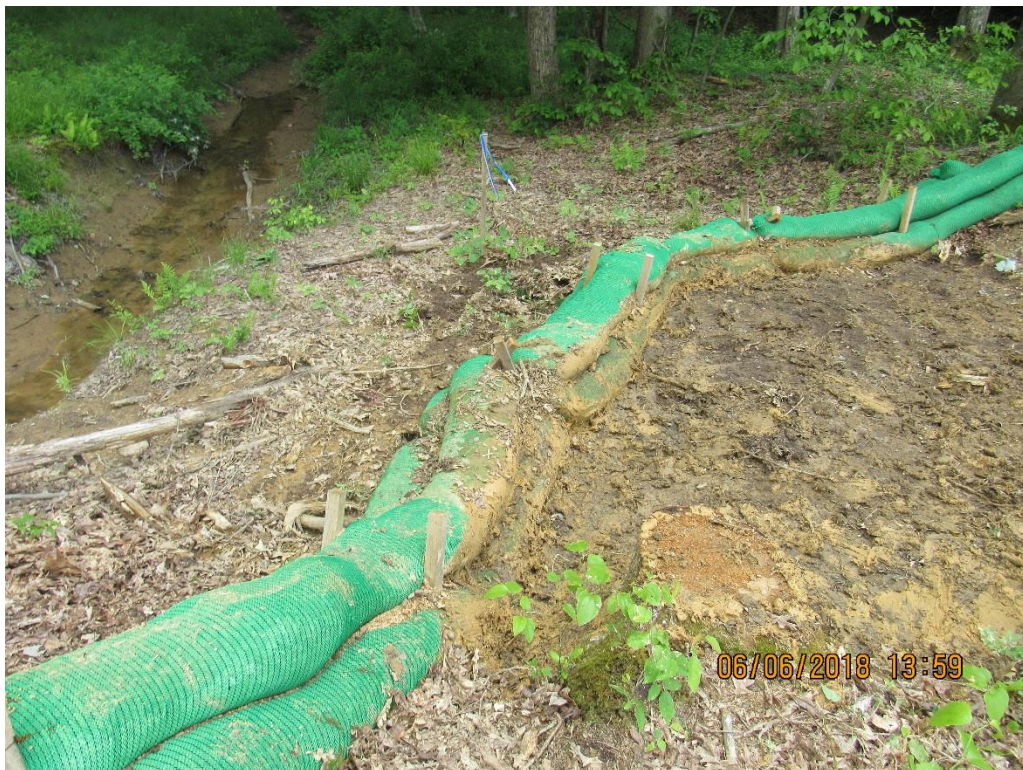
- 1. & 21. Perimeter controls near station 6782+00 (sheet 6.37) had failed. Controls were repaired, but additional controls were not added (Photos 1 & 2). Discussed with Adam and Muggs about additional controls. Both agreed area needs additional controls and decided to add a row of Priority 1 silt fence.

Photo 1: Station 6782+00 control failure repair but additional controls not added.

Photo 2: Station 6782+00 control failure repair but additional controls not added.

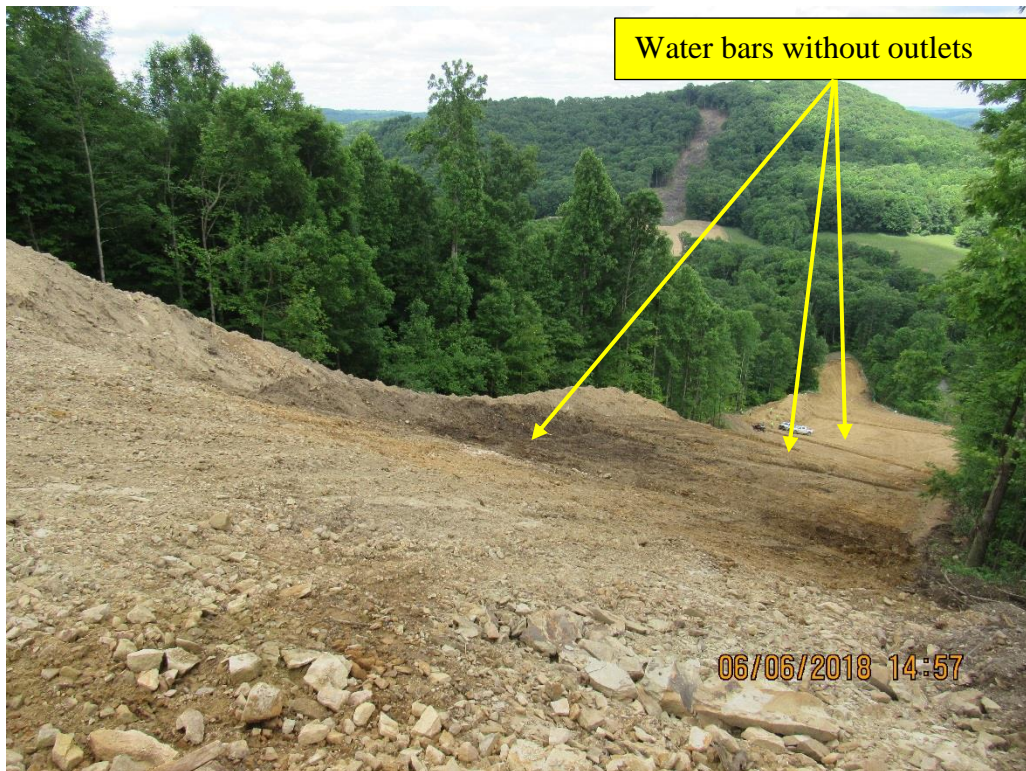
- 7. Water bars near station # 6801+38 (sheet 6.37) with <24° to >30° slope were installed with outlets leading to large pile of soil, outlet over cleared slope, and were installed at a very steep angle. EI Adam Ledbetter did some training/instructing ECD installation crew and equipment operators on proper installation during inspection. Also, inadequate number of water bars/were installed on slopes. Per EI Adam Ledbetter, corrections to water bars would be completed by end of business day on 6/7/2018.

Photo 3: Water bars installed without adequate outlets near station # 6801+38 with  $<24^{\circ}$  to  $>30^{\circ}$  slope.

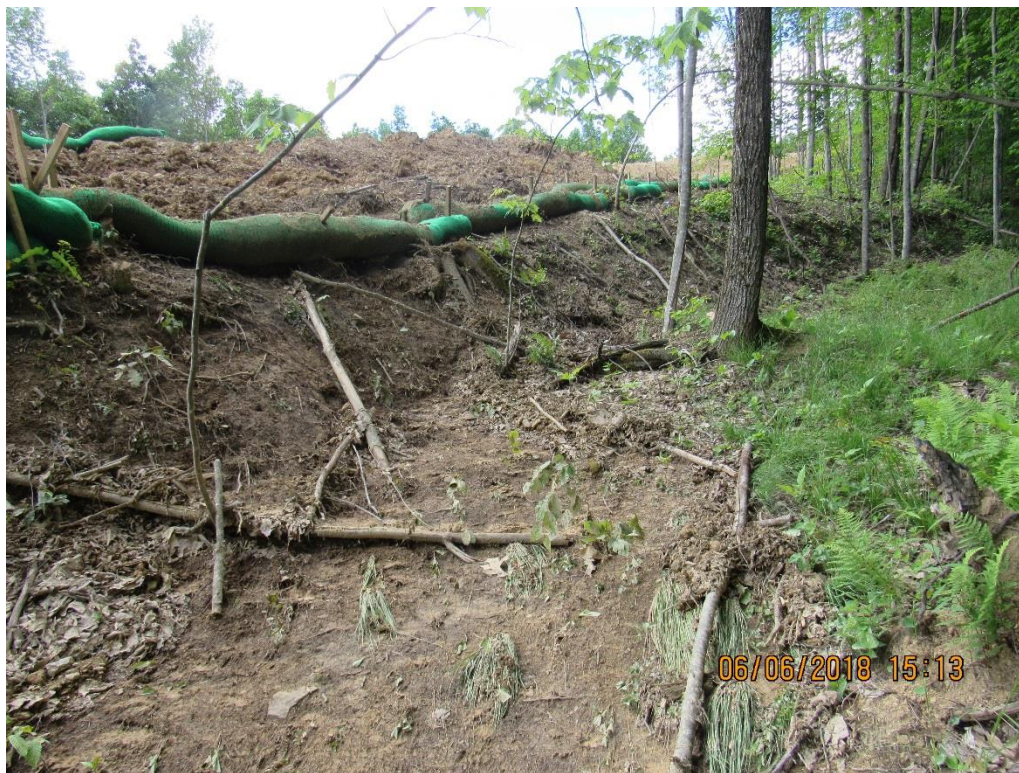
- 19. Evidence of sediment laden water was observed at 2 separate locations where water bar outlets failed at Stations 6812+58 (sheet 6.38) and 6854+00 (sheet 6.39).

Photo 4: Control failure at station 6812+58 allowing sediment laden water to leave site.

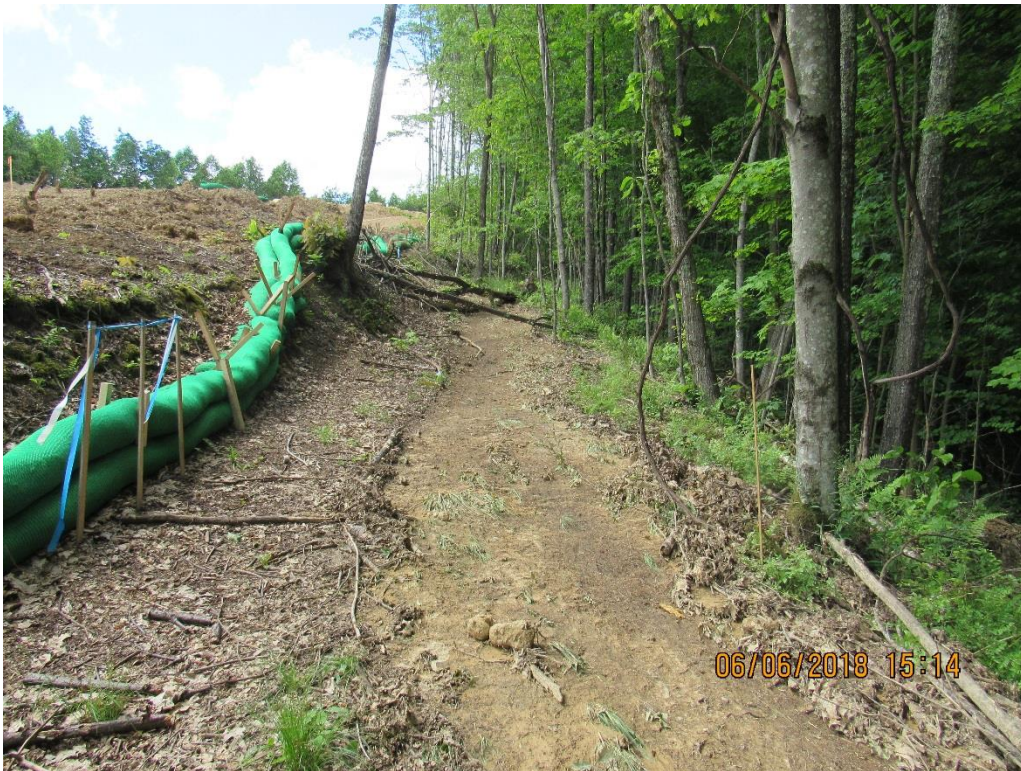
Photo 5: Scoured path from control failure at station 6812+58.

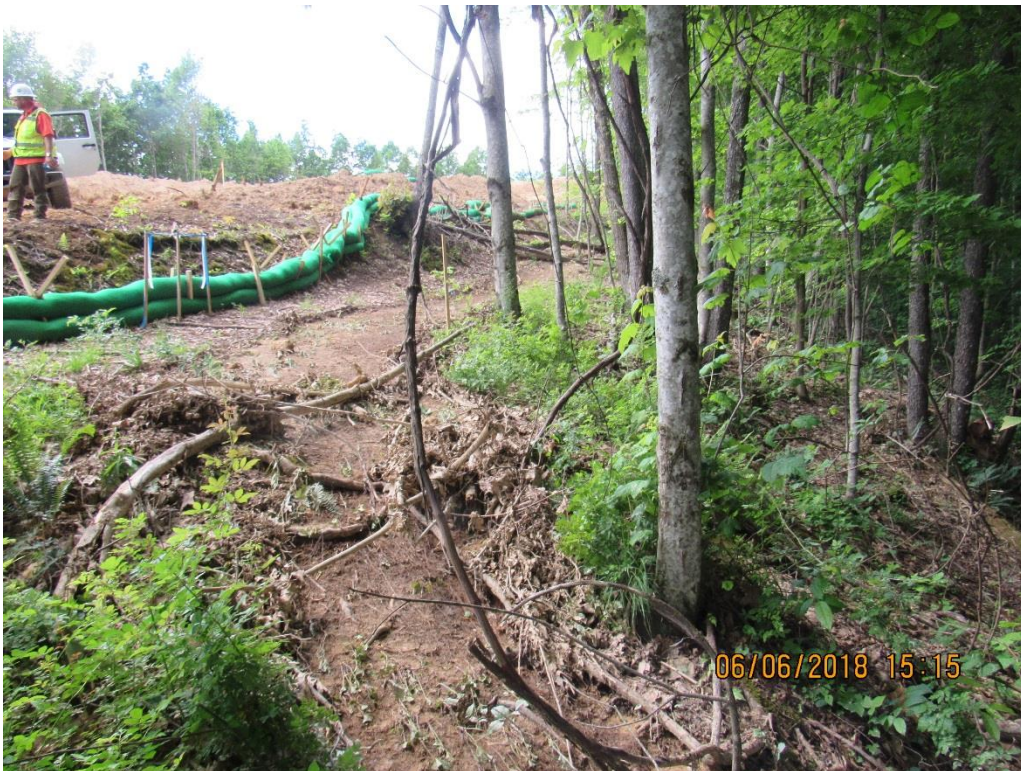
Photo 6: Continued scoured path from control failure at station 6812+58.

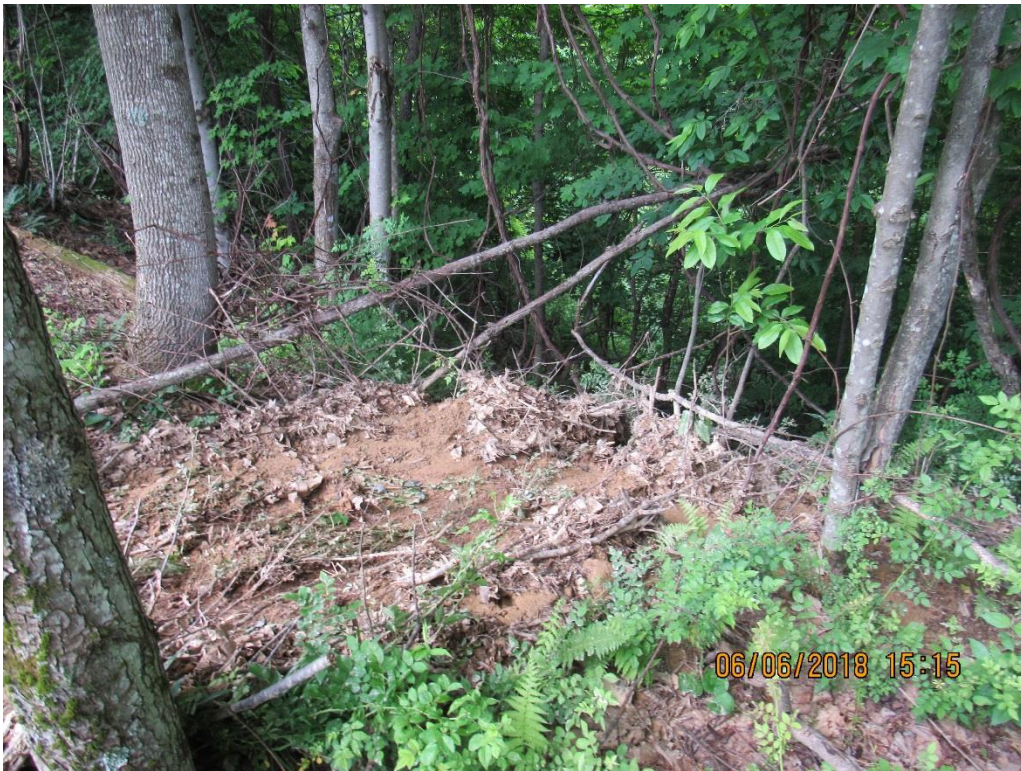
Photo 7: Water leaving the site from control failure at station 6812+58.

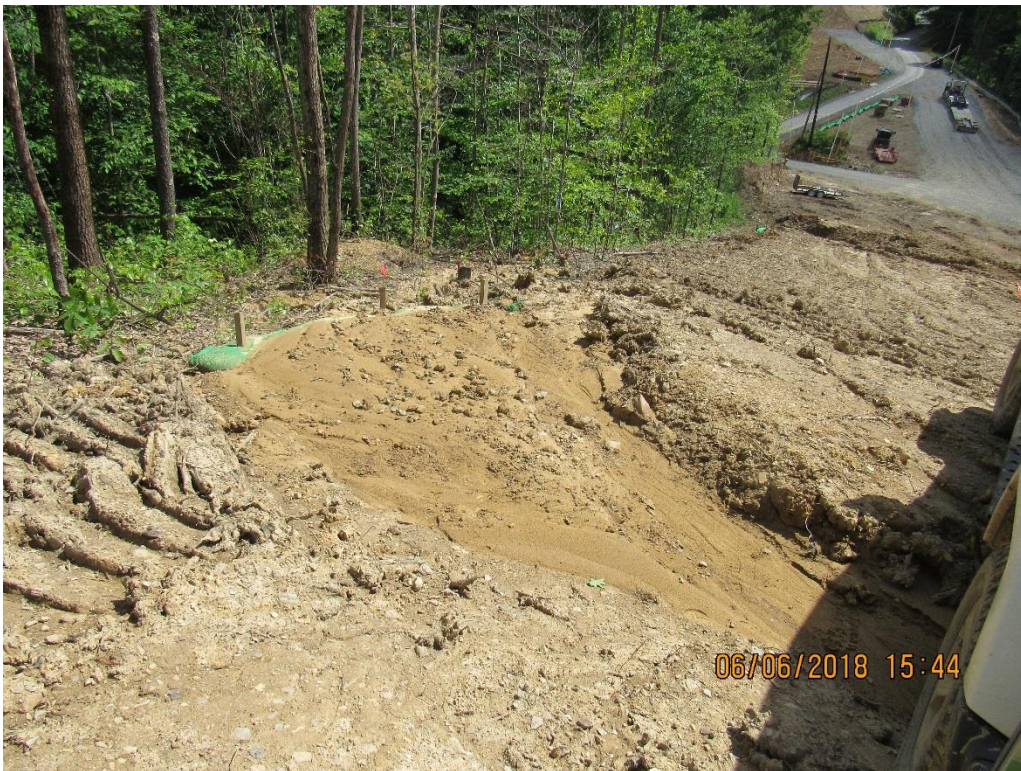
Photo 8: Control failure near station 6854+00 where sediment laden water left site.
