**CALIFORNIA PUBLIC UTILITIES COMMISSION
Safety and Enforcement Division
Utilities Safety and Reliability Branch**

Incident Investigation Report

Incident Number: E20170505-01

Location of the Incident: Bahia Substation
Benicia, CA
County: Solano

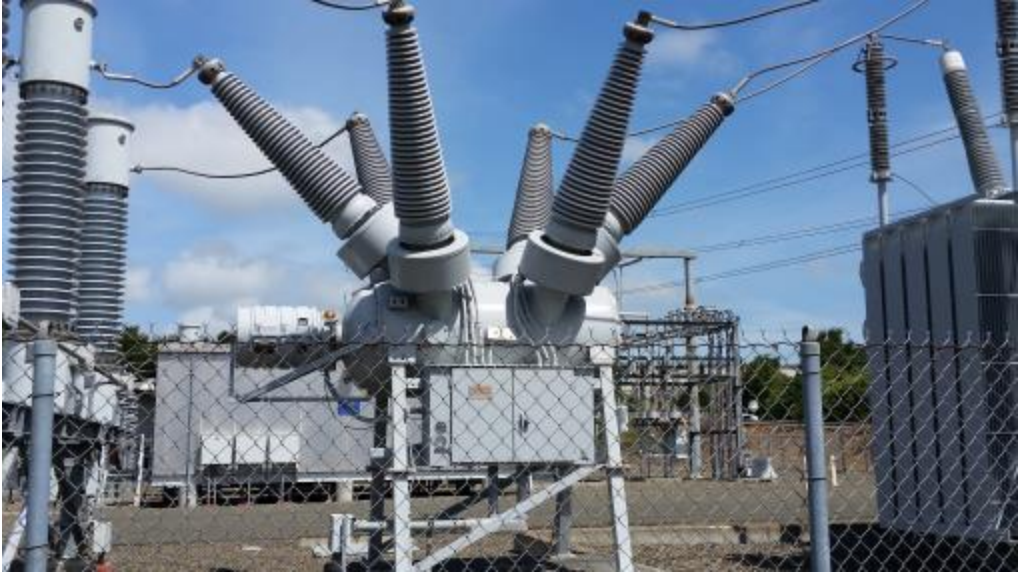
Figure 1: One of Valero Substation's breakers located within PG&E's Bahia Substation
