**CAL FIRE - Office of the State Fire Marshal
Pipeline Safety Division**

OPERATOR, LOCATION, AND CONSEQUENCES

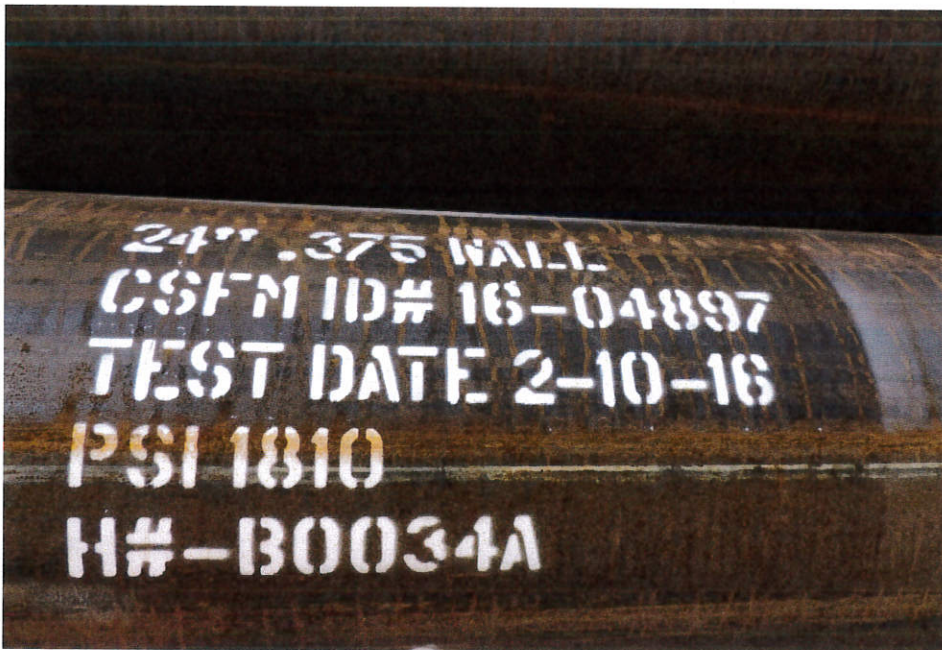
Photo taken by Pipeline Safety Engineer Thomas Williams on the morning of May 21, 2016. This is a view of the rupture on The San Joaquin Valley 20/24" Heavy Crude Oil (CSFM #0708)

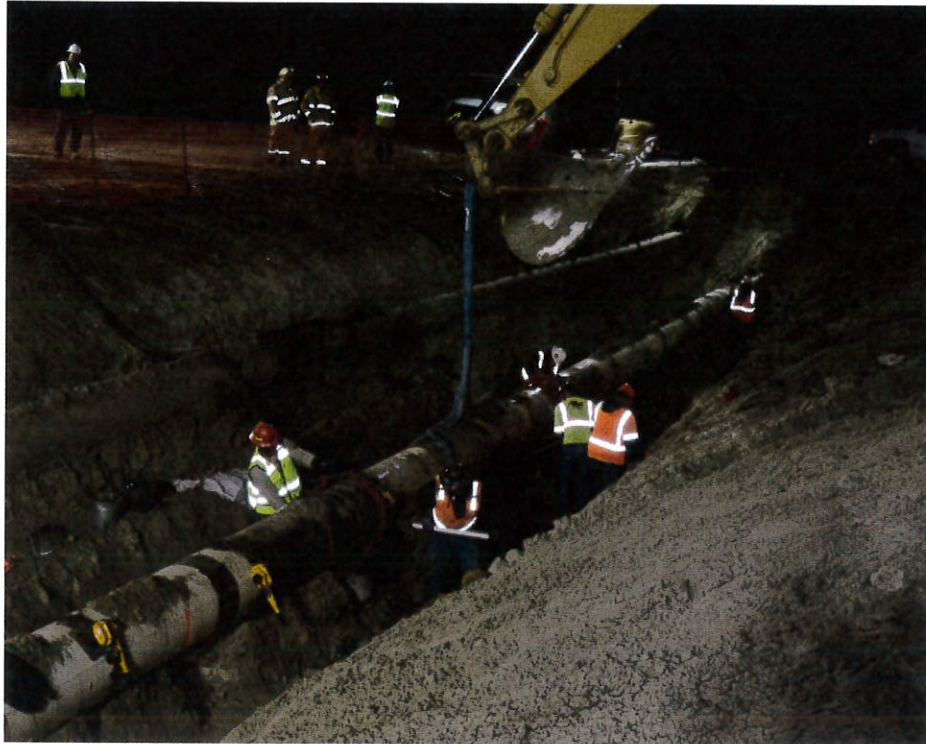
Description of Photograph:
Photo taken by Pipeline Safety Engineer Thomas Williams on May 22, 2016.
This is a photo of Doty Brothers Construction Company cutting out the failed section of pipe to send to Lab.

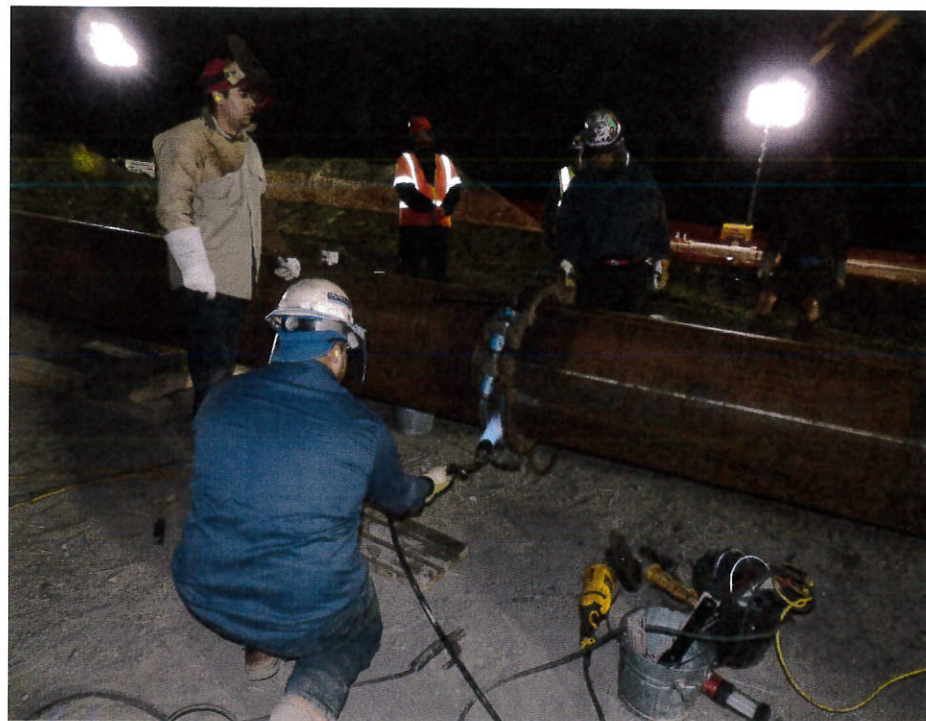
Description of Photograph:
Photo taken by Pipeline Safety Engineer Thomas Williams on the early morning of May 22, 2016. This is a photo of Doty Brothers Construction Company weld the new section of pipe.

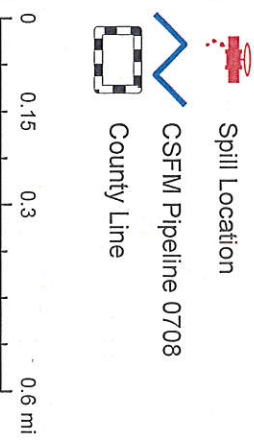
Please be aware that BY ACCEPTING THIS FILE YOU AGREE TO THE FOLLOWING: I understand that any and all data/information obtained from the Office of the State Fire Marshal's Pipeline Mapping System is sensitive security information and I agree to: resist disclosure of and access to this data/information to persons with official state and local government responsibility to not redistribute the data/information; and to refer requests by other persons for such information to the Mapping Coordinator for CSFM. I also agree to maintain a list of those persons that have been provided access to this information.

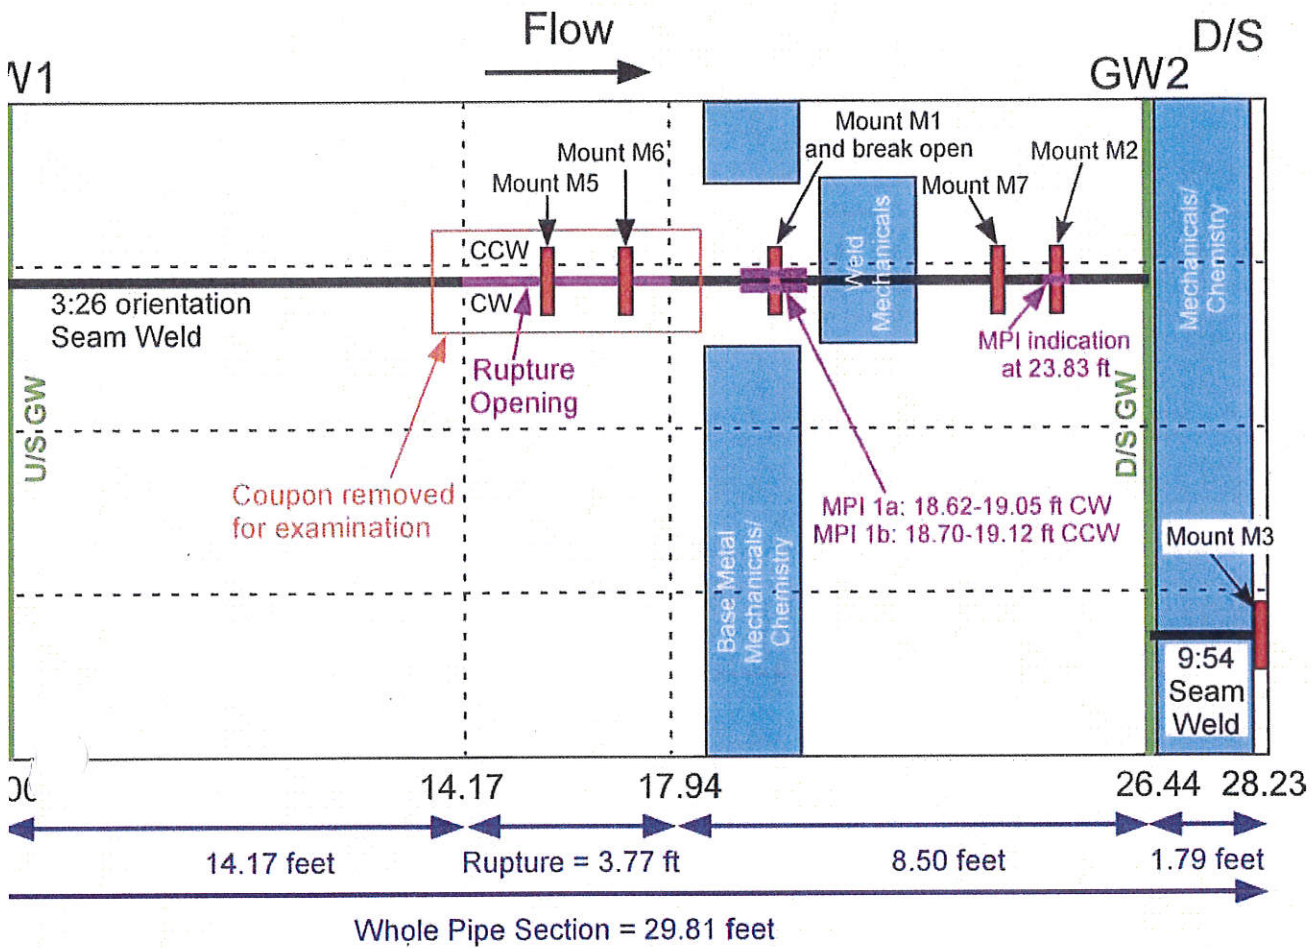
Distance to U/S GW (feet)

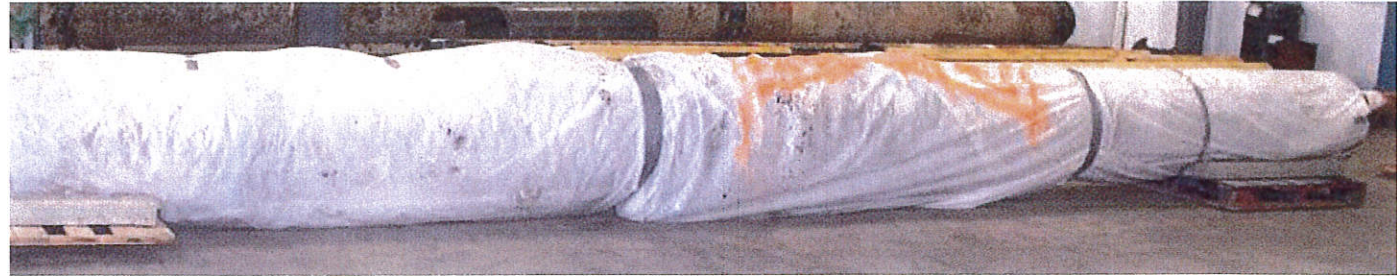
Figure 2. Photograph of Pipe Section in the as-received condition at DNV GL.

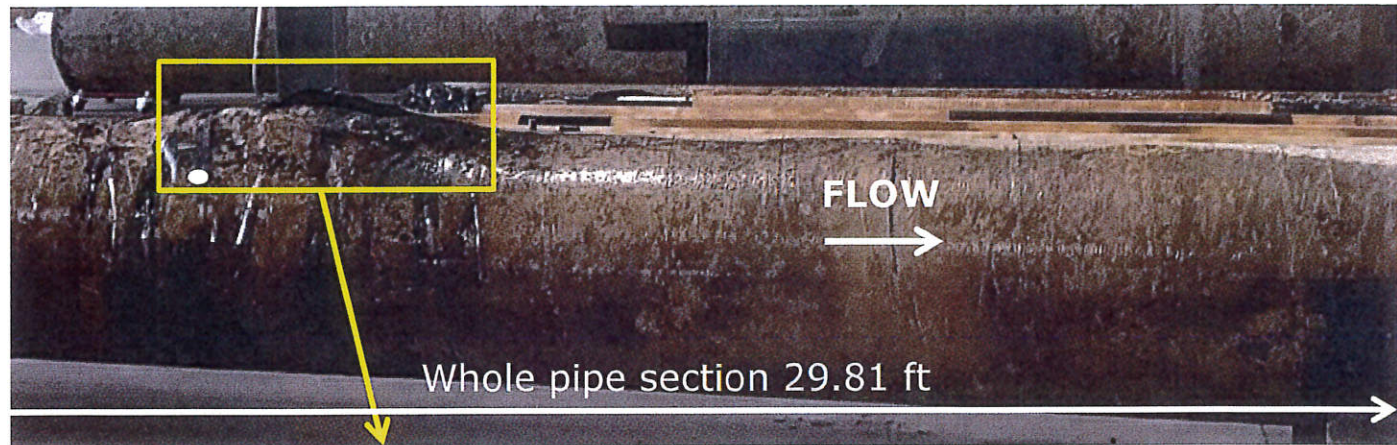
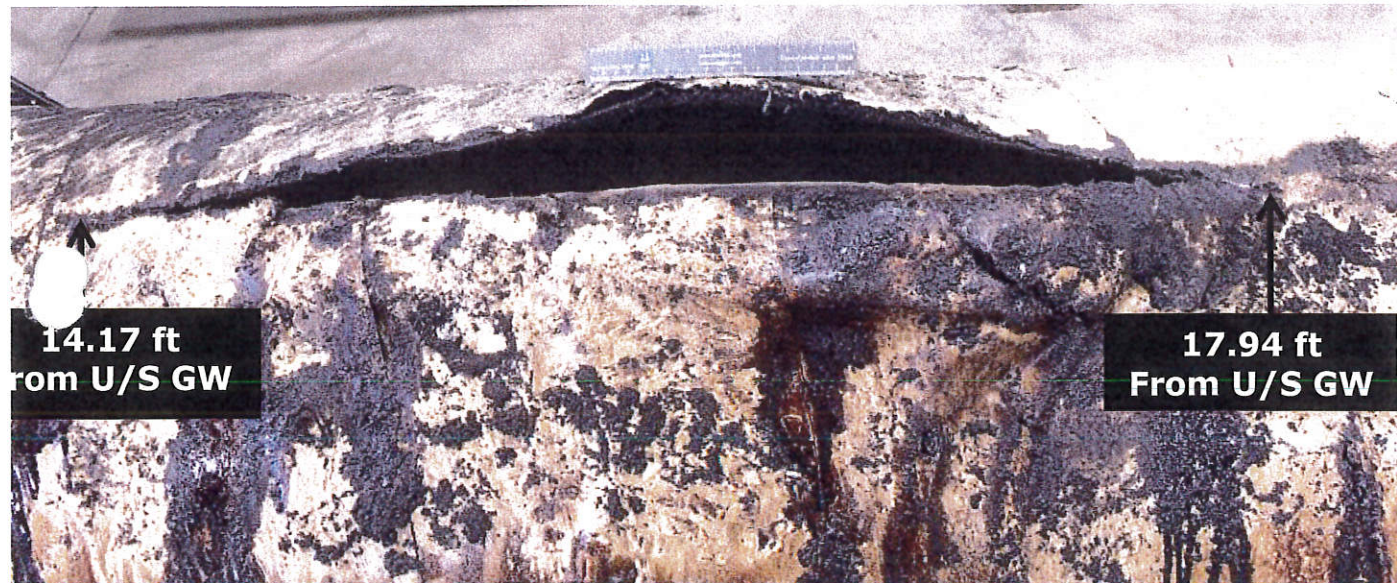
Sections of Pipe Section showing the rupture location following removal of the protective plastic wrappings.

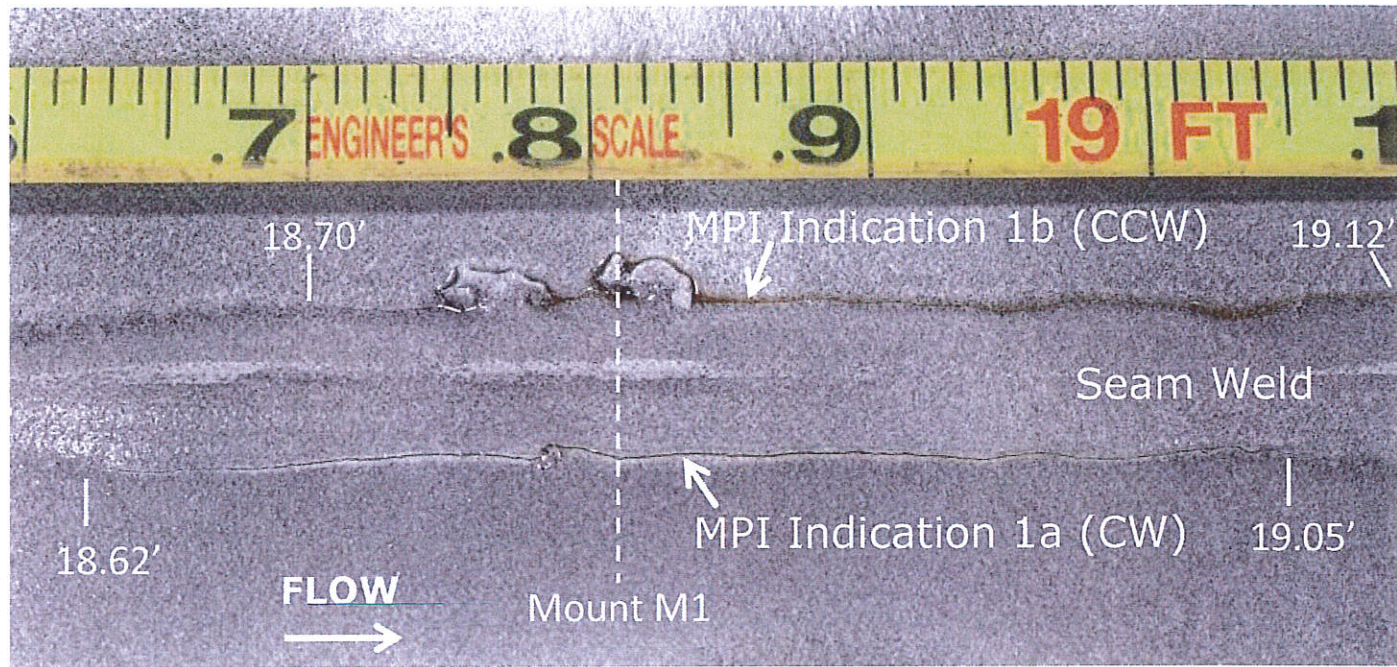
Photograph of the internal pipe surface showing MPI Indication 1a and MPI Indication 1b along the clockwise and counterclockwise (CCW) side of the seam weld, approximately 2.7 feet downstream of the rupture (18.62 – 19.12 ft D/S from U/S GW), and location where Mount M1 was removed.

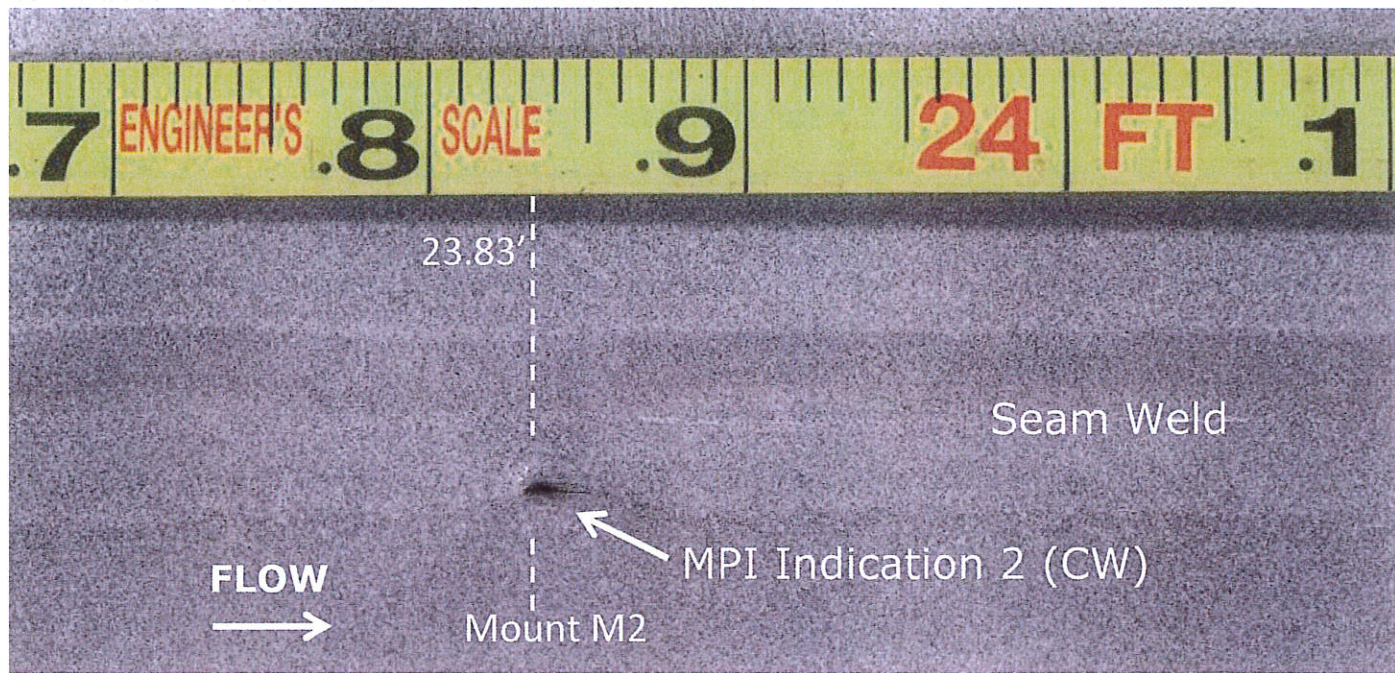
Photograph of the internal pipe surface showing MPI Indication 2 along the clockwise (CW) side of the seam weld, approximately 7.7 feet downstream of the rupture location (23.83 ft D/S from U/S GW), and location where the weld was removed.

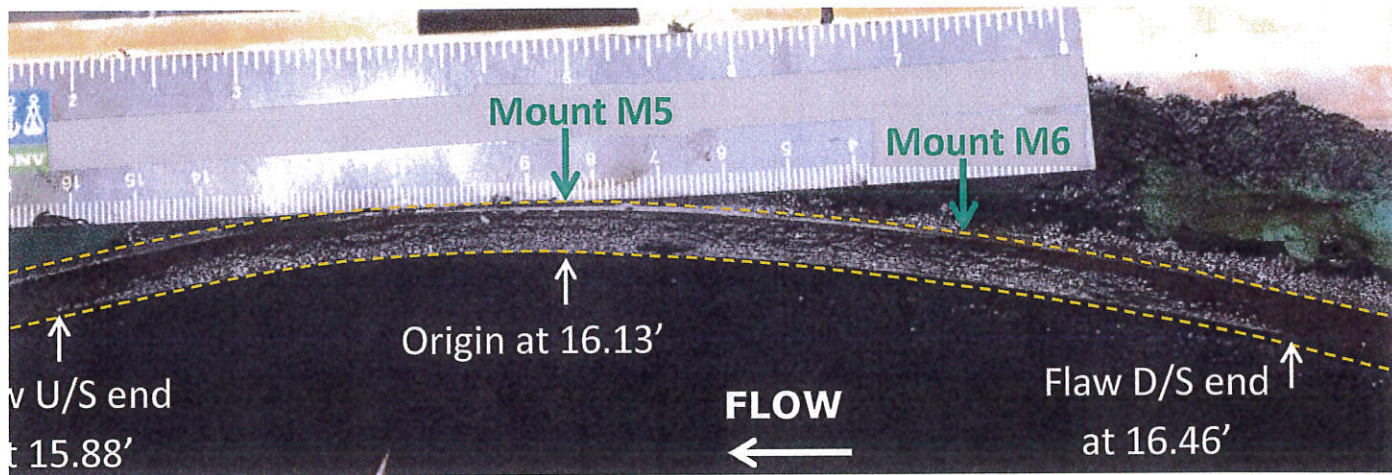
Photograph of the fracture surface (clockwise side) at the suspected rupture origin before cleaning. Light gray area is the pre-existing flaw that initiated from the pipe inside surface.

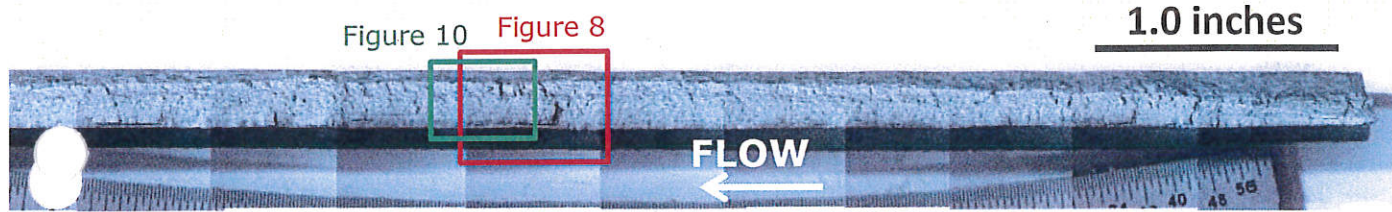
Close-up photograph of the fracture surface (clockwise side) at the suspected rupture origin after cleaning in a degreaser and alcohol. Light gray area is the pre-existing flaw that initiated from the pipe inside surface.

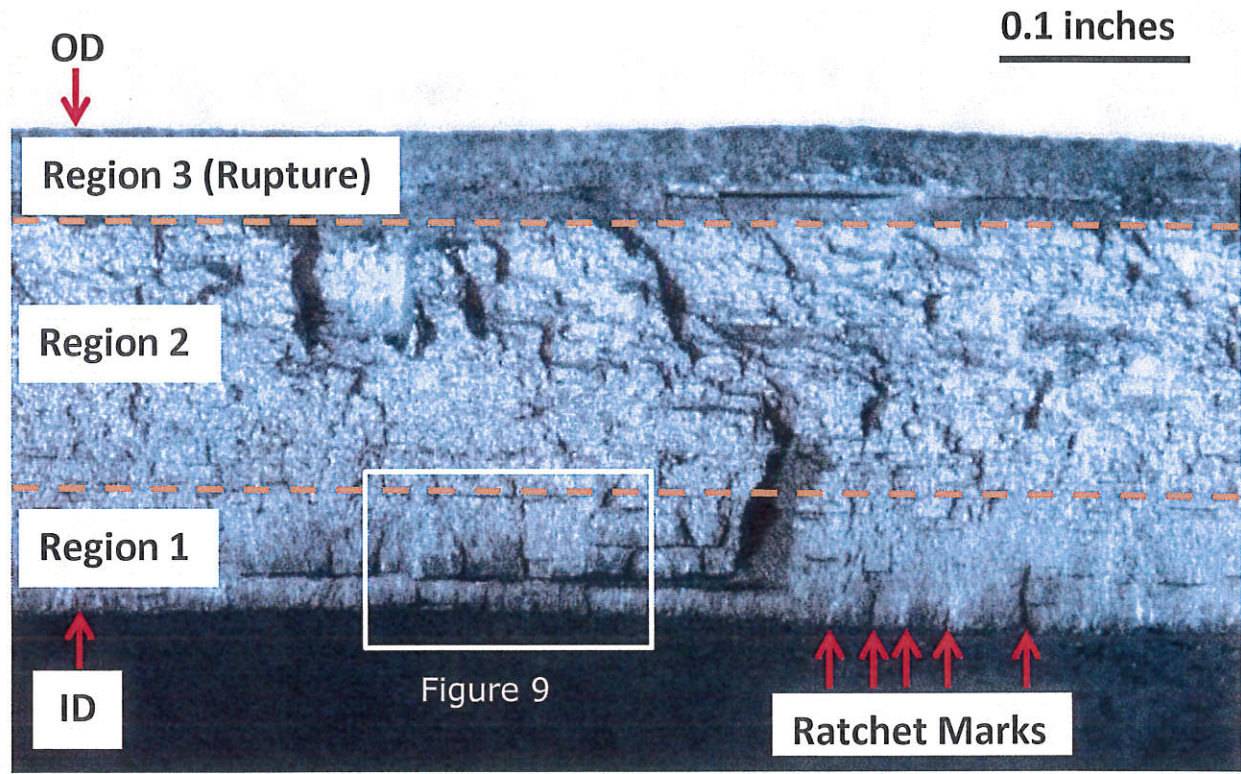
Figure 8. Photomicrograph showing a portion of the fracture surface from the rupture, clockwise (CW) side of the seam weld, after cleaning with a degreaser and methanol. Area indicated in Figure 7.

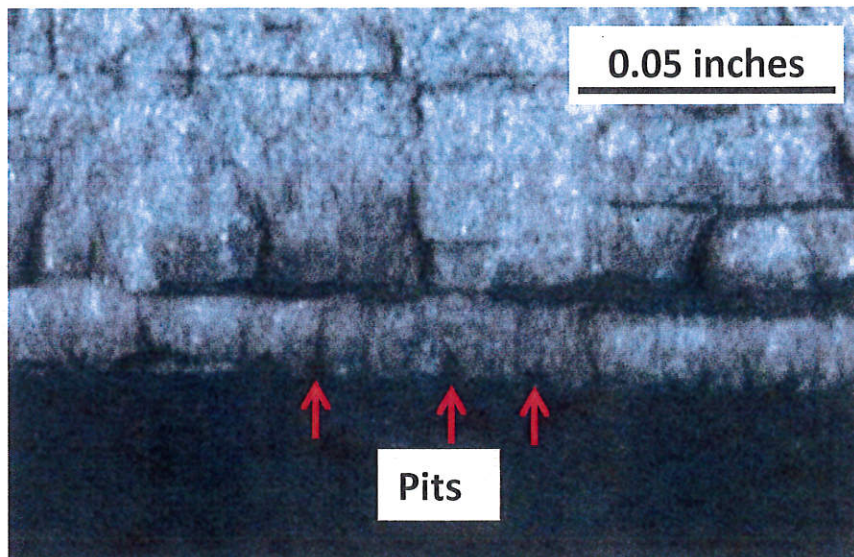
Figure 9. Photomicrograph showing close-up view of pits at ID pipe surface; area indicated in Figure 8.

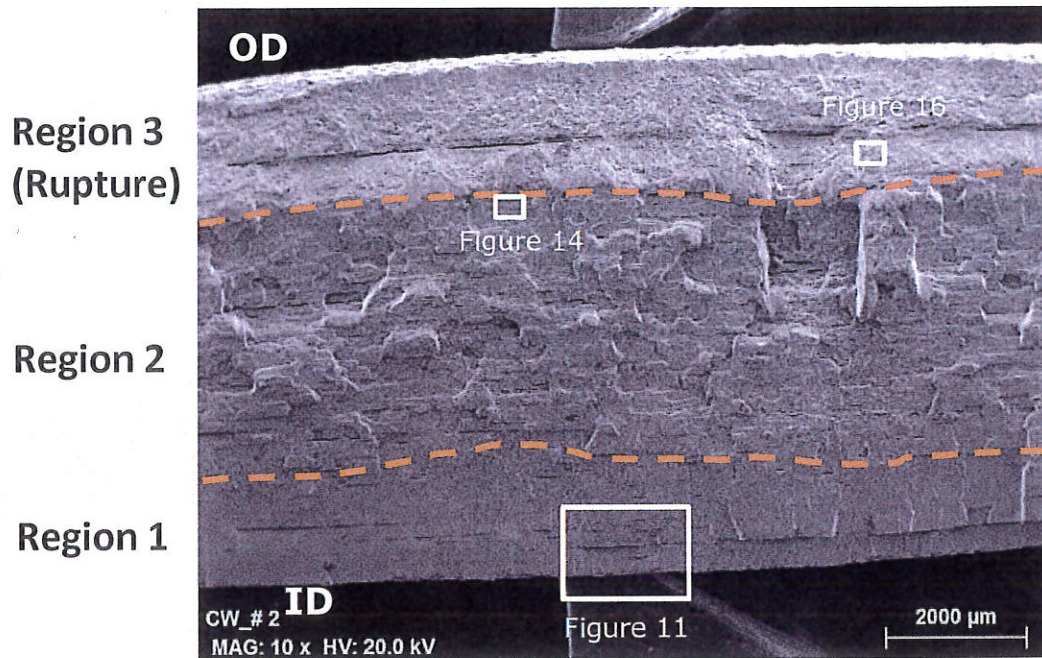
Figure 10. SEM photomicrograph showing three distinct morphologies on fracture surface from rupture, 10X; area indicated in Figure 7

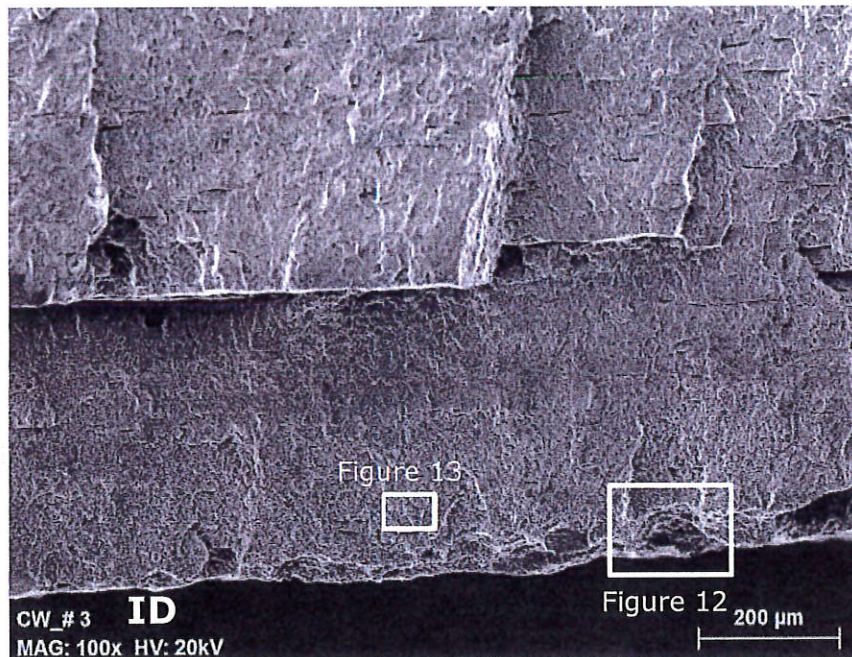
Figure 11. SEM photomicrograph showing Region 1 of fracture surface from rupture, 100X; area indicated in Figure 10.

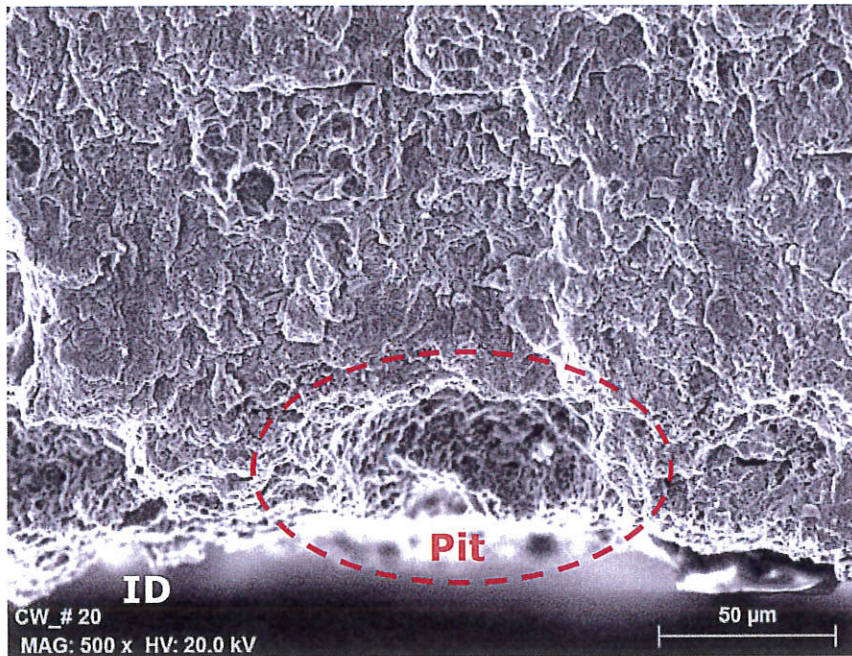
Figure 12. SEM photomicrograph showing pit at ID surface 500X; area indicated in Figure 11.

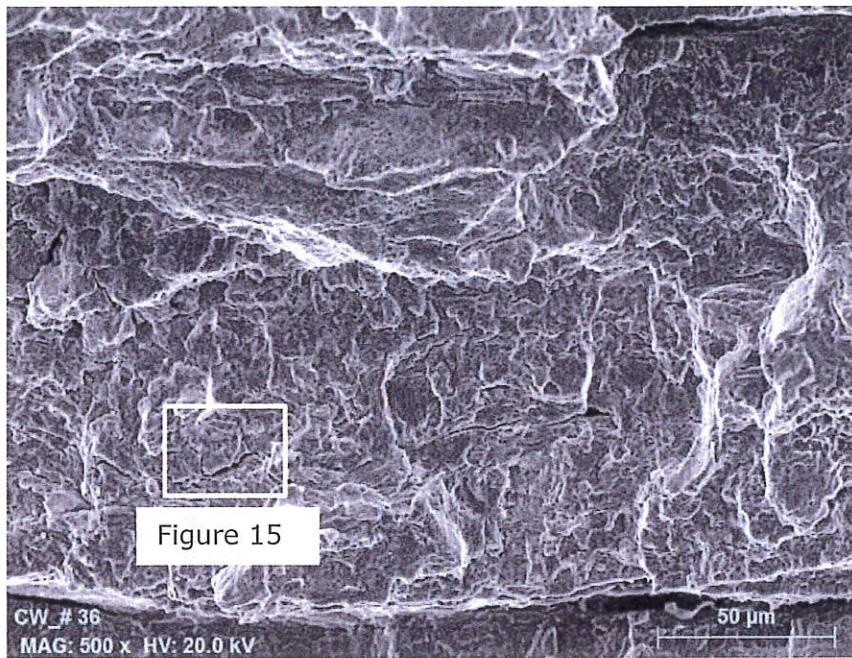
Figure 14. SEM photomicrograph showing secondary cracking within Region 2, 500X; area indicated in Figure 10.

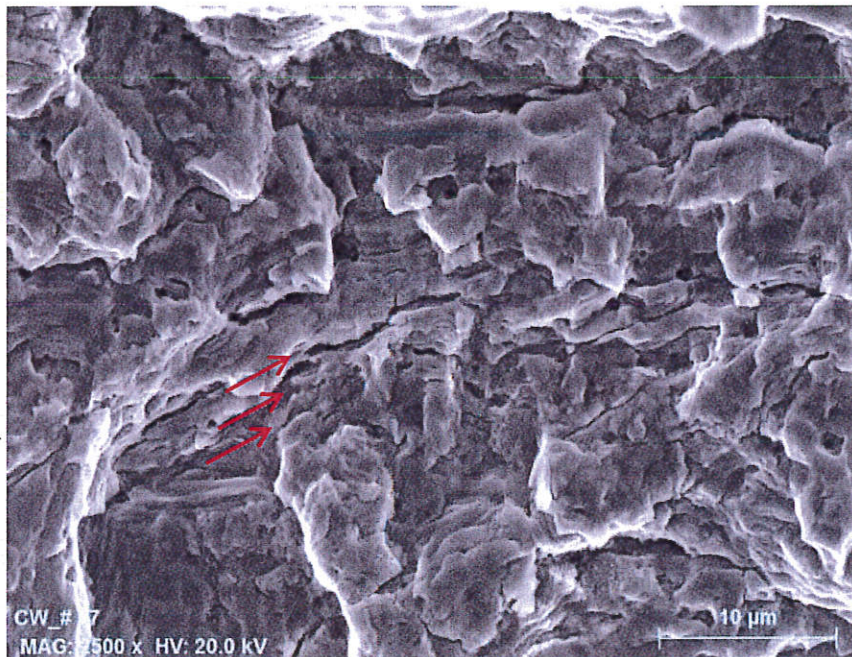
Figure 15. SEM photomicrograph showing small cracks on corrosion product-covered fracture surface in Region 2, 2500X; area indicated in Figure 14.

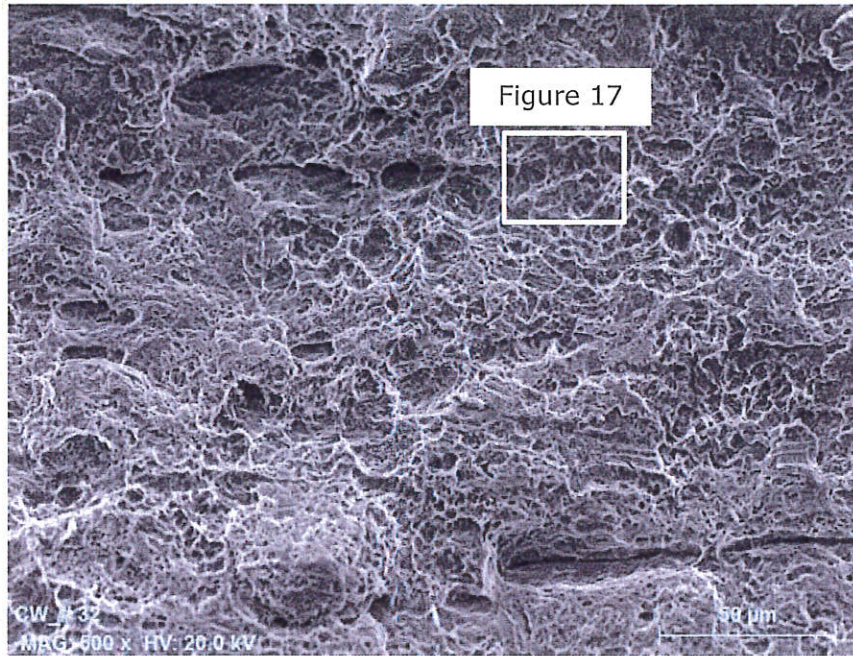
Figure 16. SEM photomicrograph showing ductile fracture morphology in Region 3, 500X; area indicated in Figure 10.

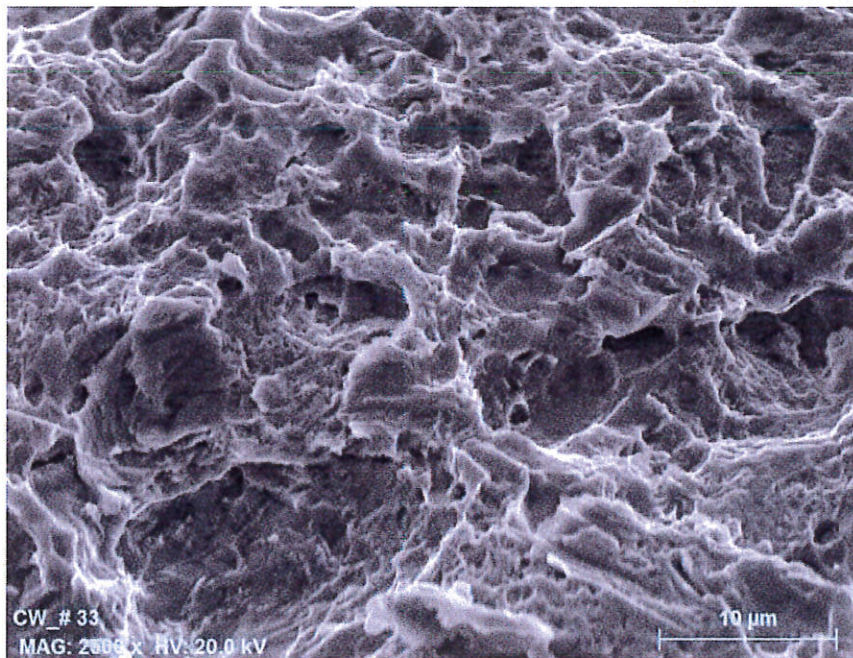
Figure 17. SEM photomicrograph showing ductile fracture morphology in Region 3, 2500X; area indicated in Figure 16.

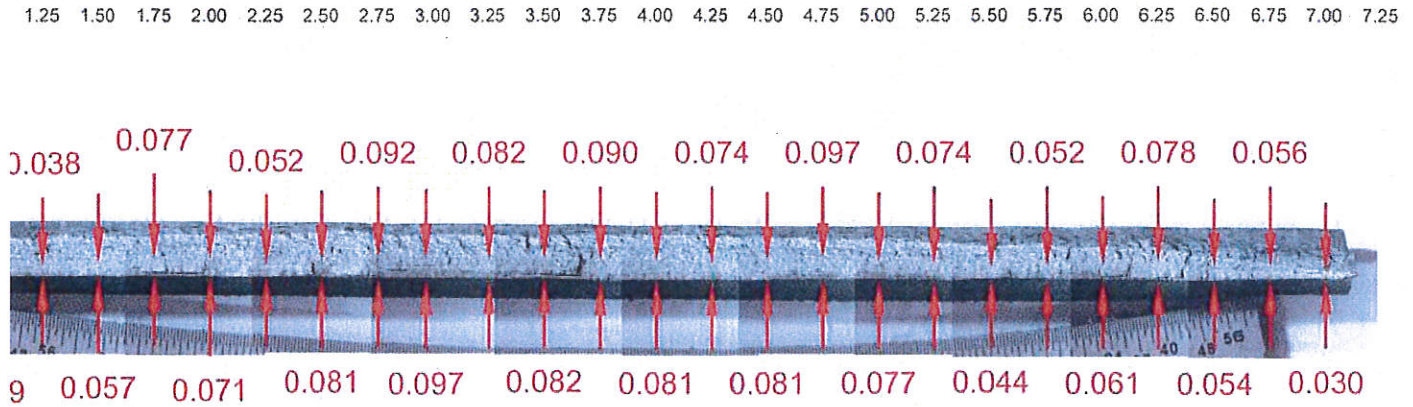
age of the fracture surface (clockwise side), showing depth measurements (red) of Region 1 of the pre-aw.

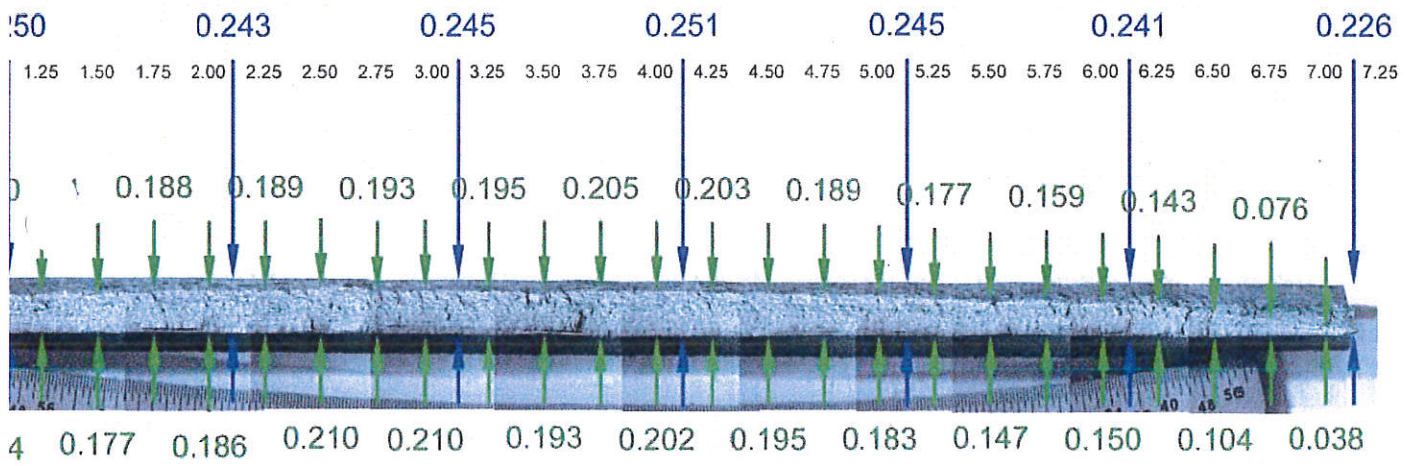
age of the fracture surface (clockwise side), showing depth measurements (green) of Region 1 and of the pre-existing flaw, together with wall thickness measurements (blue).

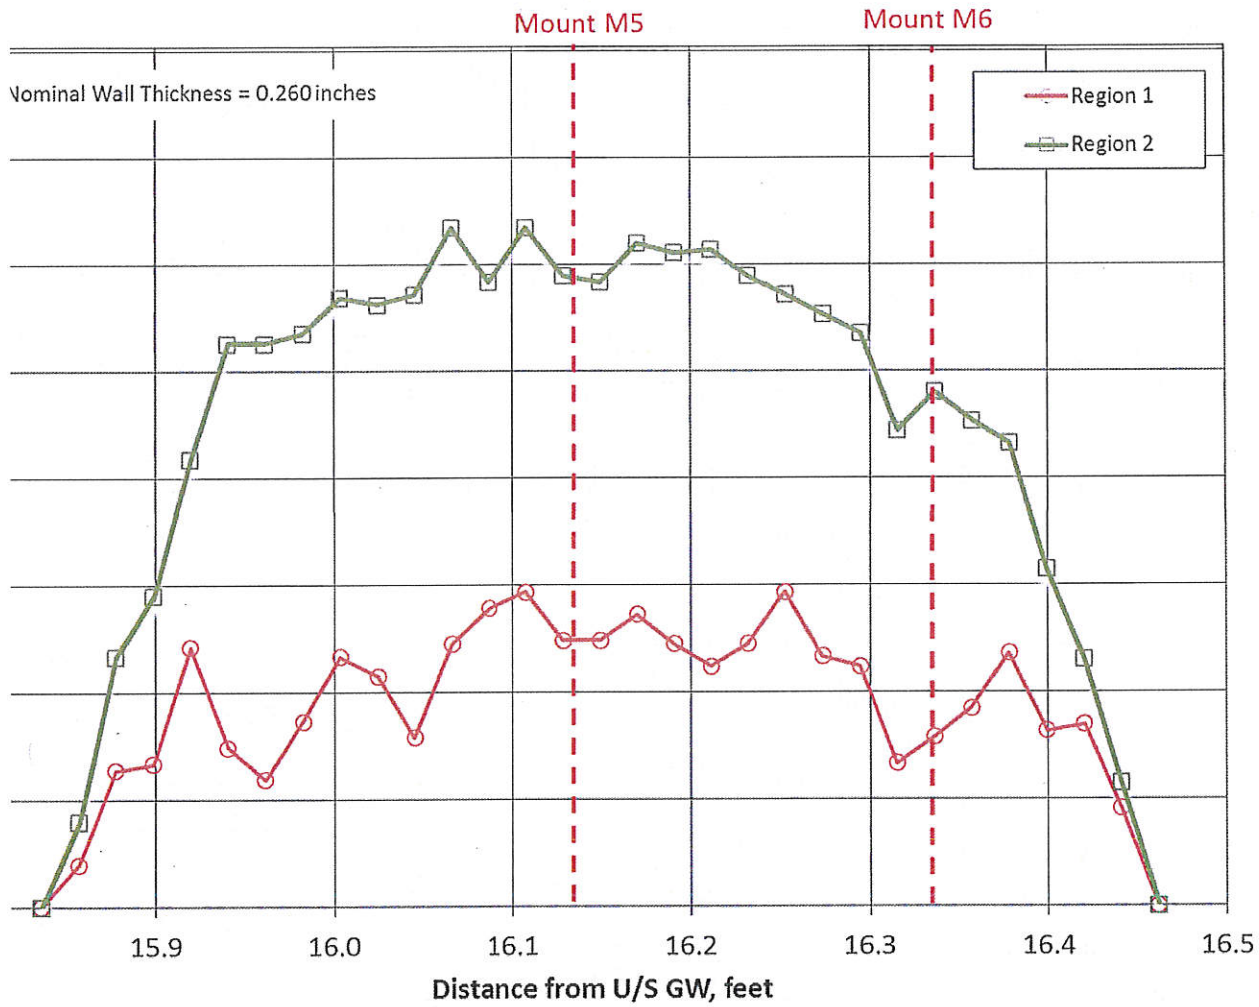
h versus distance from the U/S GW for Region 1 and Region 2 identified on the fracture surface. The location of Mount M5 and Mount M6 are indicated by dashed lines.

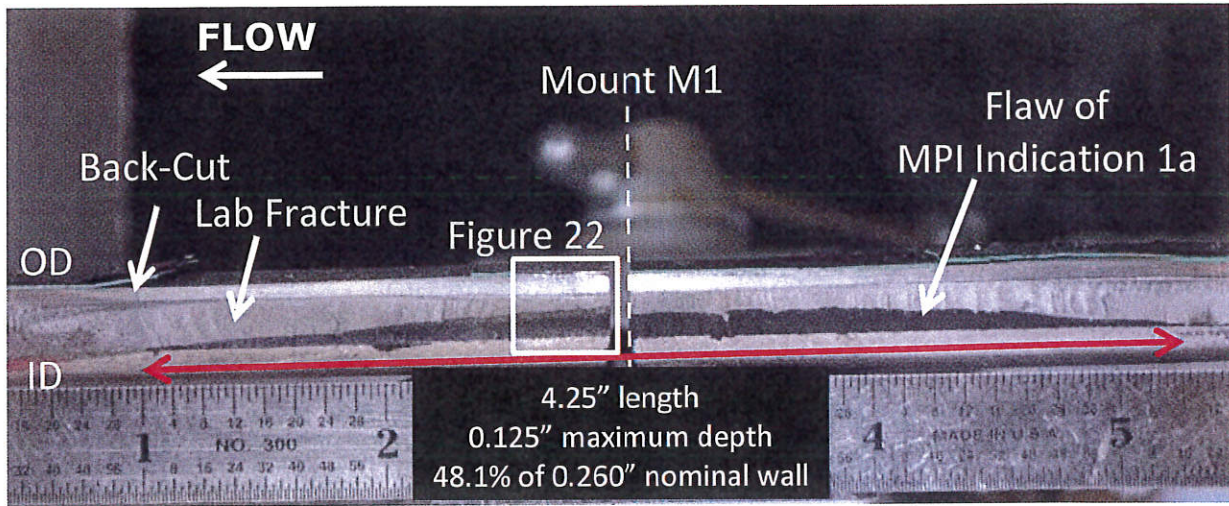
Figure 21. Photograph of the clockwise (CW) side of the fracture surface associated with MPI Indication 1a, and location of Mount M1.

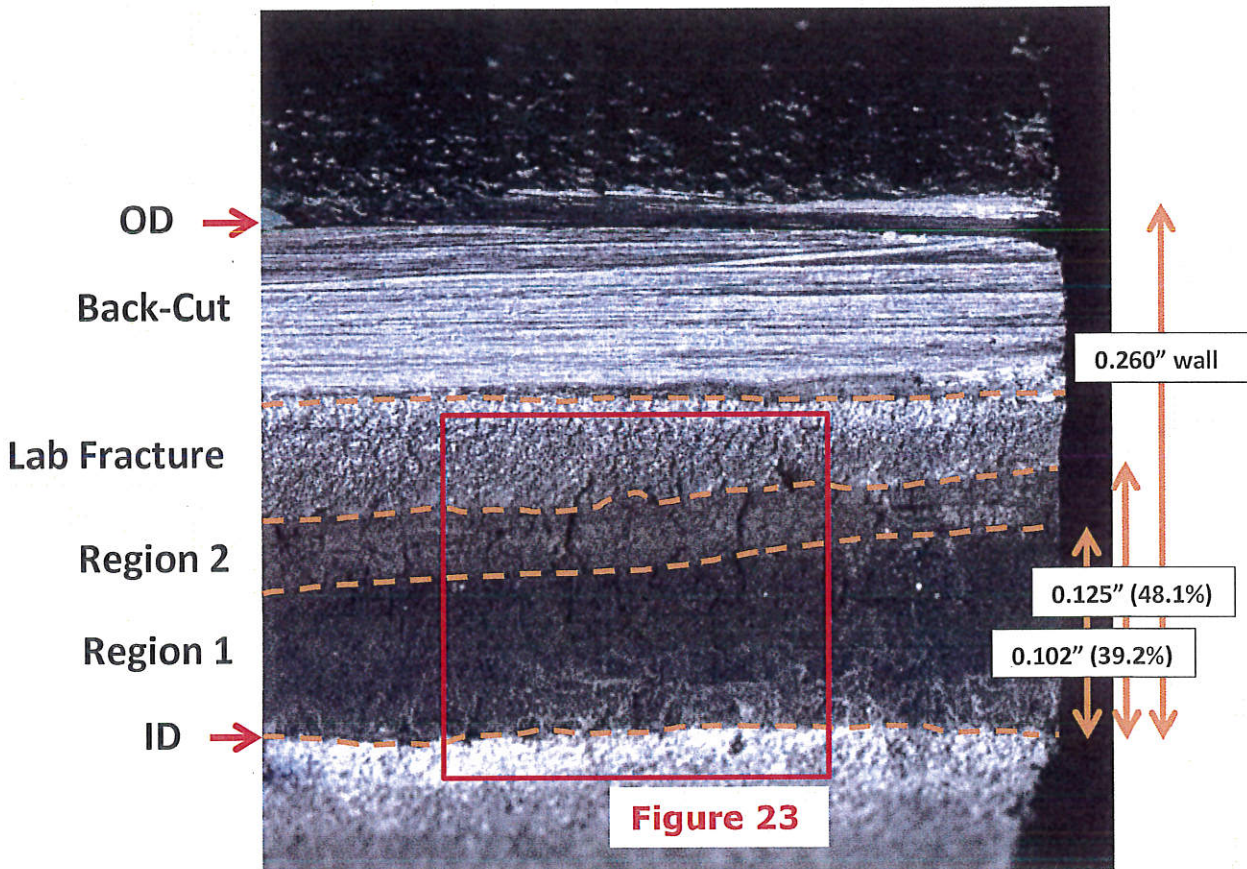
Figure 22. Stereo-photograph showing a portion of the fracture surface associated with broken open MPI Indication 1a, without cleaning. Area indicated in Figure 21.

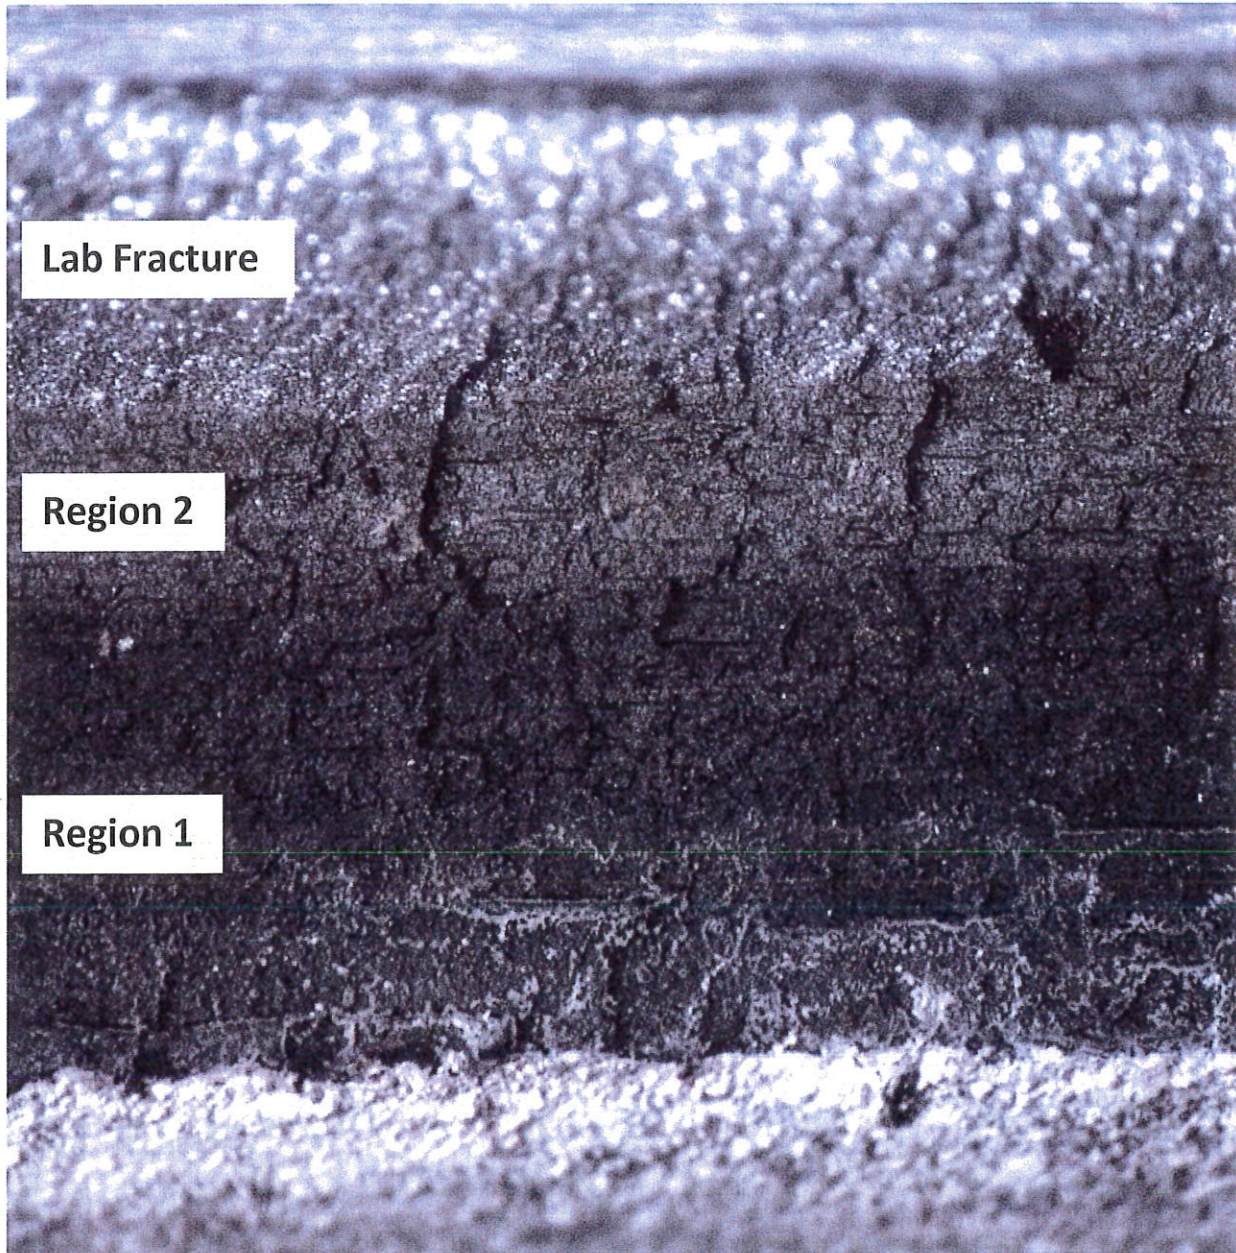
Figure 23. Stereophotograph showing a close-up view of the fracture surface associated with broken open MPI Indication 1a, without cleaning. Area indicated in Figure 22.

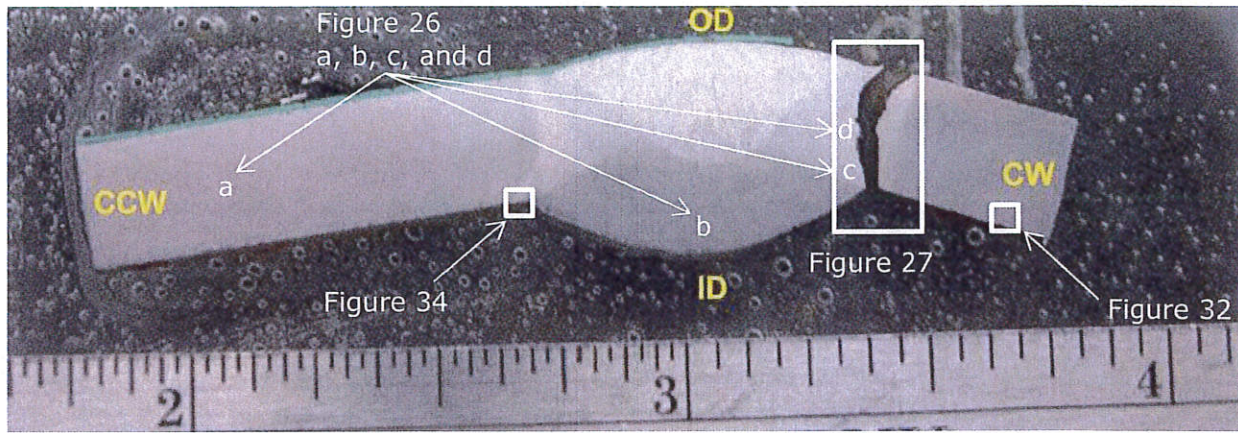
Figure 24. Photograph of the mounted cross-section (Mount M5) removed from the likely rupture origin; 16.13 feet from the U/S GW. Flow direction is into the page. Location indicated in Figure 1. 4% Nital Etch.

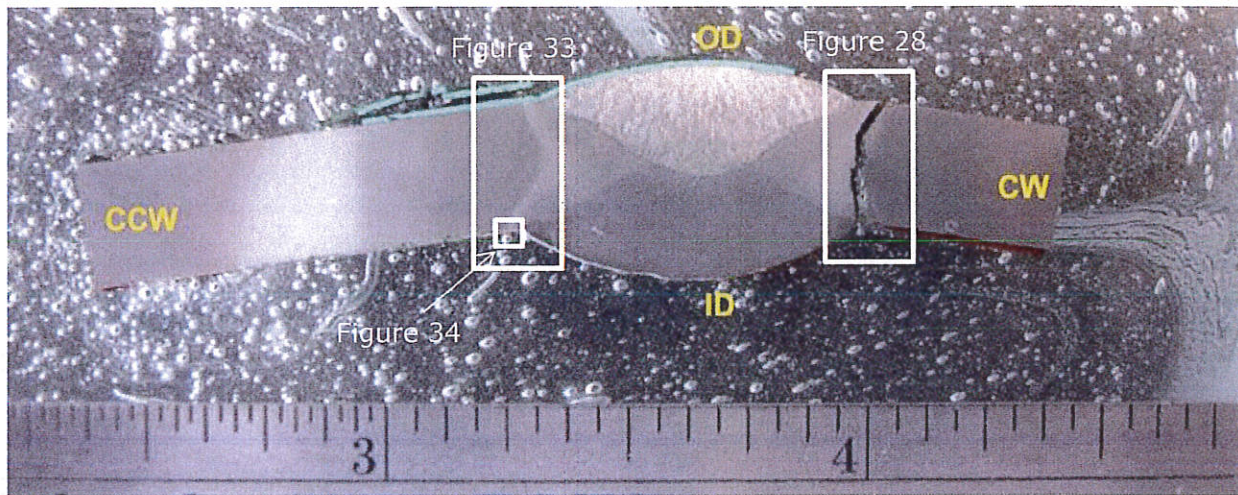
Figure 25. Photograph of the mounted cross-section (Mount M6) removed from the ruptured joint, just D/S from the likely rupture origin; 16.33 feet from the U/S GW. Flow direction is into the page. Location indicated in Figure 1. 4% Nital Etch.
