**CAL FIRE - Office of the State Fire Marshal
Pipeline Safety Division**

OPERATOR, LOCATION, AND CONSEQUENCES

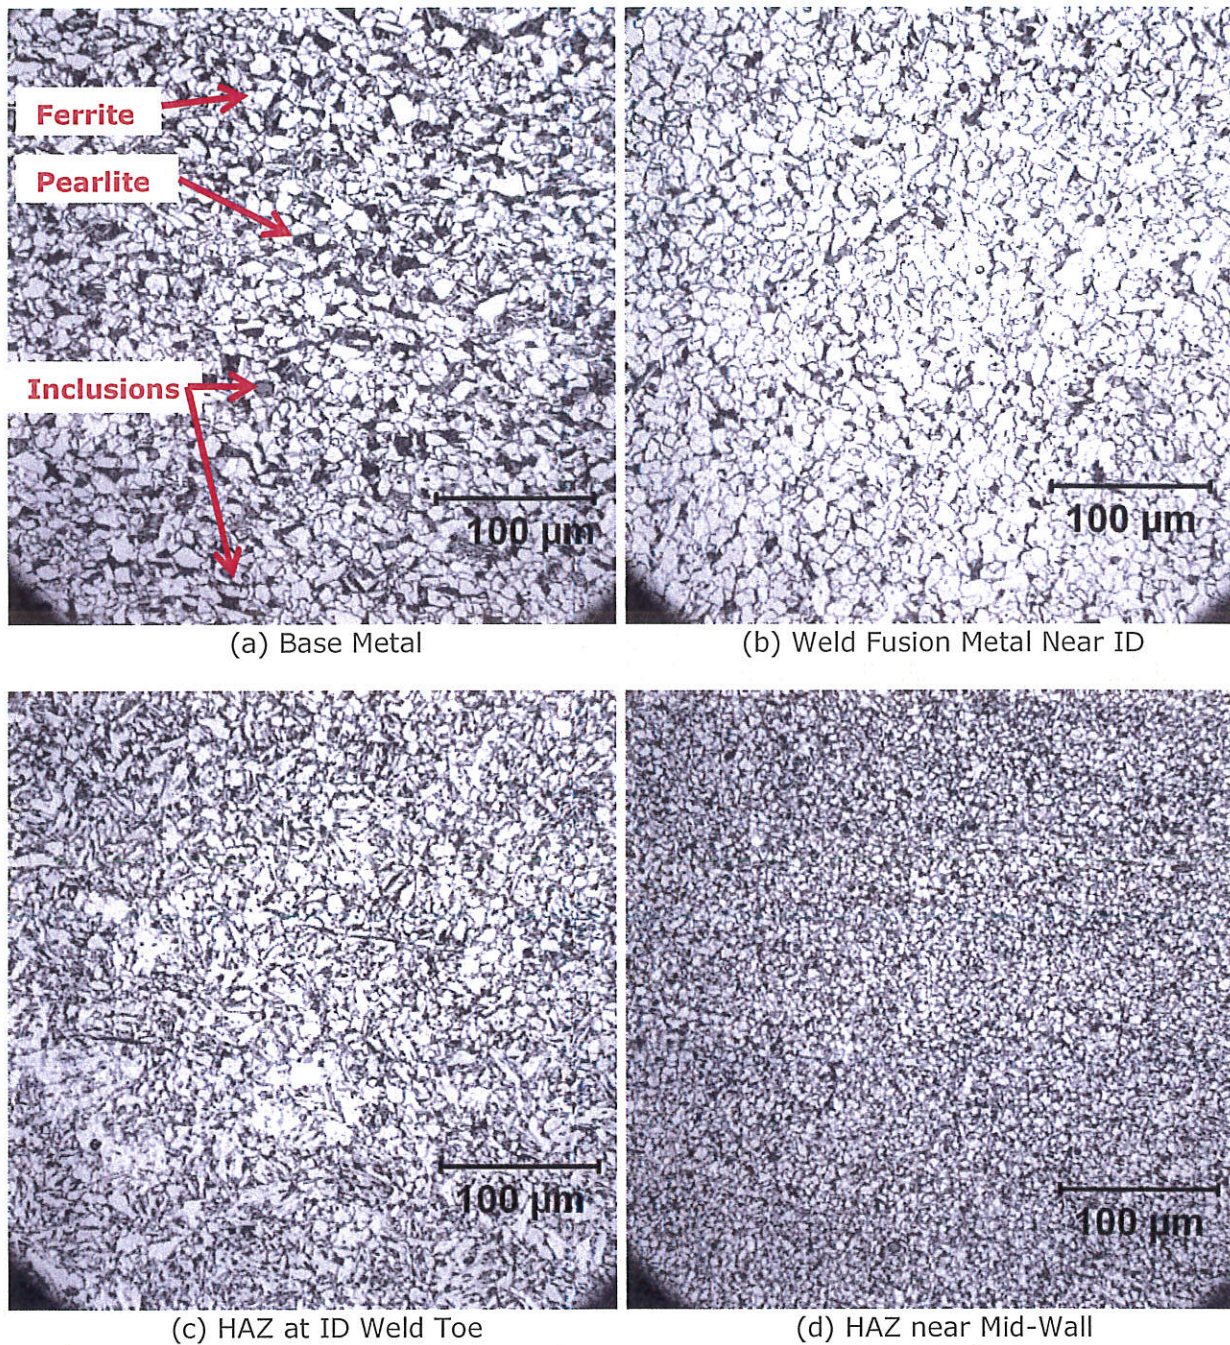
Figure 26. Photomicrographs of Mount M5, showing microstructure of (a) base metal, (b) weld fusion metal near ID, (c) HAZ metal near ID weld toe, and (d) HAZ metal near mid-wall. Locations indicated in Figure 25. 4% Nital Etch.

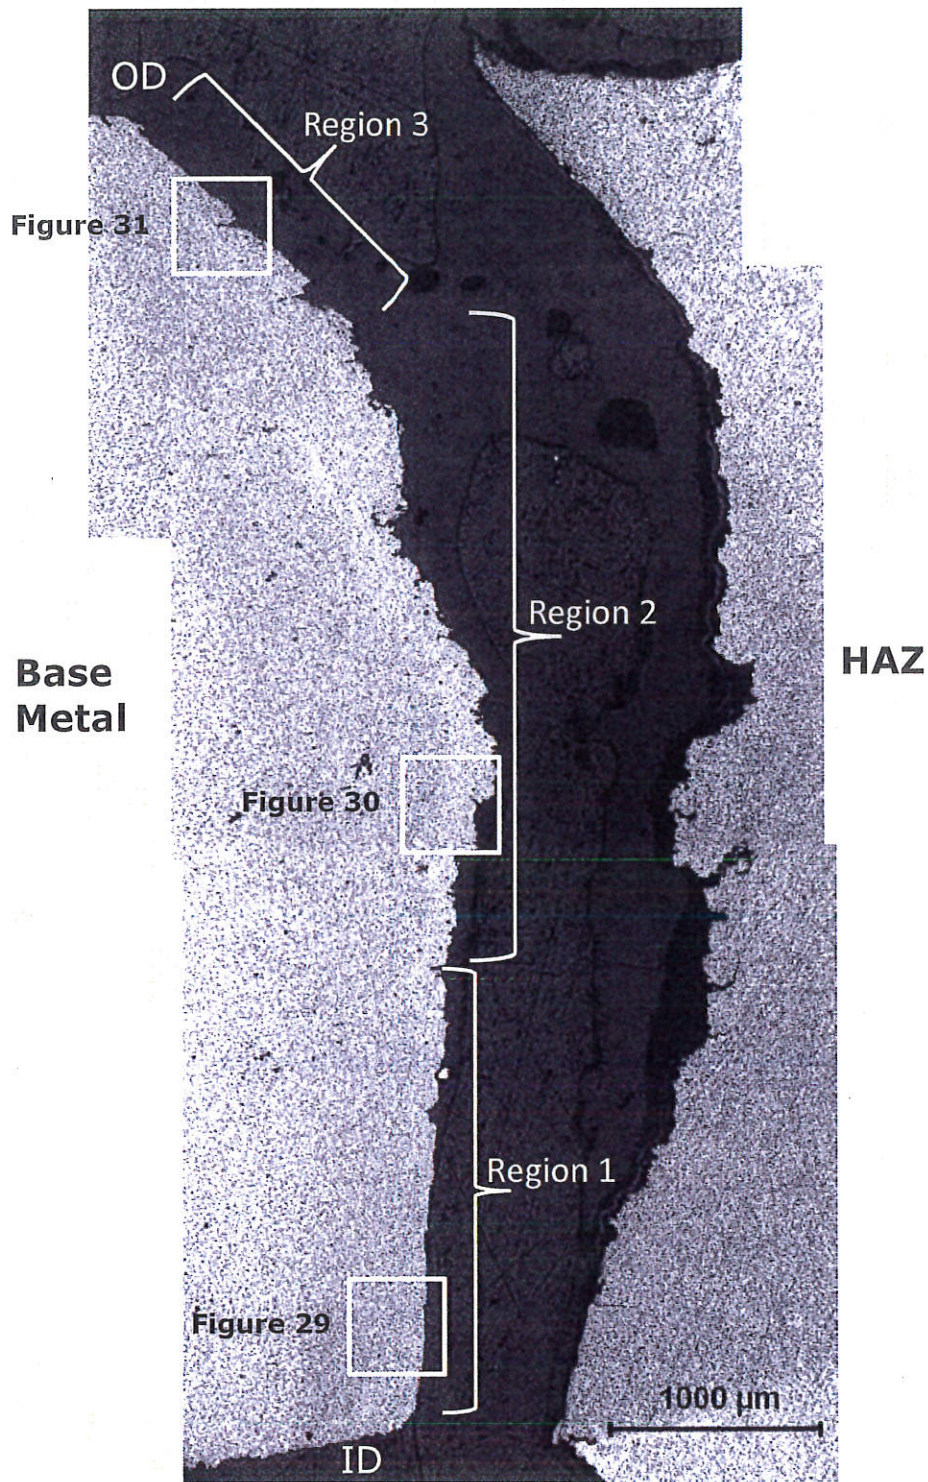
Figure 27. Photomicrograph of Mount M5, clockwise (CW) side of the weld, showing the fracture path in cross-section; area indicated in Figure 24. 4% Nital Etch.

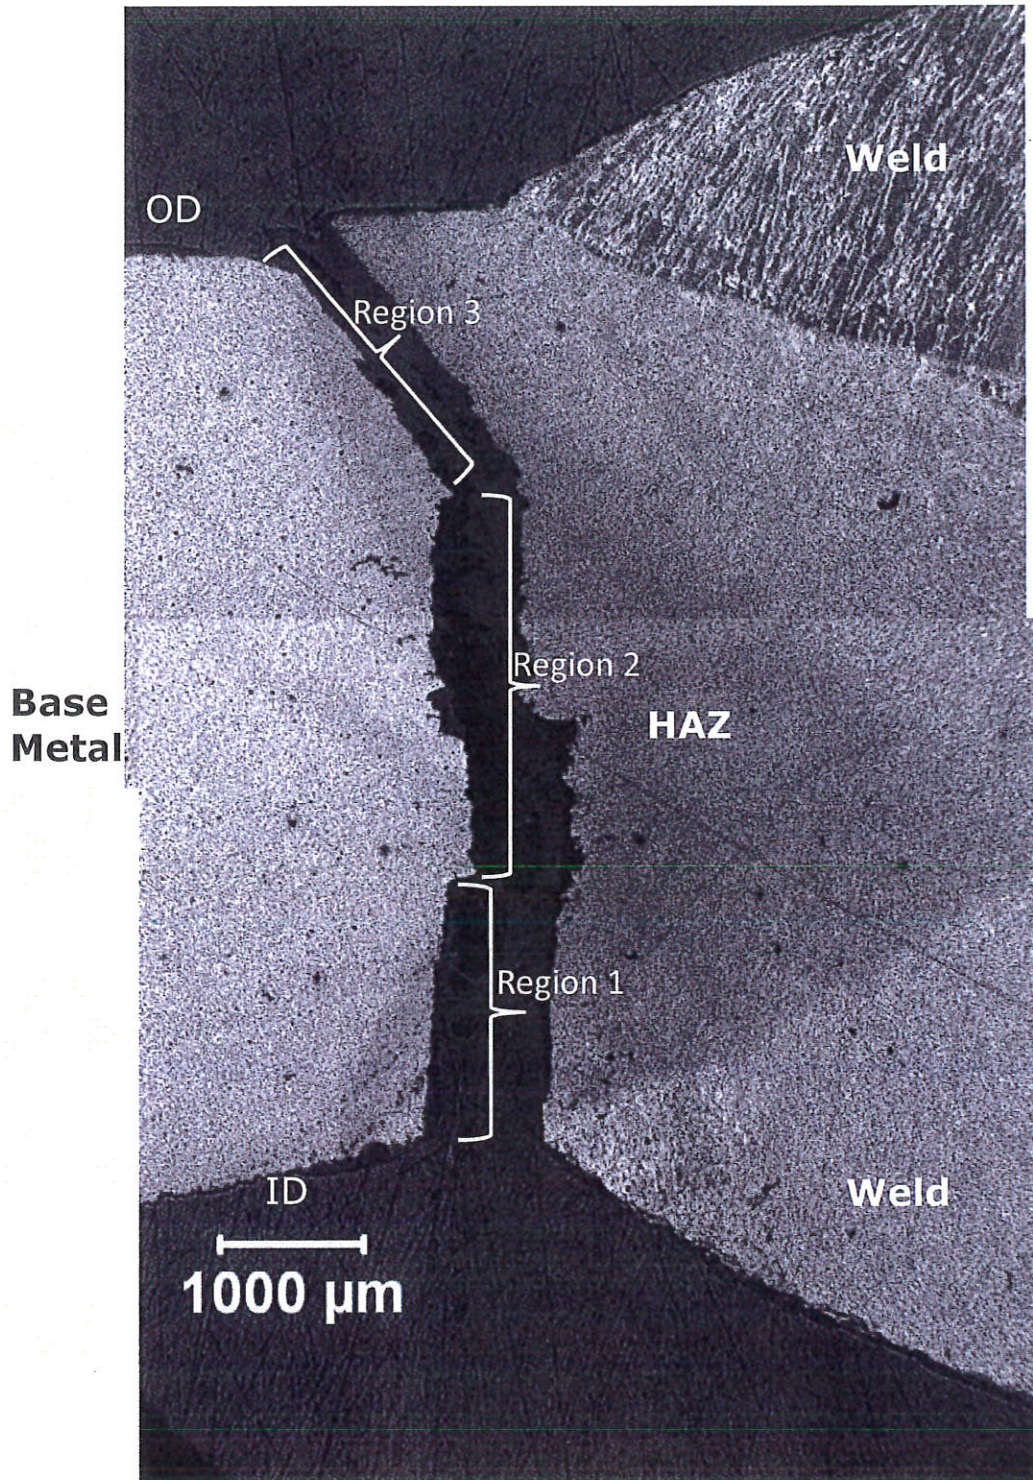
Figure 28. Photomicrograph of Mount M6, clockwise (CW) side of the weld, showing the fracture path in cross-section; area indicated in Figure 25. 4% Nital Etch.

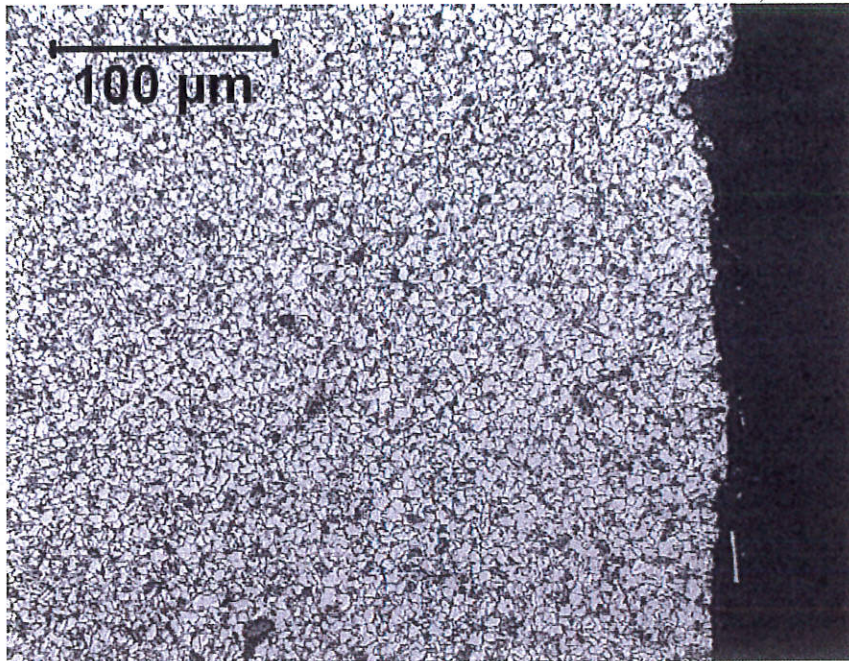
Figure 29. Photomicrograph of Mount M5 showing the microstructure and the fracture profile within Region 1 near the internal pipe surface; area indicated in Figure 27. 4% Nital Etch.

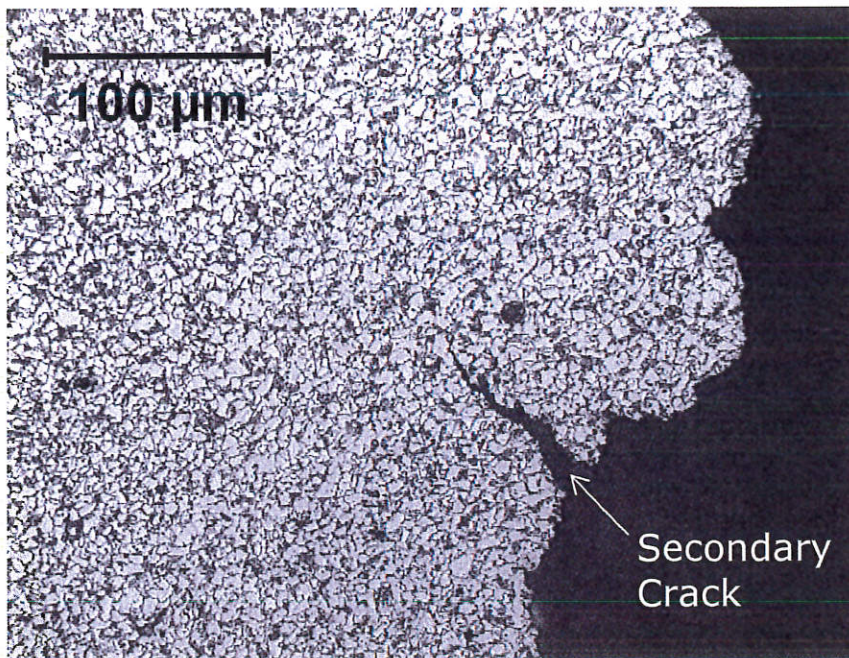
Figure 30. Photomicrograph of Mount M5 showing the microstructure and the fracture profile within Region 2; area indicated in Figure 27. 4% Nital Etch.

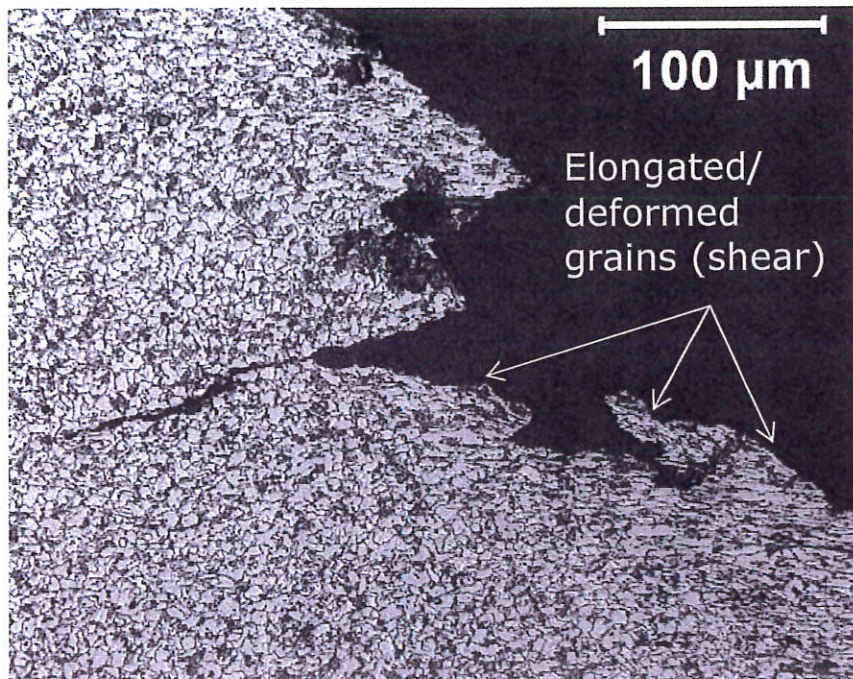
Figure 31. Photomicrograph of Mount M5 showing the microstructure and the fracture profile within Region 3 near the external pipe surface; area indicated Figure 27. 4% Nital Etch.

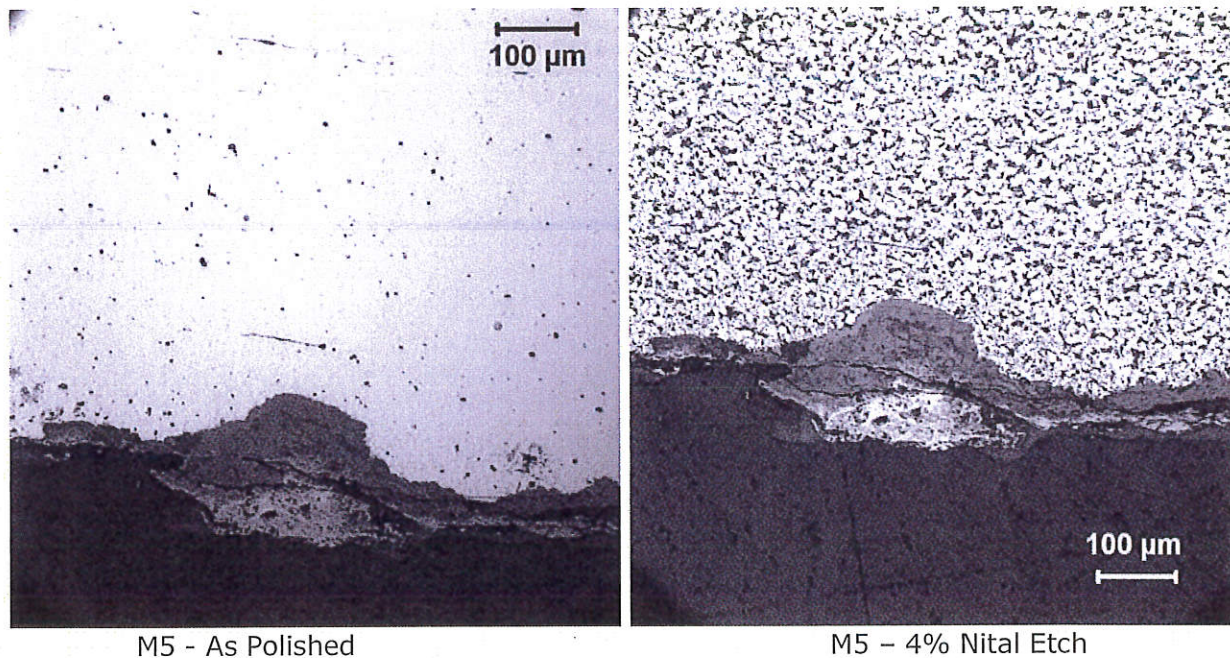
Figure 32. Photomicrographs of Mount M5 showing round and elongated inclusions in the base metal and corrosion product in a micro-pit on the ID surface of the pipe; area indicated in Figure 24.

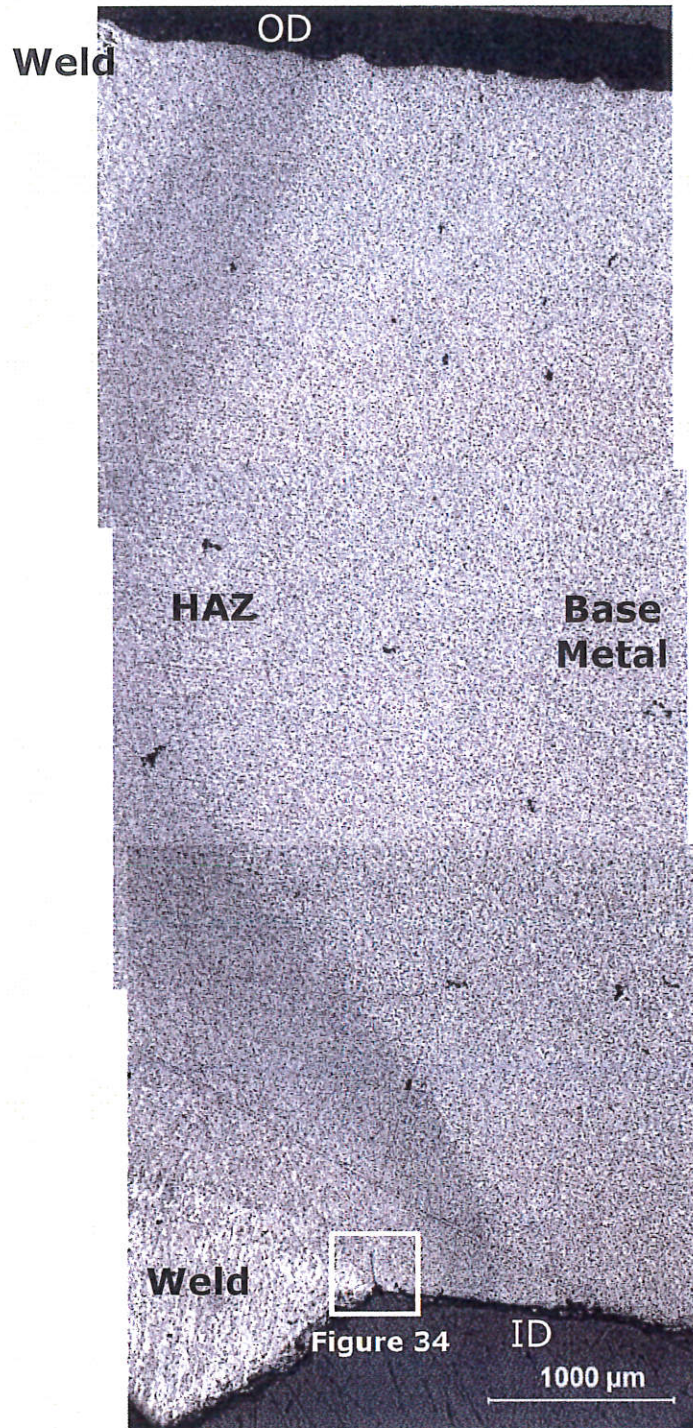
Figure 33. Photomicrograph of Mount M6, counterclockwise (CCW) side of the weld, showing a small crack at the weld toe; area indicated in Figure 25. 4% Nital Etch.

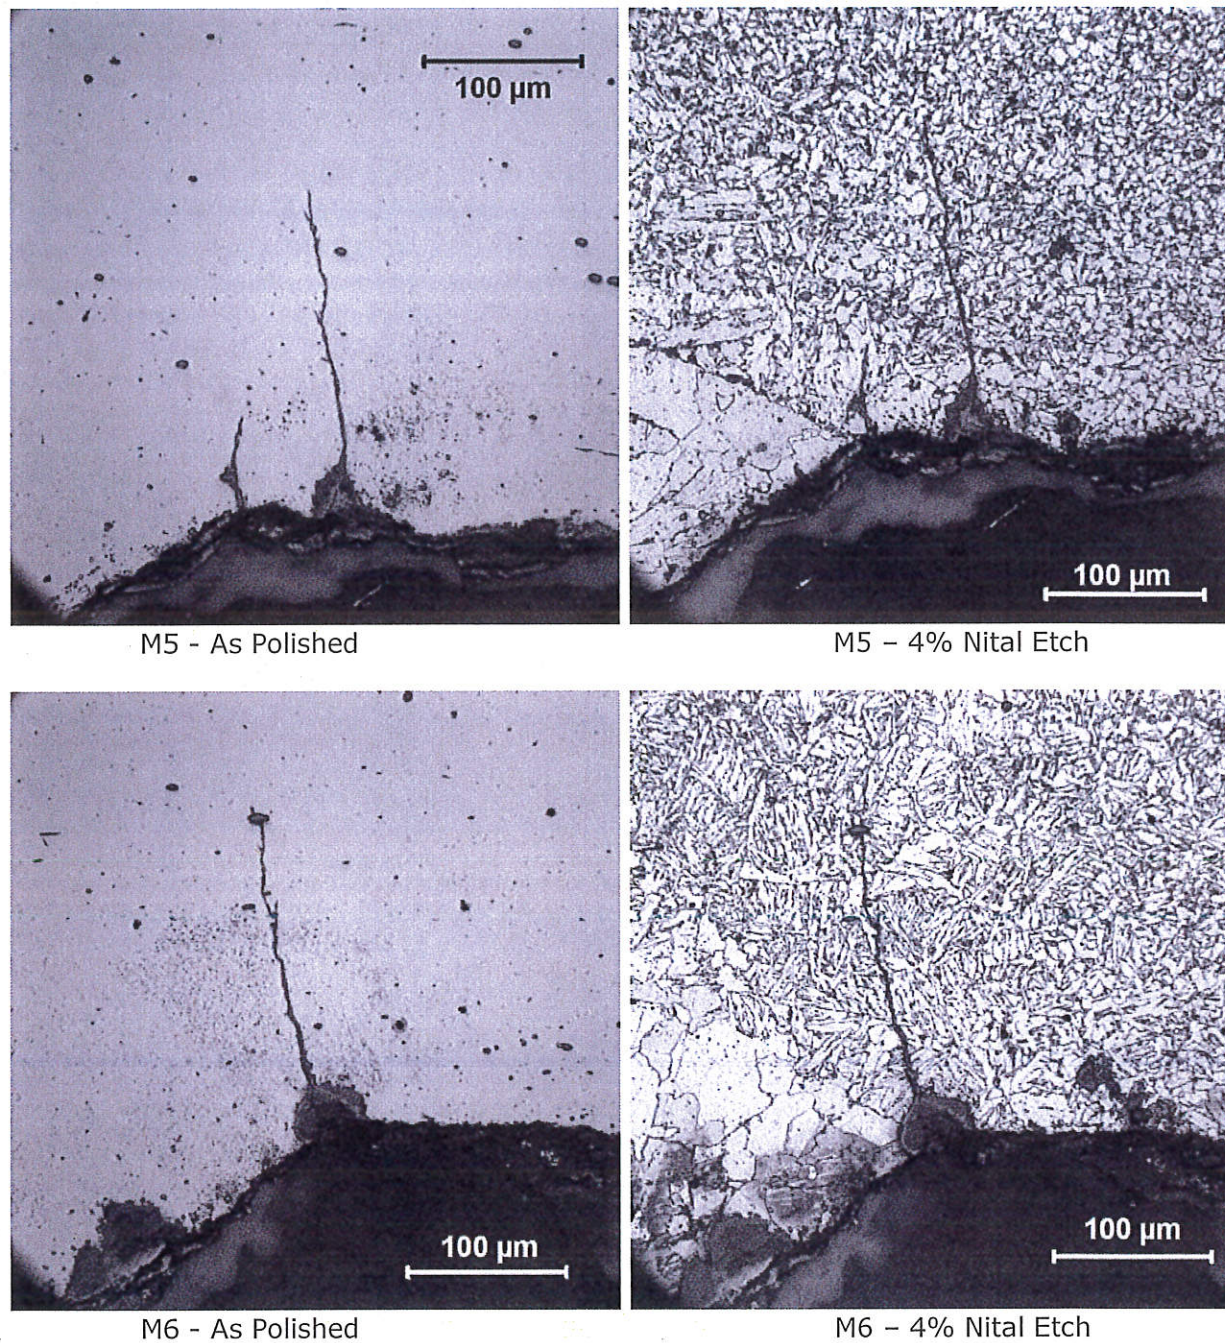
Figure 34. Photomicrographs of Mount M5 (top, refer to Figure 24) and Mount M6 (bottom, refer to Figure 25, showing cracks at weld toe with pits and corrosion products on ID pipe surface; counterclockwise (CCW) side of the seam weld.

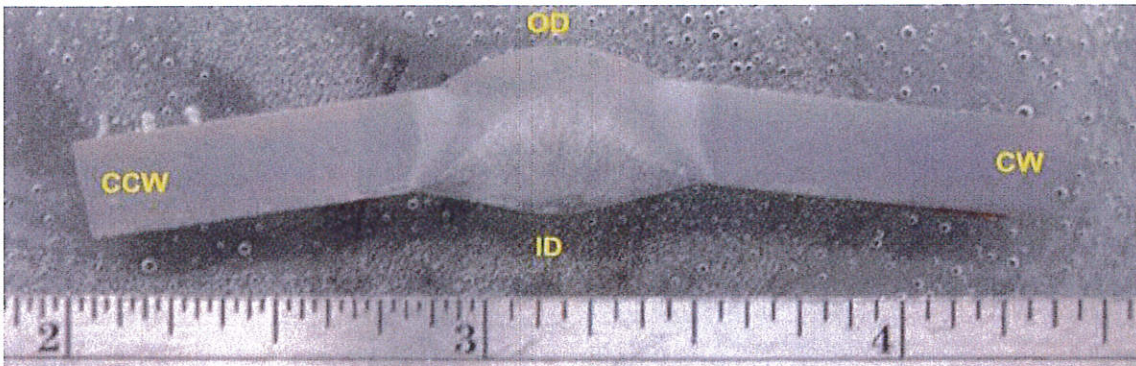
Figure 35. Photograph of the mounted cross-section (Mount M7) removed from the ruptured joint, away from the failure; 21.16 feet from the U/S GW. Flow direction is into the page. Location indicated in Figure 1. 4% Nital Etch.

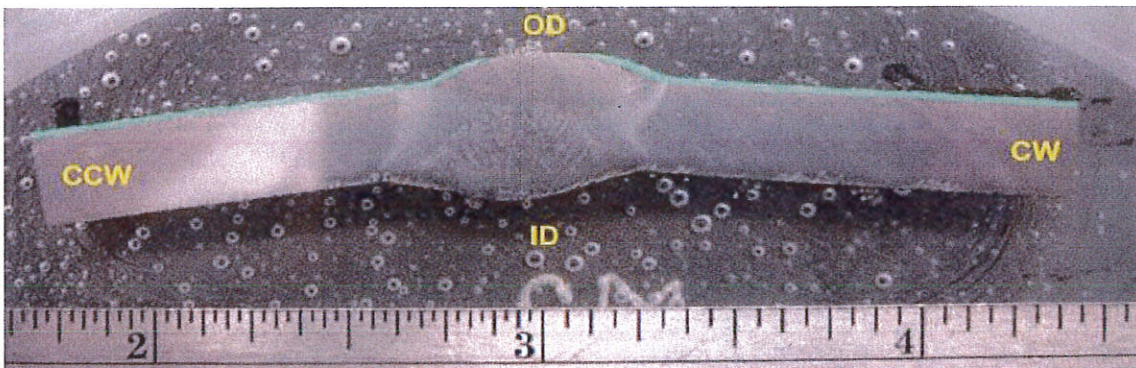
Figure 36. Photograph of the mounted cross-section (Mount M3) removed from D/S joint; 28.19 feet from the U/S GW (of the ruptured joint). Flow direction is into the page. Location indicated in Figure 1. 4% Nital Etch.

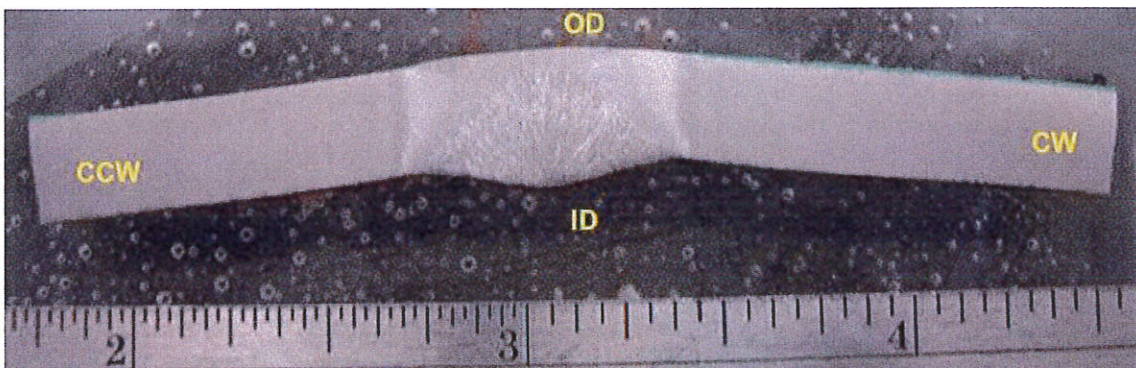
Figure 37. Photograph of the mounted cross-section (Mount M4) removed from U/S joint; -1.54 feet from the U/S GW (of the ruptured joint). Flow direction is into the page. Location indicated in Figure 1. 4% Nital Etch.

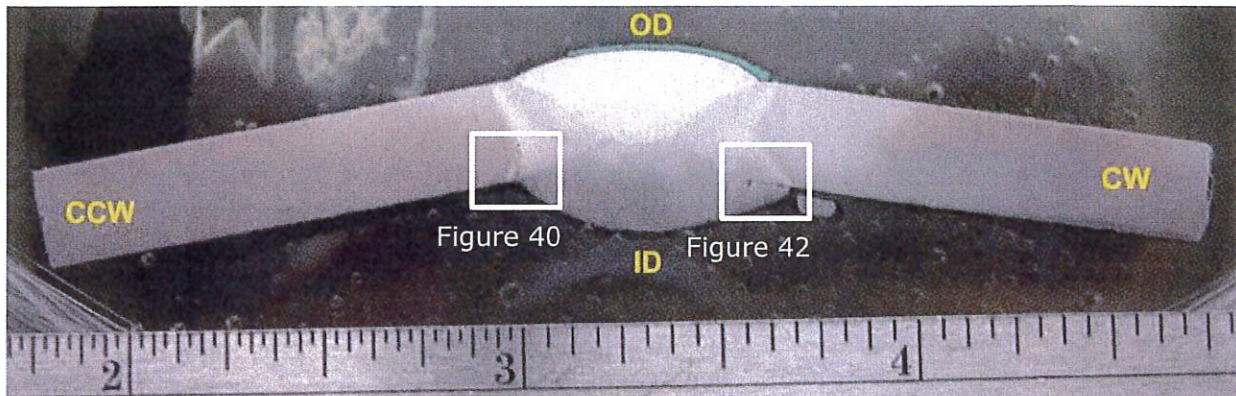
Figure 38. Photograph of the mounted cross-section (Mount M1) removed from MPI Indication 1a (CW) and MPI Indication 1b (CCW) of the ruptured joint, away from the rupture; 18.81 feet from the U/S GW. Flow direction is into the page. Location indicated in Figure 1. 4% Nital Etch.

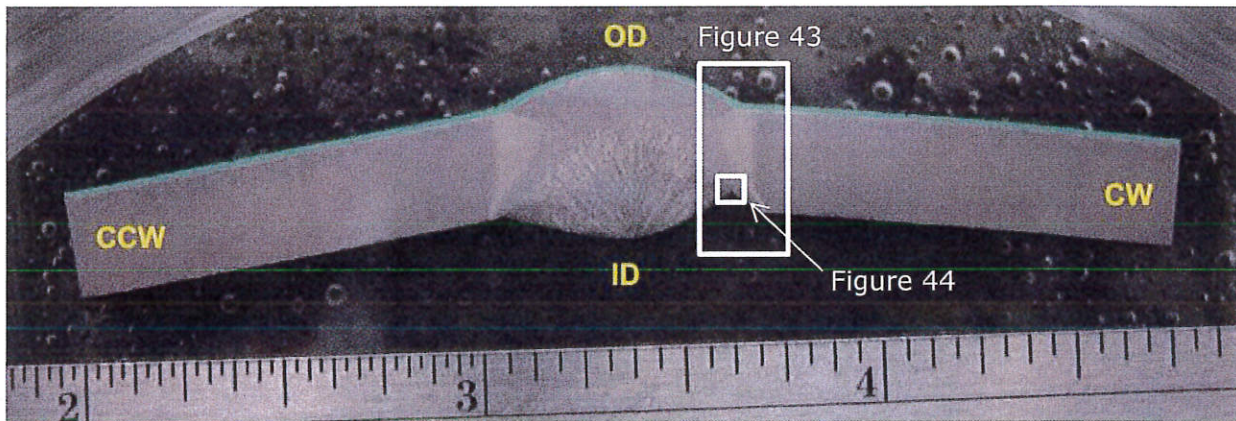
Figure 39. Photograph of the mounted cross-section (Mount M2) removed from MPI Indications 2 (CW) of the ruptured joint, away from the rupture; 23.83 feet from the U/S GW. Flow direction is into the page. Location indicated in Figure 1. 4% Nital Etch.

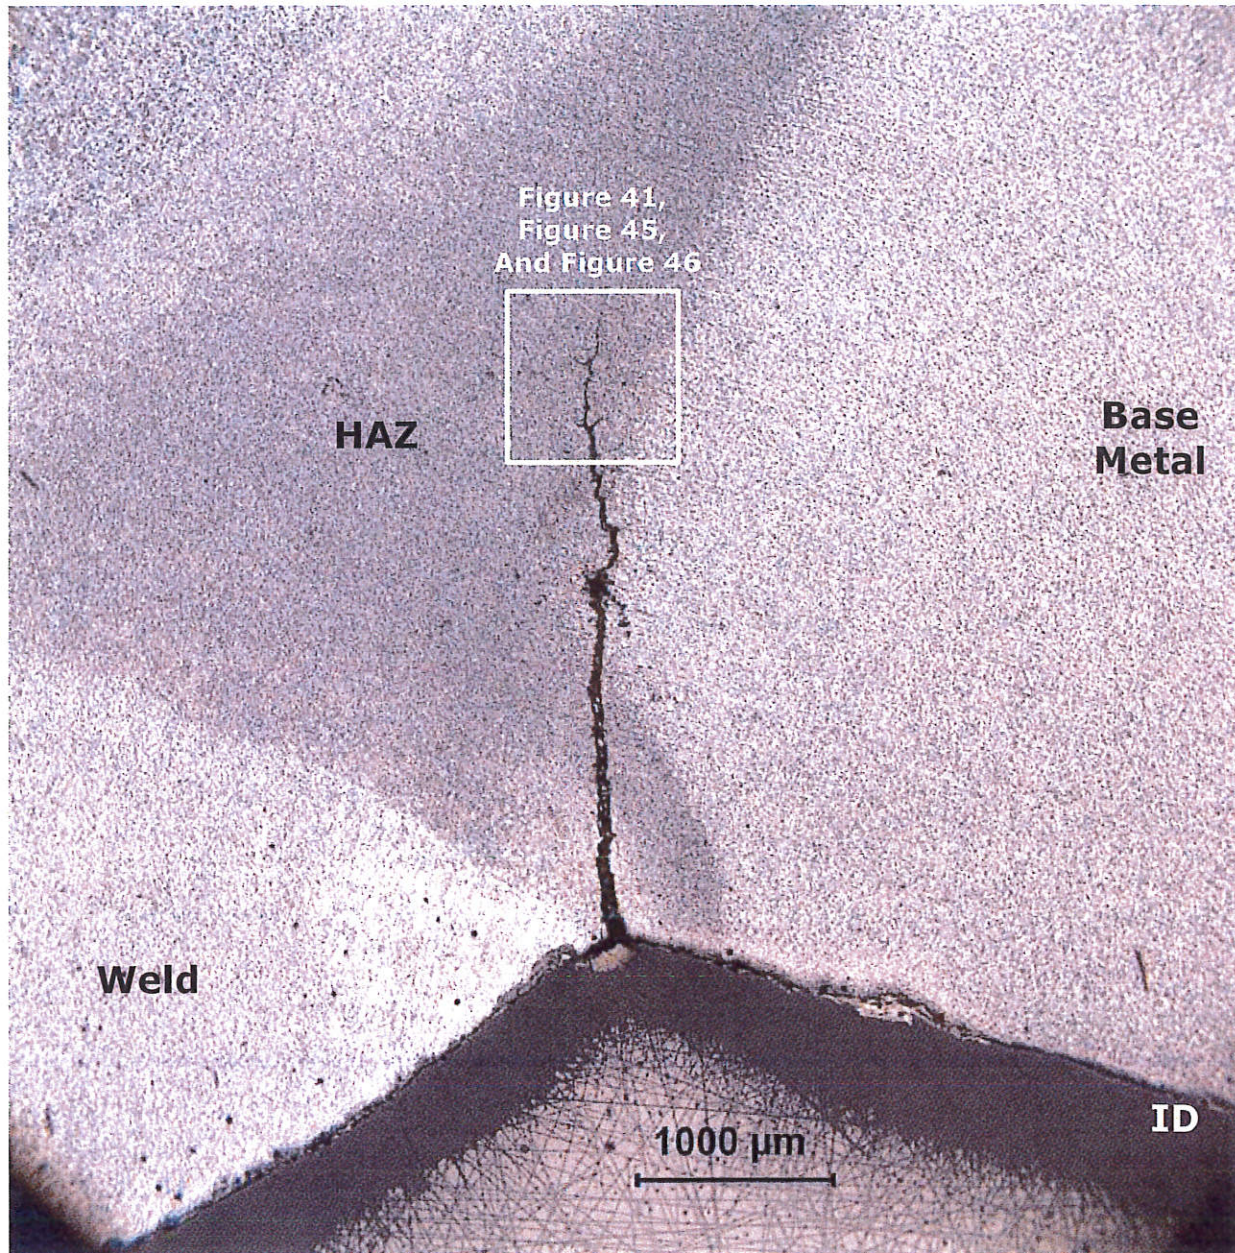
Figure 40. Photomicrograph of Mount M1 (MPI Indication 1a) showing crack at weld toe from ID surface on clockwise (CW) side of the seam weld; mirror image of area indicated in Figure 38. 4% Nital Etch.

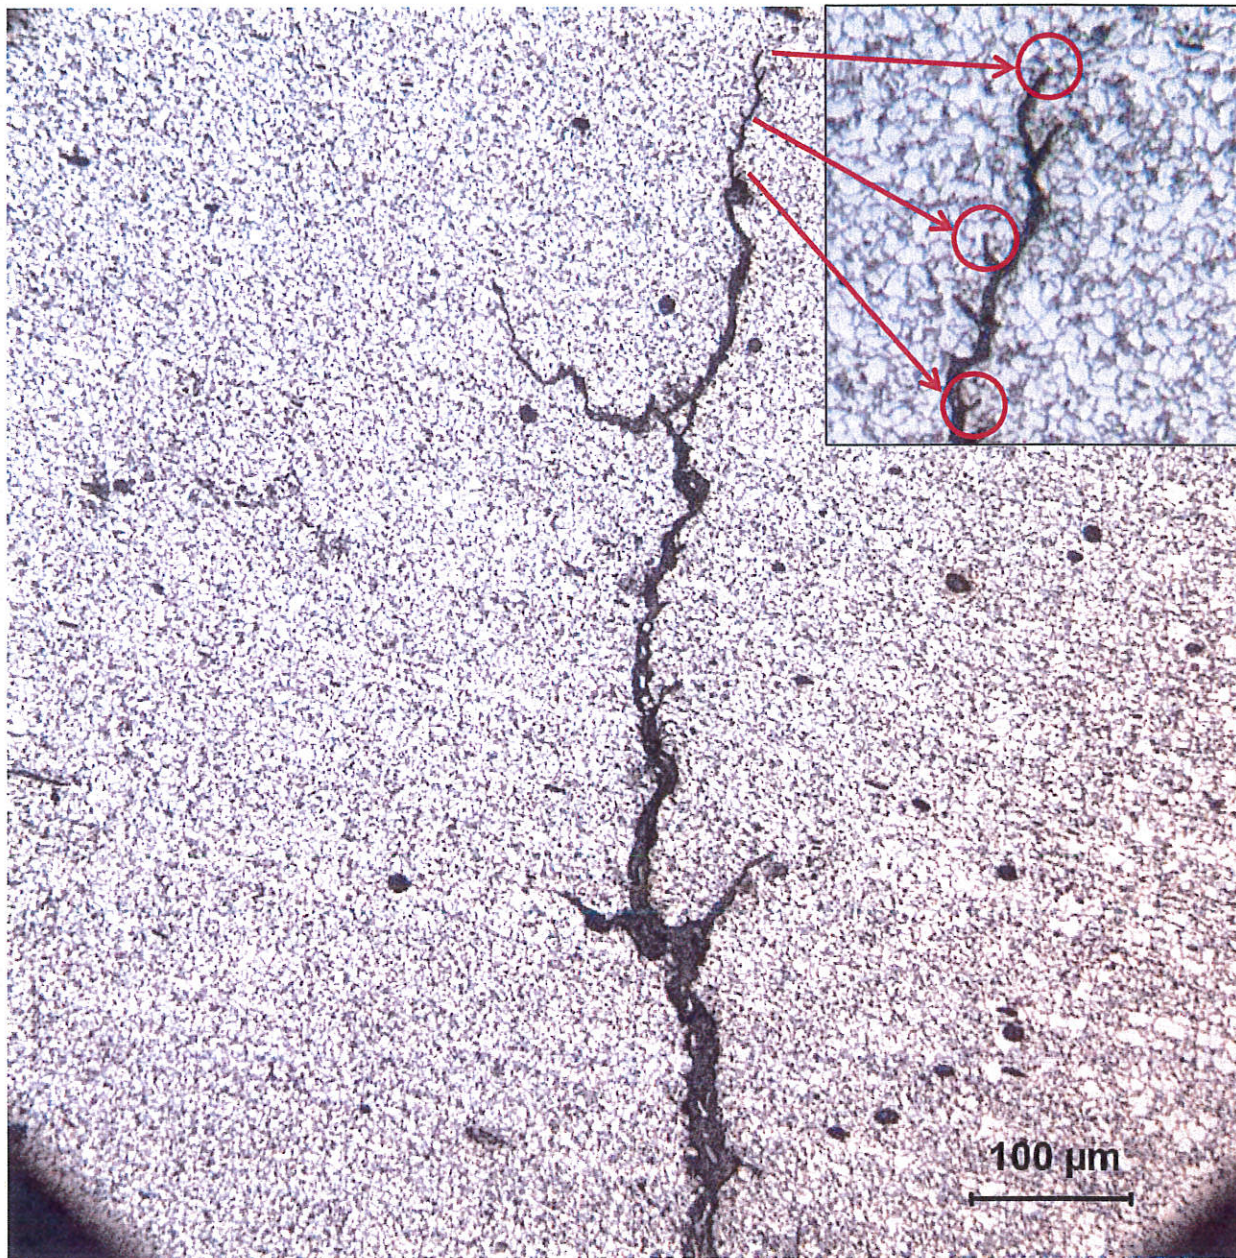
Figure 41. Photomicrograph of Mount M1 (MPI Indication 1a) showing crack tip on clockwise (CW) side of the seam weld; area indicated in Figure 40. 4% Nital Etch. Inset photo shows close-up of transgranular morphology at crack tip.

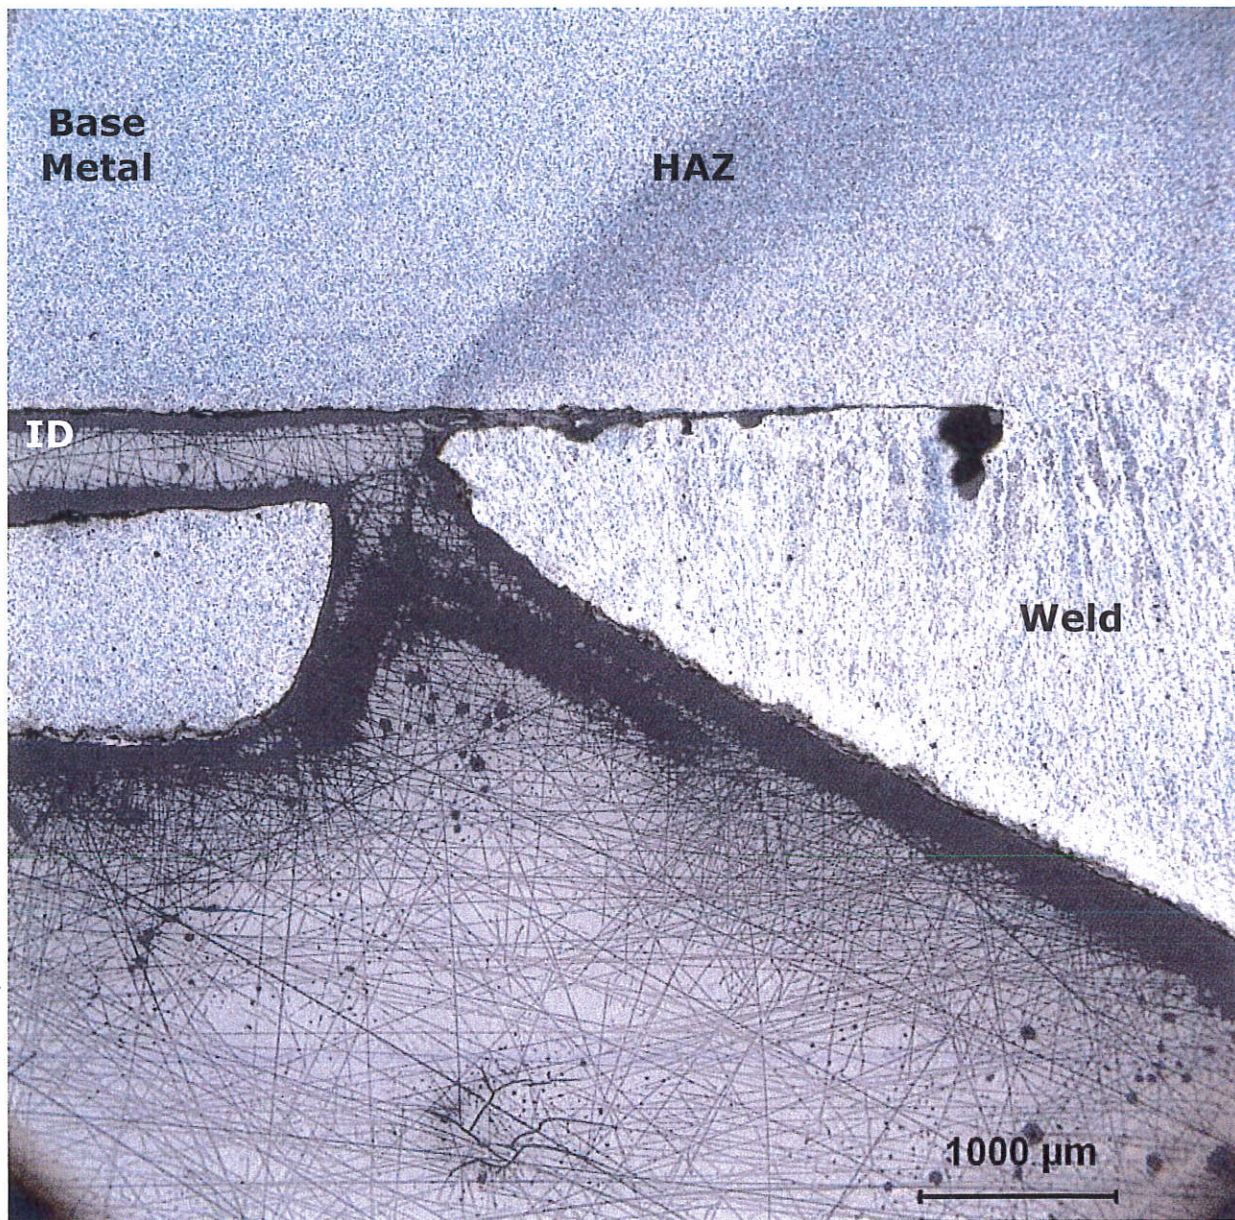
Figure 42. Photomicrograph of Mount M1 (MPI Indication 1b) showing overlap of weld bead on ID surface, counterclockwise (CCW) side of the seam weld; mirror image of area indicated in Figure 38. 4% Nital Etch.

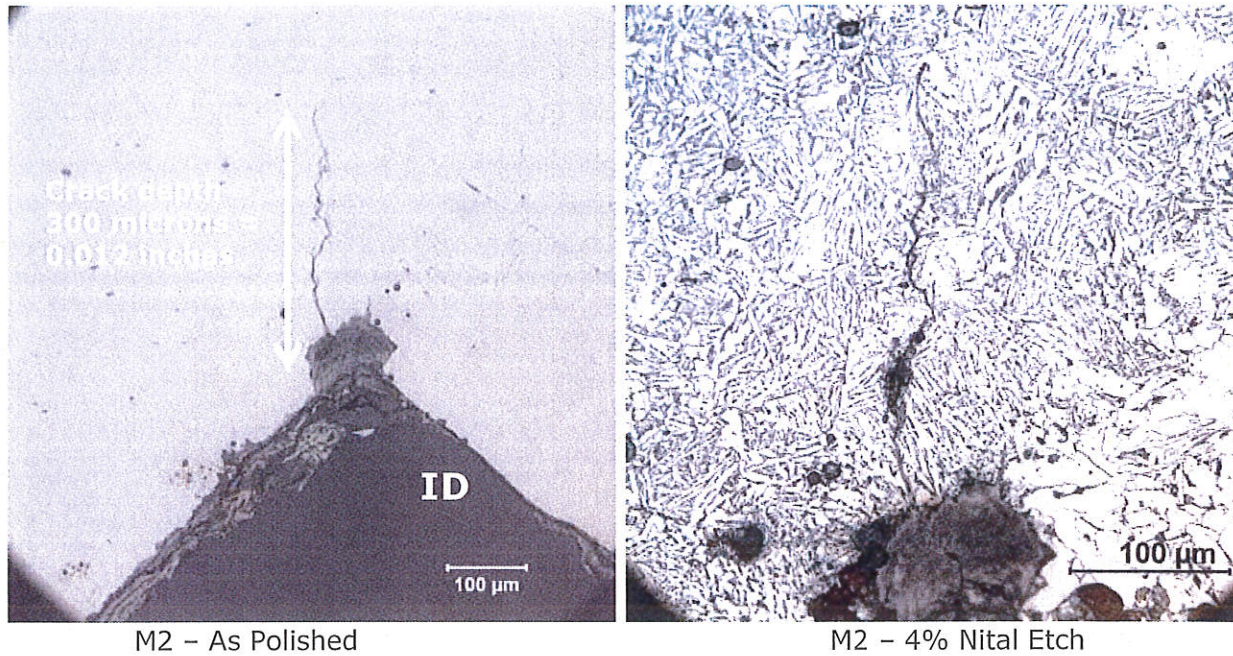
Figure 44. Photomicrographs of Mount M2 (MPI Indication 2) showing crack at weld toe from ID surface on clockwise (CW) side of the seam weld; mirror images of area indicated in Figure 39.

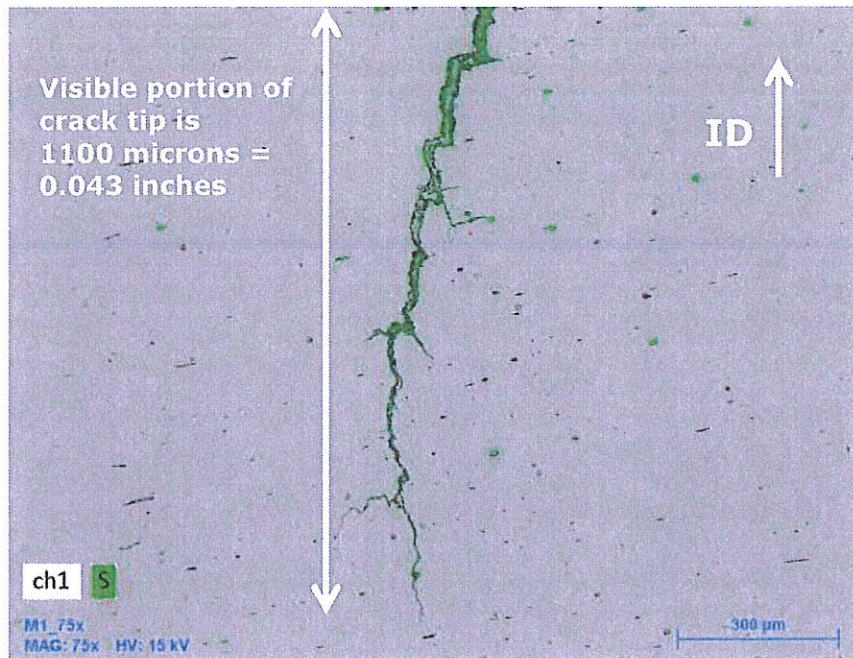
Figure 45. EDS map of Mount M1 (MPI Indication 1a) at crack shown in Figure 40, showing presence of sulfur at tip of the crack that started at weld toe from ID surface on clockwise (CW) side of the seam weld.

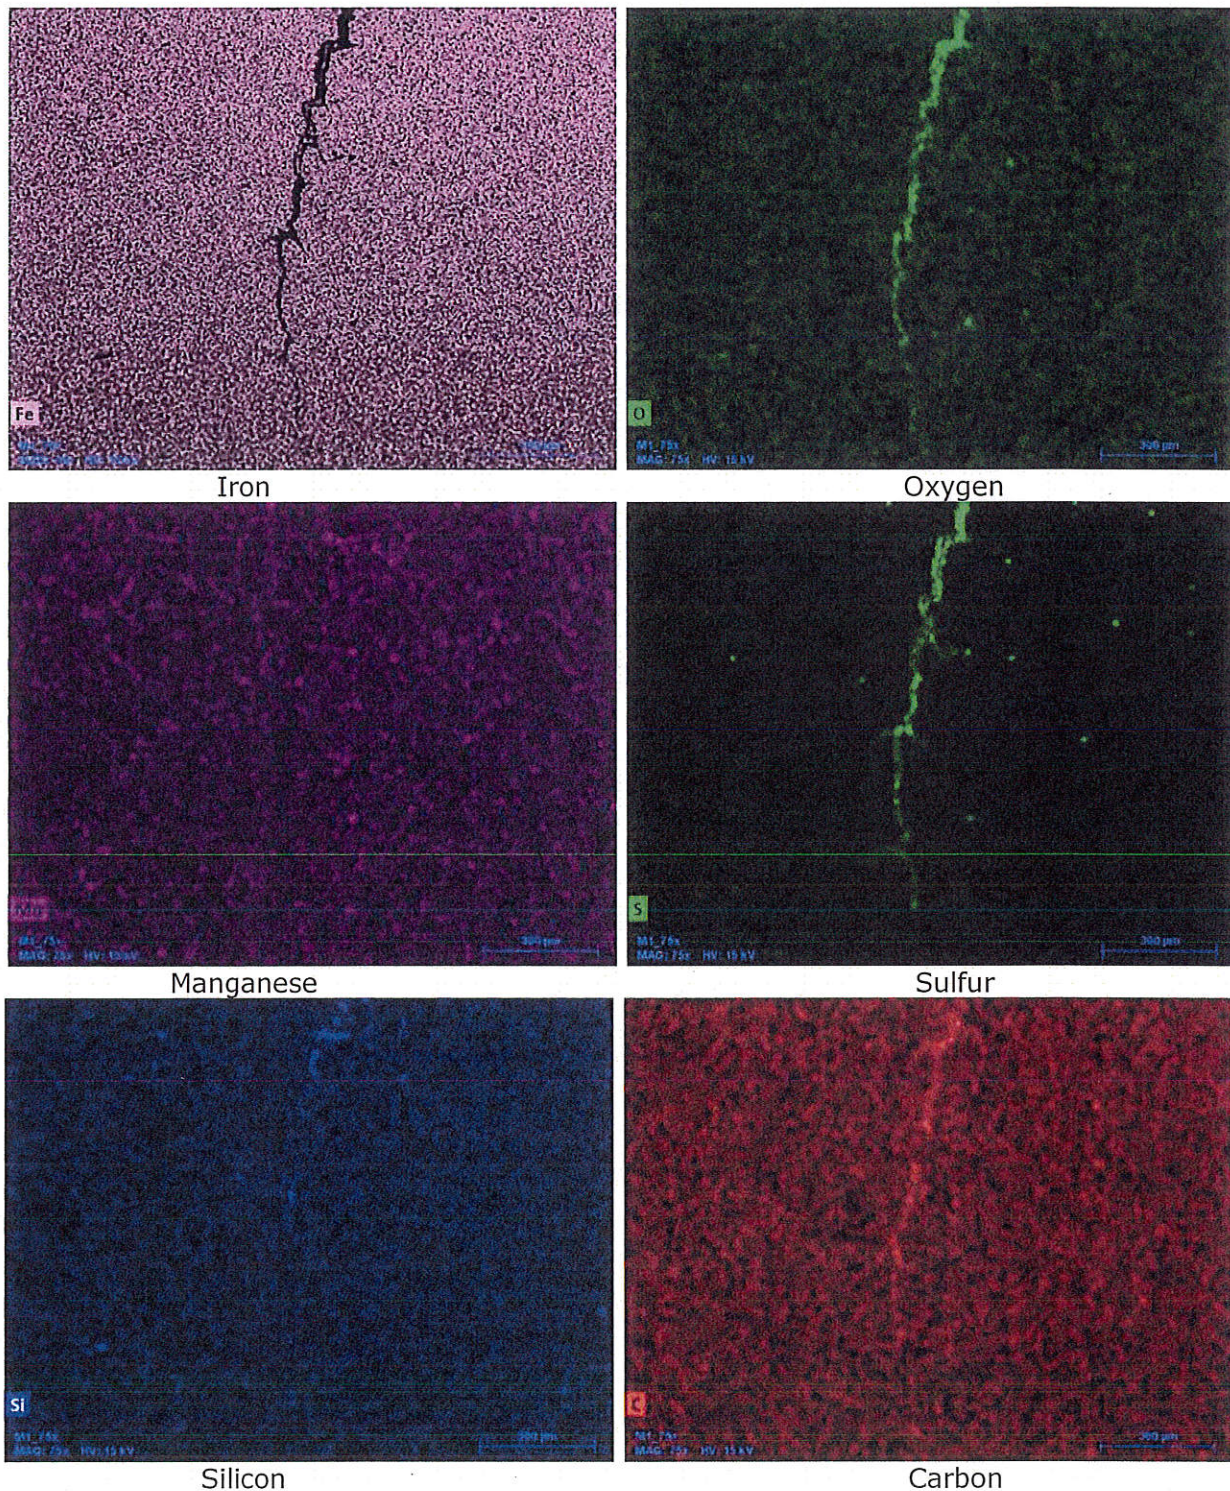
Figure 46. EDS map of Mount M1 (MPI Indication 1a) at crack shown in Figure 40, showing distribution of Fe, O, Mn, S, Si, and C at tip of the crack that started at weld toe from ID surface on clockwise (CW) side of the seam weld.

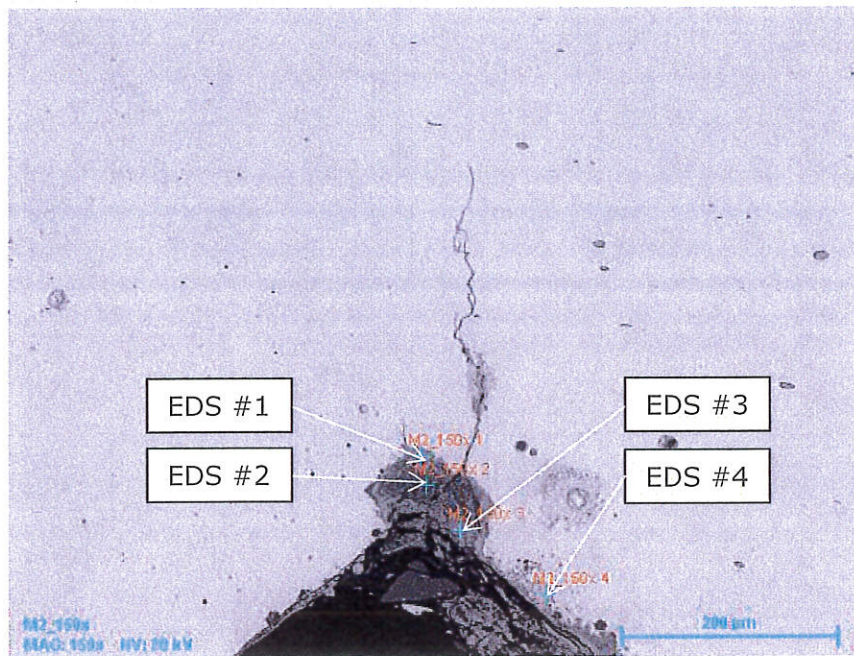
Figure 47. EDS measurement locations on Mount M2 (results shown in Table 5; also refer back to Figure 44), at weld toe crack with pit and corrosion product, from ID surface on counterclockwise (CCW) side of the seam weld.

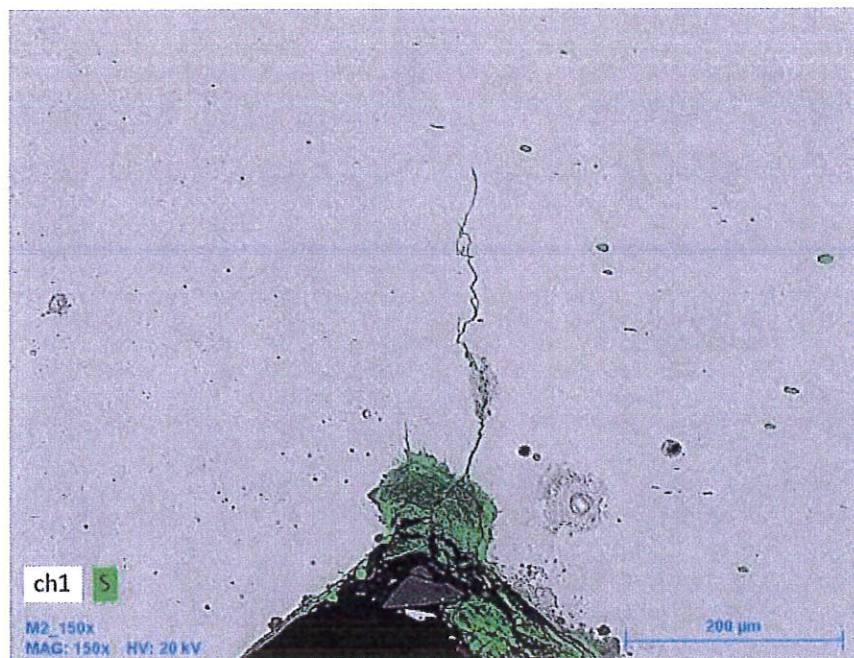
Figure 48. EDS map of Mount M2 (MPI Indication 2) at crack shown in Figure 47, showing distribution of sulfur.
