**CAL FIRE - Office of the State Fire Marshal
Pipeline Safety Division**

OPERATOR, LOCATION, AND CONSEQUENCES

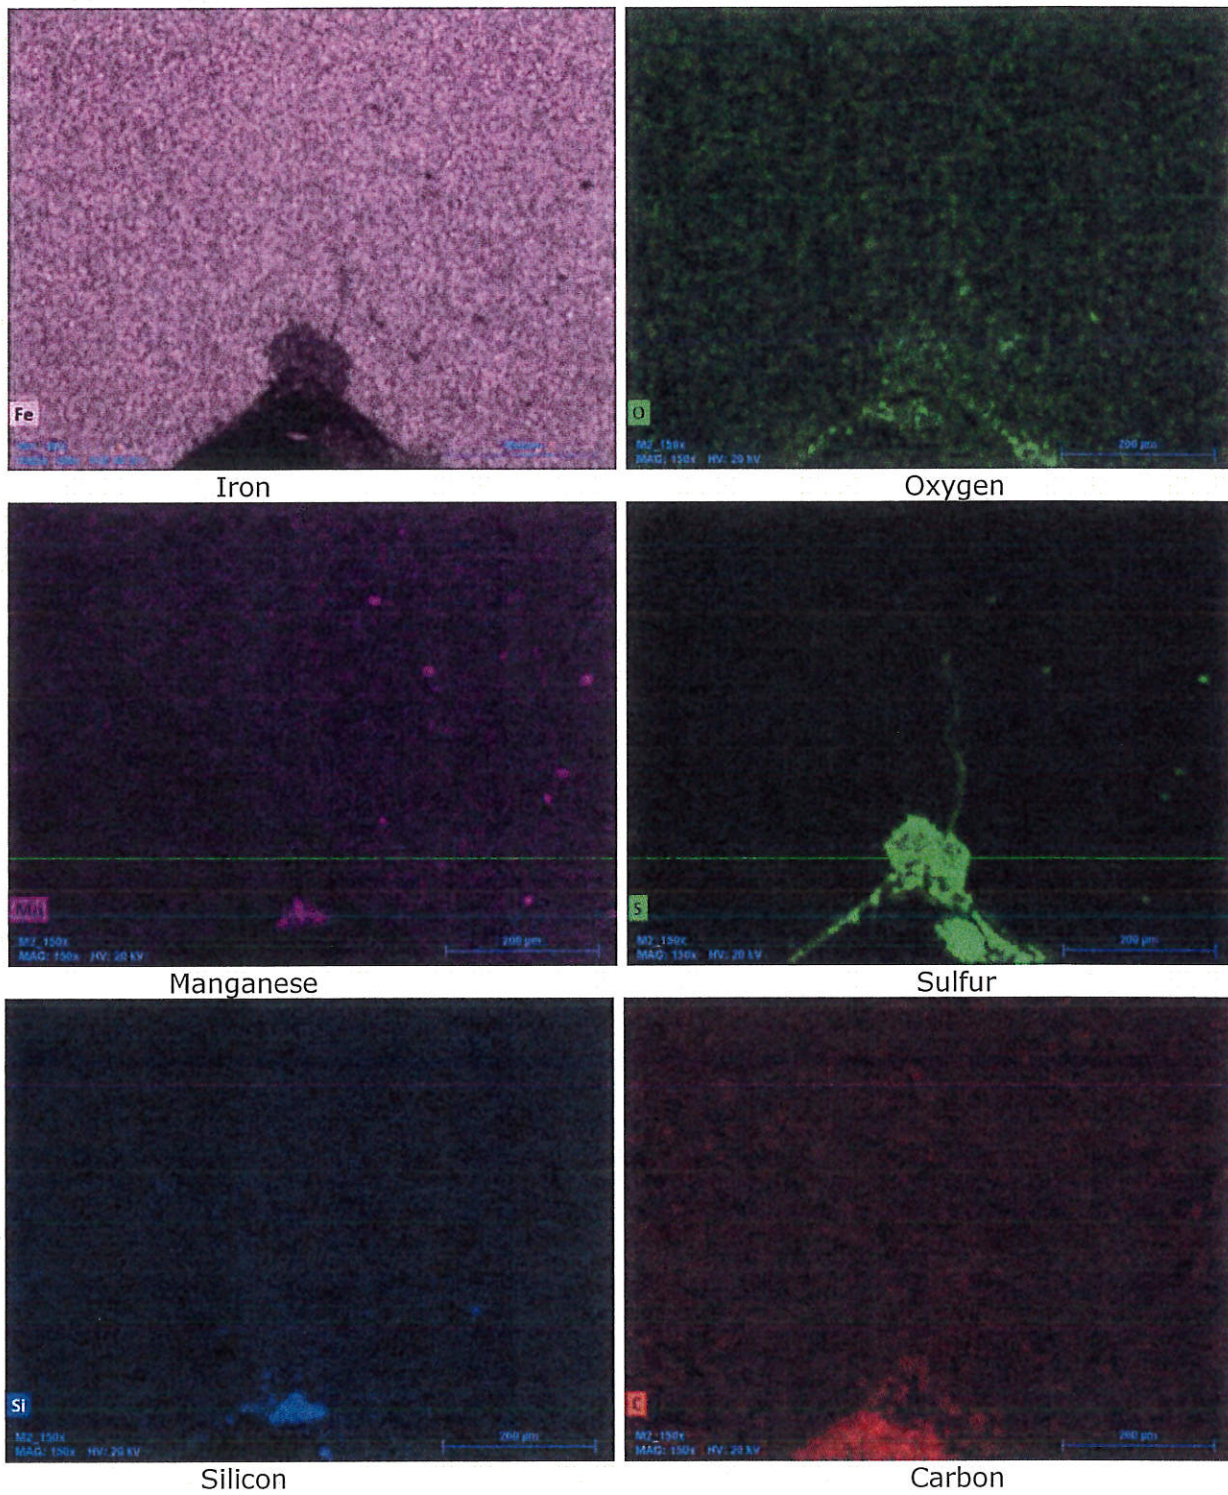
Figure 49. EDS map of Mount M2 (MPI Indication 2) at crack shown in Figure 47, showing distribution of Fe, O, Mn, S, Si, and C.

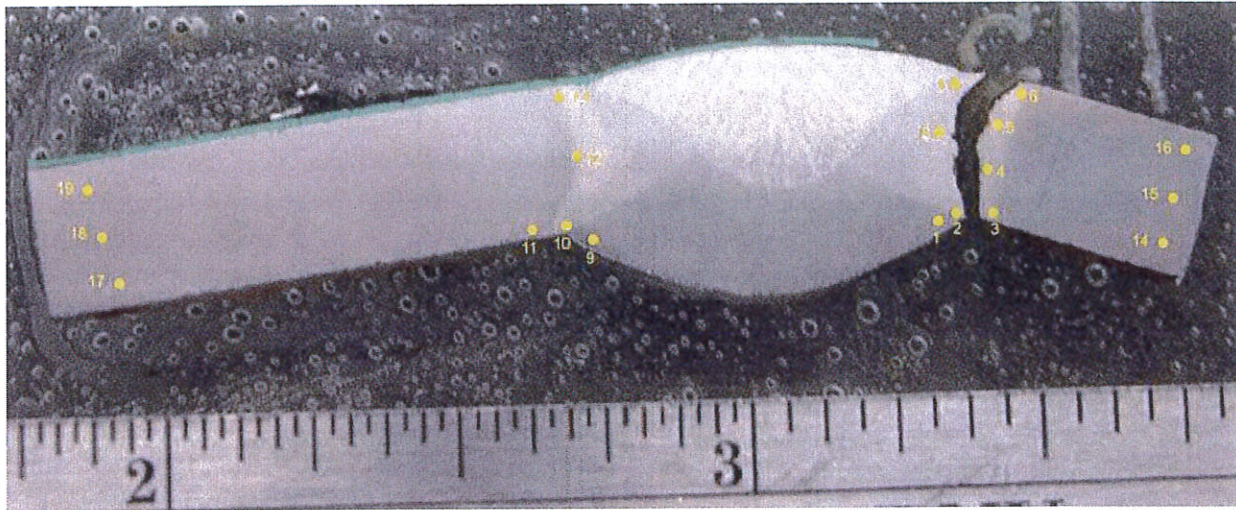
Measurement Location	Hardness (HV)	
	Mount M5 16.13 ft from U/S GW	Mount M6 16.33 ft from U/S GW
1	190.3	192.5
2	218.1	187.6
3	204.1	201.7
4	206.5	218.8
5	210.9	209.1
6	215.5	228.5
7	204.1	206.0
8	216.1	183.4
9	163.1	176.4
10	182.9	210.3
11	201.7	214.8
12	182.9	190.9
13	207.8	190.9
14	212.2	211.6
15	197.0	208.4
16	191.4	224.3
17	227.8	214.8
18	206.5	195.3
19	180.4	180.9

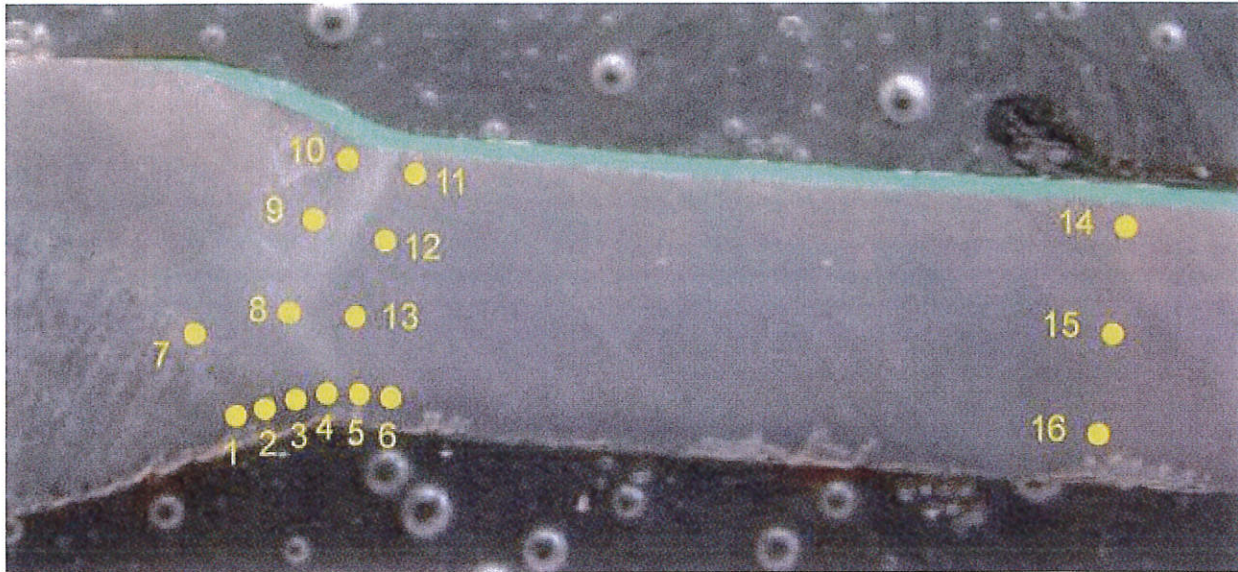
Measurement Location	Hardness (HV)		
	Mount M3 D/S joint	Mount M4 U/S joint	Mount M7 Failed joint
1	183.4	213.4	193.1
2	213.5	235.1	196.5
3	195.3	226.4	218.1
4	207.8	226.4	220.1
5	205.3	227.8	225.0
6	201.7	214.2	214.2
7	205.3	216.8	214.2
8	172.1	214.2	214.2
9	201.1	205.3	200.5
10	214.8	192.0	191.9
11	201.1	227.8	204.1
12	190.3	218.1	210.3
13	180.4	199.9	210.3
14	181.4	220.1	201.1
15	183.4	205.3	193.1
16	168.9	212.9	193.1

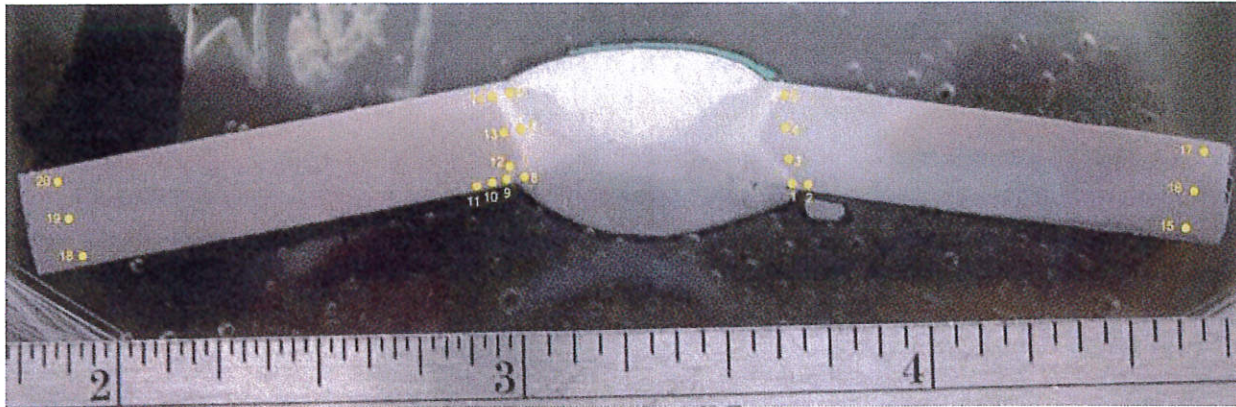
Measurement Location	Hardness (HV)
	Mount M1 MPI Indications 1a/1b
1	188.7
2	211.6
3	208.4
4	200.5
5	211.6
6	184.5
7	194.2
8	201.7
9	174.0
10	163.1
11	166.5
12	197.0
13	197.7
14	214.8
15	203.2
16	187.6
17	214.2
18	227.1
19	197.0
20	183.4

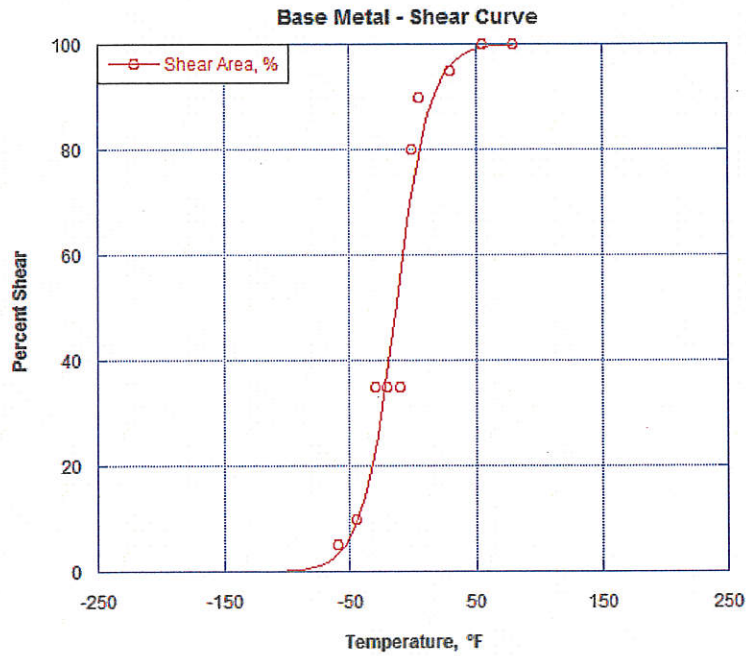
Figure 54. Percent shear from Charpy V-notch tests as a function of temperature for transverse base metal specimens removed from the pipe joint that ruptured.

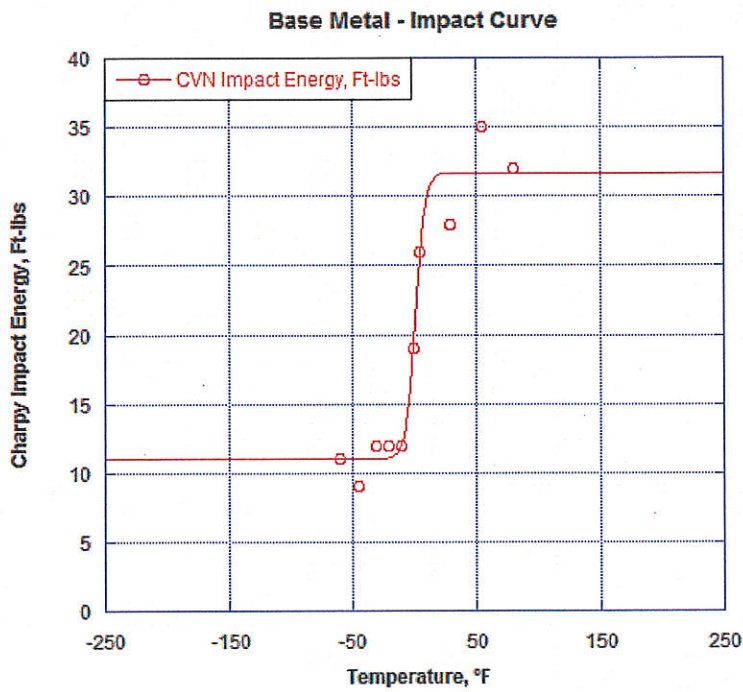
Figure 55. Charpy V-notch impact energy as a function of temperature for transverse base metal specimens removed from the pipe joint that ruptured.

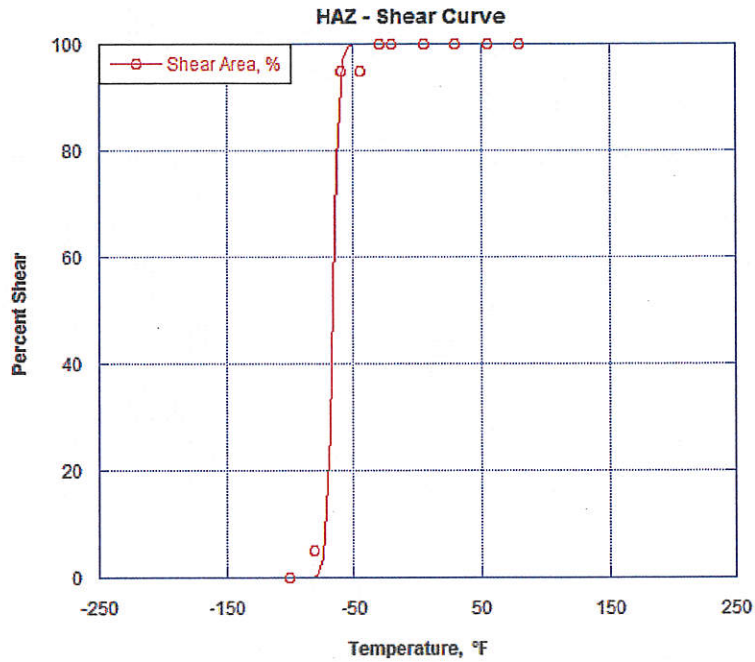
Figure 56. Percent shear from Charpy V-notch tests as a function of temperature for transverse seam weld (HAZ) specimens removed from the pipe joint that ruptured.

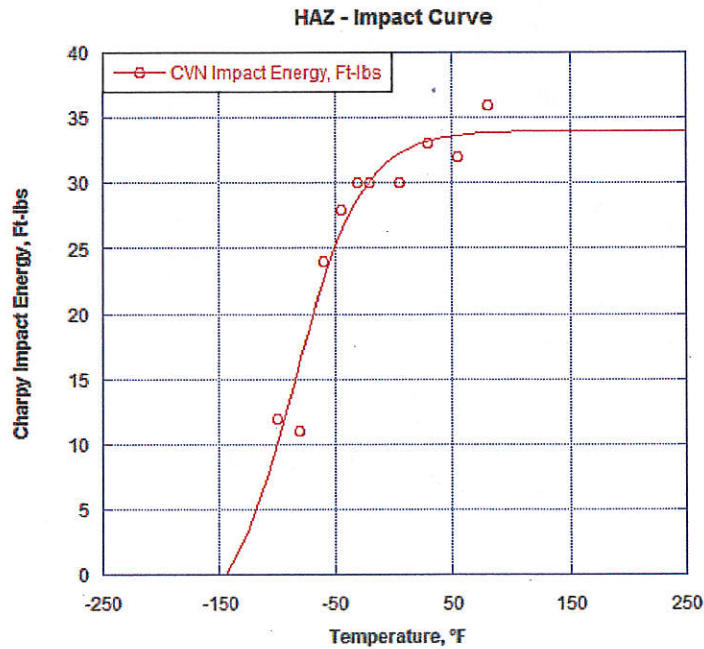
Figure 57. Charpy V-notch impact energy as a function of temperature for transverse seam weld (HAZ) specimens removed from the pipe joint that ruptured.

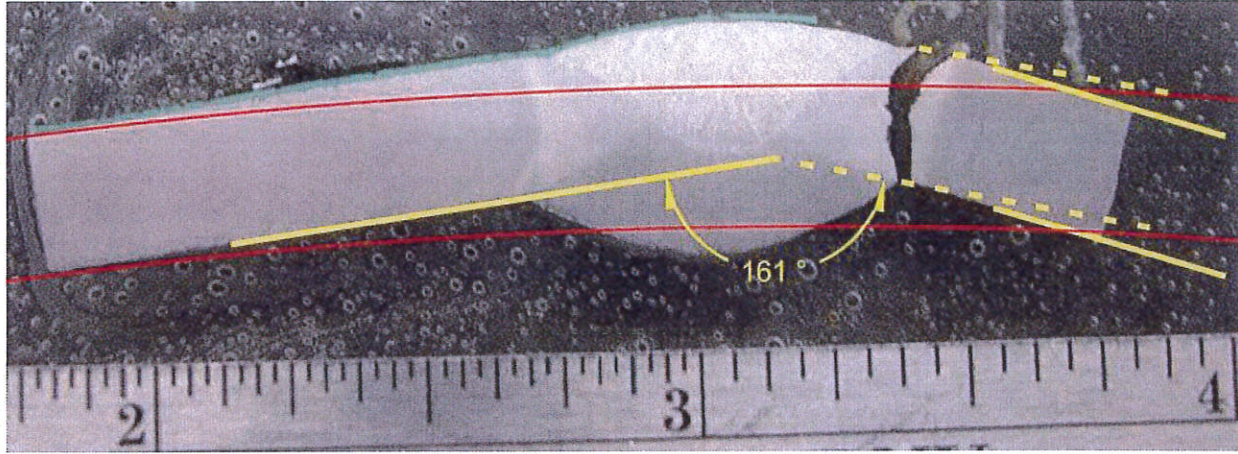
Figure A1. Photograph of the mounted cross-section (Mount M5) removed from Rupture Origin, 16.13 feet from the U/S GW.

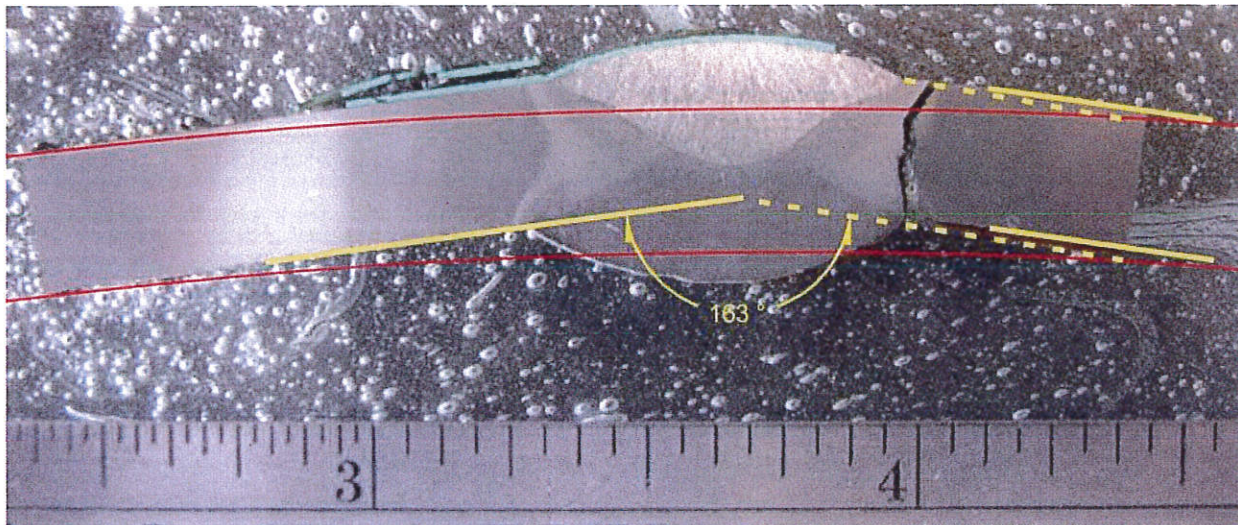
Figure A2. Photograph of the mounted cross-section (Mount M6) removed from Rupture Origin, 16.33 feet from the U/S GW.

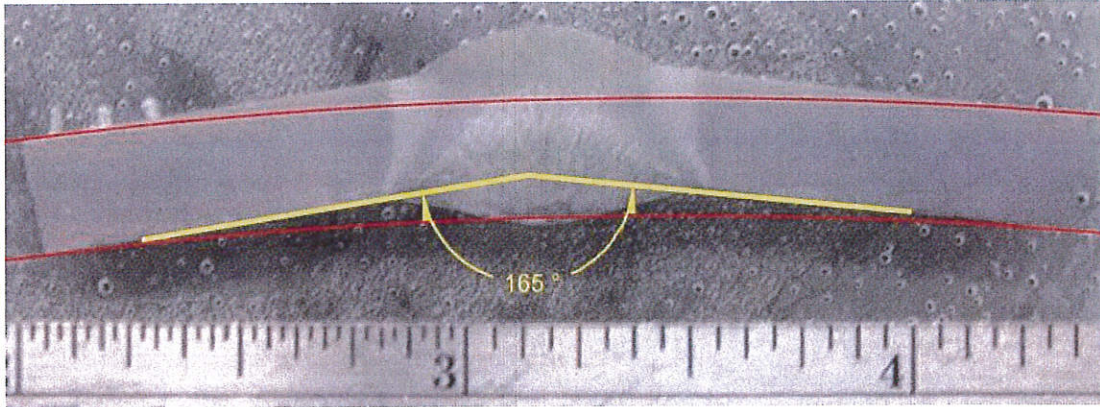
Figure A3. Photograph of the mounted cross-section (Mount M7) removed from Failed Joint, Away from the Rupture, 21.16 feet from the U/S GW.

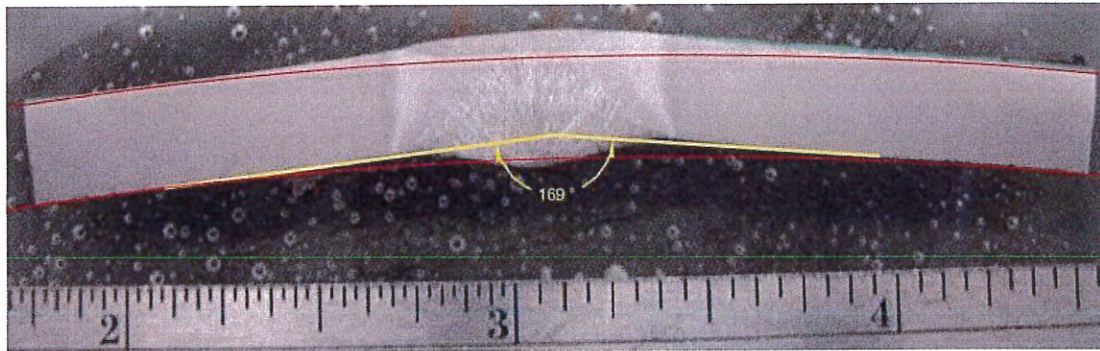
Figure A4. Photograph of the mounted cross-section (Mount M4) removed from U/S Joint, -1.54 ft from the U/S GW.

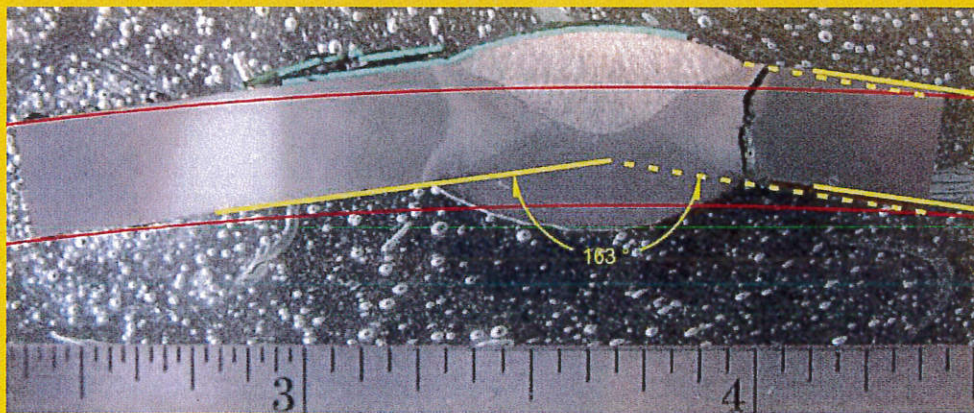
SJV 24-INCH MAY 20TH, 2016 LOPC RCA REPORT

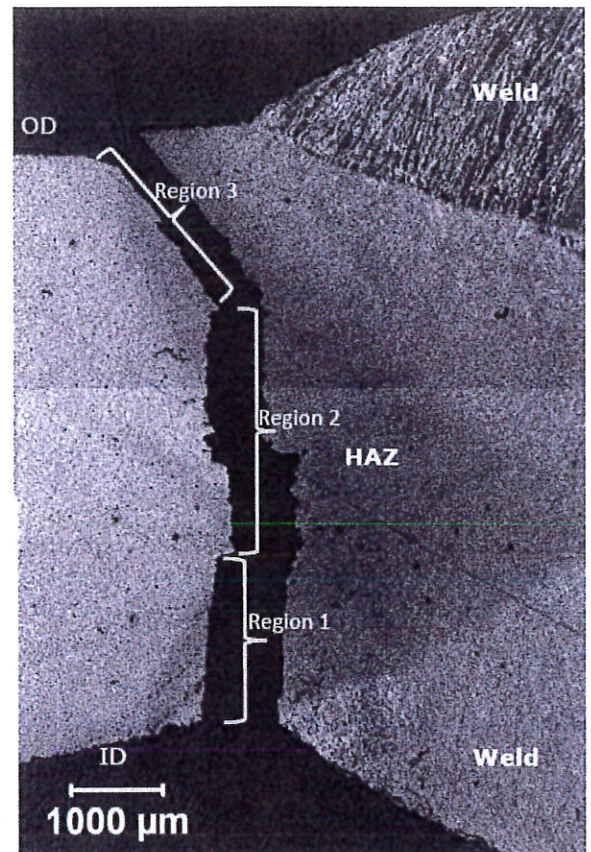
Copyright of Shell Pipeline Company

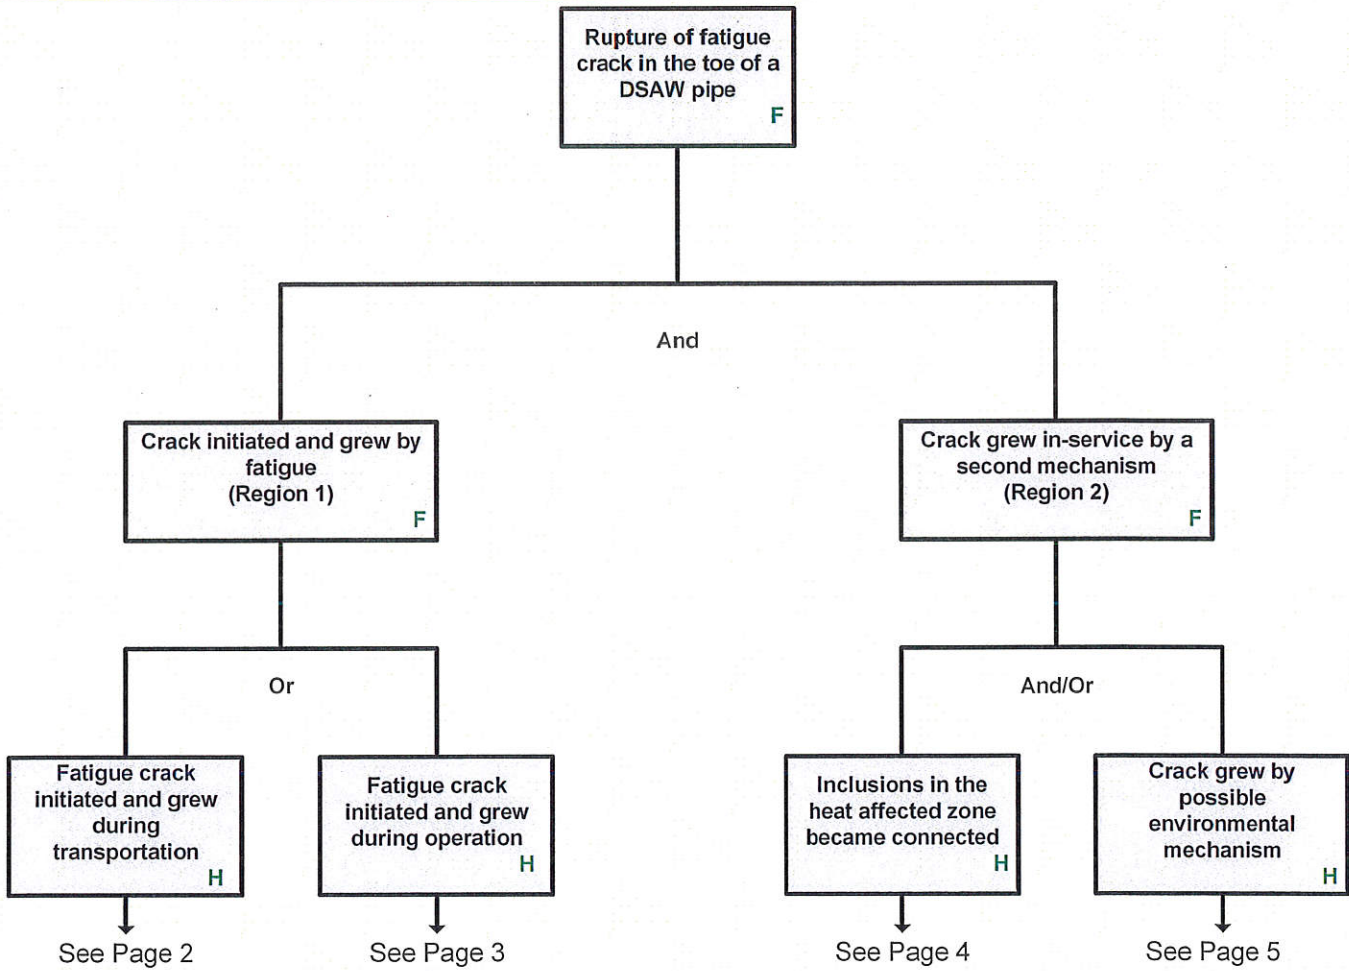
REGION 1 – FATIGUE CRACK INITIATION AND GROWTH

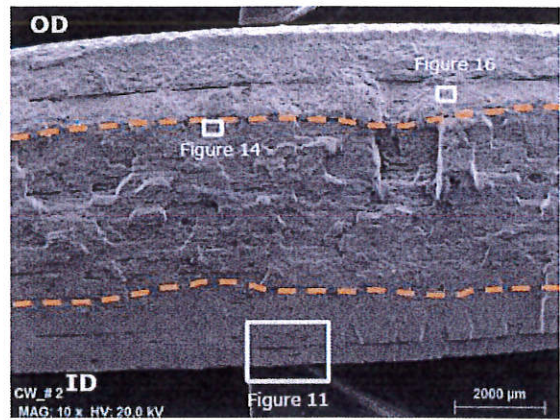
TRANSPORTATION FATIGUE

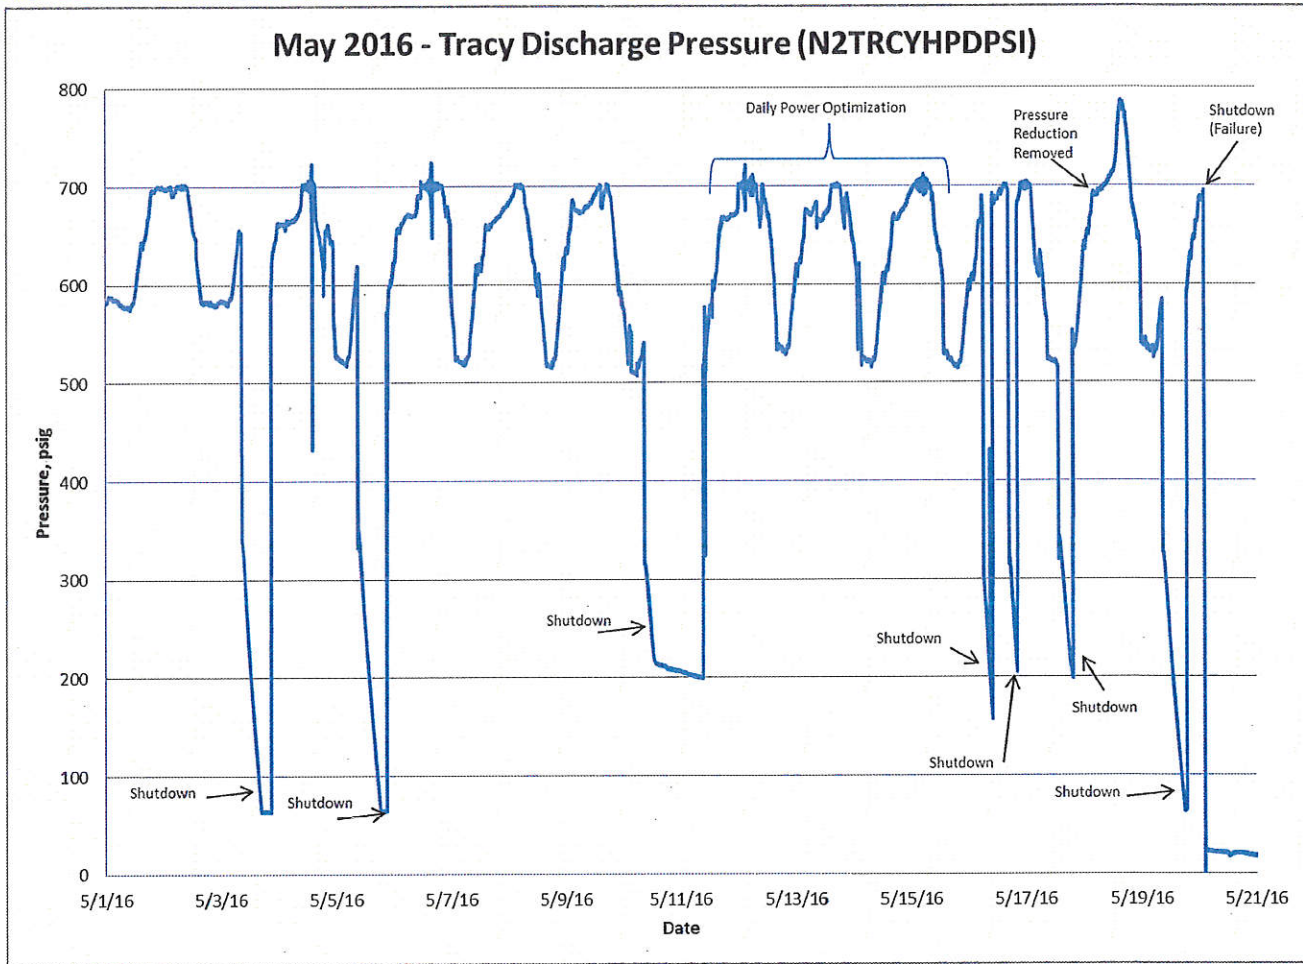
PIPELINE OPERATIONS – PRESSURE CYCLING (2)

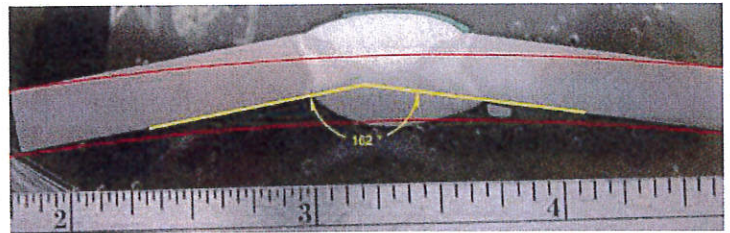
DNV GL Mount M1 - Peaked

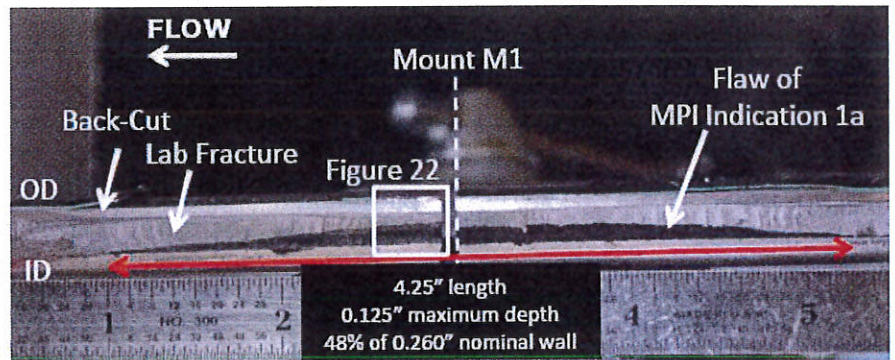
- Three additional indications were identified through magnetic particle inspection
- MPI 1a exhibited similarities to the main feature with a Region 1 and Region 2
 - Found to be 4.25 inches long and 0.125 inch (48%) deep
- Was not reported by the ILL vendor in any report
- Meets the stated detection threshold of UT-C survey
- MPI 1b and 2 were over-fill or under-fill respectively

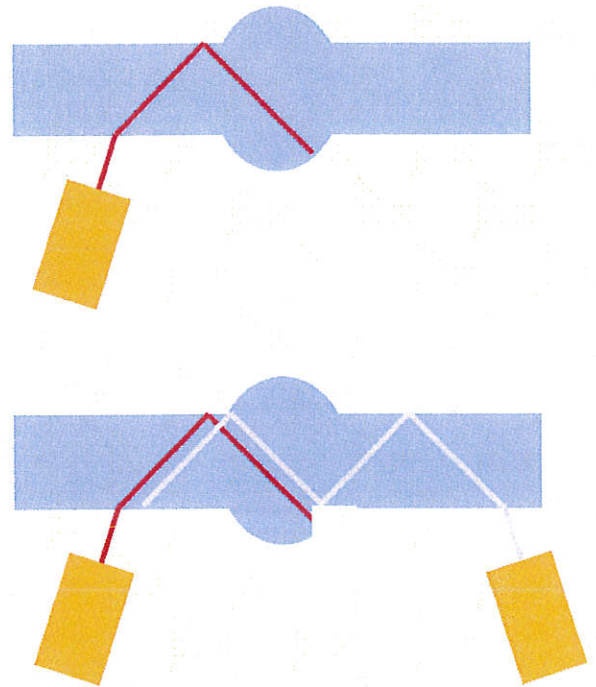
ROSEN JOINT 1250 SUMMARY
