**REPORT ON  
TOWER CRANE COLLAPSE  
BRENTON SUITES CONSTRUCTION SITE  
HALIFAX, NS**

**Department of Labour and Advanced Education**  
Government of Nova Scotia  
P.O. Box 697  
1505 Barrington Street,  
Halifax, NS  
B3J 2T8

**BMR STRUCTURAL ENGINEERING**

September 24, 2019

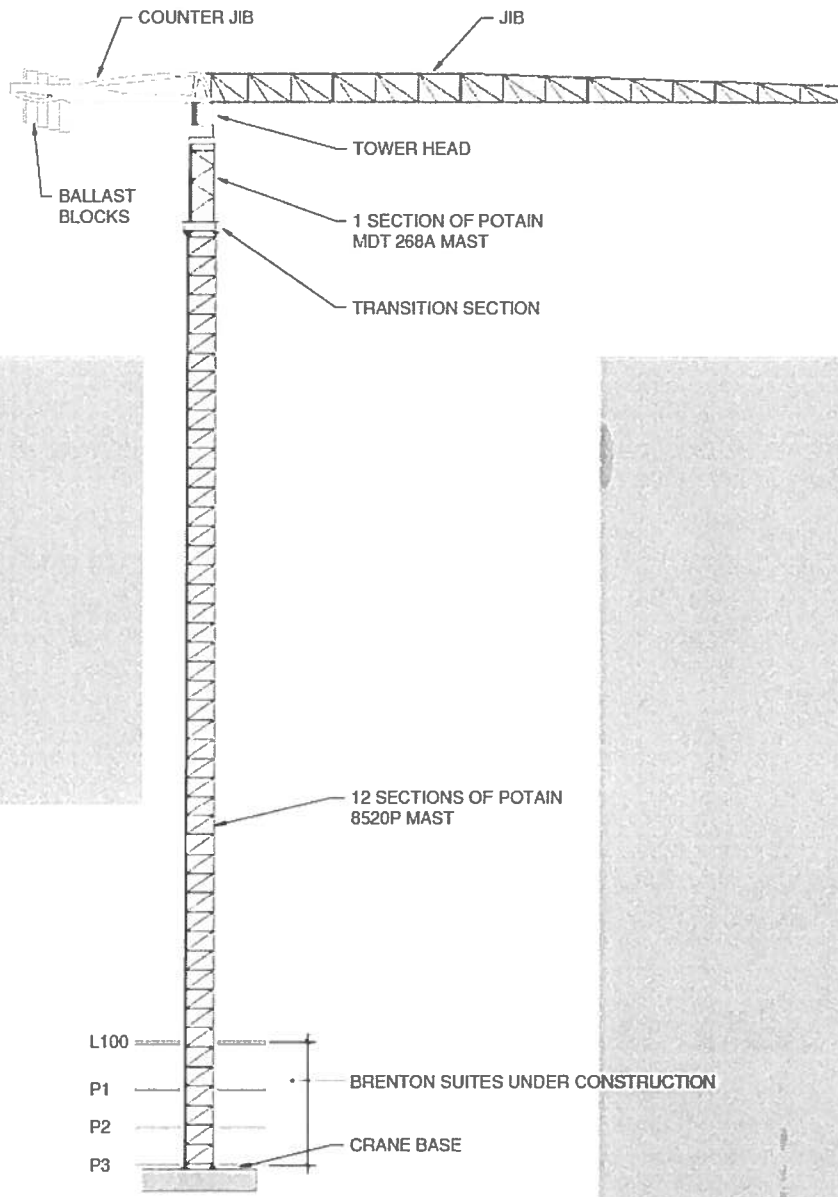
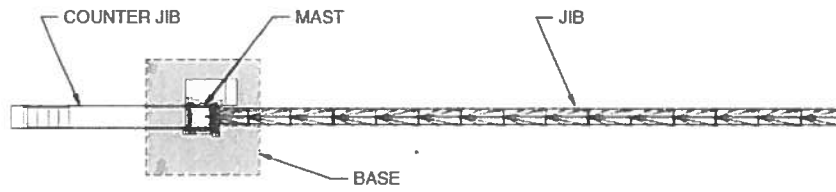
DIAGRAM 2

TOWER CRANE AS INSTALLED AT BRENTON SUITES
