617-06/15
R15W0088

22 May 2015

SUBJECT: RAIL SAFETY ADVISORY LETTER - 06/15
Communicating Changes to Work Plans during Yard Switching Operations

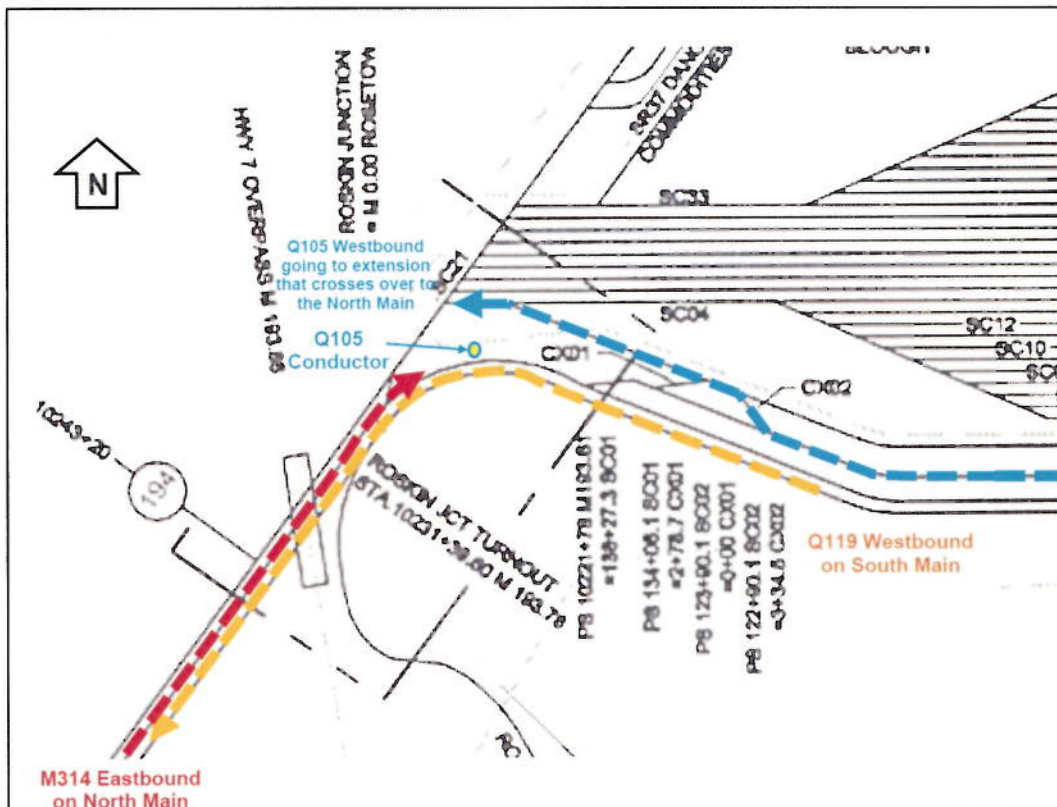
Figure 1. West end of CN Saskatoon Yard

At about the same time, the Q105 conductor had crossed over to the north main track and was walking eastward on the north end of the ties with his jacket hood up, adjacent to Q105. The conductor was foul of the north main track with his back to M314, unaware that the work plan had changed and that the north main track was now occupied by M314 (Figure 1).
