Collision between US Navy Destroyer *Fitzgerald* and
Philippine-Flag Container Ship *ACX Crystal*
Sagami Nada Bay off Izu Peninsula, Honshu Island,
Japan
July 17, 2017

Marine Accident Report

NTSB/MAR-20/02
PB2020-101007

NTSB/MAR-20/02
PB2020-101007
Notation 65315
Adopted August 3, 2020

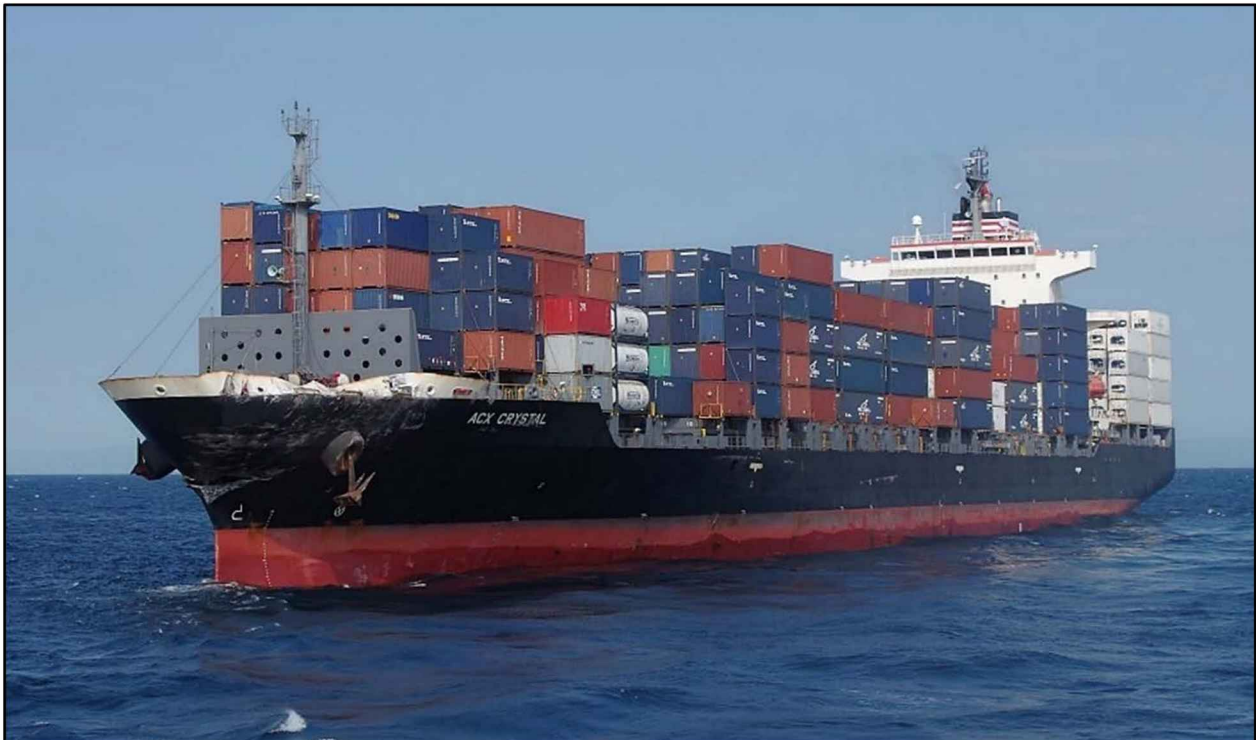
Figure 5. Container ship *ACX Crystal*, post collision. (Source: Sea Quest Management)

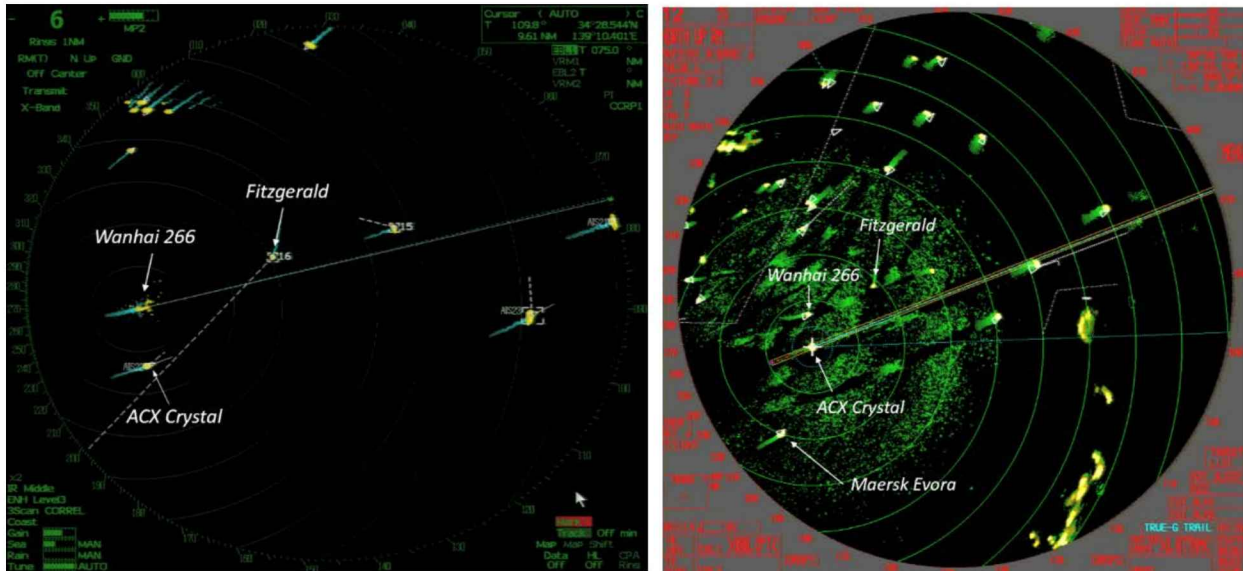
Figure 6. A comparison of radar screens from different vessels before the collision. Left, screen capture from the *Wan Hai 266* electronic navigation software, about 6 minutes before the collision. Right, screen capture from the *ACX Crystal* electronic navigation software (radar and ARPA), at the same time. (Vessel names have been added to screen images.)

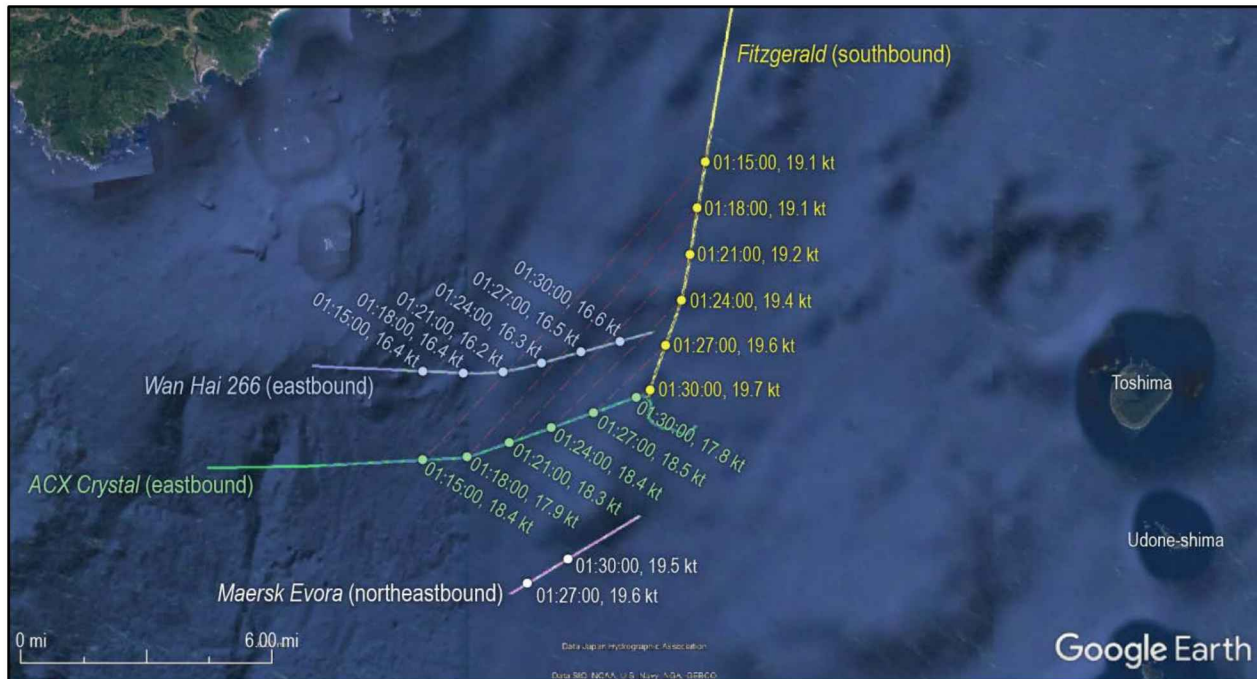
Figure 7. NTSB reconstruction of the paths of the *Fitzgerald*, *Wan Hai 266*, *ACX Crystal*, and *Maersk Evora*. (Background source: Google Earth)

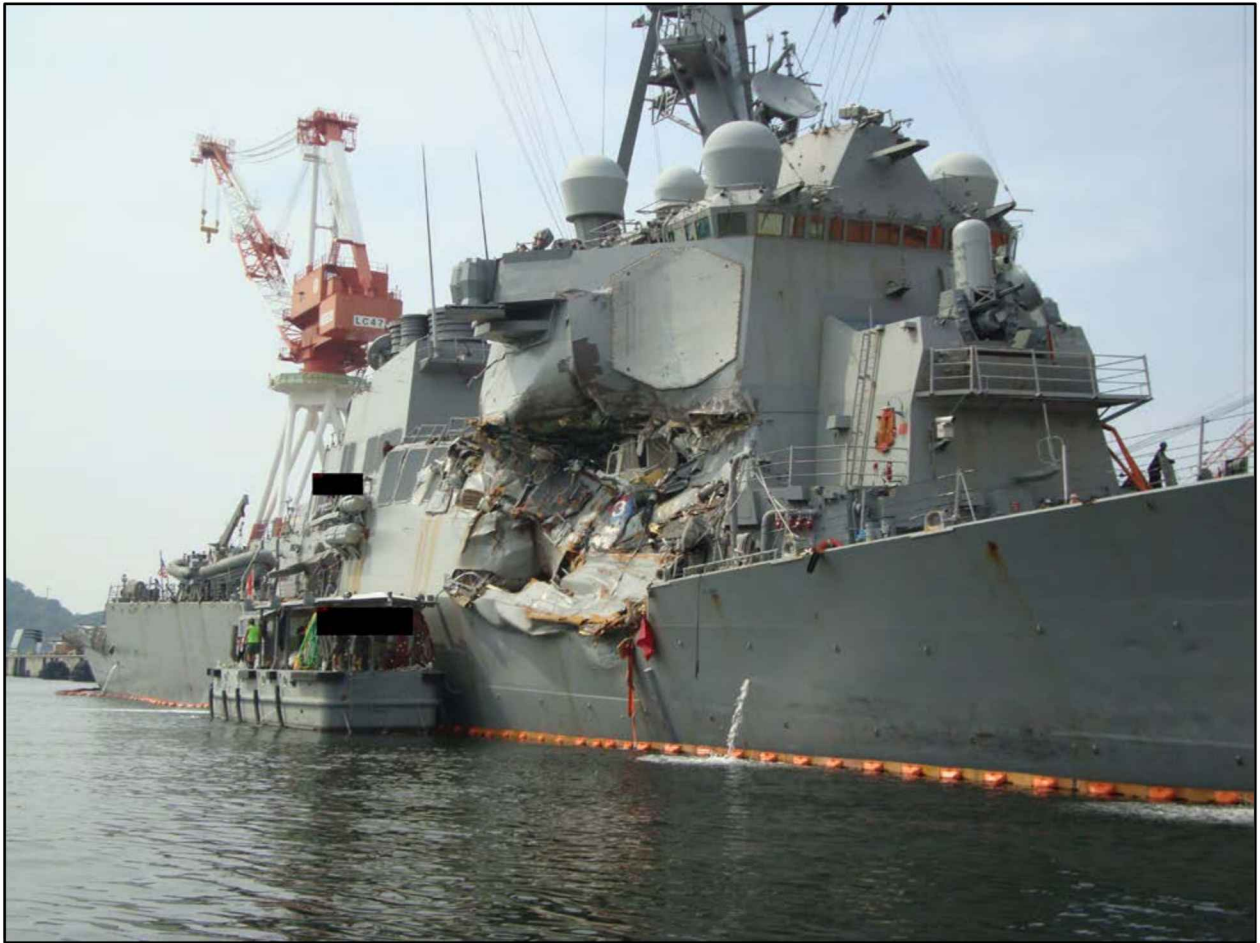
The *ACX Crystal*'s bow penetrated the *Fitzgerald*'s hull and superstructure, trapping numerous crewmembers aboard the destroyer, and the vessel took on a 7° starboard list. The *Fitzgerald*'s crew went to work to control the flooding, assist injured crew, and search for the missing. Seven crewmembers, trapped in their berthing compartment, perished. The destroyer sustained damage in excess of \$300 million.

Figure 8. Post collision damage to the *Fitzgerald*'s starboard side. (Source: US Navy)

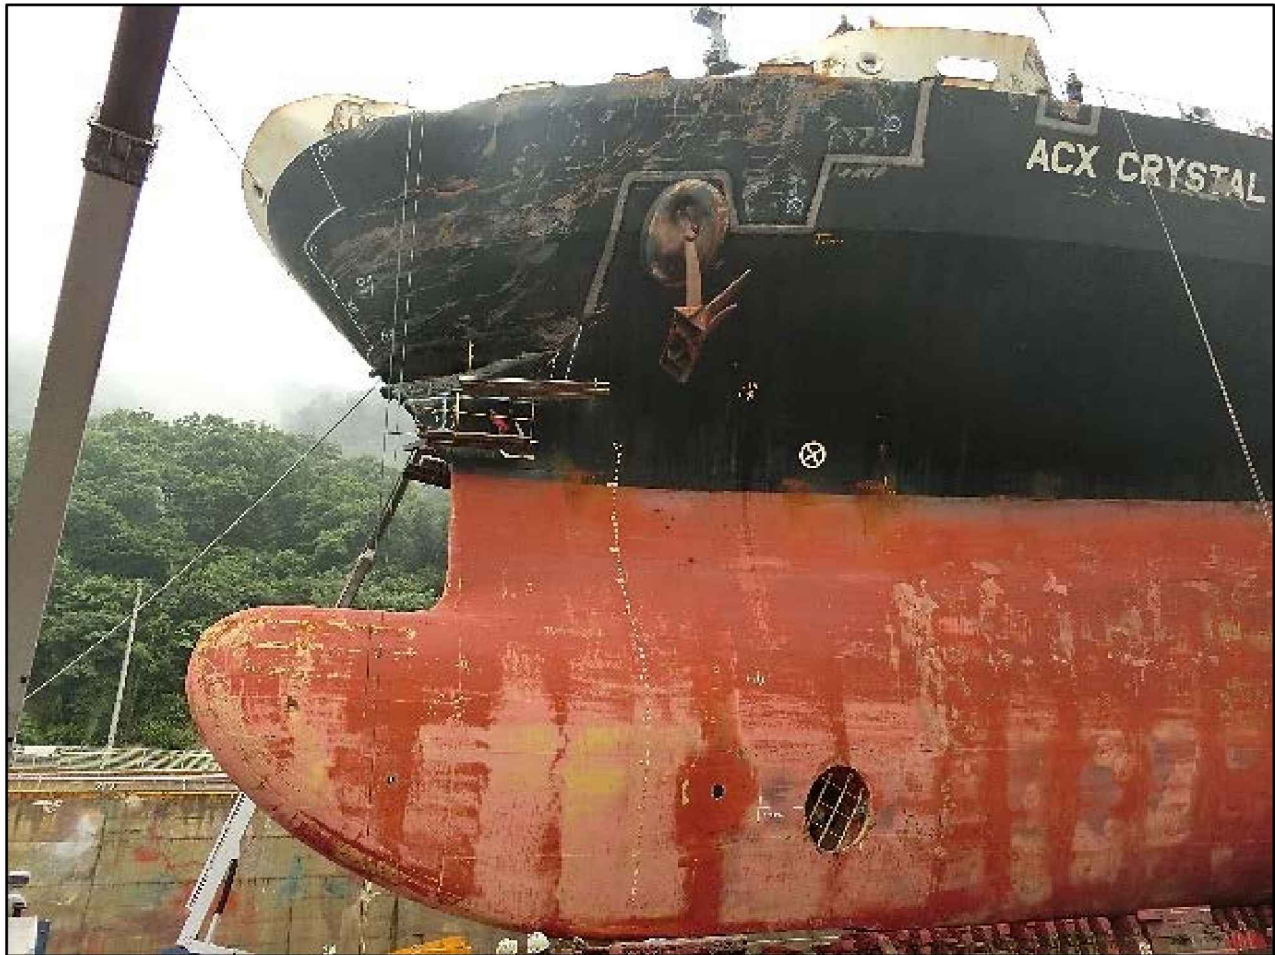
No one was injured on board the *ACX Crystal*, but the container ship sustained damage to its bow and forward compartments. The vessel's forepeak tank sustained a large gash, and a smaller gash was noted in the boatswain's stores compartment. Penetrations to the hull were above the waterline. The cost to repair the *ACX Crystal* was not reported to investigators.

Figure 9. Postaccident damage to the *ACX Crystal*'s bow. (Source: Japan Transport Safety Board)

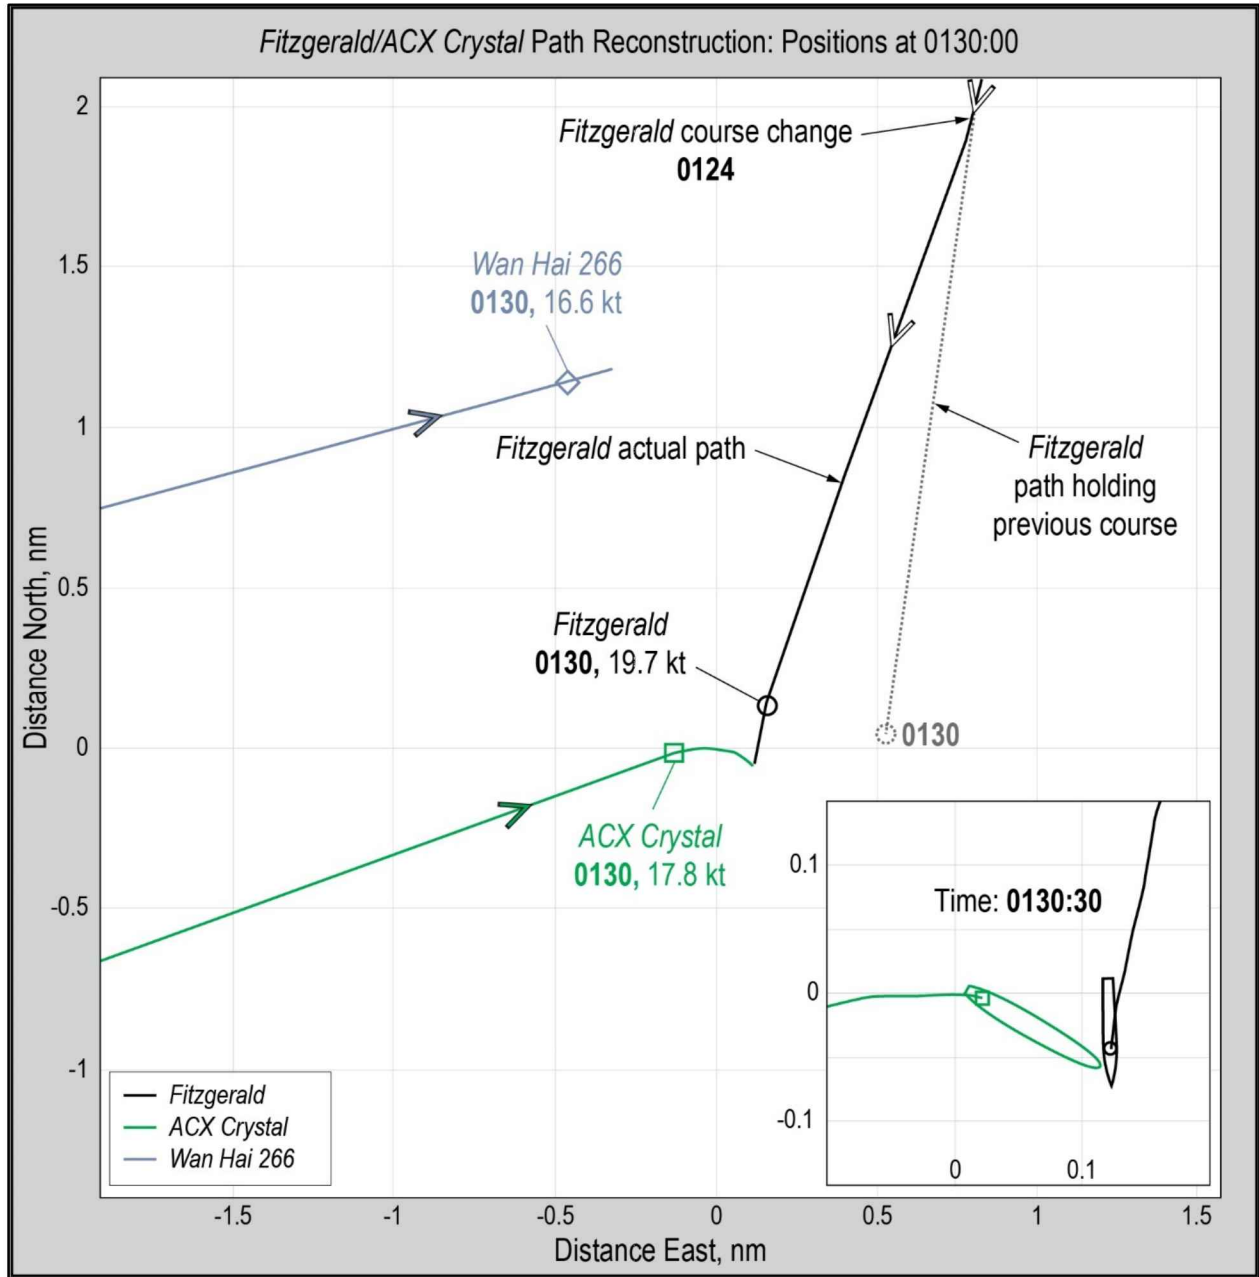
Figure 10. NTSB path reconstruction for *Fitzgerald* and *ACX Crystal*, from data compiled from NTSB Vehicle Performance Study.

The *Fitzgerald*'s deck log shows that a course change was ordered at 0122, and the vessel came right from 190° to 200°. They had steadied on the new course by 0124. This course change proved to be a critical error, and investigators were unable to determine the reason for it. The NTSB conducted a Vehicle Performance Study using GPS data as well as course and speed data for the *Fitzgerald*, *ACX Crystal* and *Wan Hai 266*, to recreate the tracks of the vessels leading up to the accident. The study found that if the *Fitzgerald* had not made the course change from 190° to 200° 8 minutes before the collision, the destroyer would have passed ahead of the *ACX Crystal* with a CPA of about 1,000 yards, or about 0.5 nautical mile. Therefore, the NTSB concludes that the
