# **Engineering Evaluation of Bollard Fence**

## Rio Grande, Hidalgo County, Texas

United States of America v. Fisher Sand and Gravel Company, Civil Action No. 7:19-CV-403

August 2021

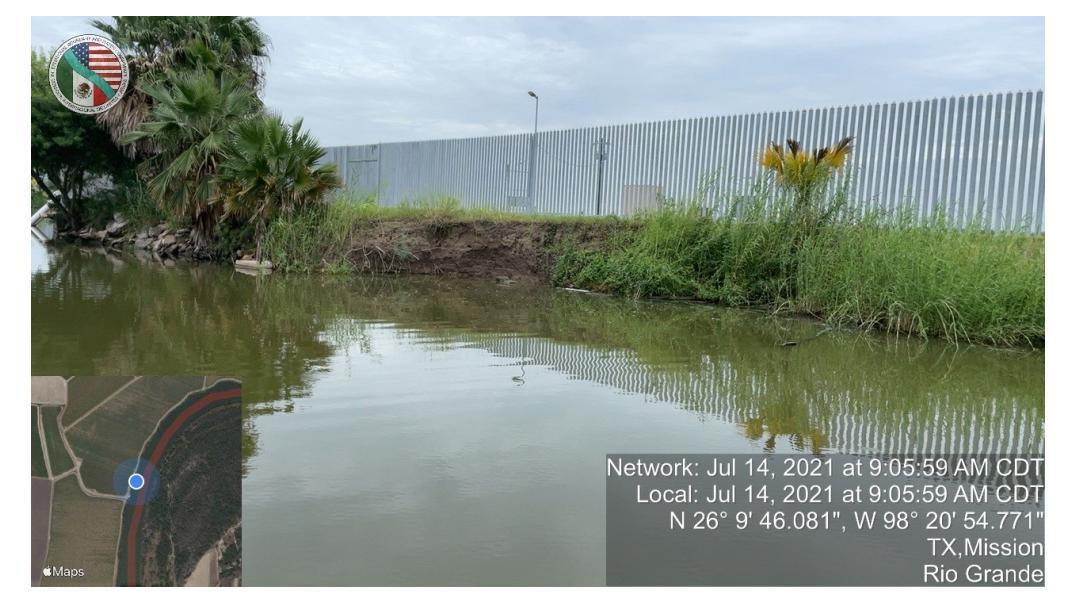
Figure 2.1. Bank erosion near fence, northeast side of fence

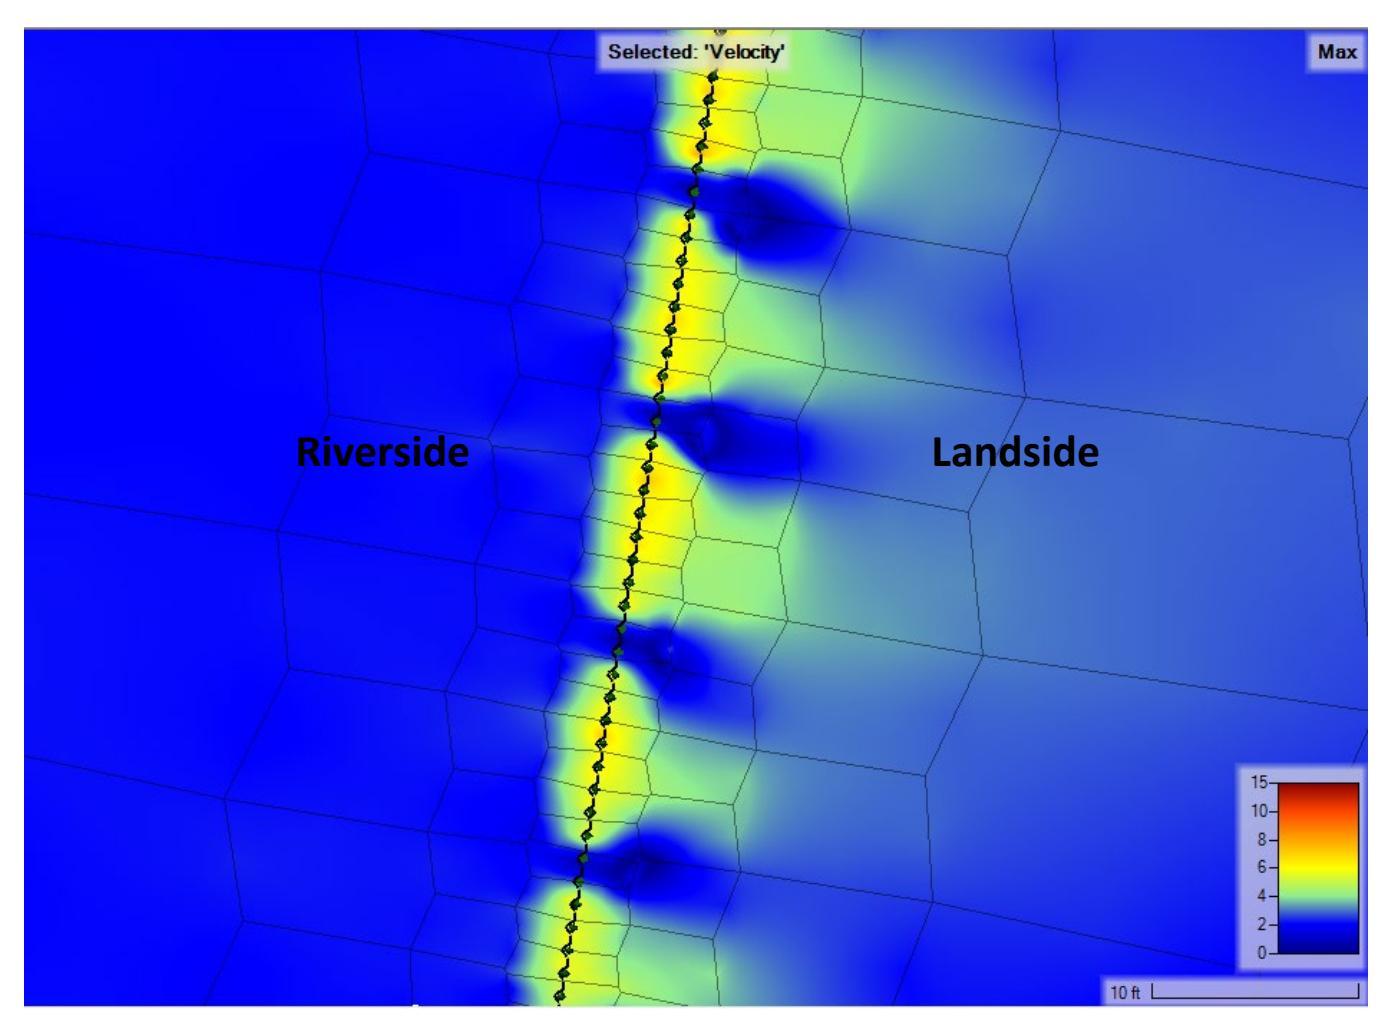
Flow velocities in the river channel along the fence line range between 1 and 3 fps for the pre-project condition. For the post-project condition, however, maximum flow velocity through the unblocked fence openings on the western portion of the fence reaches 7.9 and exceeds 5 fps on the eastern portion of the fence. Figure 4.29 shows a color-coded map of maximum velocities through typical unblocked openings on the western portion of the fence. Figure 4.30 zooms out, showing the prevalence of high-velocity openings along most of the western fence line. Both figures show high-velocity plumes extending for several feet to the inside (land side) of the fence.

Figure 4.29. Maximum velocity plumes through typical unblocked openings on western portion of fence

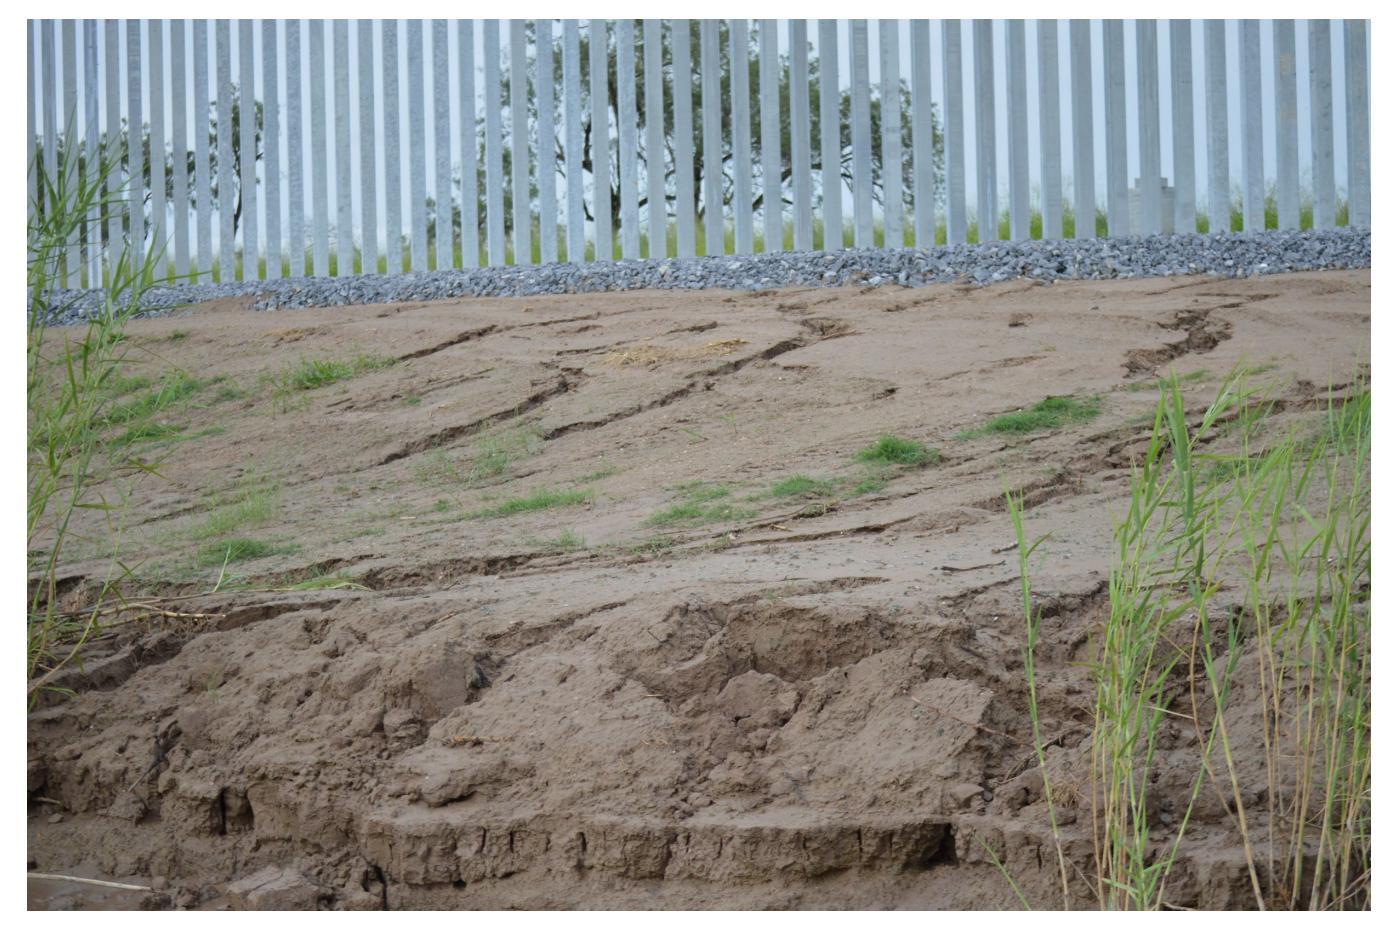
exacerbated bank erosion by some or all of the above-described mechanisms in comparison to pre-project conditions. Bank stabilization may be necessary to prevent river meandering and to ensure caving of the bank does not progress to the point of weakening the base of the bollard fence.

Figure 4.34. Severe erosion at base of fence

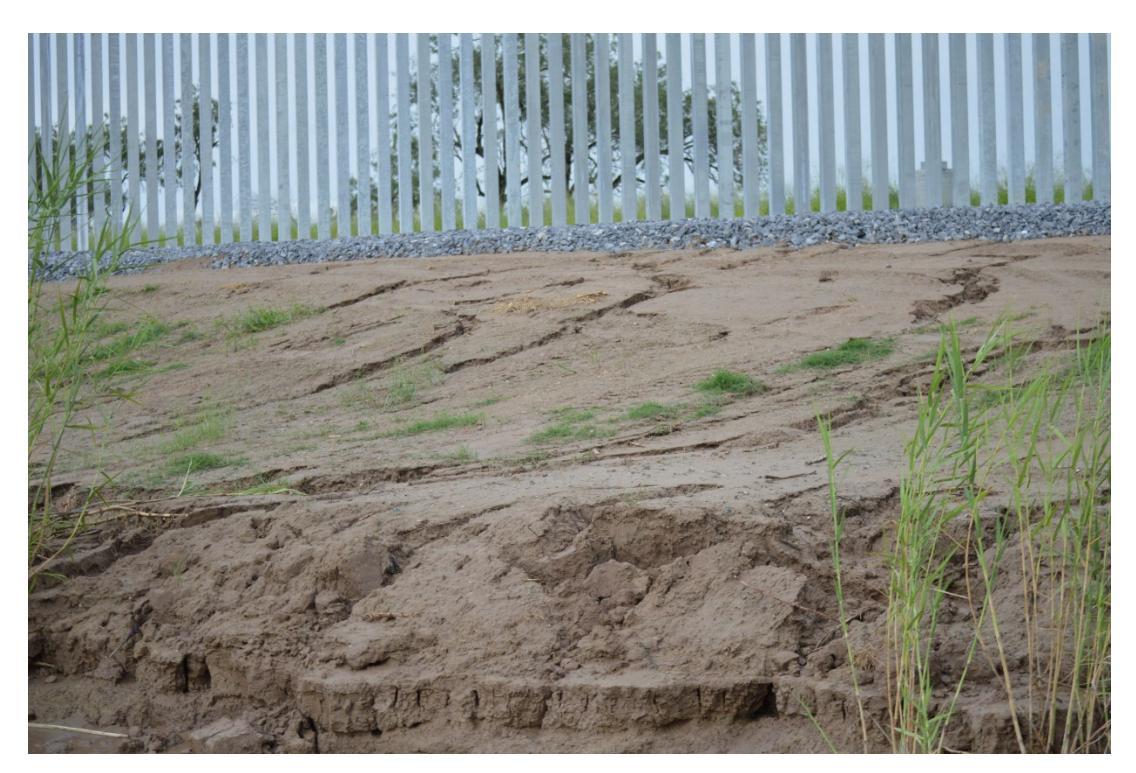
Figure 5.8. Rills and gullies characteristic of dispersive soil (source DOJ)

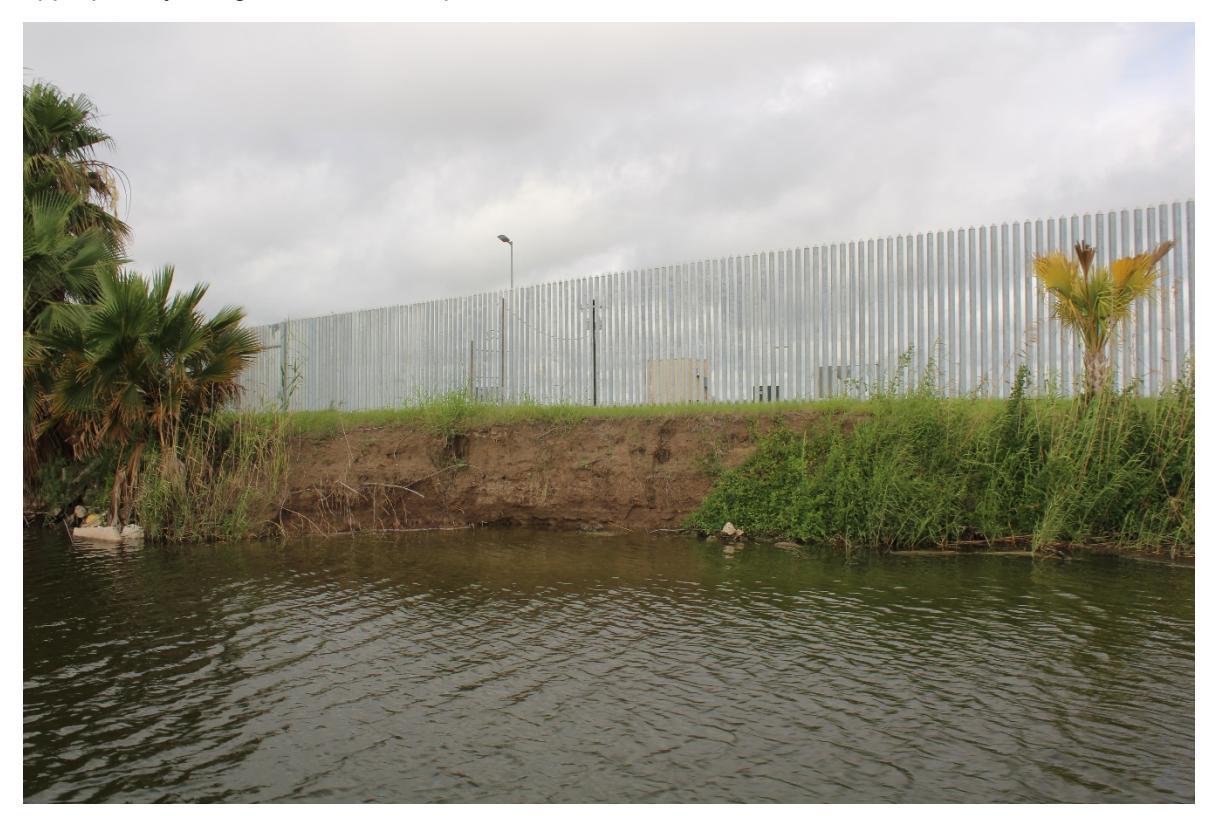
Figure 5.9 is a photograph showing severe bank erosion near the Fisher fence, which is caused by natural fluctuations in the river level, wave action, and boat wakes. The removal of existing bank vegetation without immediate replacement by properly designed erosion protection can lead to bank caving, which may eventually threaten the stability of the fence. Additional repair is warranted given the erodible nature of site soil; the presence of dispersive soil in certain areas; observed bank undermining by fluctuating river levels, waves, and boat wakes; and the possibility of high velocity water flow during floods. Repairs should include special details such as appropriately designed filters for dispersive soil.

Figure 5.9. Severe bank erosion caused by fluctuating river levels, wave action, and boat wakes (source DOJ)

Intervention to correct minor erosion problems is generally considered to be acceptable practice if 1) there is a predetermined plan for correction of problems; 2) there are resources available to make the corrections; and 3) there is a commitment by the owner to intervene when required. However, during major floods on the Rio Grande, access to the fence will be difficult and intervention may not be possible. Major flooding is likely to cause erosion from local turbulence around fence bollards, which could undermine the shallow foundations causing fence failure. For this reason, prudent practice would be to include adequate erosion protection during design and construction to reduce the likelihood of erosion and fence failure.

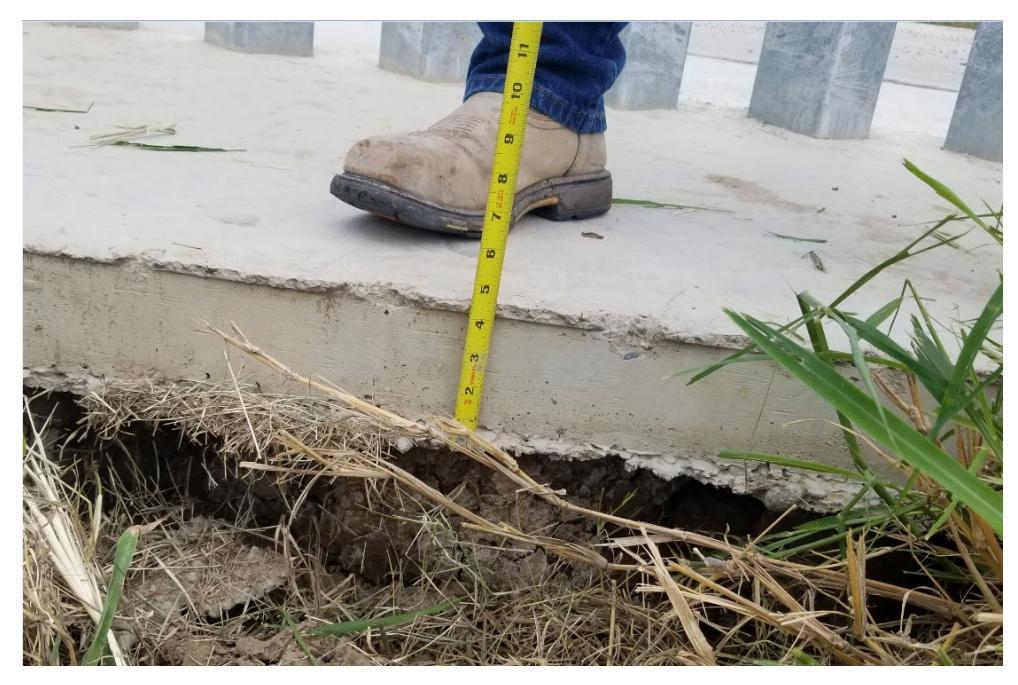
The overall width of the base foundation was verified to be 8 feet as shown on the plans (see Figures 6.1, 6.4, and 6.5). However, the thickness at some locations where the edge of the foundation was exposed due to erosion was less than the 1 foot shown on plans (see Figures 6.1 and 6.5). Figure 6.9 shows a non-conforming thickness of  $4\frac{1}{2}$  inches.

Figure 6.9. Non-conforming thickness of base foundation

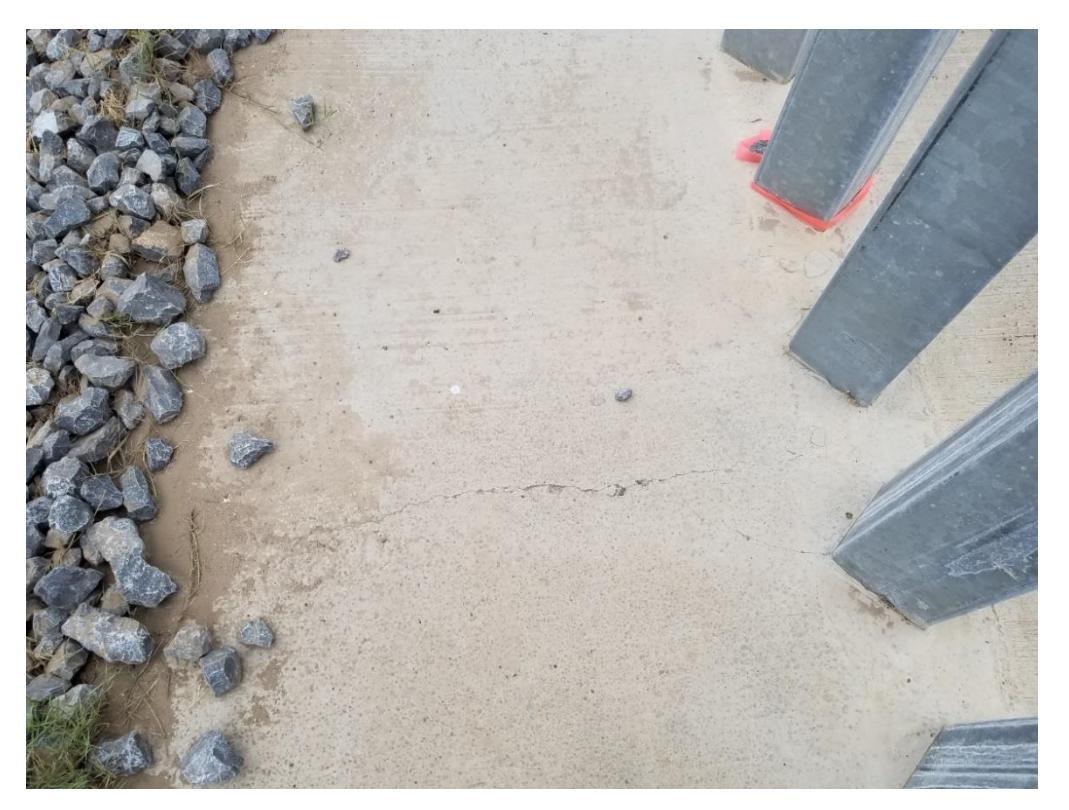
The surface condition of the concrete was observed to be fair to good, with minor cracking and joint separation detected at various locations along the fence alignment. Cracks in the fence footing appeared to be surficial only as shown on Figure 9, which is typical of shrinkage cracking that starts near the angle of the bollard and extends to the edge of footing in both directions as shown on Figure 10 and Figure 11. Cracks and Joint separation were also observed on the access road that abuts the fence footing as shown in Figure 12 and Figure 13.

Figure 9: Surface Cracking Near STA 152+50 from Bollard to Edge of Footing

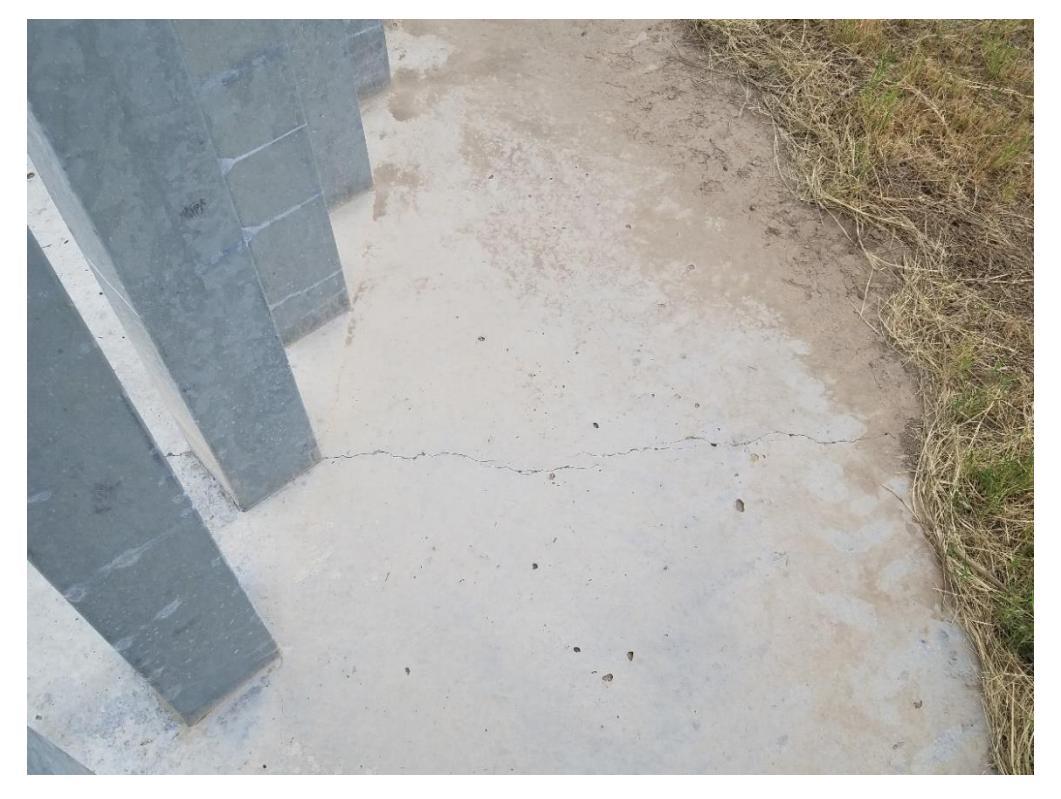
Figure 10: Surface Cracking Near STA 36+50 All the Way Across Footing and Around Bollard

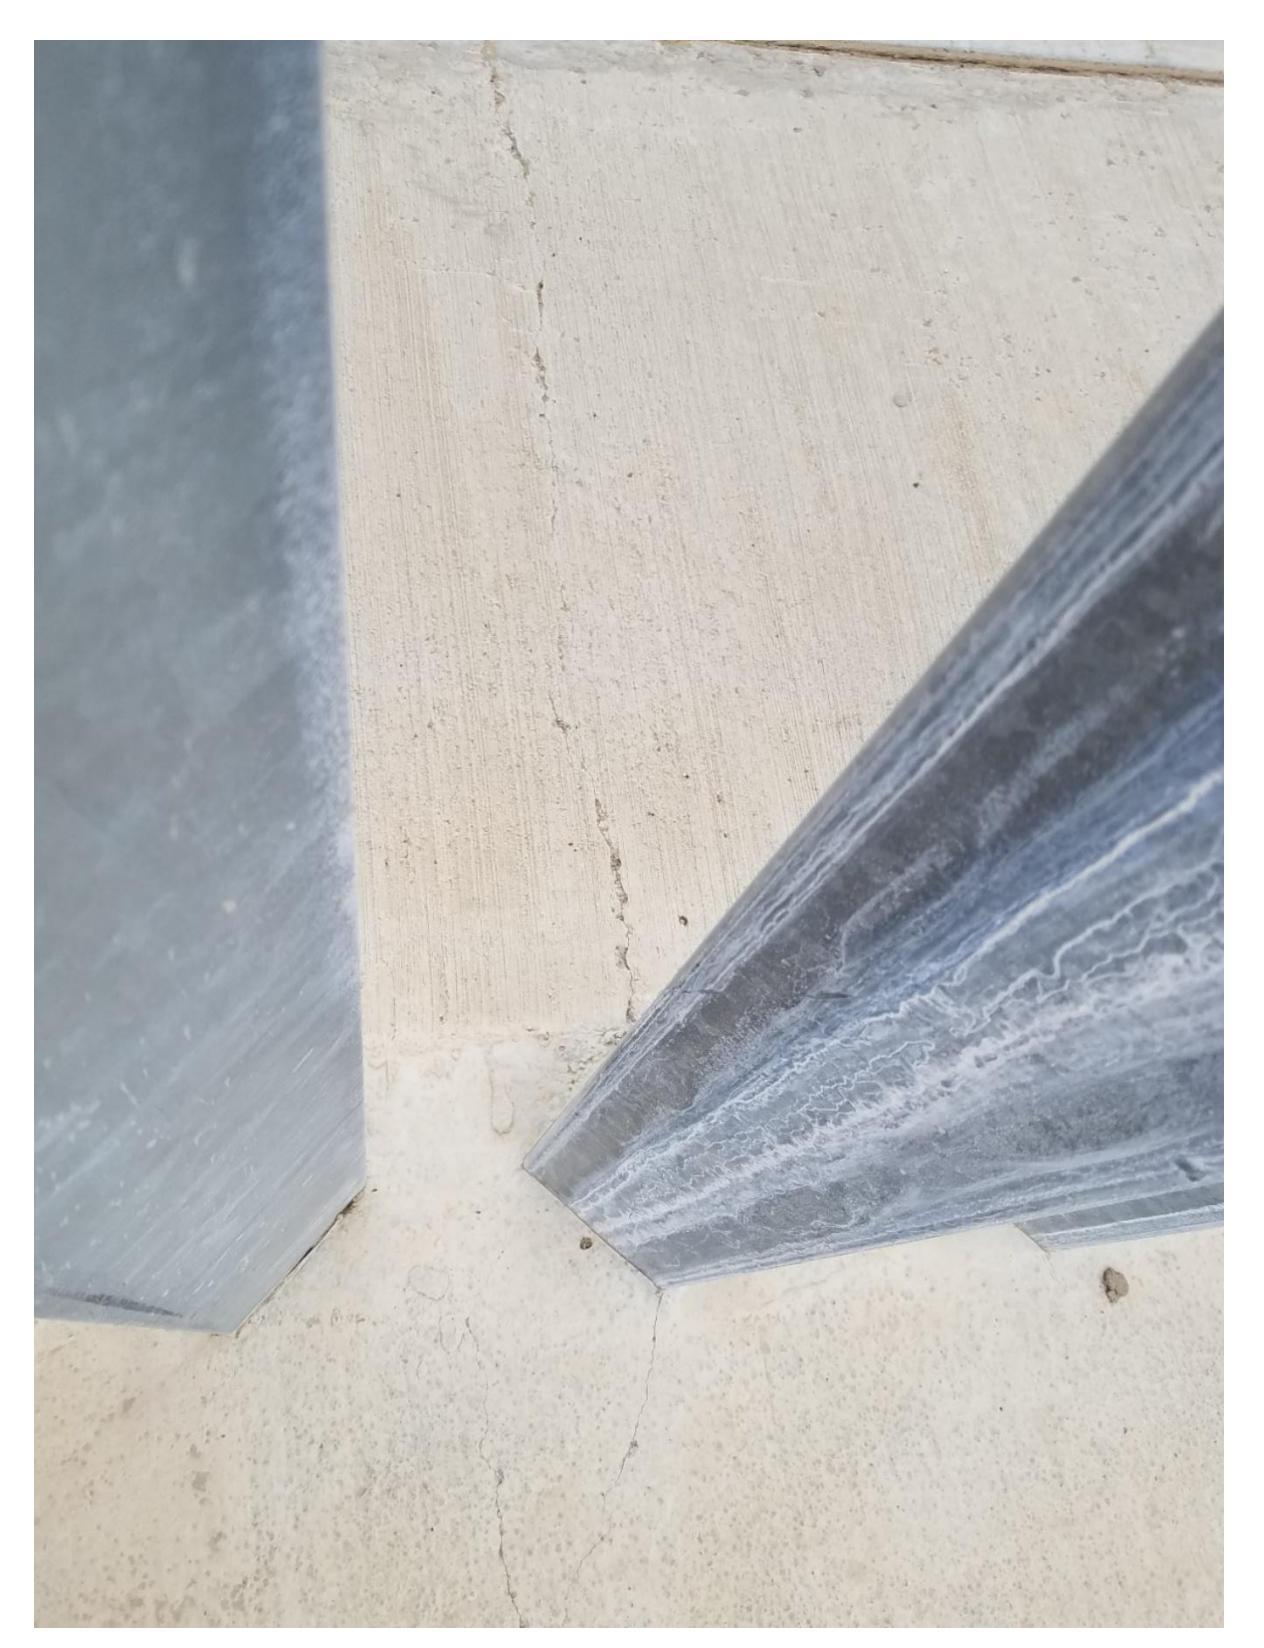
Figure 11: Surface Cracking Near STA 152+50 Around Bollard and to Edge of Footing

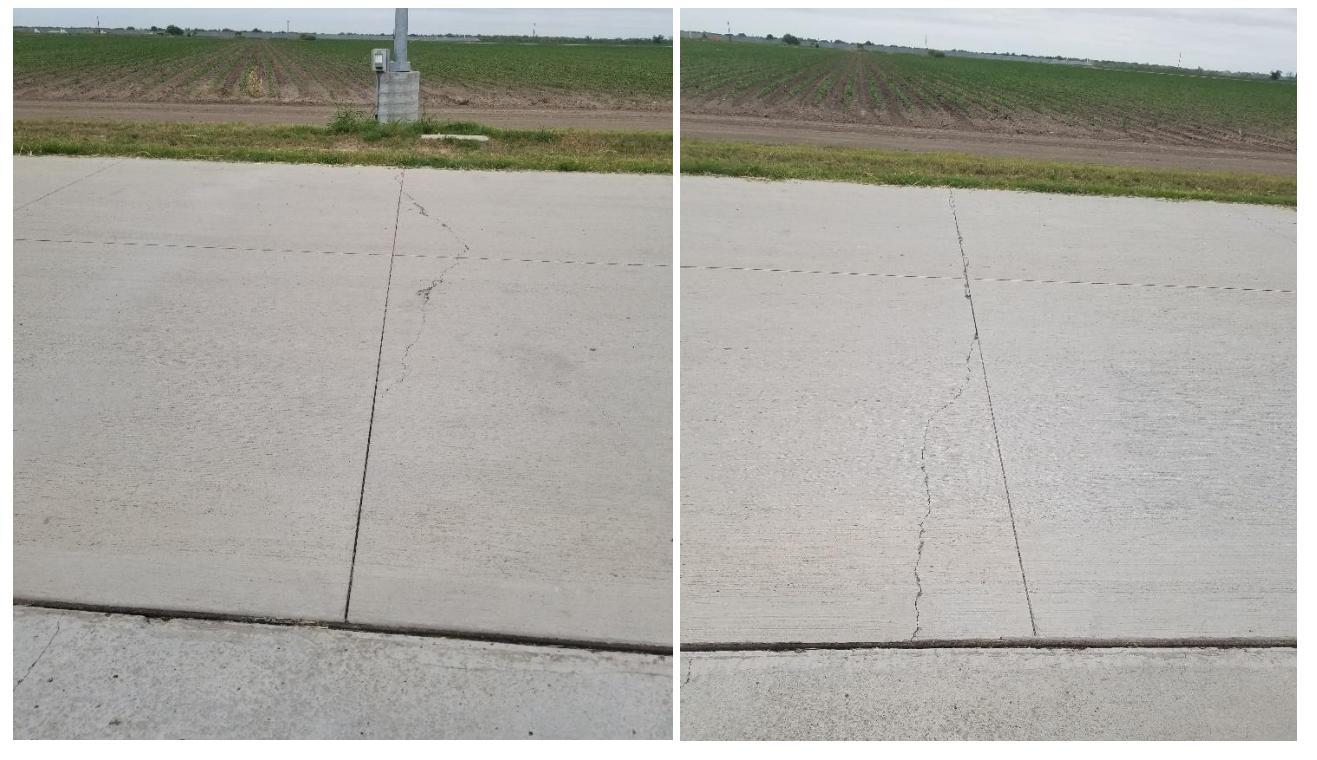
Figure 12: Typical Cracking of Concrete Surface along Access Road

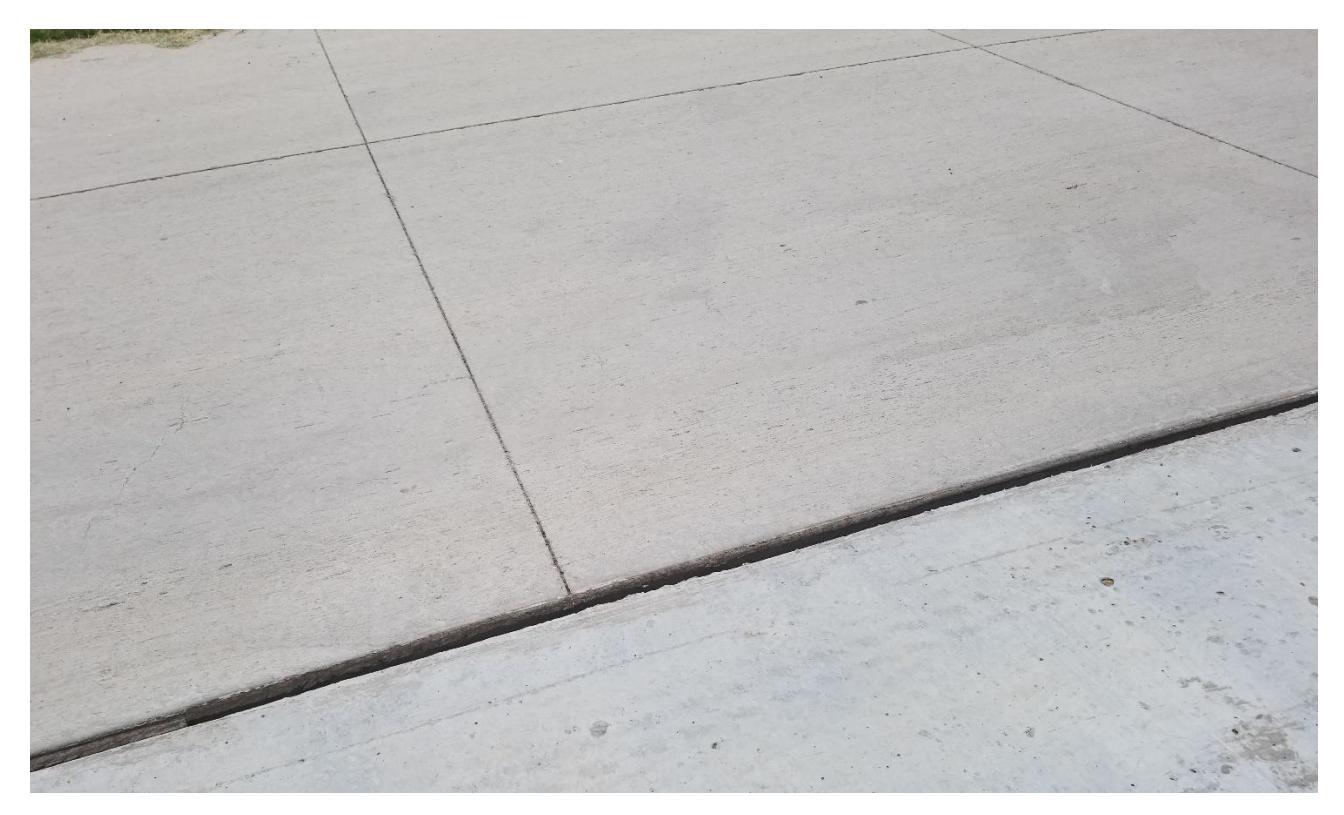
Figure 13: Typical Joint Separation along Access Road Abutment to Concrete Footing
