# **Engineering Evaluation of Bollard Fence**

## Rio Grande, Hidalgo County, Texas

United States of America v. Fisher Sand and Gravel Company, Civil Action No. 7:19-CV-403

August 2021

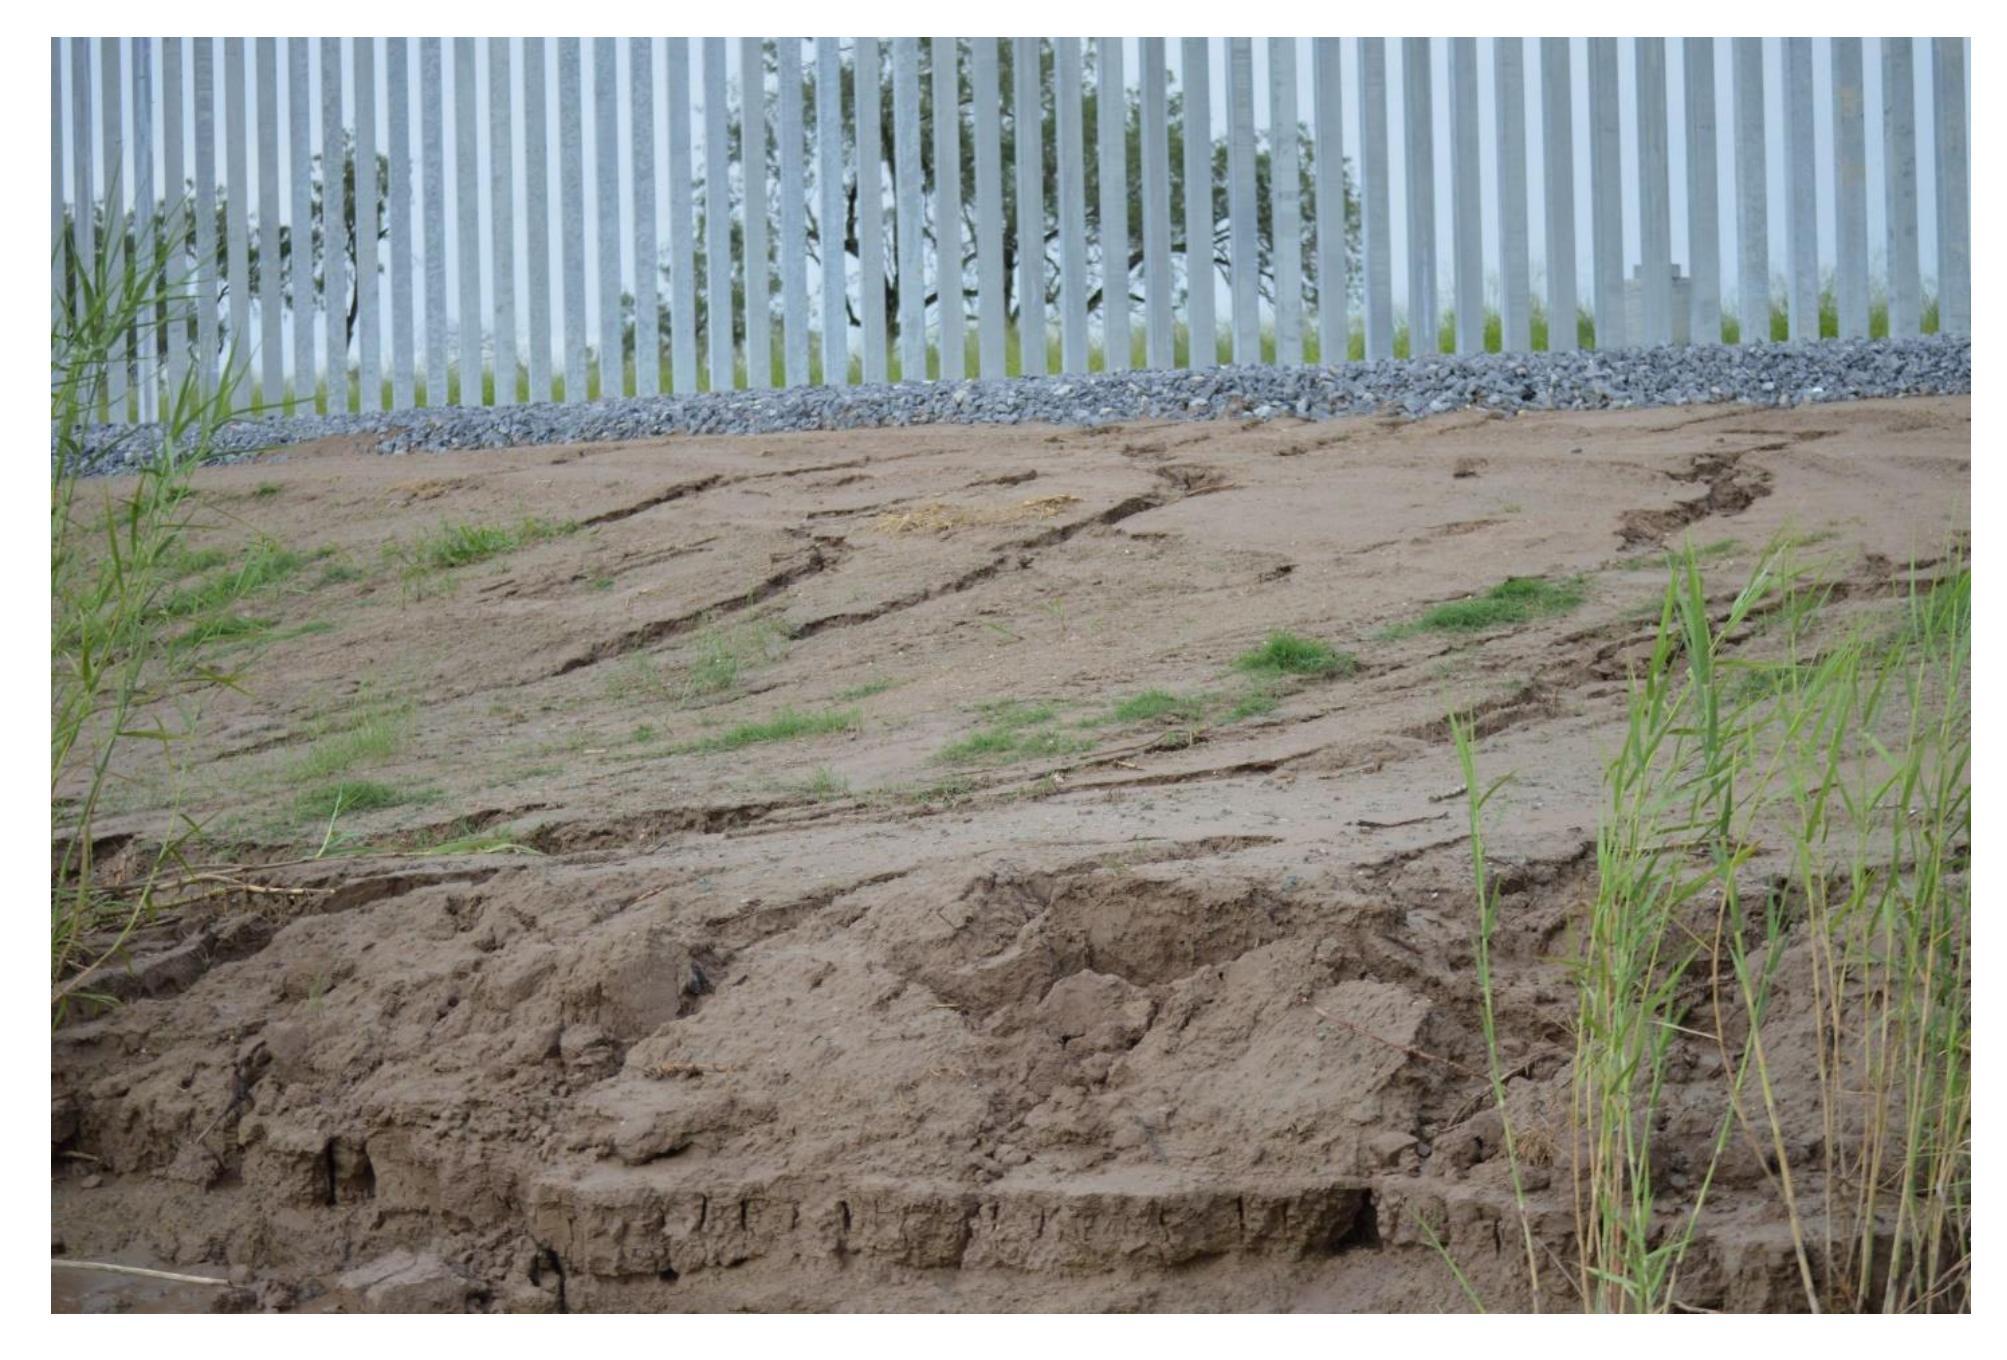
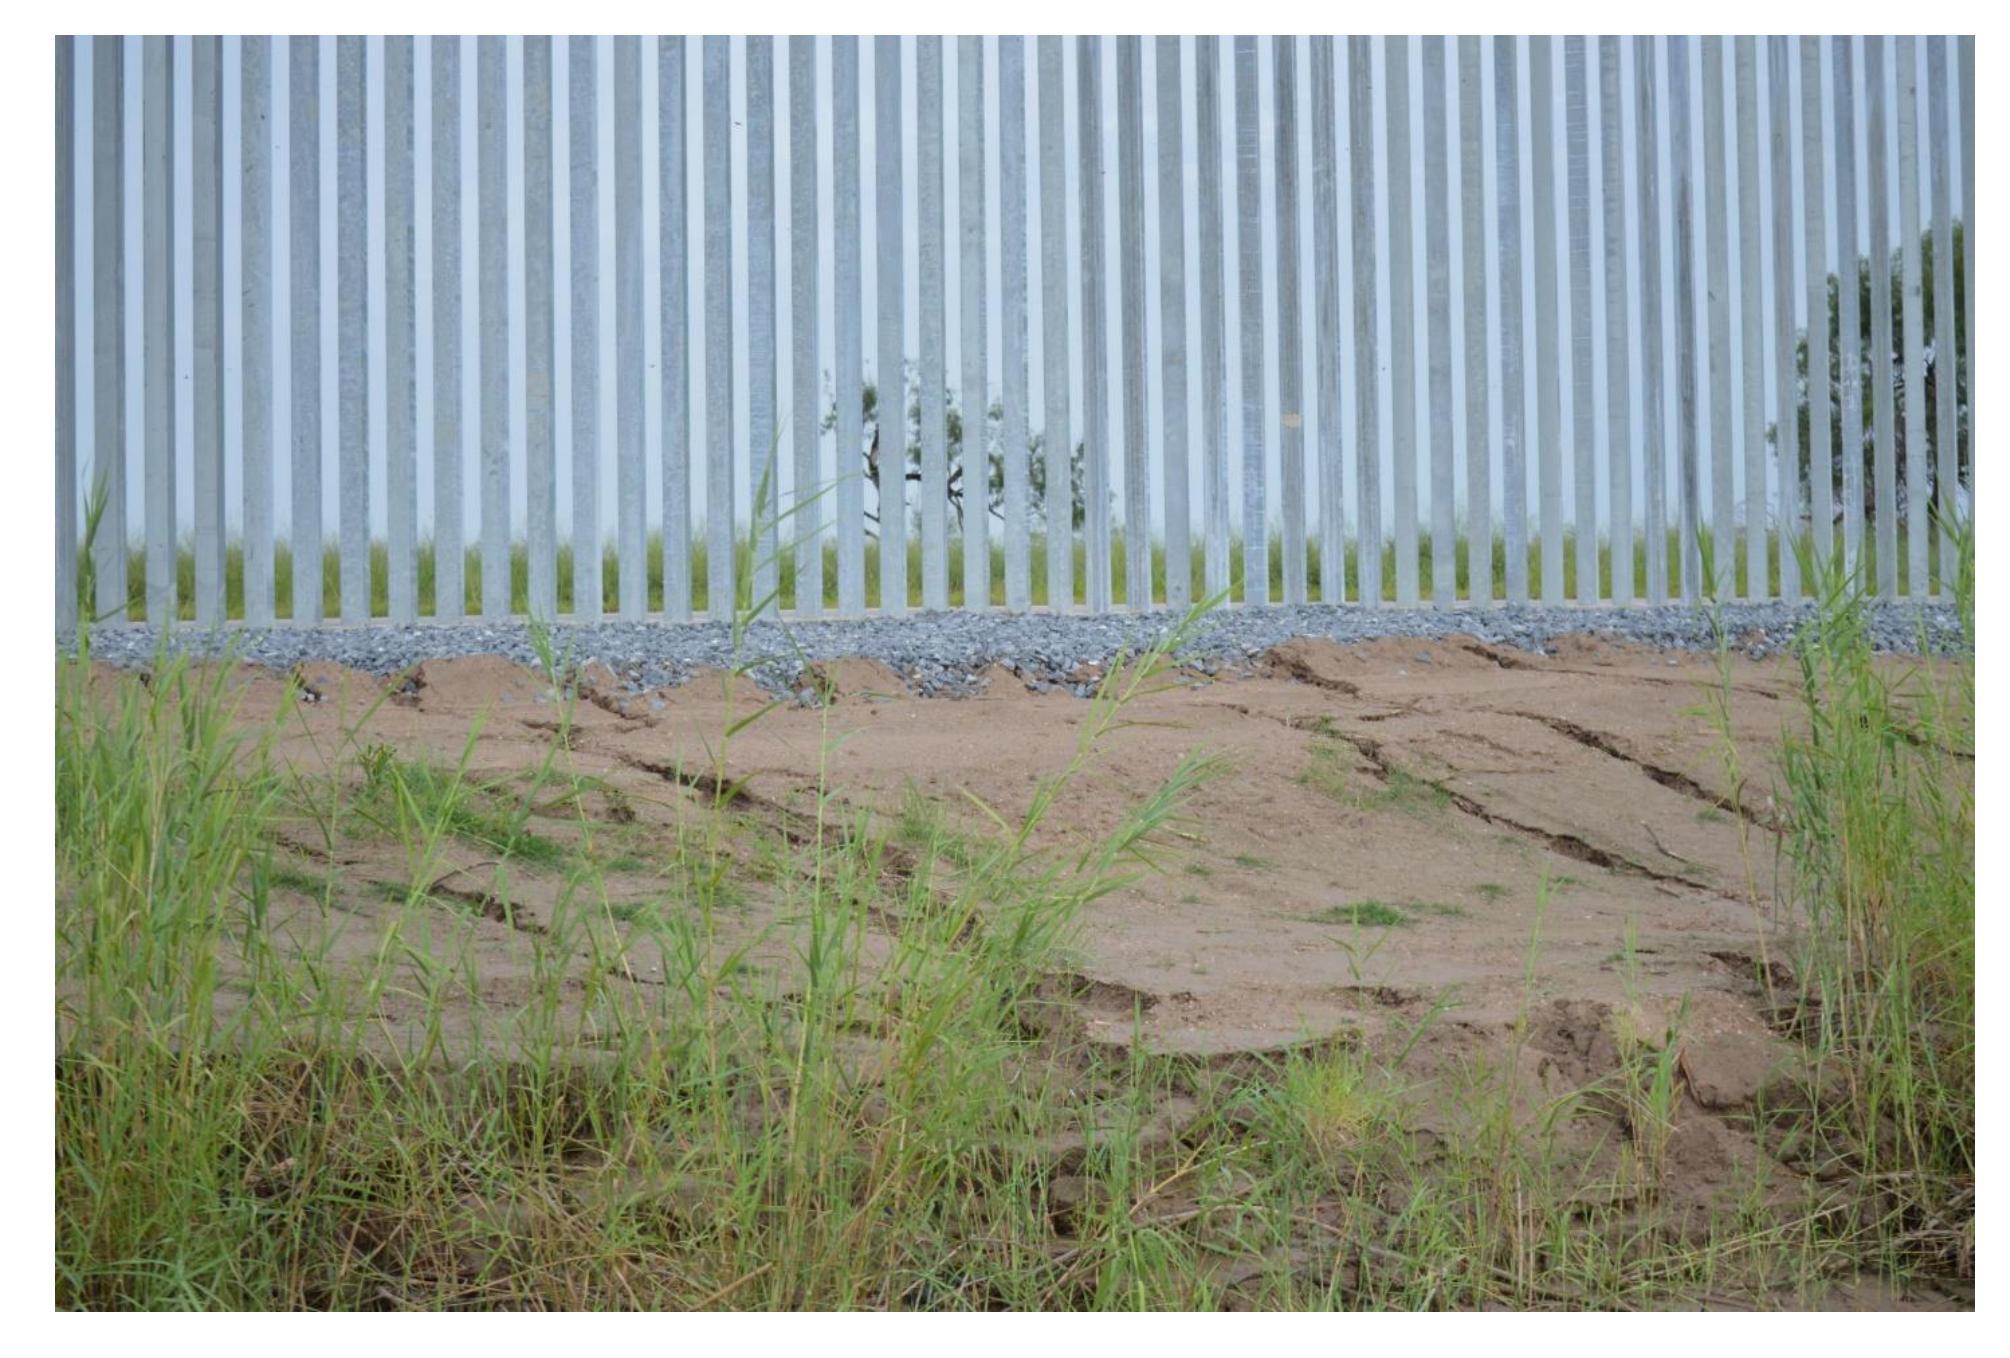
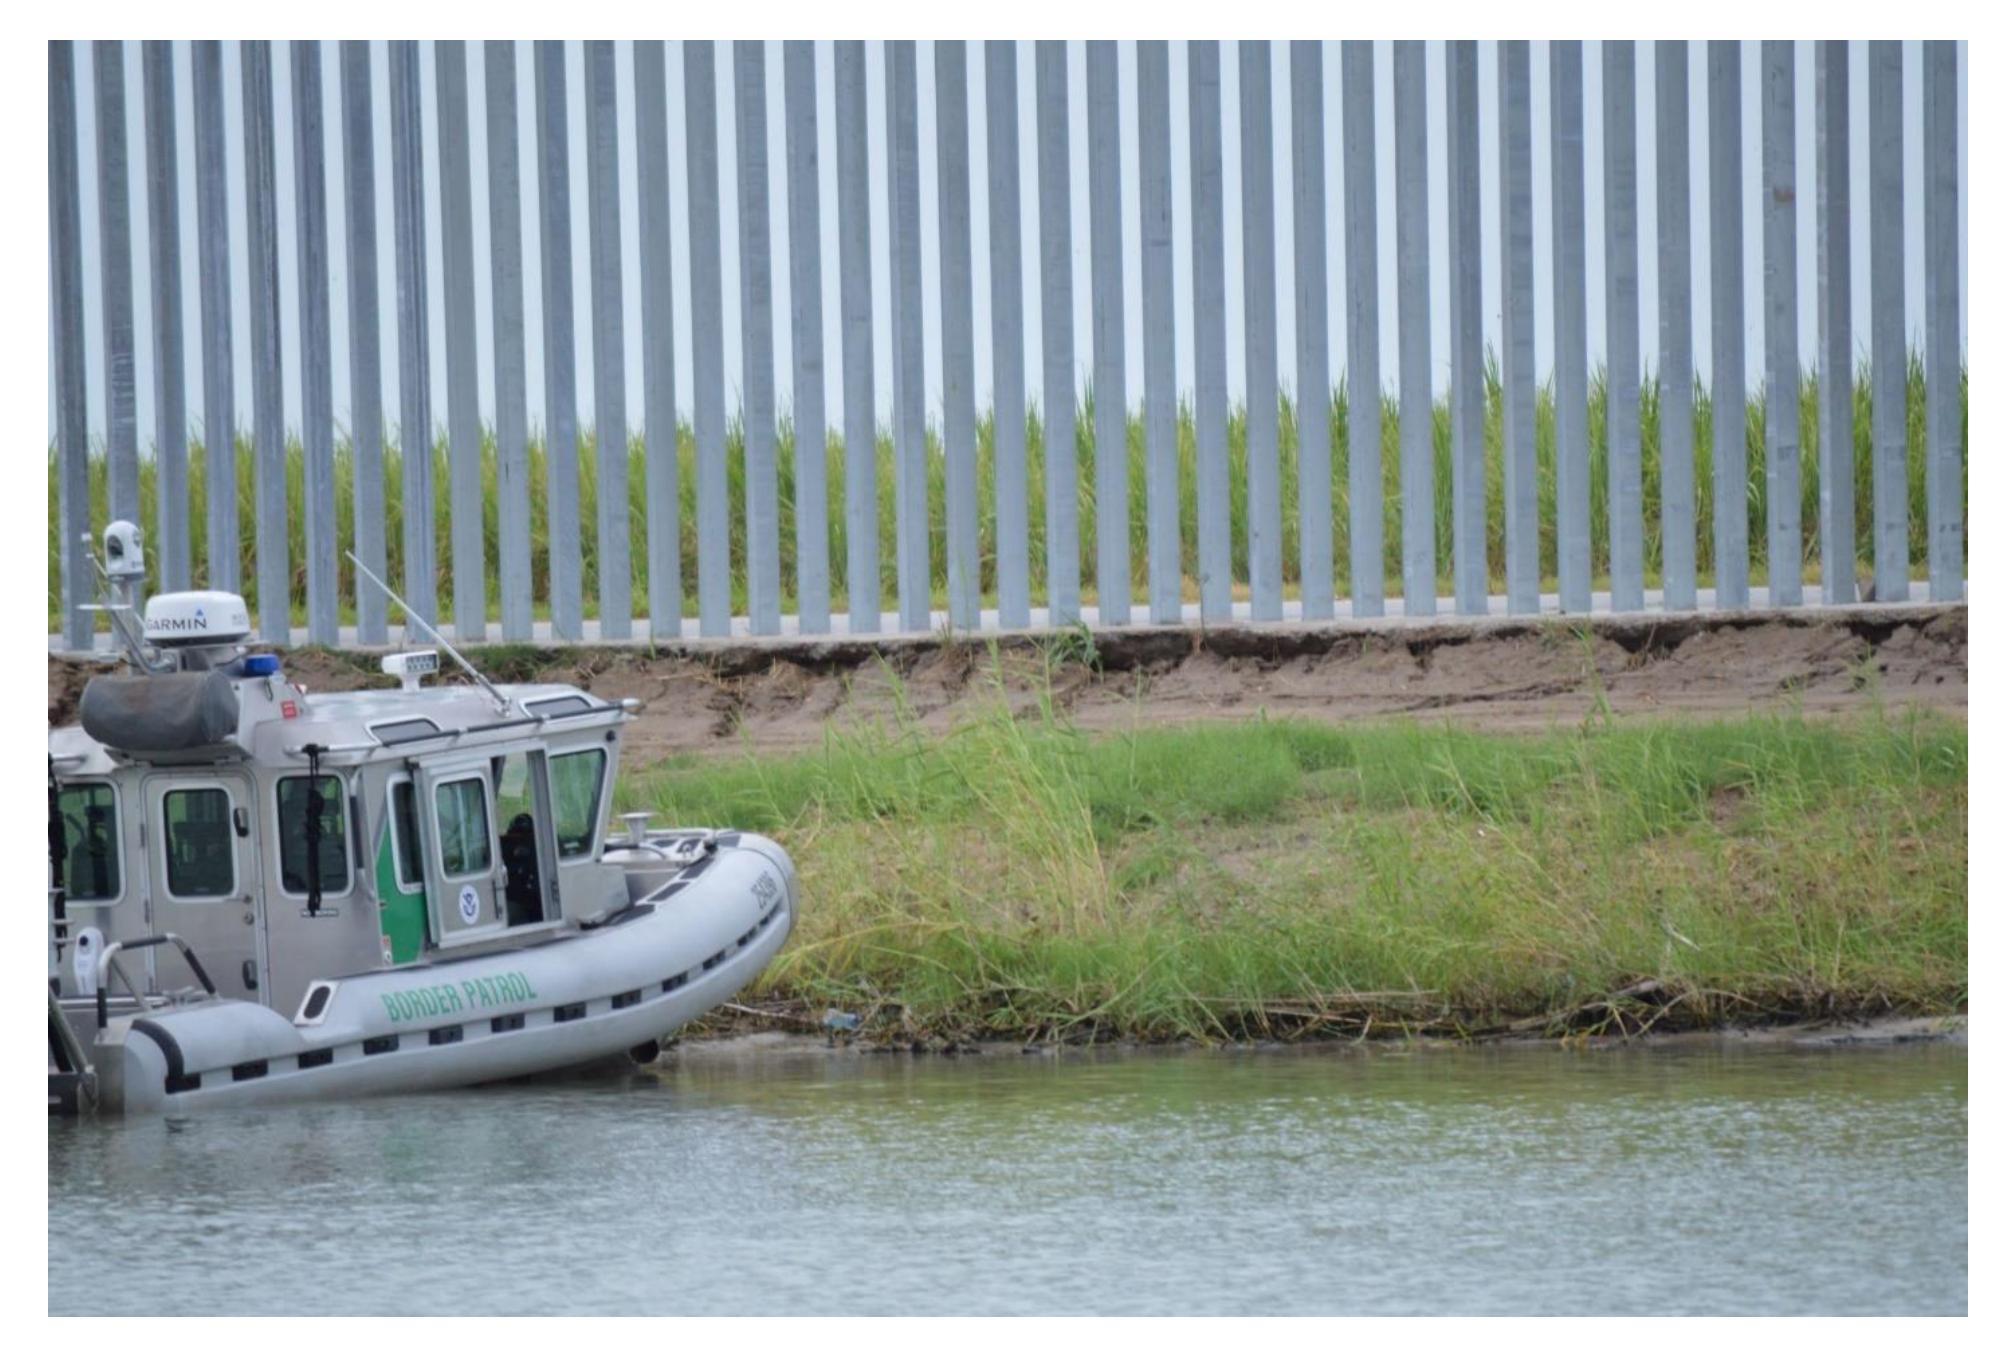
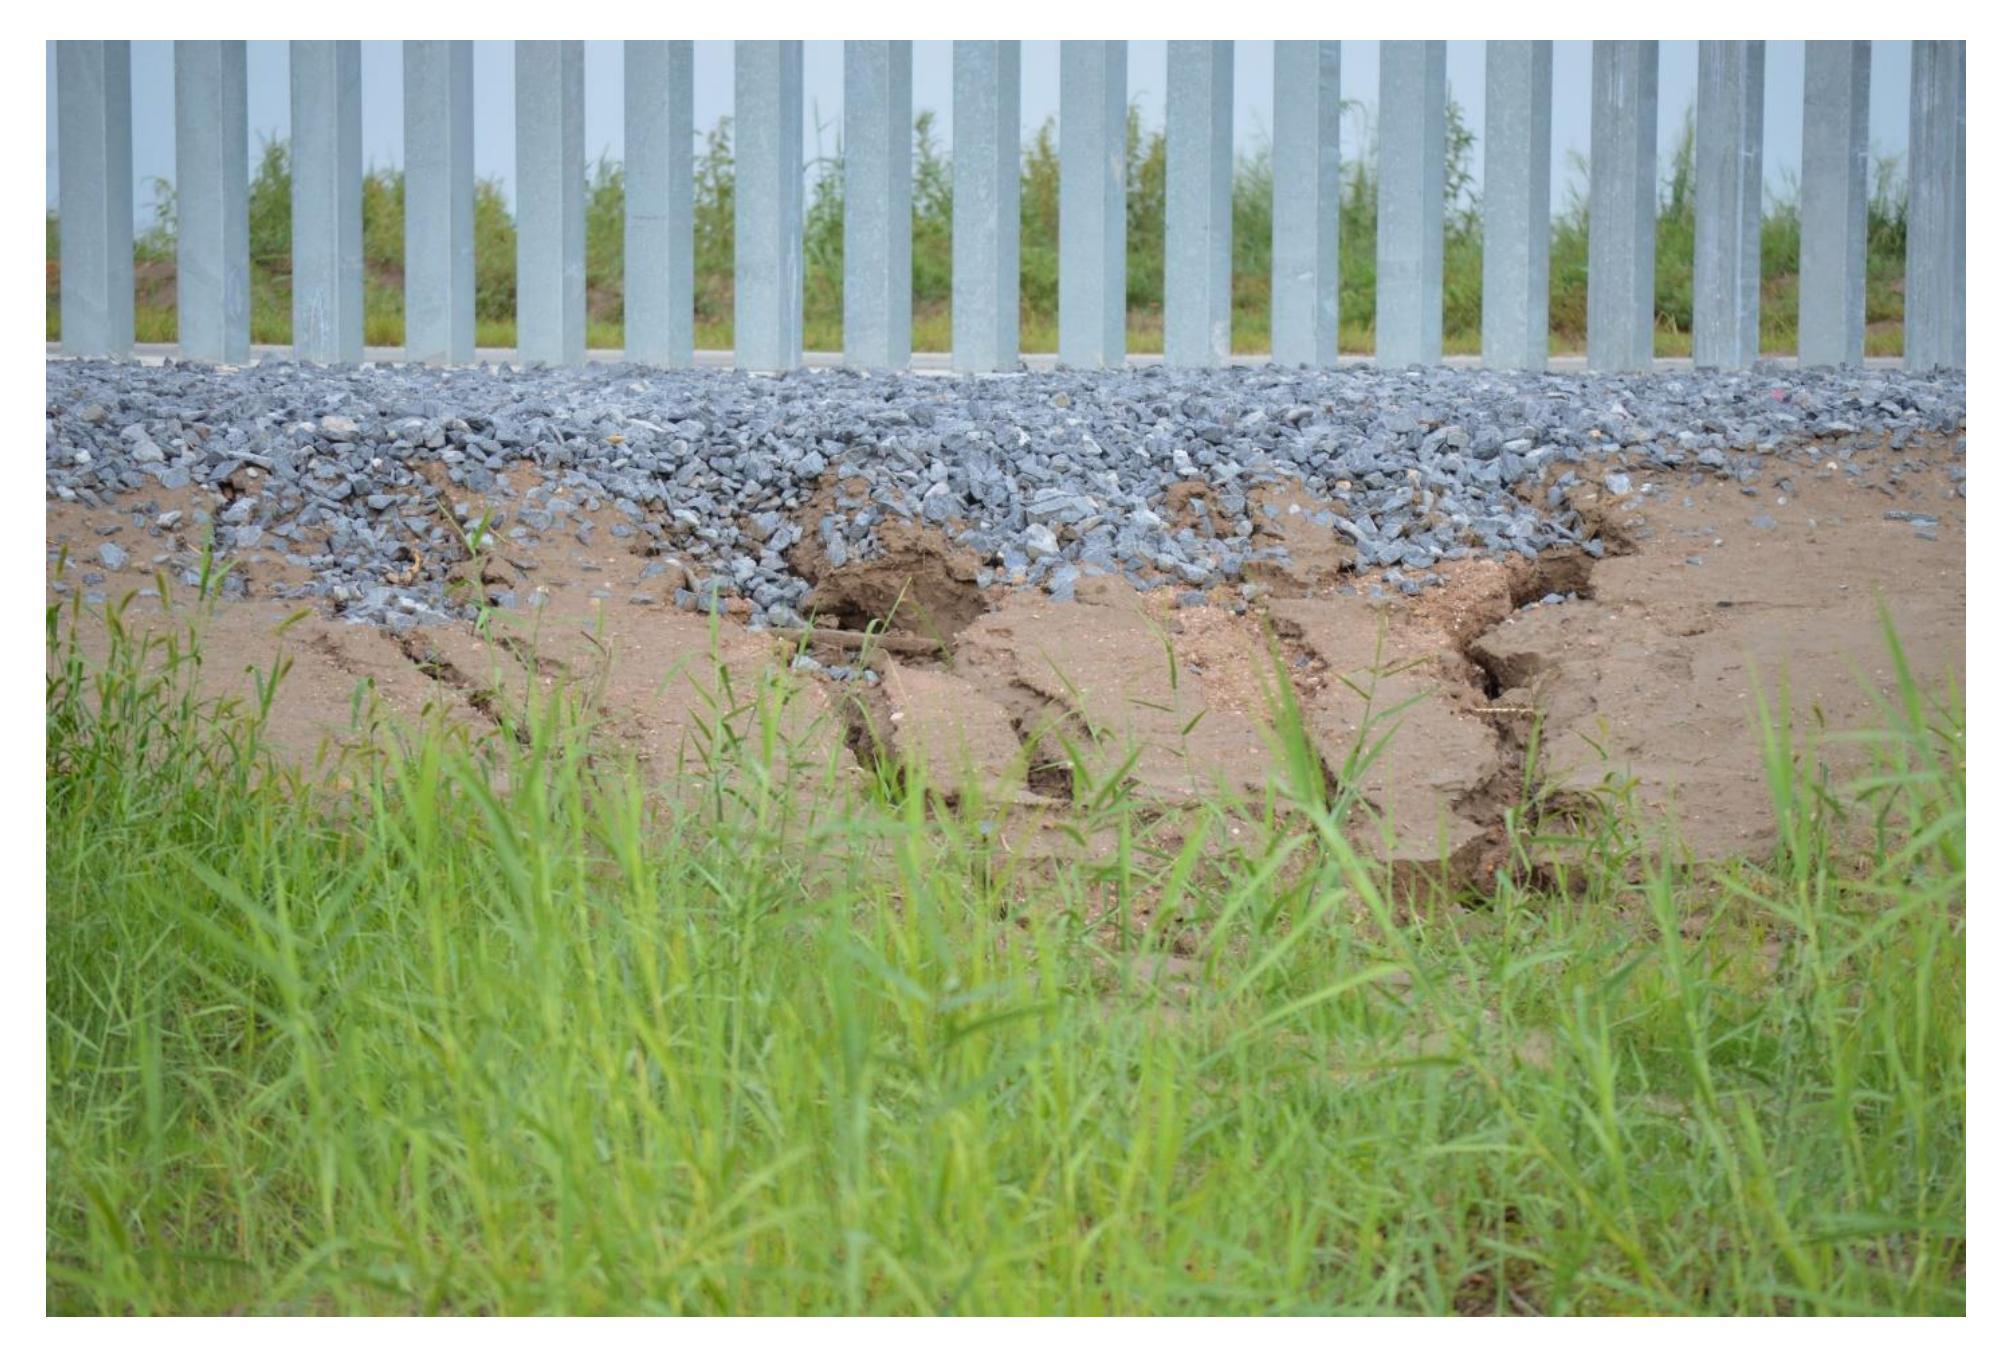
Photographs of Erosion Damage from August 2020 Provided by DOJ as received from Butterfly Center

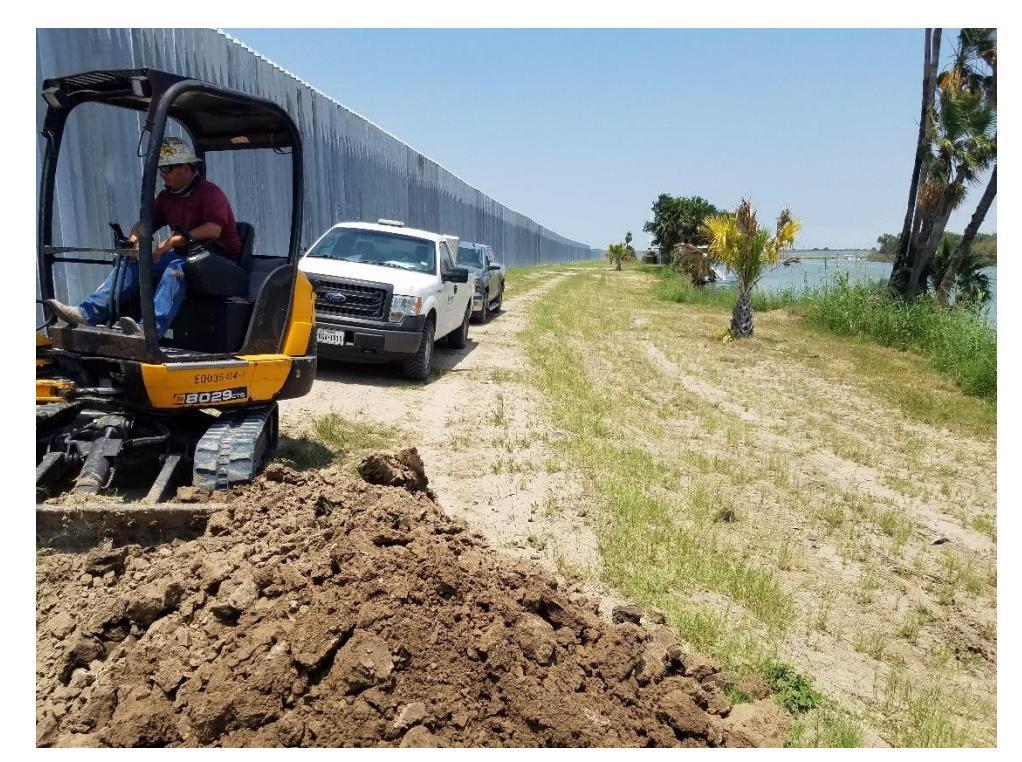
Photograph: 71 Description: TP-10 excavation soil materials from trench excavation.
