Shorebird nest fates at Boca Chica after rocket test launch

Prepared by Justin LeClaire, David Newstead
Coastal Bend Bays & Estuaries Program
June 6, 2024

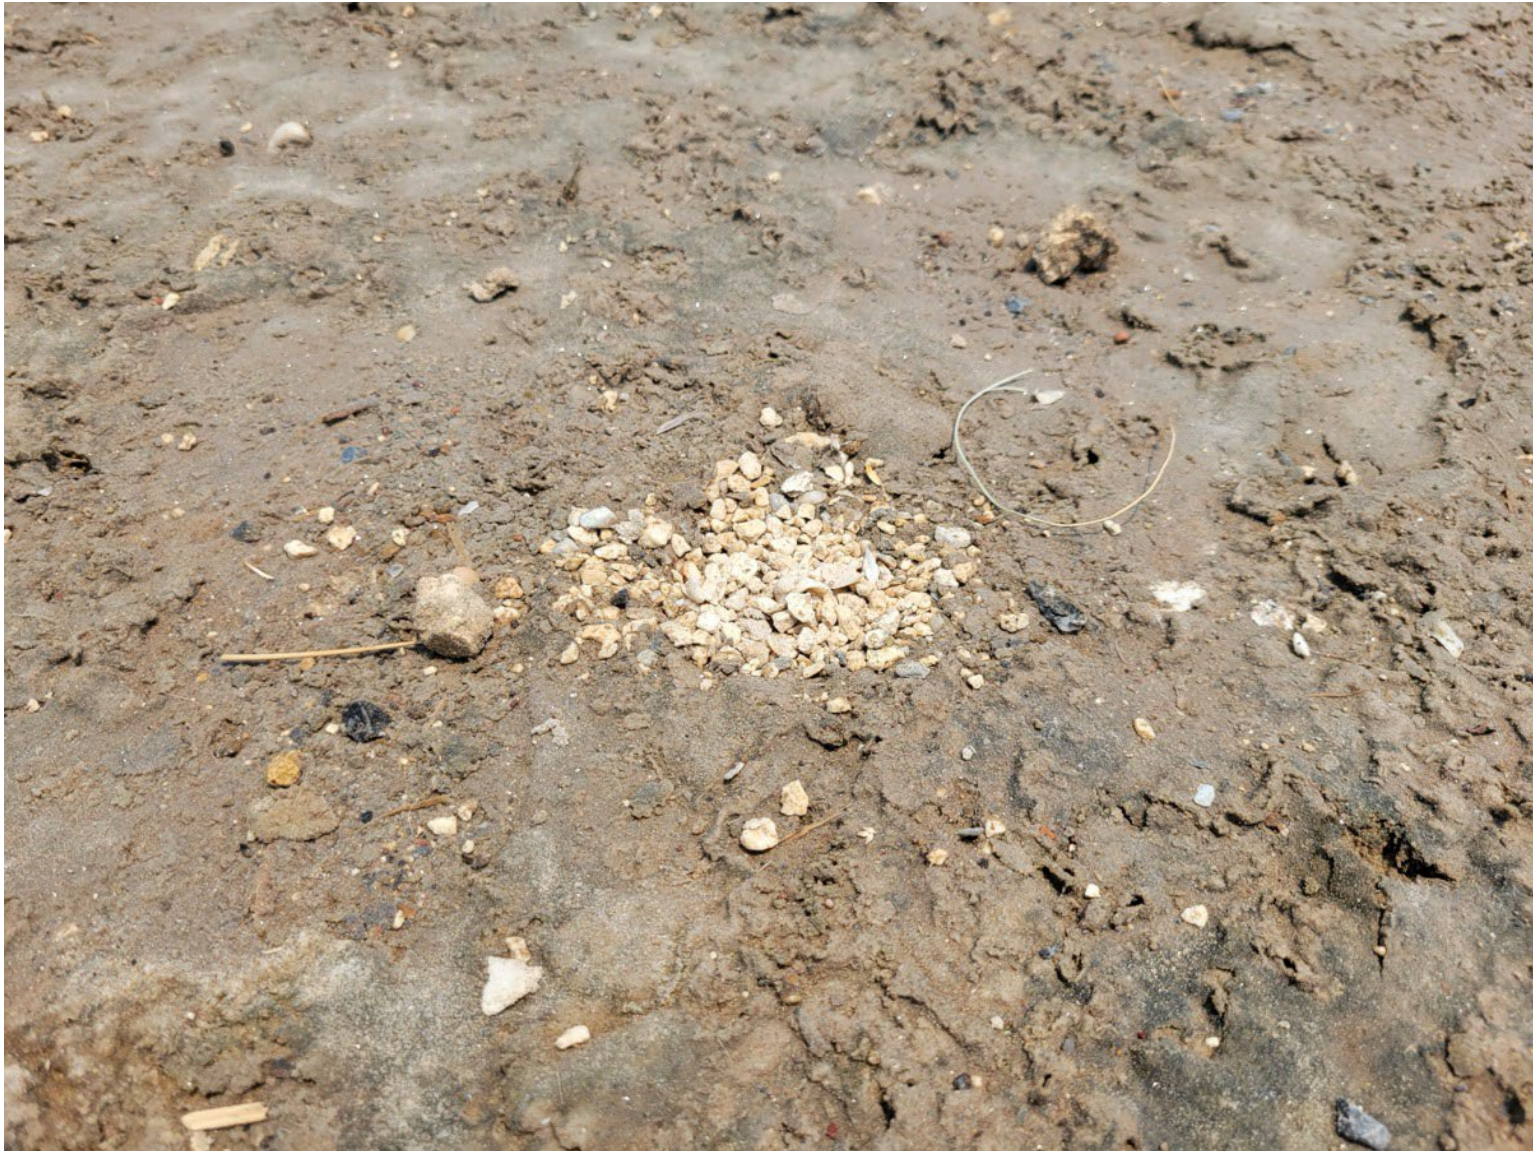
Figure 3. SNPL 1 nest with 0 eggs and no signs of predator tracks despite moist ground that would be highly impressionable by any predators on June 6, 2024.

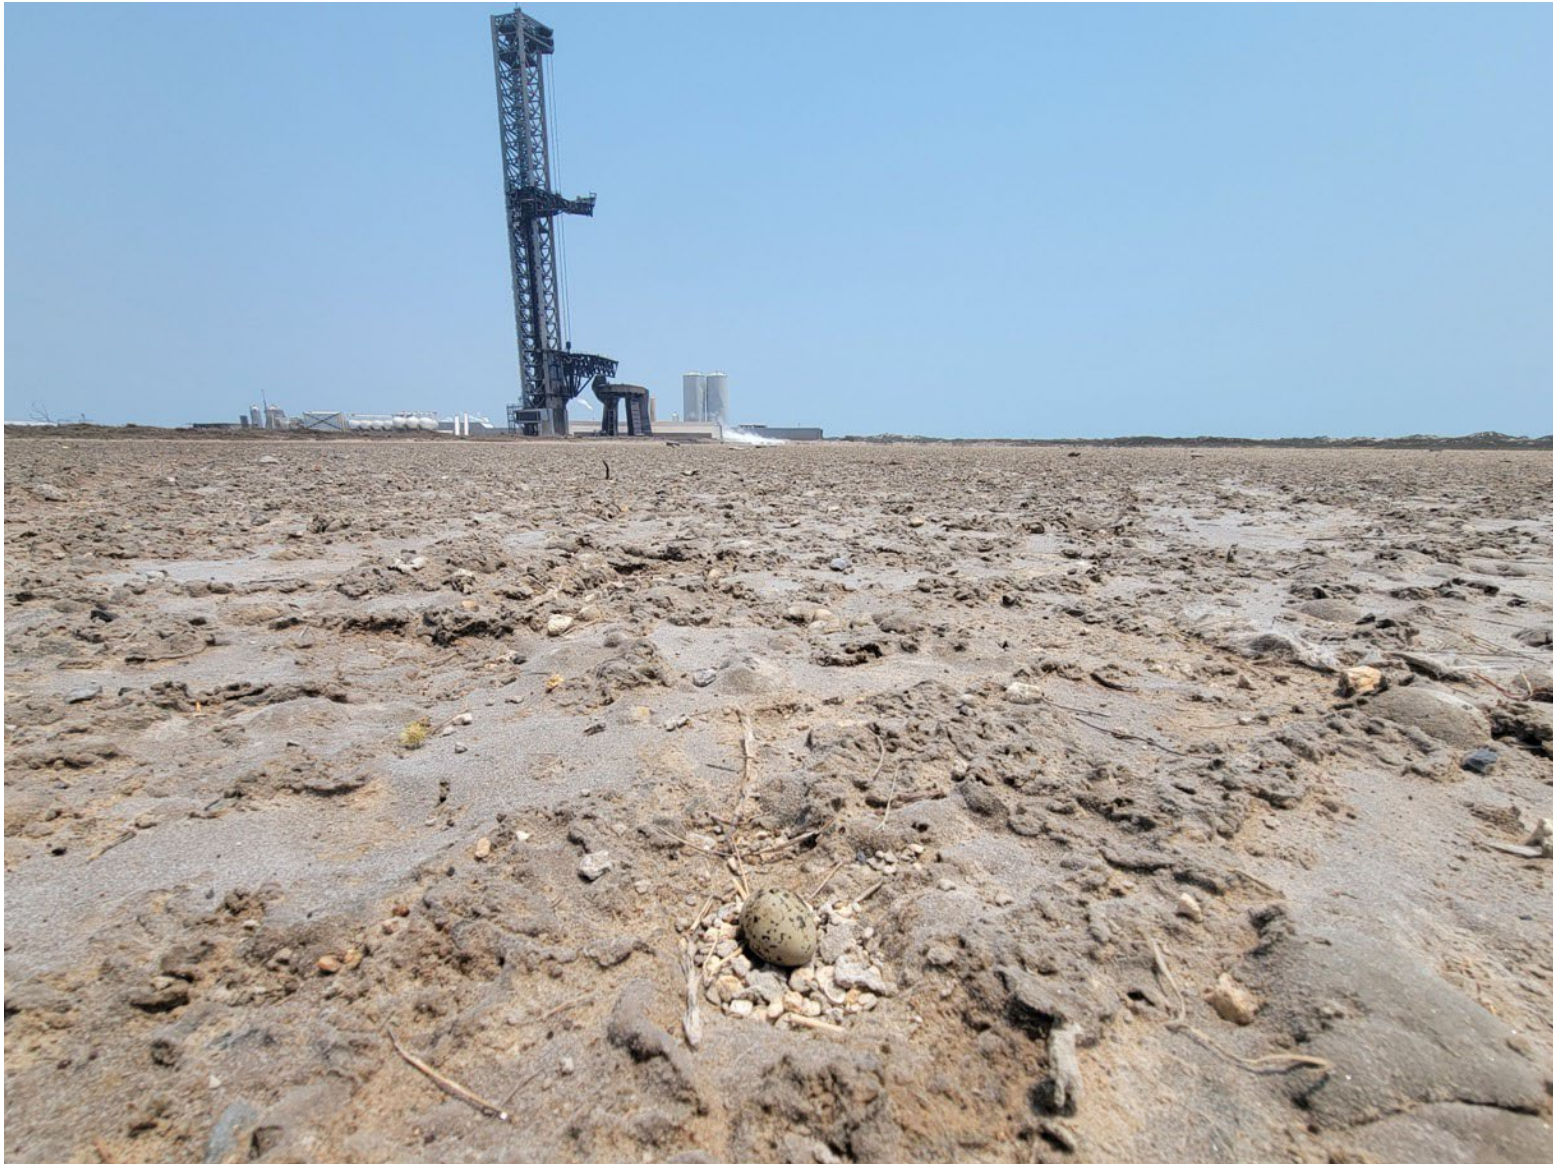
Figure 4. SNPL 2 nest with only one egg remaining and the rocket launchpad in the background on June 6, 2024.

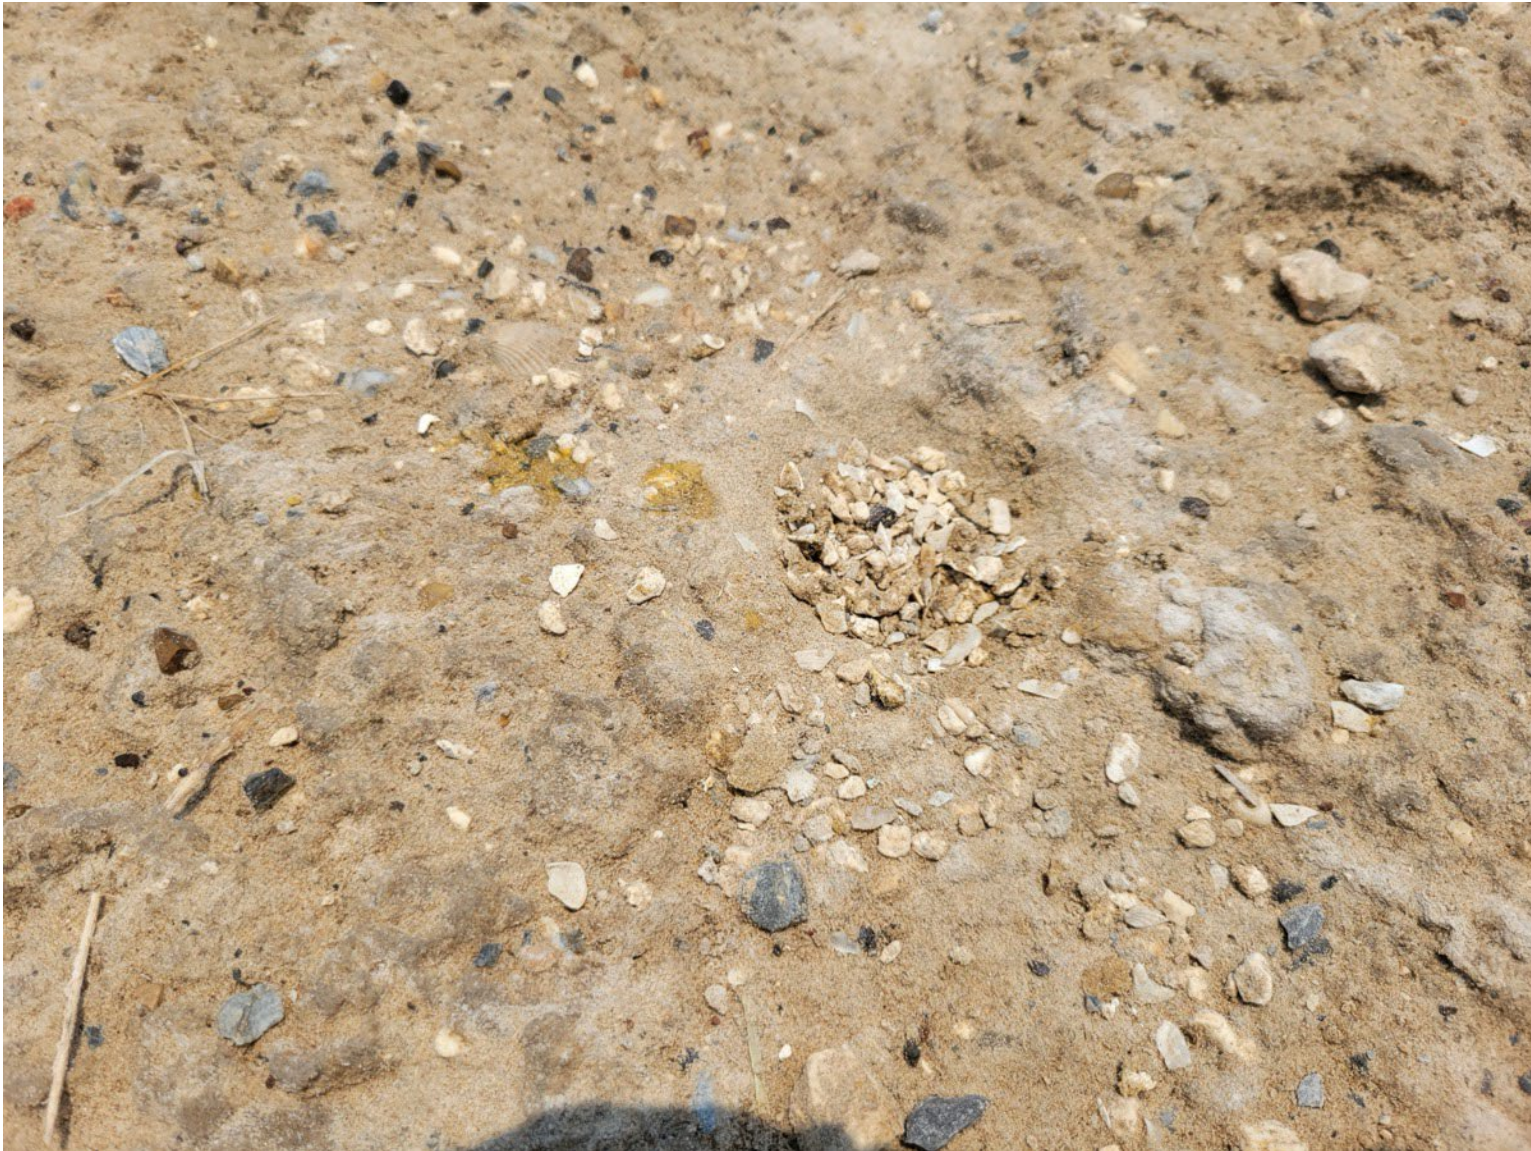
Figure 9. SNPL 4 with dried egg contents spilled in the nest cup and droplets moving away from it in a straight line on June 6, 2024.

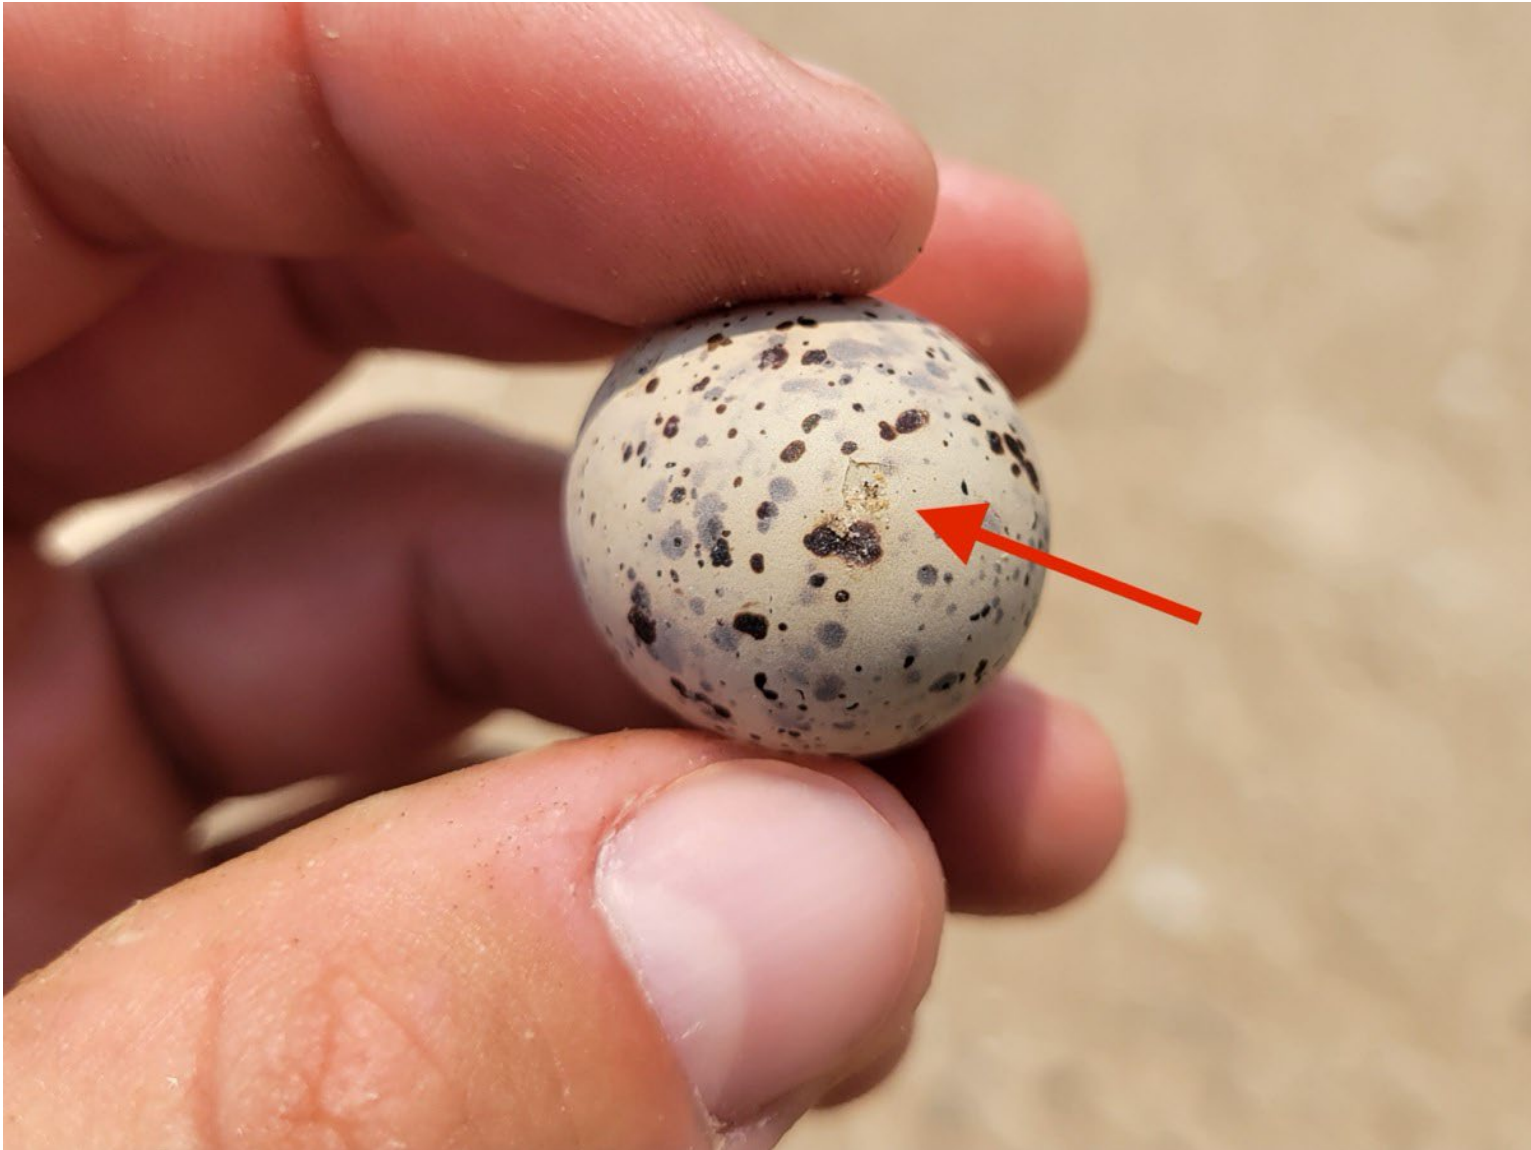
Figure 10. Lone egg from SNPL 5 with a small but significant depressed crack on June 6, 2024.

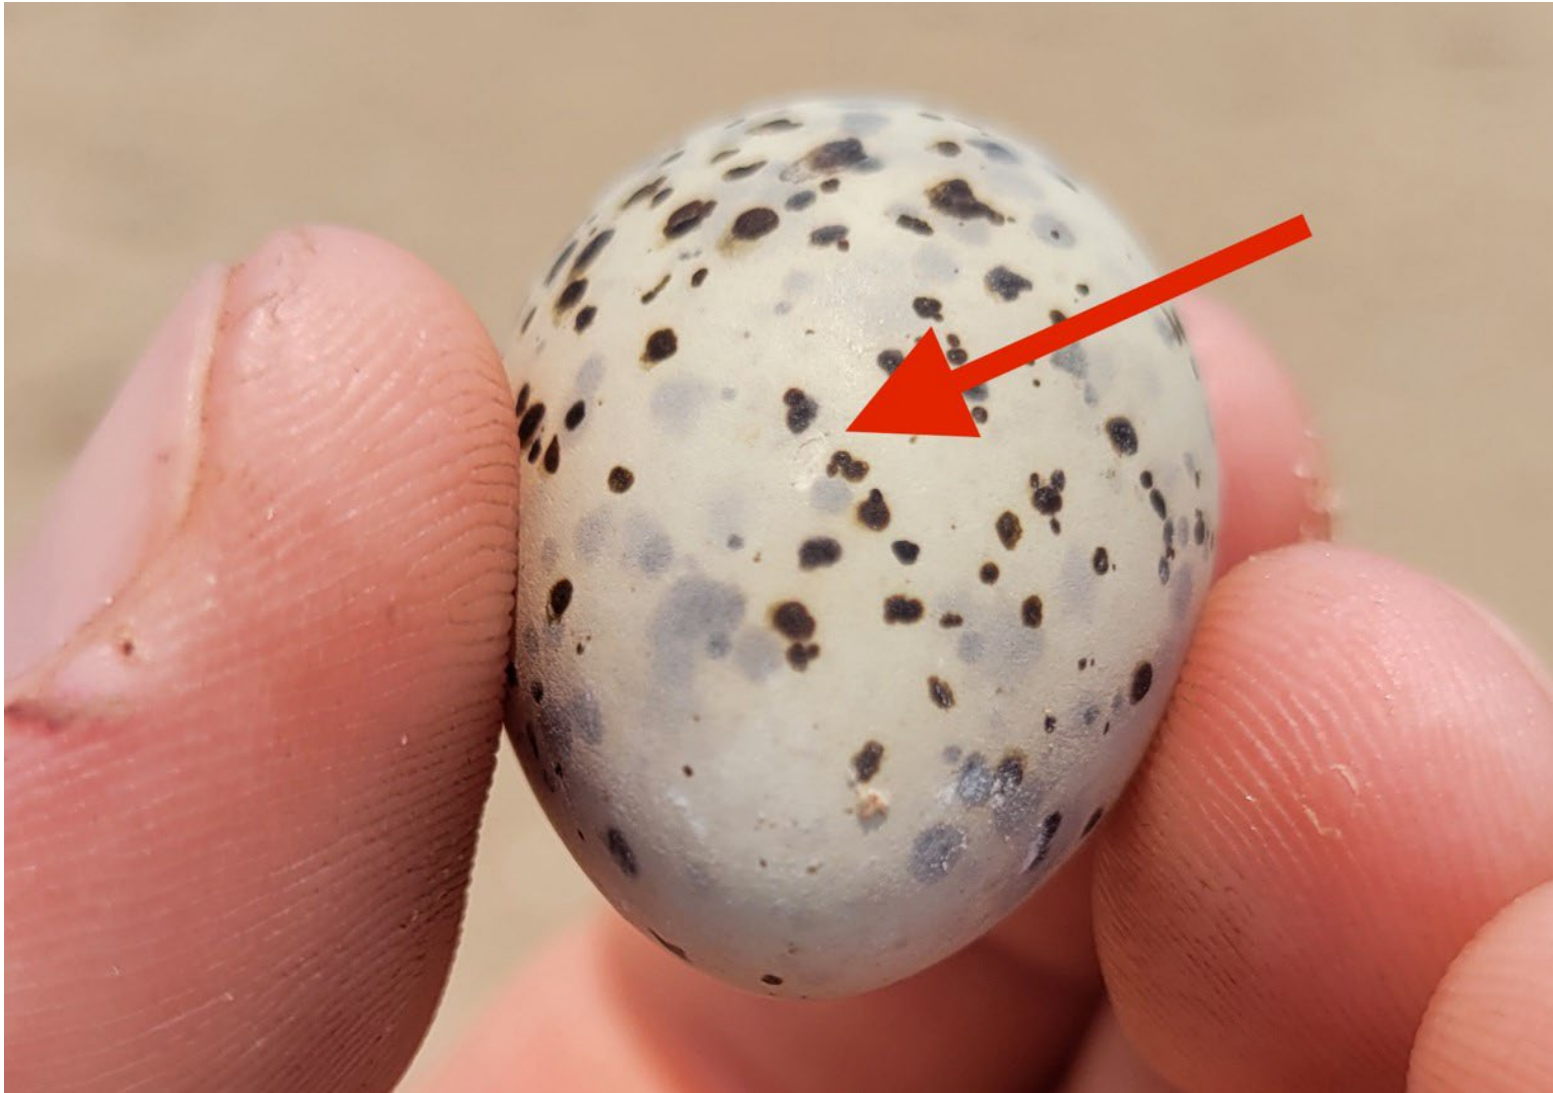
Figure 11. Small but noticeable crack on egg from LETE 2 on June 6, 2024.

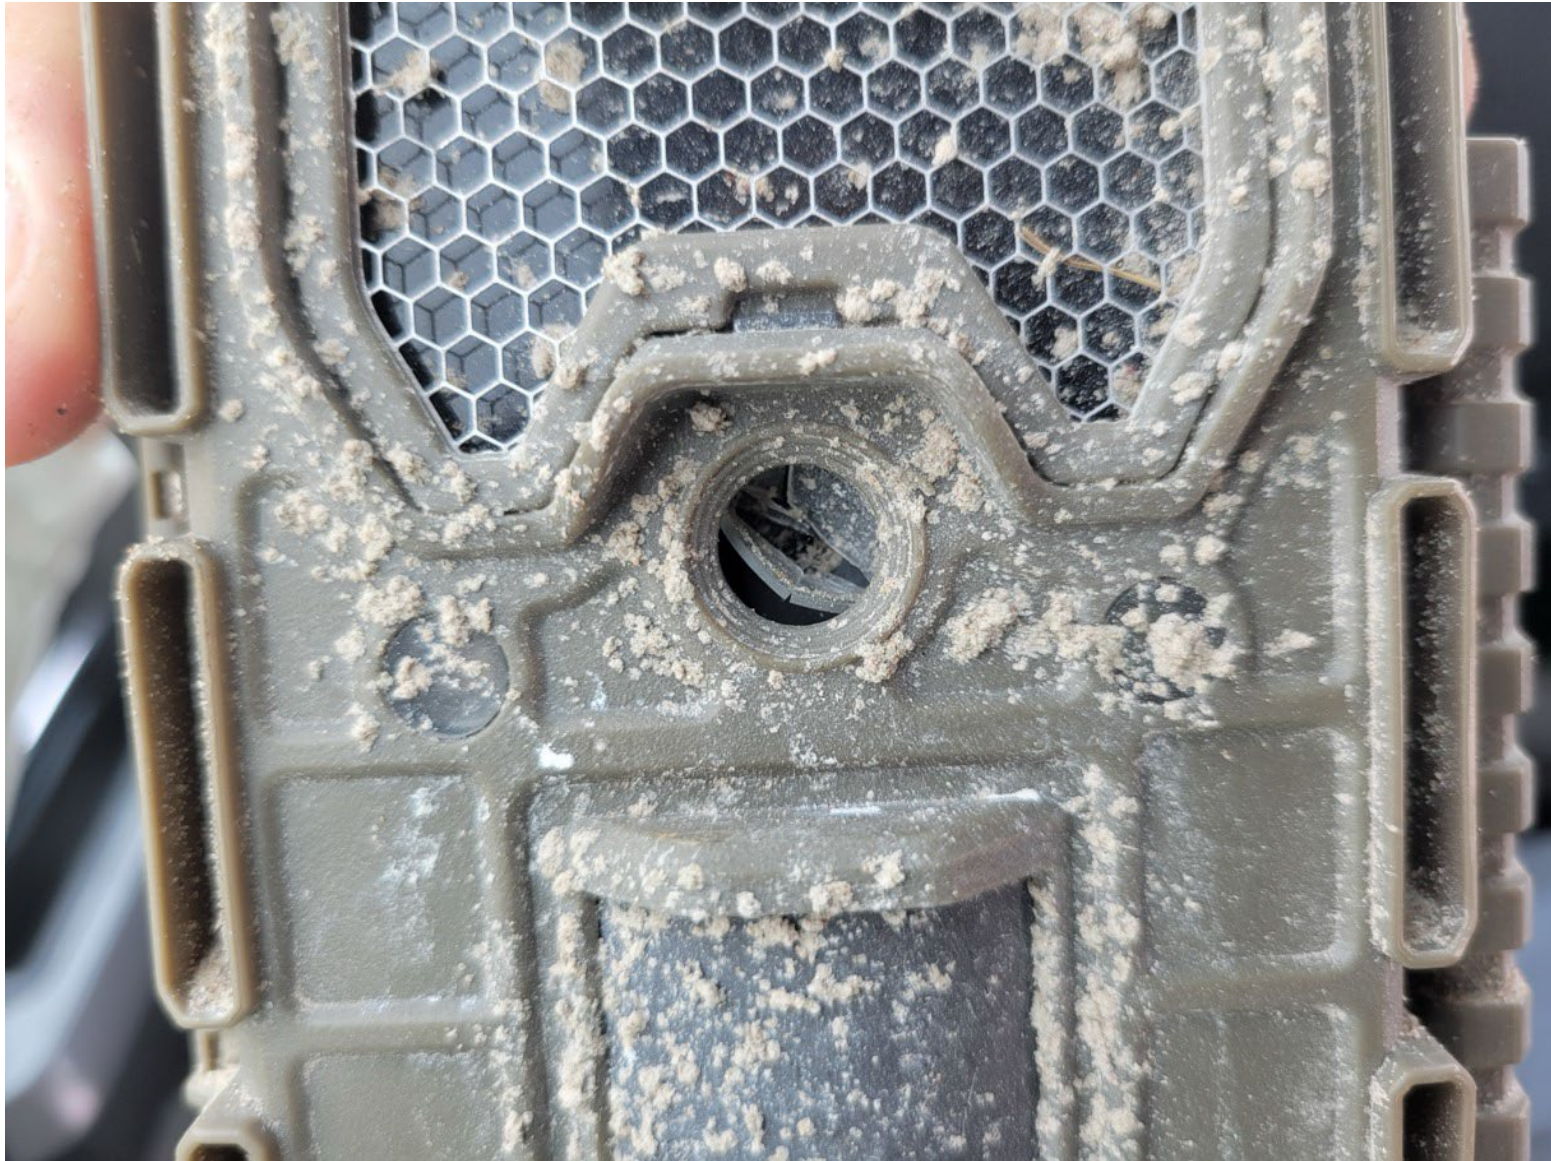
Figure 15. Game camera from WIPL 1 showing completely cracked camera lens after pebble was removed post-launch on June 6, 2024.

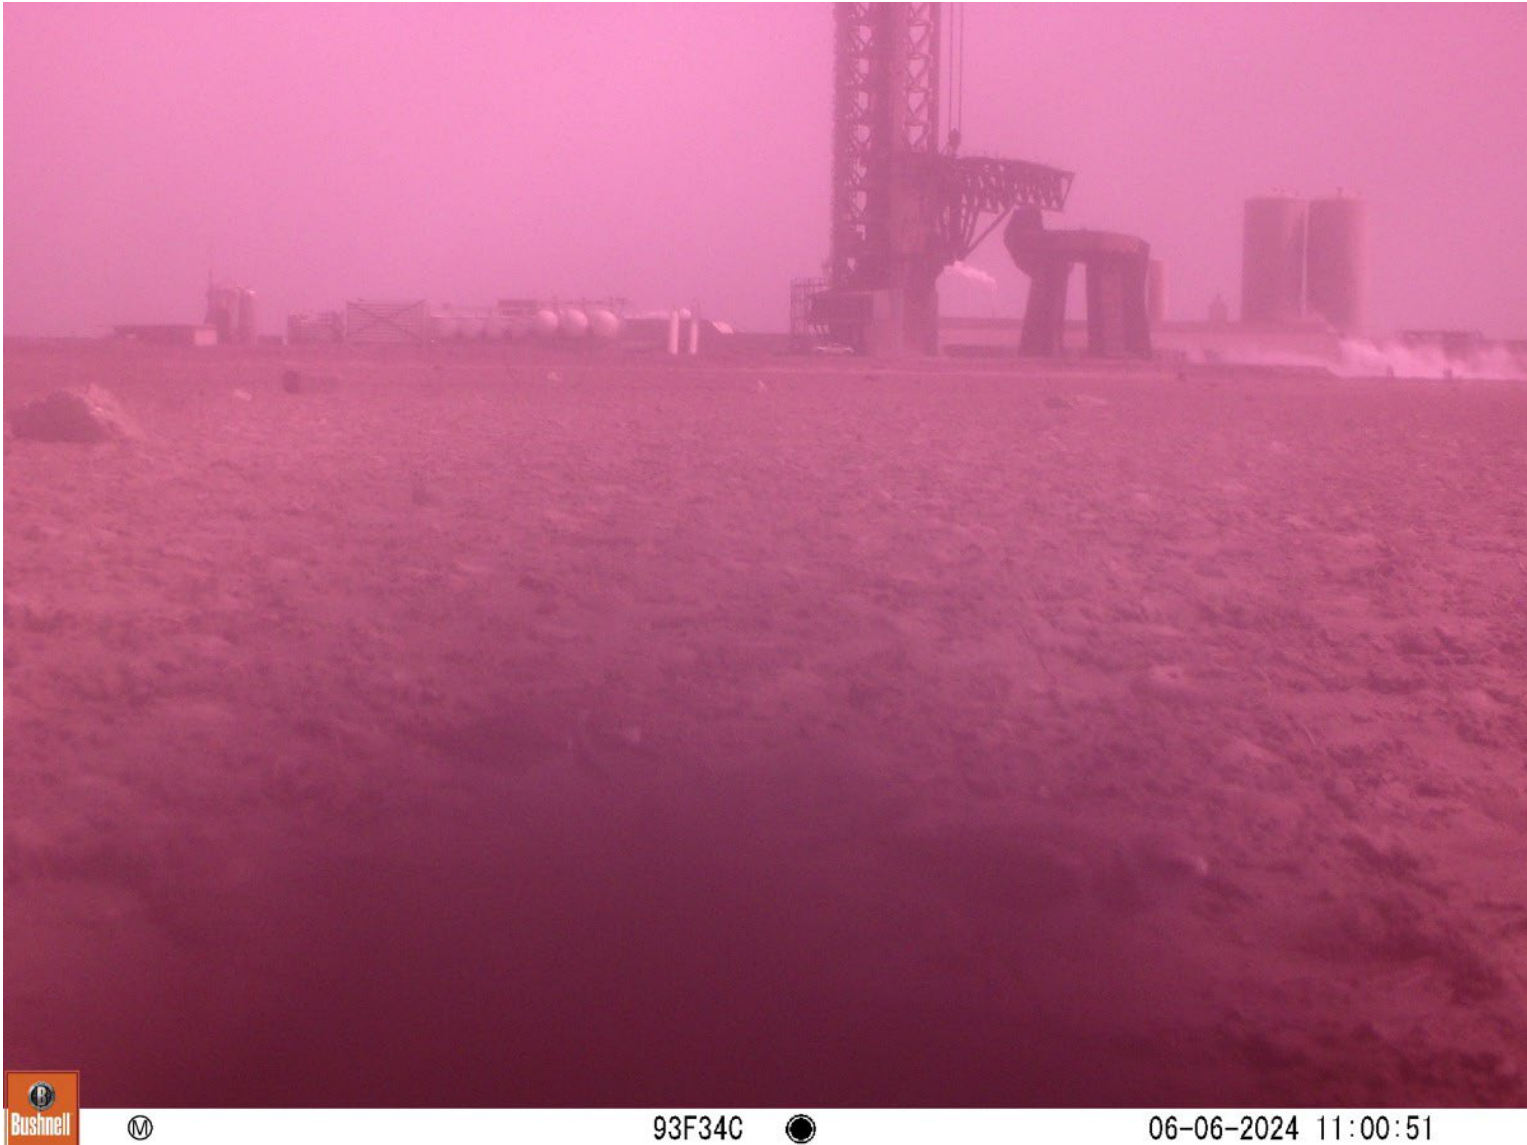
Figure 19. WIPL 1 game camera showing both WIPL adults in attendance but nest cup not quite visible due to pebble lodged in camera lens and overall pinkish hue post-launch on June 6, 2024.

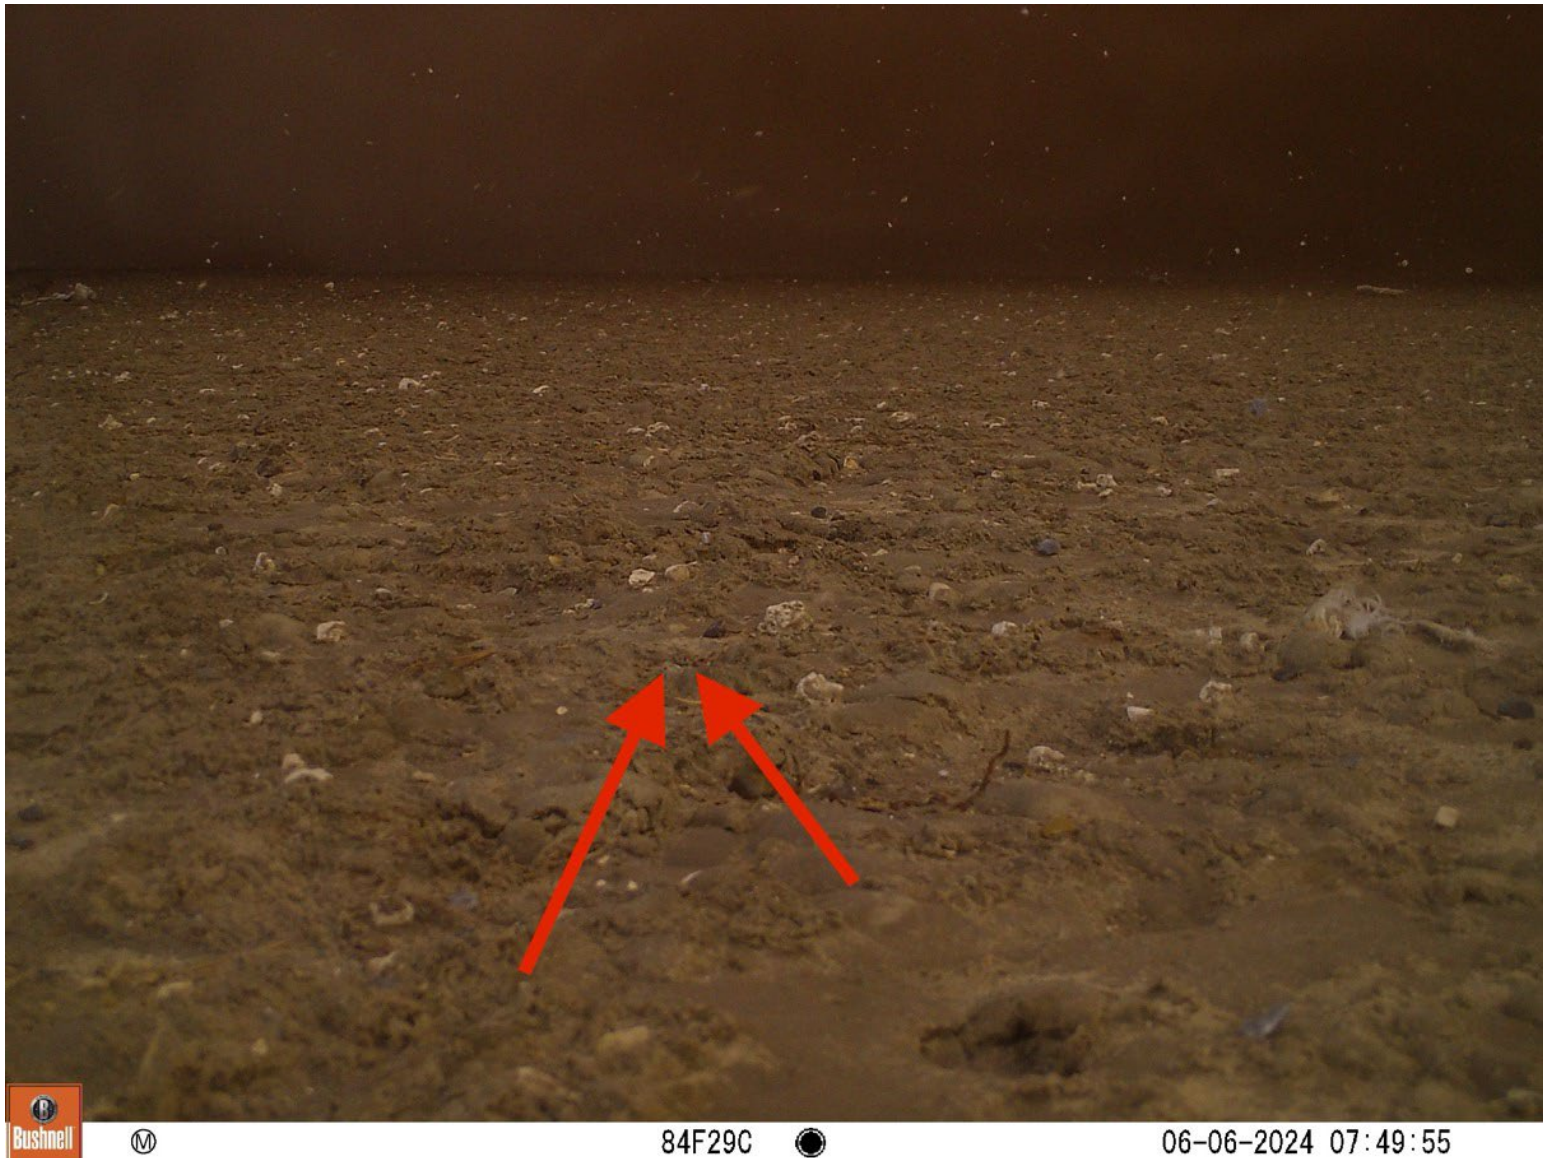
- SNPL 2 camera: camera angle did not allow for clear viewing of nest contents, but the SNPL pair did return to incubate the 3-egg nest after camera installation for a few photos. No other photographs were taken until 7:50am on June 6, just after the rocket launch when the dust cloud and debris can again be seen rapidly moving towards the camera. Nest contents are not perfectly clear in the images but the edge of at least two eggs appear to be visible in the nest cup. The images turn a yellowish hue after the dust settles and no more photographs were taken until CBBEP staff checked the nest at 12:28pm. The nest was then observed with just a single egg in it that was cracked and no longer viable, though the attending SNPLs were still incubating the nest.

Figure 22. SNPL 2 game camera showing dust cloud and small pale-colored debris moving toward nest and game camera at a high rate of speed, with nest cup and at least two eggs possibly visible as referenced by red arrows on June 6, 2024.
