**EME AUDIT
REPORT**

853418 Rosemont

370 Stevens Avenue
Portland, Maine

U.S. Cellular

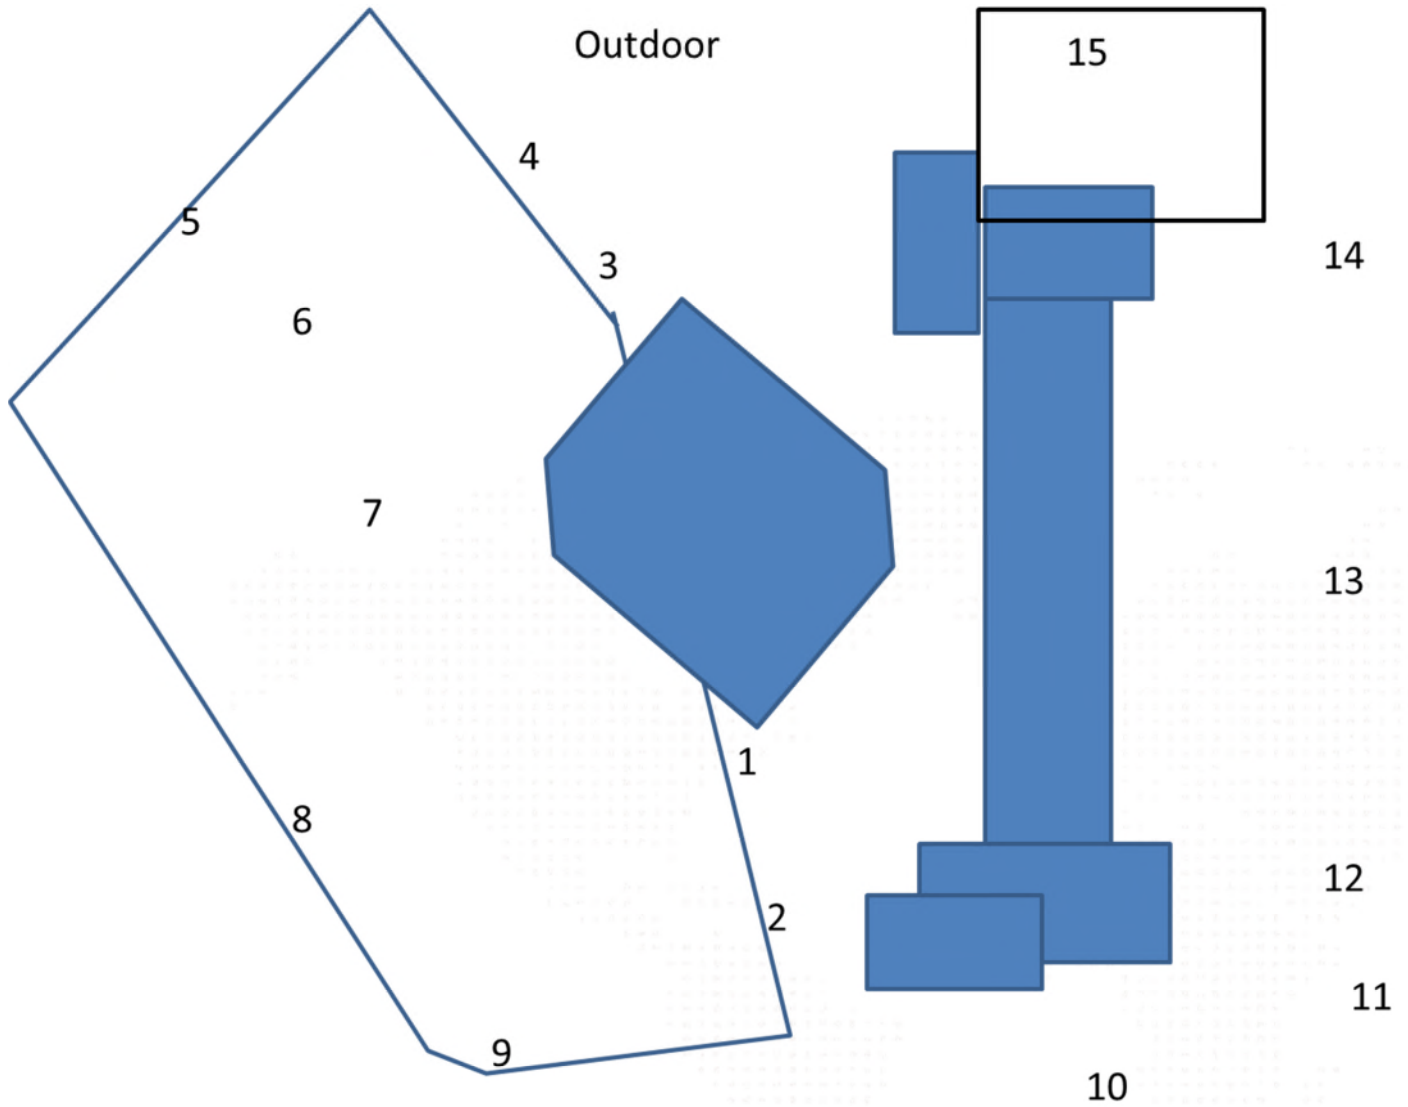
APPENDIX 3.1

Measurement Locations Outside the Building

U. S. Cellular - Site Rosemont (Outside)	
Map Locations	EXISTING LEVELS Readings taken 06-24-15
PERCENTAGE OF MPE (General Population)	
1	0.70%
2	0.20%
3	4.30%
4	0.20%
5	0.10%
6	0.30%
7	0.30%
8	0.10%
9	0.20%
10	0.10%
11	0.30%
12	1.30%
13	1.10%
14	1.20%
15	0.90%

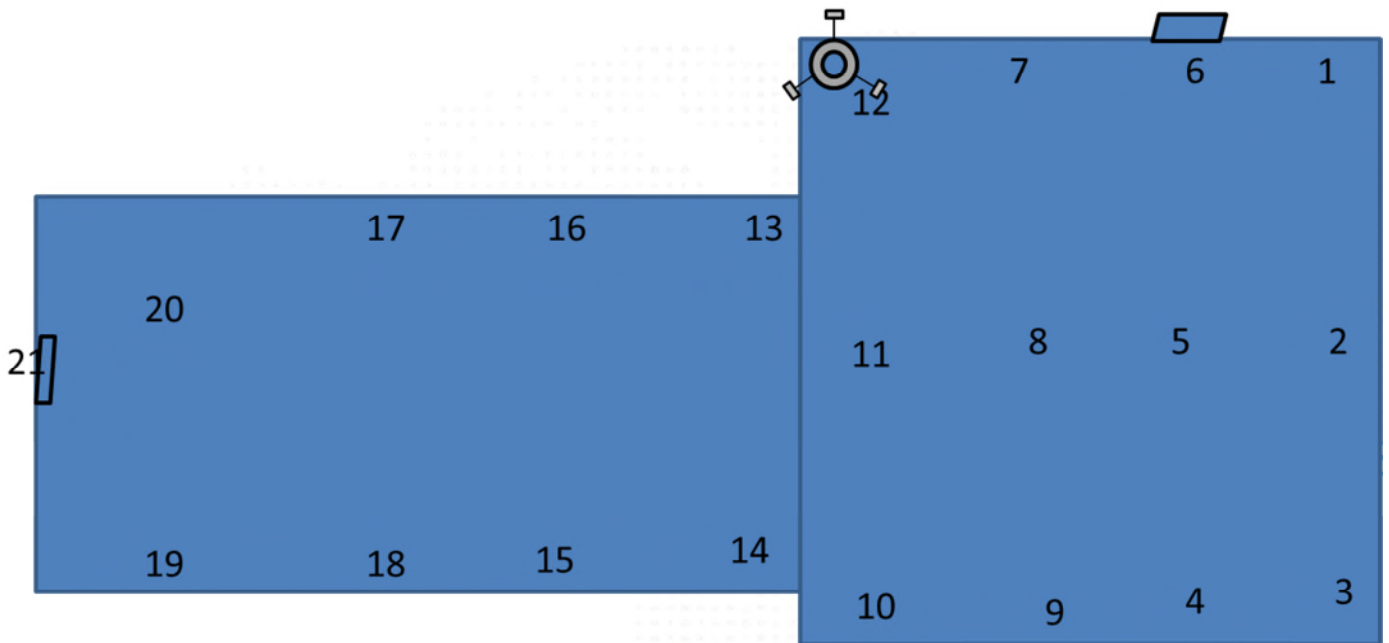
APPENDIX 3.2

Measurement Locations On the Roof

U. S. Cellular - Site Rosemont (roof)	
Map Locations	EXISTING LEVELS Readings taken 06-24-15
PERCENTAGE OF MPE (General Population)	
1	11.30%
2	11.10%
3	11.10%
4	10.00%
5	11.30%
6	12.20%
7	13.30%
8	13.10%
9	13.20%
10	15.80%
11	16.60%
12	17.90%
13	15.20%
14	15.80%
15	15.20%
16	17.30%
17	15.50%
18	15.20%
19	15.80%
20	17.30%
21	16.10%

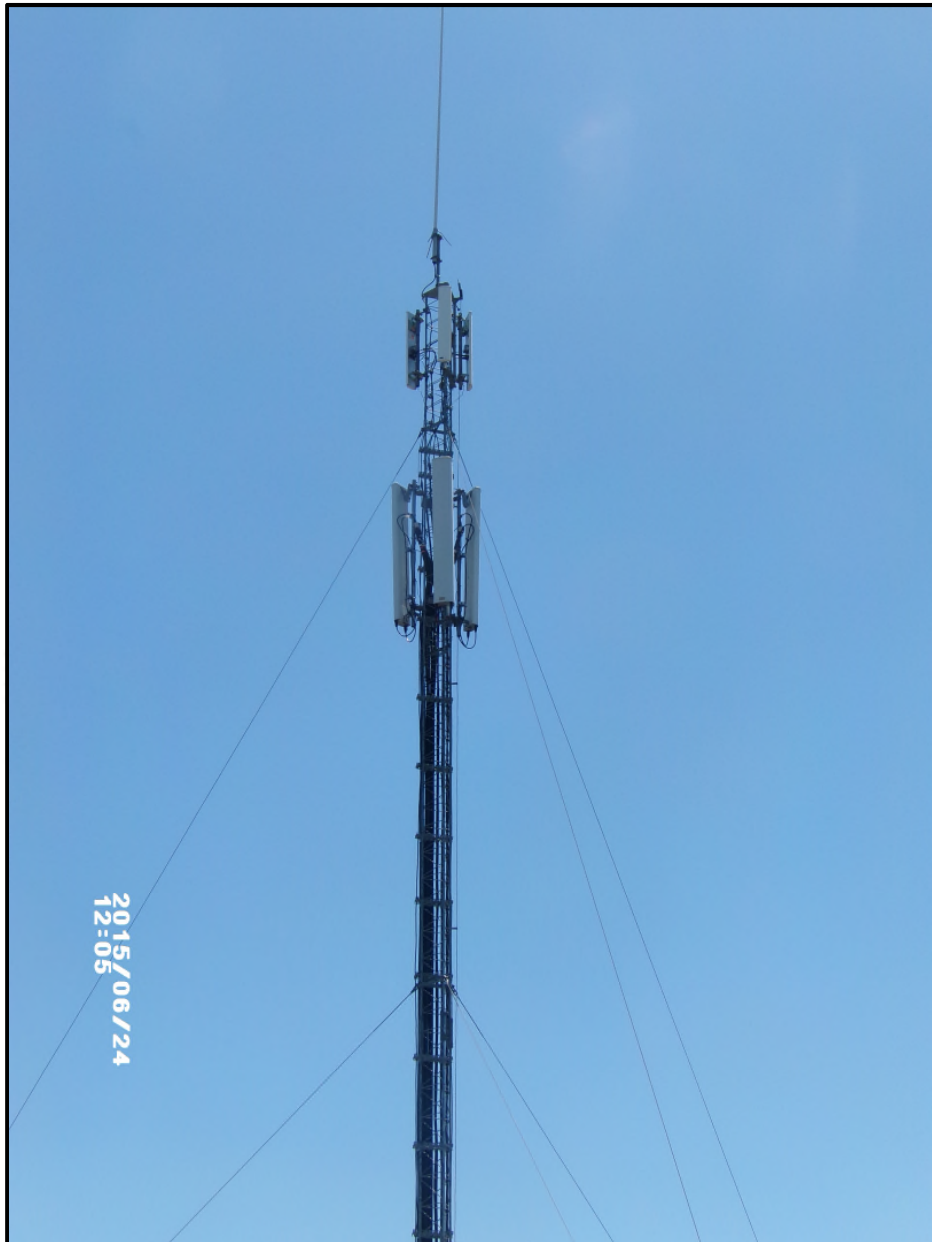
APPENDIX 7.4

- This is an existing 70-foot tower on top of a 39-foot tall building at Deering High School. U.S. Cellular has existing antennas mounted on the tower.

*Tower
June 24, 2015*

- This U.S. Cellular site is in compliance with the current FCC RF human exposure regulations.
- LBA recommends that any worker attempting to service this antenna facility have RF awareness training and wear a personal RF monitor.
- LBA recommends placement of RF signage in accordance with U.S. Cellular RF signage policy.
- Procedures described in OET Bulletin-65 should be followed during the performance of work on or near the antenna facilities.

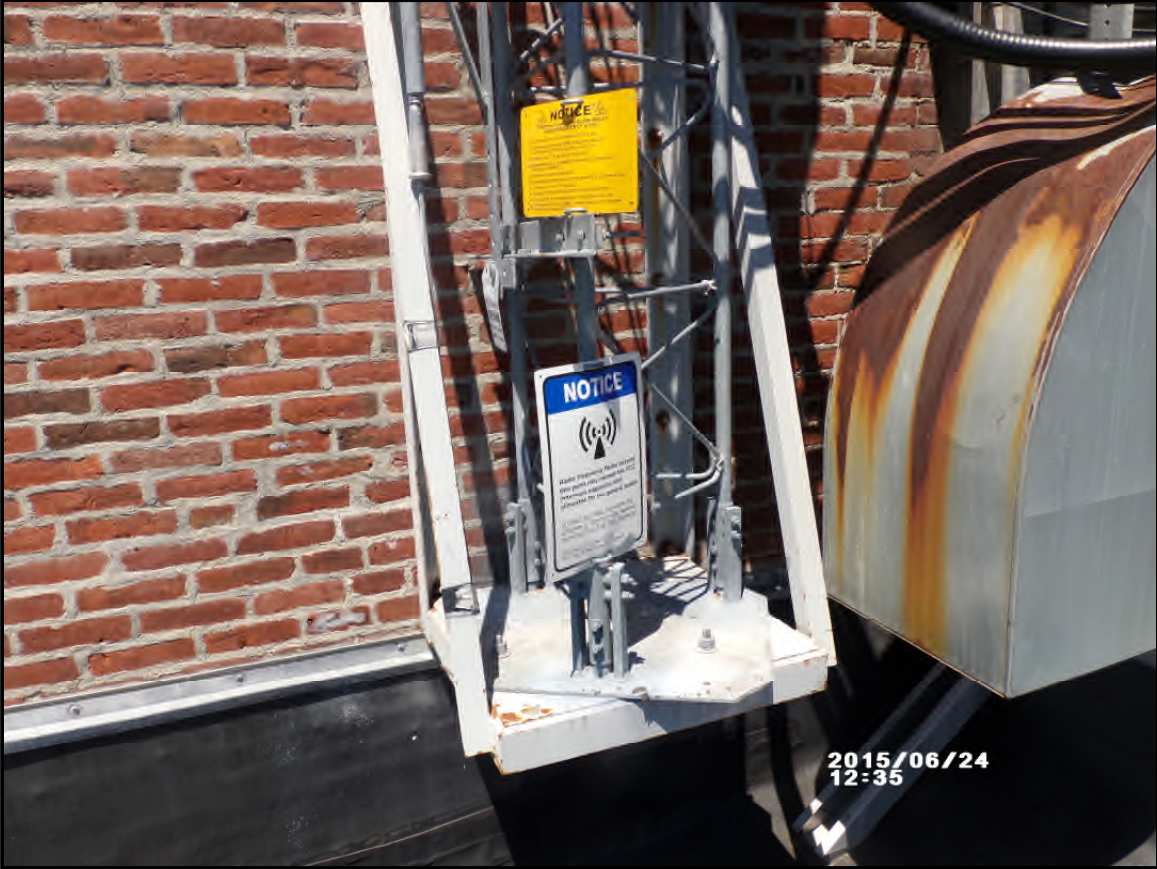
APPENDIX 7.5

*Signage
June 24, 2015*
