## **Treasure Island Naval Station Historical Radiological Assessment**

### **FORMER NAVAL STATION TREASURE ISLAND, SAN FRANCISCO, CALIFORNIA**

**February 2006**

**Weston Solutions, Inc.  
750 Dump Road  
P.O. Box 2135  
Vallejo, California  
94592**

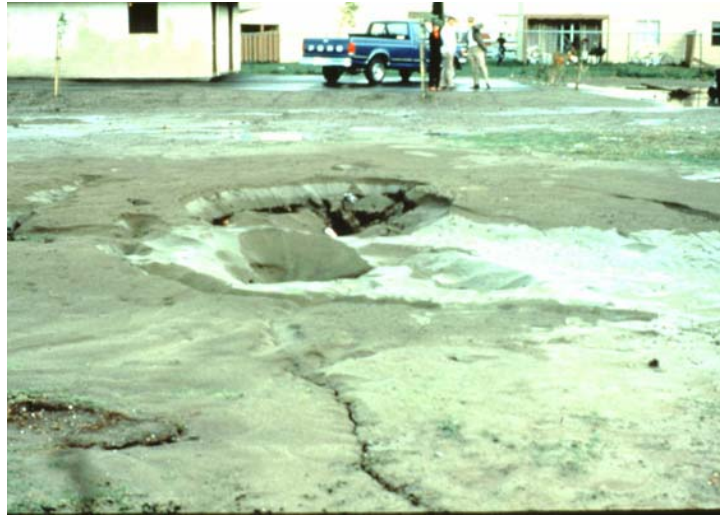
**Figure 3.4 Liquefaction on Treasure Island after Loma Prieta Earthquake (TI-HRA-16)**

During the Loma Prieta Earthquake on 17 October 1989, some lateral spreading and liquefaction were experienced on TI. (See Figure 3.4)

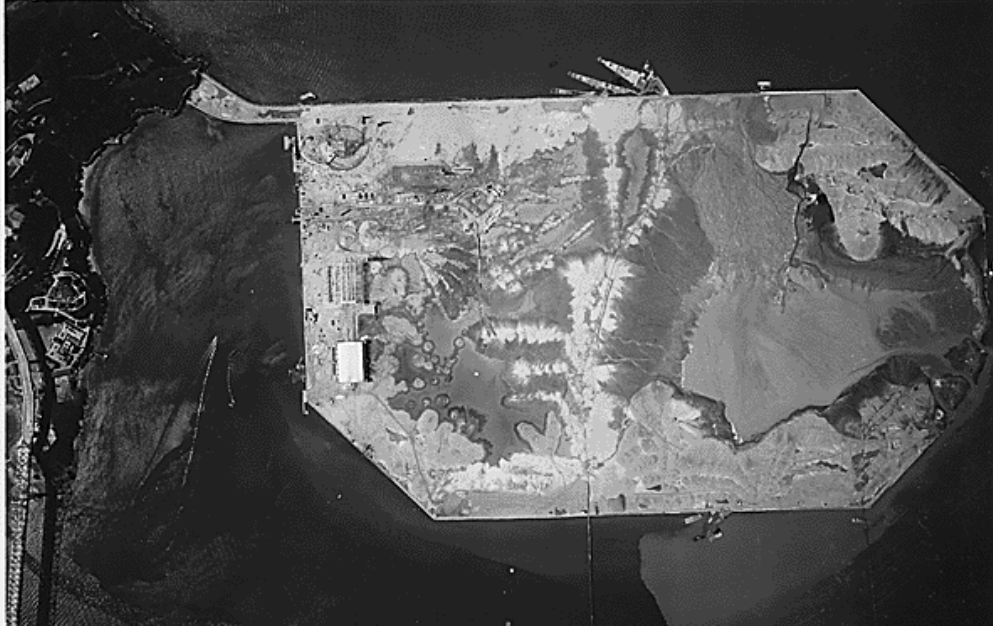
**Figure 6.1 Construction of Treasure Island 1937  
(TI-HRA-60)**

Construction of TI was begun in February of 1936. The island was built by creating a rock seawall on the Yerba Buena shoals on the north side of YBI. After the seawall was built up, almost 30 million cubic yards of sand and gravel fill were deposited into the cavity made by the seawall.

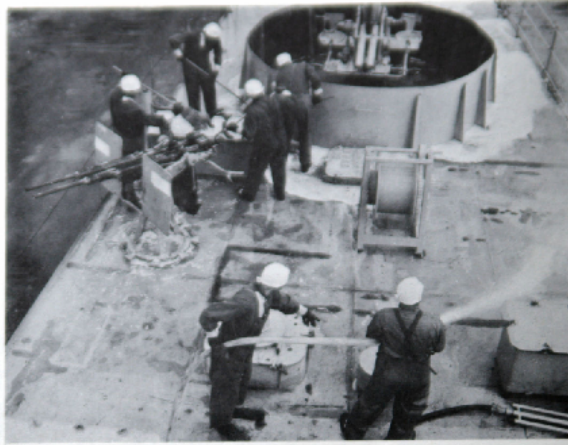
**Figure 6.5 Decontamination Training on USS Pandemonium.**

Decontamination is the process of removing radioactive contamination from an undesirable location to another location where the contamination is acceptable. DECONTAMINATION DOES NOT DESTROY THE RADIOACTIVITY. The radiological hazard is controlled by concentrating and confining the radioactive material as is done in industrial operations, or by diluting and dispersing the radioactive material as in field situations.

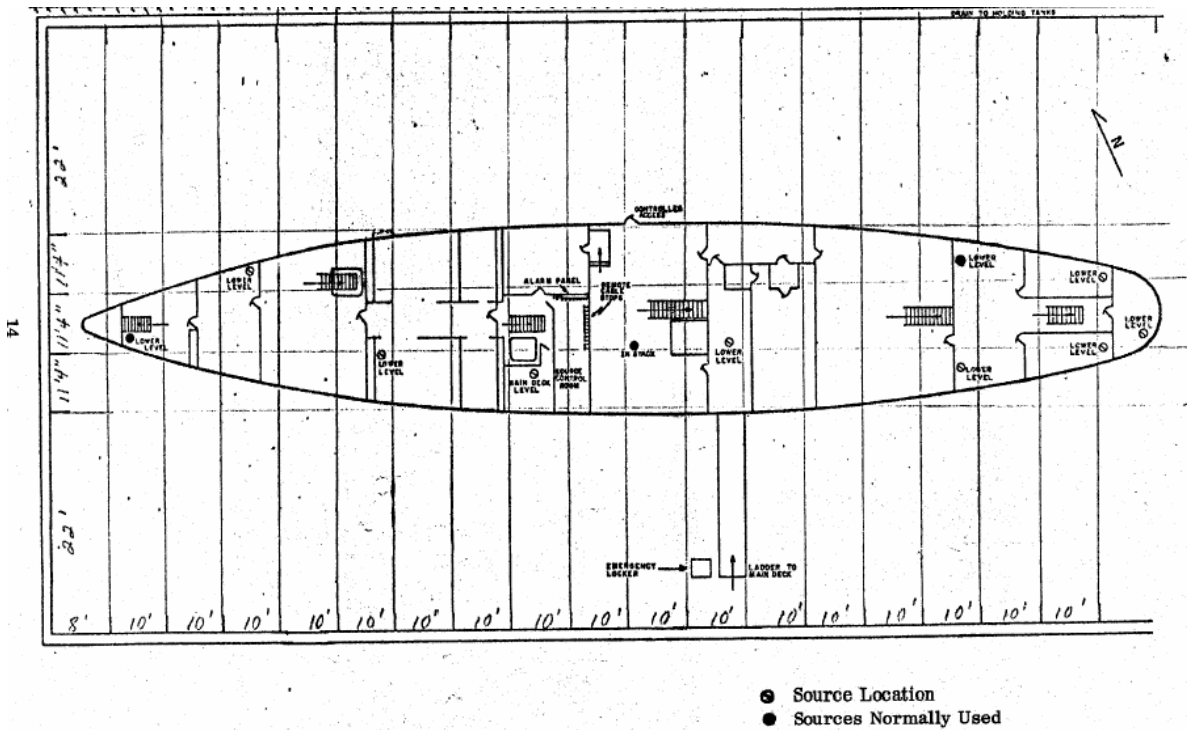
**Figure 6.6 Plan View of USS Pandemonium (TI-HRA-45)**

A plan view of the layout of the USS Pandemonium training ship showing the location of the installed cesium-137 sources is contained in Figure 6.6.

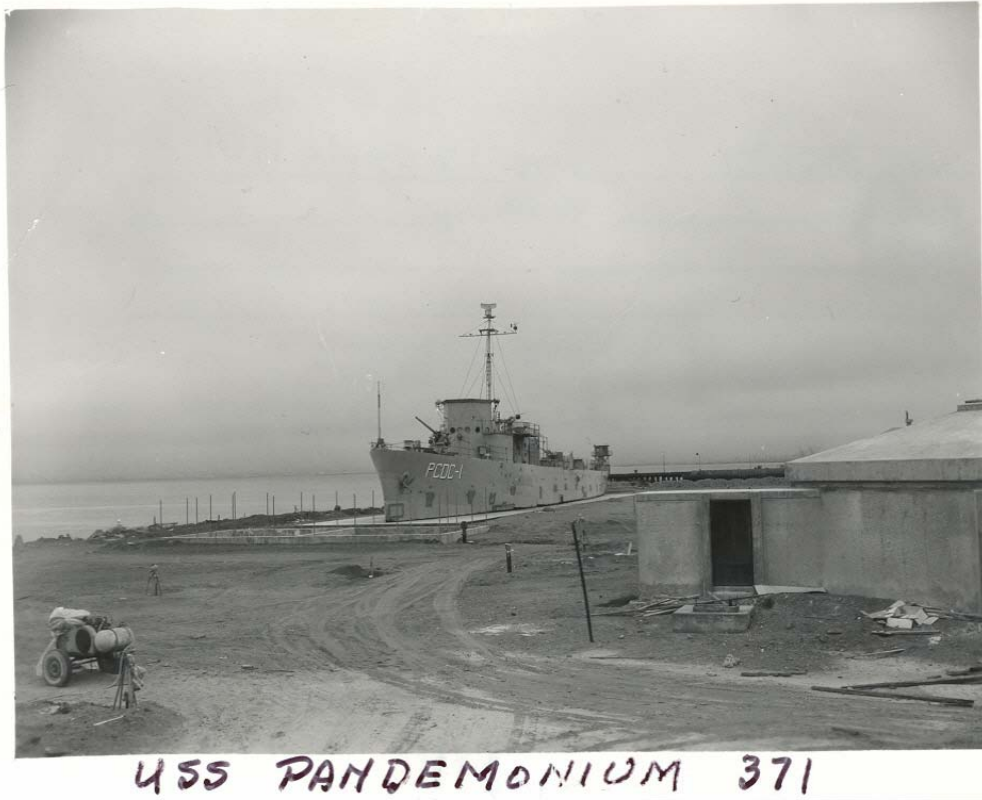
**Figure 6.7** USS Pandemonium after move to Northeast corner of Treasure Island Approximately 1970. (TI-HRA-85)

Pandemonium remained continuously in effect. License No 04-04346-02 was renewed for the last time by Amendment No. 32 on January 8, 1986. The main change affected by Amendment No. 32 was deletion of authorization for the Cs-137 sources used in the USS Pandemonium. The following year, the Byproduct Material License was superseded by Navy Radioactive Material Permit 04-62639-C1NP. At that time, the Radiological Affairs Support Office took over the detailed management of the radioactive material licensing for the Navy. The initial issue of the NRMP authorized a Cs-137 source of approximately 63 curies, a Cs-137 source of approximately 20 curies, and an americium-241/beryllium-7 neutron source. These same sources were authorized in each amendment of the NRMP until the permit termination on February 24, 1994. The radioactive sources were transferred to the Service School Command in Orlando, Florida (**TI-HRA-83**). Throughout the history of the USS Pandemonium, no mention was ever made to indicate a problem with the use or control of the Cs-137 sources. Some of the survey instruments utilized during decontamination training contained installed instrument check sources. All sources were required to be leak checked every six months. In 1980, the Radiological Affairs Support Office of the Naval Nuclear Power Unit analyzed leak tests performed by NTTC on eleven Cs-137 sources used on the USS Pandemonium. The leak test results were all at or below the minimum detectable activity of  $8.19 \times 10^{-6}$  microcuries. Also tested at the same time were three other devices containing Cs-137 sources, a TS-1216 calibrator, a TS-1189 calibrator, and a UDM-1 calibrator. These three sources were also well below the NRC limit for indication of a leaking source (**TI-HRA-84**). In addition to the specific leak tests just discussed, there were no reports of leaking check sources submitted. Thus there is no evidence to indicate a loss of control of radioactivity at either of the USS Pandemonium sites or at the buildings (461 and 462) associated with the final USS Pandemonium site. The short-lived isotopes used with the radioactive spreader device had a half-life of less than 36 hours, were last used in 1972 and are no longer present.

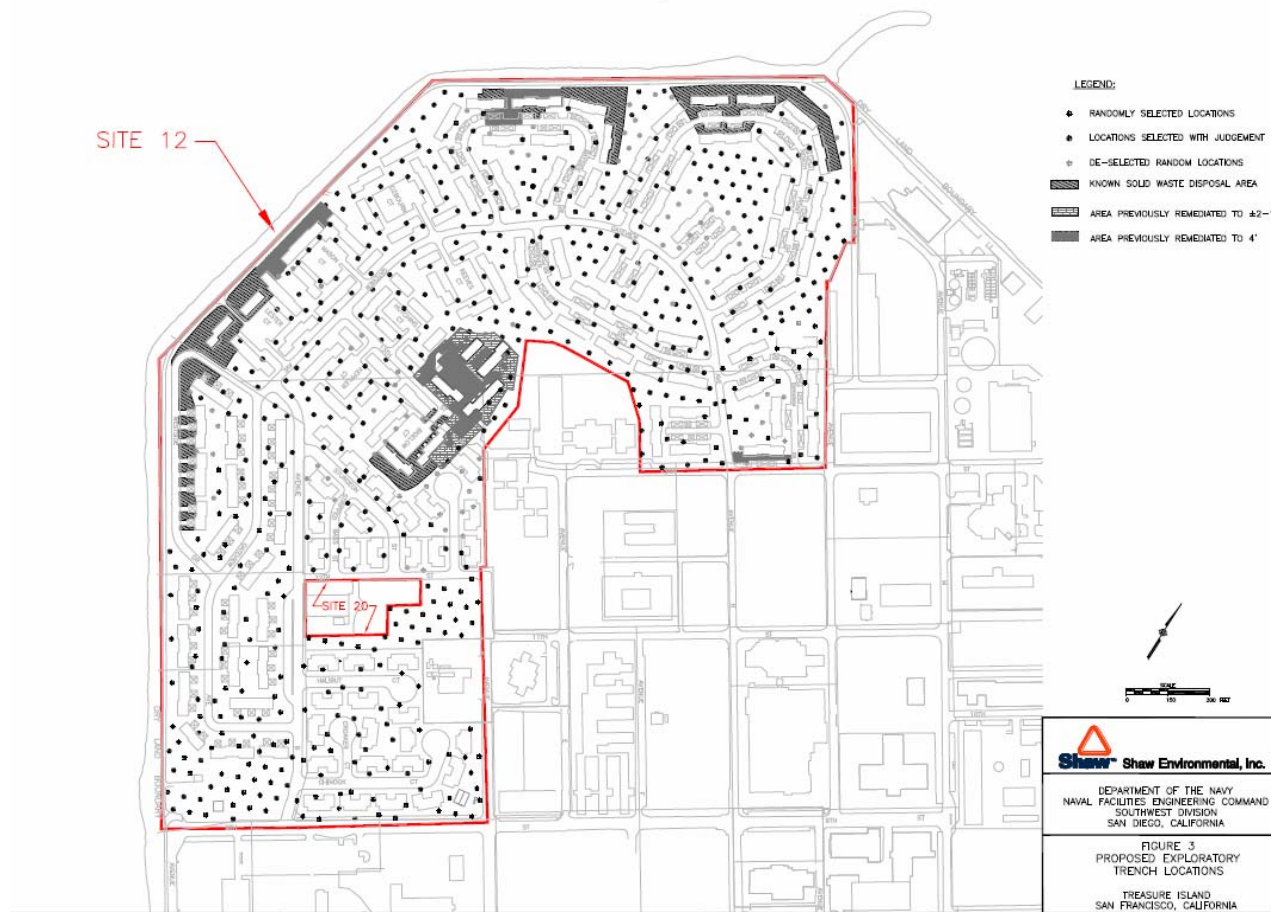
**Figure 6.8 Installation Restoration Site 12 (TI-HRA-91)**

report. This recent sampling and analysis plan for chemicals possibly disposed of over the years in IR Site 12 shows the boundaries of IR Site 12 as well as the locations within IR Site 12 known to be areas of solid waste disposal (TI-HRA-91). See Figure 6.8.

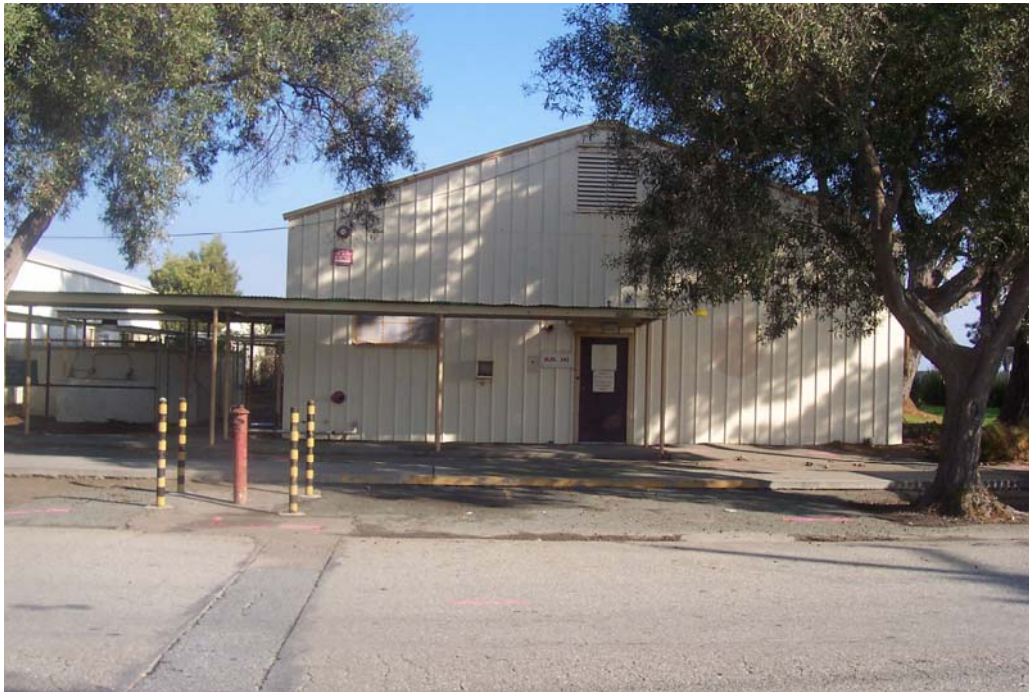
**Figure 8.3-3 Building 343**

**Site Description** - Metal one story building built on a concrete foundation. The building was completed in 1951 and covers approximately 8000 ft<sup>2</sup> similar to Building 342. During peak use of this building, it contained a radiological detection instrument issue and storage room, instrument repair shop, three classrooms, staff offices and lounges, washrooms, and the UDM-1A (gamma calibrator using a large Cs-137 source) laboratory.

**Recommended Actions** - Final Status Survey in the storeroom. Navy's 1993 leak tests demonstrated the building is free of radioactivity except for the instrument storeroom.

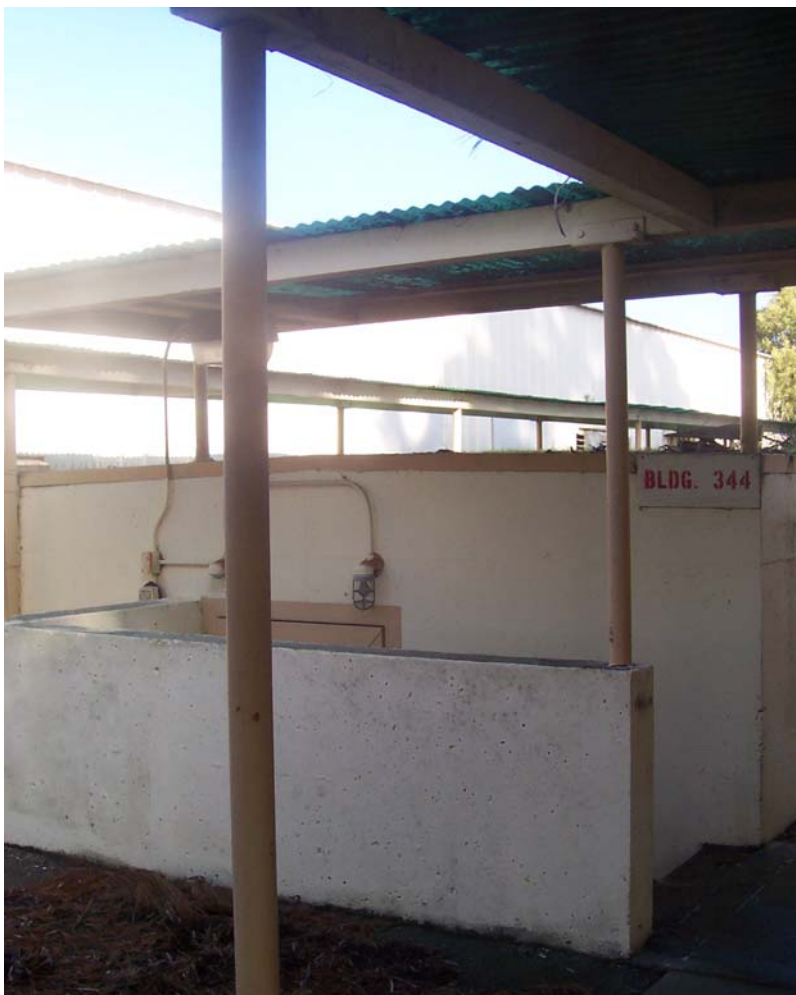
**Figure 8.3-5 Building 344**

**Site Description** - Building 344 is a small 244 ft<sup>2</sup> concrete building approximately 15 feet by 17 feet. This concrete vault was built in 1951 in conjunction with Buildings 342 and 343. The walls and ceiling are 14-inch thick reinforced concrete to provide radiation shielding for the sources stored within. The floor is set approximately five feet below grade. There is a one-half inch thick steel door. Access to the door is from inside the fenced compound containing the three buildings.

**Recommended Actions** - Final status survey. The Navy closeout surveys by swipe surveys demonstrated the building was free of residual radioactivity. However, contamination had been discovered in the waste containers in the building. A final status survey is warranted to permit release of the building.

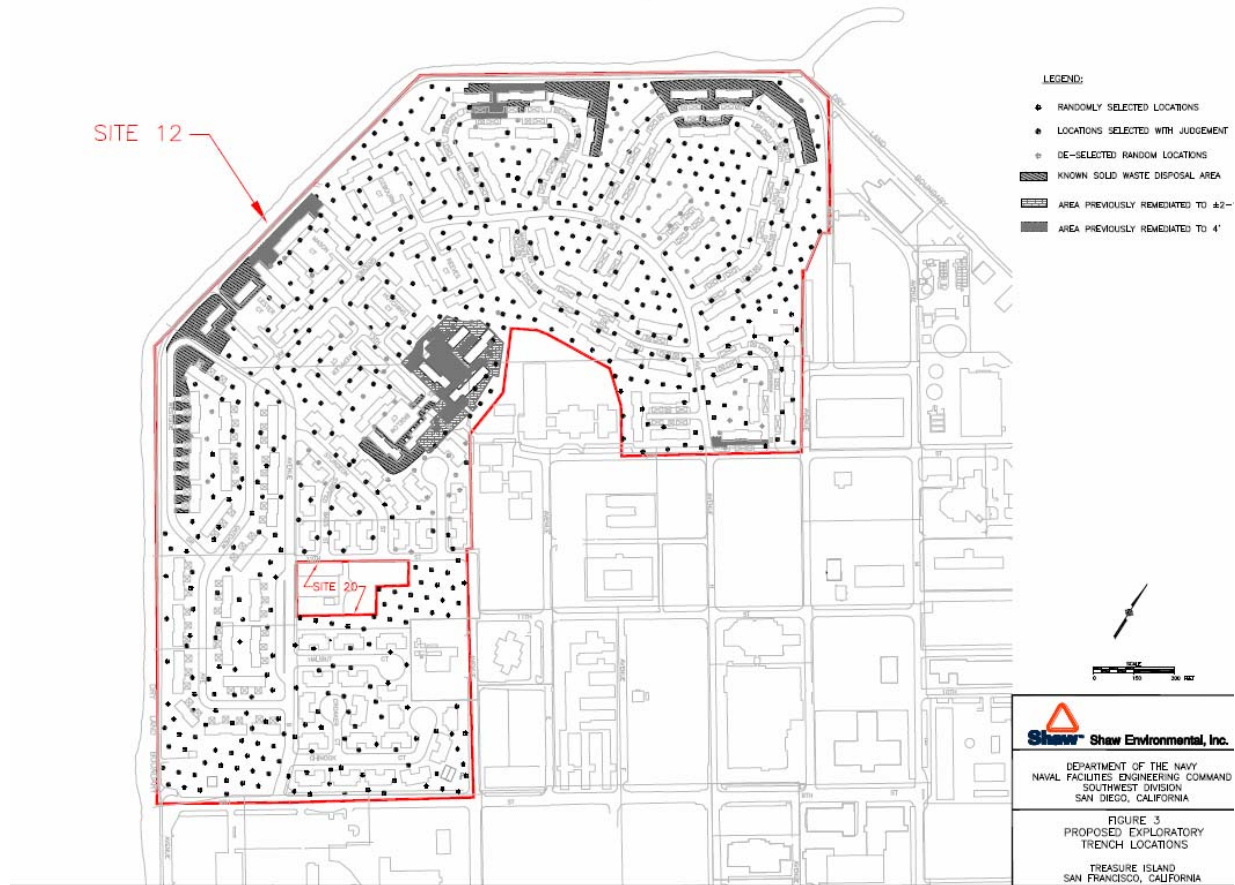
**Figure 8.3-7 Installation Restoration Site 12 (TI-HRA-91)**

**Site Description** - What is now known as Installation Restoration 12 on the northern end of NAVSTA TI was once a disposal area for trash and debris. Four discrete solid waste disposal areas have been identified. Parts of Site 12 were used for storage of ammunition in bunkers and also for the disposal and incineration of refuse. Later, portions of the site were used for material storage. Beginning in the 1960s, the area was developed for military housing. It is believed that over the course of development of the northern portion of the island for residential use, some of the debris and ash has been incorporated into fill material or otherwise scattered as a result of site grading operations (TI-HRA-91). General waste disposal took place around and in-between bunkers. Waste disposal operations continued until approximately 1963.

**Recommended Actions** - Perform radiation monitoring during soil excavation of the known solid waste disposal areas.

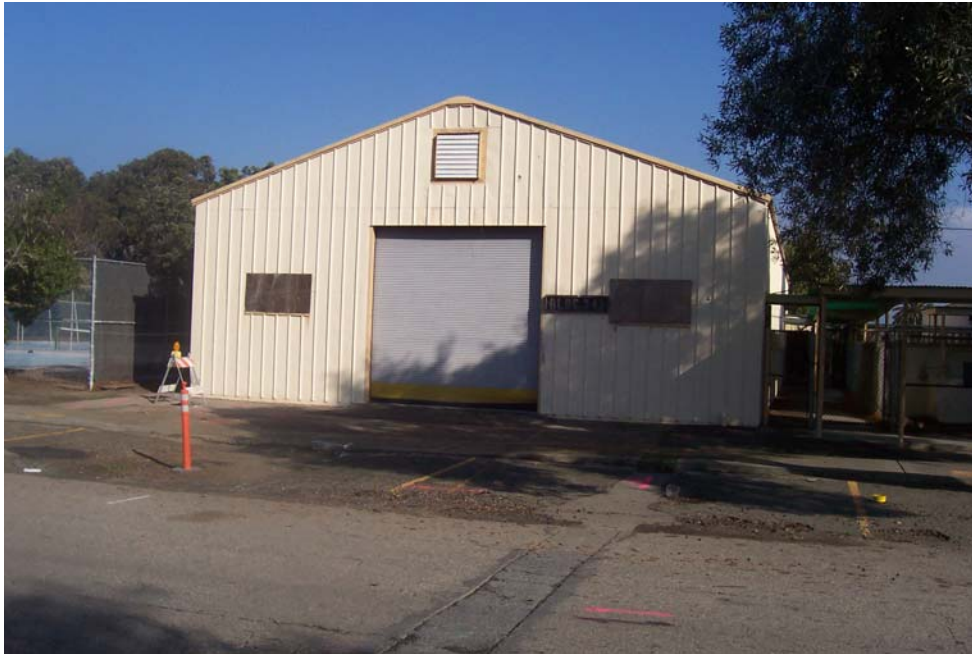
**Figure 8.3-9 Building 342**

**Site Description** - Metal one story building built on a concrete foundation. The building was completed in 1951. As originally configured, this building of approximately 8000 ft<sup>2</sup> contained three laboratories of equal size. The floor plan of the building as used for instrument calibration and instruction in 1965 is shown below. Laboratories 2 and 3 were used to conduct training exercises and instrument calibrations with sources in fixed locations. The radiation beams from the sealed sources were controlled in specific directions. Periodic leak tests of all sealed sources were required by operational procedures. The use of the building was gradually reduced, and the last use of radioactive sources was in 1972. No reports of leakage were made.

**Designated** - Non-impacted. Only sealed sources were utilized in this building. There is no history of source leakage.

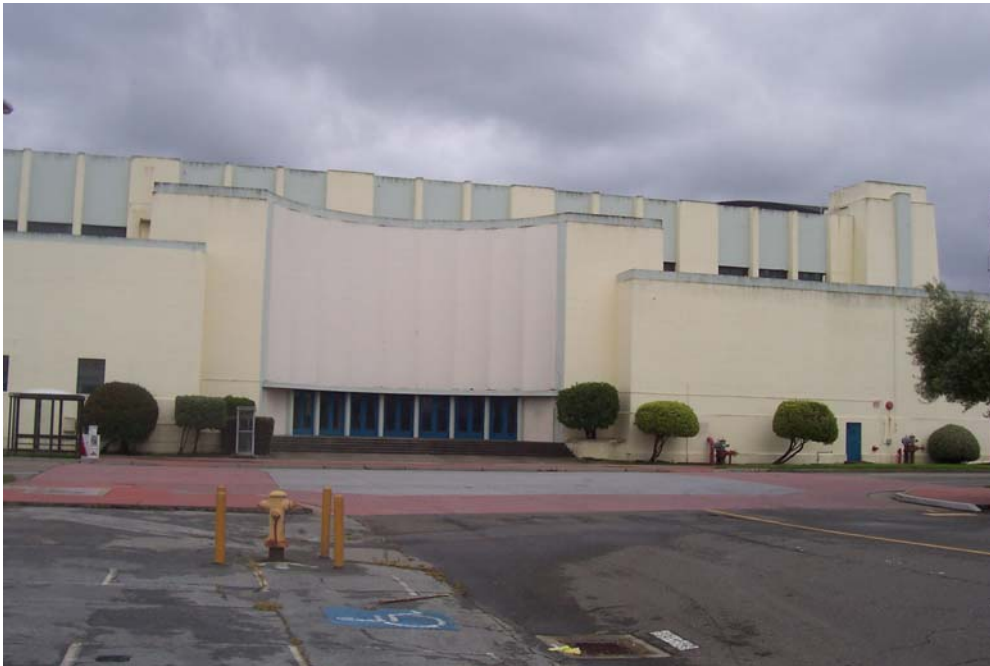
**Figure 8.3-12 Building 3**

**Site Description** - Building 3 is one of the original buildings constructed on Treasure Island for the 1939 Exposition. It is a large general warehouse building with both arched and flat roofs. The building covers an area of approximately 145,000 square feet.

**Designated** - Non-impacted. Only instrument check sources were stored in this building. There were no reports of check source leakage.

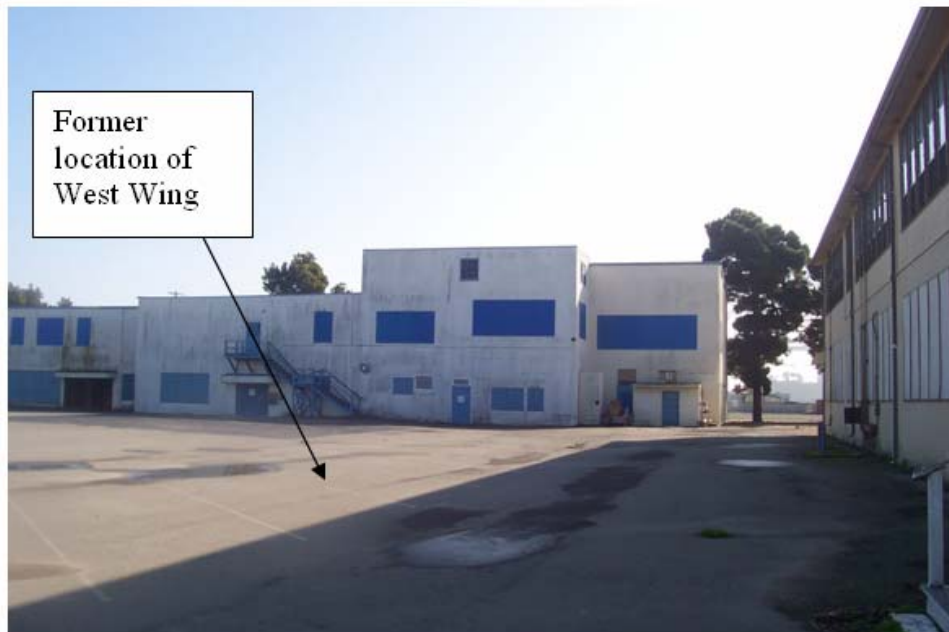
**Figure 8.3-14 Former Location of Building 7 West Wing**

**Site Description** - Building 7 was constructed in 1938 and is one of the original buildings constructed on Treasure Island for the 1939 Golden Gate International Exposition. It was originally a “U” shaped structure of approximately 68,000 ft<sup>2</sup>. The east wing and the south wing were two-story structures and the west wing (destroyed by fire in September 1956) was a four-story structure. The footprint of the west wing is now a parking lot.

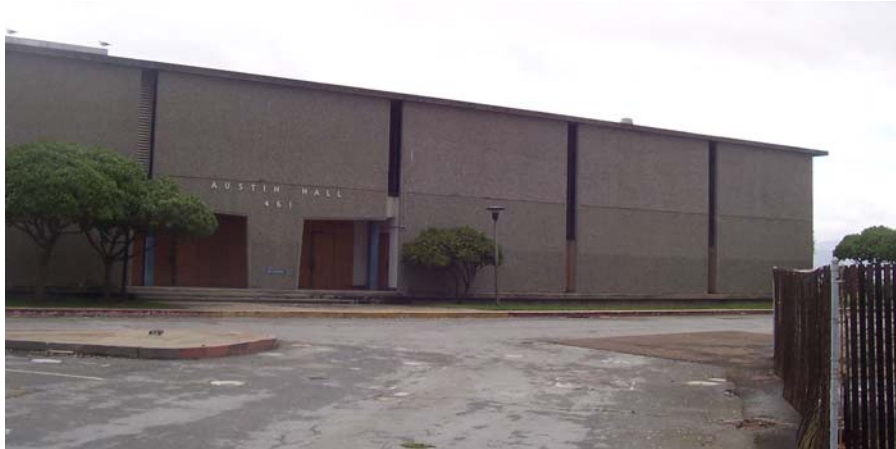
**Figure 8.3-16 Building 461**

**Site Description** - Building 461 was constructed in 1970 and is part of the new Damage Control School complex that included Buildings 462 and 463 and the training ship mockup, USS Pandemonium, after it was moved from the northwest corner of NAVSTA TI.

**Designated** - Non-impacted. Only instrument check sources were used in this building. There were no reports of check source leakage.

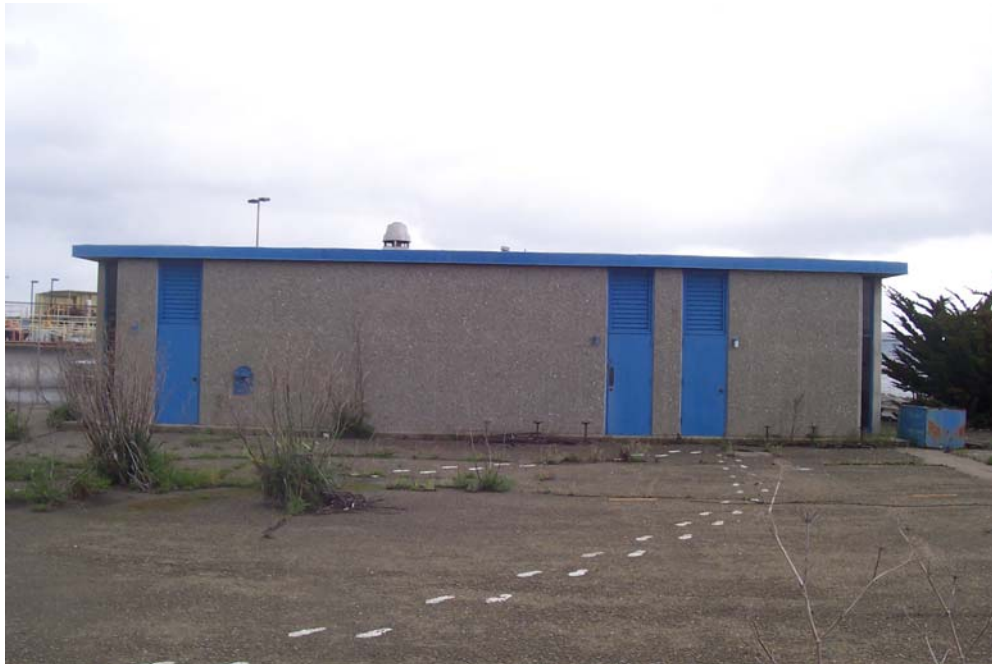
**Figure 8.3-18 Building 462**

Site Description - Building 462 was constructed in 1970 and is part of the new Damage Control School complex that included Buildings 461 and 463 and the training ship mockup, USS Pandemonium, after it was moved from the northwest corner of NAVSTA TI. Building 462 is inside the compound containing the USS Pandemonium and the below-grade collection tanks for run-off water. Building 462 was the normal entrance to the compound and to the USS Pandemonium. RADIAC instruments with attached check sources were maintained in the building for use during decontamination exercises on USS Pandemonium (TI-HRA-40). There were no reports of leaking check sources.

**Designated** - Non-impacted. Only instrument check sources were used in this building. There were no reports of check source leakage.

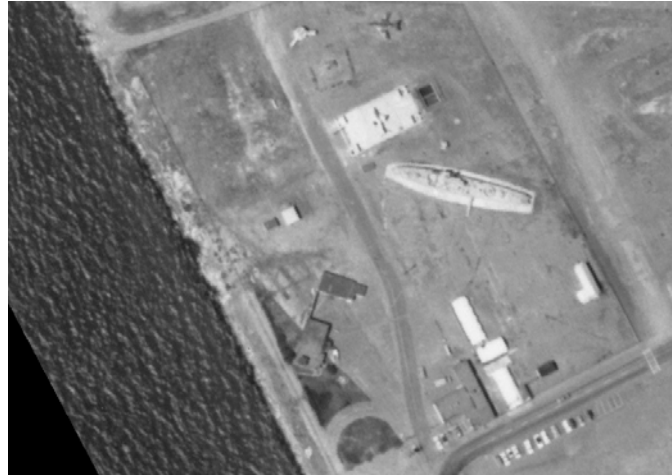
**Figure 8.3-20 USS Pandemonium Training Site Northwest Corner—1969 (TI-HRA-100)**

**Site Description** - The USS Pandemonium training ship was ‘launched’ in 1956. The training ship was ‘commissioned’ for use in February 1957 and remained in service in the northwest corner until July 1969. The fenced off training area was approximately 400 feet by 600 feet and was gravel surfaced. The area enclosed eight buildings, two obsolete aircraft, the USS Pandemonium mockup and a paved road. During testing of the radioactive spreader device for short-lived isotopes, the radioactive water was allowed to soak into the soil. Later, radioactive water from the decontamination training was collected in two sub-grade concrete tanks and stored until the short-lived isotopes had decayed. When the radioactivity was within allowable limits, the water was discharged to the bay via a six-inch pipe. The USS Pandemonium was moved to the Northeast corner of NAVSTA TI in 1969. The area has since been converted into multiple family military housing units.

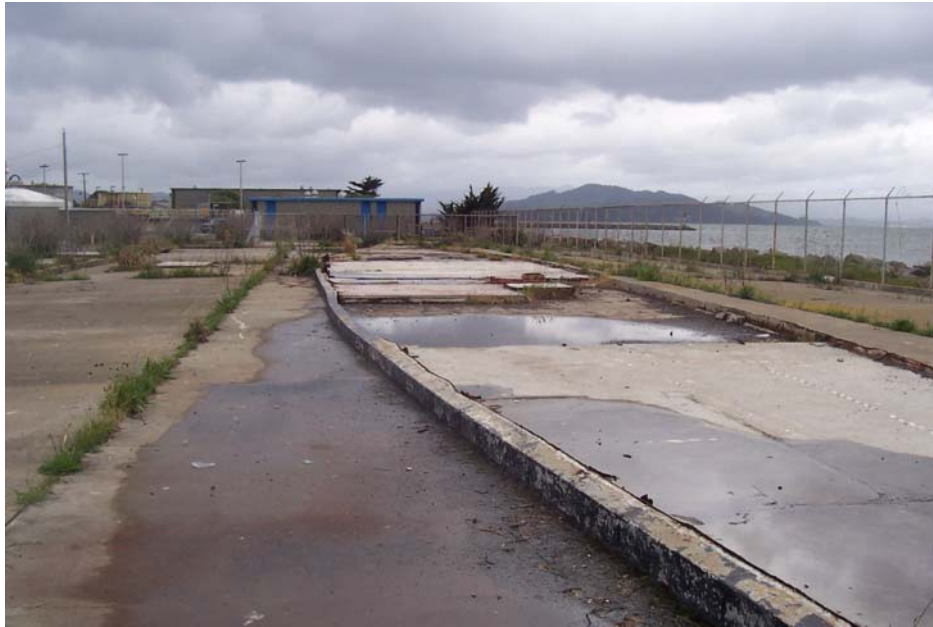
**Figure 8.3-22 USS Pandemonium Training Site Northeast Corner**

**Site Description** - The USS Pandemonium training ship was moved to the northeast corner of NAVSTA TI in 1969 where it remained until it was demolished in 1996. The training ship was part of the new Damage Control School complex that included Buildings 461, 462, and 463. Access to the area was by the tear gas decontamination building (462). An eight foot high fence separated the training area from the rest of the island. Although the mock-up remained until 1996, the use of the mockup was ended in 1992. While in use, the training ship was used to simulate radioactive fallout using the short-lived isotopes discussed earlier and also using the fixed location Cs-137 sources. Two below grade concrete holding tanks were used to collect the washdown water when decontamination of short-lived isotopes was conducted. The washdown water was released to the bay via a 6-inch pipe after it had decayed away.

**Designated - Non-impacted.** Sealed Cs-137 sources were used for fallout simulation. Leak test of the Cs-137 sources confirmed there was no leakage. The short-lived liquid isotopes decayed away within three months of last use (1972). There were no reports of instrument check source leakage.

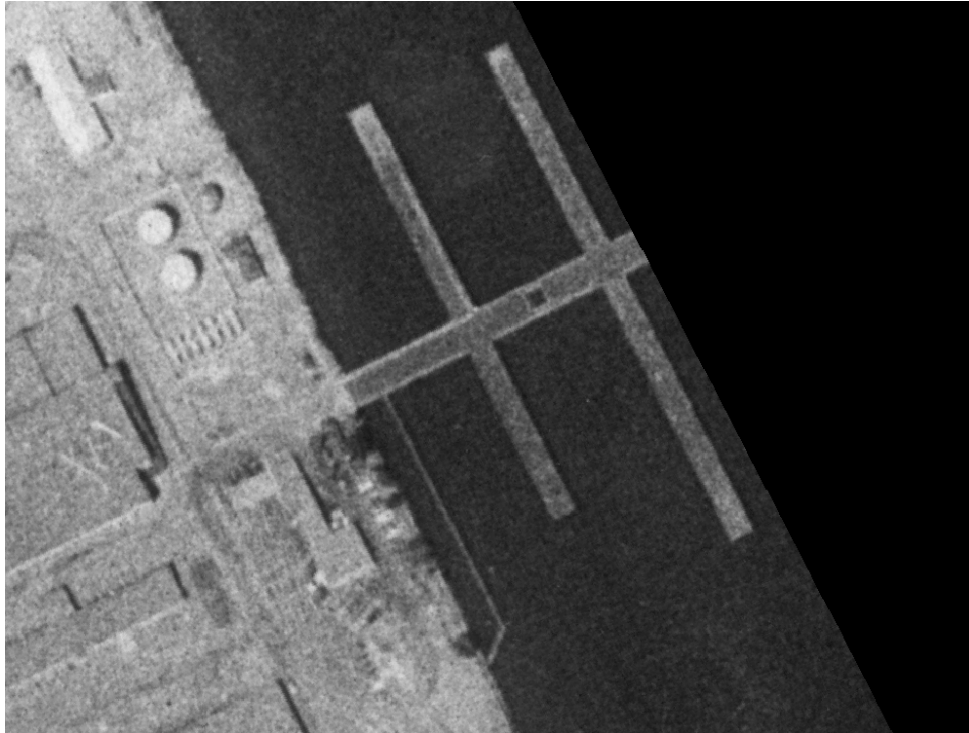
**Figure 8.3-26 Pier 21 Area 1975 Photograph (TI-HRA-101)**

**Site Description** - Previous location of multiple-finger piers on northeast side of Treasure Island. Pier 21 was built in approximately 1942. The pier had a 500 foot main stem, a 404 foot finger and 2-248 foot fingers on the north side of the main stem. It was intended to provide sufficient docking space for the destroyers and minesweepers based at TI. By 1945 additional fingers had been added to the south side of the main stem. Some fingers were demolished by the time the above photograph was taken in 1975. The pier was demolished after 1995.

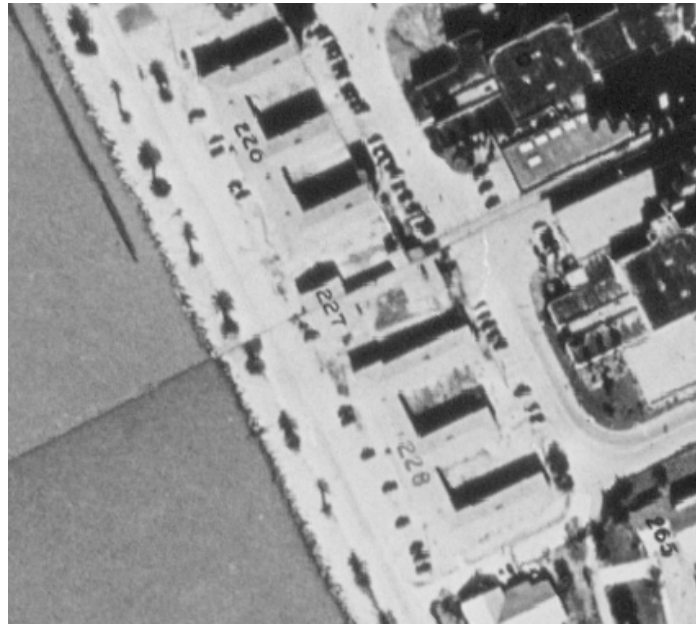
**Figure 8.3-29 Building 226 – 1945 Photograph (TI-HRA-102)**

**Site Description** - Building 226 was one of two identified Bachelor Officer's Quarters. It was a multi-story "E" shaped structure constructed approximately 1944. Building 226 was part of a three building group including Buildings 226, 227 (the officers dining hall), and Building 228 (an identical Bachelor Officer's Quarters). Building 226 was demolished by 1966.
