The Medina County Courthouse : Architecture, History, and Restoration

Medina County Courthouse Restoration Schedule

Structural Stabilization Project

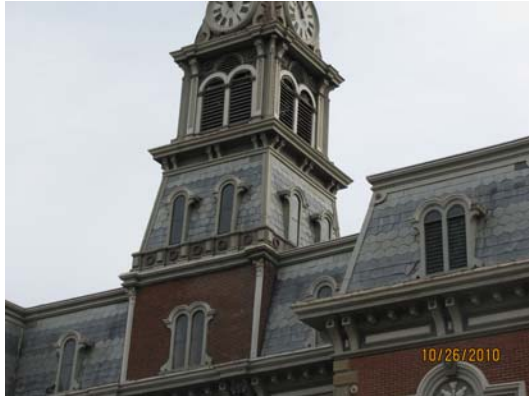
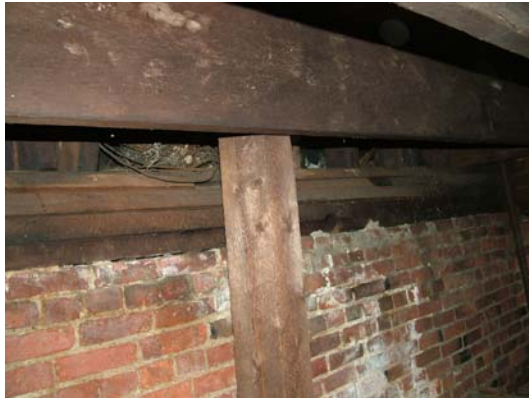
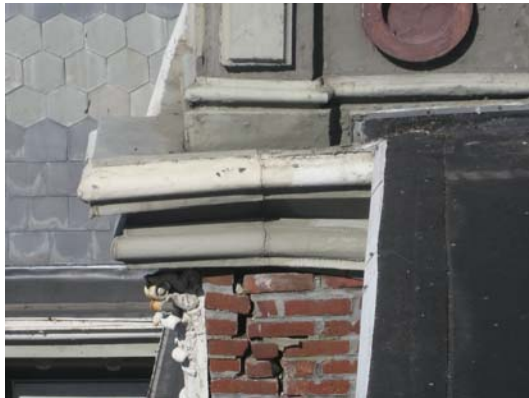
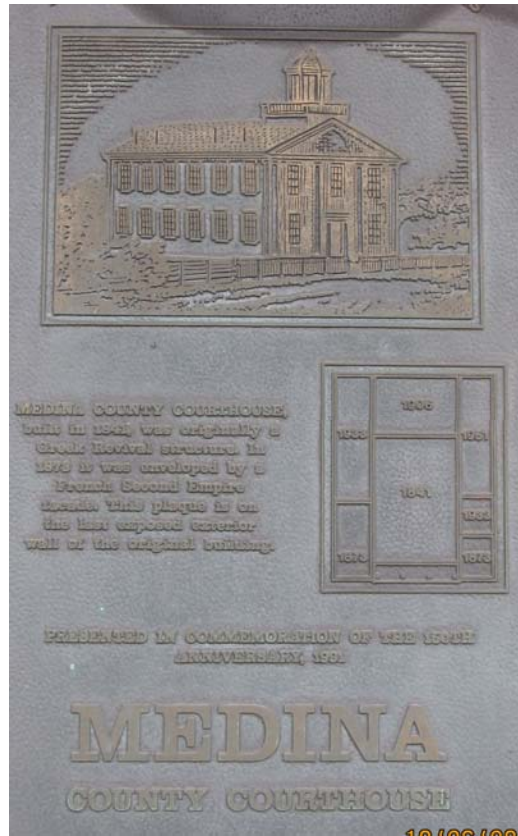
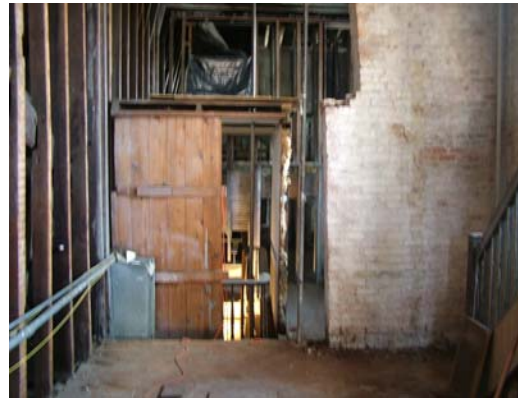
Phase 1 – Assessment

- The structure supporting the tower was failing.
- The tie rods between beams was cut.
 - Water was entering the building at numerous points
 - Wood structural elements were rotted, displaced and delaminating
 - Brick exterior wall was displaced and bricks were cracked and loose.
- The exterior elements of the tower (trim, louvers, windows, cornices, brackets, scrolls and roofing) were severely deteriorated and failing.
 - The clock mechanism and bell were working except for one clock face.
 - Squirrels, bats, pigeons and other *fauna* were calling the tower “home”.

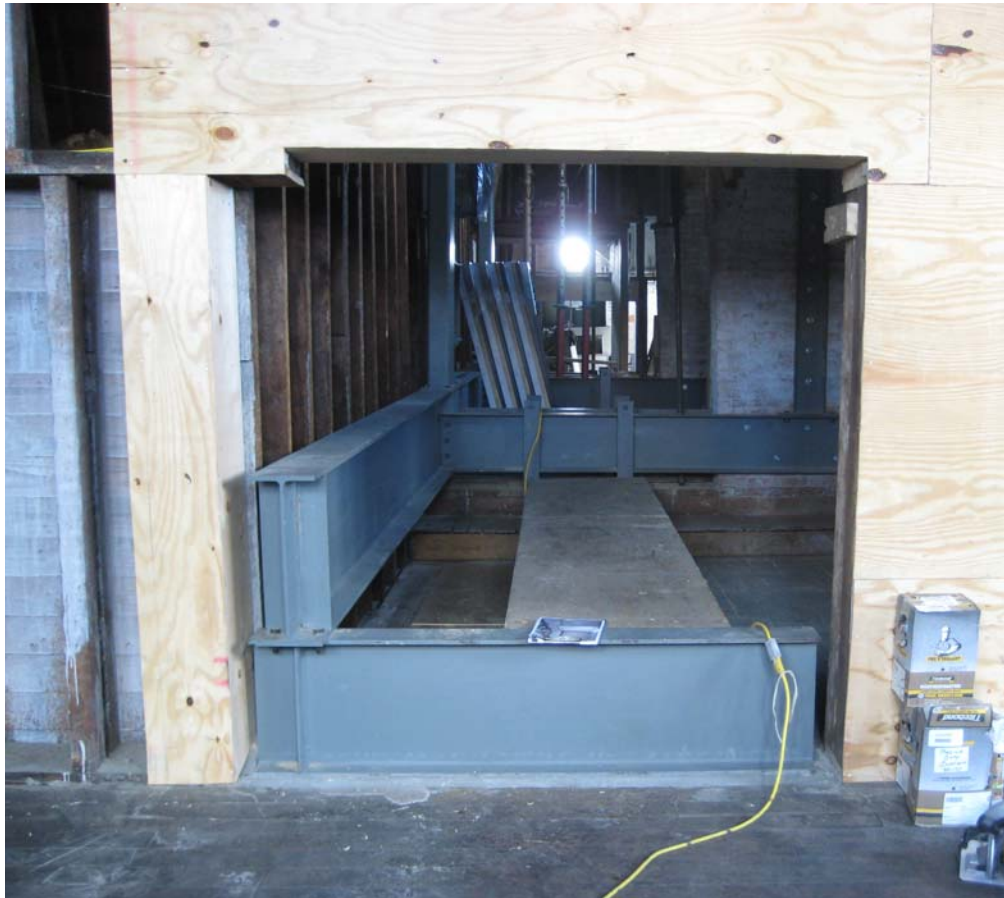
Structural Stabilization Project

Thousands of pounds of steel added to shift load from 1841 trusses and 1873 wood framing to masonry walls of 1841 and 1873 structures.

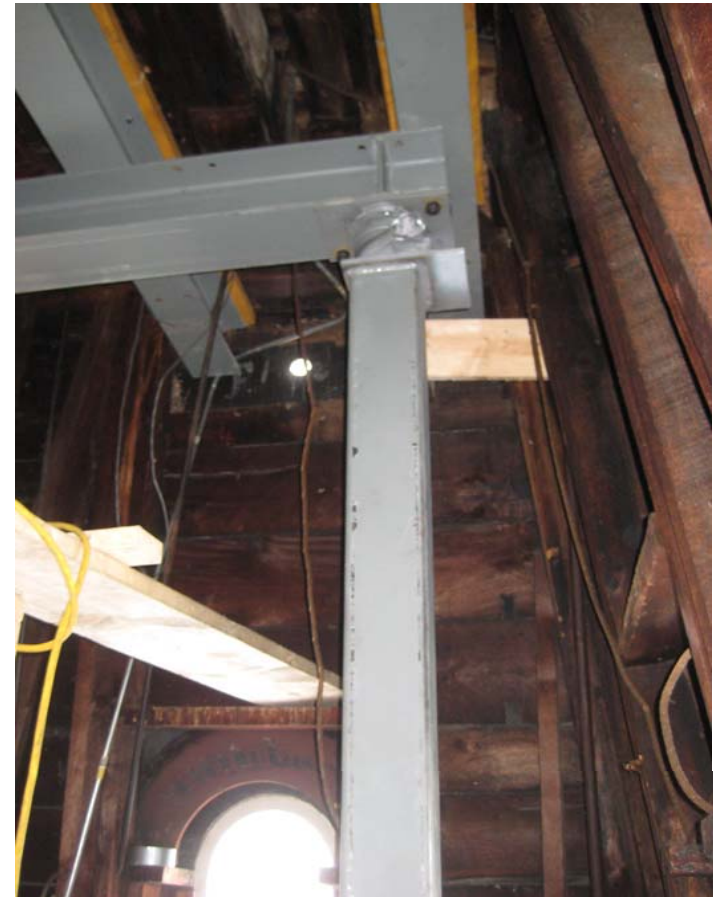
Structural Stabilization Project

- Wood framing added throughout tower to supplement or replace existing framing.
- Screw-jacks added to straighten tower in later phase.

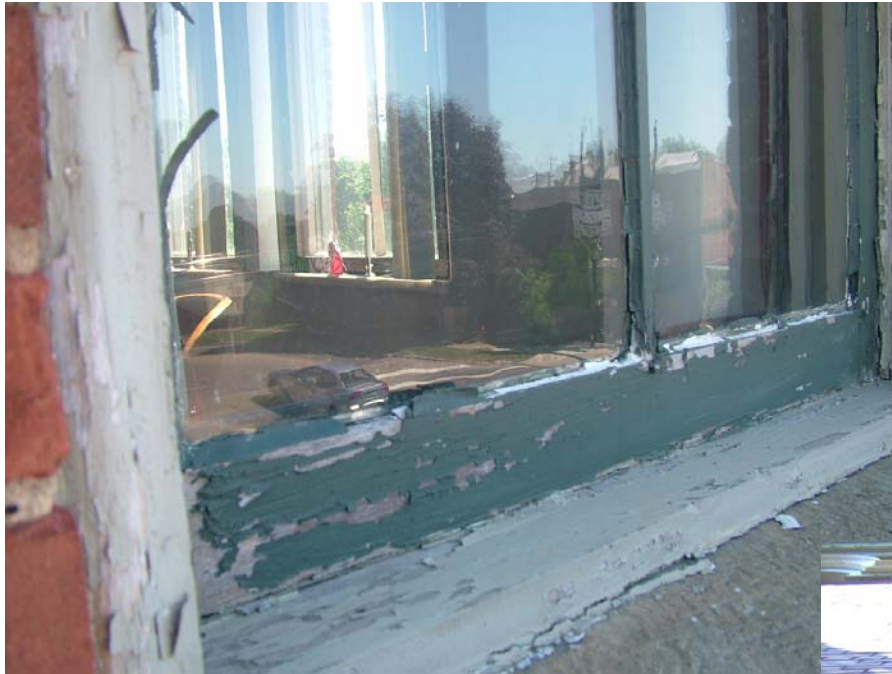
Window Restoration

More than 20 windows (including the arched topped windows in the 1873 addition) restored.

- Sashes disassembled, repaired, refinished.
- Hardware repaired or replaced; Sash cords replaced
- Insulating glass added
- Sills, frames and trim repaired and refinished

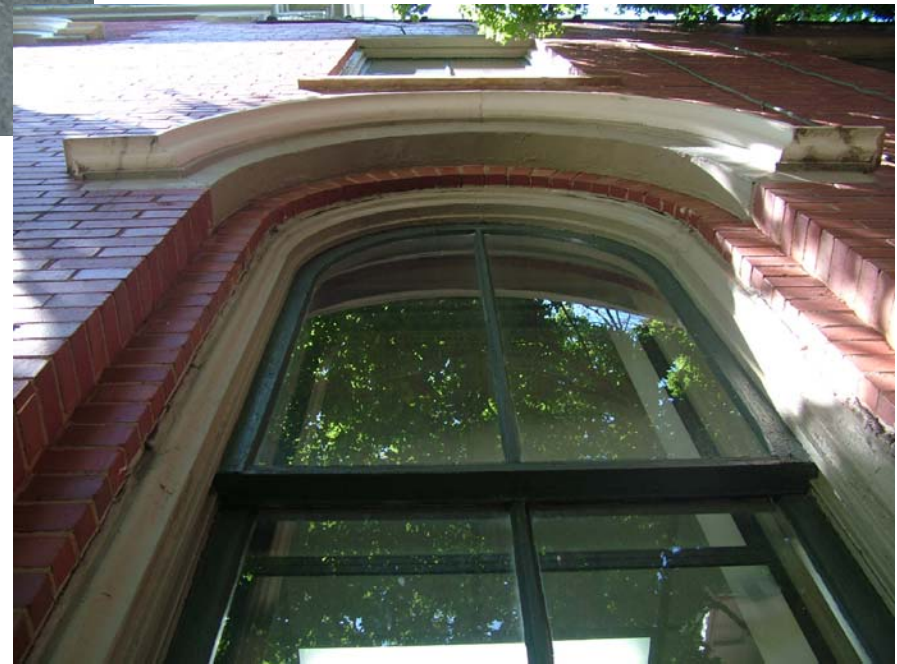
Window Replacement

Replaced windows included details, moldings and extrusions to match existing window including rounded corner, detailed brick molding, narrow profile sash and muntins.

Full scale drawings of existing and proposed windows, frames and trim submitted to Historic Preservation Board for approval along with samples and color selections.

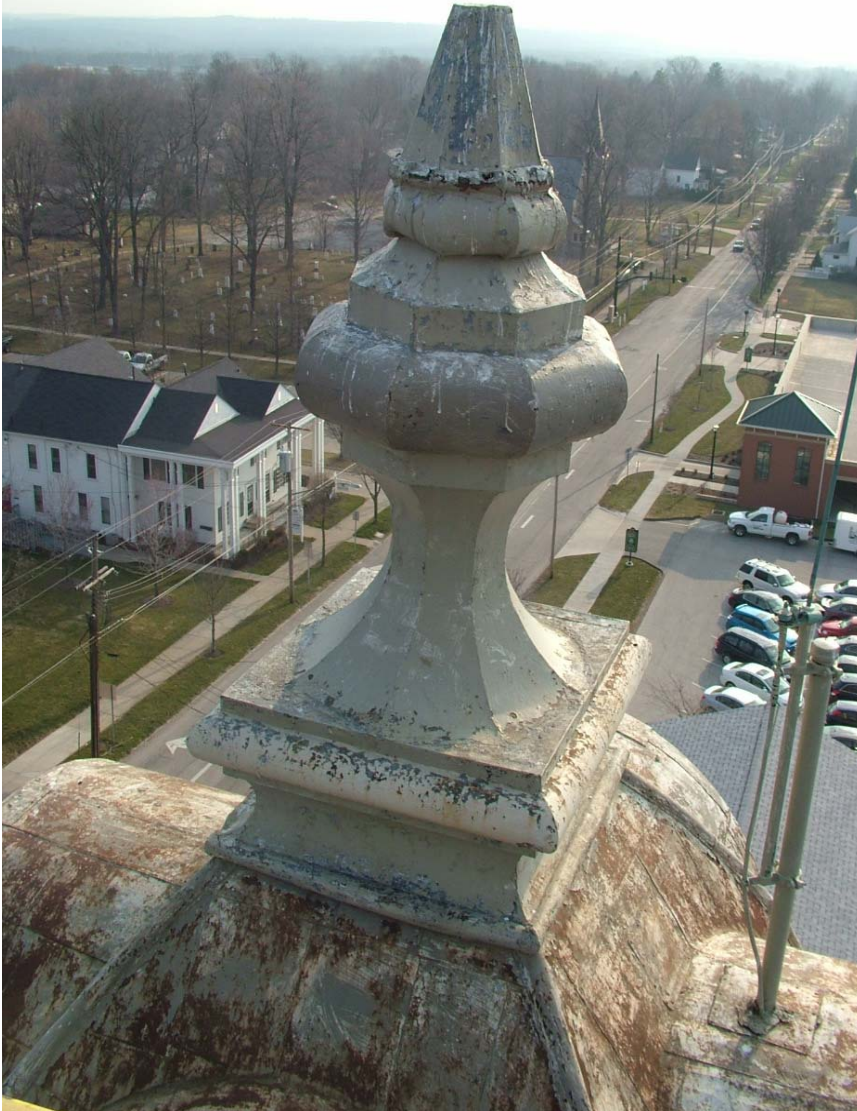
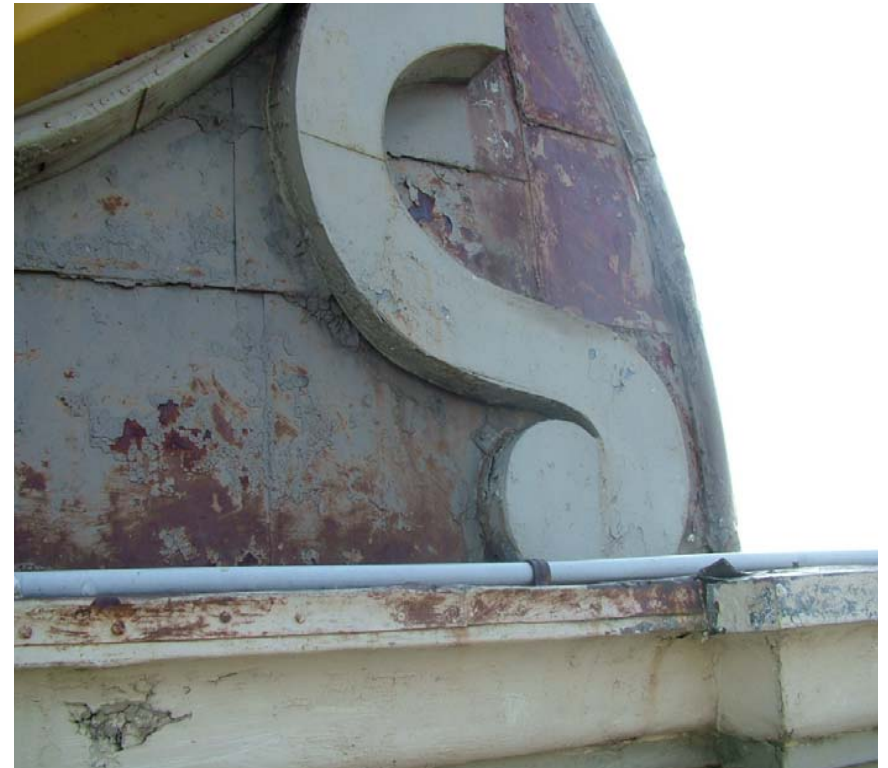
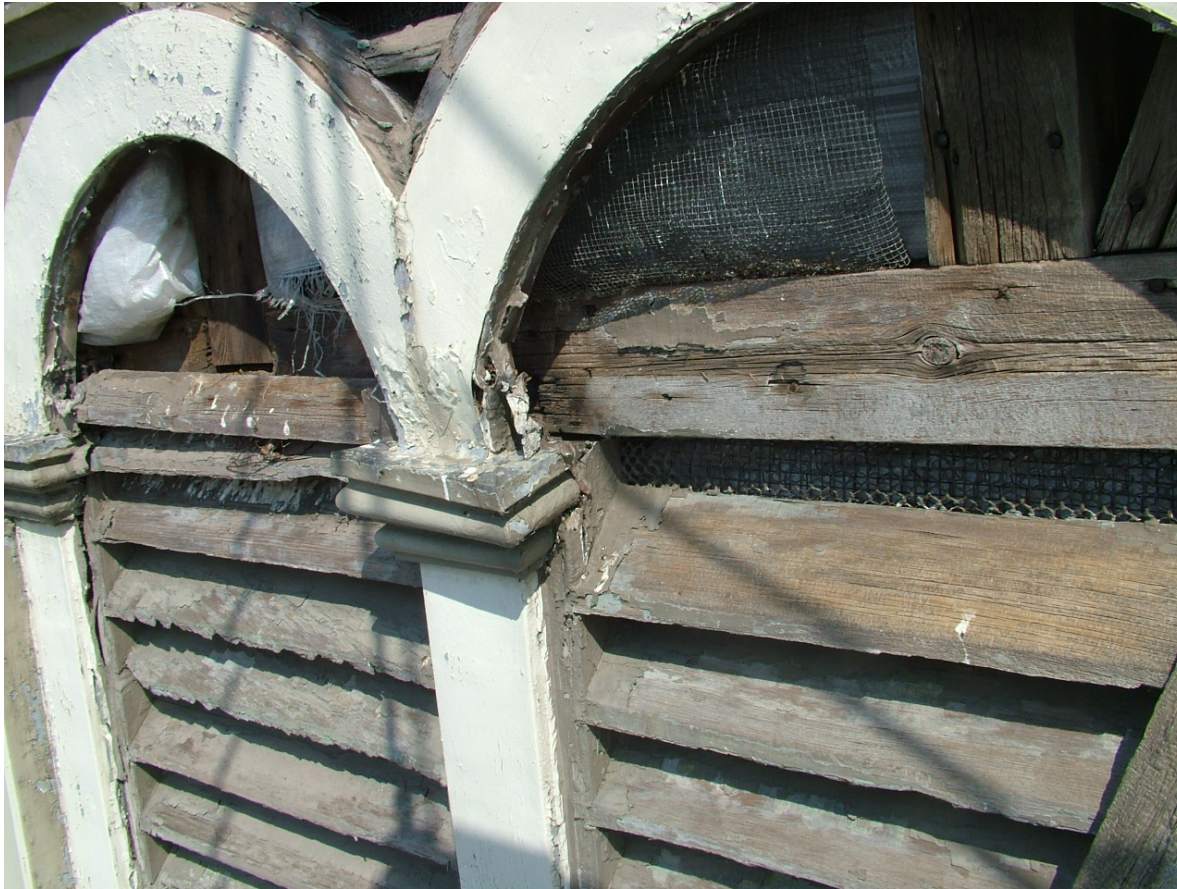
Tower Restoration

The “Before” pictures – taken from 125’ crane.

These photos show the deterioration of the painted tern-coated steel roofing and decorative elements.

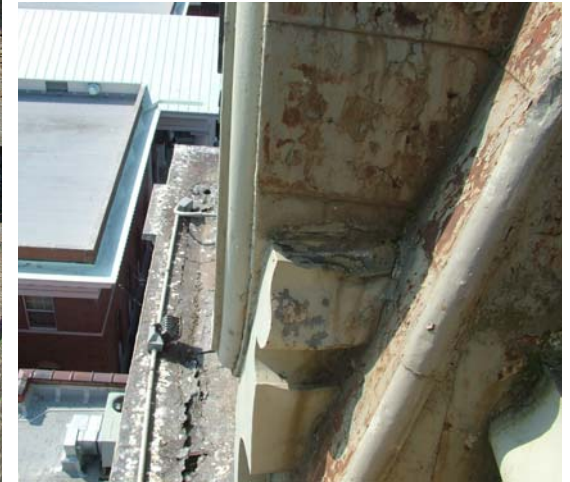
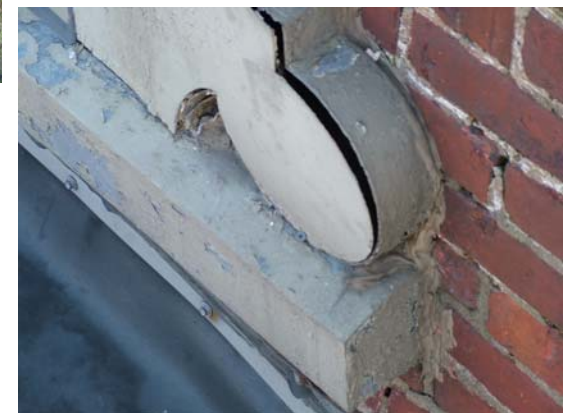
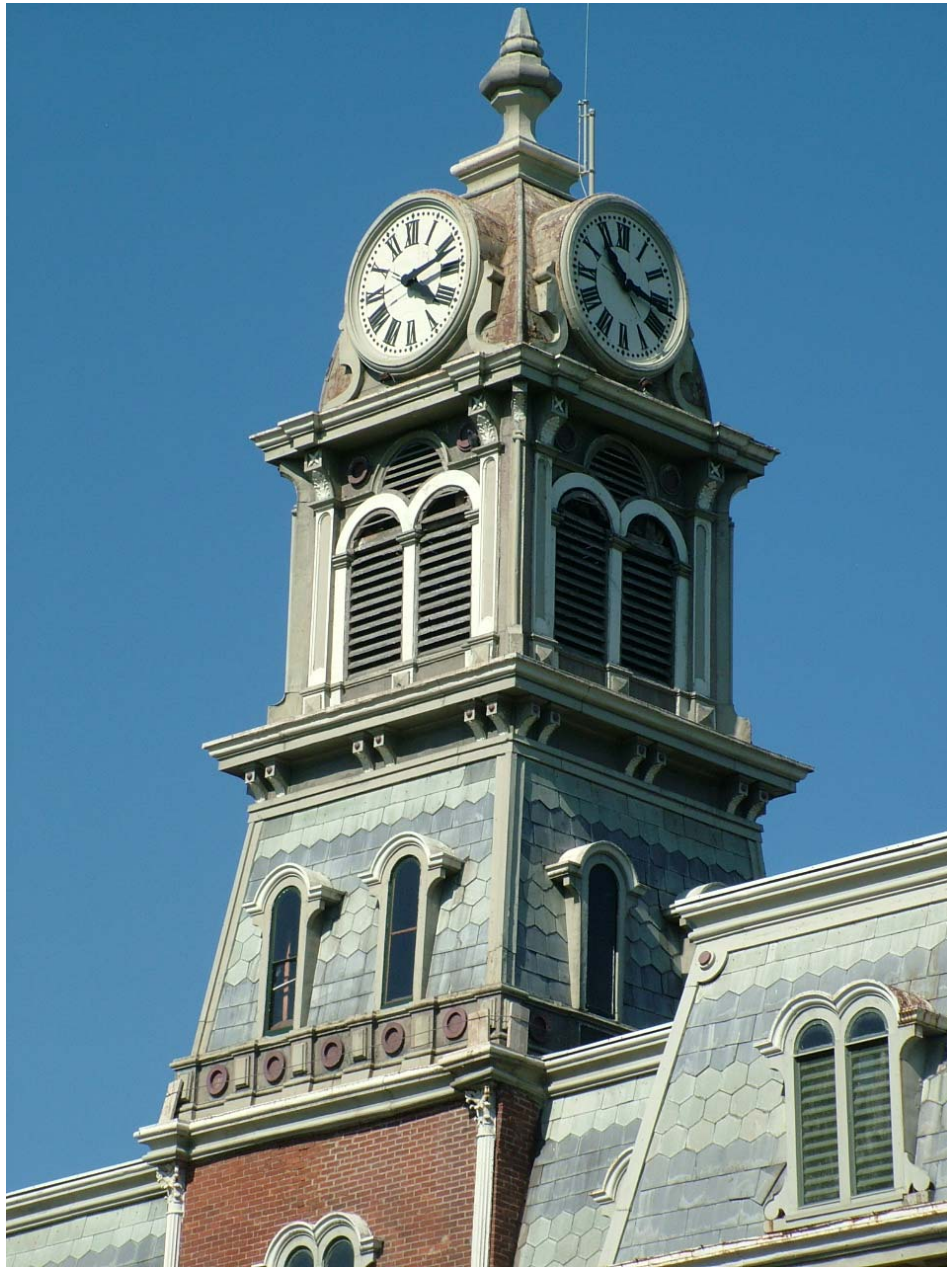
Tower Restoration

Wood deterioration,
roofing failures,
metal corrosion and breaks

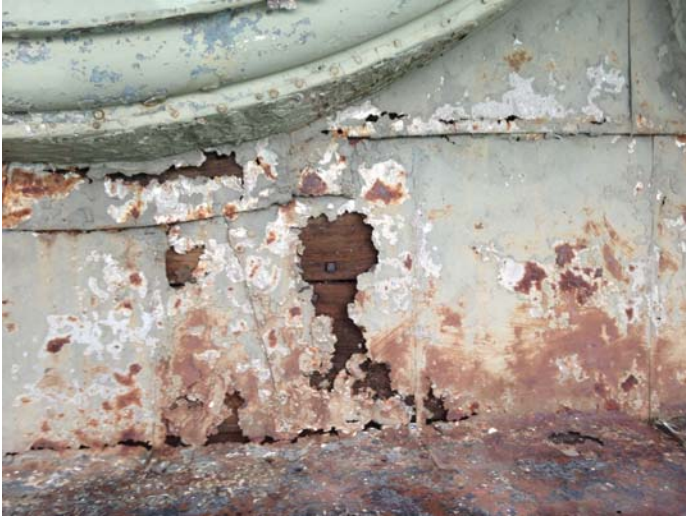
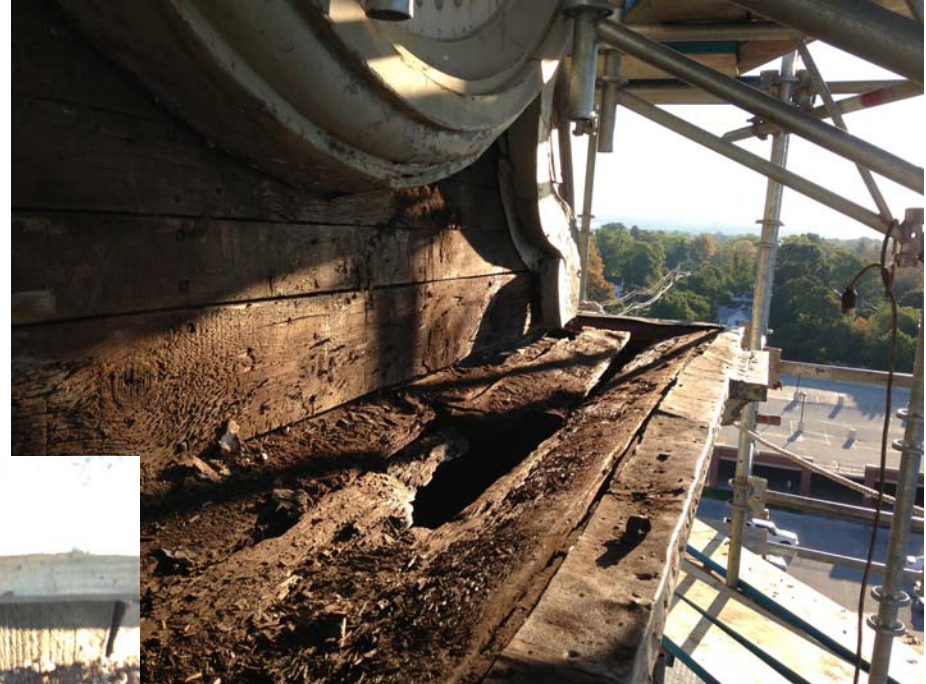
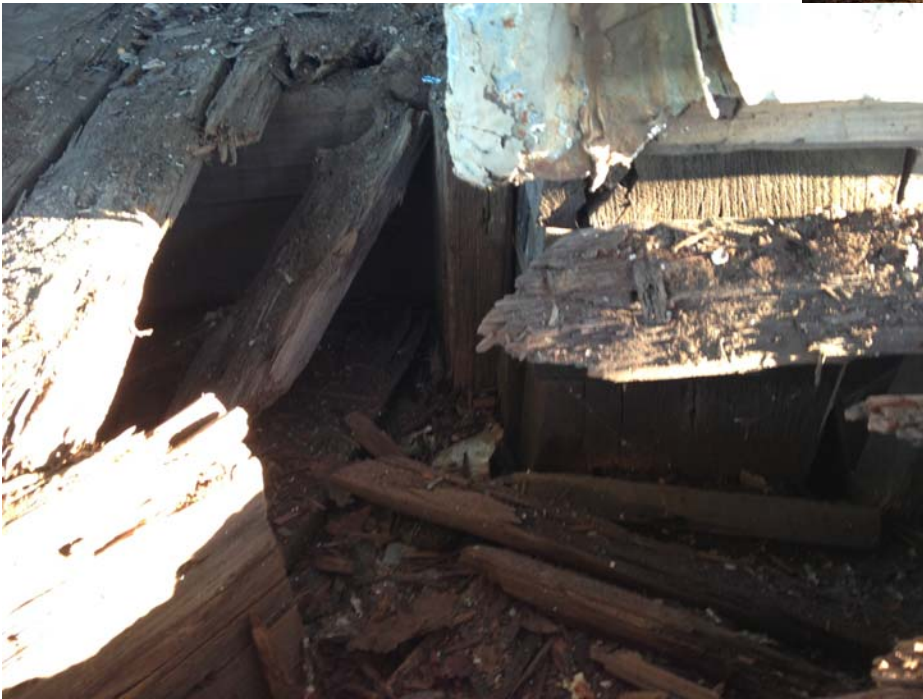
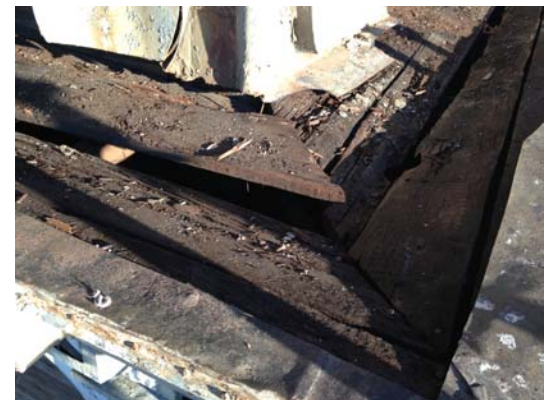
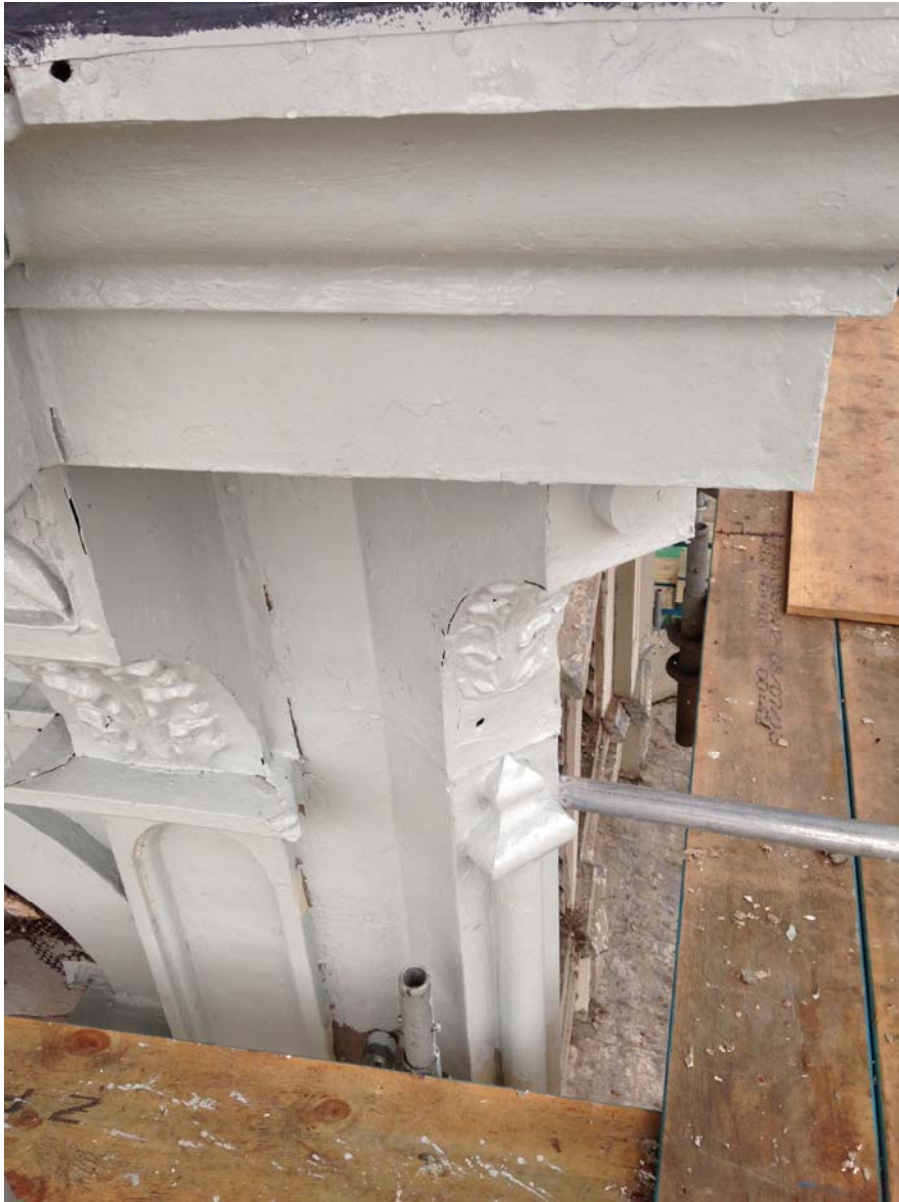
Tower Restoration – Start of Construction

One step backwards before two steps forwards

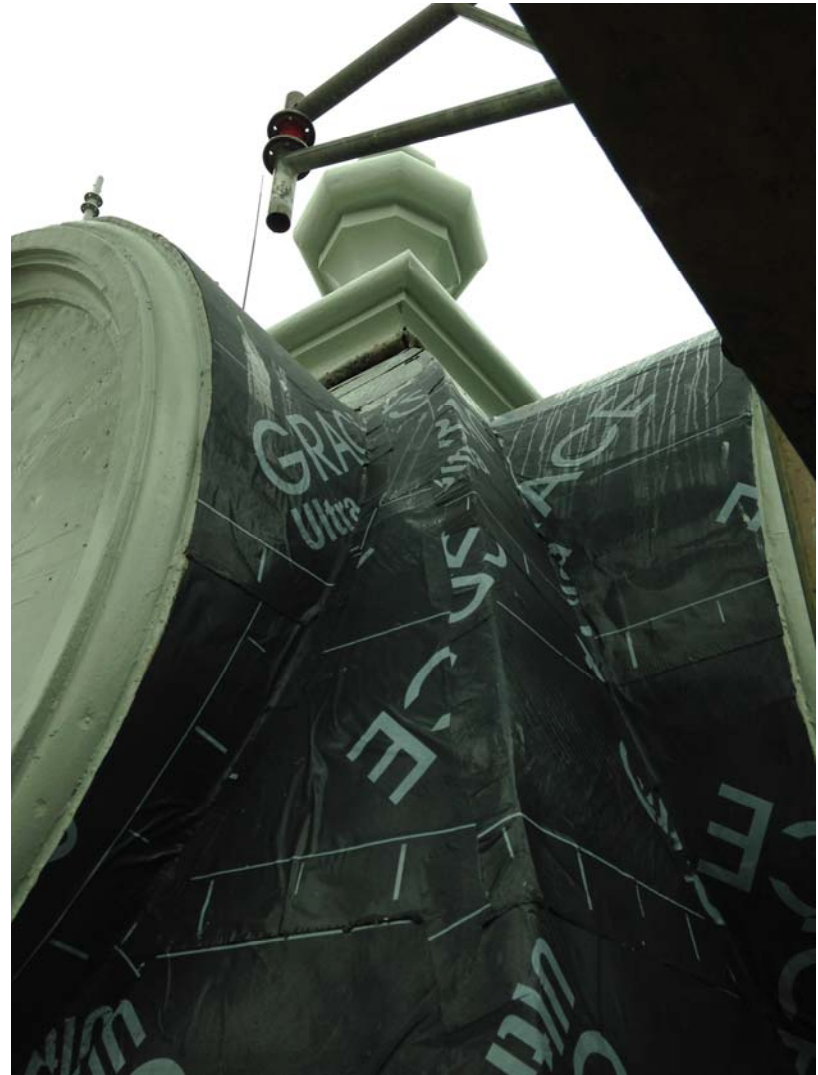
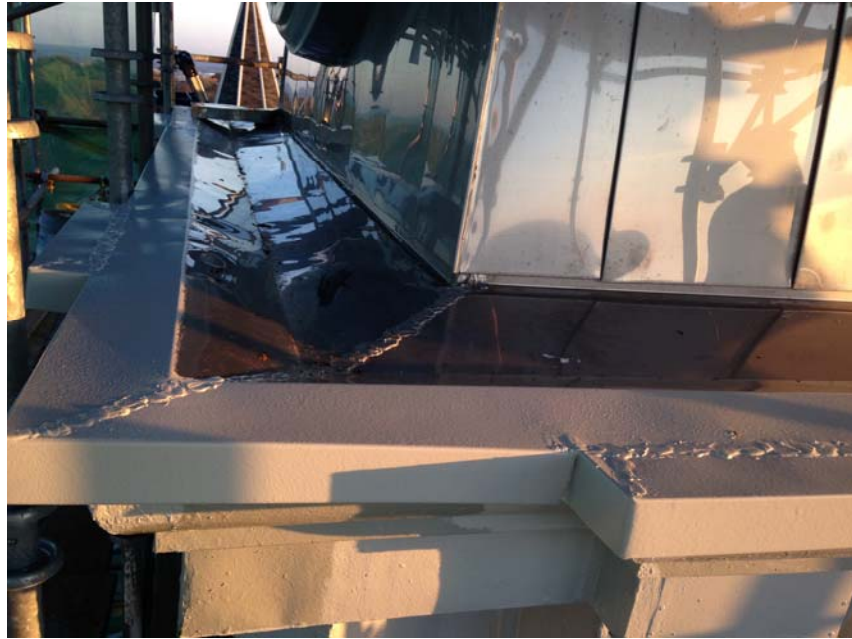
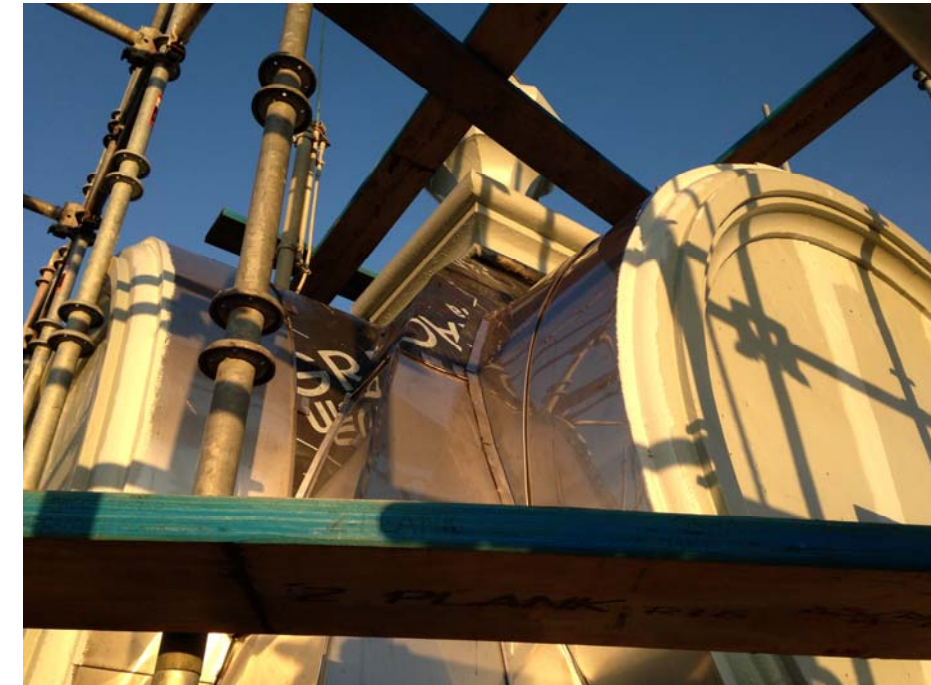
Tower Restoration

Restoration begins

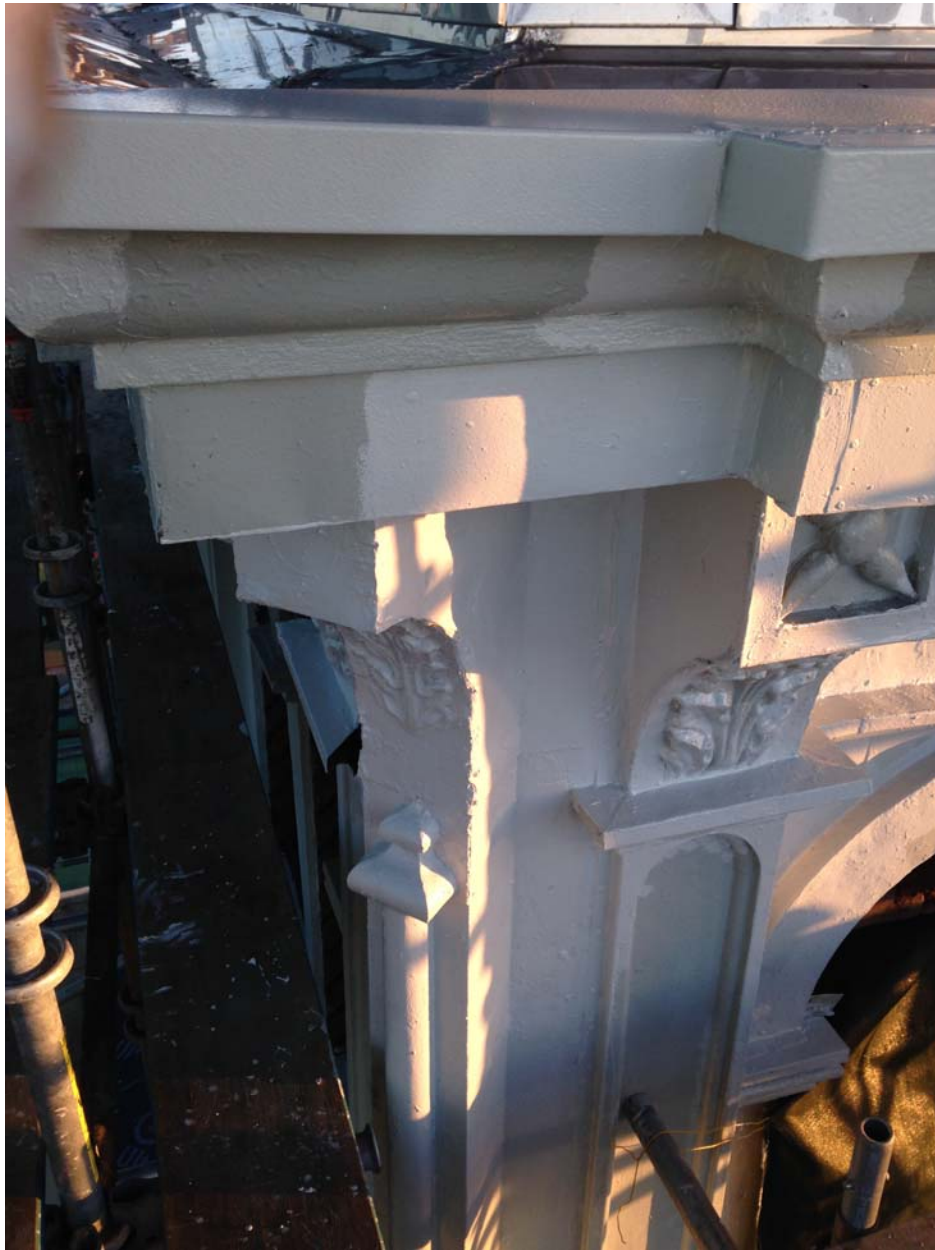
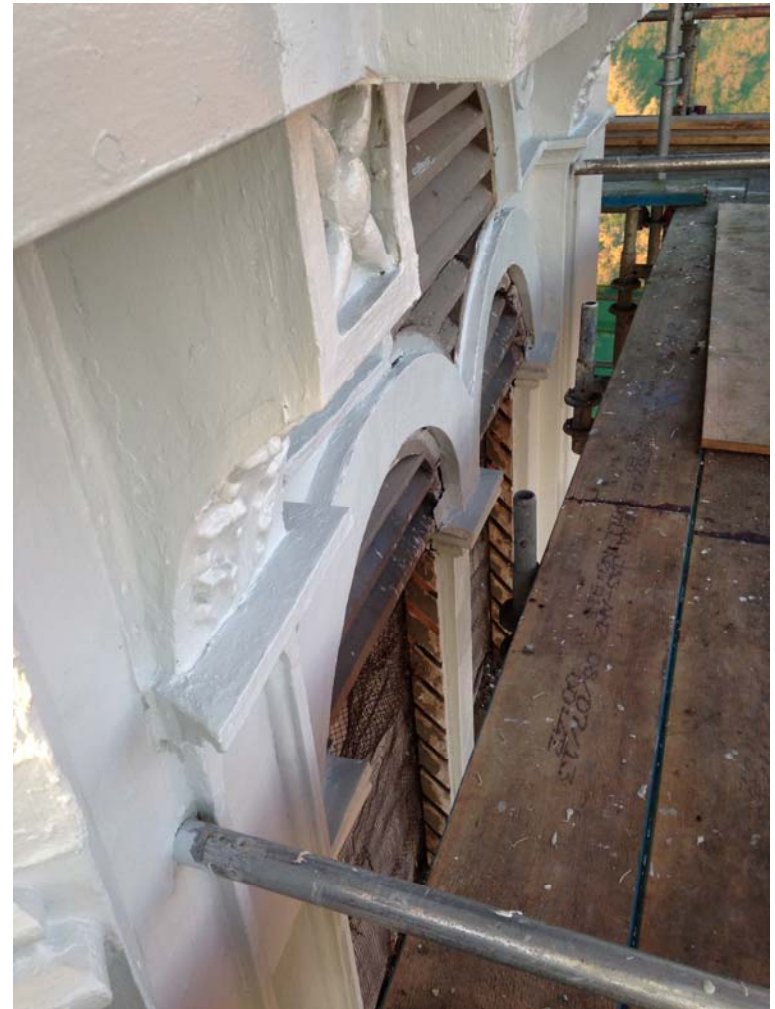
Tower Restoration

Restoration begins
