Detailed Site Investigation at Tiwai Point

Rio Tinto
 NZAS Preliminary Closure Study
 Detailed Site Investigation Report

Project No. 12535044
 Revision No. A
 Date 25 Mar 2021

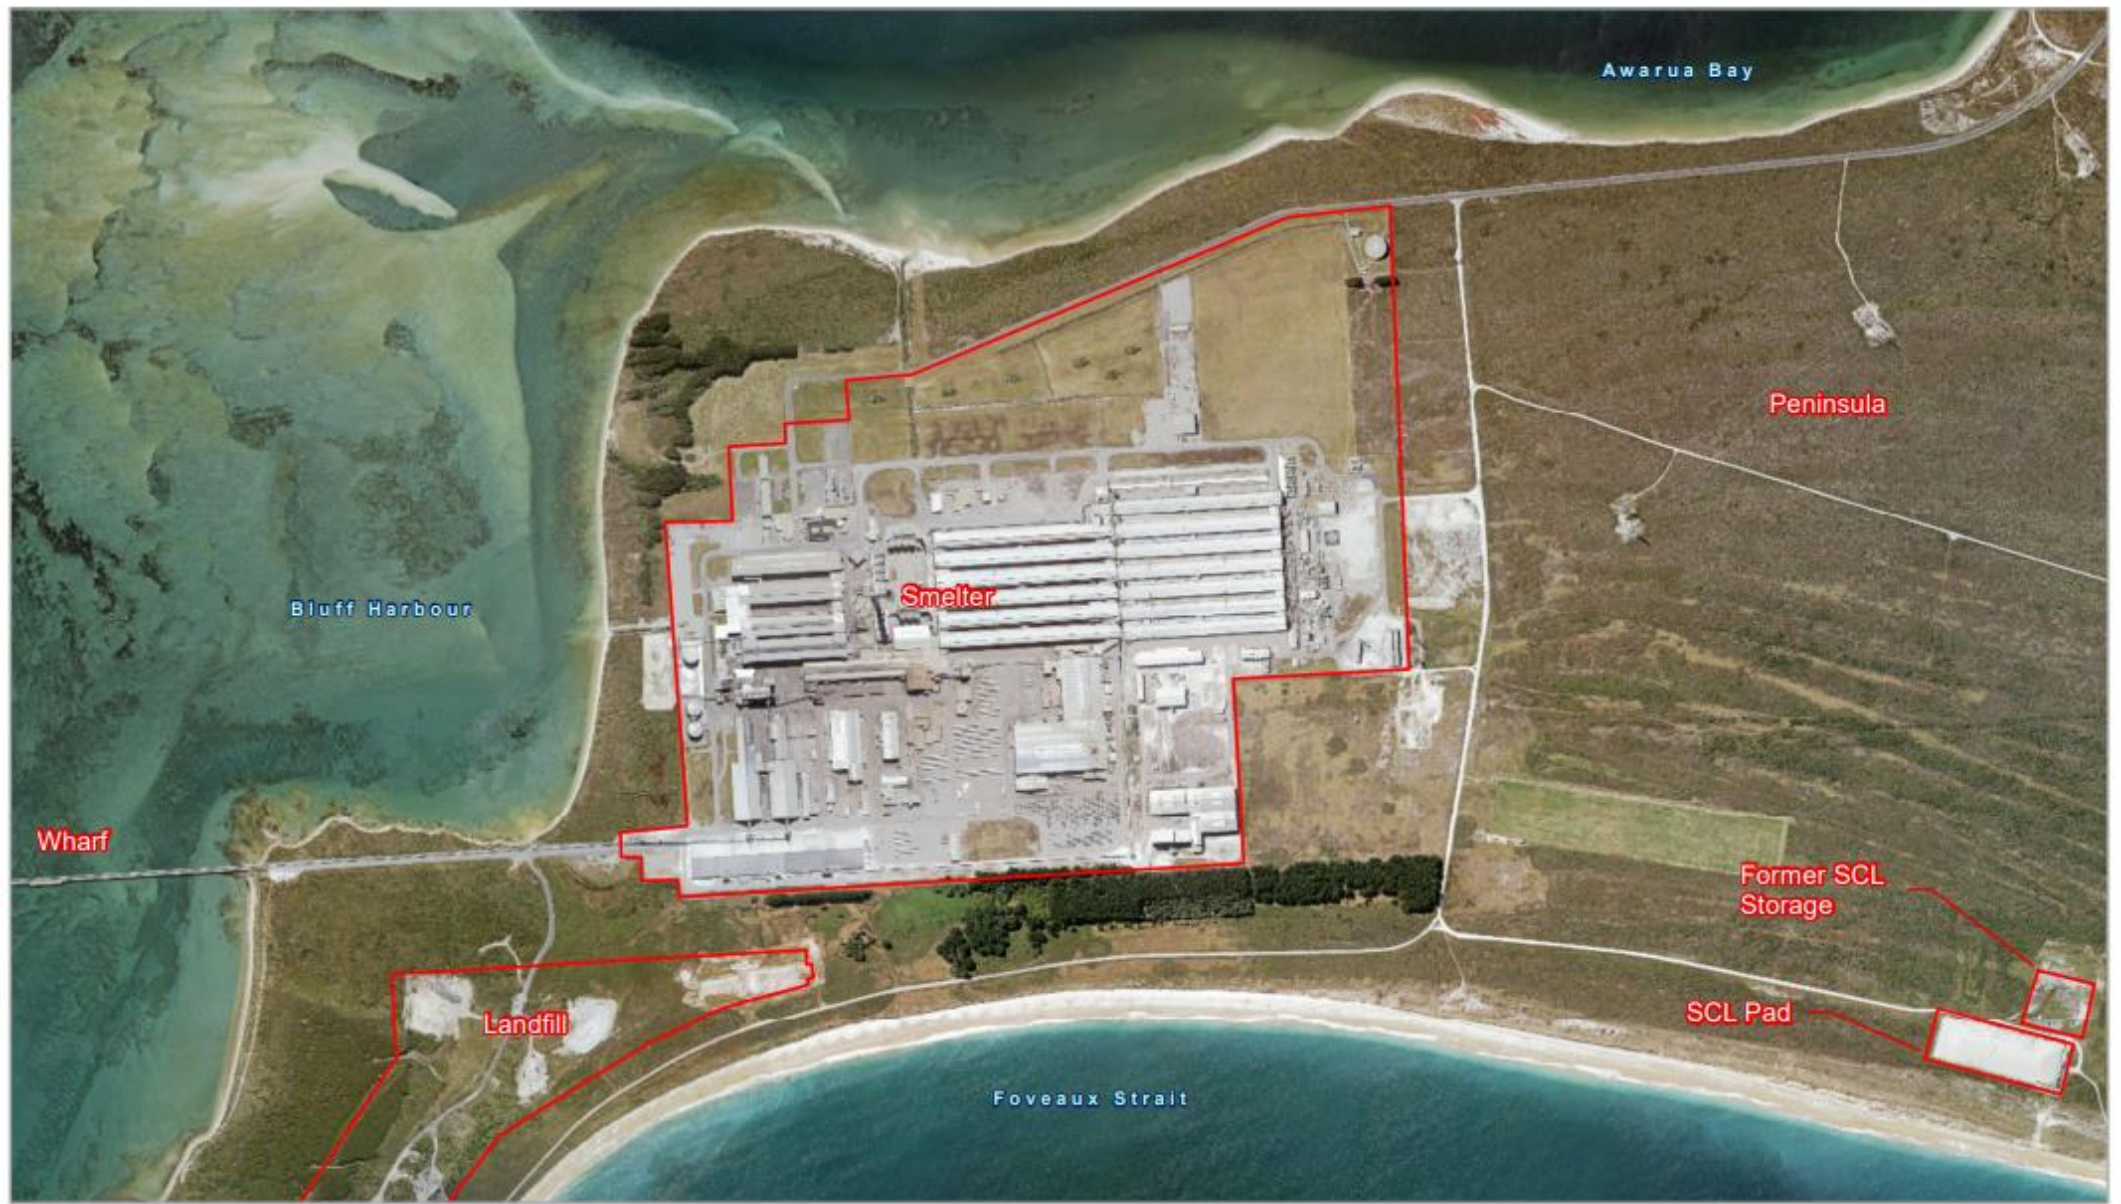
FIGURE A2

Key Site Features

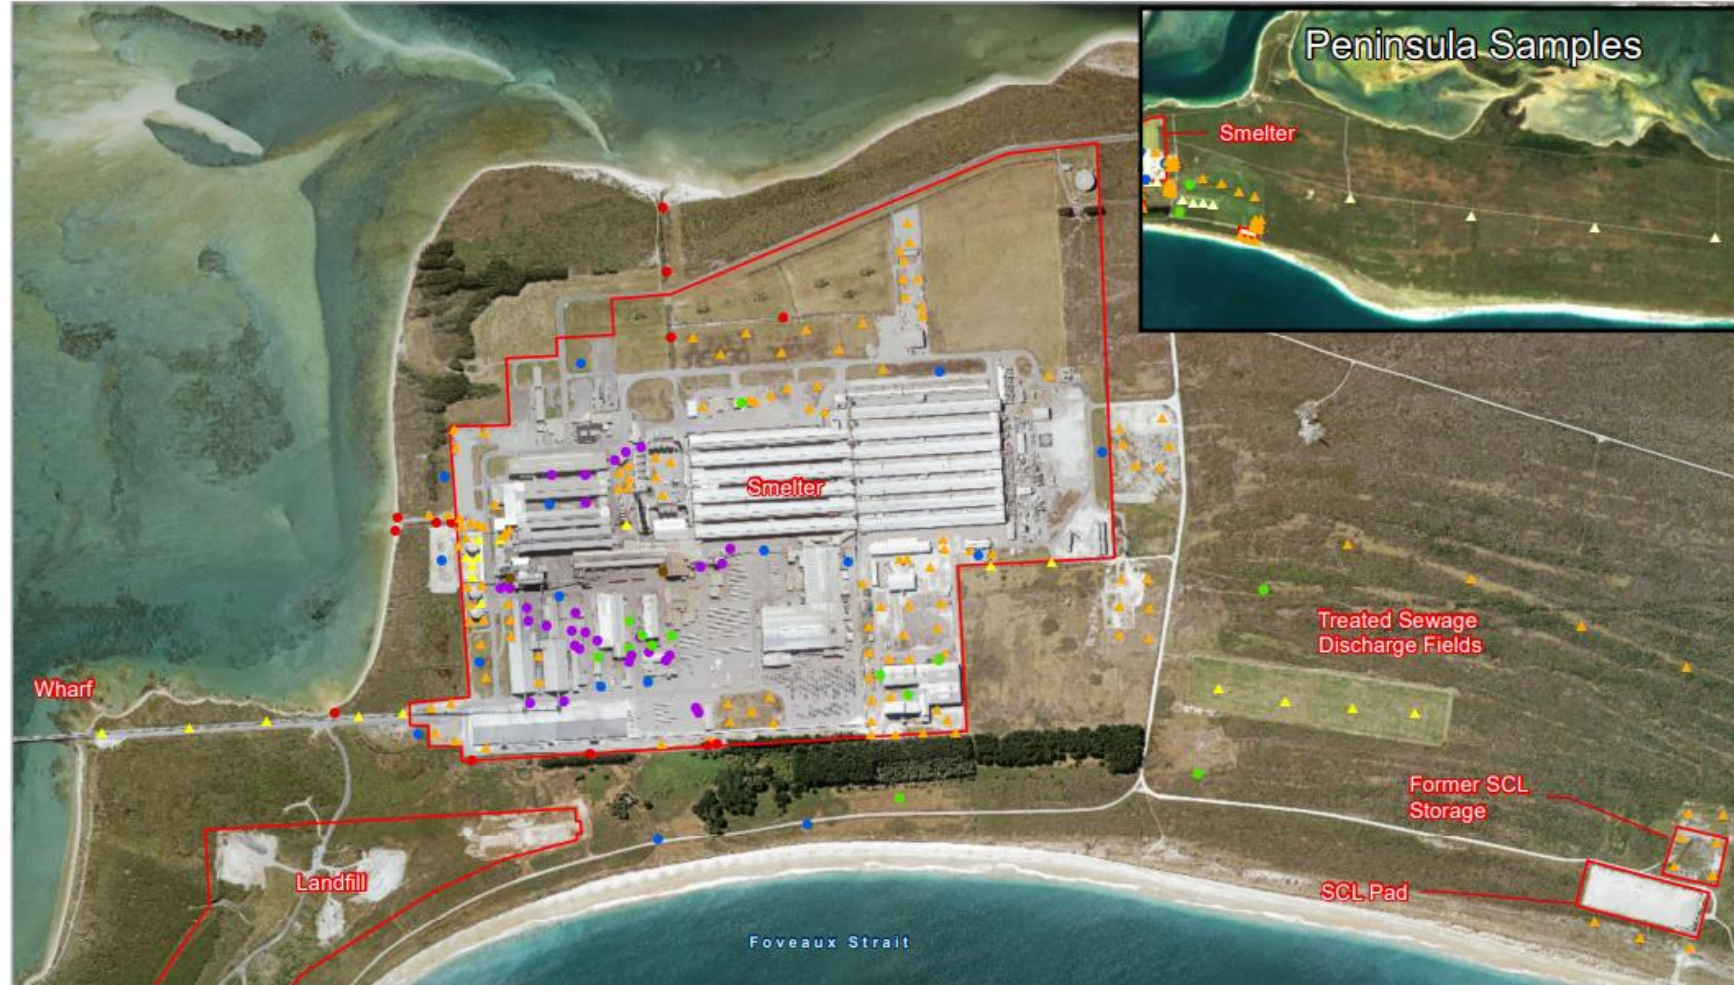
FIGURE A4

- 238 test sites across the Smelter, SCL Pad and Peninsula

All Sample Locations

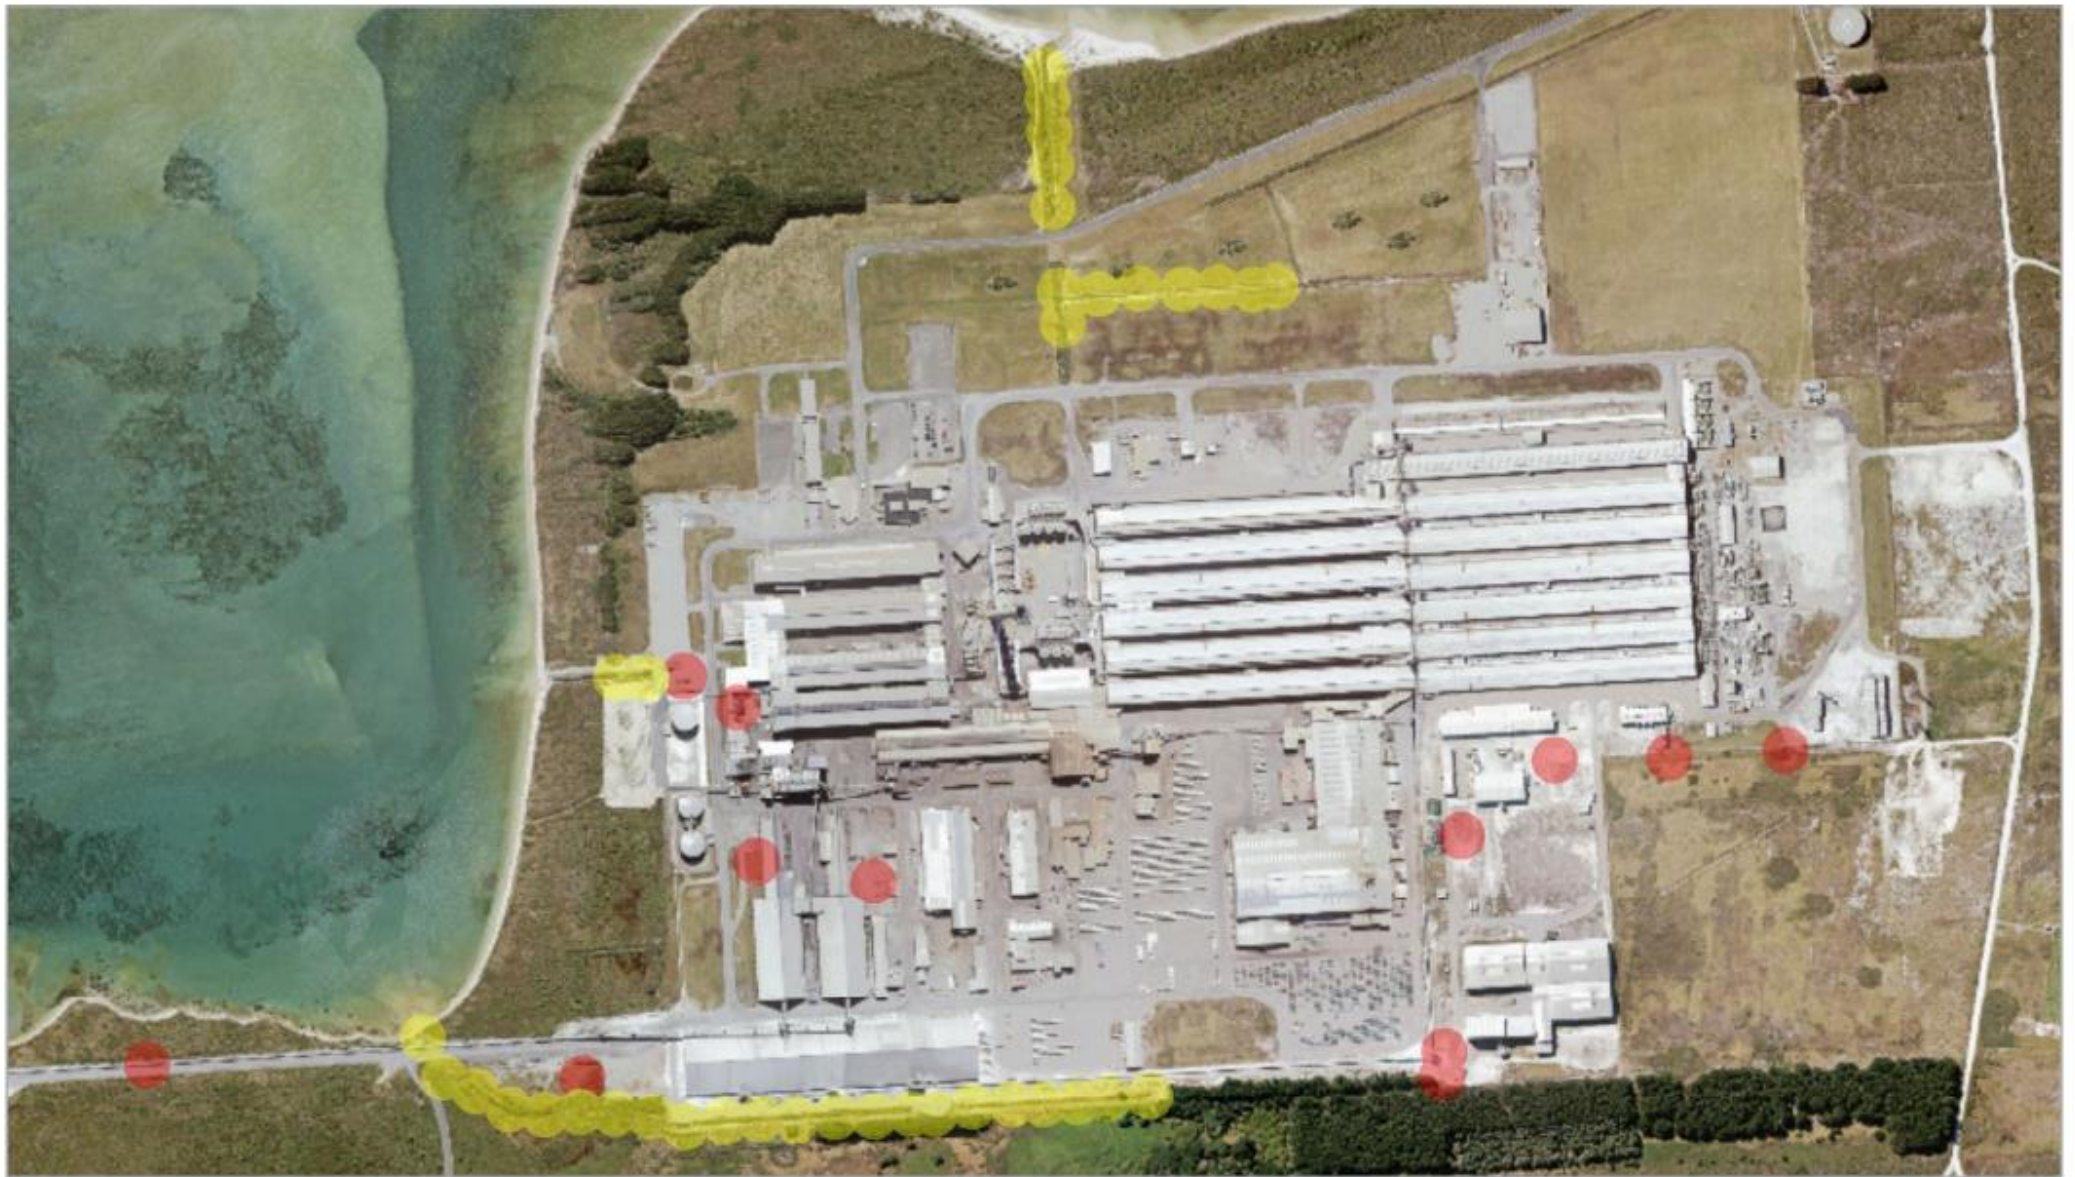
FIGURE A23

- Contaminant Exceedance Area for Sediment
- Contaminant Exceedance Area for Soil

Site Wide
 Industrial Criteria Exceedances

- NZAS will be conducting further testing to better understand the areas of identified contamination and impact on the environment
- We will also work with key stakeholders, including Ngāi Tahu to identify options and develop plans to remediate the contaminated areas

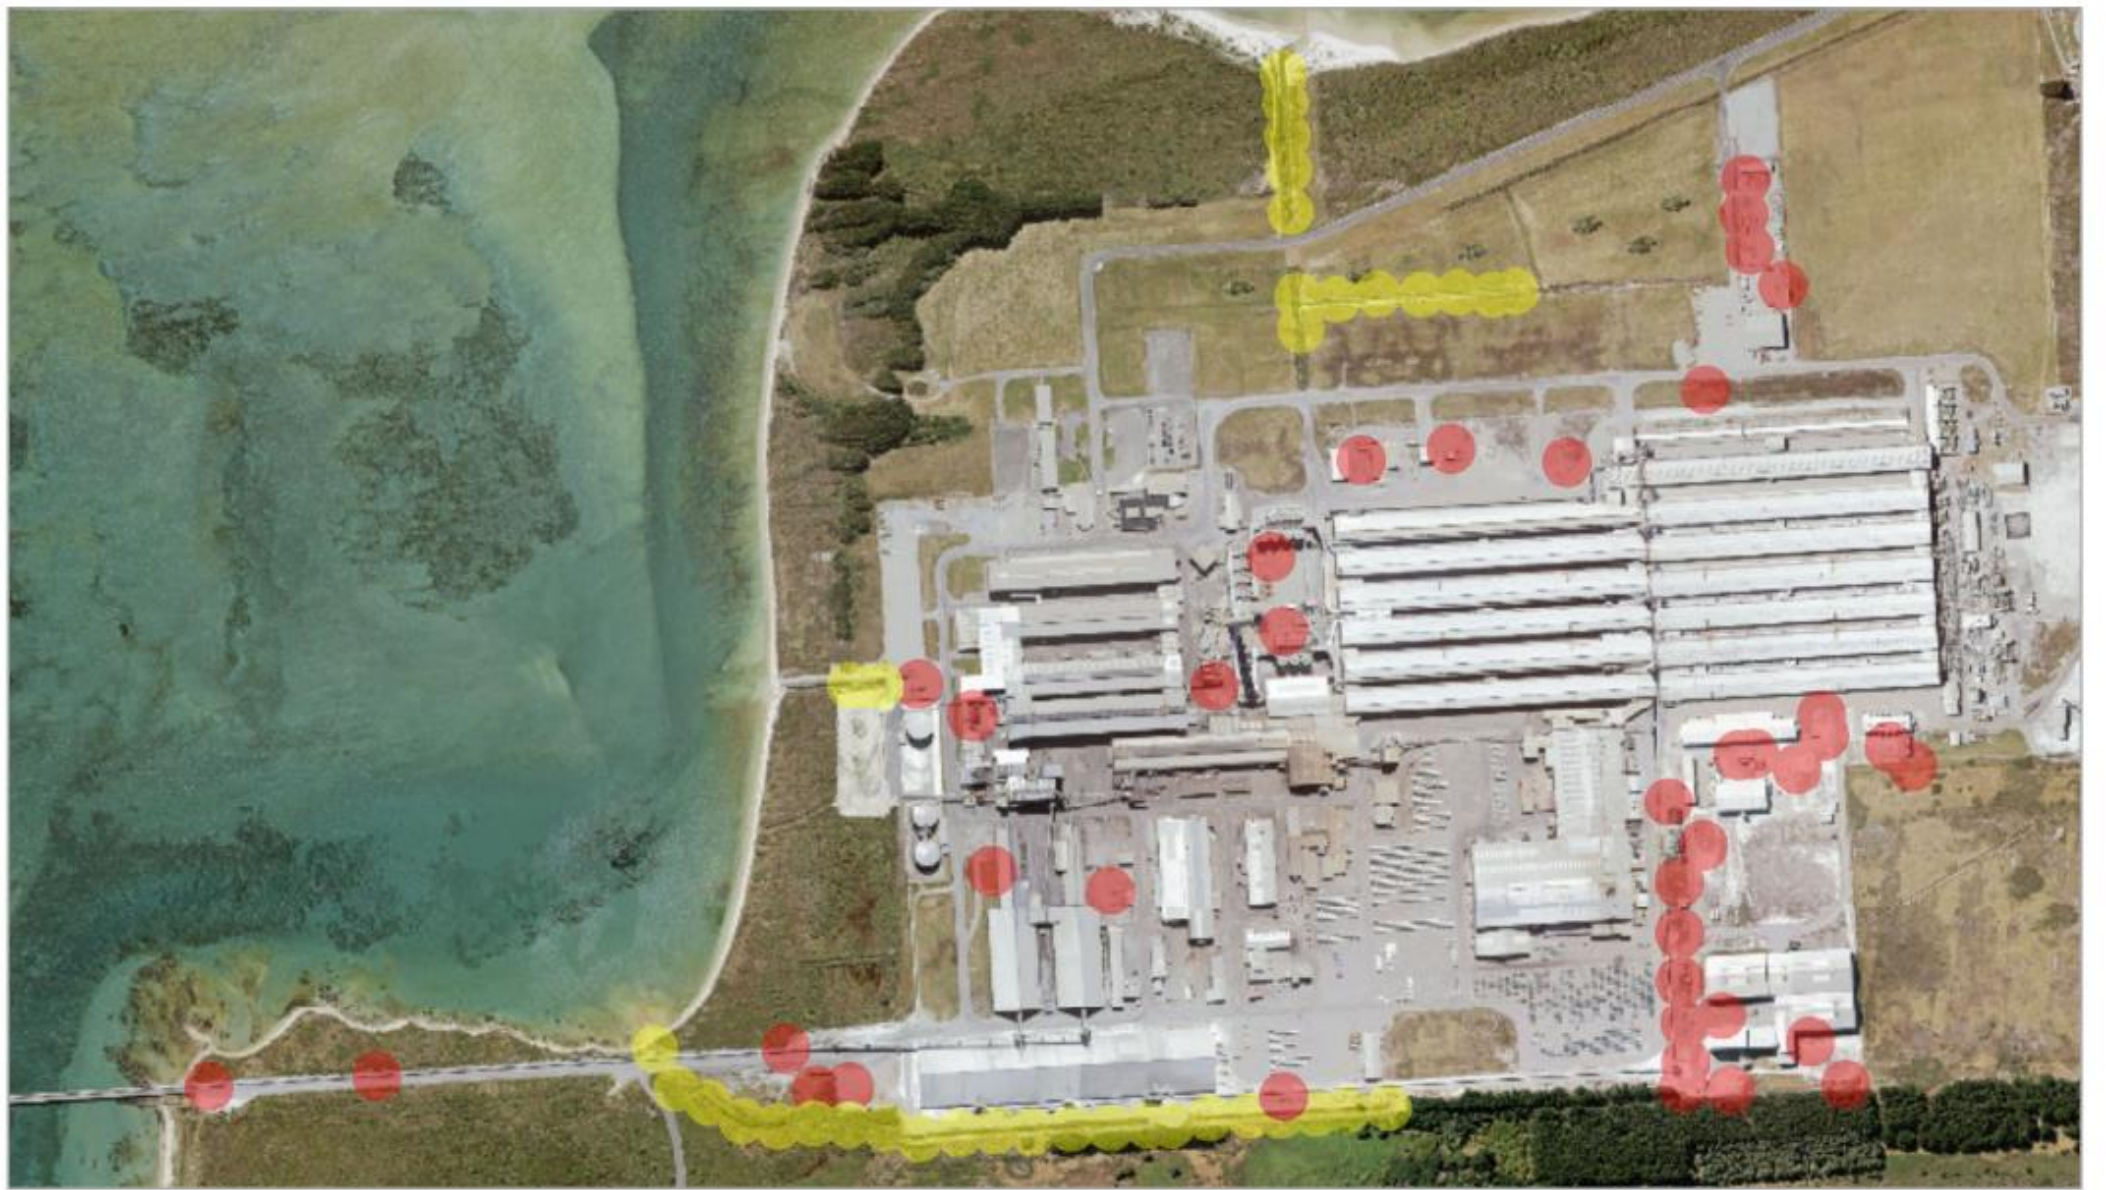
FIGURE A24

- Contaminant Exceedance Area for Sediment
- Contaminant Exceedance Area for Soil

**Site Wide
 Recreational
 Criteria Exceedances**

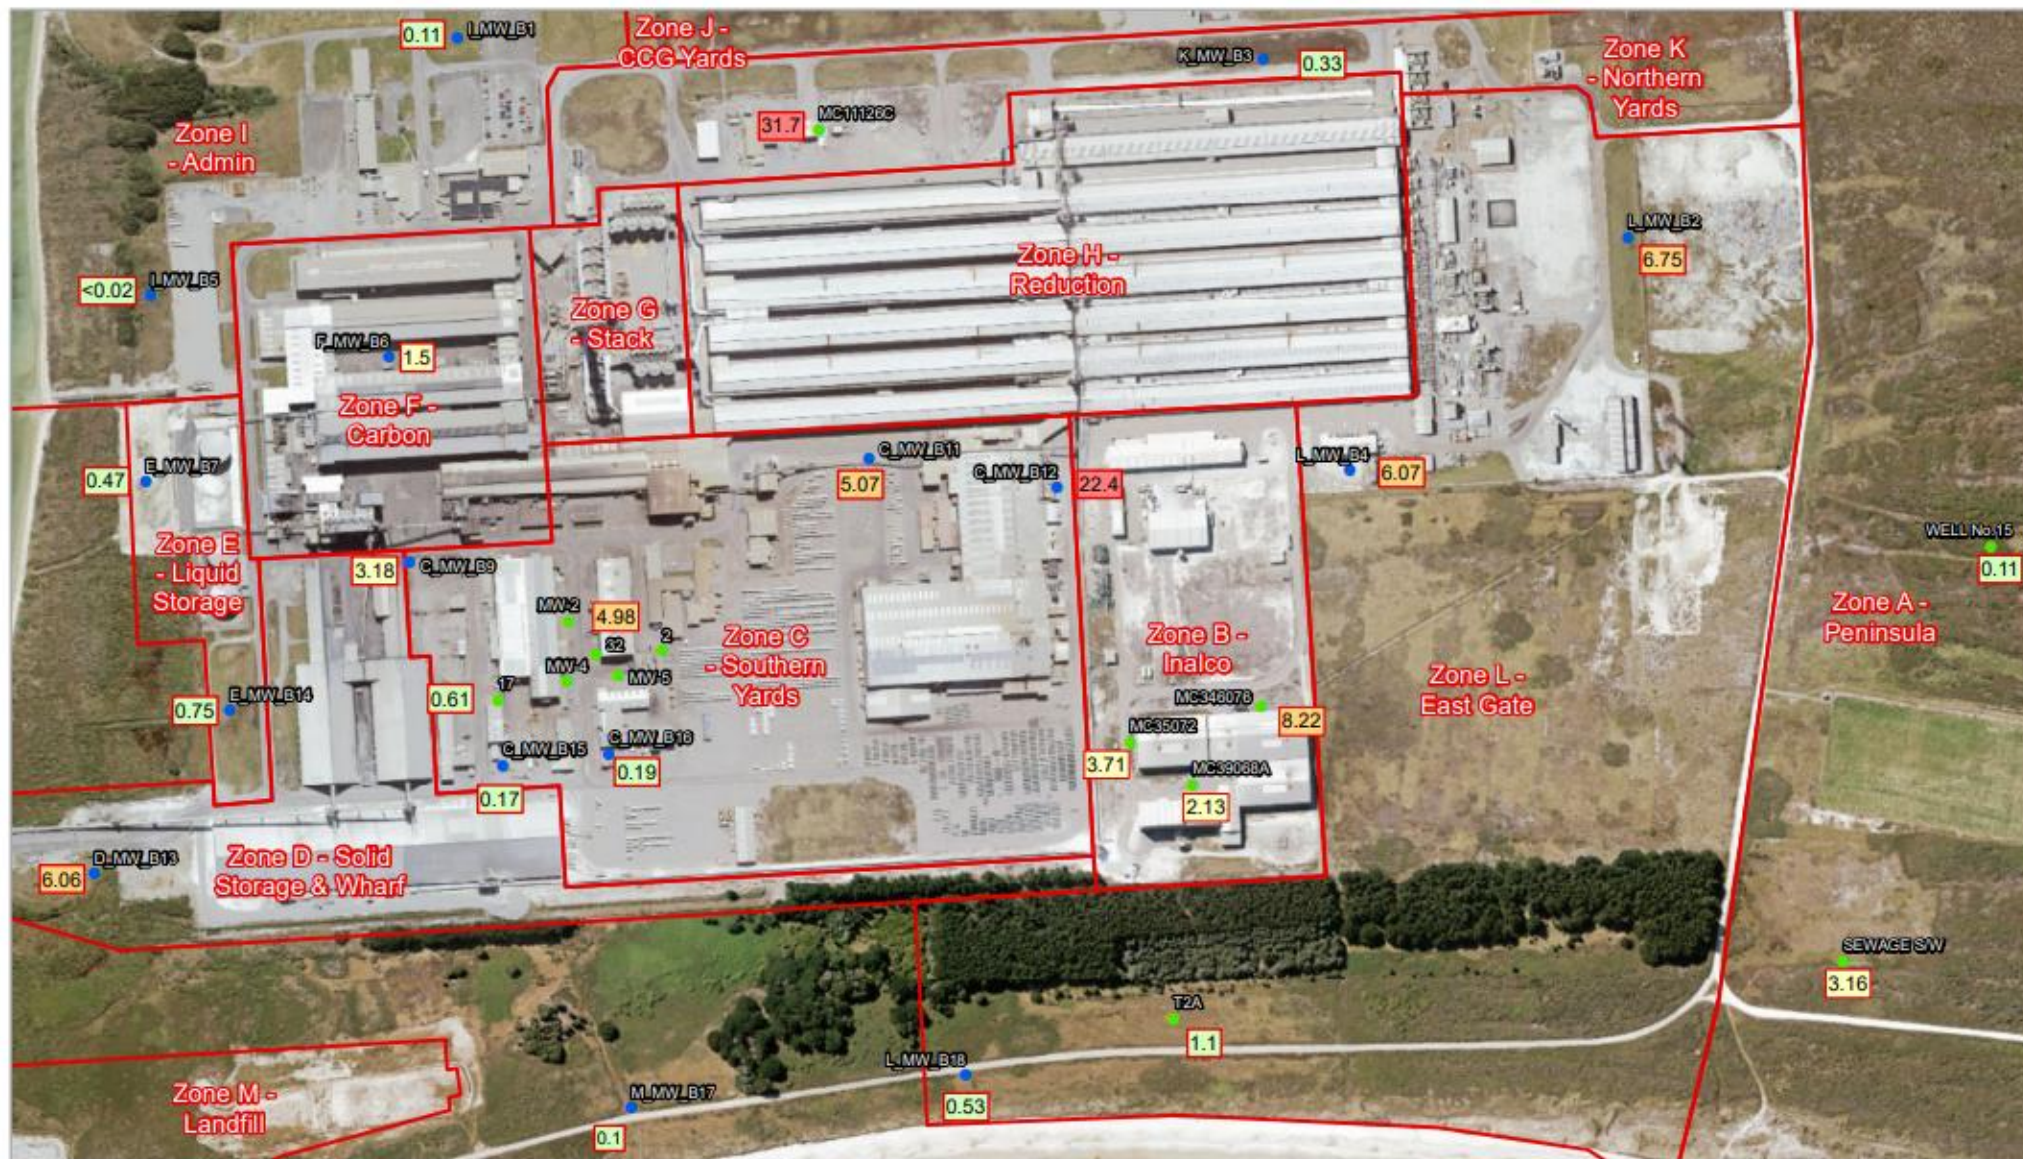
FIGURE A20

- Monitoring Well
 - Existing Monitoring Well
 - Investigation Zones
- All units are presented as mg/L
 Monitoring wells 32, 2, 17, MW2, MW4 and MW5 are all <math><1.5</math> mg/L but are not shown due to spatial constraints

$<1.5</math> mg/L$
1.5 - 4 mg/L (1.5 mg/L - Drinking-Water Standards for New Zealand 2005 (Revised 2008))
4 - 10 mg/L (4 mg/L - es rule 46 - Environmental Guideline)
$>10</math> mg/L$

**Fluoride Concentrations
 for Groundwater**

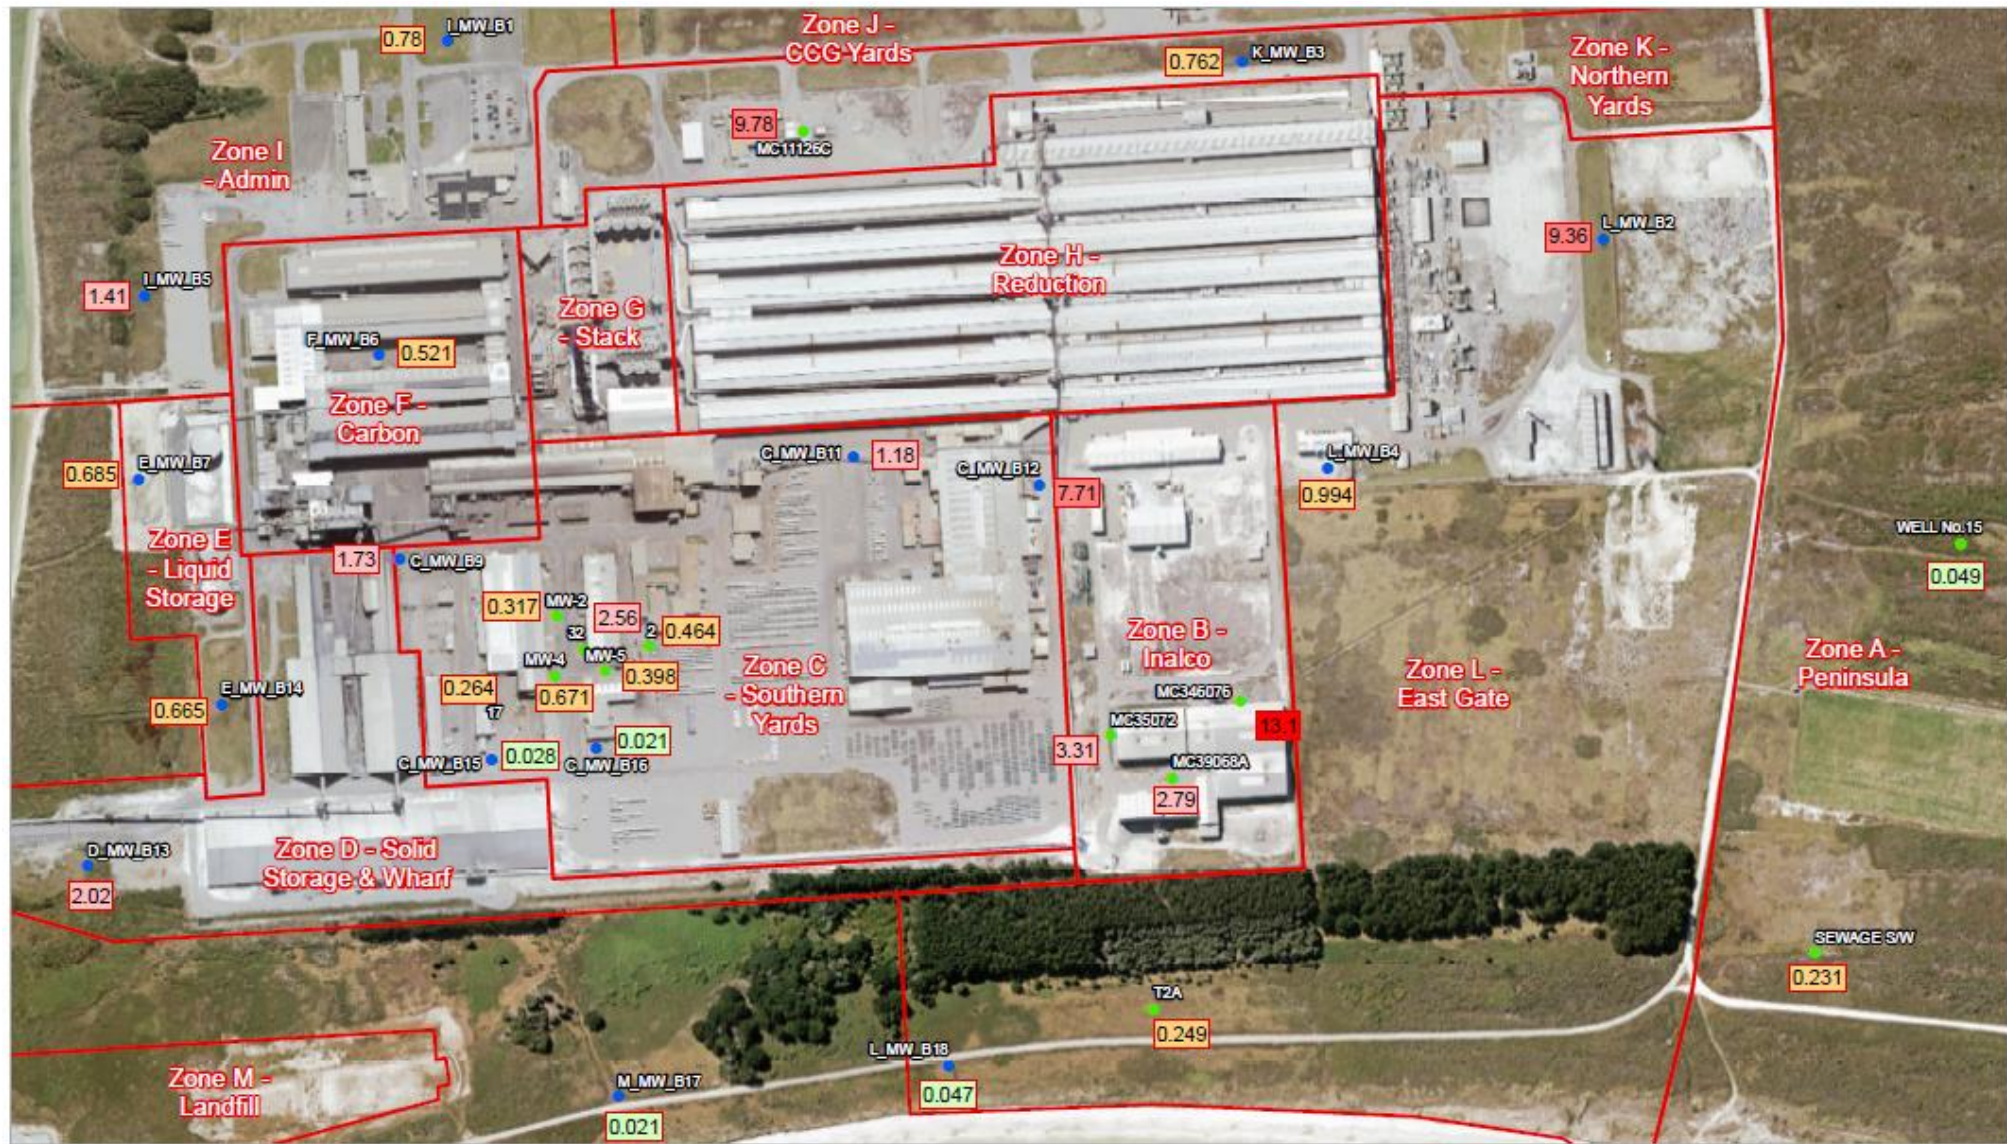
FIGURE A19

0.1 - 0.15 mg/L (0.1 mg/L - Drinking-Water Standards for New Zealand 2005 (Revised 2008))

0.15 - 1.0 mg/L (0.15 mg/L - es rule 46 Environmental Guideline)

Aluminium Exceedances
for Groundwater
