Cyclone Gabrielle and Hawke's Bay

... the HBRC response

Size and scale of the event

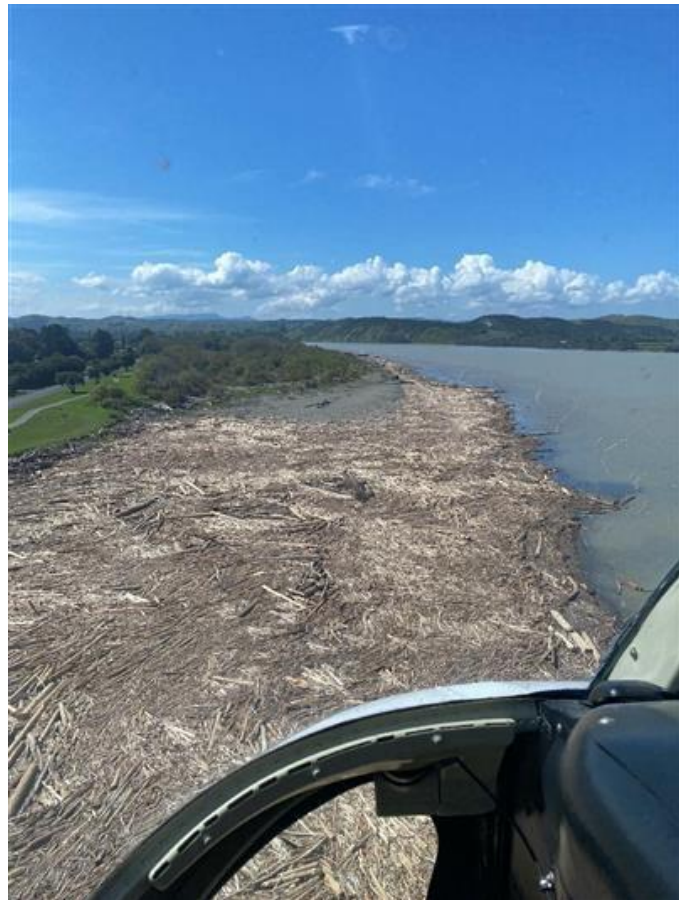
Flooding extent - Wairoa

(photo source: HBRC flight, 21/2/2023)

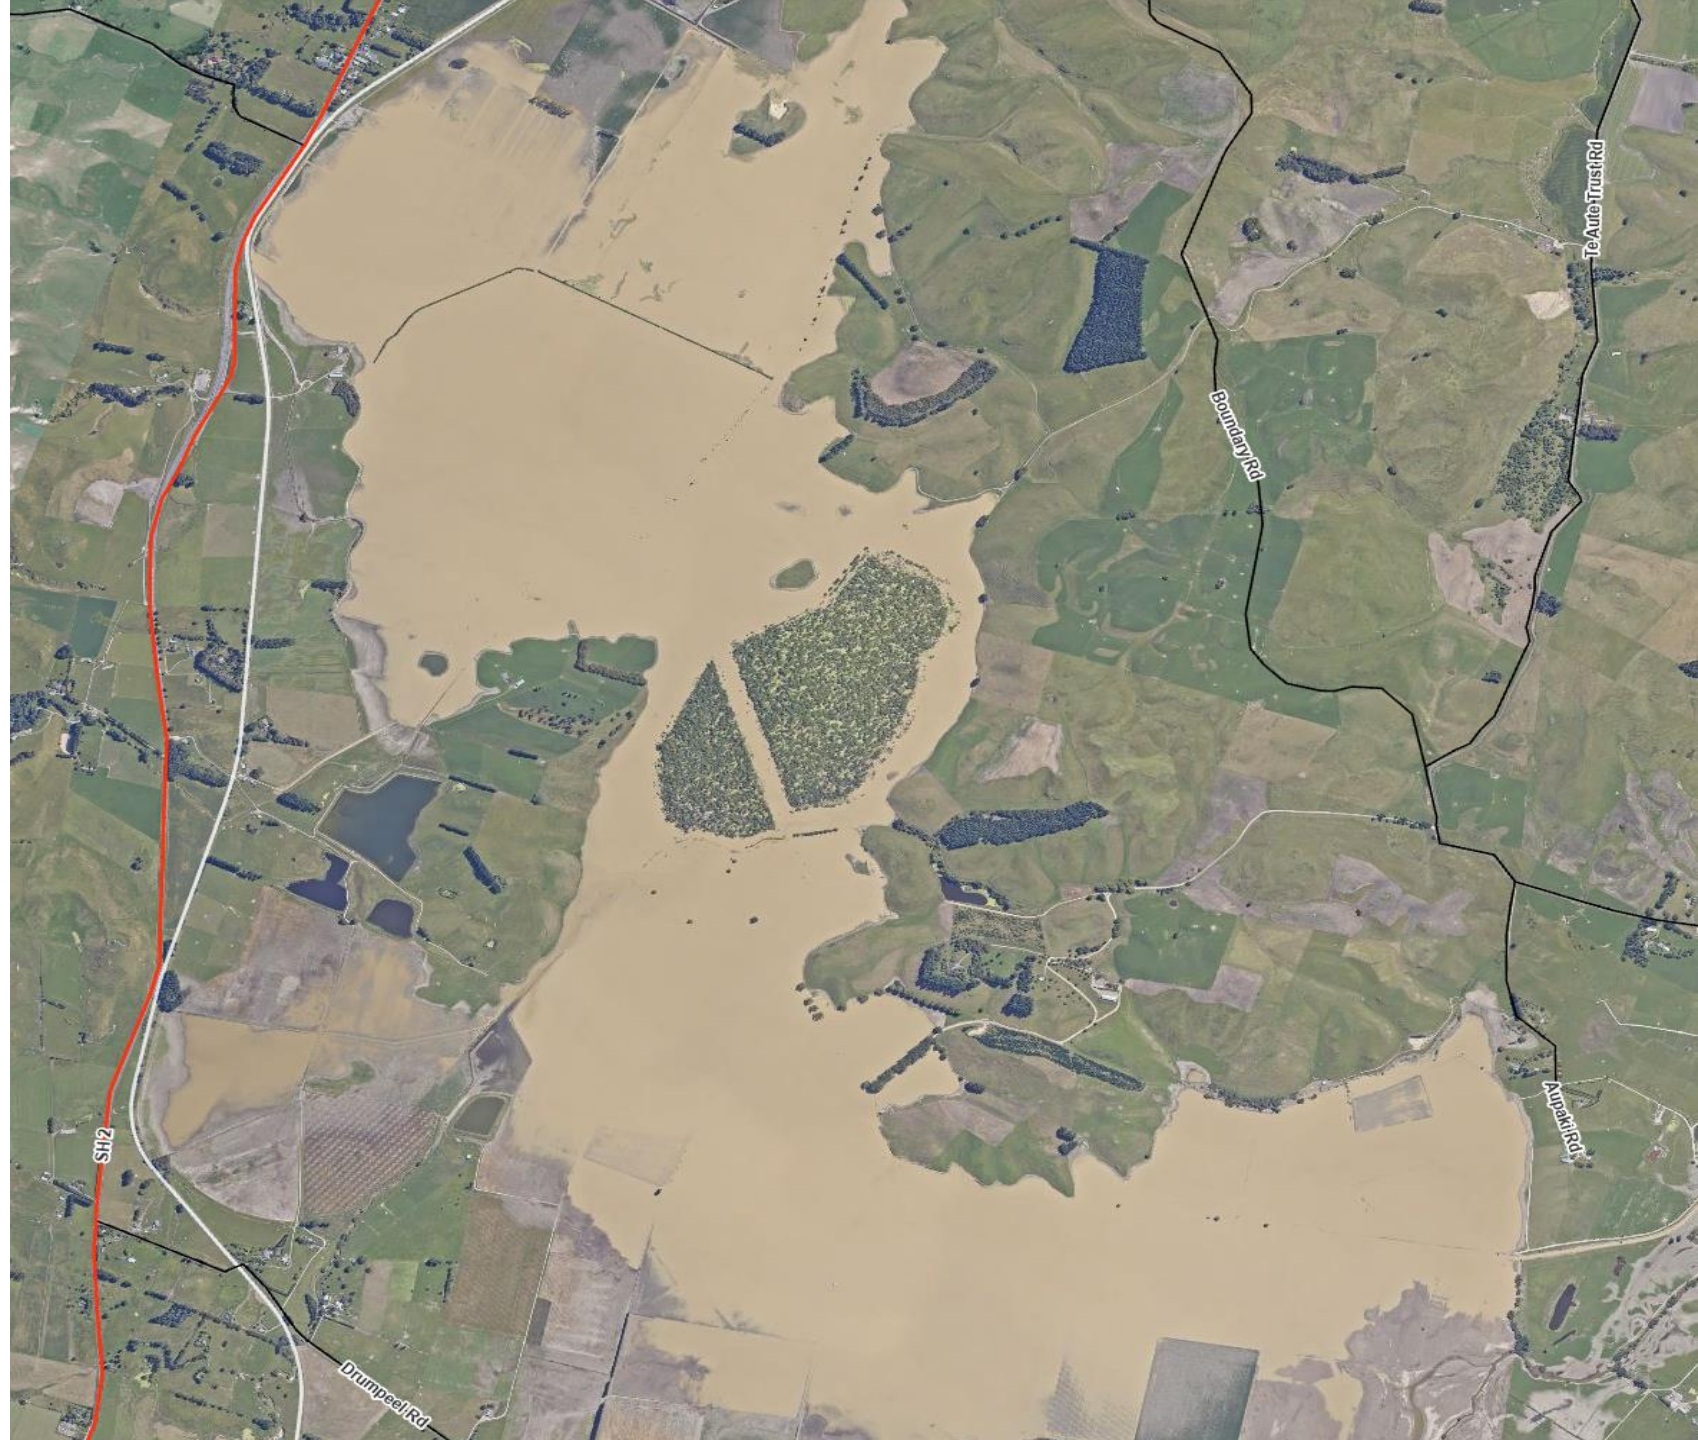
**Flooding
extent –
Central
Hawke's Bay**

(source: aerial view)
