**From:** Out of scope  
**Sent:** Monday, 3 October 2022 12:28 pm  
**To:** s 9(2)(a) s 9(2)(a)@tsvconsultants.co.nz  
**Subject:** Action Manufacturing DHB - Dental Trailers.

Over the past few of years there have been a number of incidents relating to dental trailers, used for providing dental clinic services to schools. These incidents related to the wheel assembly and the “sheering off” of the wheel mount while being towed on an open highway. No injuries were reported in both incidents.

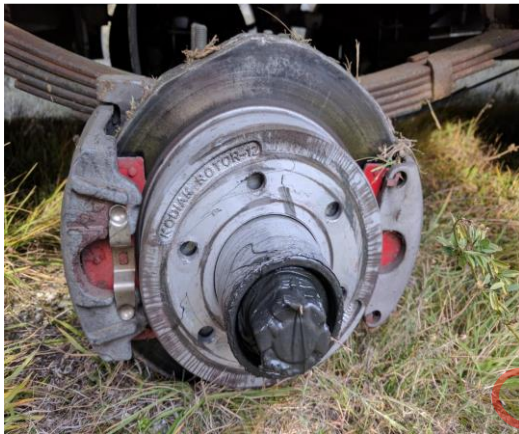
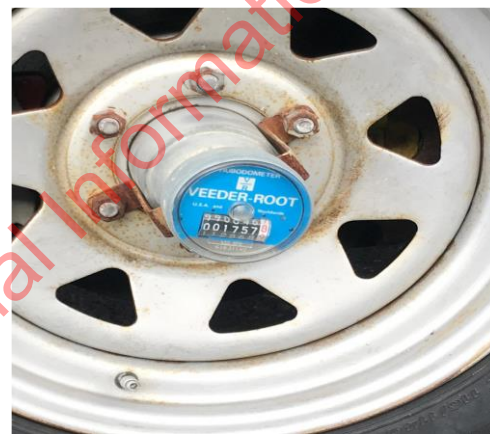
Enquires and subsequent incident investigations concluded that the incorrect wheel assemble was attached to the hub resulting in the sheering of the wheel studs while being towed, leading to the wheel coming adrift from the MDU trailer.
