Landslides and USAR

Outline:

- Recent, large, multiple fatality landslides
- Can't happen in NZ right?
- Life safety risks - if engulfment occurs
- USAR considerations
- Exercise: Oso Landslide

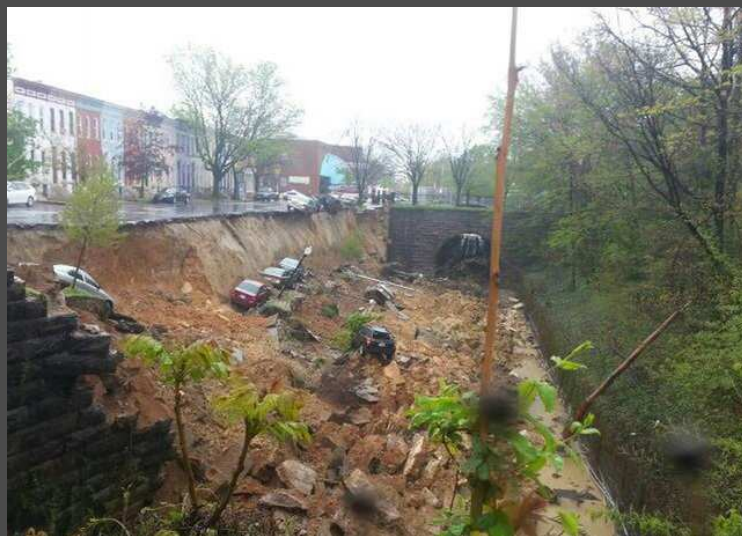
Baltimore, USA – post failure

Baltimore, USA. Retaining wall failure, April-May 2014. No fatalities <http://www.youtube.com/watch?v=MrNluXrrHKY>

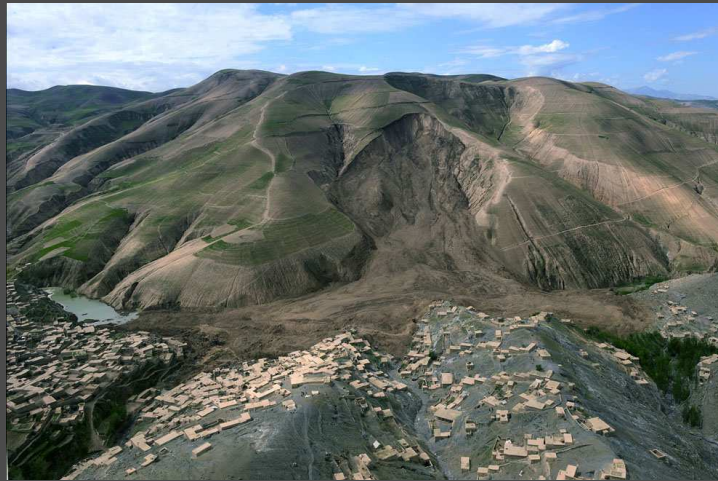
Ab Barak, Afghanistan – post-failure with 300-2700 fatalities. Some survivors rescued.

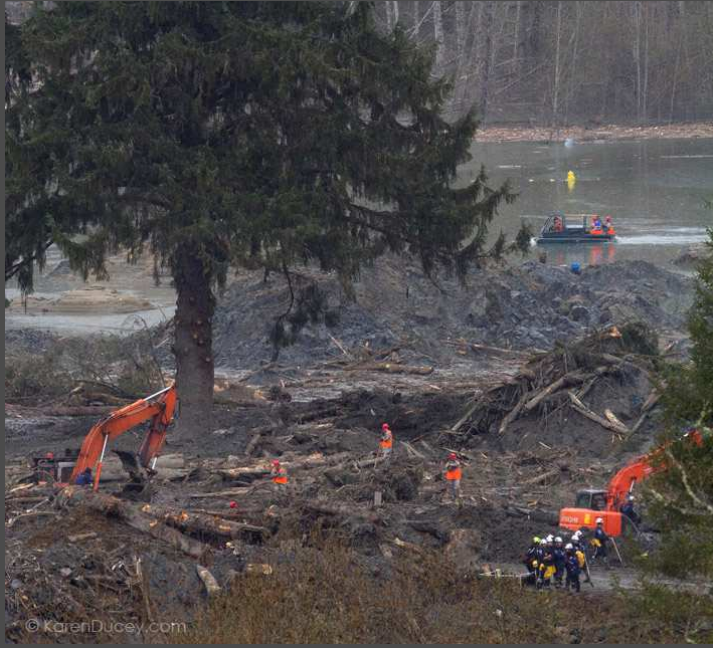
Personnel and equipment work in 40x40 foot sections of the SR 530 mudslide area reviewing all material down to native soil, near Oso, Washington on April 8, 2014. Today, 35 people are confirmed dead in the SR530 slide.
