Rager Mountain Well #2244 Casing Failure Root Cause Analysis

Prepared for:
Equitrans, L.P.

RCA report on well #2244 7 in.
casing failure root cause analysis.

Date:
August 24, 2023

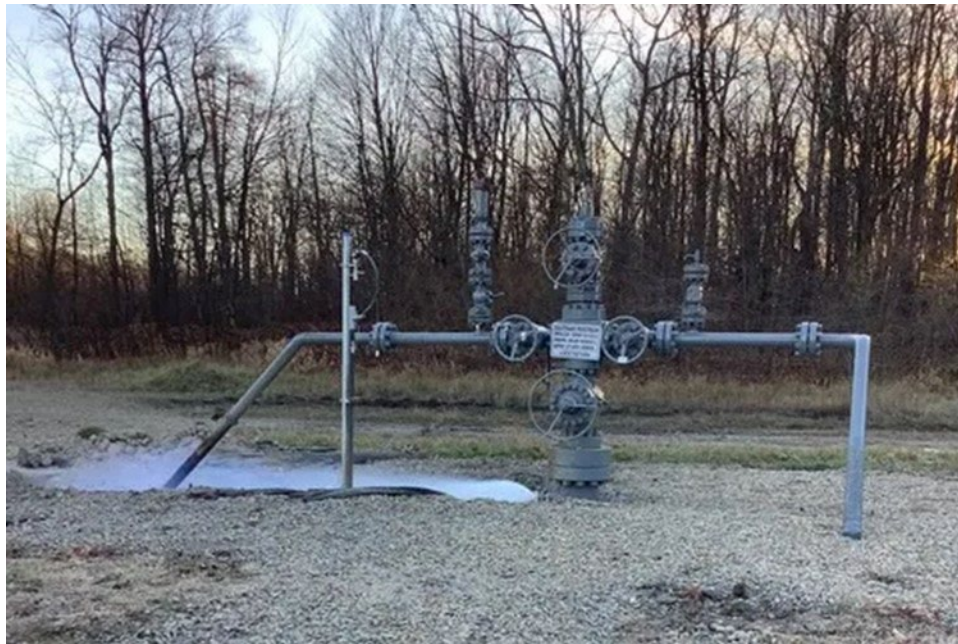
Figure 1: Well #2244 (George L. Reade #1) Gas Leaking Through the Annulus Valve

Well #2244 had a leak on November 6, 2022, and natural gas was vented at surface through the 2 in. annulus ball valve. This valve accessed the 7 in. × 9 5/8 in. annulus. Figure 1 shows a picture of well #2244's wellhead and leaking gas. The well was killed on November 19, 2022.

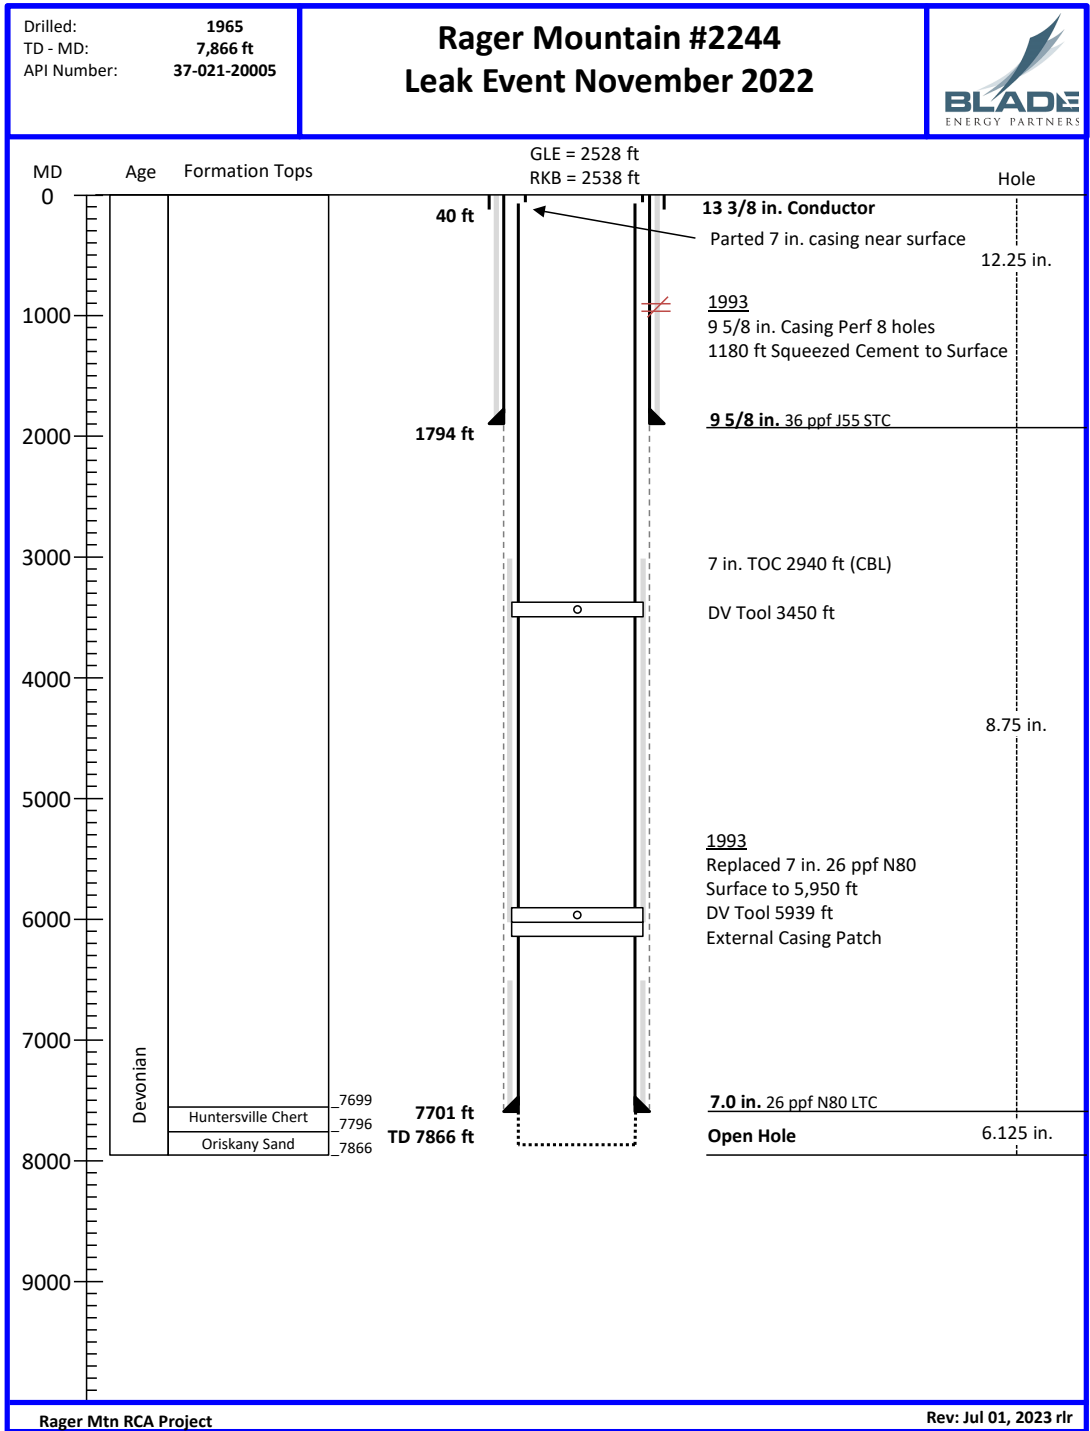
Figure 2: Well #2244 Wellbore Schematic

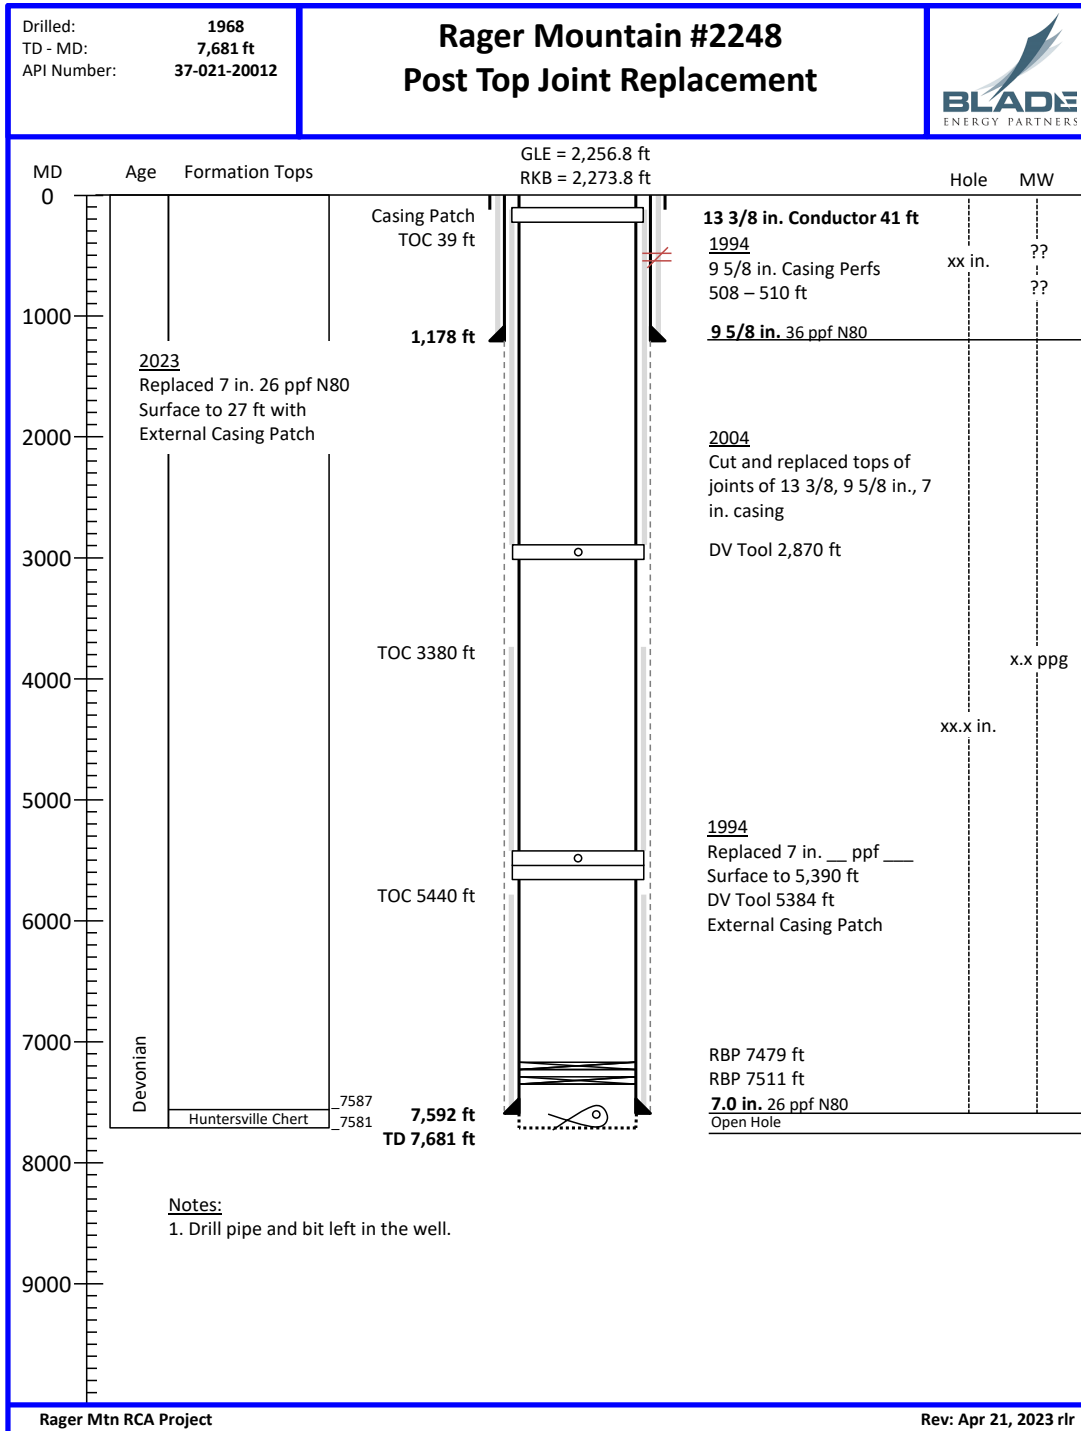
Figure 3: Well #2248 Wellbore Schematic Post Top Joint Replacement

Figure 3 and Figure 4 show the respective wellbore schematics for wells #2248 and #2251.

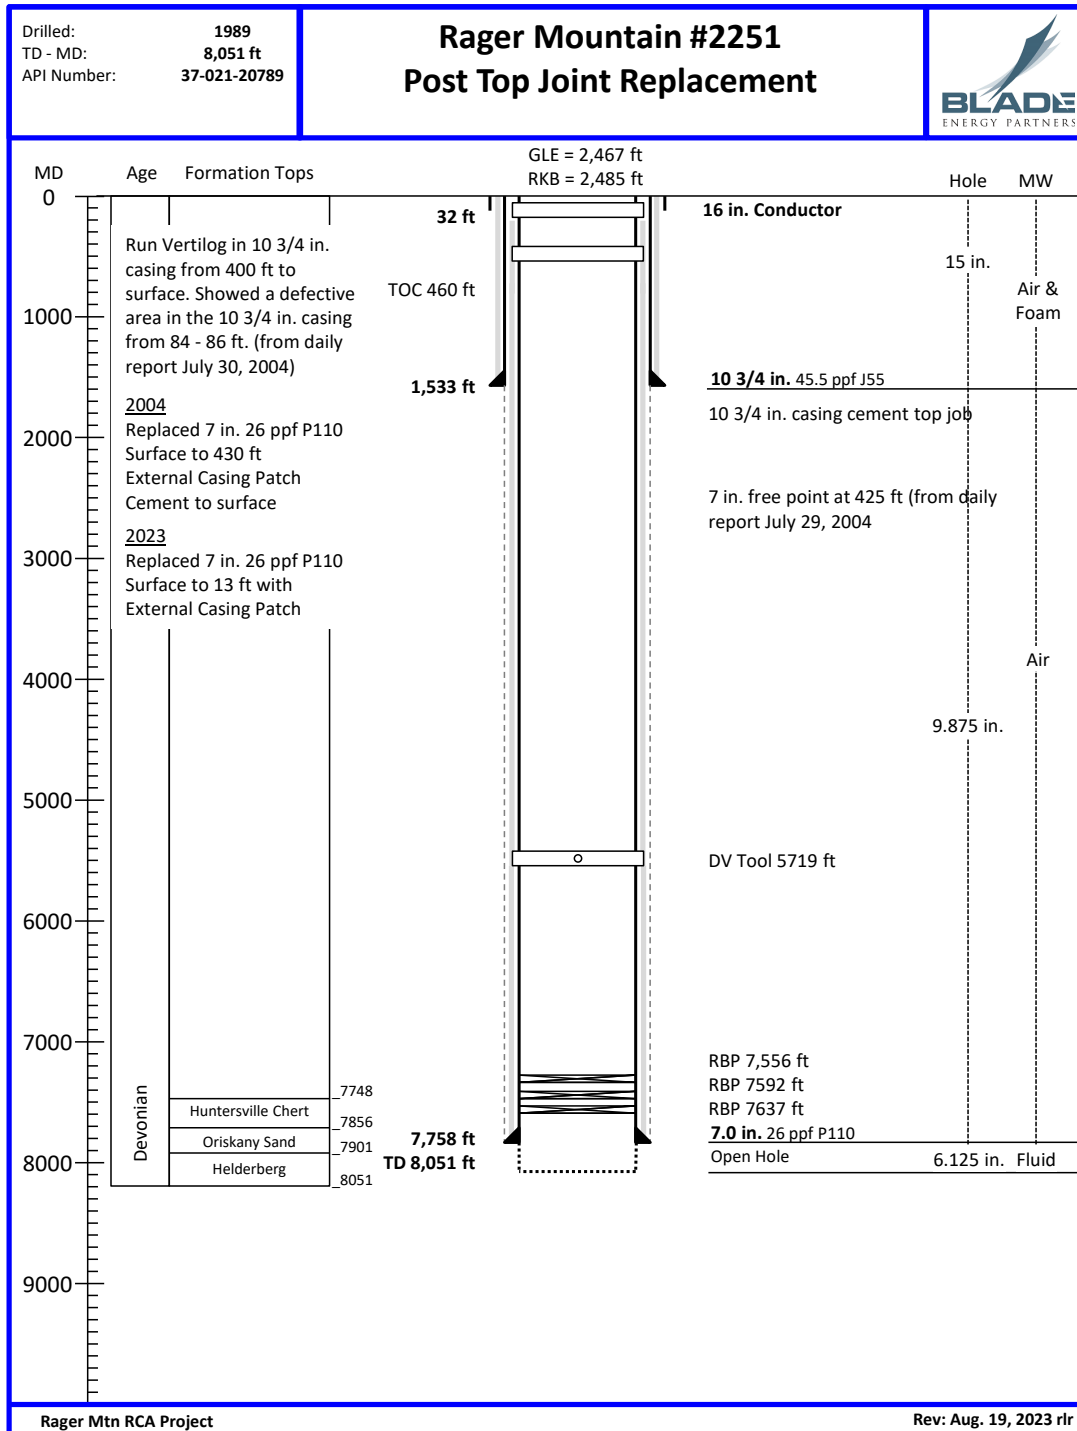
Figure 4: Well #2251 Wellbore Schematic Post Top Joint Replacement

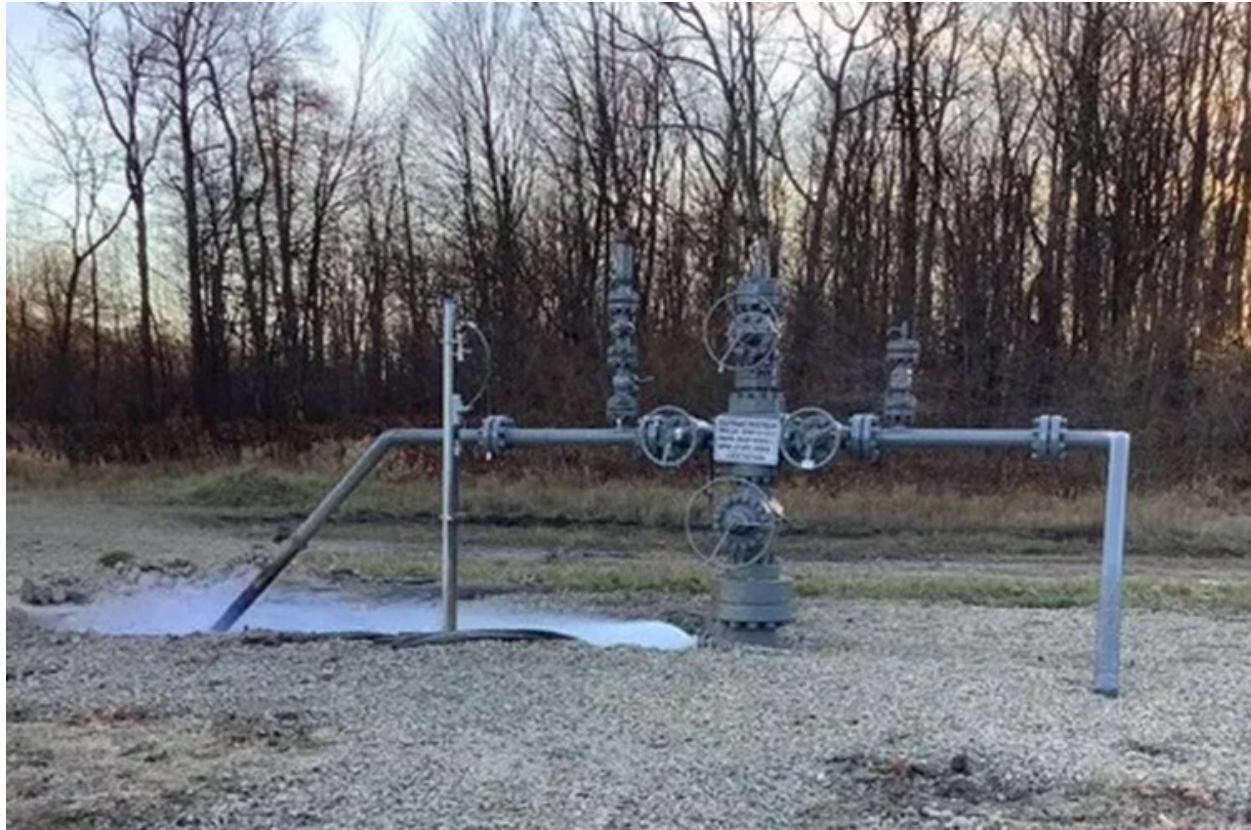
Figure 12: Well #2244 Venting Gas Out the Annulus Valve

The Rager Mountain Field was at the end of the injection cycle in late October 2022. The wells and the field were shut in on Tuesday, November 1, 2022, for the semiannual inventory verification test. On Sunday, November 6, 2022, at 3:28 pm, Equitrans was notified of a possible event at the Rager Mountain storage field. Equitrans personnel investigated at 4:15 pm and found well #2244 was venting to the atmosphere through the open annulus valve. The annulus valve was in communication with the 7 in. x 9 5/8 in. casing annulus. Figure 12 shows the gas venting through the annulus valve. Wells in the Rager Mountain Field were normally operated with the annulus valve open.

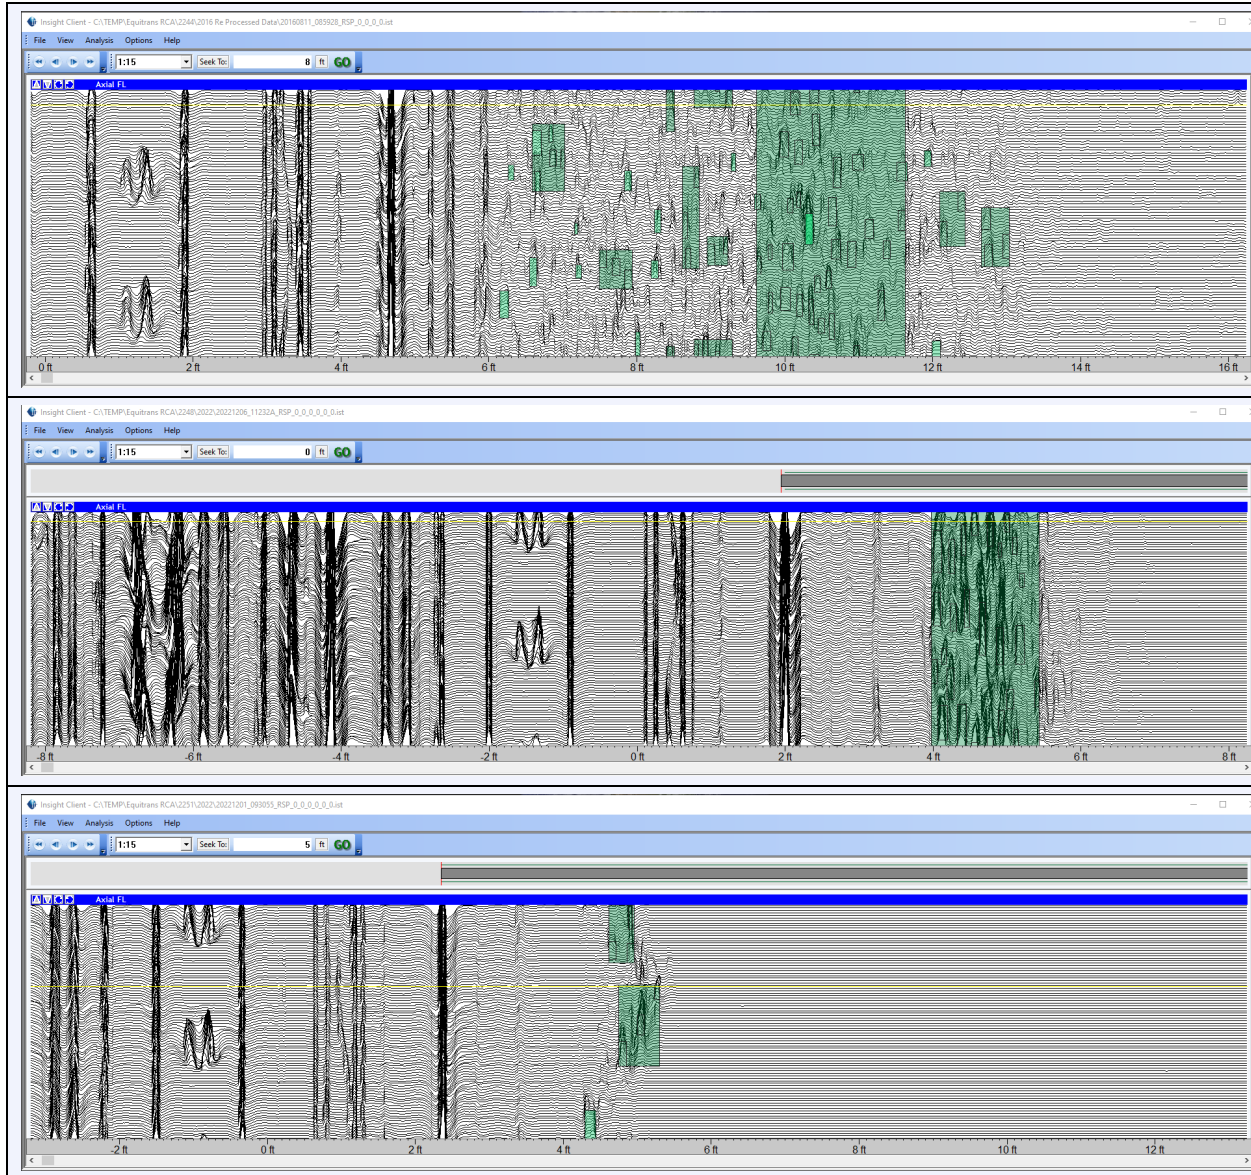
Figure 19 shows a comparison of the top joints of wells #2244 (2016), #2248 (2022), and #2251 (2022). Each green box represents individual metal loss defects or a defect cluster. The patterns of corrosion are not identical in terms of location and density. The #2244 well has a greater extent of corrosion than the #2248 and #2251 wells. During extraction, cement was observed a few feet below ground level in the #2248 and #2251 wells. Cement was not observed in the #2244 well.

Figure 19: Comparison of HRVRT Logs, Top Joints, #2244 (2016-reprocessed, top), #2248 (2022, middle), and #2251 (2022, bottom)

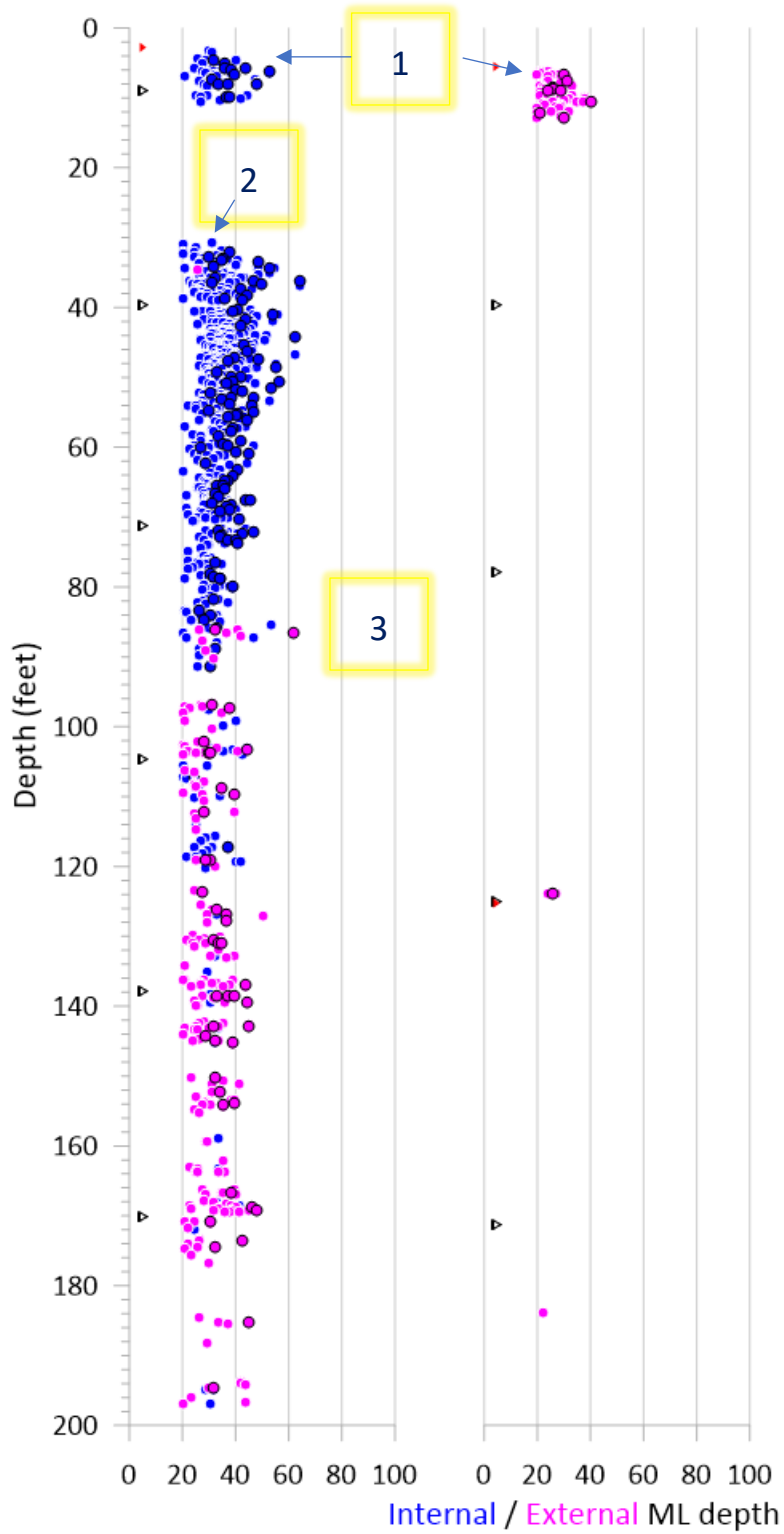
Label '3' identifies a region of external corrosion on the surface casing. This is believed to be the region of aquifers that would have resulted in the external corrosion. The corrosion changes from internal above this depth to mostly external corrosion below this depth.

Figure 21: #2244 Metal Loss from HRVRT Logs, 9 5/8 in. (2023, Left), 7 in. (2016, Right)

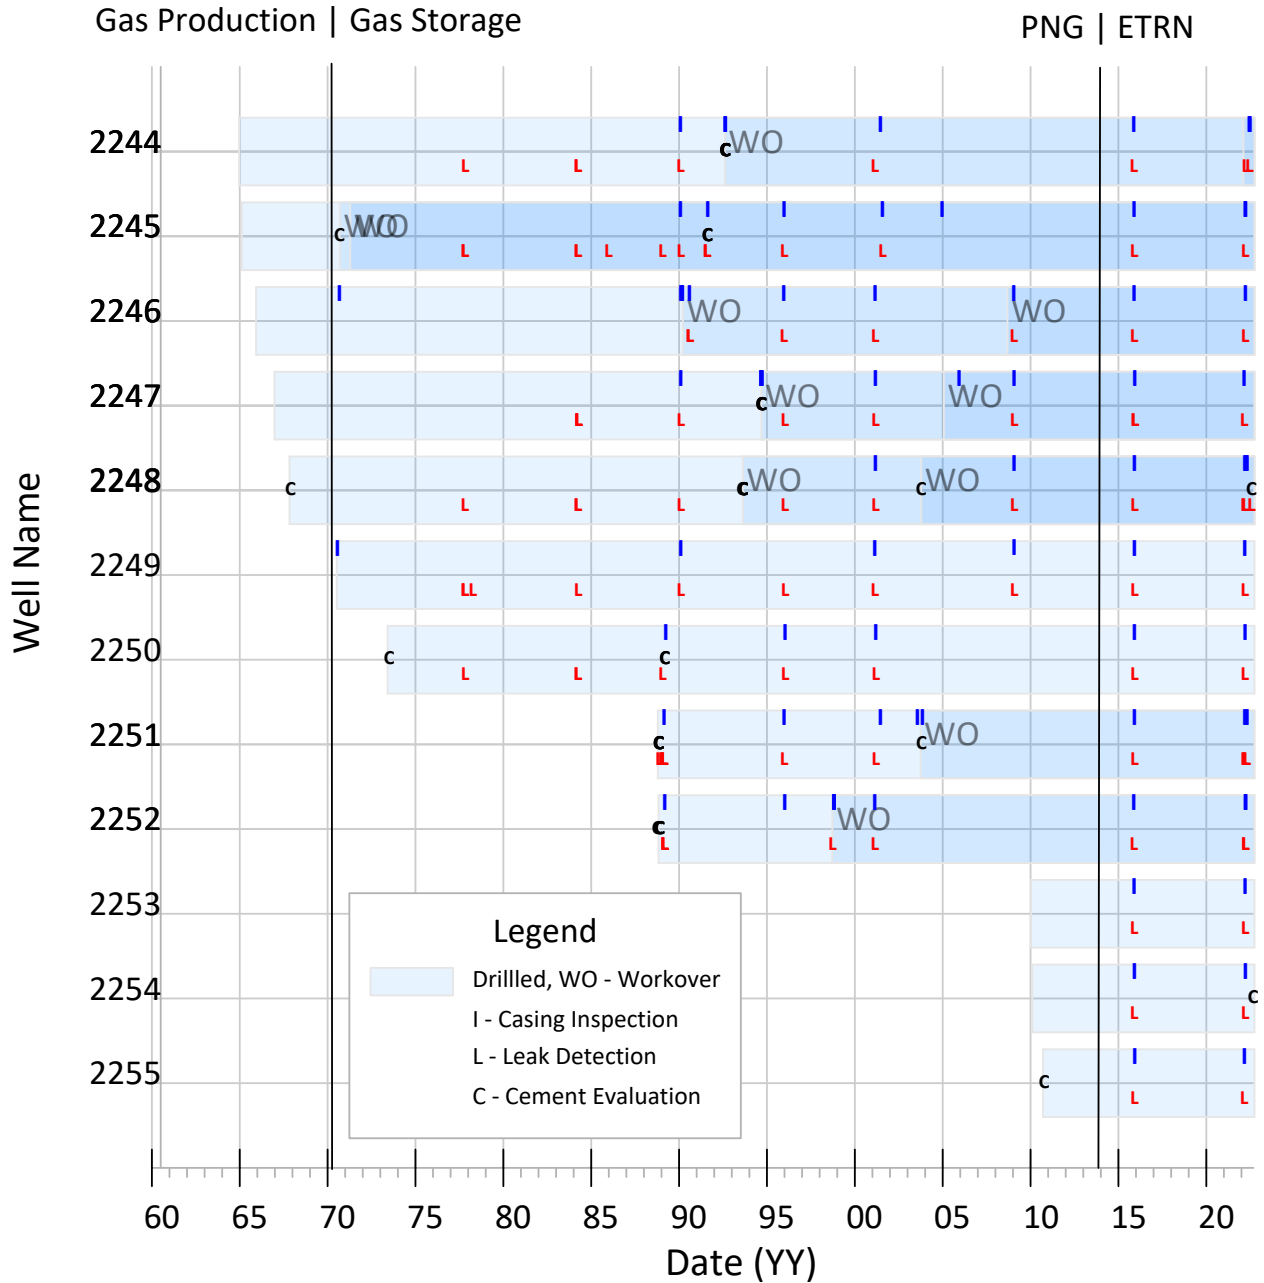
Figure 22: Timeline of Logging Activity

Figure 22 shows a timeline of when three types of logs were run by well. The time frame is from January 1965 to April 2023. The types of logs displayed, casing inspection, leak detection, and cement evaluation are denoted by I, L, and C, respectively. This discussion will collectively refer to these types of logs as integrity logs. The formation evaluation and other types of logs are not displayed but listed in Appendix A.3.

Table 12 shows the breakdown of the logs by type for each well. The well names are listed vertically, and the type of logs are presented horizontally. The #2244 well was one of the most logged wells, reflective of it being the discovery well, consequently the oldest. A total of five casing inspection logs were run in #2244. The well with the greatest number of casing inspection logs is #2247 with ten logs. This is because there were five casing inspection logs between May 31, 1995, and June 15, 1995, that were associated with a workover. Three wells have one casing integrity log each, namely #2249, #2253, and #2254; and two wells, #2253 and #2254 (the newest wells), have no cement evaluation logs. The most recent wells, #2253, #2254, and #2255, have the least amount of information from a logging perspective. Figure 22 displays the timeline of the logging activity.

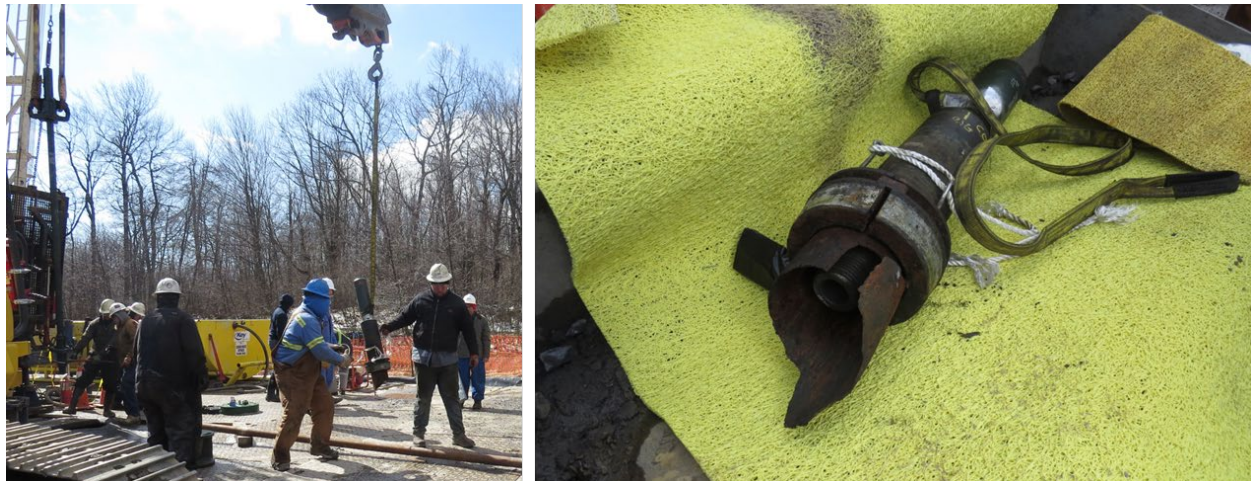
Figure 23: C001A Extraction

The upper portion of the failed casing was extracted on March 5, 2023. The casing was then cut at a depth of 20.5 ft, and the lower portion of the failed joint was extracted. The upper and lower sections of the failed joint were designated C001A and C001B. Figure 23 and Figure 24 show the extraction of C001A and C001B, respectively. The fishing tool used to pull the upper section of casing is also shown in Figure 23.

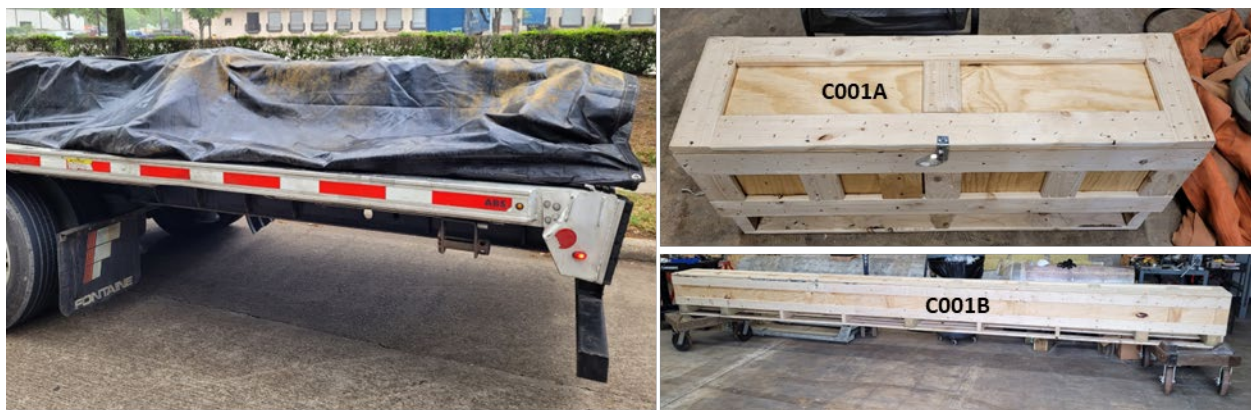
Figure 25: As-Received Condition of C001A and C001B Specimens

Section 3.2.1. discusses the workover summary to recover well #2244 casing. Thirty-four joints were recovered from the well, totaling 1,468 ft of 7 in. casing. The results from the post-event logging and rig inspection of the extracted casing found the corrosion was isolated to the top joints. The top six joints (including the failure joint) were selected for further examination in Houston. Casing joint C030 was also selected as a representative sample for the remaining joints extracted from the well and was also shipped to Houston. Figure 25 shows the as-received condition of the crates with the C001A and C001B specimens.

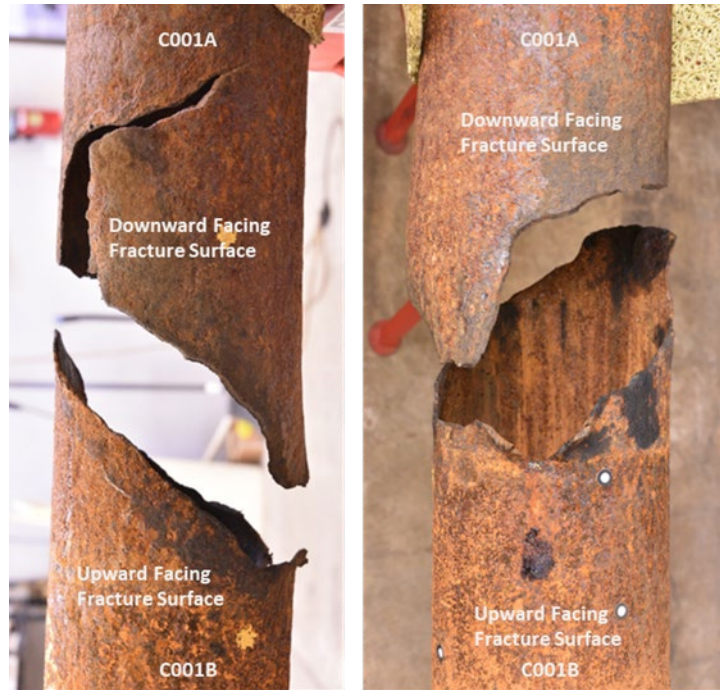
Figure 26: Photo of Axial Rupture and Parting of Joint C001 Rotated Approximately 180°

Figure 26 shows the top (C001A) and bottom (C001B) fracture surfaces of the parted casing (C001) retrieved from well #2244. The downward-facing fracture surface from the top-parted casing (C001A) was 0.9 ft below the slips. C001A contained the axial rupture that has an upper turning point and a lower turning point. Visual examination of C001A showed that the axial rupture extends to circumferential parting at the lower turning point and a small circumferential crack at the upper turning point.

C001B contained the circumferential fracture surface that was facing upward in the well. Figure 26 also shows that a small portion of joint C001 is missing (i.e., not retrieved from the well). The fracture surfaces were examined in detail at the Blade Laboratory in Houston, TX. The results of the evaluation are provided in the following sections.

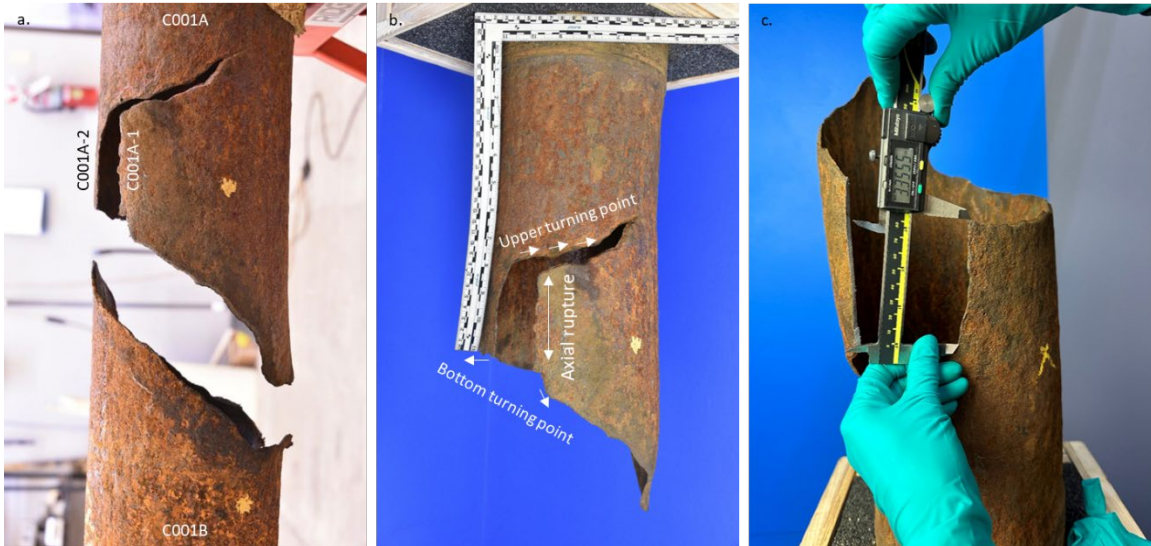
Figure 29: (a) C001B and C001A Fracture Fragments Showing Location of Axial Rupture in C001A, (b) Crack Direction in Axial Rupture, and (c) Measurement of Axial Rupture Length

The objective of the visual and stereoscopic examination is to identify the key features of the axial rupture, such as the length of the axial rupture, the thickness along the axial rupture, and the location of the turning points. The axial rupture produced two mating surfaces: fracture surfaces 1 (C001A-1) and 2 (C001A-2). The length of the axial rupture is approximately 3.36 in.

Figure 29 shows C001A (bottom-facing fracture surface) and C001B (upward-facing fracture surface) rotated to align the mating fracture fragments. The axial rupture is only present on C001A. The figure also shows the upper and lower turning points in C001A. C001A-1 and C001A-2 experienced plastic deformation, as evidenced by the bulge in Figure 29 a and b. Figure 30 shows the fracture surfaces of the axial rupture (C001A-1 in Figure 30a and C001A-2 in Figure 30b) and the upper turning point (Figure 30c). Chevron marks were not identified during the visual examination of C001A-1 and C001A-2 fracture surfaces.

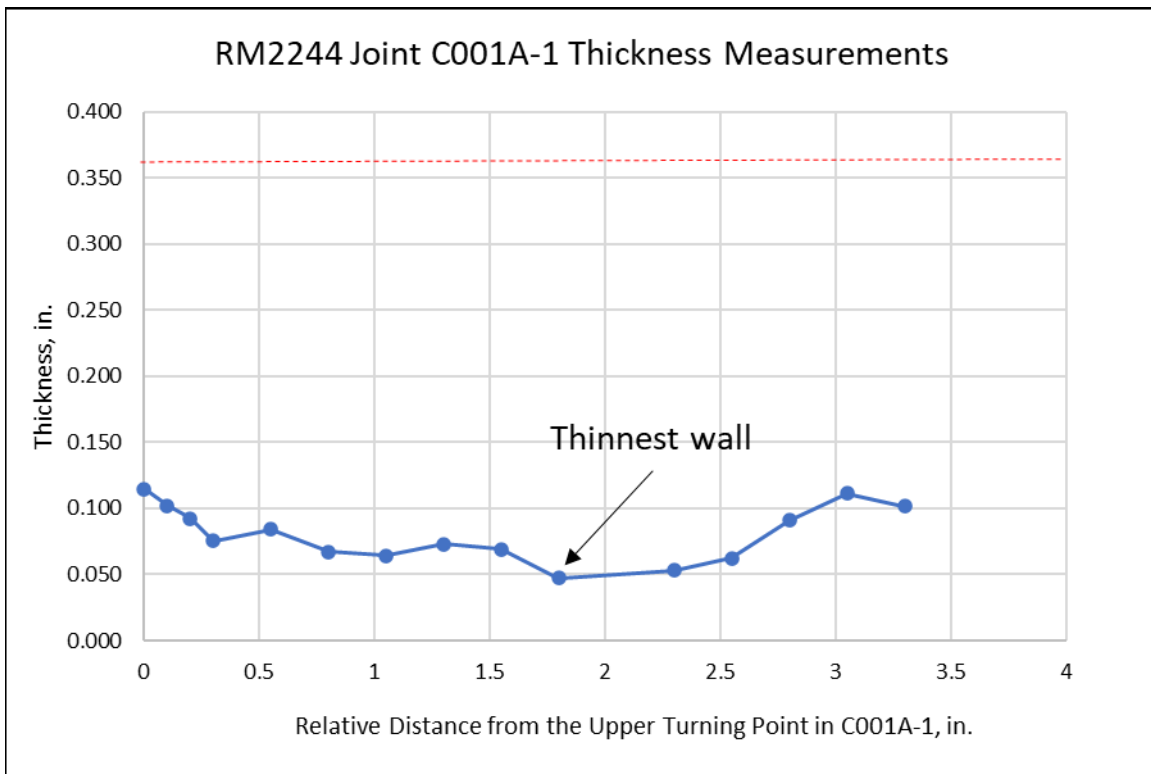
Figure 33: Plot of Thickness Measurements in C001A-1 Relative to the Upper Turning Point Location (Bottom of Figure 32b)

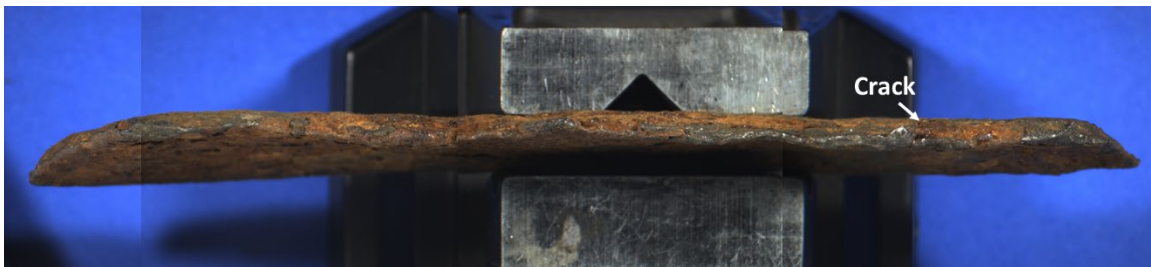
Figure 35: Stitched Stereoscope Image of C001A-1 Fracture Surface

Figure 35 and Figure 36 show the stitched stereoscope image of the fracture surface of C001A-1 and C001A-2 before any cleaning was performed. A small crack was observed at the step in C001A-1. The C001A-1 crack is indicated in Figure 35 by the white arrow. More details are presented about this crack in the circumferential parting section of the report.

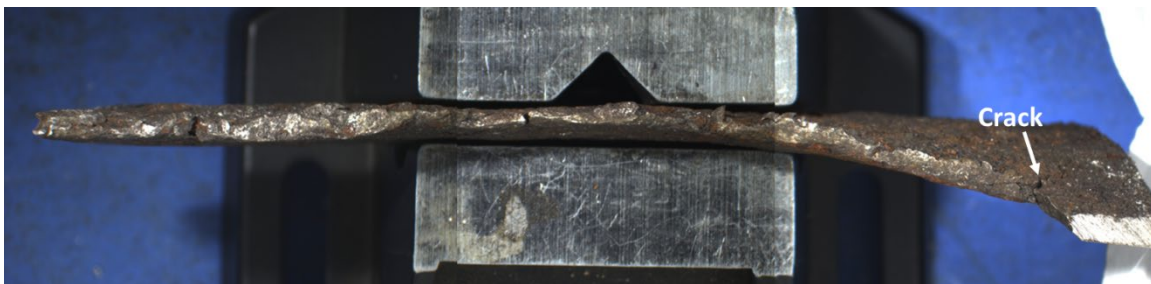
Figure 36: Stitched Stereoscope Image of C001A-2 Fracture Surface

A similar small crack was observed in C001A-2 at the upper turning point. The location of the crack at the upper turning point is indicated by the white arrow in Figure 36. Features were not observed on the fracture surfaces during the stereoscope examination. Chevron marks were not observed, consistent with visual examination.

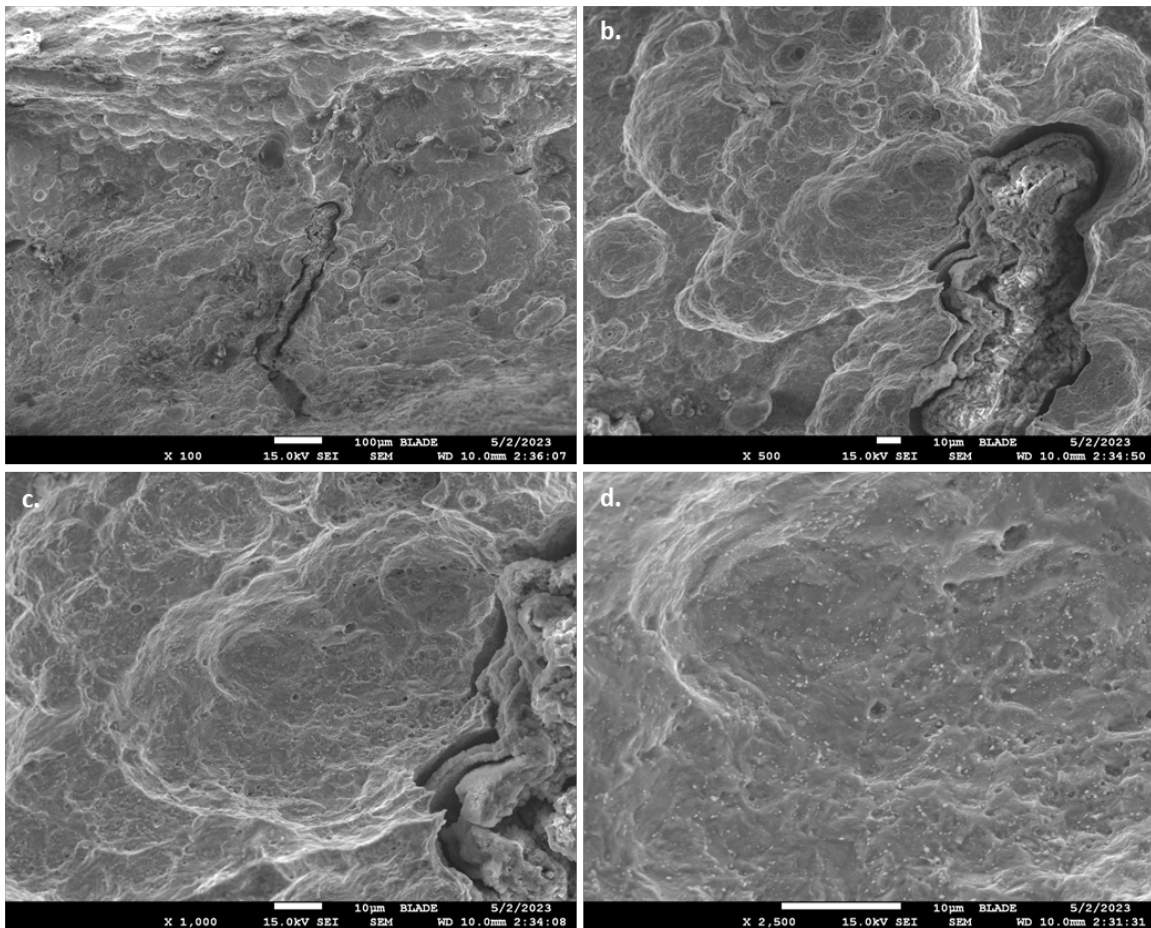
Area 1 is the thinnest region in C001A-1A specimen. Figure 44 shows the high magnification SEM images of Area 1. These images show the rounded pits observed on the fracture surface. Small, circular rounded pits are side by side and inside the bigger pits. Aside from the rounded pits, tiny (less than 10 μm) pits due to corrosion are also visible at 1000x and 2500x.

Figure 44: SEM Images of Area 1 in C001A-1A Fracture Surface Taken at (a) 100x, (b) 500x, (c) 1,000x, and (d) 2,500x

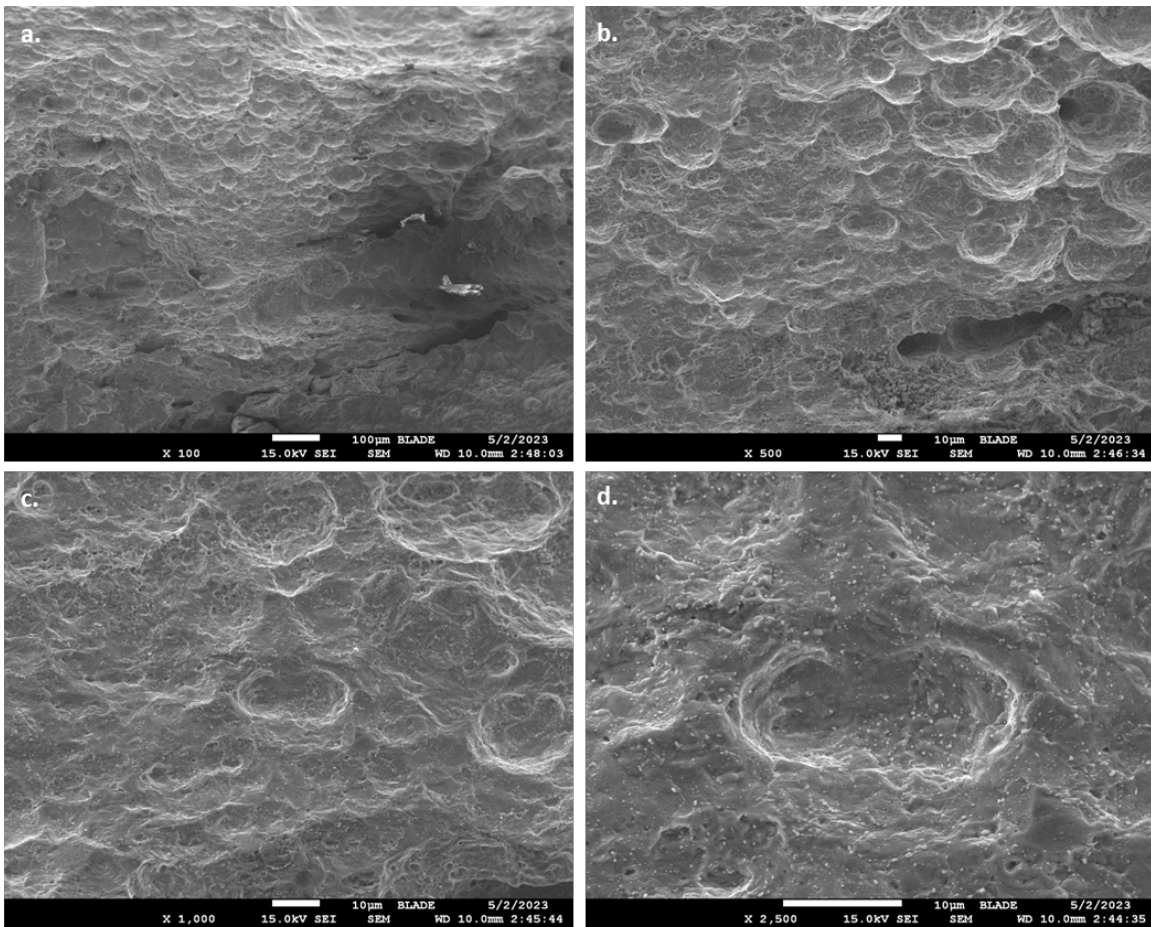
Figure 45 shows the higher magnification SEM images of Area 2 in the C001A-1A fracture surface. The images show the corrosion damage on the fracture surface, evidenced by the rounded pits and tiny pits observed on the fracture surface.

Figure 45: SEM Images of Area 2 in C001A-1A Fracture Surface Taken at (a) 100x, (b) 500x, (c) 1,000x, and (d) 2,500x

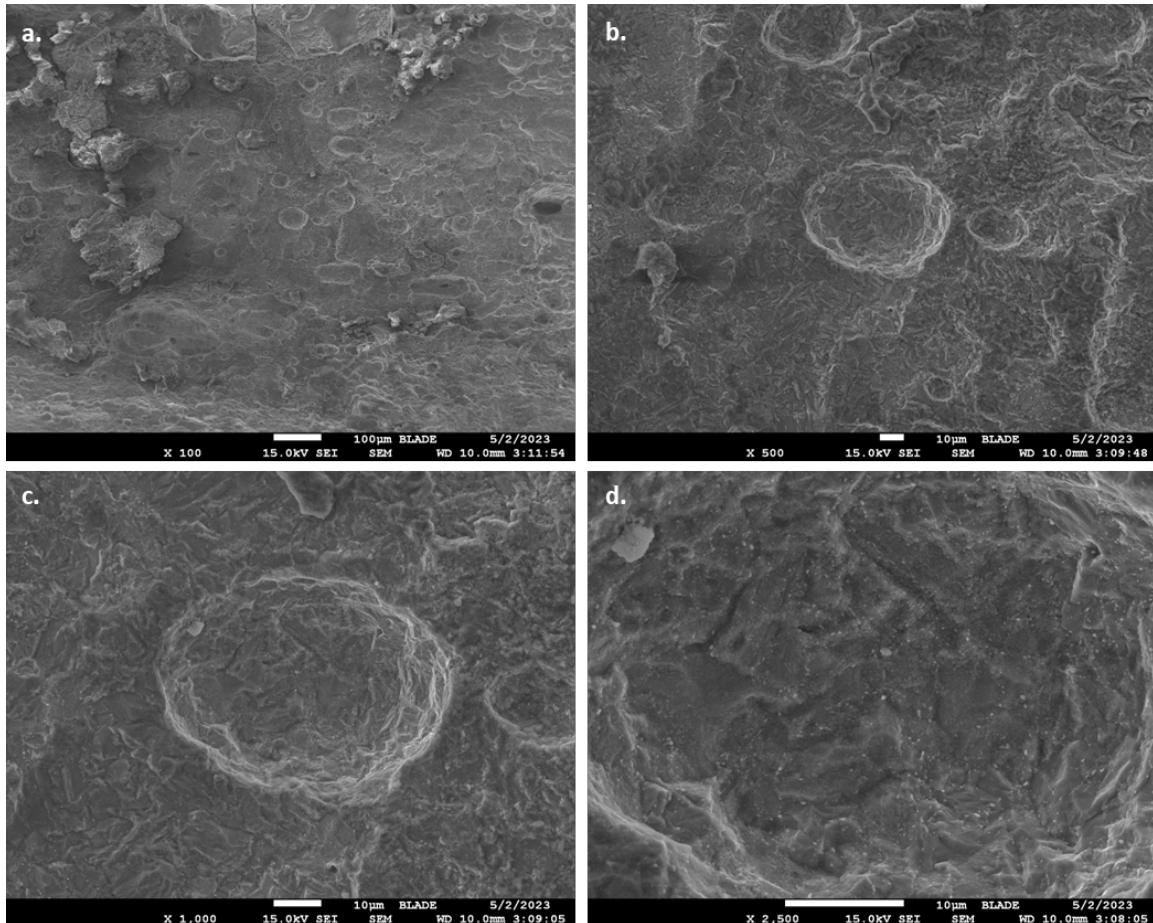
Figure 47 shows the SEM images of the corroded fracture surface in region 2. The circular pits are visible on the fracture surface. No clear evidence of cleavage nor facets exists in this region. The shape of the corroded region in Figure 47d takes the form of the underlying base metal microstructure (Figure 53 and Figure 238).

Figure 47: SEM Images of Area 3 in C001A-1A Fracture Surface Taken at (a) 100x, (b) 500x, (c) 1,000x, and (d) 2,500x

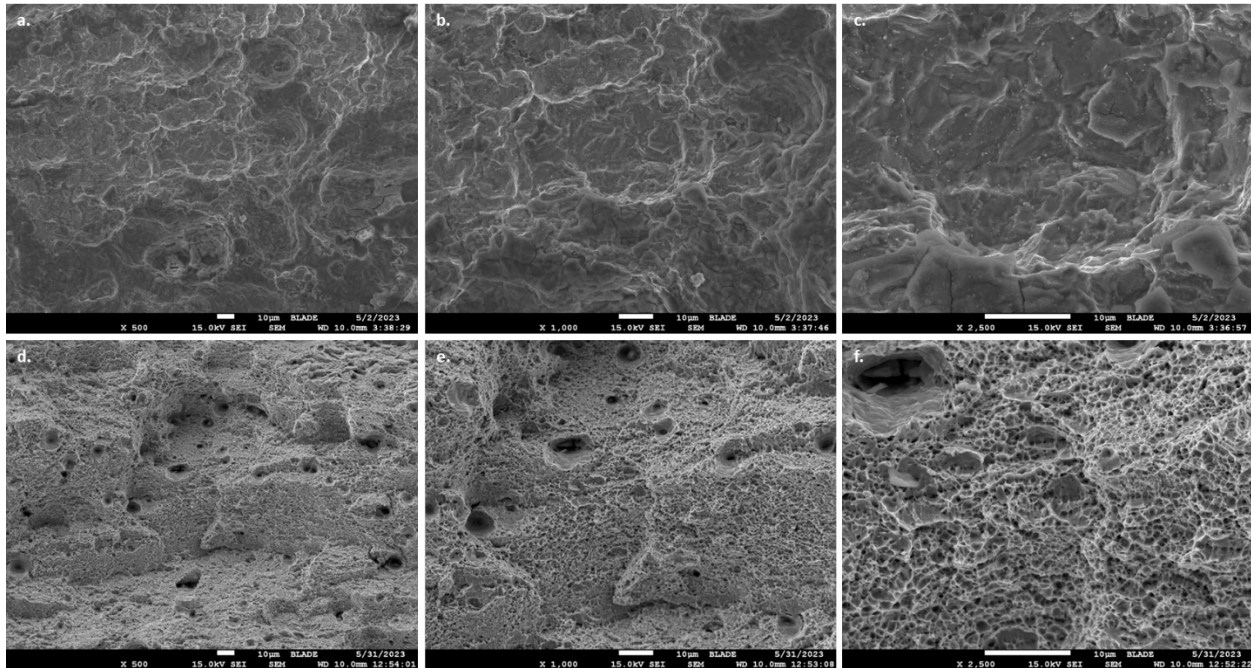
Figure 50: Comparison of Fracture Surface Features in C001A-1A (a, b, c) and N80 Base Metal Tensile Specimen Fracture Surface Micro-Void Coalescence Features (d, e, f) Imaged at 500x, 1,000x, and 2,500x

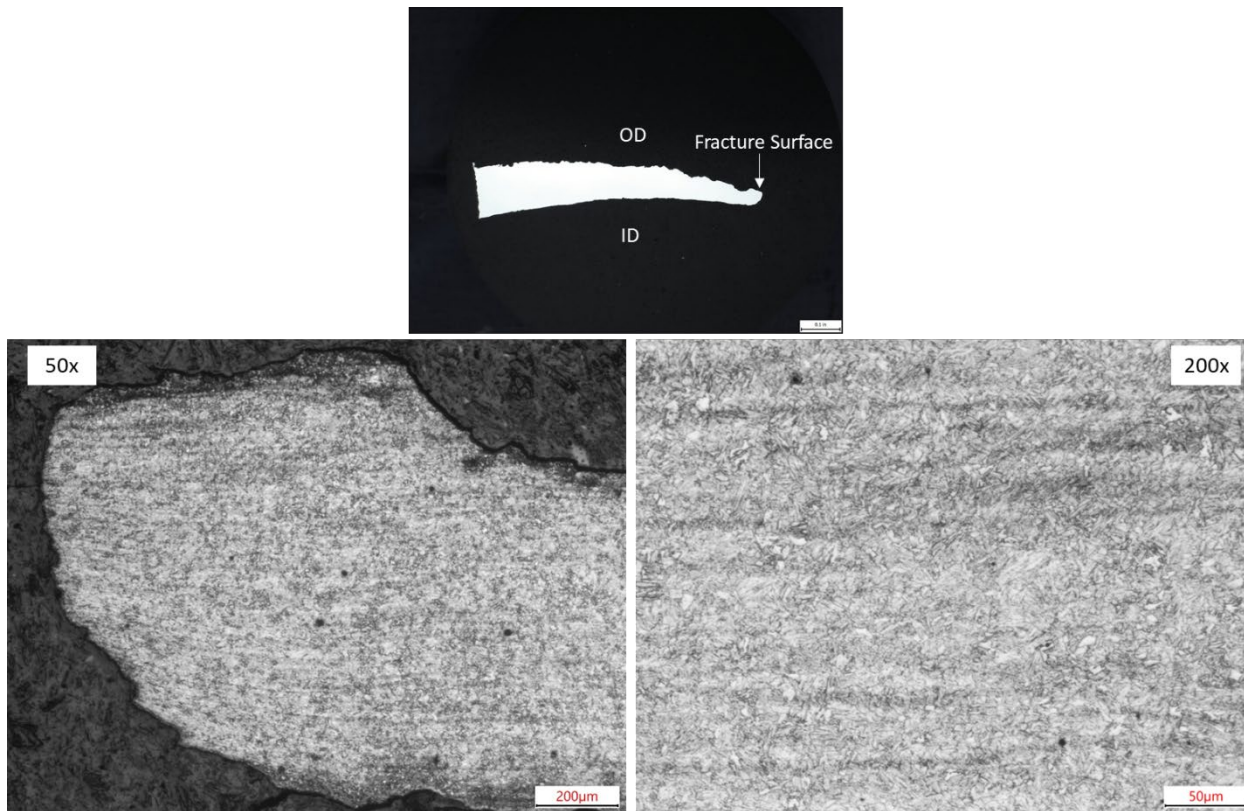
The image also shows the pits on the OD surface near the fracture surface. The ID surface has minimal-to-negligible corrosion pits. Figure 53 shows that the grains near the fracture surface are more deformed compared to the grains in Figure 54, which shows the microstructure away from the fracture surface. The microstructure is similar to the base metal microstructure reported in Section A.10.2.

Figure 53: Metallographic Images of C001A-1A2 Near the Fracture Surface, Etched in 2% Nital
