Rager Mountain Well #2244 Casing Failure Root Cause Analysis

Prepared for:
Equitrans, L.P.

RCA report on well #2244 7 in.
casing failure root cause analysis.

Date:
August 24, 2023

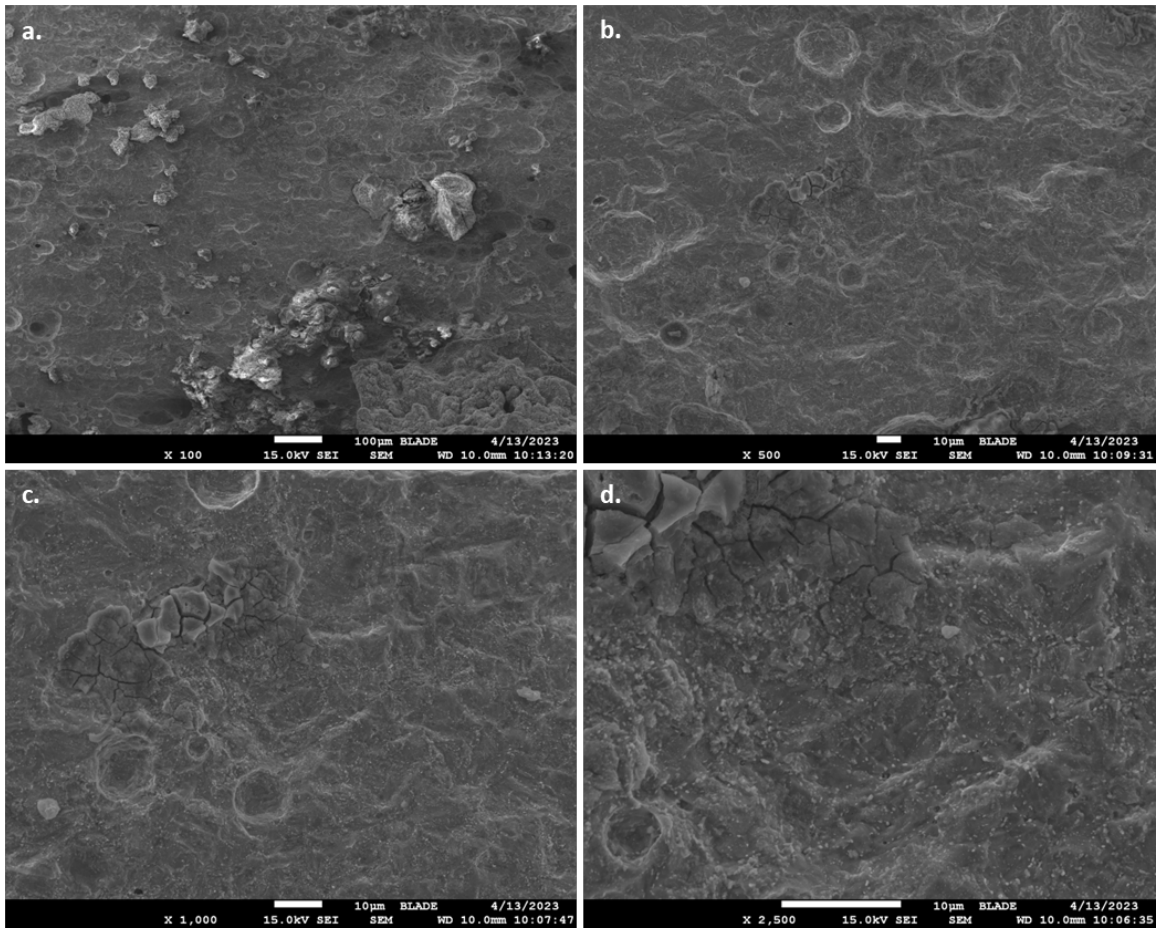
Figure 57 shows the higher-magnification images of the C001A-1B fracture surface. The fracture surface is corroded. No distinct cleavage or facet features are observed on the fracture surface.

Figure 57: Representative SEM Images of C001A-1B Fracture Surface Taken at (a) 100x, (b) 500x, (c) 1,000x, and (d) 2,500x

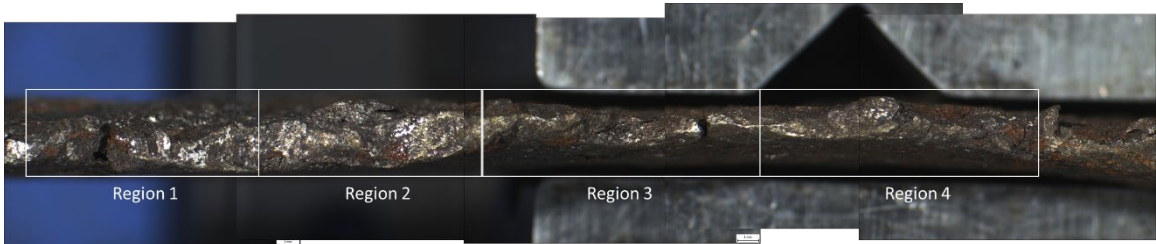
Figure 58: Different C001A-2A Regions Examined in the SEM

Figure 58 shows the four regions examined in the SEM in the C001A-2A specimen. Two small cracks are perpendicular to the axial fracture surface, one in region 1 and another in region 3. Figure 59 shows the stitched SEM photos of the four different regions. Based on the SEM examination, the features present in fracture surface of C001A-2A are similar to the ones observed in C001A-1A. The fracture surface contains rounded pits that signify corrosion damage. There are no distinct cleavage or facet features on the fracture surface. Figure 60 shows representative SEM images taken in each region.

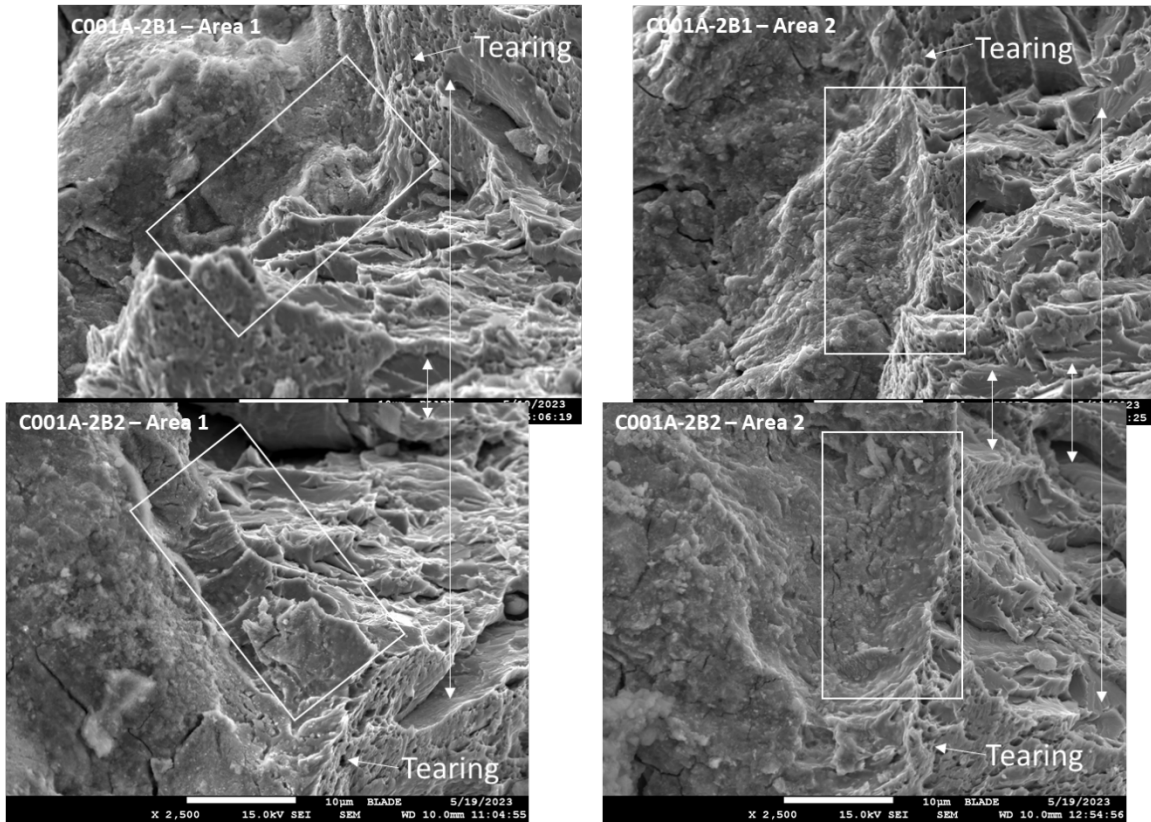
Figure 65 shows the areas examined in C001A-2B1 and C001A-2B2. Mating of the fracture surfaces at the crack front was attempted. The results from the examination show that the crack front is still covered with oxide. The transition to the liquid nitrogen fracture feature is marked by tearing.

Figure 65: Attempted Mating Features in C001A-2B1 and C001A-2B2

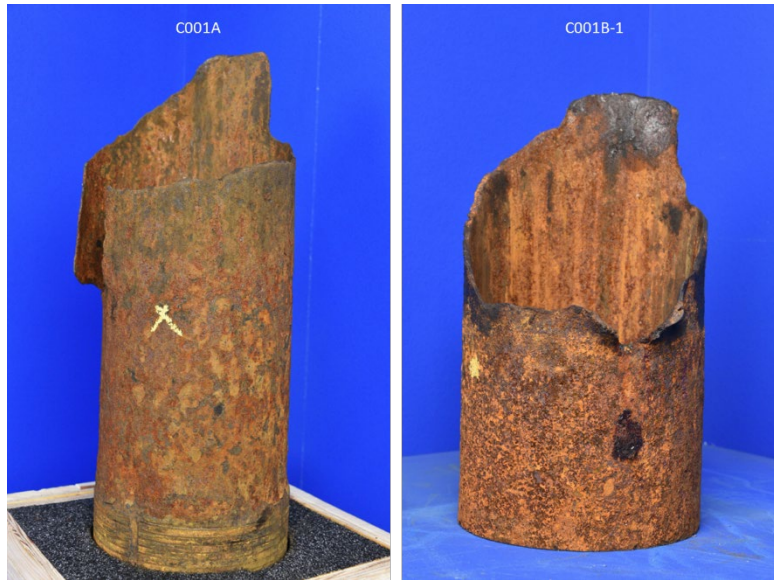
Figure 69: Specimens Containing Circumferential Fracture Surfaces

The circumferential downward-facing fracture surface is in C001A. The circumferential upward-facing fracture surface was cut from C001B and designated C001B-1. Figure 69 shows the specimens that contain the circumferential fracture surfaces. The circumferential fracture surface from C001A was chosen for the detailed fracture surface analysis, and the circumferential fracture surface from C001B-1 was preserved.

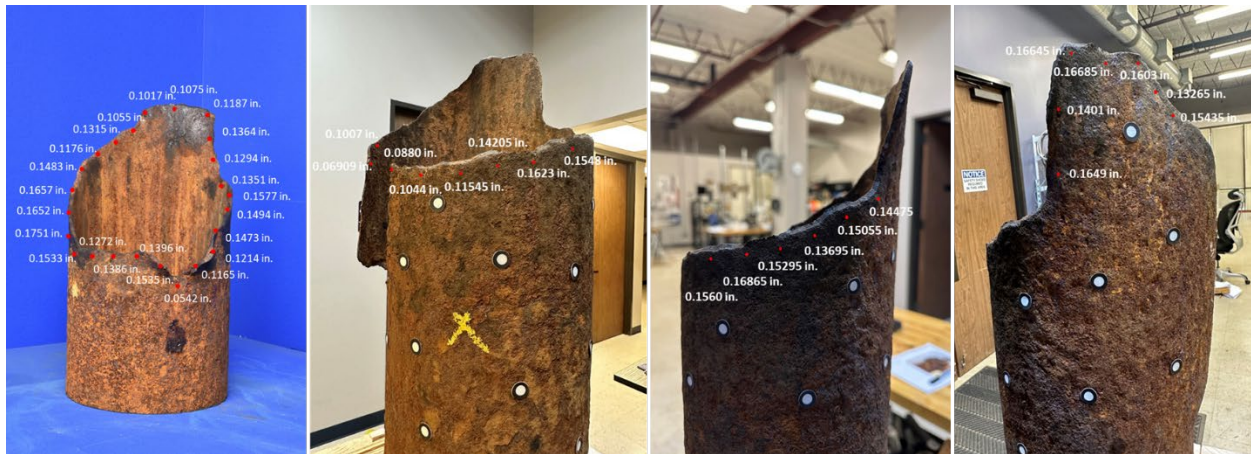
Figure 70: Thickness Measurements along the Circumferential Fracture Surface of C001B-1 and C001A

Thickness measurements were obtained along the circumferential fracture surface using a point micrometer. Figure 70 shows the individual values taken along the circumferential fracture surface in C001B-1 and C001A. The average wall thickness along the circumferential fracture surface in C001B is 0.133 in. The average wall thickness along the circumferential crack in C001A is 0.140 in.

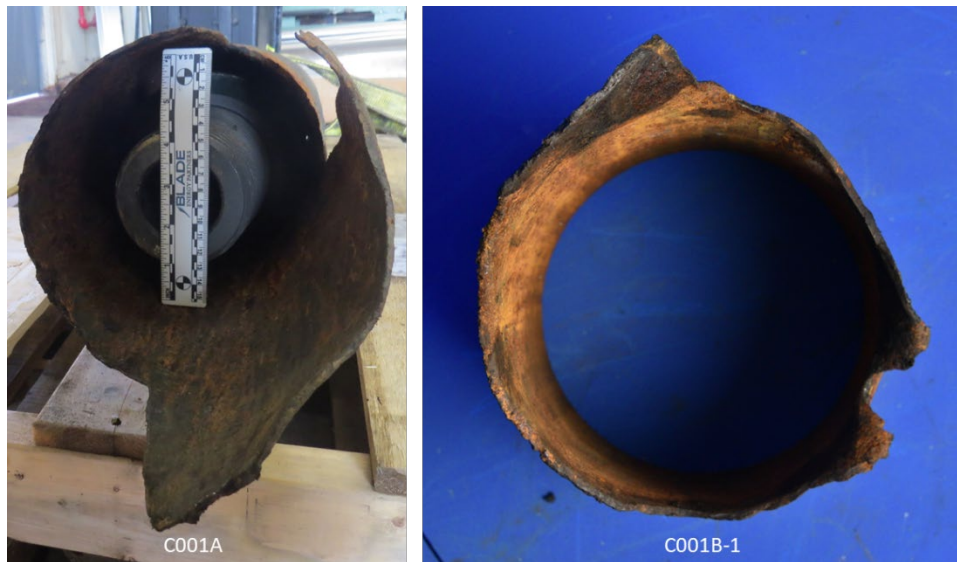
Figure 71: Circumferential Fracture Surfaces from C001A and C001B-1

The circumferential fracture surface was examined and documented using a digital camera and a stereoscope. Figure 71 shows the circumferential fracture surface from C001A and C001B-1. Examination of C001A indicates that most of the circumferential fracture surface is 45° shear and contains a shear lip.

The region in which shear lip was observed in C001B-1 matched the region where the missing fracture piece is located. From visual examination, no chevron marks are observed on the circumferential fracture surface of both C001A and C001B-1.

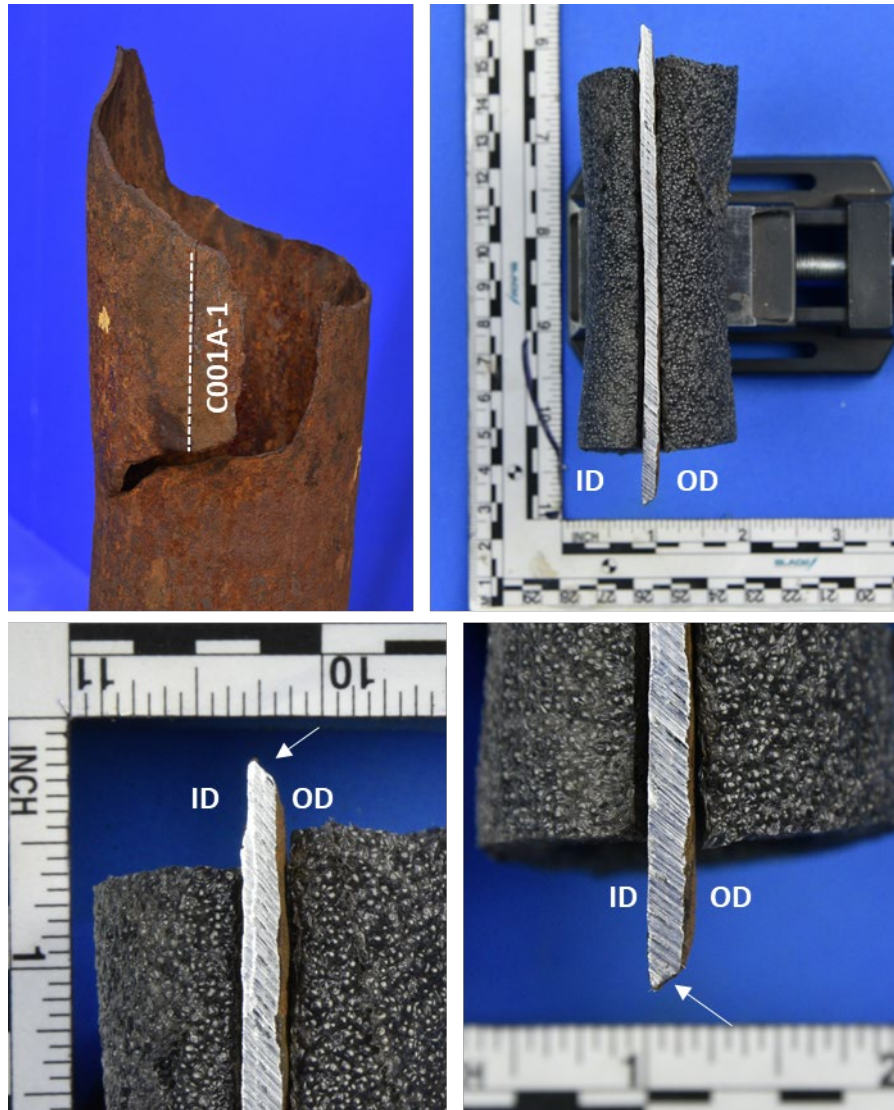
The arrows in Figure 76 show the circumferential fracture surface in C001A-1. The fracture surface is not perpendicular to the OD and ID surfaces, but about 45° oriented with respect to the OD and ID. The presence of a shear lip is prevalent in the circumferential fracture surface, indicating that the circumferential crack propagated in a shear-slip mode that is commonly considered as ductile.

Figure 76: Circumferential Fracture Surface in C001A-1A Specimen

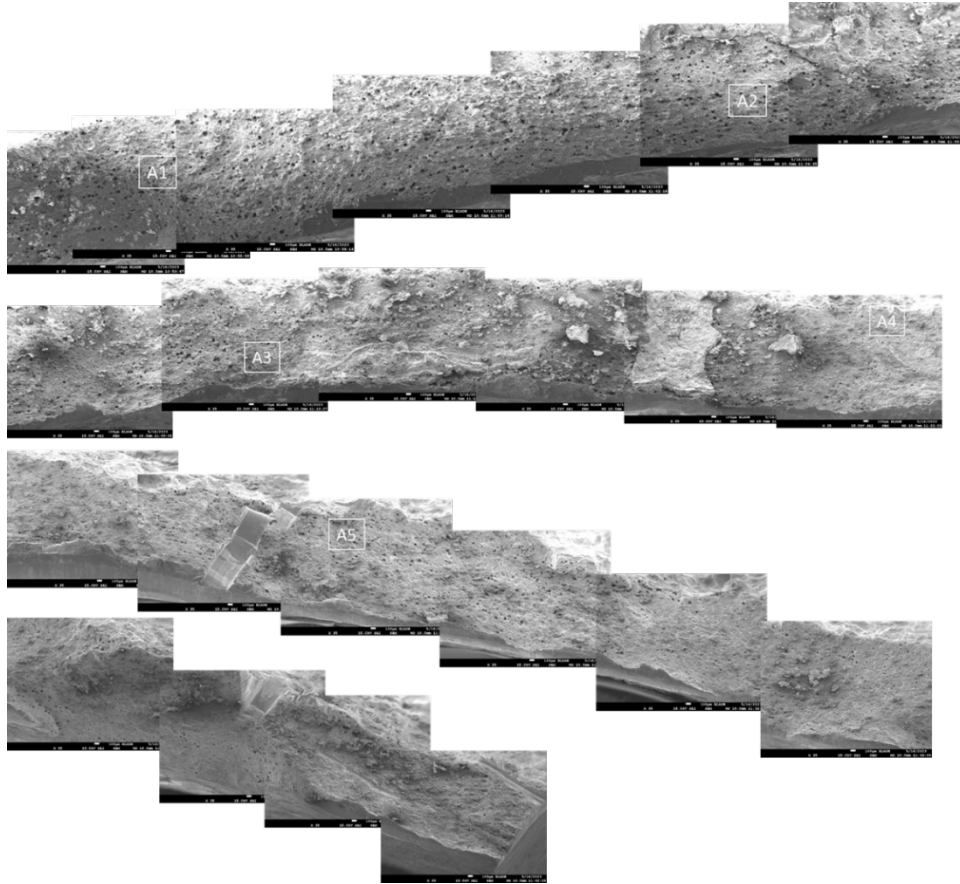
No distinct cleavage or flat features are observed on the fracture surface of C001A-4A. The circumferential fracture surface in C001A-4A is corroded. Although not presented here, the circumferential fracture surface in C001A-4B has the same features as C001A-4A. It has a shear lip and contains rounded pits. No distinct cleavage or flat features are observed on the fracture surface of C001A-4B.

Figure 80: Stitched SEM Images of C001A-4A (OD Surface at the Top of the SEM Image)

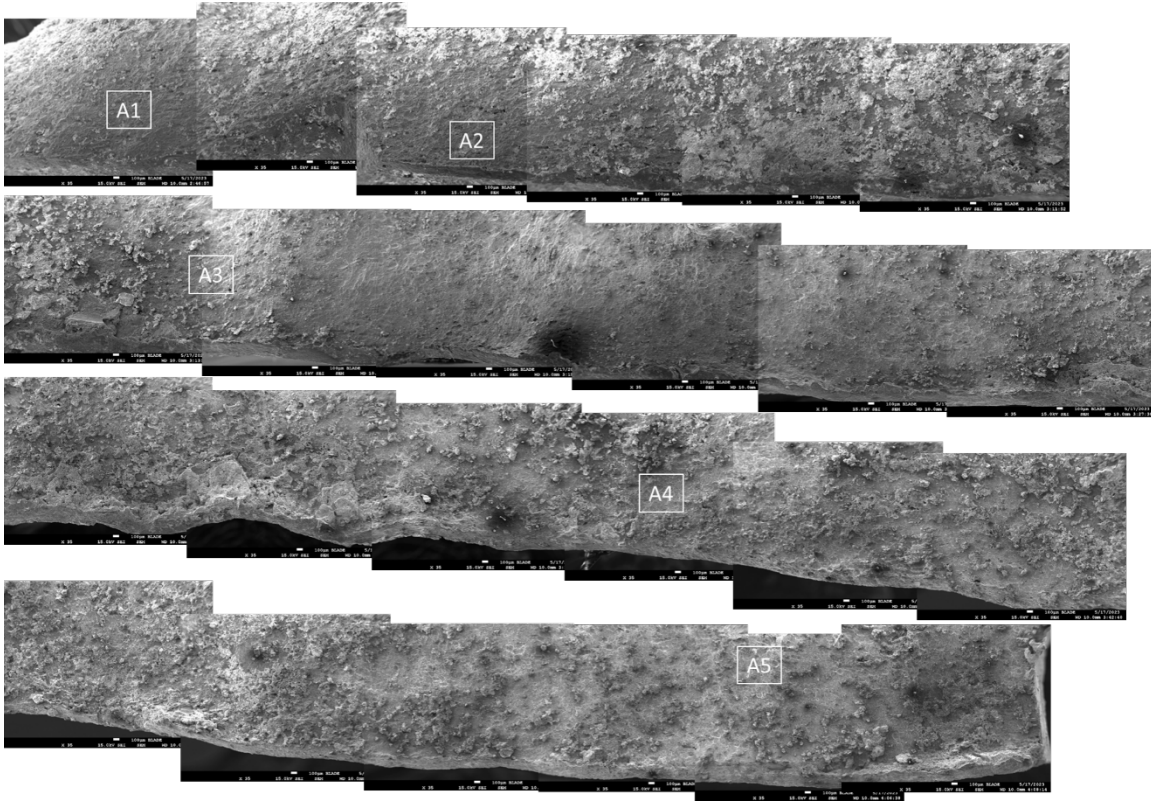
Rounded pits are also observed in the fracture surface of C001A-3B3. A3 in Figure 84 shows a relatively flat surface. This relatively flat region does not contain cleavage or flat facets. Instead, it is a smooth region, as shown in Figure 85 A3. The fracture surface in C001A-3B3 is corroded. Small corrosion pits are also observed on the fracture’s surface.

Figure 84: Stitched SEM Images of C001A-3B3

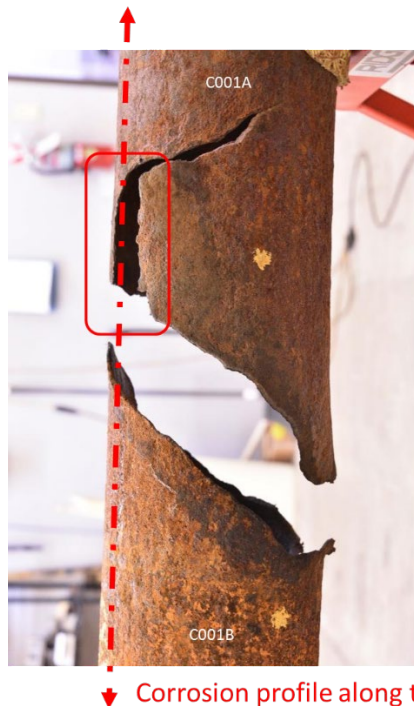
Figure 88: Orientation of Thickness Profile Used for Burst Pressure Estimation

The failure pressure was estimated in accordance with the ASME B31.6 guidelines based on the thickness of the top joint C001 in well #2244. The wall thickness profile along the rupture line was determined using a point micrometer. Figure 88 shows the rupture line along which the thickness profile was measured and used for failure pressure calculations. The wall thickness along the entire length of the C001-A and C001-B was measured using a combination of an ultrasonic thickness gauge and a point micrometer. The corrosion profile corresponding with the axial rupture was then estimated. Figure 89 shows the wall thickness profile along the axial rupture line. Figure 90 shows the schematic of the entire length of wall thinning observed in C001-A and C001-B.

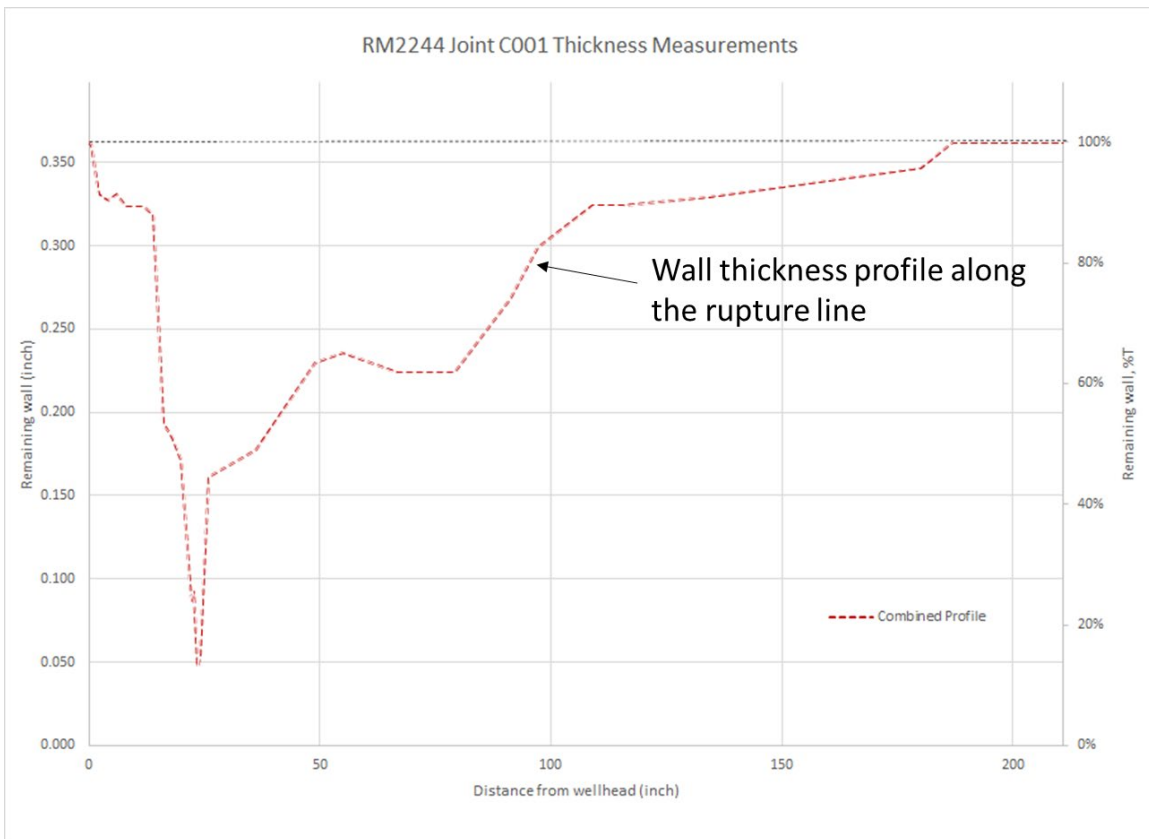
Figure 89: Wall Thickness Profile along the Axial Rupture

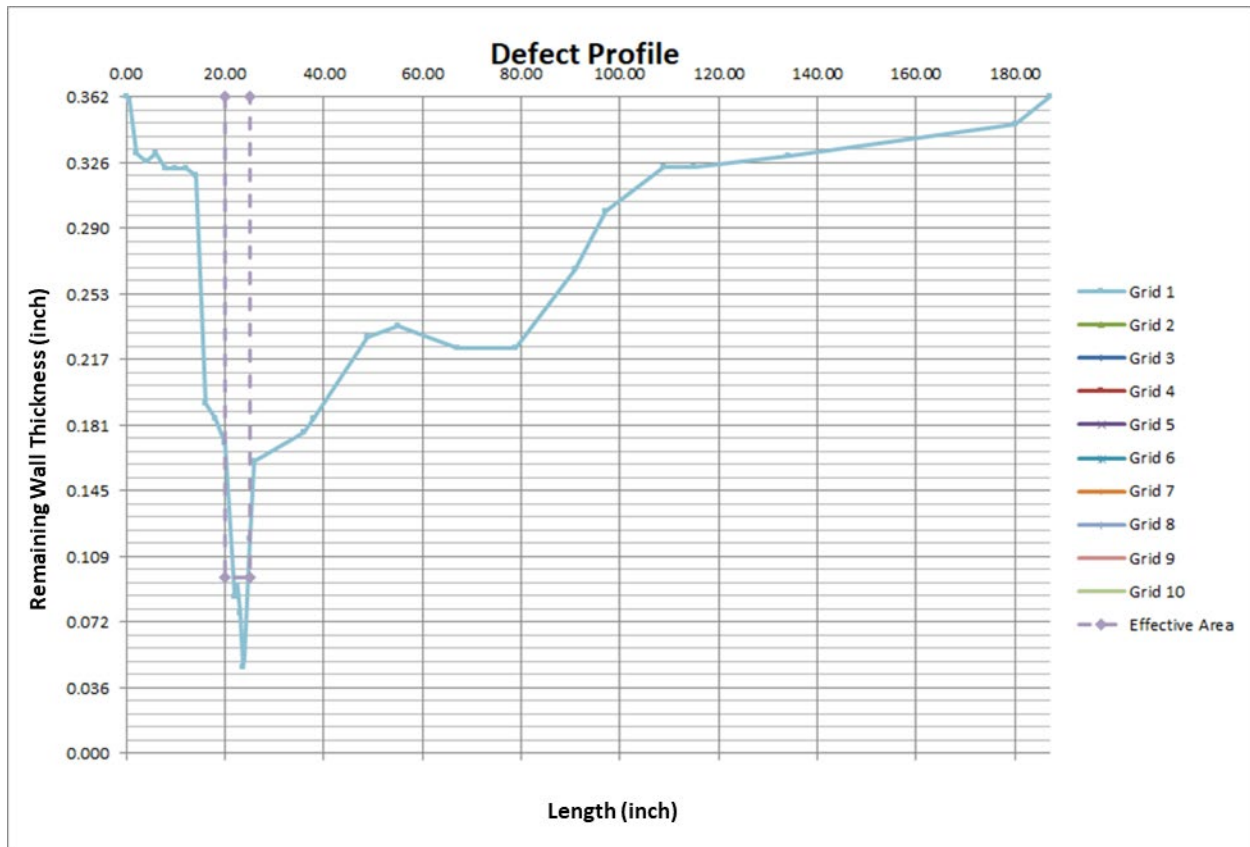
The analysis results show that the top joint's failure is due to excessive wall thinning. The remaining wall thickness of the 7 in. casing could not withstand the internal pressure in well #2244.

Figure 91: Results of Failure Pressure Calculation

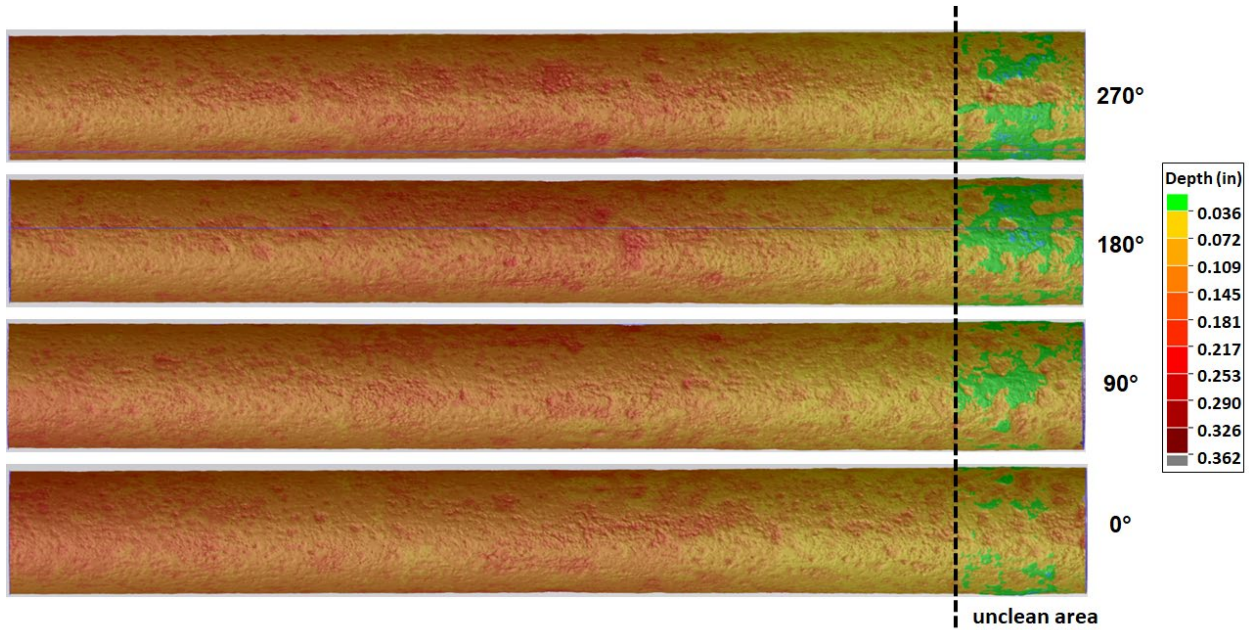
Figure 98: 360° Views Around C001B-2A

Circumferential Position hh:mm (Degree)	C001B-2A Top	C001B-2A Bottom	C001B-2C Top	C001B-2C Bottom	C001B-2E-1 Top	C001B-2E-1 Bottom
3:00 (90°)	0.220	0.259	0.292	0.320	0.330	0.355
6:00 (180°)	0.175	0.240	0.263	0.306	0.322	0.354
9:00 (270°)	0.176	0.261	0.256	0.339	0.333	0.342
12:00 (0°)	0.168	0.268	0.292	0.328	0.333	0.336
Average	0.185	0.257	0.276	0.323	0.329	0.347
Remaining Wall Thickness (% NWT)	51	71	76	89	91	96

Figure 98 and Figure 99 show, in detail, the 3D laser scan image of C001B-2A and C001B-2C around the entire circumference of the casing. These images indicate that wall thinning occurred in the entire circumference of the casing and was not concentrated on just one side. The areas that were masked from abrasive blasting are indicated by the dashed lines.

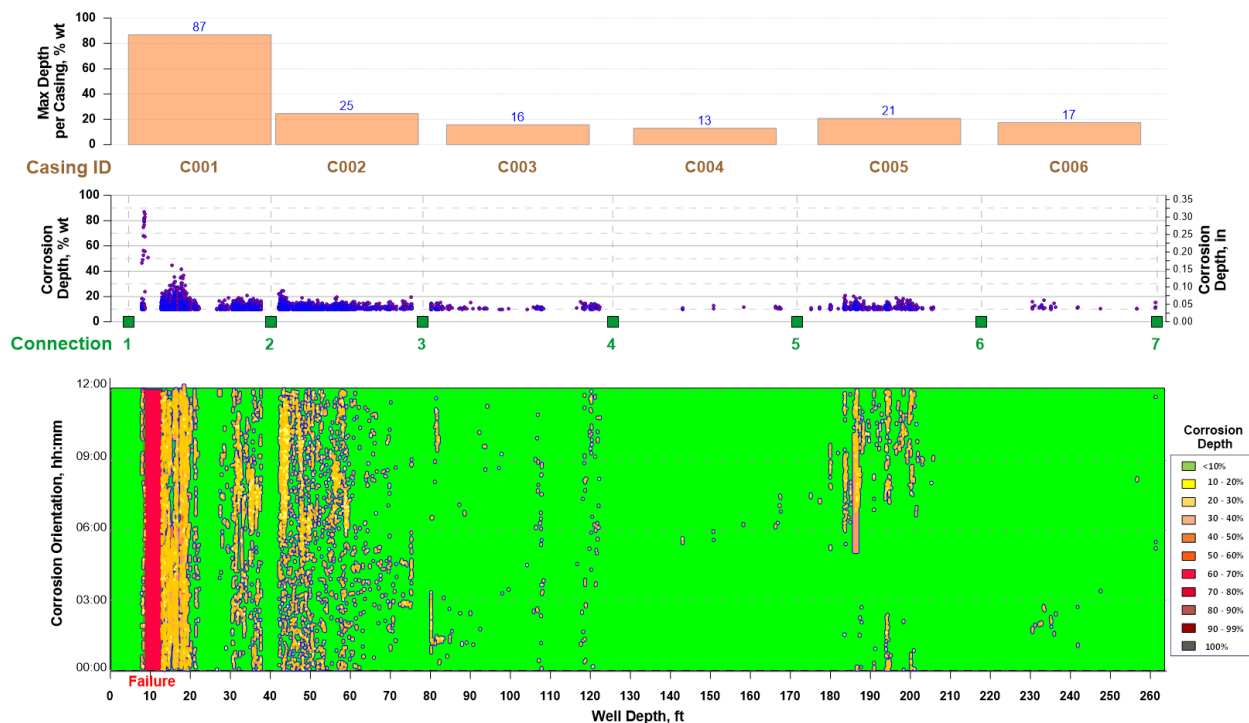
Figure 108: External Corrosion Distribution for Well #2244

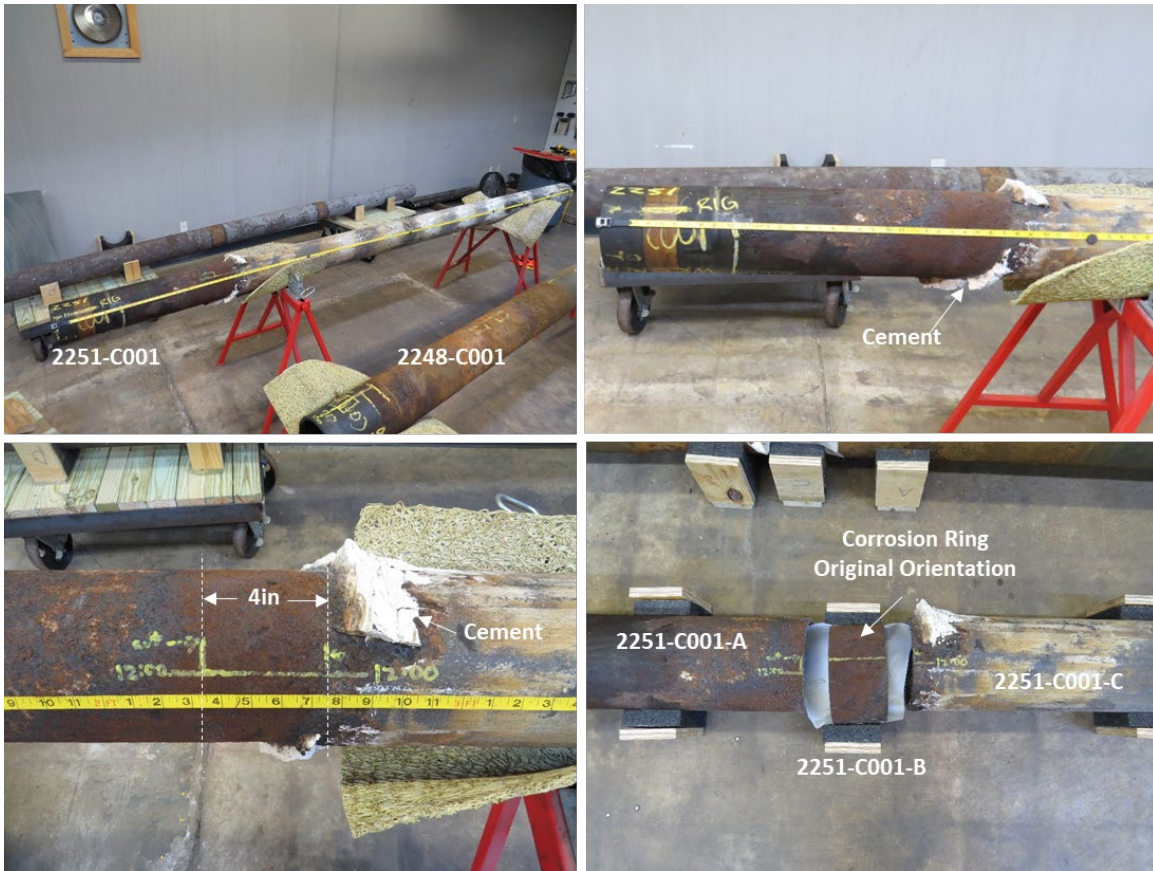
Figure 113: C001 Joint from Well #2251 Before and After Cutting

After removing small samples for analysis, the remaining 4 in. section was brushed clean and the deepest corrosion depths were measured with a micrometer, to be included in the corrosion distribution analysis. Figure 113 shows the location where the sample was extracted.

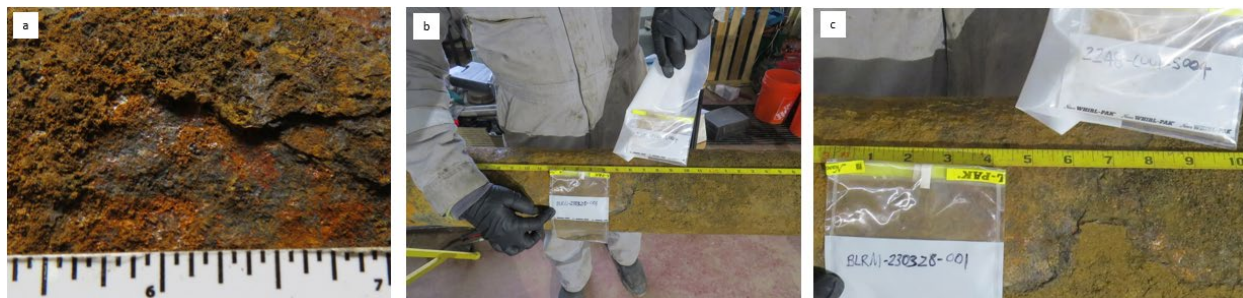
Figure 118: Example of OD Surface Scale and Deposit Collection and Bagging

In Figure 118a, the surface of #2248-C001 was photographed immediately after extraction from the well bore. The bright orange color indicates the spontaneous formation of hematite (flash rust) as the joint dries in the sunlight. The darker-colored scale consists of older, more stable corrosion products, clays, and deposits. Figure 118b and Figure 118c show the same region of the pipe under fluorescent lighting a few hours later. The location as a function of depth from the top of the joint was recorded for each scale sample.

Samples were sealed in plastic bags and shipped immediately for analysis. The BLRM prefix indicates a biological sample. Additional samples were collected separately for XRD/EDS/Raman mineralogical/elemental/compound analyses. Nineteen scale samples were collected from well #2244 for XRD/EDS/Raman analyses, six from well #2248, and four from well #2251. Biological sampling is discussed in a later section of this report.

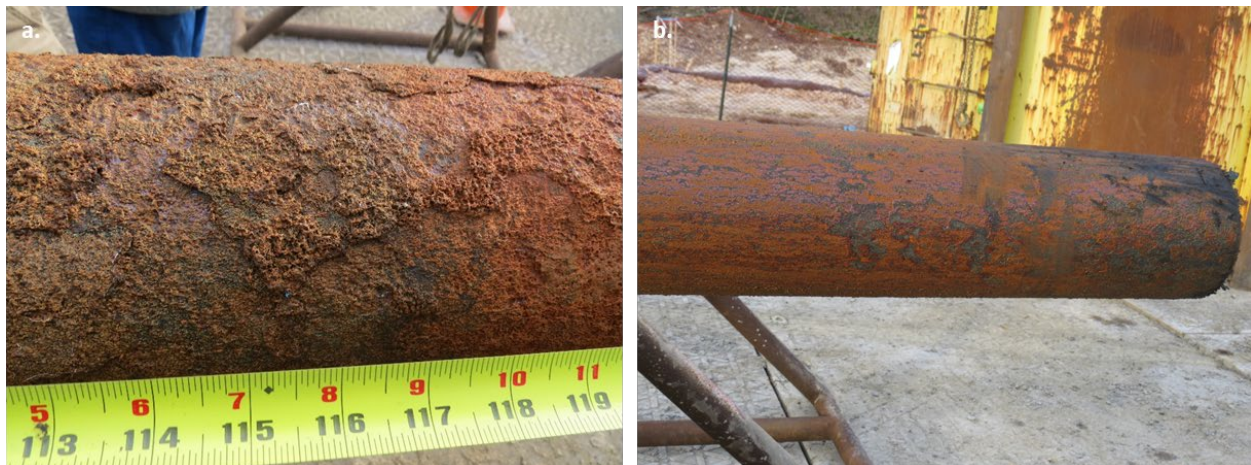
Figure 134: #2244 Joint C001B a. Top Portion Covered with Thick Scale, b. Bottom of C001B Cut End

For the case of Rager Mountain wells, it was observed that high rates of general wall loss were mainly occurring at the top joint. It was also observed from several wells where the top joint was pulled out, that a thick external deposit adhered to the top portion of the top joint. Inorganic and organic matter accessed the annular space due to the open valve. The debris mixed with the annular fluid and attached to the OD surface of the 7 in. casing.

Figure 134 shows the top portion joint C001B covered with scale or deposit after the joint was pulled out from the well. The amount of scale or deposit in the top portion of the joint is different from the portion near the cut end. Figure 135 shows the condition of the top joint from the other wells: #2248, #2251, and #2254 that is extensively covered with scale and debris.

Under-deposit corrosion is a possible corrosion mechanism in Rager Mountain wells. Under-deposit corrosion may be related to the deposited debris on the top joint of the well. The area under the debris has depleted oxygen compared to the region without deposits. The area under the deposit acts as an anode, and the uncovered region acts as a cathode. General corrosion occurred in the region under the deposit.

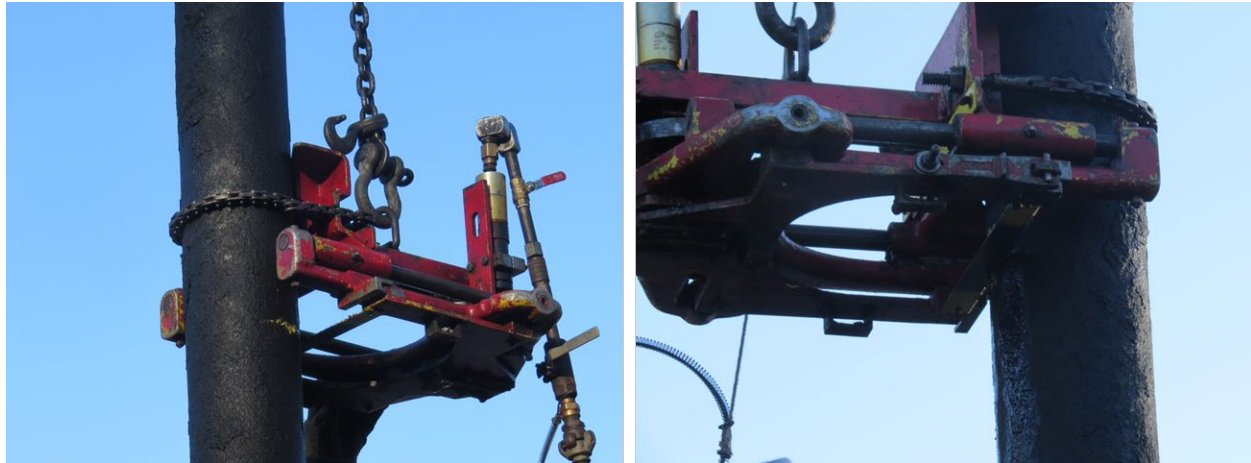
Figure 136: Casing Cutter on C002

Thirty-three 7 in. 26 ppf N80 connections from well #2244 were sent to Blade Energy Laboratories in Houston, TX, for connection testing. The objective of the testing was to determine if the connections leaked and, if so, at what rate. The connections were removed from the string during field operations by cutting each joint approximately 2 ft above the connection using a casing cutter (Figure 136). The extracted joints were shipped to a storage facility in Johnstown, PA, where the connections were removed from the joint by making an additional cut approximately 2 ft below each connection. The resulting connection samples were approximately 5 ft long and were shipped to Houston, TX, in wood crates.

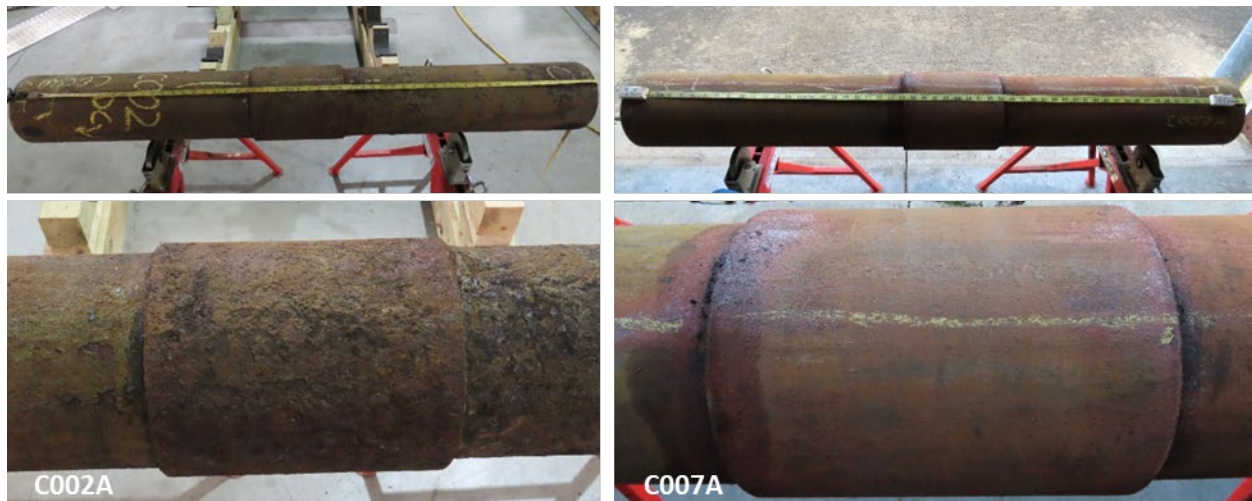
Figure 140: Connection C002A and C007A

The top joints (C002A, C003A, C004A, and C005A) had corrosion on the connection and the surrounding casing, consistent with the casing observations. The corroded casing surface required additional work to ensure a gas-tight seal between the neoprene and pipe surface, including extra cleaning in pitted areas and using epoxy to fill in corroded pits to ensure good adhesion.

Figure 140 shows the as-received conditions for C002A and C007A. The images show a clear difference between the surface conditions on the connection and pipe surfaces. C002A shows general corrosion and pitting, whereas C007A has a relatively clean surface free of corrosion and pitting.

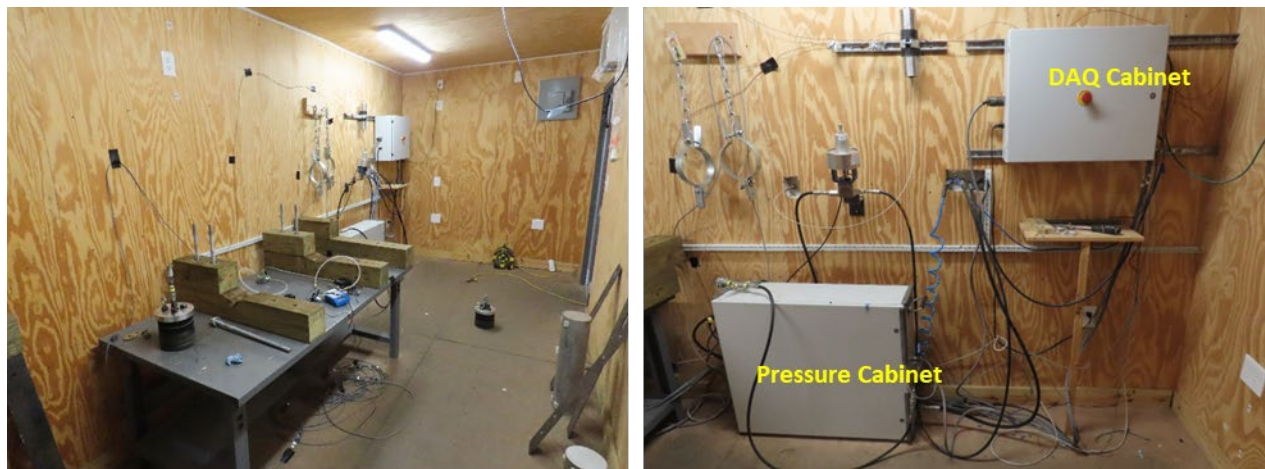
Figure 143: Interior Views of the Leak Test Structure

Blade conducted connection leak tests on 19 of the 33 connections sent to Houston for testing. The testing was conducted at Blade's warehouse inside a Conex (sea container) for safety. Figure 143 shows the interior views of the test structure. The image of the interior shows a table with wooden tie points to secure the connection during testing. The grey cabinets on the floor and mounted on the wall of the Conex are the pressure and Data Acquisition (DAQ) cabinets, which are labeled in Figure 143.

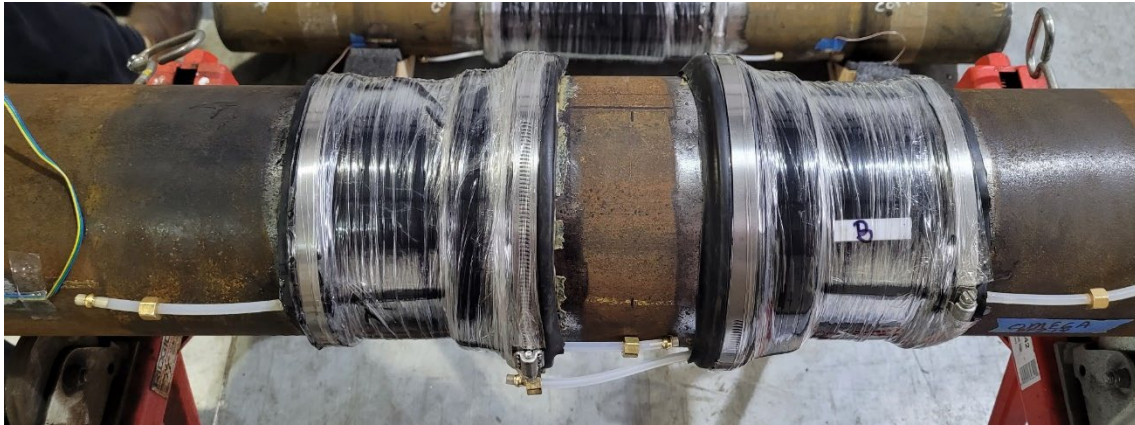
Figure 147: Double Boot for C007A

The single boot was removed and replaced with a double boot. The double boot isolated the mill and field side of the connection, allowing the engineer to determine which side of the connection was the source of the leak. Figure 147 shows the double boot after installation. Each boot was leak and flow-through tested, as done with the single boots. The mill side was tested first using the 0 – 4 SCC/minute flow meter. Figure 148 shows the results. The mill side of the connection did not leak.

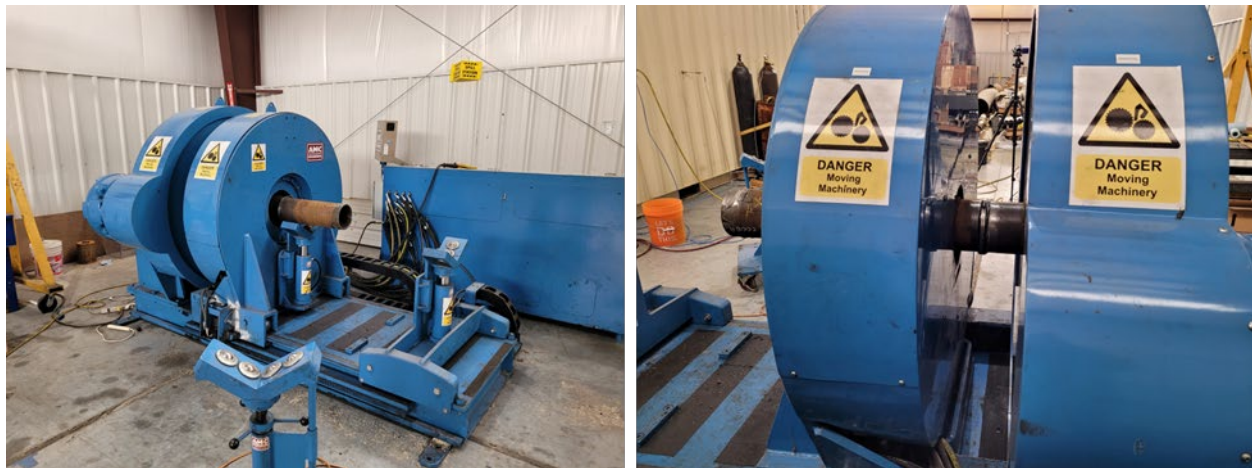
Figure 152: Torque Turn Unit

Four connections were chosen for breakout: C002A, C007A, C008A, and C019A. The connections were backed out using Blade's torque-turn unit. Figure 152 shows the torque-turn unit with a loaded specimen. The unit is made up of a tailstock and headstock.

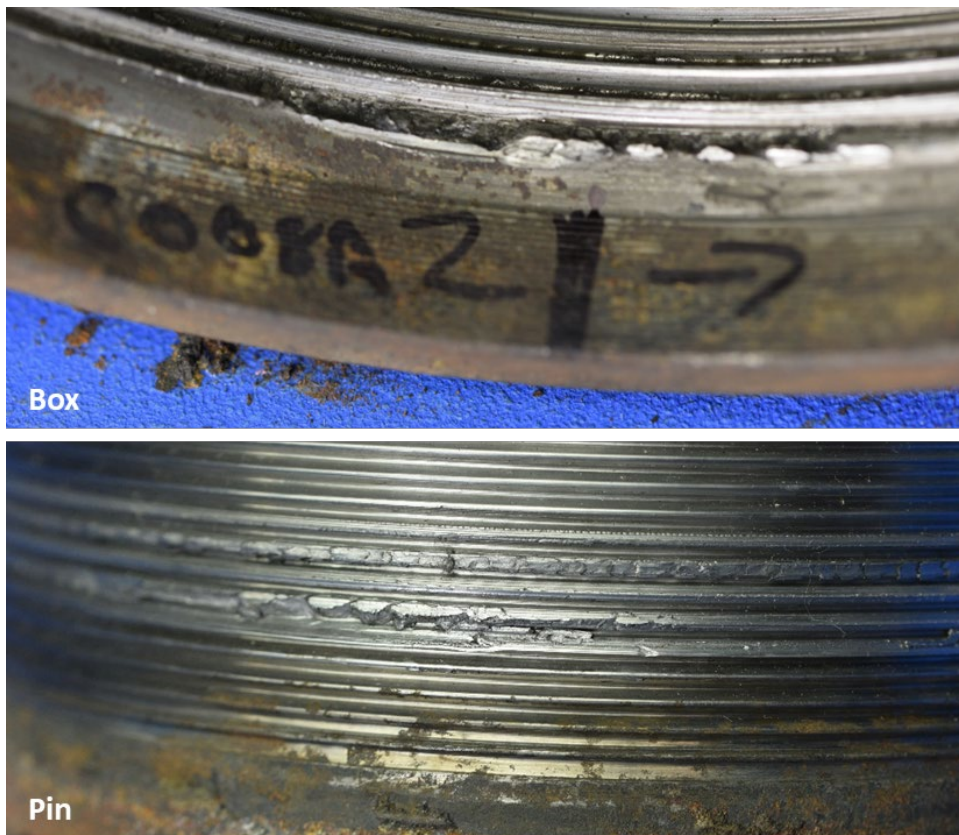
Figure 158: Galling on C008A Pin Threads

Figure 158 shows the galling observed on the threads of C008A. The galling could explain the high torque observed in the torque turn plot (Figure 155) and the anomaly at 1.65 turns.

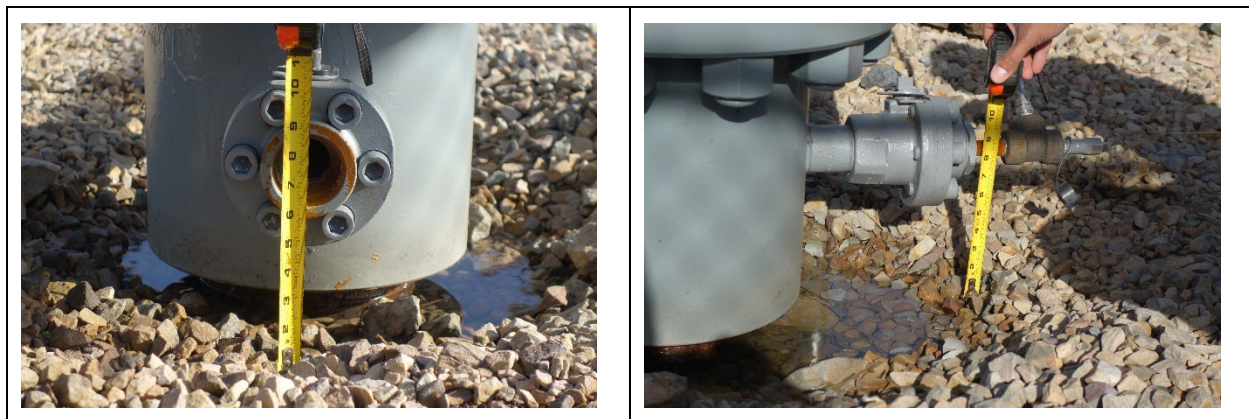
Figure 159: Well #2254, Annulus Valve Height Measurements, March 25, 2023, Open Side (Left) and Pressure Fitting Side (Right)

Blade visited nine Rager Mountains wells on March 25, 2023, to measure the height above ground of the annulus valves. These heights were taken using a standard tape measure with the ground level as zero and measured to the center of the annulus valve. Figure 159 shows the height measurement process at the #2254 well site. There were two annulus valves on the casing head directly opposite from each other. Two measurements were taken for each side. An annulus valve is shown on the left. It is in the open position. The picture on the right shows an annulus valve, also in the open position, but with a threaded pressure fitting. Typically, this pressure fitting does not permit the ingress of water and/or air; it is intermittently used for checking annulus pressure.

The wells that have top joint wall loss have varying heights of annulus valves (e.g., 4.5 – 18.5 in.). Blade did not find any direct or simple correlation from annulus valve height to amount of top joint corrosion. Blade did find local pooling adjacent to the wellhead (Figure 159), discussed later in this section.

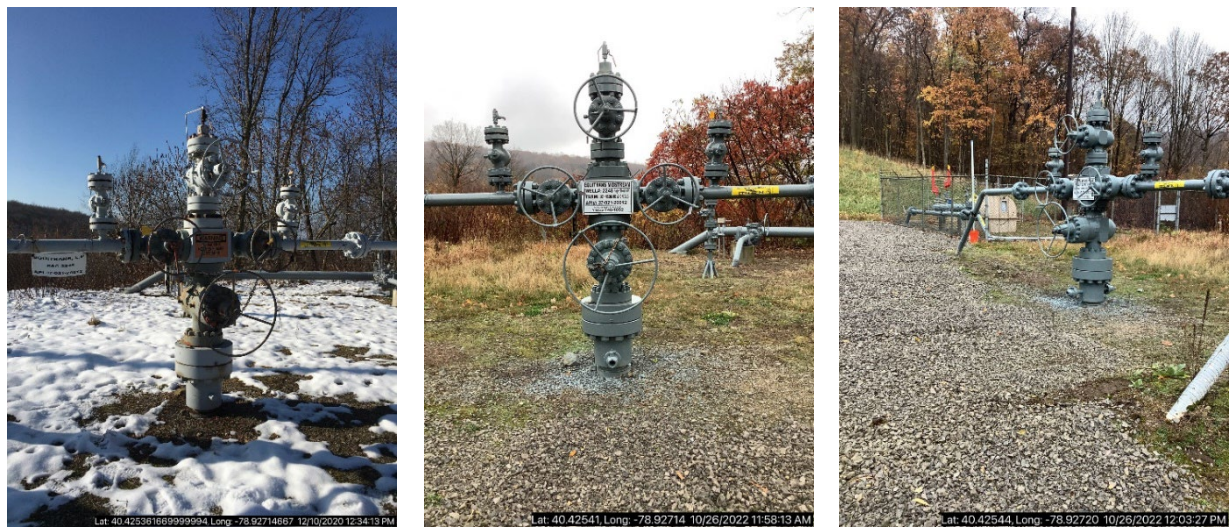
Figure 161: Well #2248 December 10, 2020, Left; October 26, 2023, Middle and Right [DEP]

Figure 161 and Figure 162 show pictures of the #2248 and #2251 well sites, respectively, at different dates by DEP inspectors. No indications of local pooling were observed. However, the ground conditions changed over time from grass to gravel/rock. No snow is located near the wellhead. Blade’s interpretation is that warm withdrawal gas has warmed the wellhead and adjacent ground. Blade’s opinion is that at times of significant snowfall or large snow drifts, this warmth could melt adjacent snow and make it possible for the water to enter the annulus through the open valve.

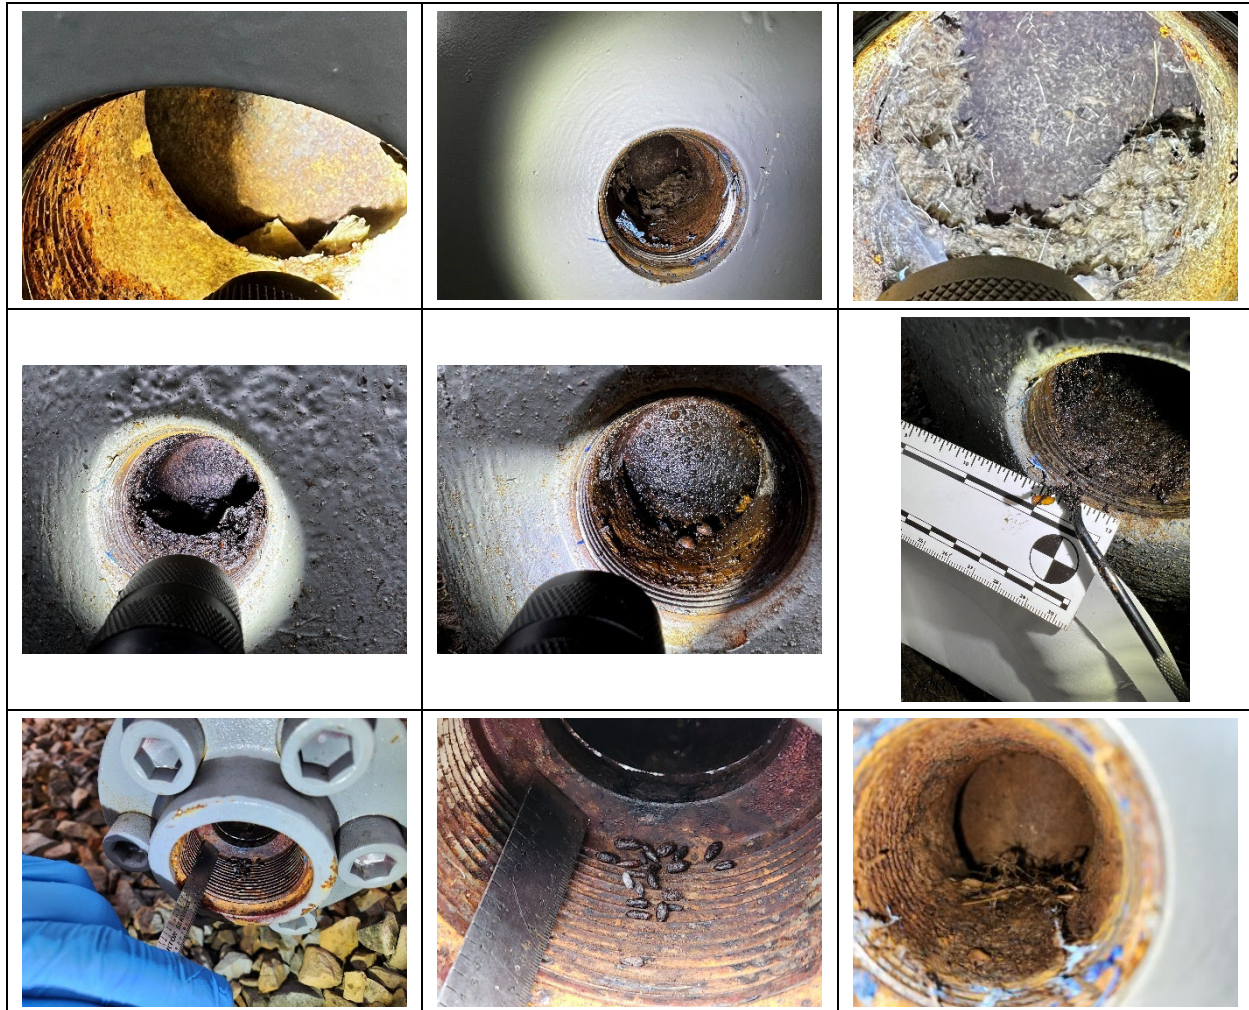
Figure 165: Material Found in the Annulus
