Rager Mountain Well #2244 Casing Failure Root Cause Analysis

Prepared for:
Equitrans, L.P.

RCA report on well #2244 7 in.
casing failure root cause analysis.

Date:
August 24, 2023

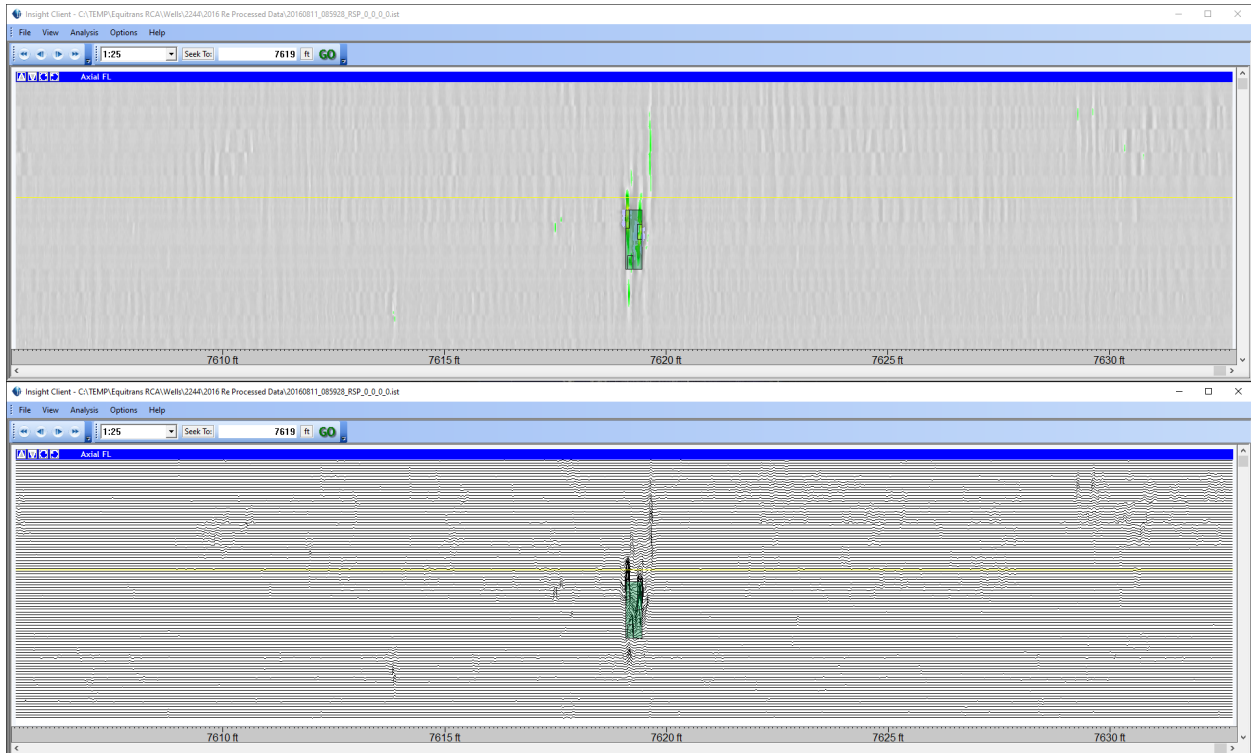
Figure 179: Well #2244, Raw Signal with Grey Scale and Flux Lines Showing the Internal Defect at around 7,618 ft.

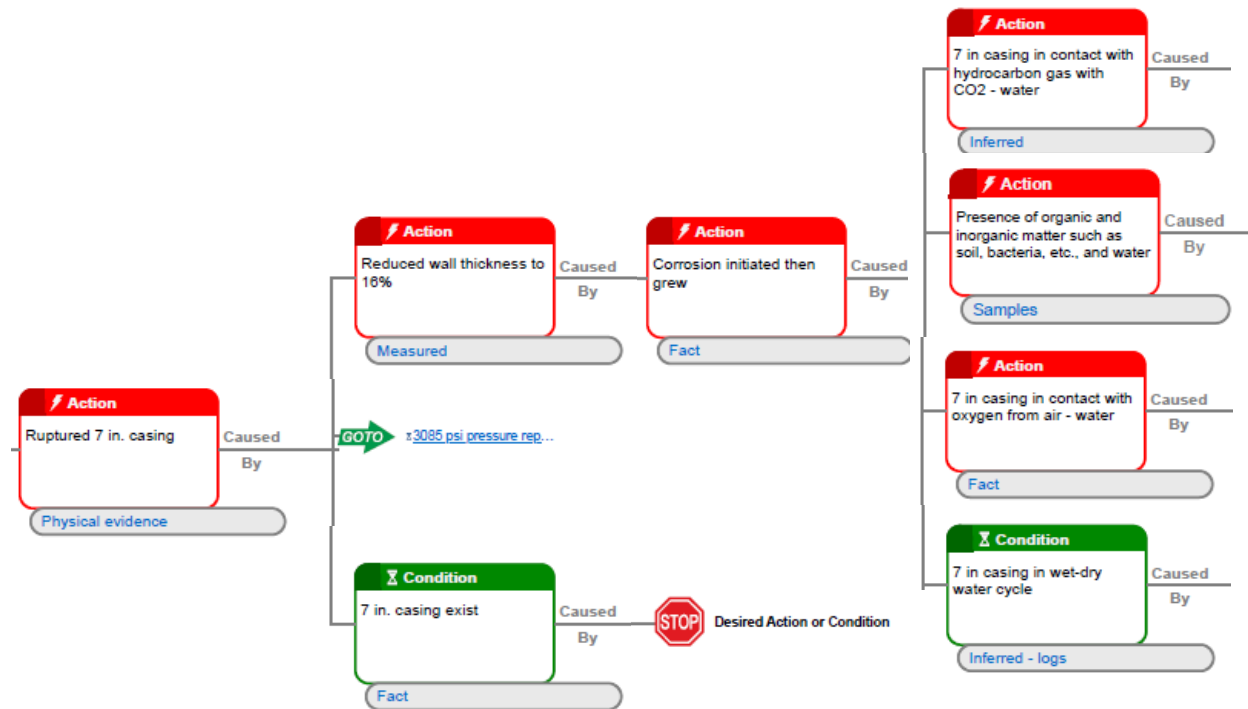
Figure 201: Ruptured 7 in. Casing Causes

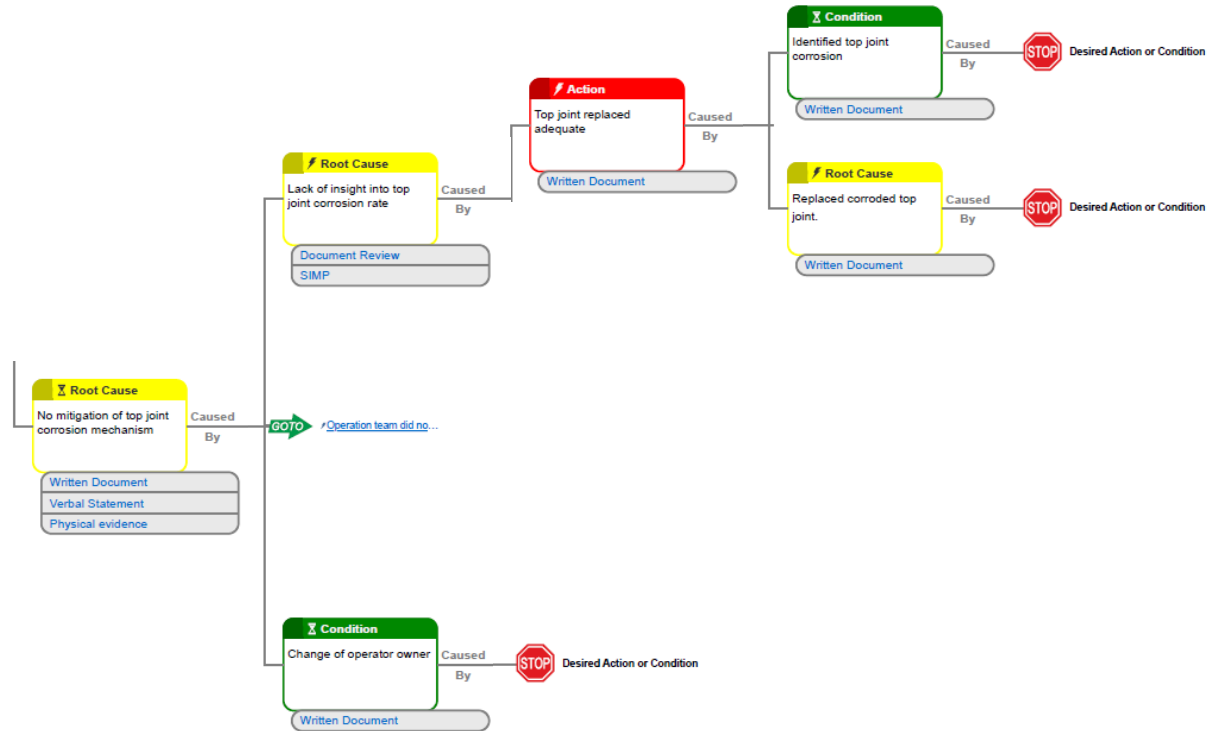
Figure 210: No Mitigation of Top Joint Corrosion
