# 2021 CROSSWALK EVALUATION

South Londonderry Township, Lebanon County, PA

RETTEW Project No. 082532034

SEPTEMBER 7, 2021

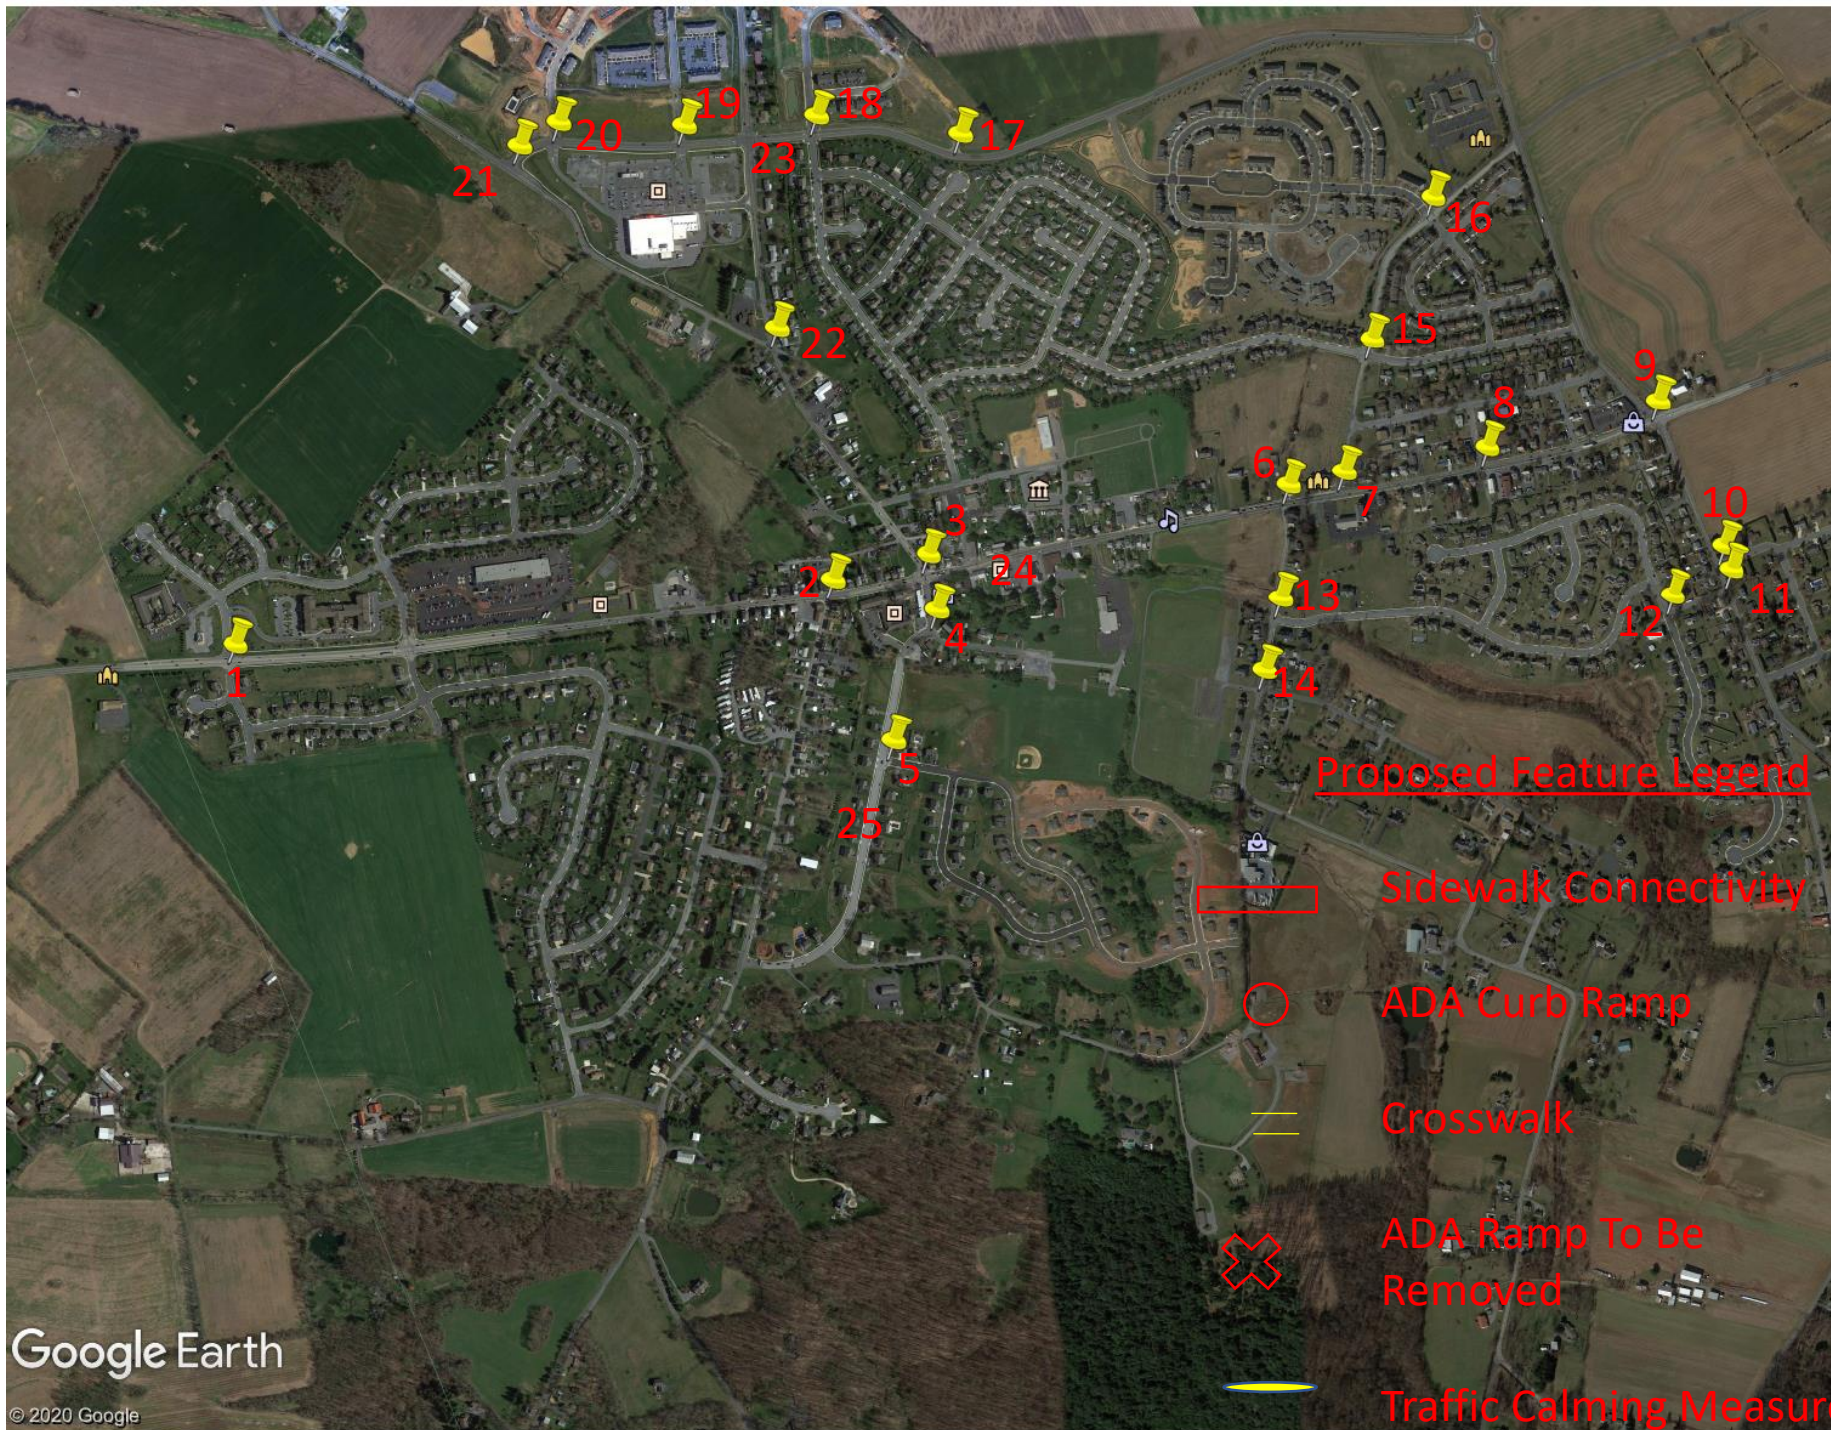
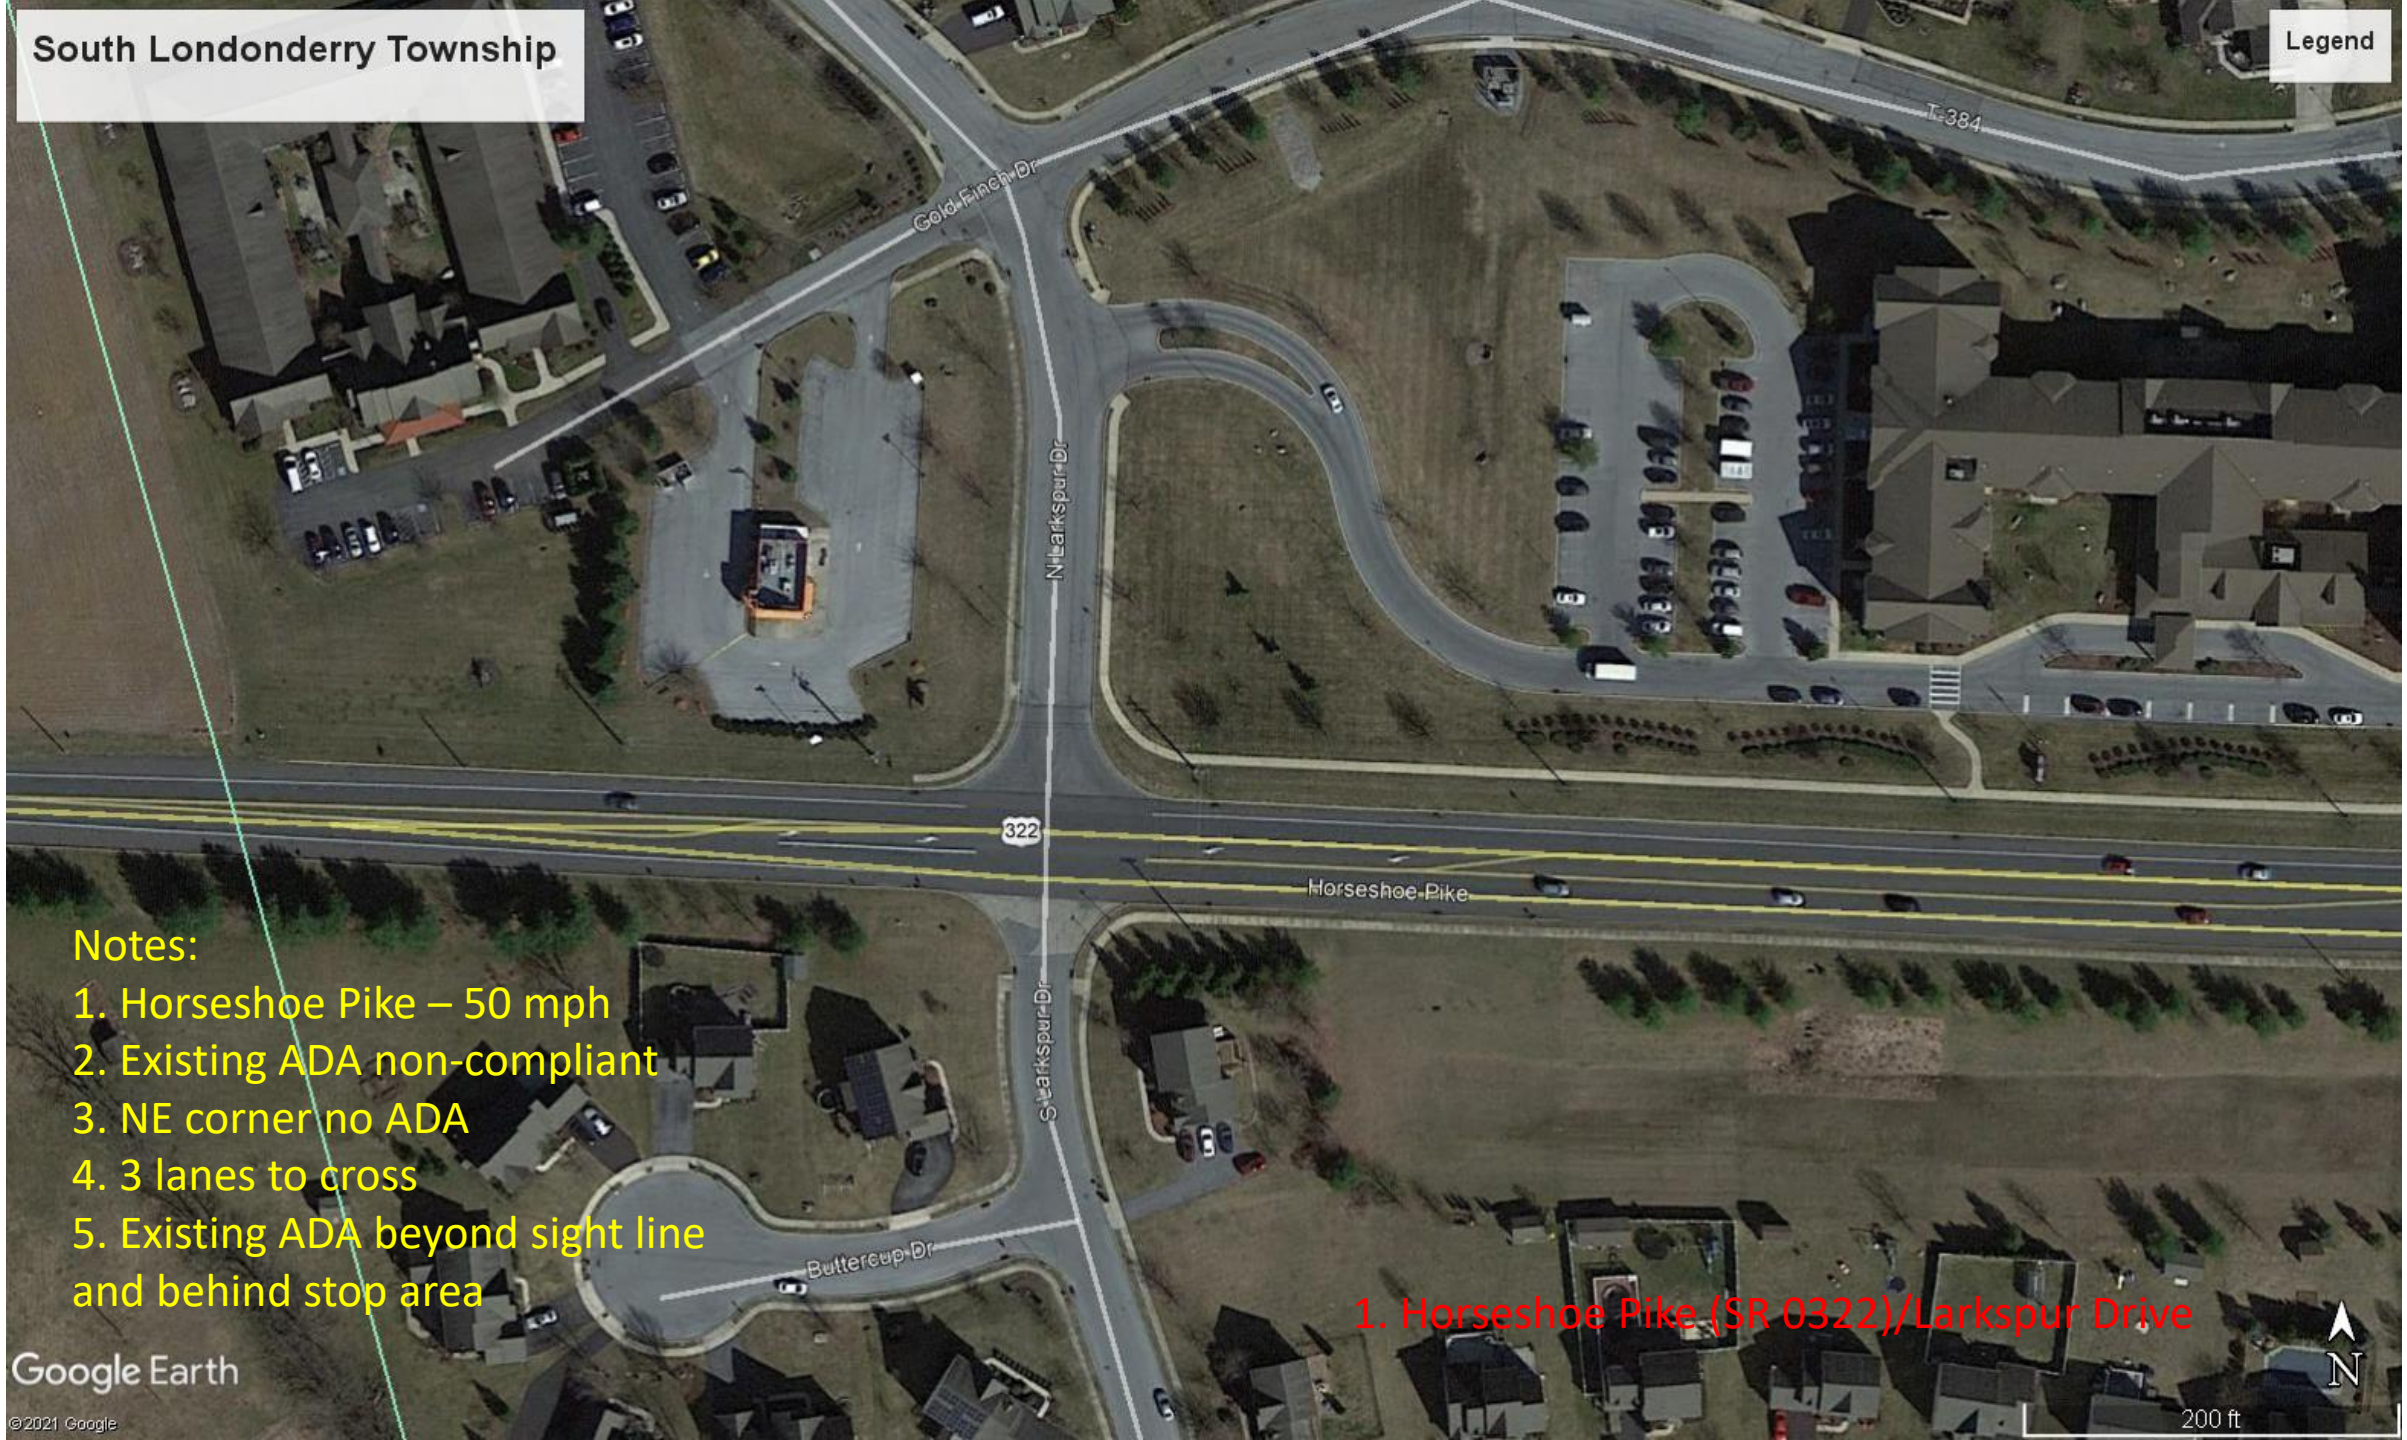
1. Horseshoe Pike (SR 0322)/Larkspur Drive

- 1. Horseshoe Pike – 50 mph
- 2. Existing ADA non-compliant
- 3. NE corner no ADA
- 4. 3 lanes to cross
- 5. Existing ADA beyond sight line and behind stop area

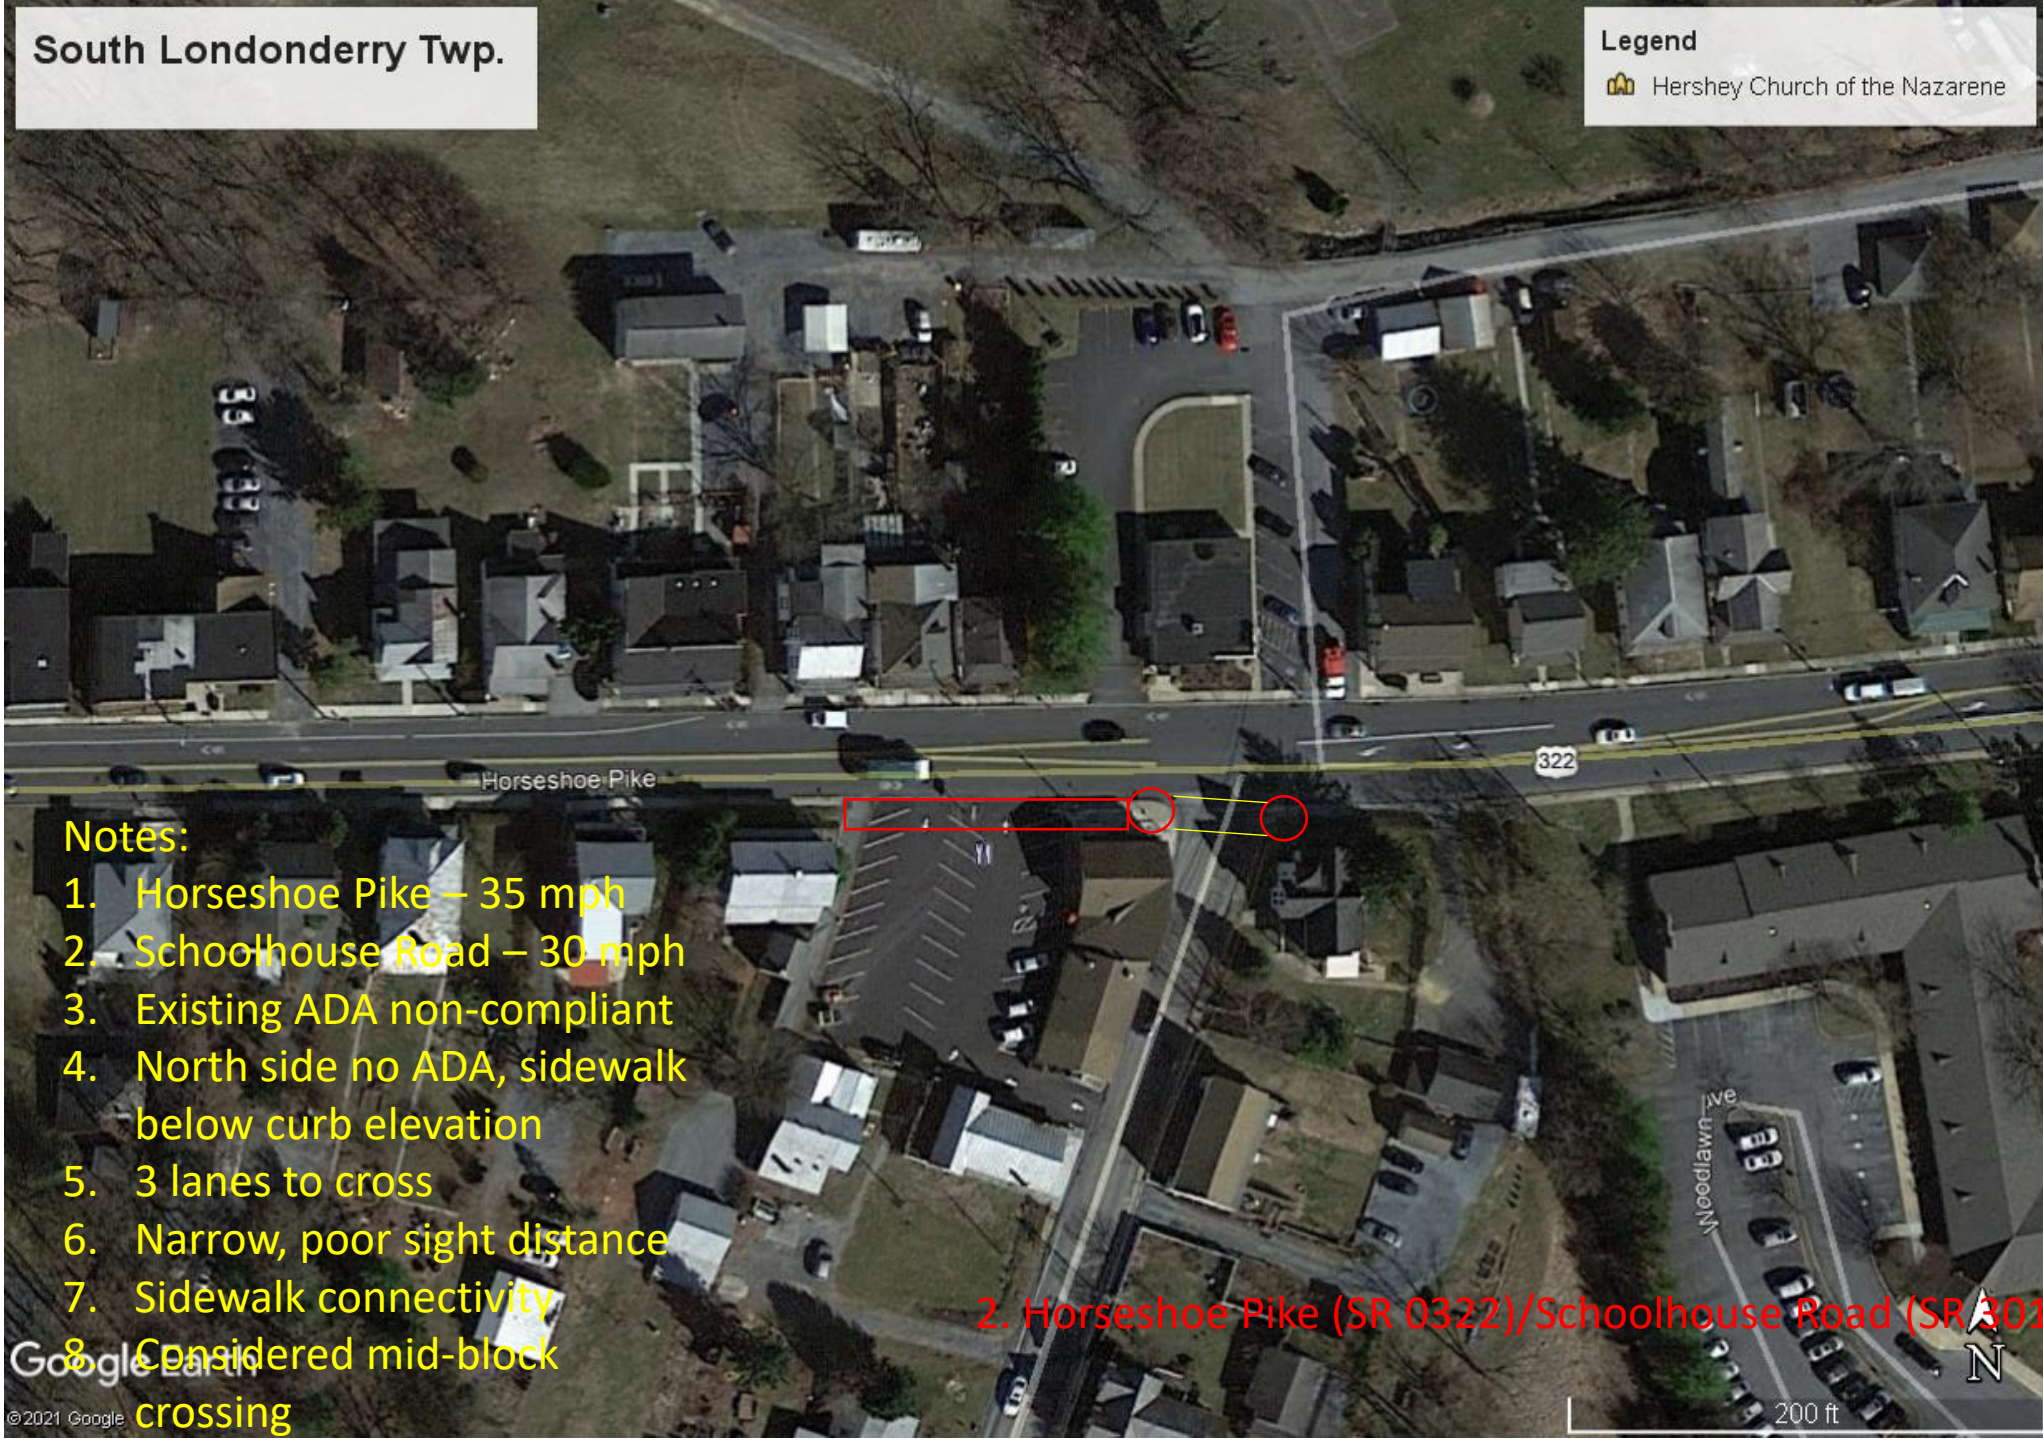
2. Horseshoe Pike (SR 0322)/Schoolhouse Road (SR 3013)

1. Horseshoe Pike – 35 mph
2. Schoolhouse Road – 30 mph
3. Existing ADA non-compliant
4. North side no ADA, sidewalk below curb elevation
5. 3 lanes to cross
6. Narrow, poor sight distance
7. Sidewalk connectivity
8. Considered mid-block crossing

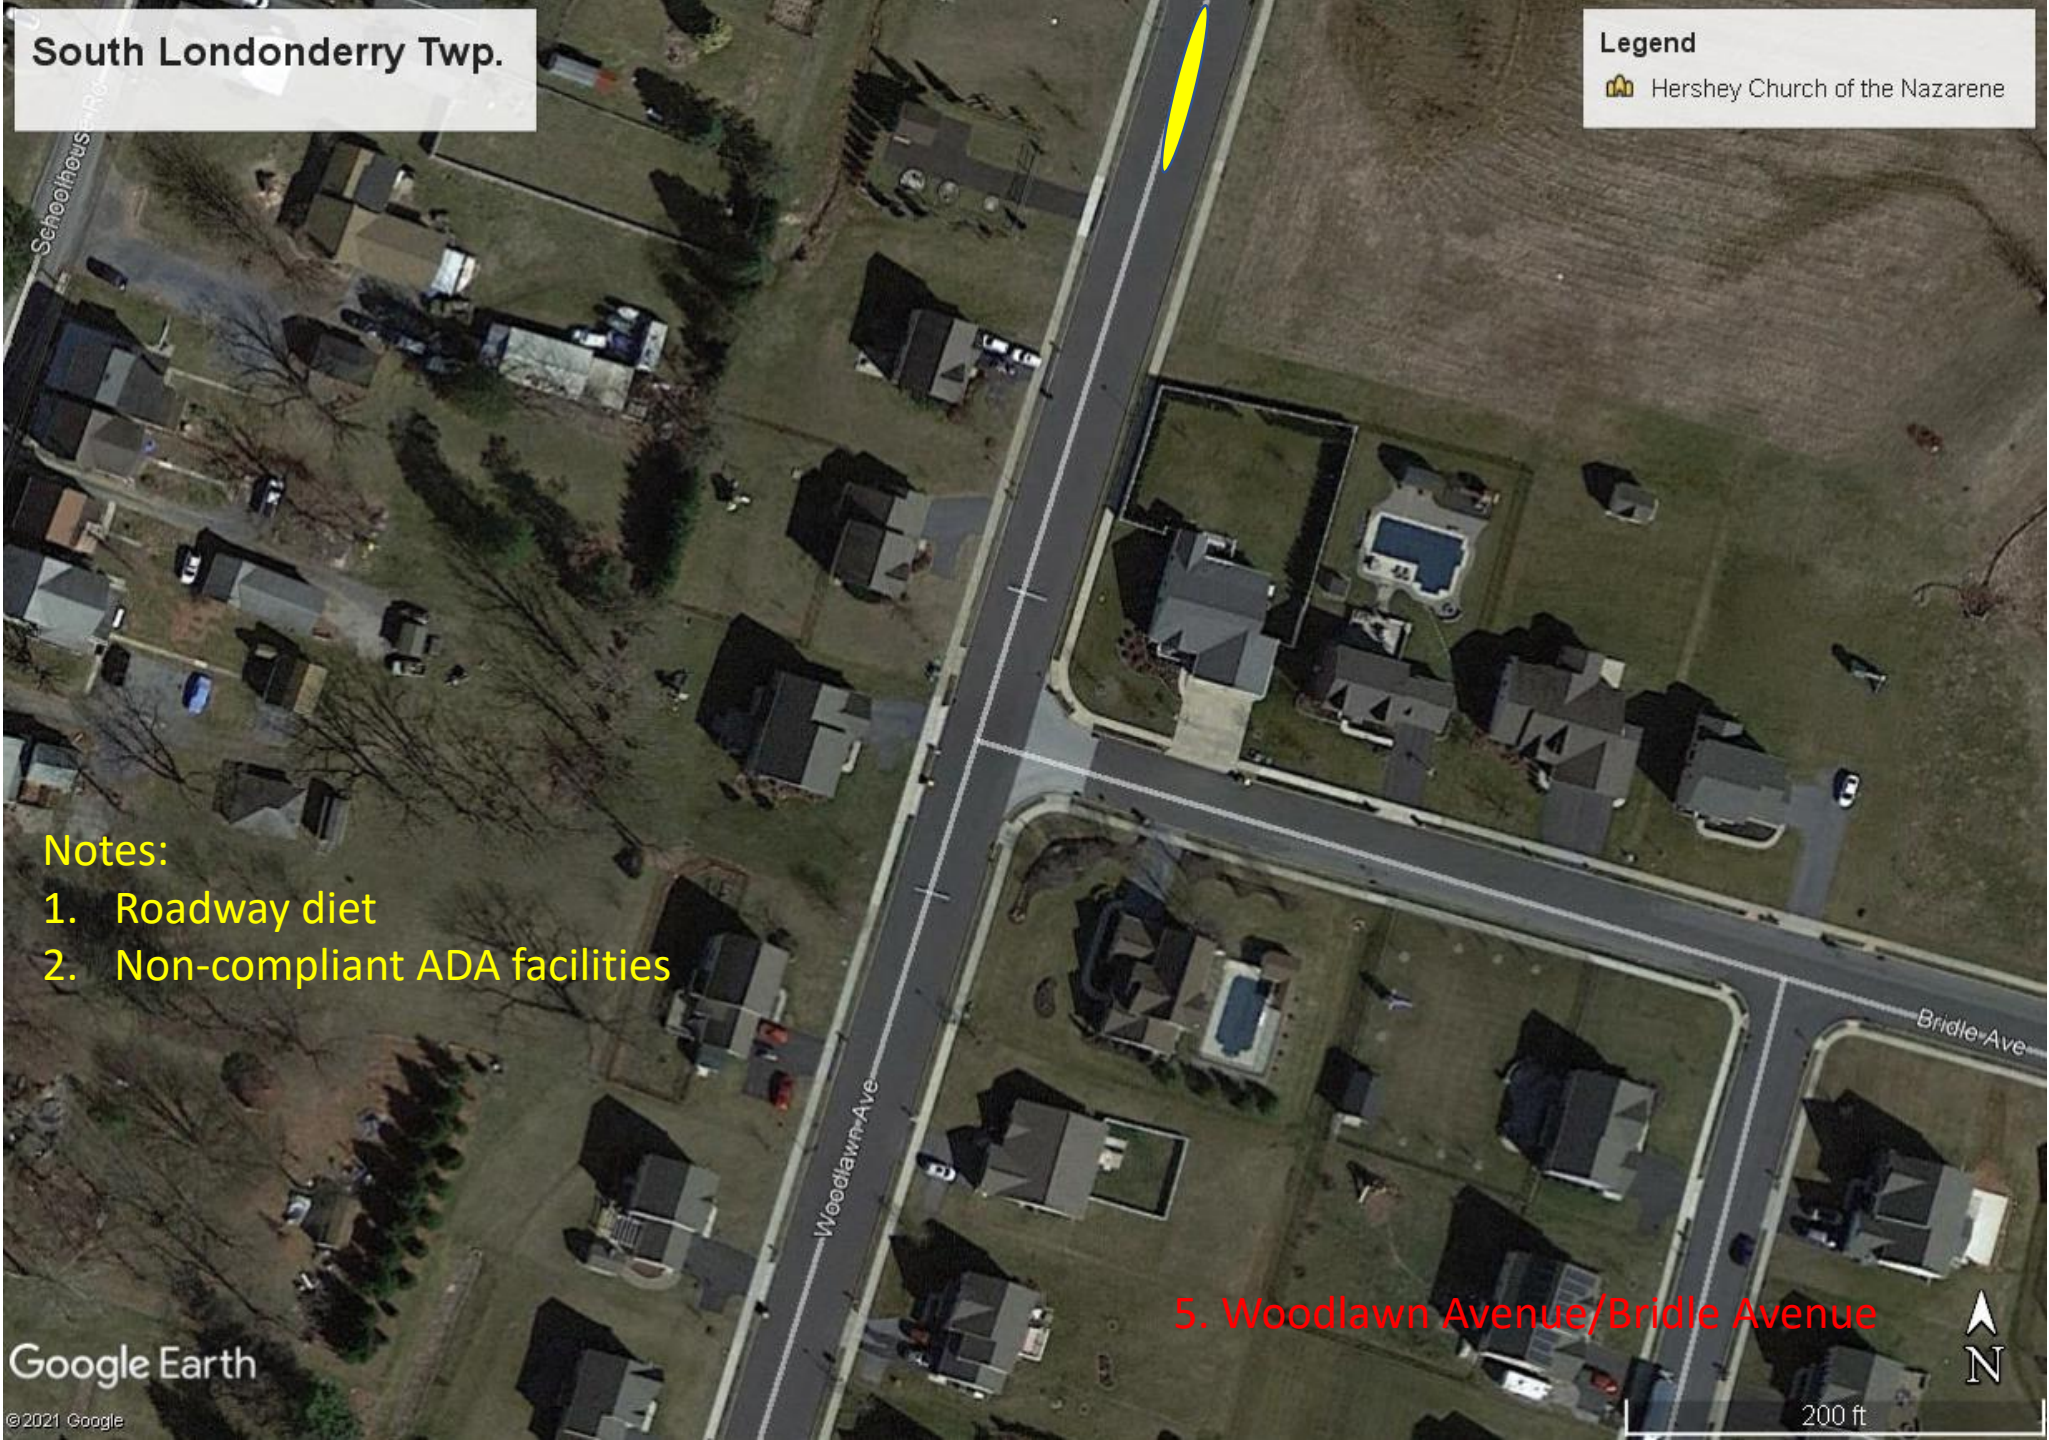
5. Woodlawn Avenue/Bridle Avenue

- 1. Roadway diet
- 2. Non-compliant ADA facilities

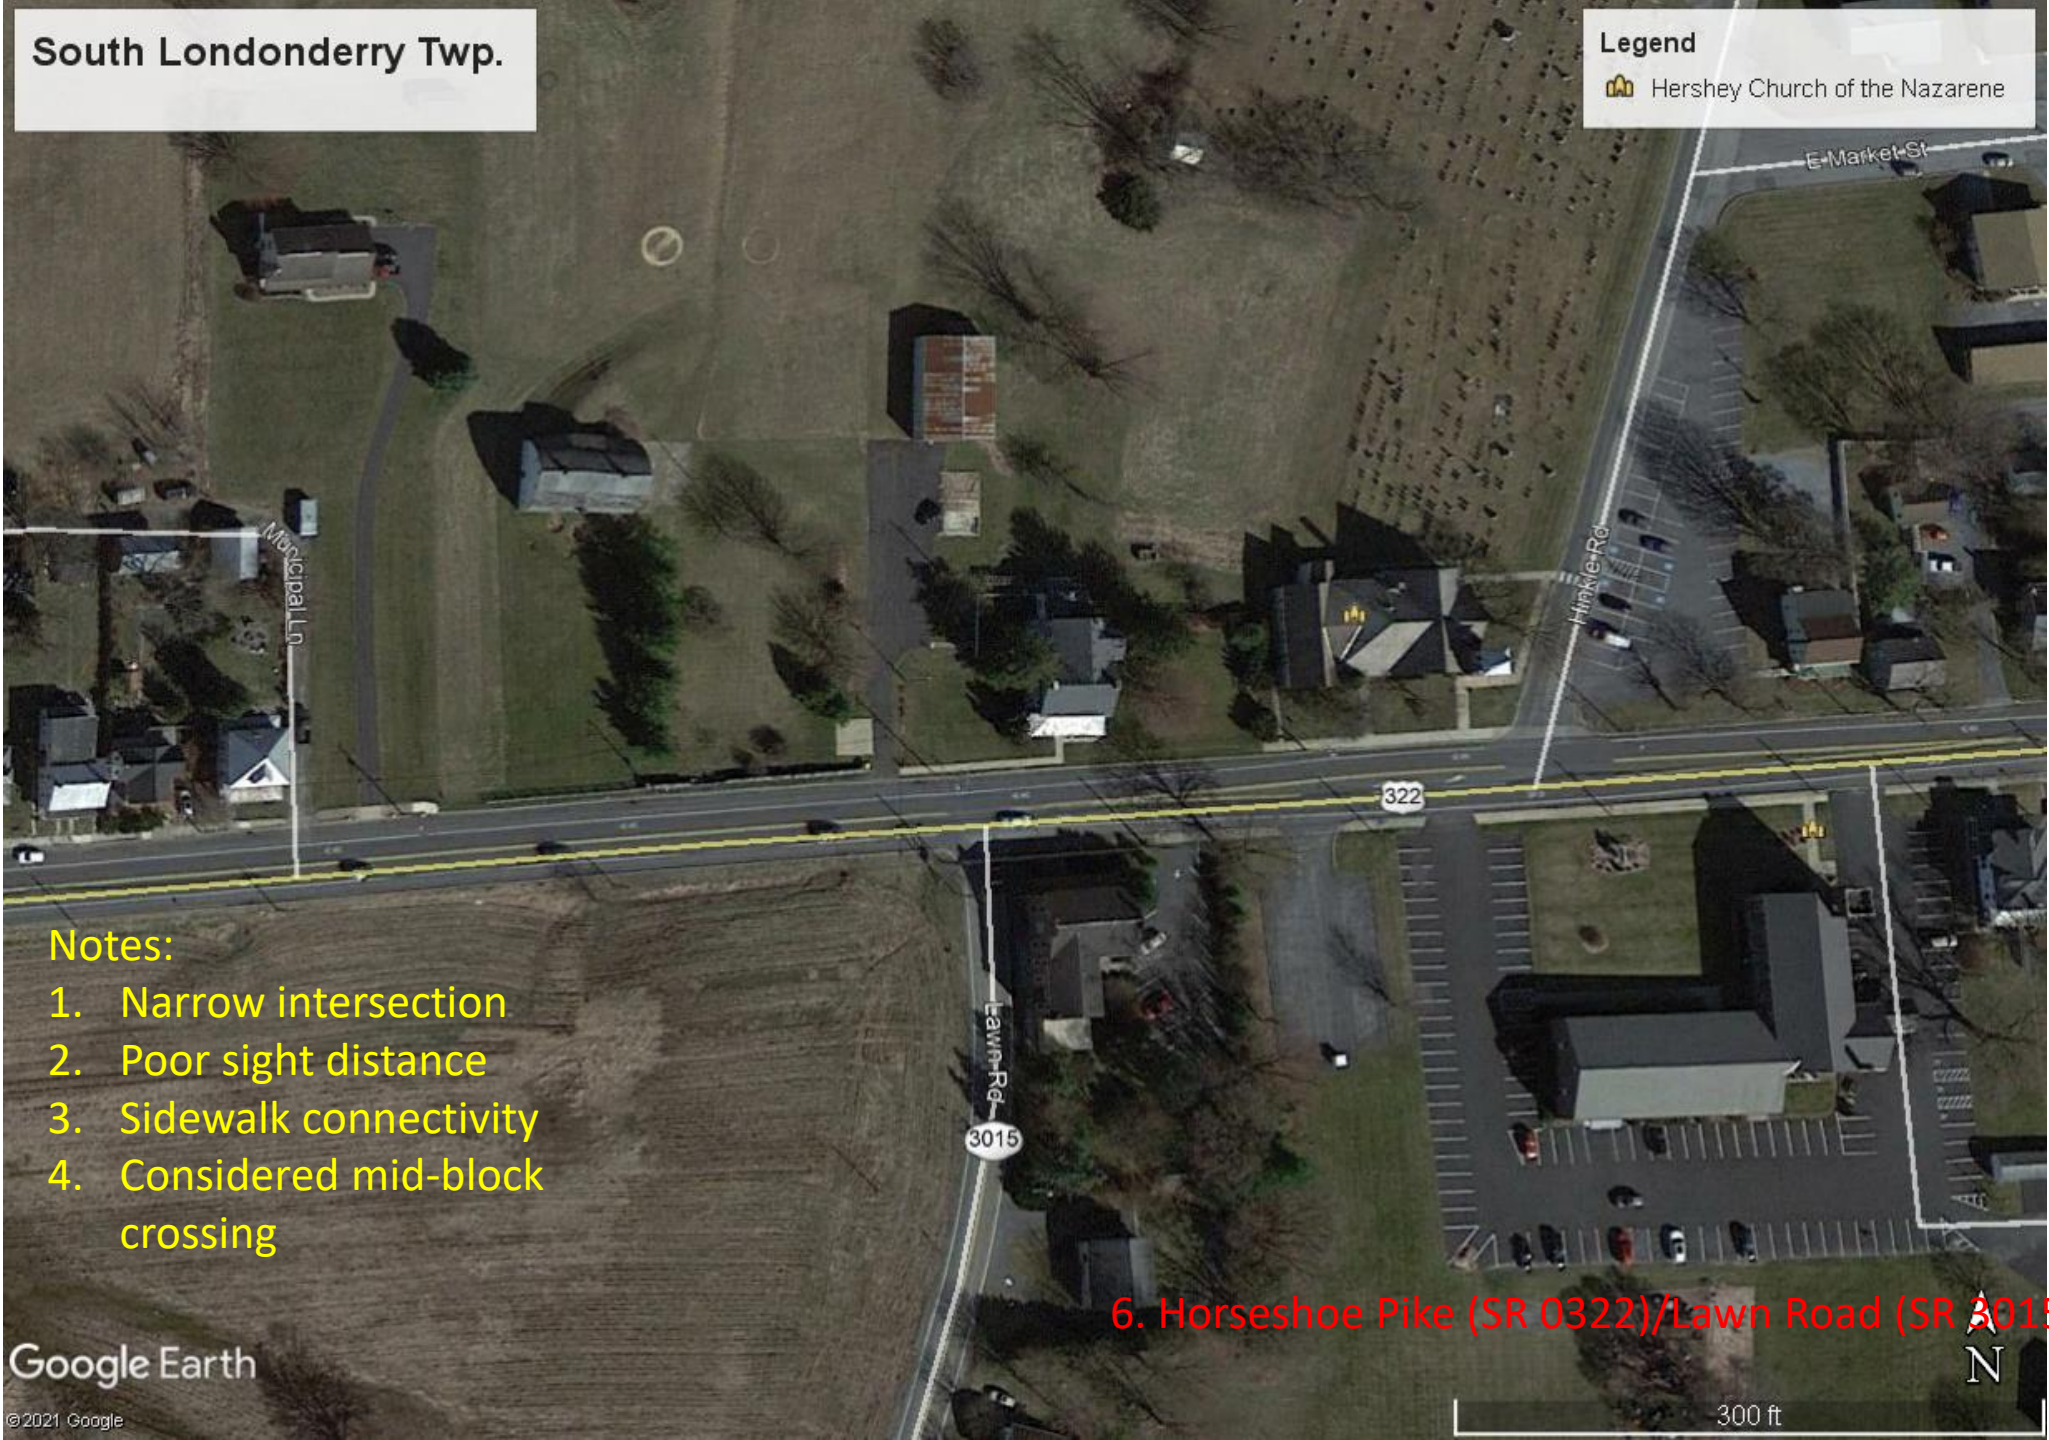
6. Horseshoe Pike (SR 0322)/Lawn Road (SR 3015)

- 1. Narrow intersection
- 2. Poor sight distance
- 3. Sidewalk connectivity
- 4. Considered mid-block crossing

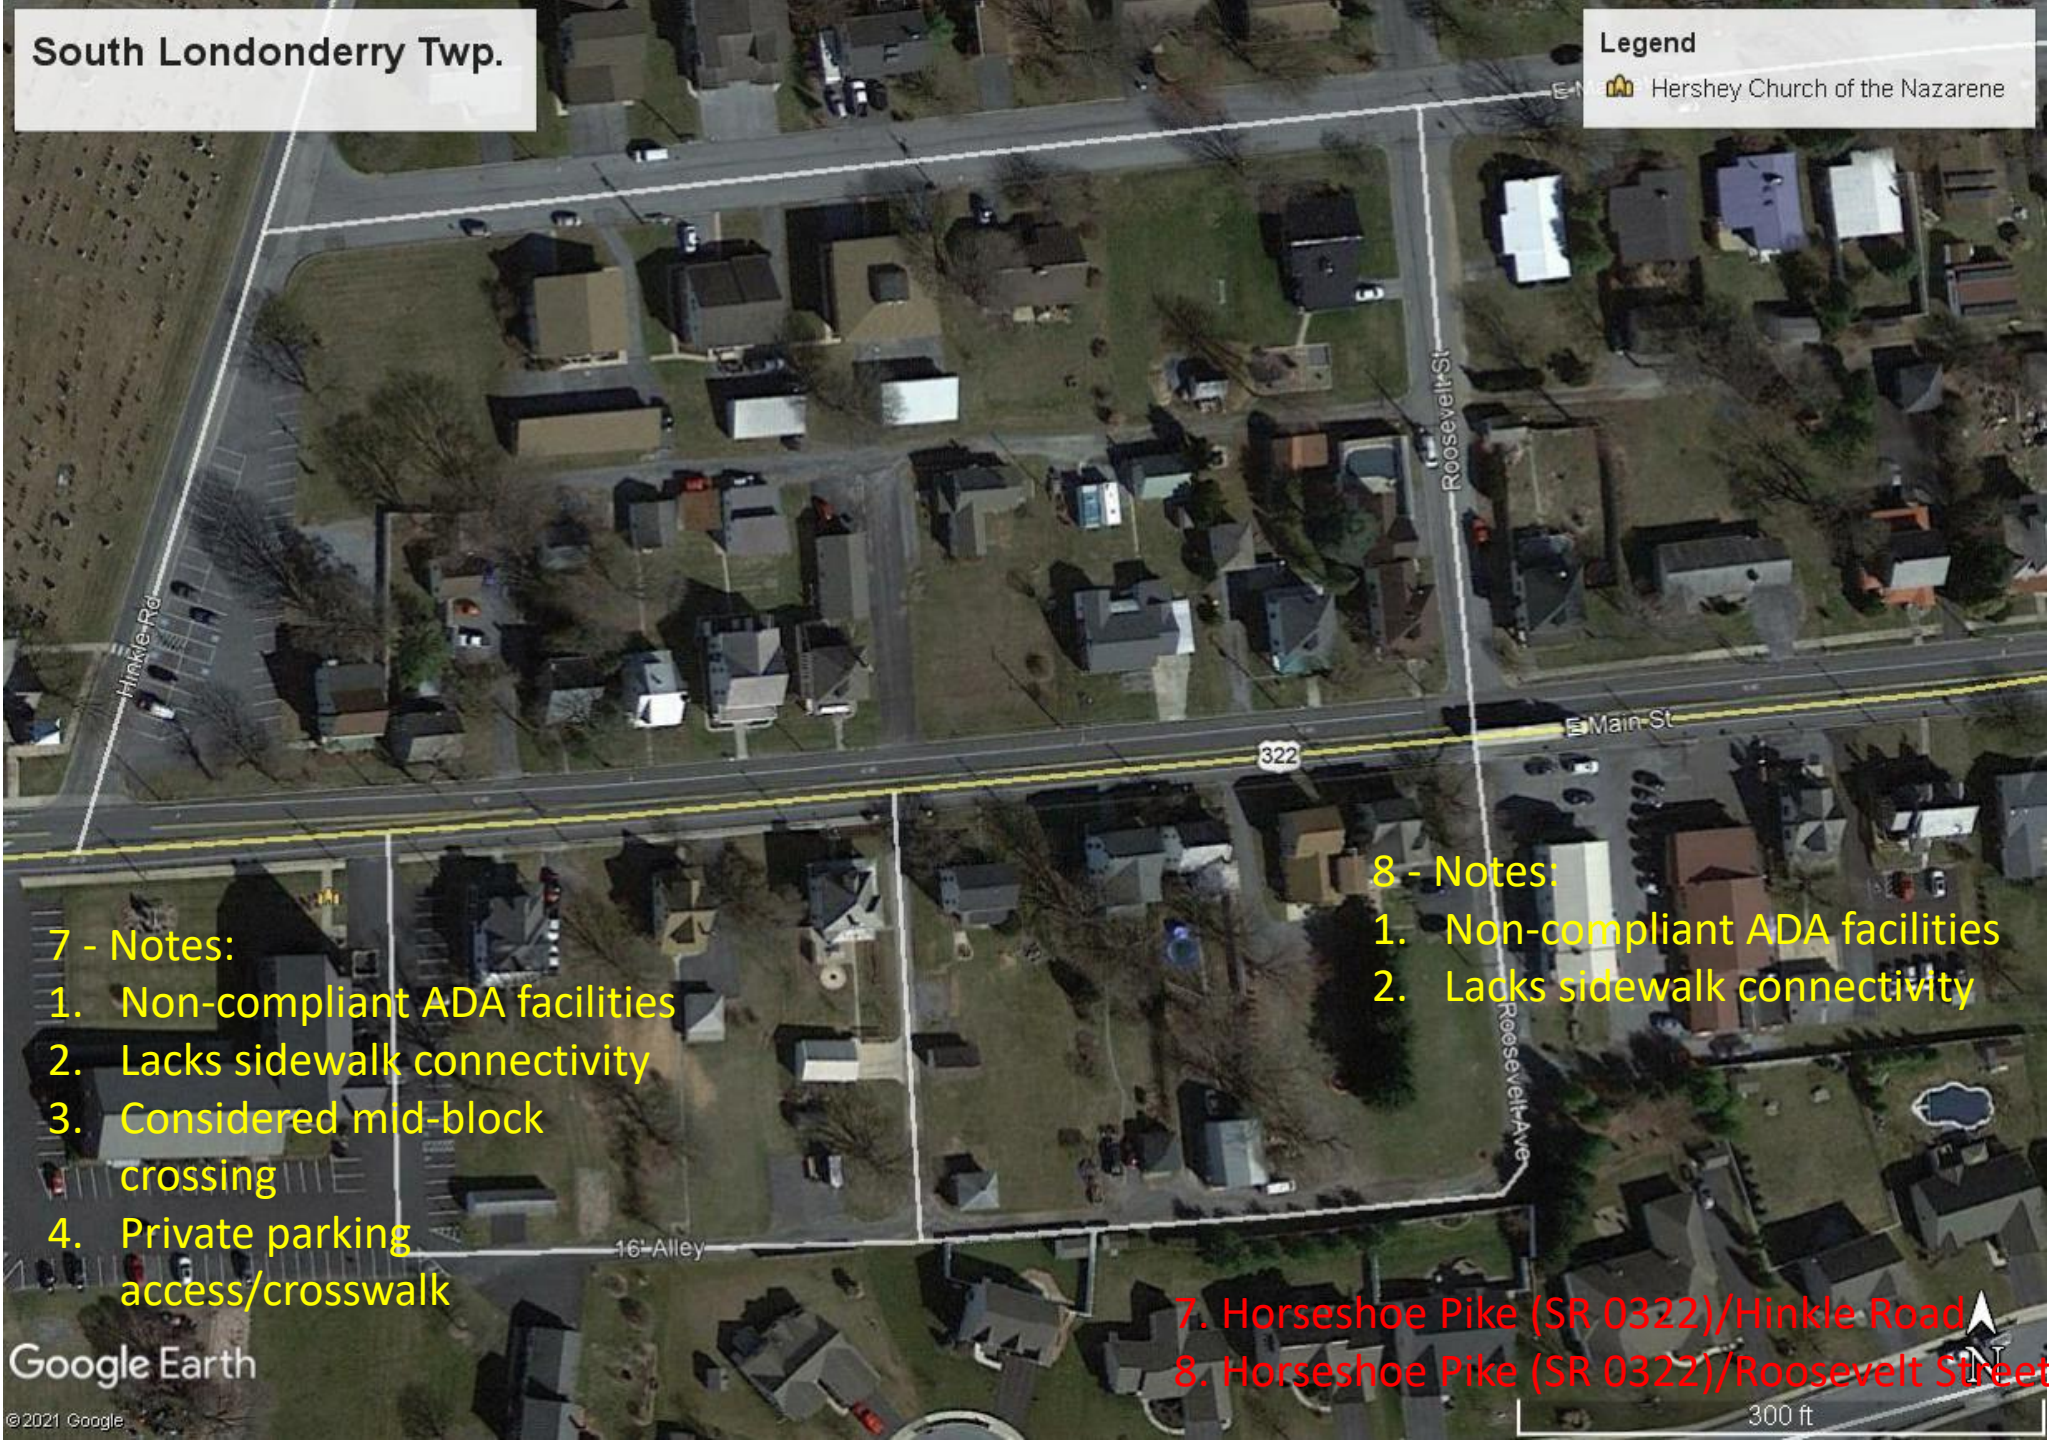
- 7. Horseshoe Pike (SR 0322)/Hinkle Road
- 8. Horseshoe Pike (SR 0322)/Roosevelt Street

- 1. Non-compliant ADA facilities
- 2. Lacks sidewalk connectivity
- 3. Considered mid-block crossing
- 4. Private parking access/crosswalk

- 1. Non-compliant ADA facilities
- 2. Lacks sidewalk connectivity

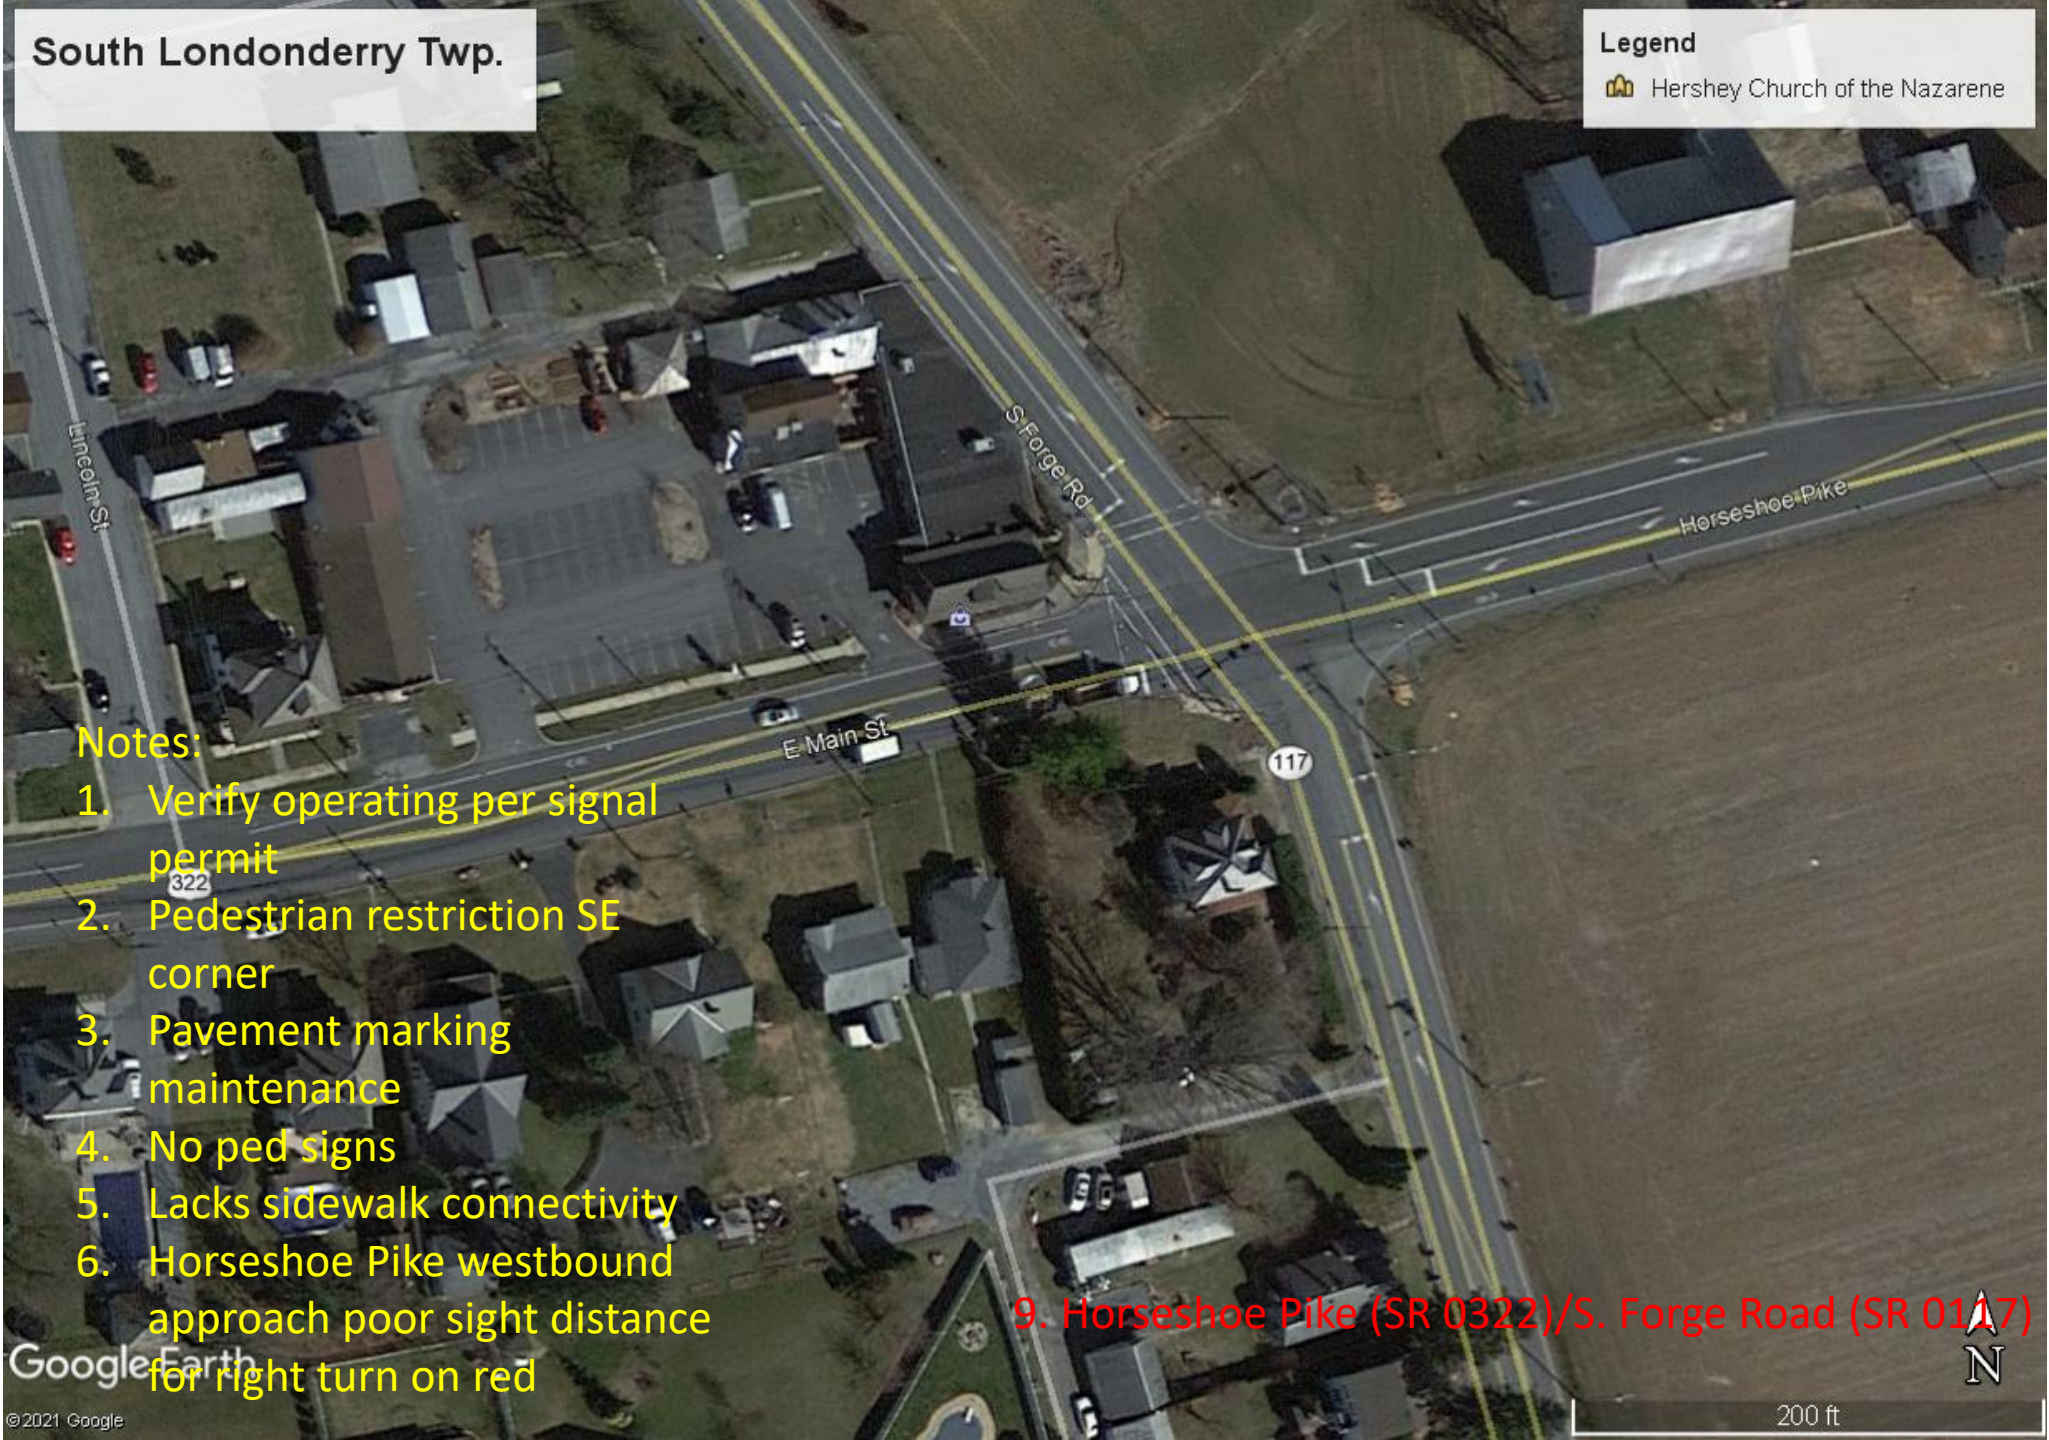
9. Horseshoe Pike (SR 0322)/S. Forge Road (SR 0117)

- 1. Verify operating per signal permit
- 2. Pedestrian restriction SE corner
- 3. Pavement marking maintenance
- 4. No ped signs
- 5. Lacks sidewalk connectivity
- 6. Horseshoe Pike westbound approach poor sight distance for right turn on red
