# 2021 CROSSWALK EVALUATION

South Londonderry Township, Lebanon County, PA

RETTEW Project No. 082532034

SEPTEMBER 7, 2021

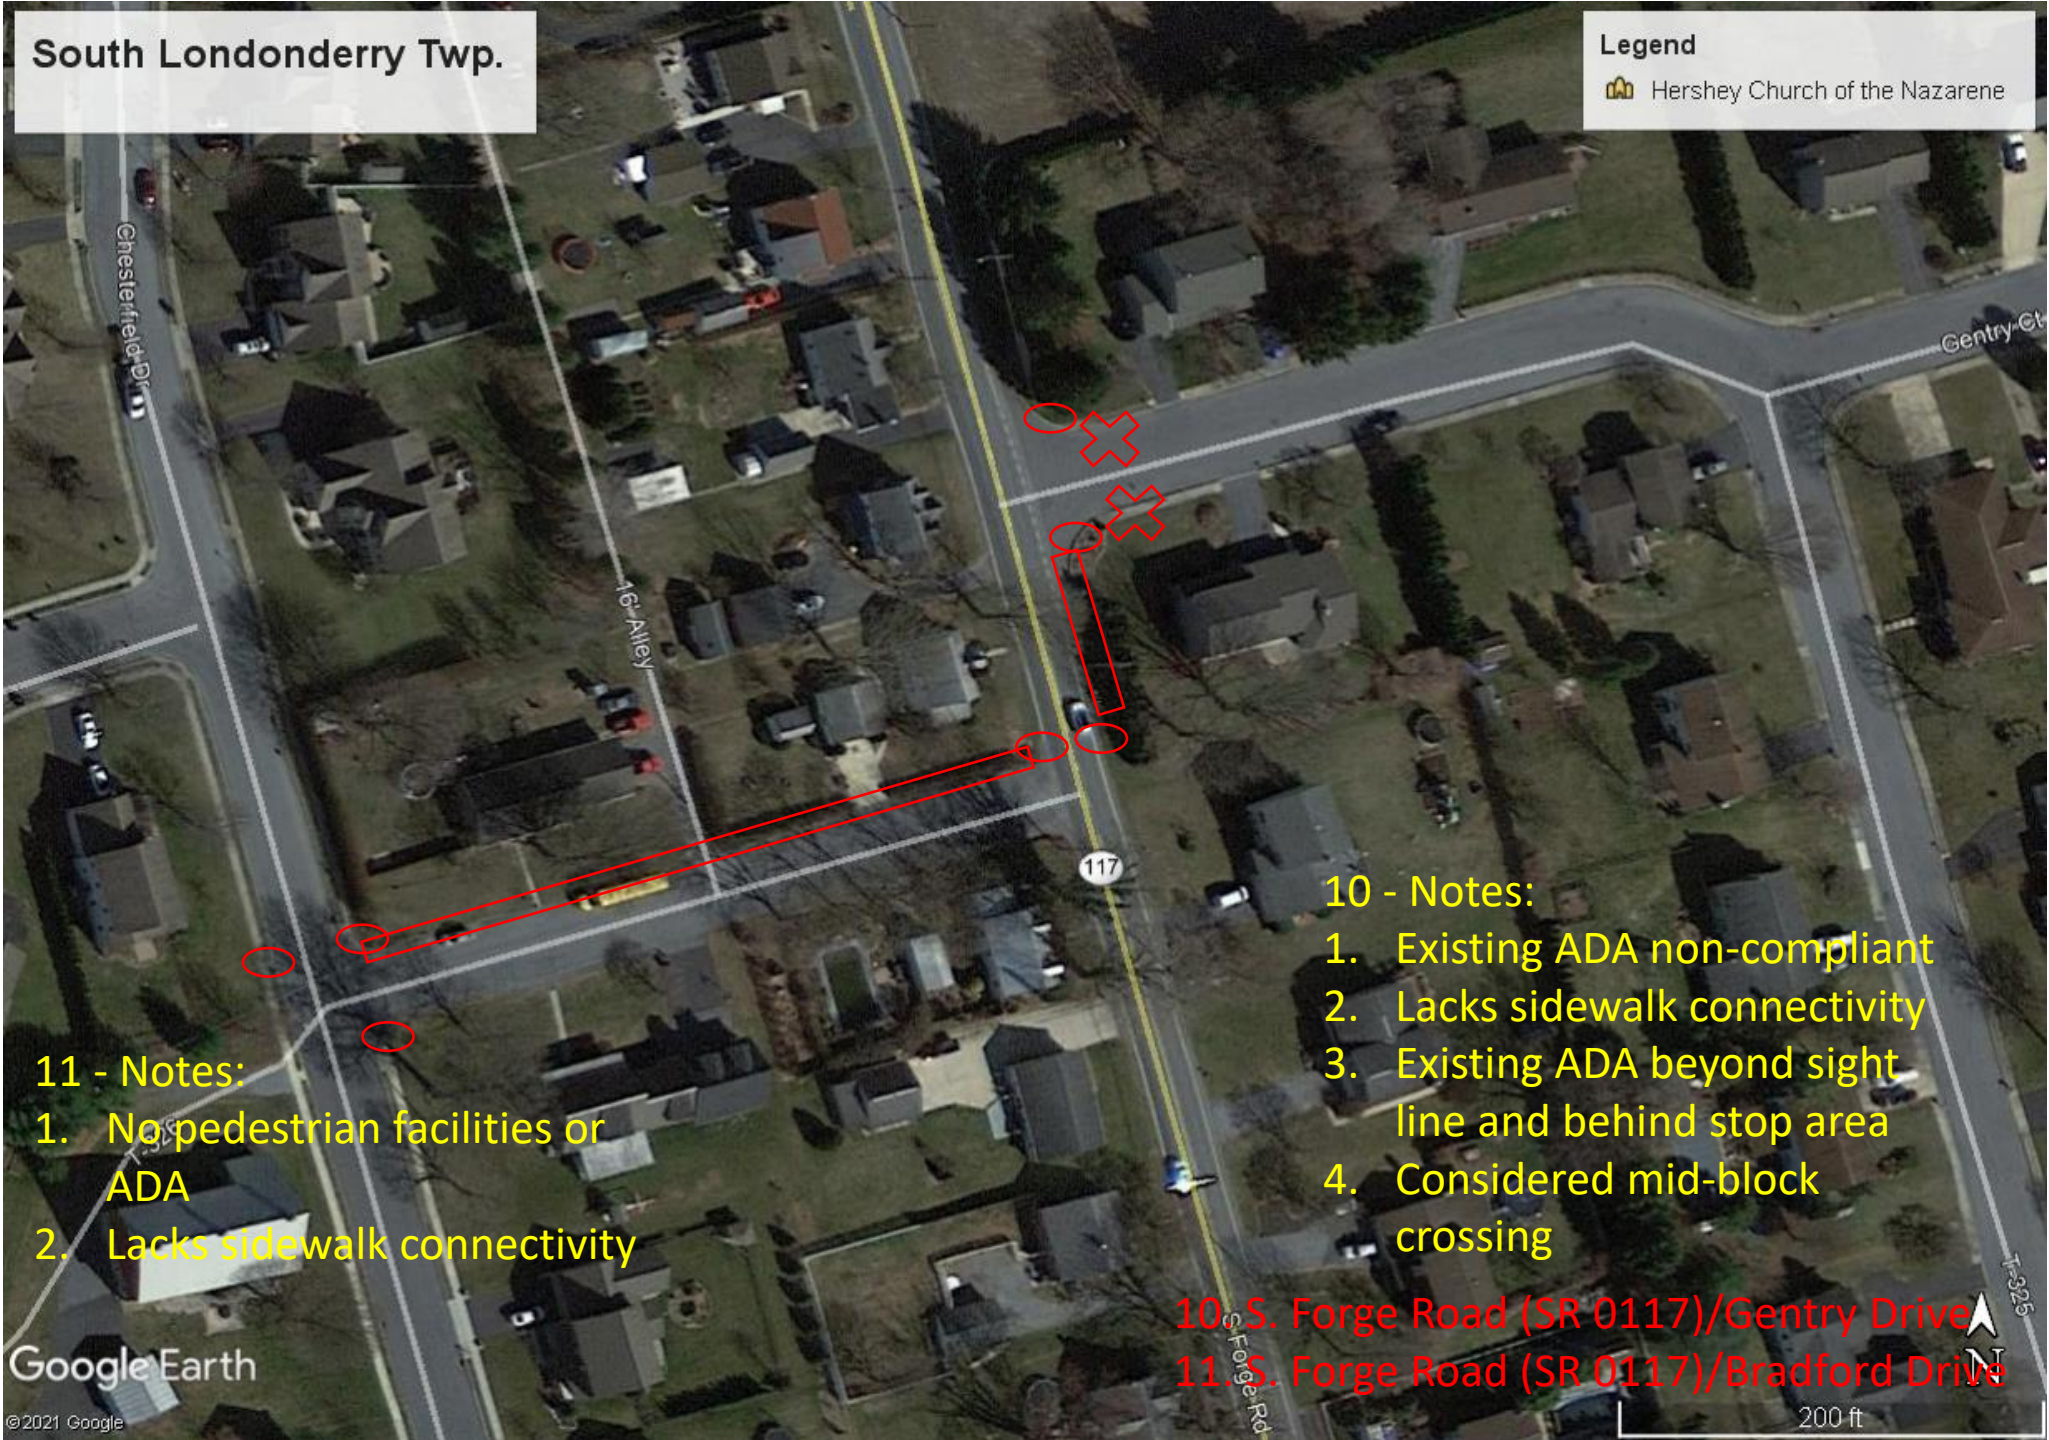
10 - S. Forge Road (SR 0117)/Gentry Drive  
11 - S. Forge Road (SR 0117)/Bradford Drive

- 1. No pedestrian facilities or ADA
- 2. Lacks sidewalk connectivity

- 1. Existing ADA non-compliant
- 2. Lacks sidewalk connectivity
- 3. Existing ADA beyond sight line and behind stop area
- 4. Considered mid-block crossing

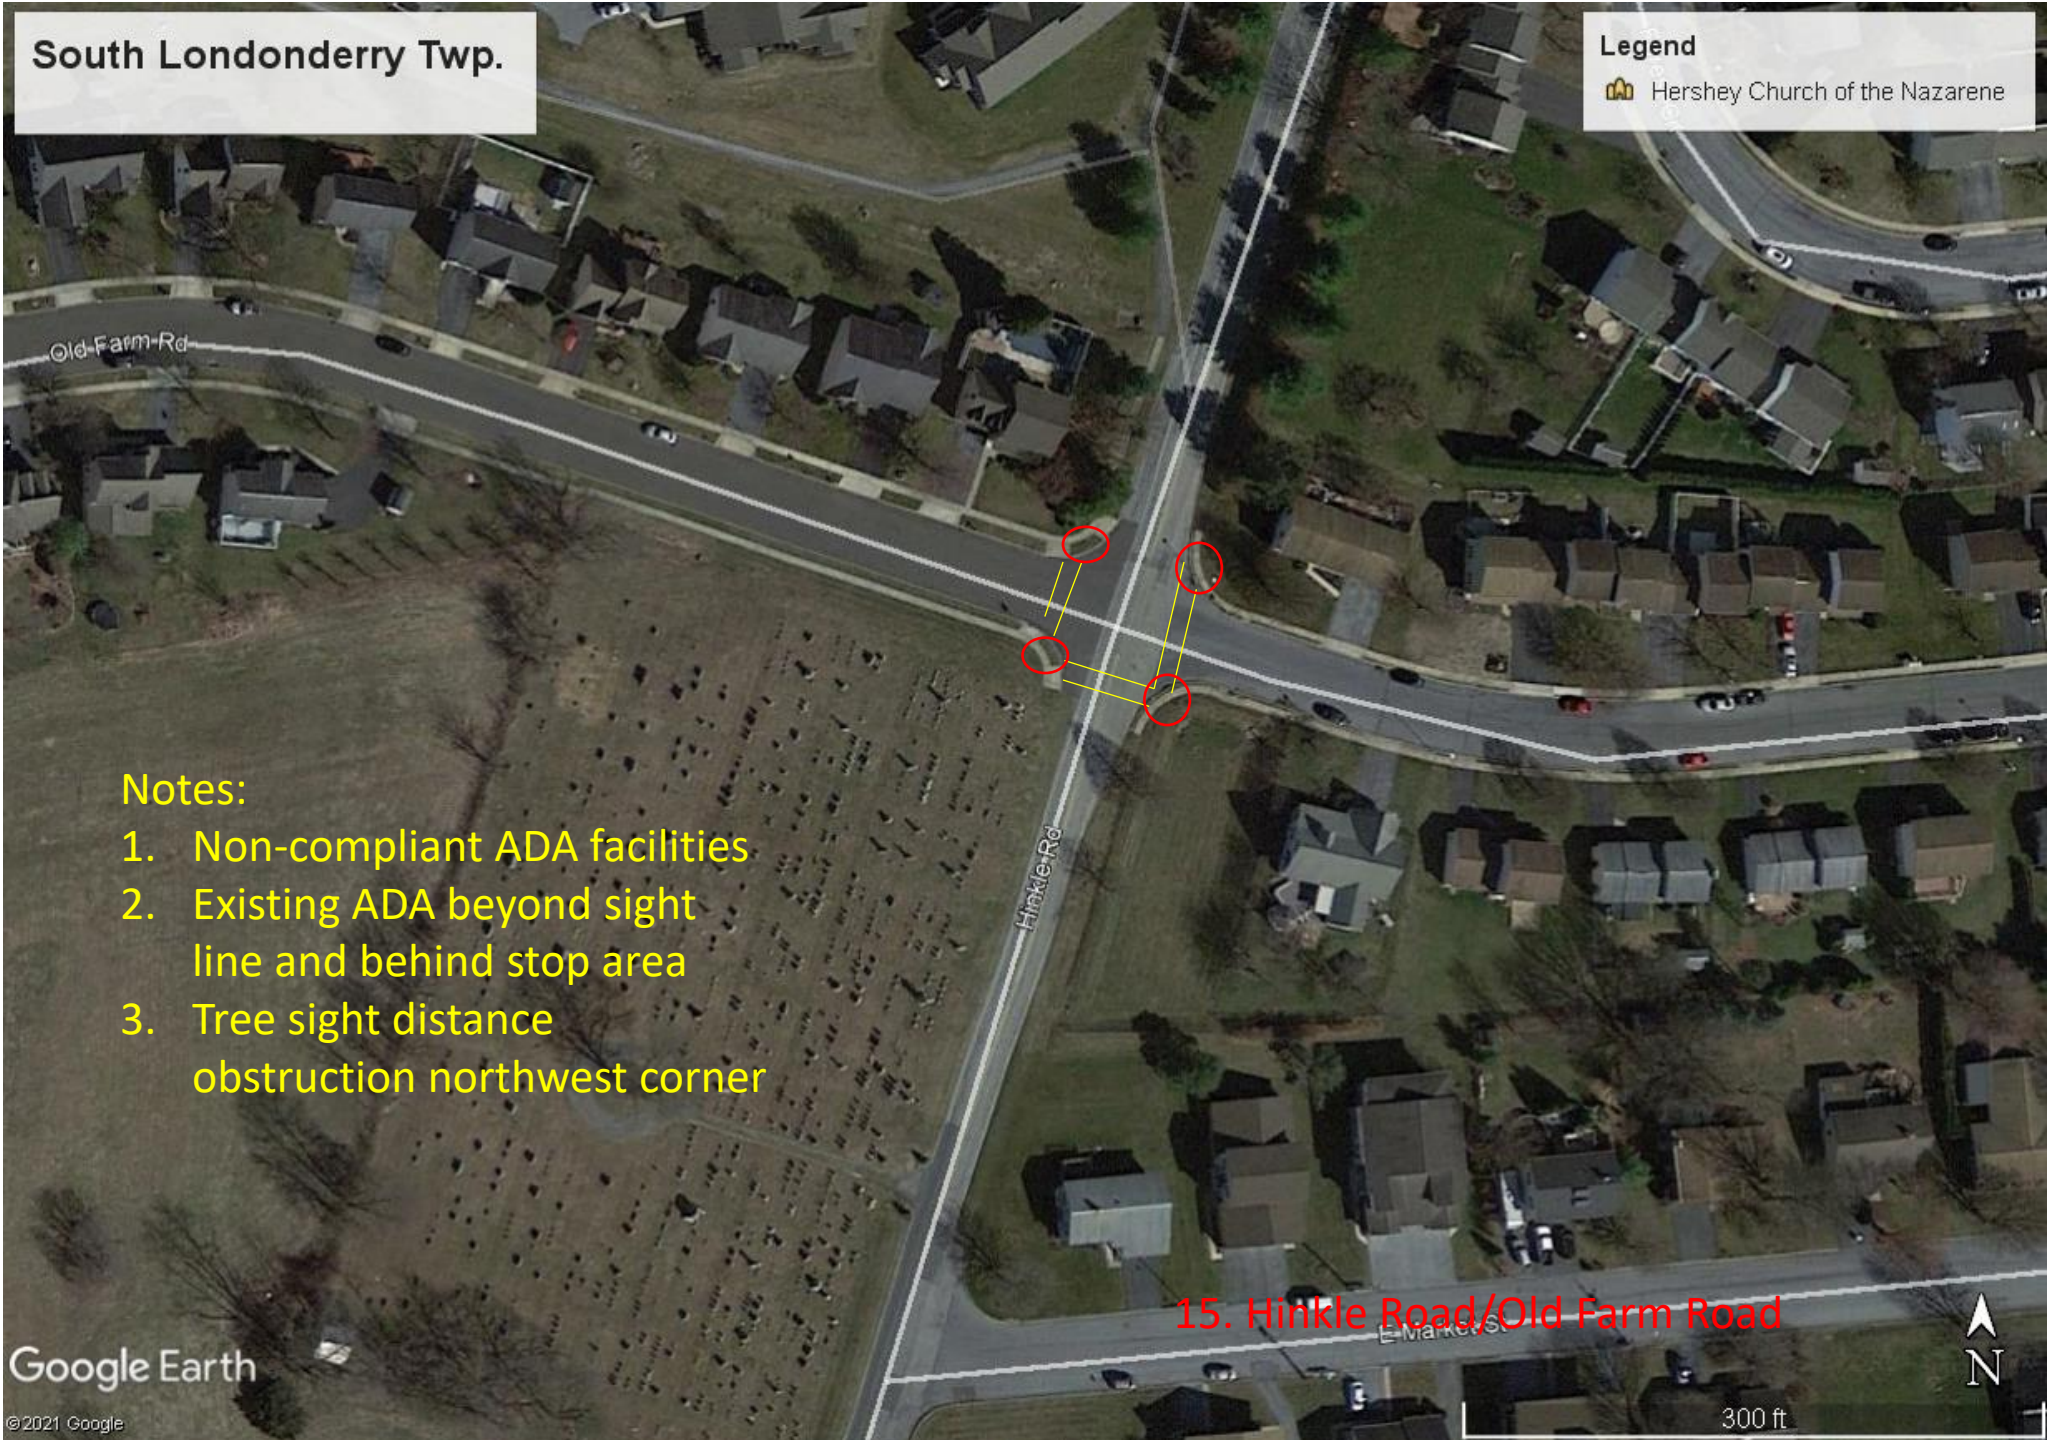
15. Hinkle Road/Old Farm Road

- 1. Non-compliant ADA facilities
- 2. Existing ADA beyond sight line and behind stop area
- 3. Tree sight distance obstruction northwest corner

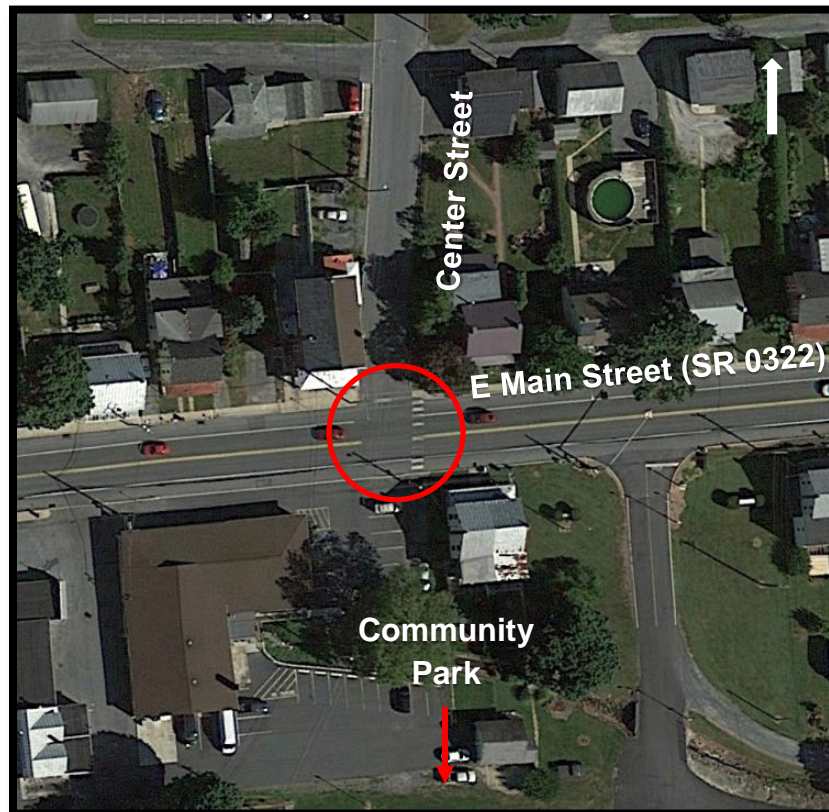
Figure 1: E Main Street (SR 0322) Crosswalk

According to PennDOT ITMS data, SR 0322 is classified as an urban other principal arterial with approximately 17,400 vehicles per day, and 4% truck traffic. SR 0322 is two-lane, two-way, with a double yellow center line, white edge lines, and a posted speed limit of 35 mph. The roadway width at the location of the crosswalk is 40 feet.

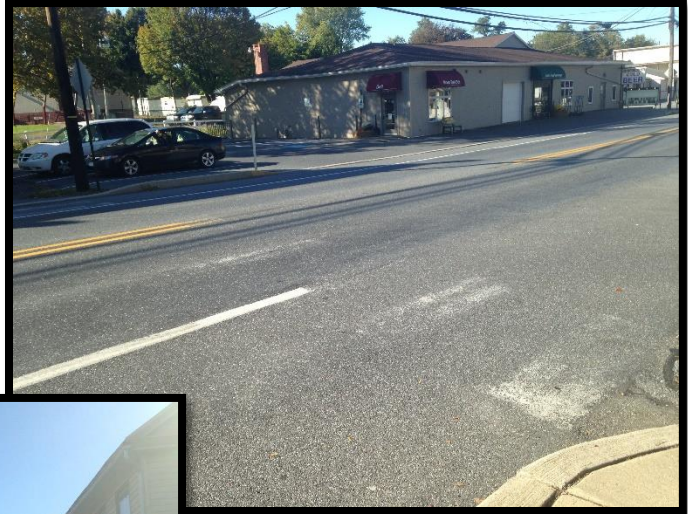
The crossing is marked by a type C crosswalk, however, it was hardly noticeable. There are also non-standard Pedestrian Crossing Warning Signs on each approach. We also observed low driver compliance yielding to pedestrians waiting to cross. There were no sight distance issues.

**Figure 3: Faded Pavement Markings**

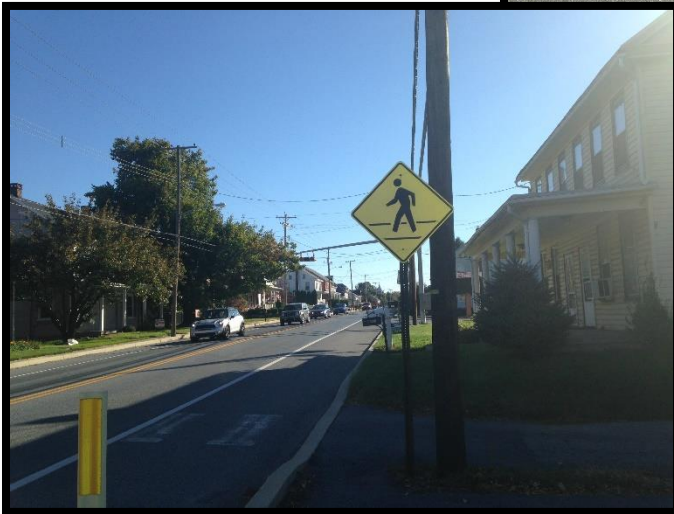
**Figure 2: Pedestrian Warning Sign**

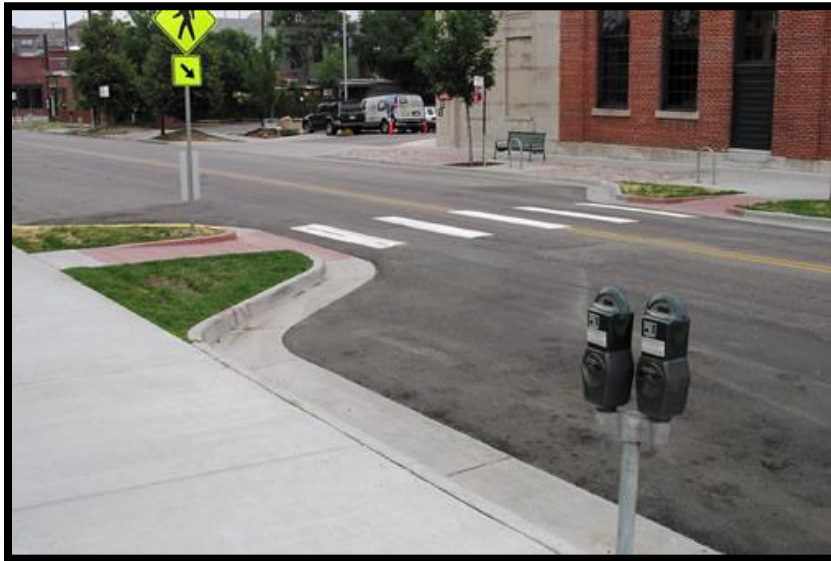
Once pedestrians cross over to the south side of E. Main Street, they must walk on the shoulder to their destination. If they are going the community park to the south they must walk east on E. Main Street to the fire house driveway. Before a crosswalk should be marked, proper pedestrian facilities including sidewalks and curb ramps should be installed. Bump outs should also be considered to narrow the roadway at the crossing providing a safe refuge for pedestrians to wait as well as effectively narrowing the crossing distance and creating a choke point in the roadway, potentially slowing vehicles.

Figure 4: Sidewalk Bump Outs

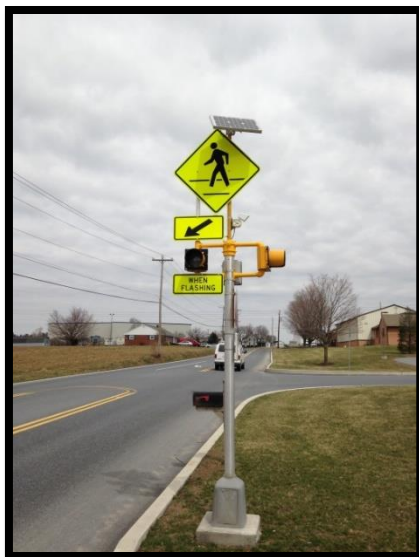
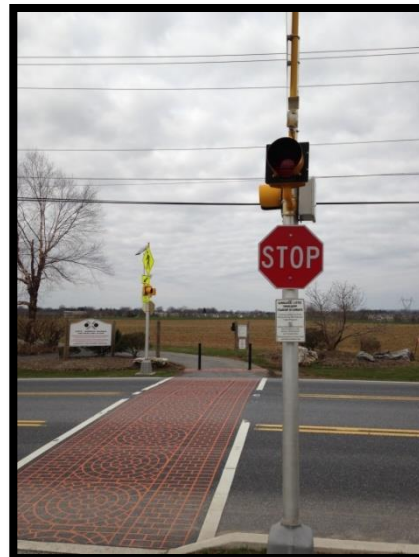
**Figure 5: Sample Pedestrian Improvements**

Other treatments that can improve pedestrian safety in mid-term or longer term efforts include (examples of some of these treatments are shown in Figure 5):

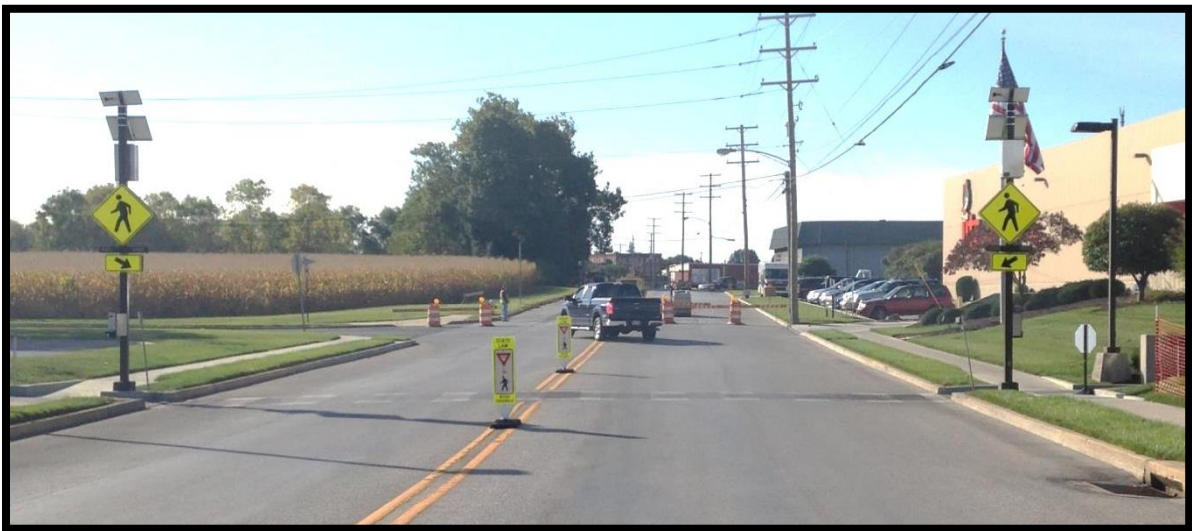
**Figure 6: Example of "doubled up" Pedestrian Warning Signs with Rectangular Rapid Flashing Beacons**

Another option the Township could consider is adding Rectangular Rapid Flashing Beacons to the pedestrian signs at the crossing. These beacons are pedestrian activated, and flash in pattern that attracts the attention of motorists. Lastly, at the location of the advance pedestrian crossing signs, the Township could consider installing “Ped Xing” pavement markings on E. Main Street.

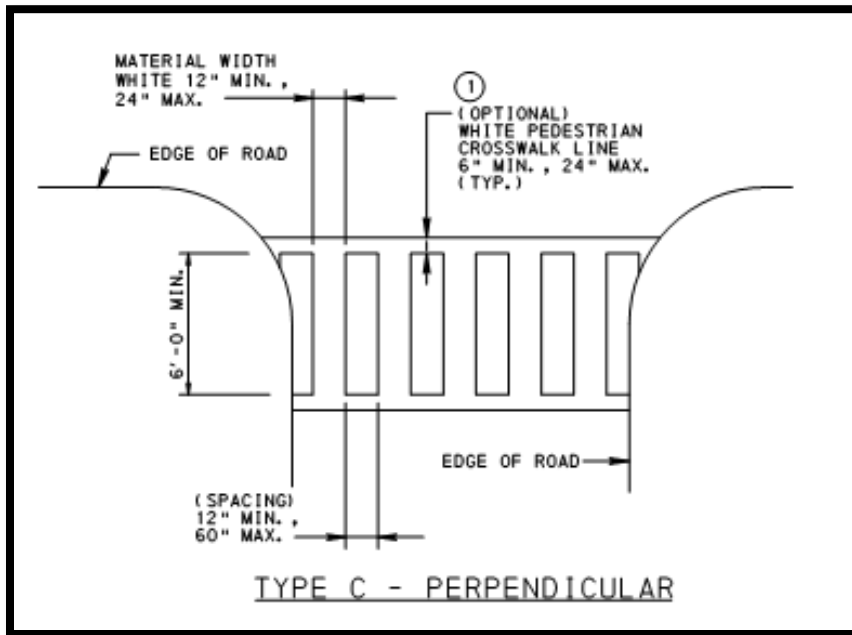
Figure 7: Sample Crosswalk Detail from PennDOT Pub 111

For all signing and pavement markings purchases and installation, make sure to follow PennDOT guidelines. PennDOT Publication 111 provides details on the post installation, sign placement (height and lateral offset), and pavement marking installation

details. Where in urban areas where pedestrian activity is present, install signs so that the bottom of the sign is 7 feet above the top of the curb in accordance with Section 2A.18 of the 2009 MUTCD. The Township should also continually restripe faded pavement markings, such as stop bars, centerlines, and crosswalk markings, and replace faded and/or damaged/defaced signs. The Township can consider using thermoplastic pavement markings for the crosswalk to increase visibility and decrease maintenance. Establish a schedule for inspecting, cleaning, and replacing these traffic control devices. In accordance with Section 2A.08 of the 2009 MUTCD, implement an assessment or management method that is designed to maintain sign retroreflectivity at or above the required minimum levels. A sign management tool can be found on LTAP's website free of charge. On the website, click on "LTAP News / Events" under "News" to find information related to the free sign inventory and management tool. If Township officials have questions about the tool, please contact LTAP.

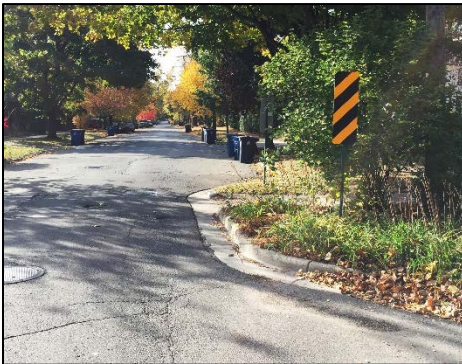
(Source: City of An Arbor, Michigan)

- Can be created by a pair of curb extensions, often landscaped
- Encourages lower travel speeds by reducing motorist margin of error
- One-lane choker forces two-way traffic to take turns going through the pinch point
- If the pinch point is angled relative to the roadway, it is called an angled choker
- Can be located at any spacing desired
- May be suitable for a mid-block crosswalk
- Appropriate for arterials, collectors, or local streets

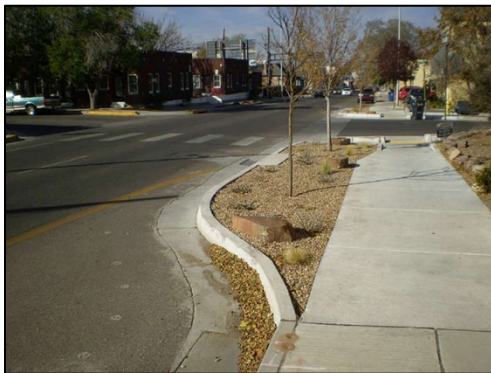
(Source: James Barrera, Horrocks, New Mexico)

- When combined with on-street parking, a corner extension can create protected parking bays
- Effective method for narrowing pedestrian crossing distances and increase pedestrian visibility
- Appropriate for arterials, collectors, or local streets
- Can be used on one-way and two-way streets
- Installed only on closed-section roads (i.e. curb and gutter)
- Appropriate for any speed, provided an adequate shy distance is provided between the extension and the travel lane
- Adequate turning radii must be provided to use on bus routes

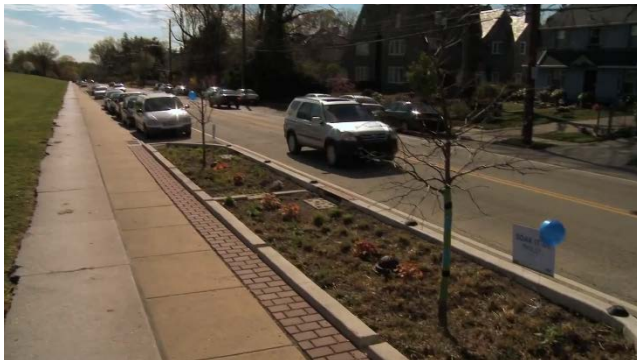
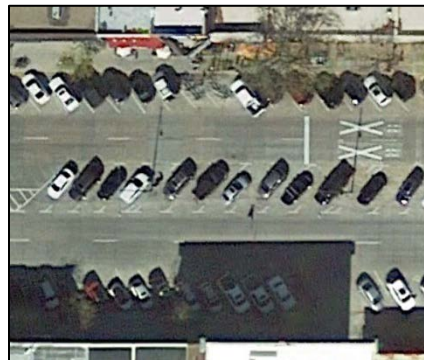
- High likelihood of acceptability for nearly all roadway functional classifications and street functions
- More appropriate in urban or suburban settings
- Can be combined with other traffic calming measures
- Can apply alternating sides of street for chicane effect
- Can combine with curb extensions for protected parking, including landscaping for beautification
- Can apply using time-of-day restrictions to maximize throughput during peak periods
- Can be used on one-way or two-way streets
- Preferable to have a closed-section road (i.e. curb and gutter)
- Appropriate along bus transit routes
