Texas Commission on Environmental Quality  
Monitoring Division

Permian Basin Survey  
Region 7 Midland  
December 9-13, 2019

Document Number  
PB1912

The Strategic Sampling Work Group (SSWG) traveled to the Permian Basin area December 9 – 13, 2019, to conduct a survey trip for hydrogen sulfide (H<sub>2</sub>S) and sulfur dioxide (SO<sub>2</sub>) at selected locations within Region 7 (R7) Midland. Surveys were predominantly conducted around areas/facilities of concern identified by R7 or Emissions Event Database queries.

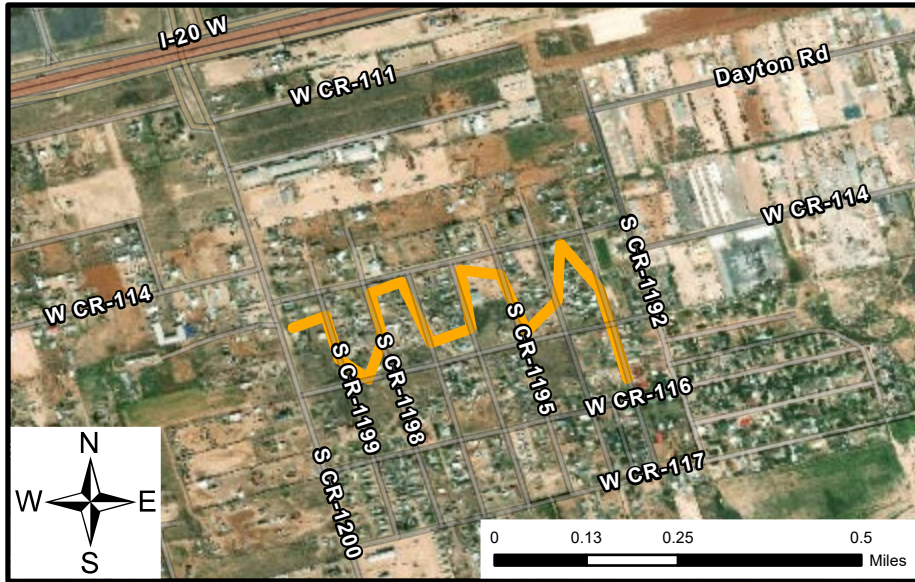
Figure 1a

Winds were predominantly west (W)/northwest (NW) until noon when they became light and variable. Three survey routes were mapped (Attachment C). Mapped surveys were conducted in the southwest Midland area (Attachment C, Figure 1a, Figure 1c, and Figure 1d) and in the southeast Midland area along the fence line of the tank fire site where an explosion event occurred on November 21, 2019 (Attachment C, Figure 1b and Figure 1d). No H<sub>2</sub>S concentrations over 80 ppbv were detected, and therefore no stationary monitoring was conducted. Handheld instrument surveys were conducted in the Midland and Gardendale areas. No odors or TRS concentrations above background were detected. By noon, the rain was too heavy for further sampling.

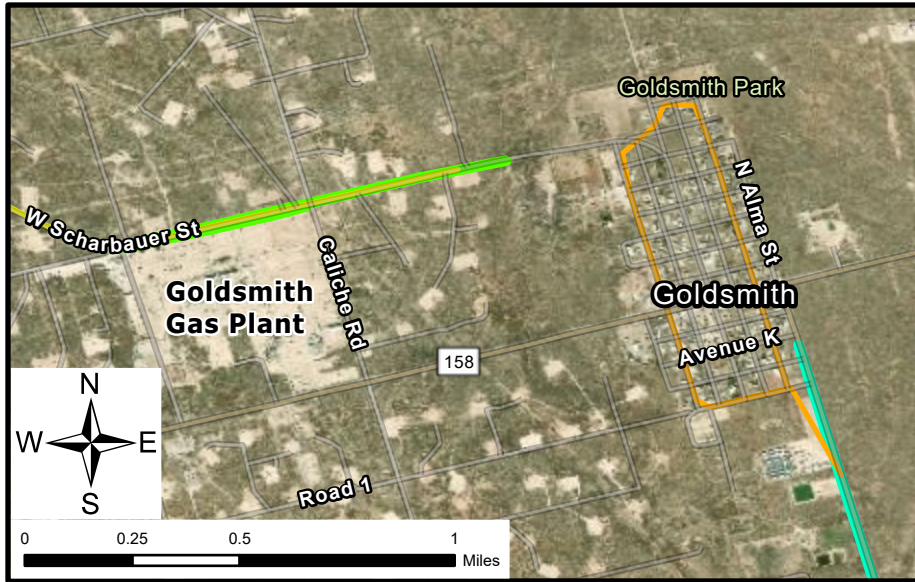
Figure 2a

morning northeasterly winds on highway 866, west of Clyde Cowden tank batteries and James Lake Gas Plant, detected a maximum 1-min average concentration of 324 ppbv H<sub>2</sub>S (Attachment E; Attachment D, Figure 2c and Figure 2d). Surveys were then conducted along the perimeter of Goldsmith Gas Plant (Attachment D, Figure 2a, Figure 2c, and Figure 2d), but no H<sub>2</sub>S concentrations above 80 ppbv were detected.

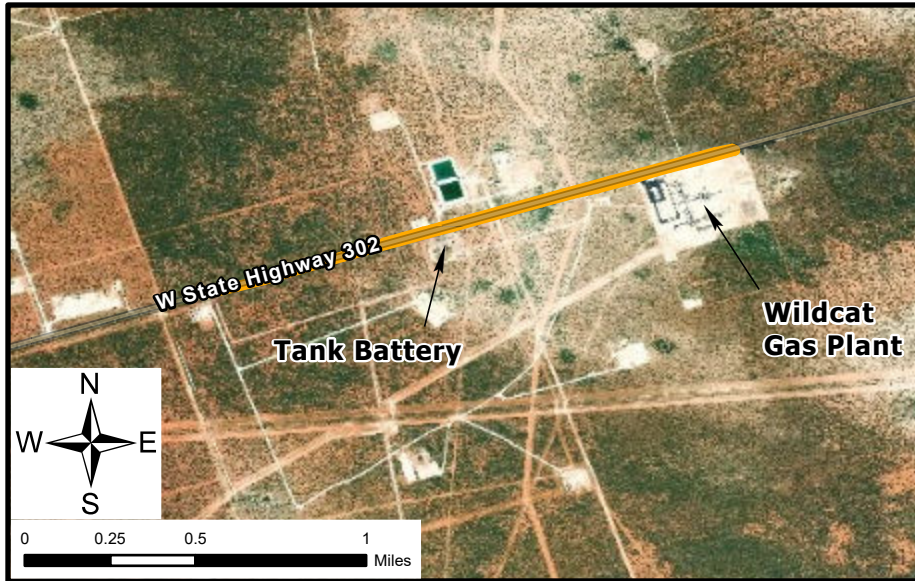
Handheld instrument surveys conducted along highway 302 north of Wildcat Gas Plant resulted in a maximum TRS concentration of 60 ppbv. A mapped survey on highway 302, along the same route, resulted in a 1-min average concentration of 138 ppbv H<sub>2</sub>S (Attachment H; Attachment G, Figure 3a and Figure 3d). Stationary monitoring was then conducted on highway 302 NW of Wildcat Gas Plant for approximately 30 minutes; a maximum 5-min average of 150 ppbv H<sub>2</sub>S, and a maximum 30-min average of 53 ppbv H<sub>2</sub>S was detected (Attachment I). The stationary concentrations detected on highway 302 were monitored northwest of the tank battery west of Wildcat Gas Plant during southeasterly winds and not directly downwind of Wildcat Gas Plant (Attachment I; Attachment G, Figure 3a).

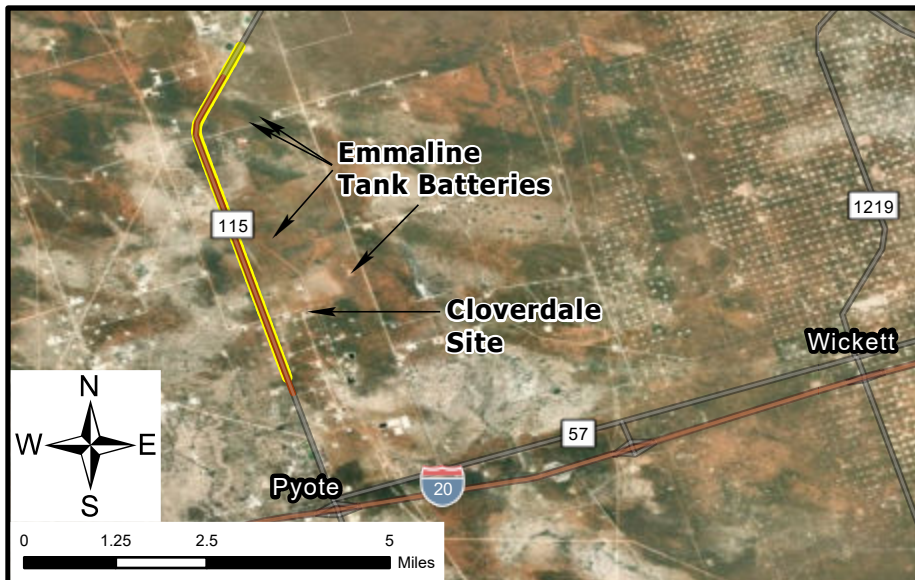
Winds were variable between east and southeast throughout the day. Four survey maps were created (Attachment G). A mapped survey was conducted west of the Cloverdale site and Emmaline tank farm, along highway 115 north of Pyote (Attachment G, Figure 3c and Figure 3d). Stationary monitoring was conducted on highway 115 for approximately 40 minutes due to strong odors, but no concentrations above background were detected; therefore, this stationary data was not included in this report. No further stationary monitoring was conducted at this site.

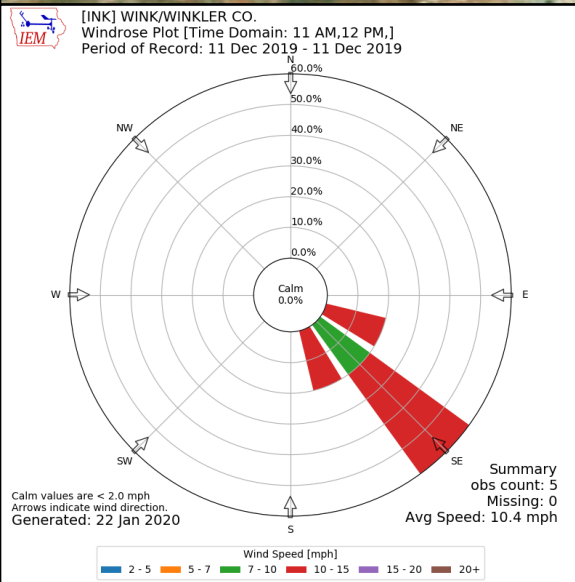
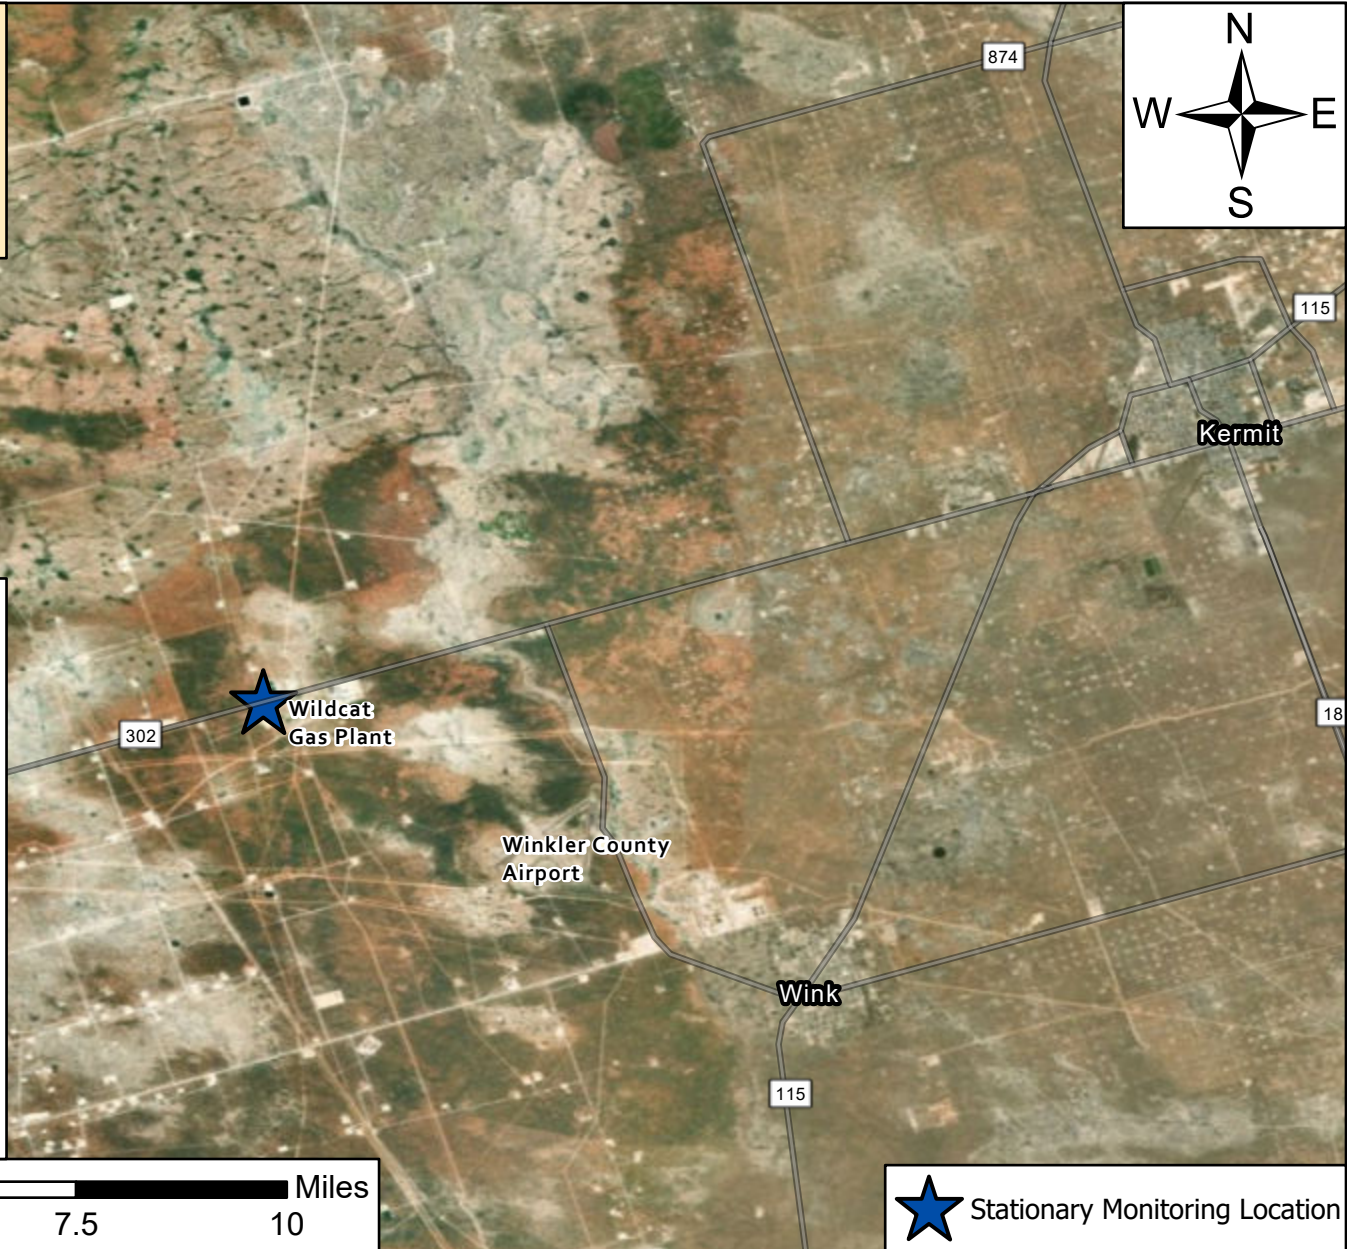
# Day 3, December 11, 2019 Stationary Monitoring Highway 302/Wildcat Gas Plant

5-min average = 150 ppbv  
30-min average = 53 ppbv

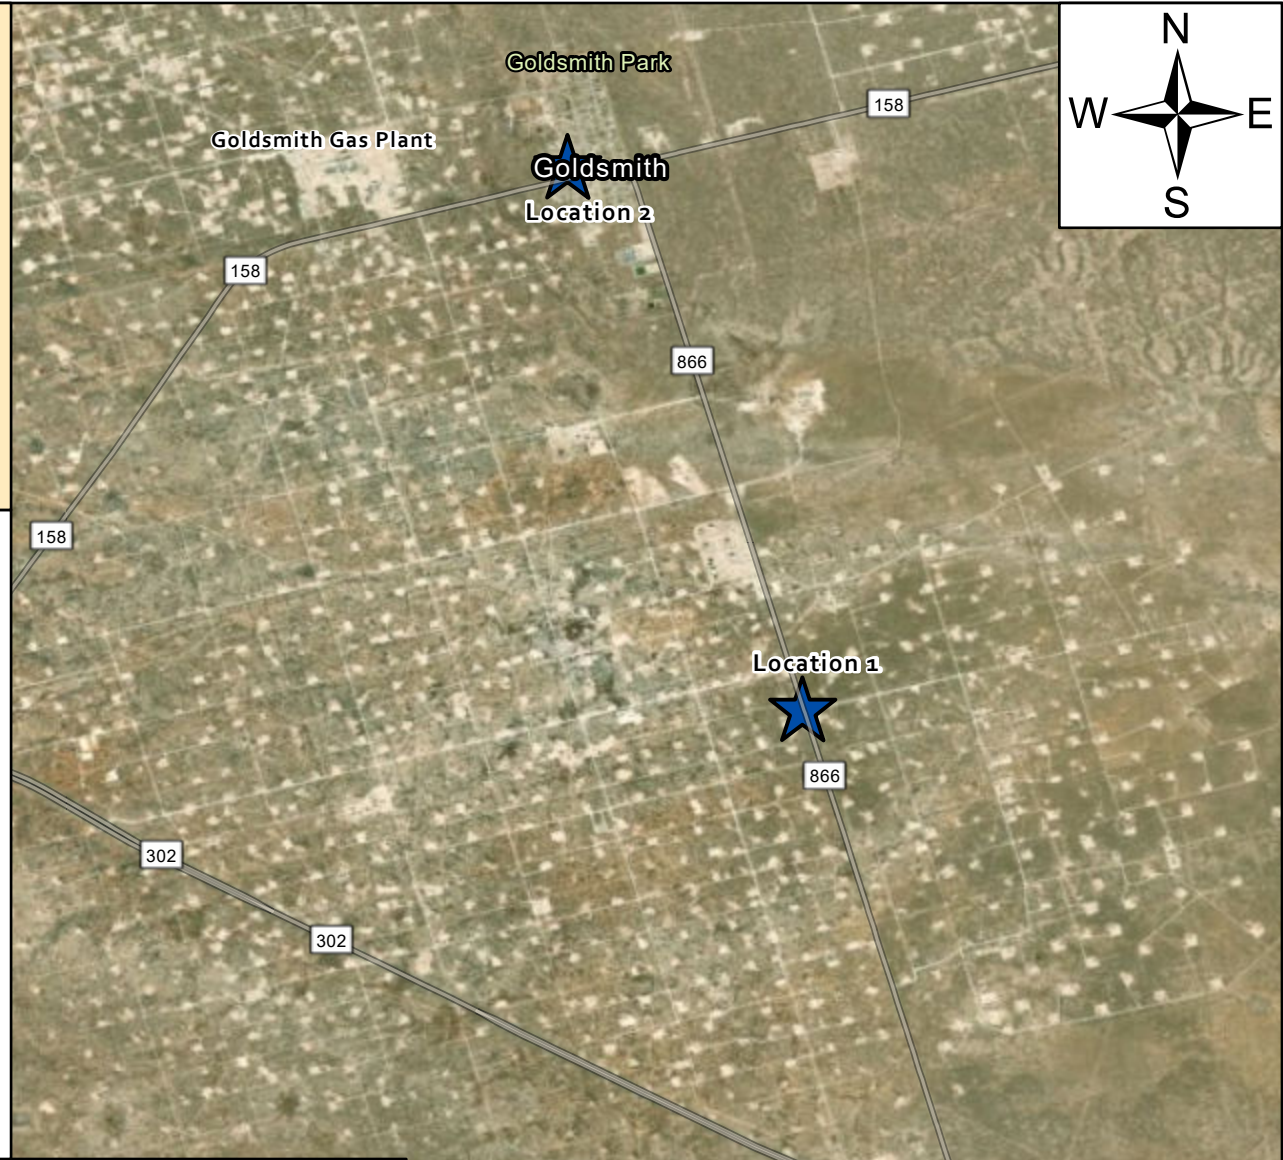
# Day 4, December 12, 2019 Stationary Monitoring Highway 866 and Goldsmith Overnight Sampling

5-min average = 200 ppbv  
30-min average = 49 ppbv

5-min average = 220 ppbv  
30-min average = 130 ppbv

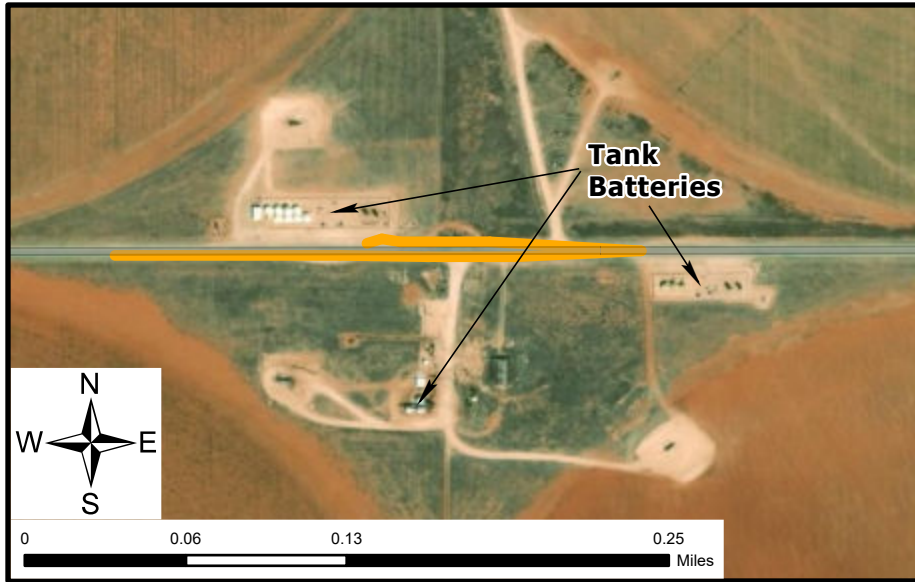
Figure 5a

Strong rotten egg odors were observed NE of Seminole Gas Plant along CR-208, and TRS readings of 836 ppbv and 1,100 ppbv were detected downwind (NW) of a tank battery along CR-208. A subsequent mapped survey included a 1-min average H<sub>2</sub>S concentration of 151 ppbv (Attachment M; Attachment L, Figure 5a, Figure 5b, and Figure 5d). Stationary monitoring at this same location was conducted for approximately 30 minutes and detected a maximum 5-min average H<sub>2</sub>S concentration of 270 ppbv, and a 30-min average H<sub>2</sub>S concentration of 150 ppbv (Attachment N).

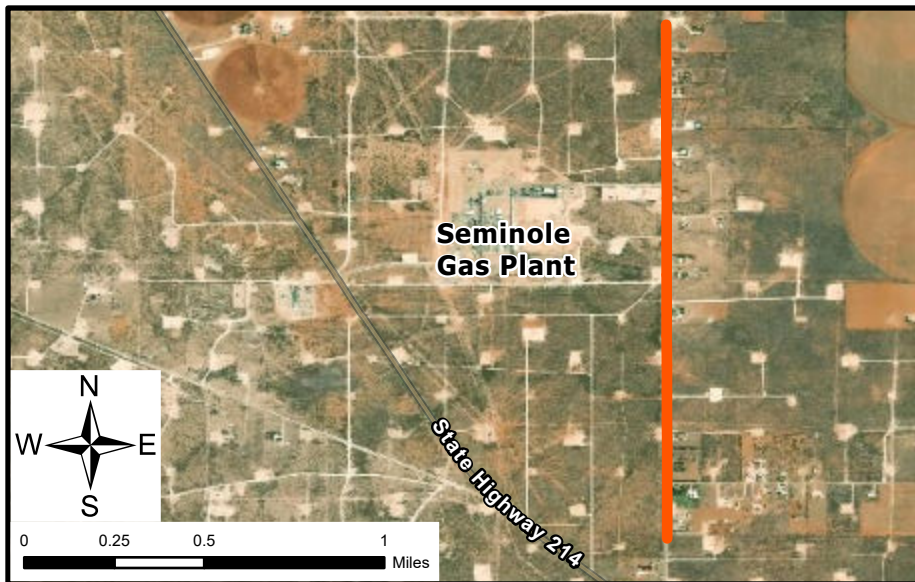
Winds were predominantly NW/WNW for the day. Two survey maps were created (Attachment L). Handheld instrument surveys were conducted east of Seminole Gas Plant on CR-205; no TRS above background was detected. A mapped survey conducted along CR-205 for approximately 15 minutes resulted in no H<sub>2</sub>S concentrations above background (Attachment L, Figure 5c and Figure 5d).
