AI 3319—Big Rivers Electric Company (D B Wilson Station).

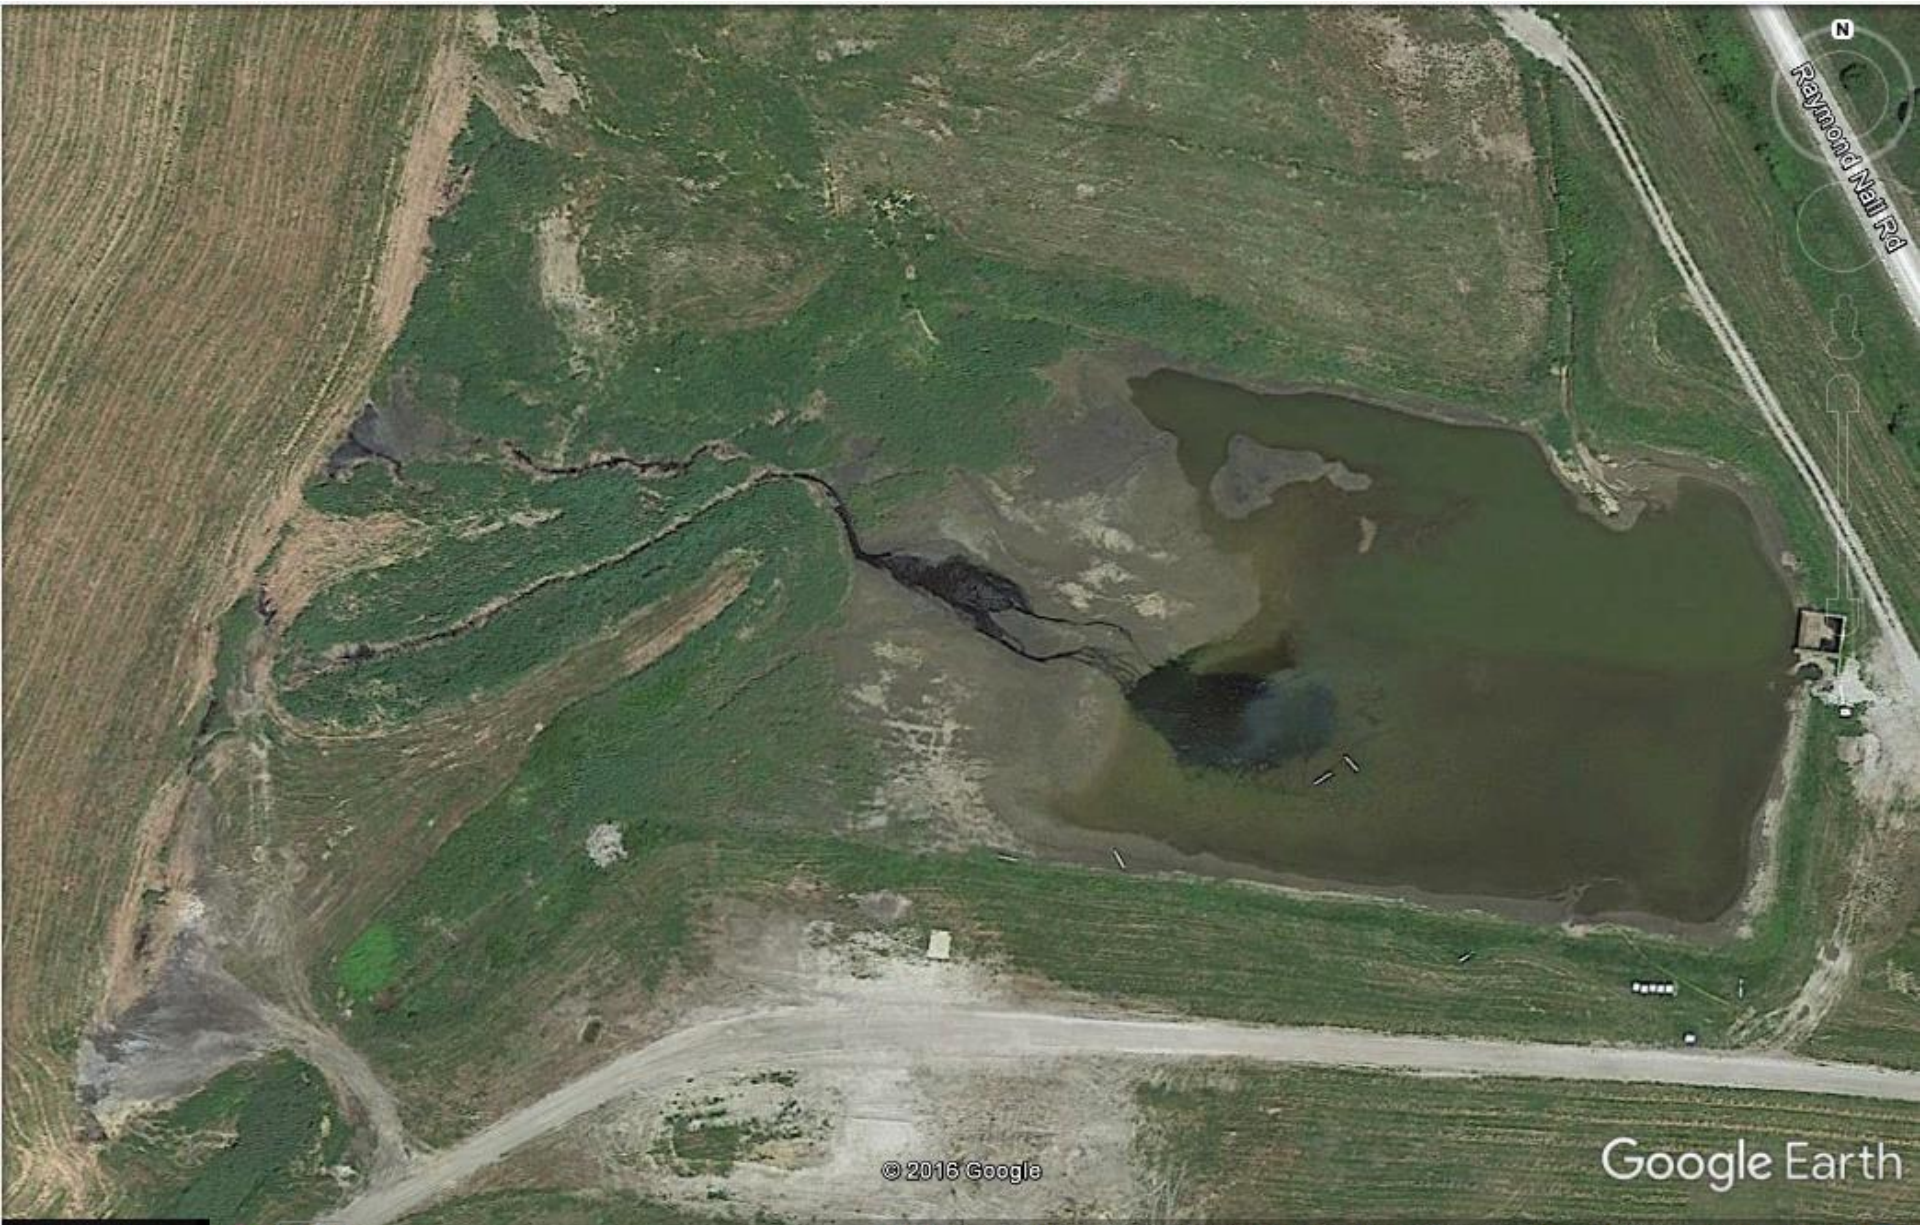
Google Earth imagery from 2016 showing leachate draining from north-east portion of Phase I Waste Area into sediment pond associated with KPDES Outfall 002. Google Earth imagery date = 6-9-16.

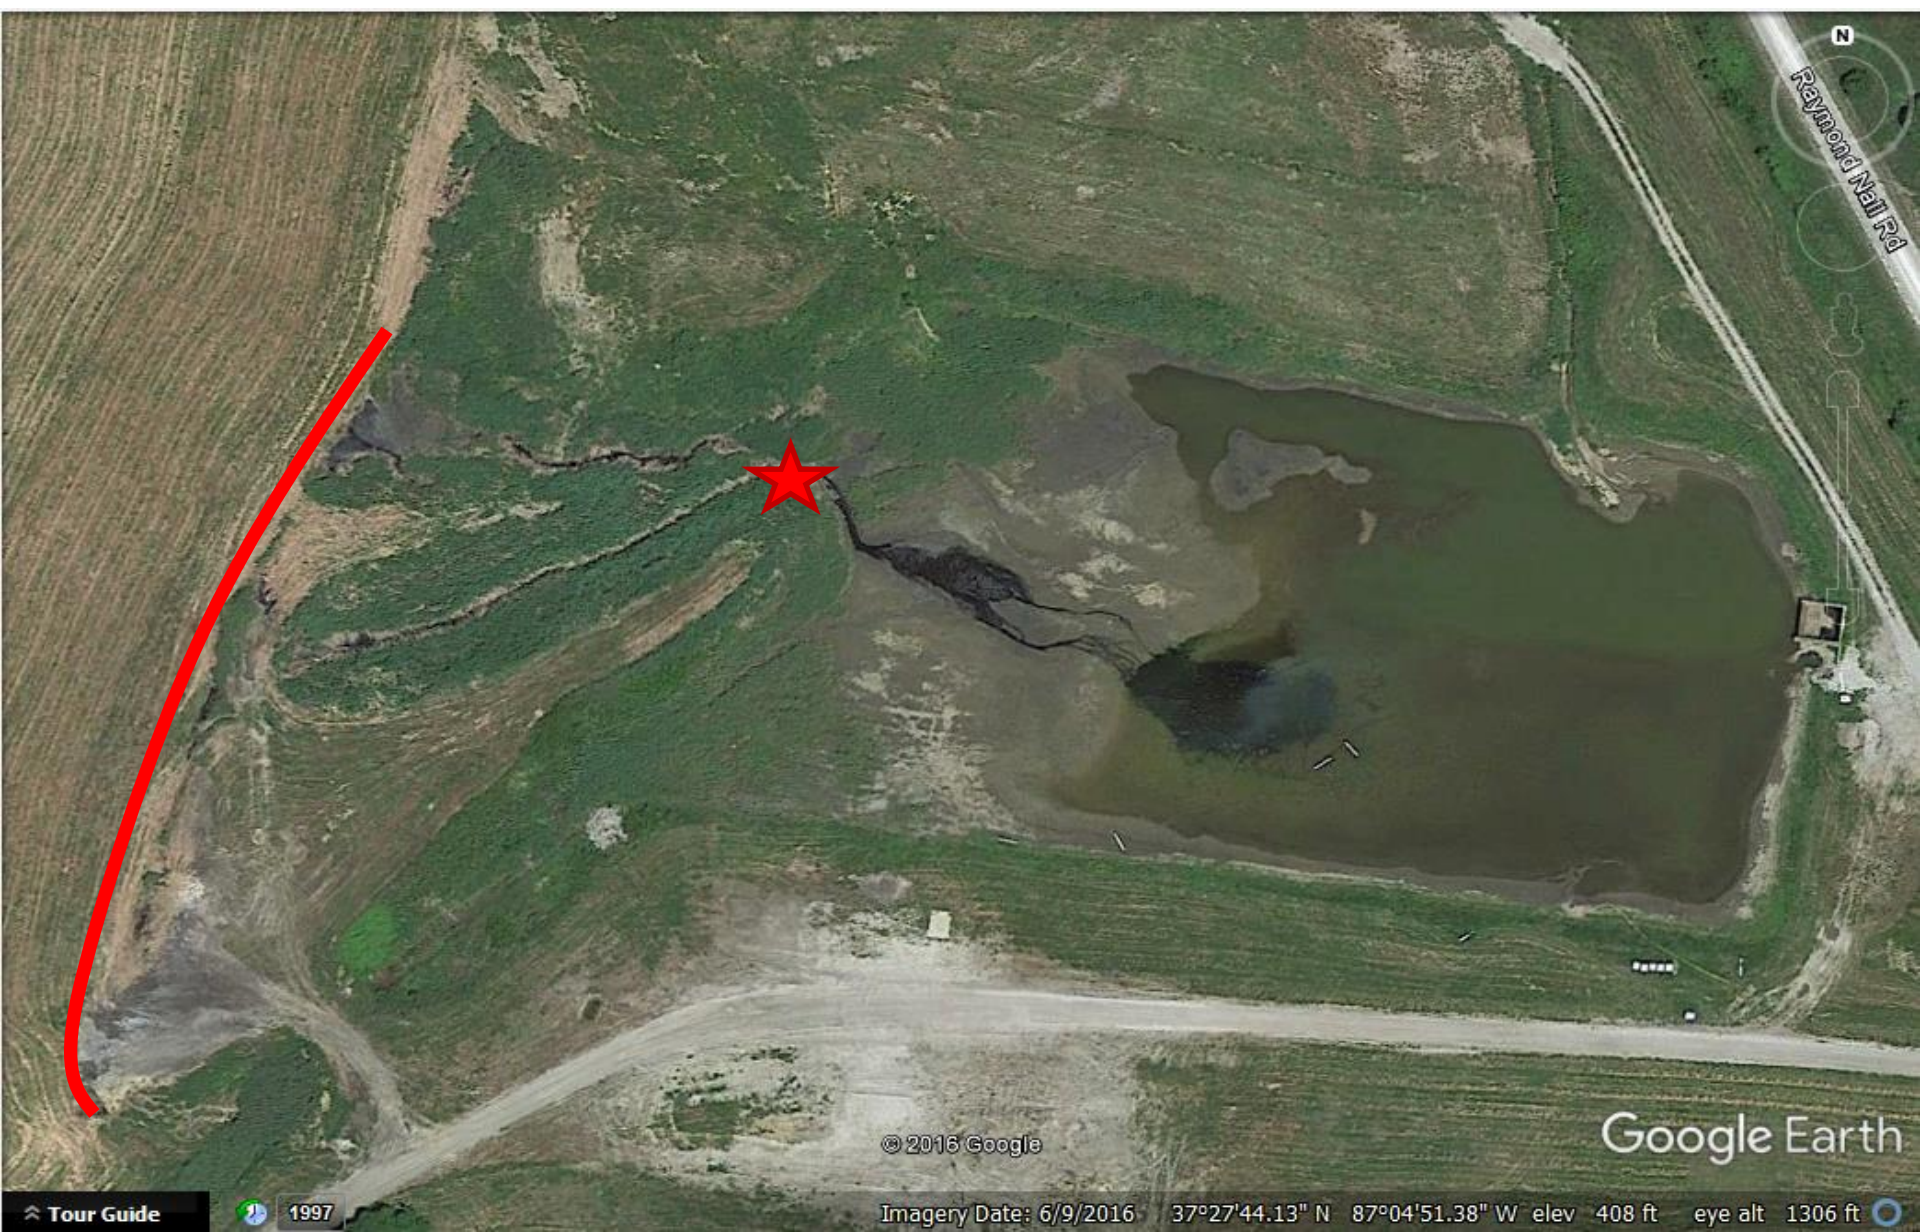
Red curved line shows approximate area where multiple small leachate outbreaks were observed. Red star = approximate location where sample was collected – the water elevation in the pond was higher during the inspection on 10-3-16. Google Earth imagery date = 6-9-16.

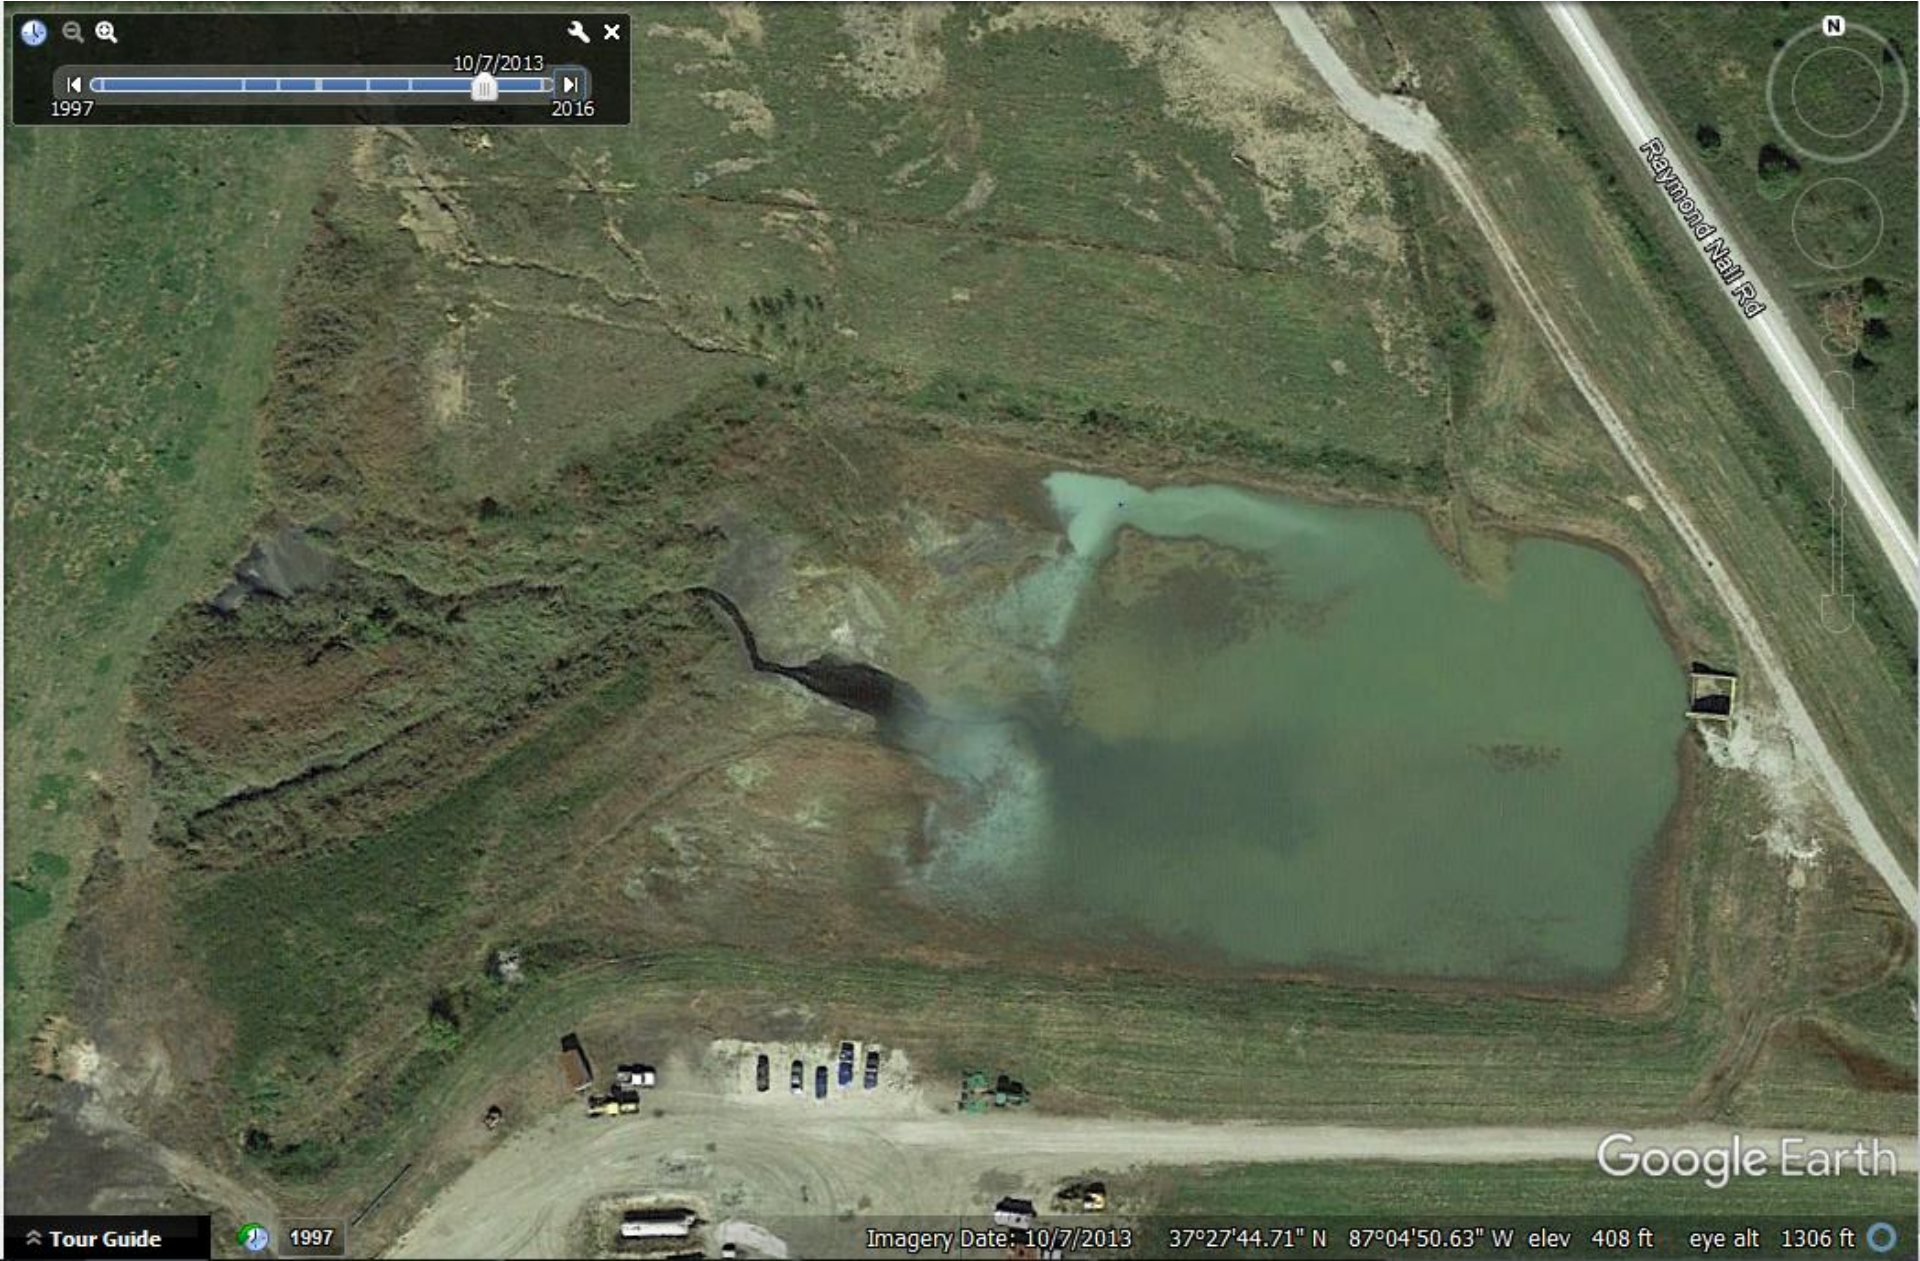
Google Earth imagery from 2013 showing leachate draining from north-east portion of Phase I Waste Area into sediment pond associated with KPDES Outfall 002. Google Earth imagery date = 10-7-13.
