SAFER SEAS Digest 2020

Lessons Learned from Marine Accident Investigations

NTSB National Transportation Safety Board

NTSB/SPC-21-01

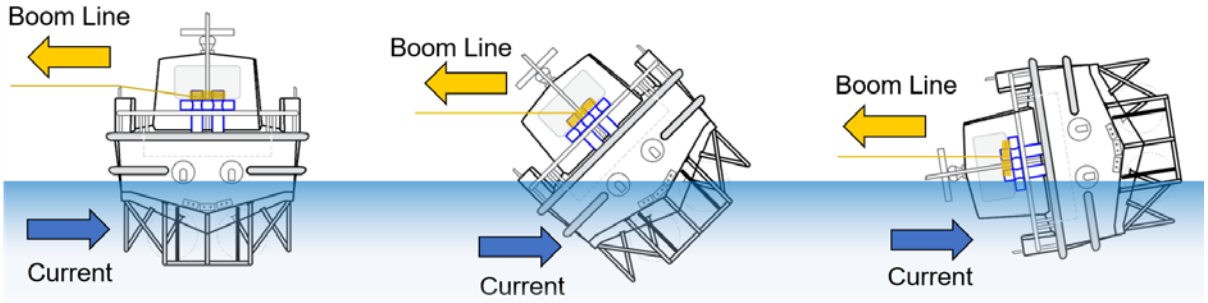
Figure 5. H-bitt on a workboat of the same design as *MSRC 8-1*, with towline secured to the bitt.

The investigation found that the arrangement of the towline and H-bitt on the *MSRC 8-1* made the transitioning of the boom from directly astern of the OSRV into the J-configuration inherently dangerous in the prevailing current. The company conducted a postaccident analysis and modified each of its similar boats with a towline guide on the stern and buoyancy collar at the waterline to reduce the capsizing hazard, conducted risk assessments, and enhanced procedures and training in its SMS.

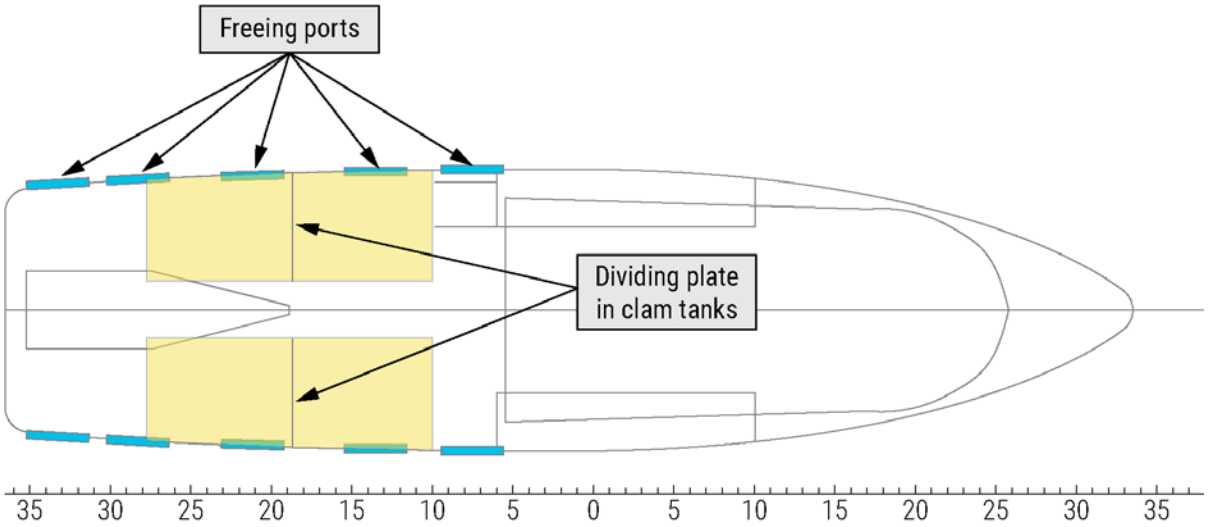
The probable cause of the capsizing and sinking of fishing vessel *Misty Blue* was flooding of the port clam tank from an undetermined point of ingress, which led to a decreased freeboard and a list allowing boarding seas to be trapped on deck, thereby decreasing the vessel's stability. Contributing to the sinking was the relatively small freeing port area of the vessel, which likely increased water accumulation on deck.

Figure 9. Plan view of *Misty Blue*'s tank layout and freeing port locations. The clam tanks are highlighted in yellow.
SOURCE: COAST GUARD; ANNOTATED BY NTSB.

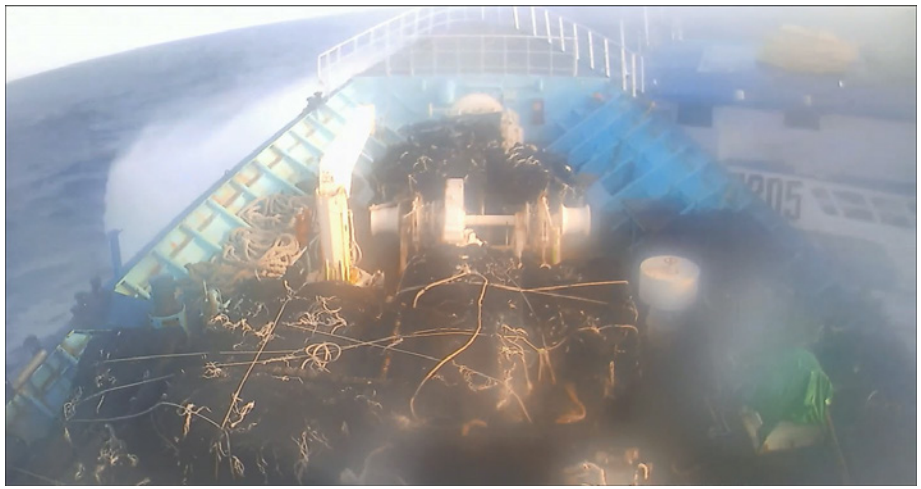
Figure 10. Below: Still image captured from the bow CCTV camera aboard the *American Eagle*.

The probable cause of the collision between the fishing vessels *American Eagle* and *Koorale* was both vessels' captains and fishmasters not following international collision regulations or communicating to make arrangements while pursuing the same school of fish.

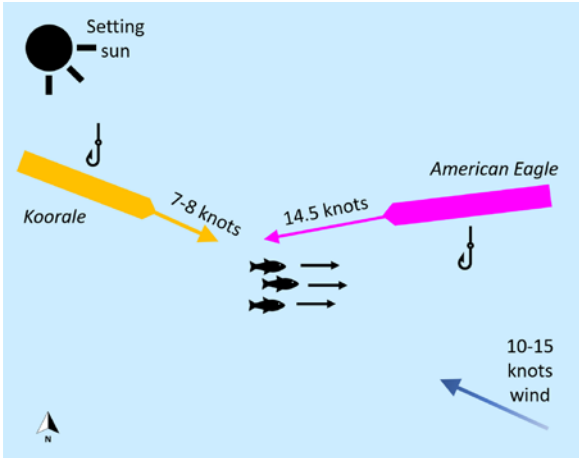
Figure 12. Estimated locations of the vessels and fish (not to scale) approximately 10 minutes prior to the collision.

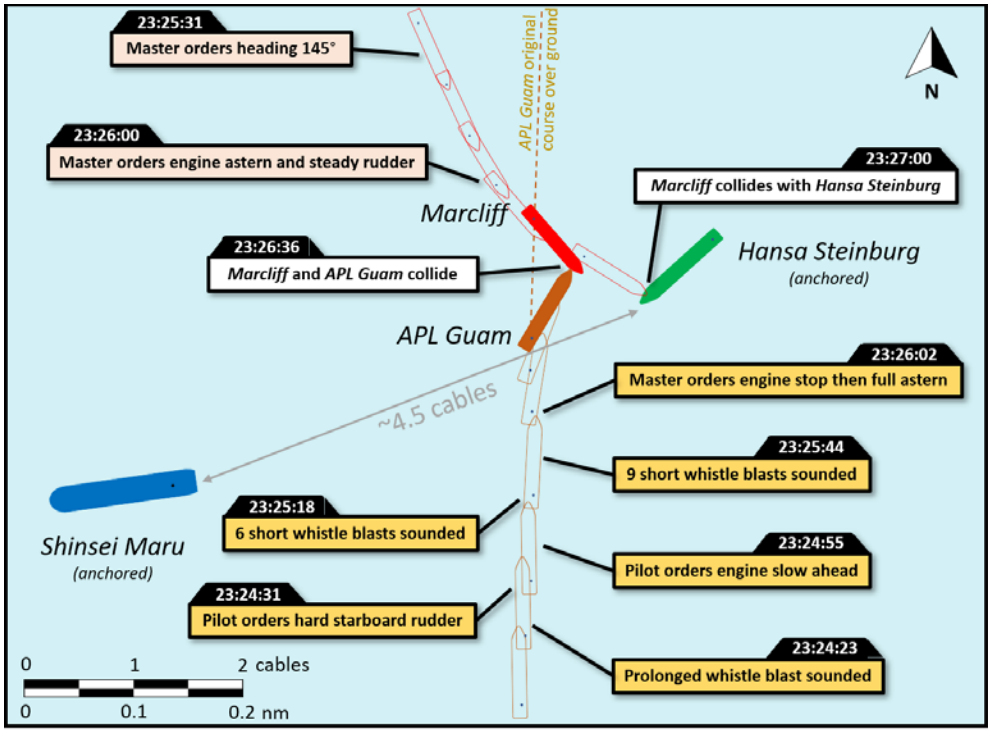
Figure 17. Right: Accident timeline. Vessels drawn approximately to scale; positions compiled from AIS and VDR data.

The probable cause of the collision between the containerships *Marcliff* and *APL Guam* was the *Marcliff* master's attempt to pass between the *APL Guam* and the anchored *Hansa Steinburg* with insufficient safe maneuvering room. Contributing to the accident was a lack of communication between the *Marcliff* bridge team and the *APL Guam* pilot and bridge team to establish their maneuvering intentions.

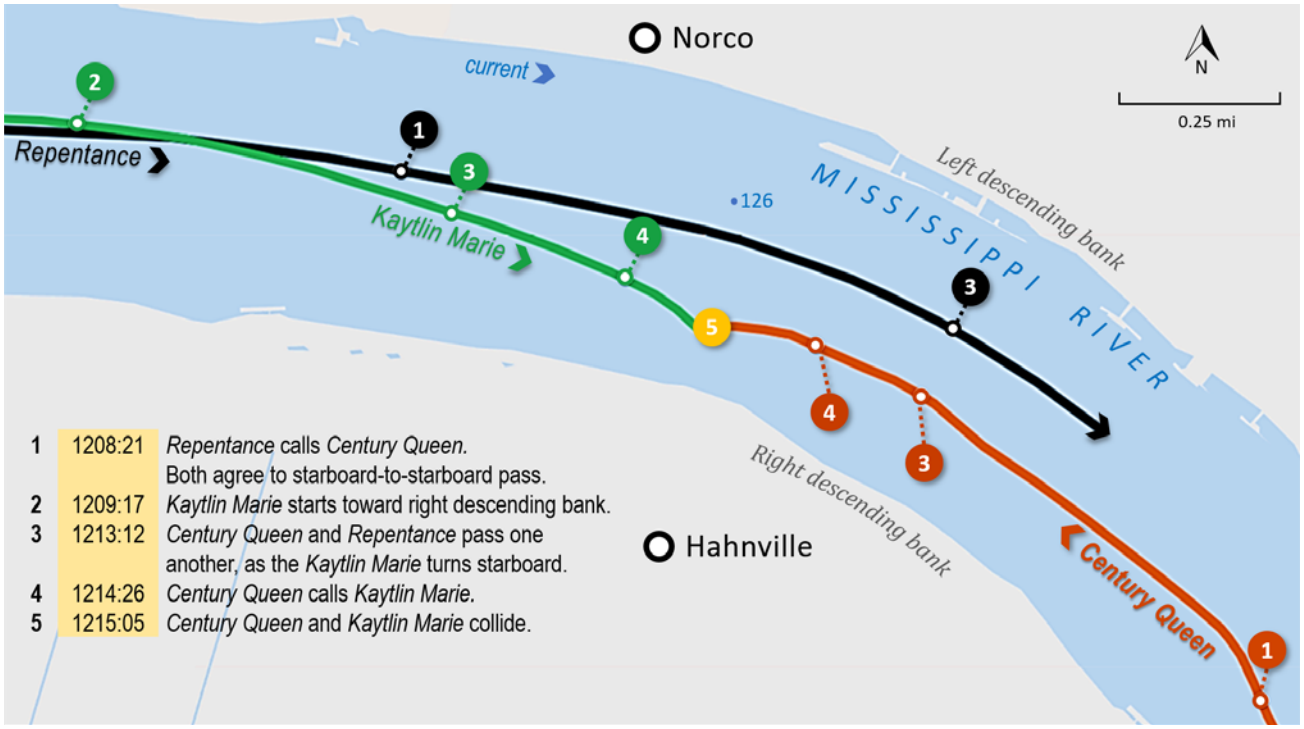
The probable cause of the collision between the bulk carrier *Century Queen* and the towing vessel *Kaytlin Marie* was the lack of early and effective communications to confirm a passing arrangement between the two vessels.

Figure 23. Tracklines of the vessels during the last 7 minutes prior to the collision. The *Century Queen* is represented in red, the *Kaytlin Marie* in green, and the *Repentance* in black. BACKGROUND SOURCE: GOOGLE MAPS.

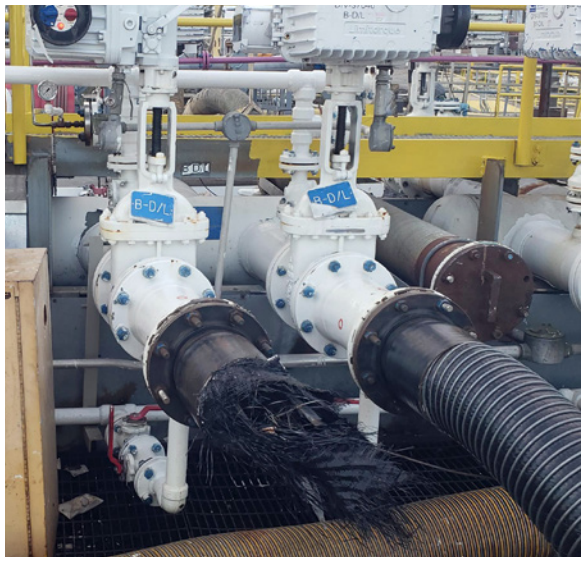
Figure 24. Damaged shoreside cargo hose and deformed piping at the manifold at the Kinder Morgan facility.

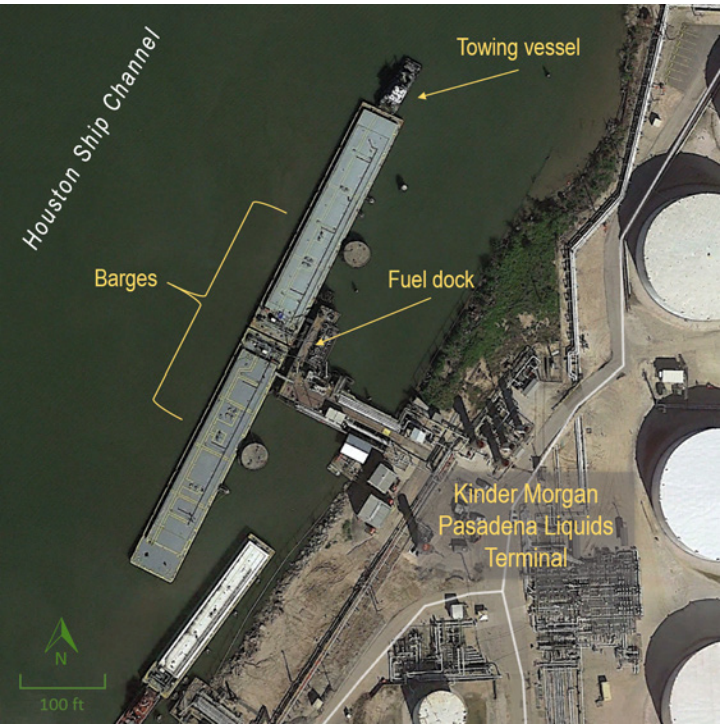
Figure 26. Left: Aerial view of the Kinder Morgan Pasadena Liquids Terminal with a towing vessel and two barges moored in a similar arrangement to the *Trinity*, *Kirby 29051*, and *EBL 2997*.
BACKGROUND SOURCE: GOOGLE EARTH, ANNOTATED BY NTSB.

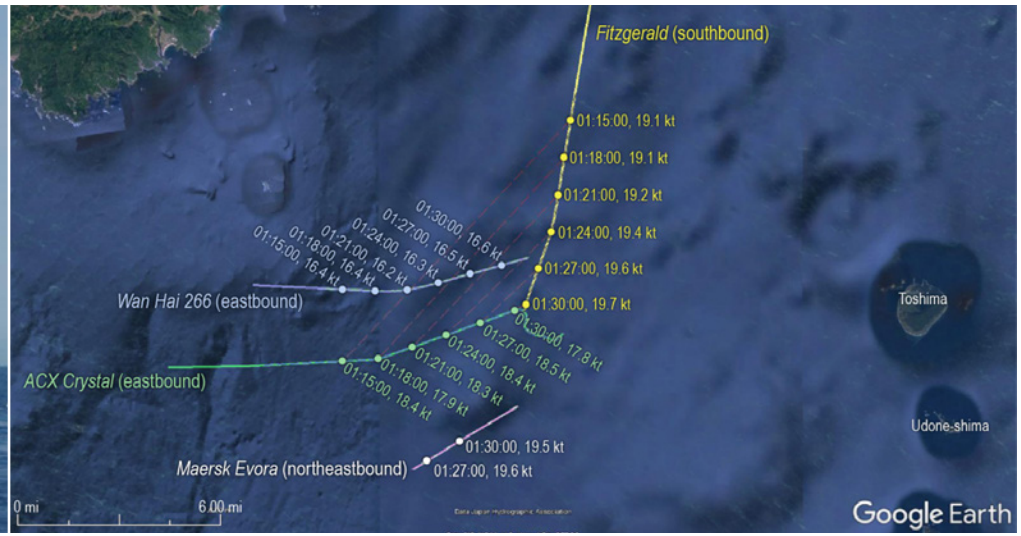
Figure 31. NTSB reconstruction of the paths of the *Fitzgerald*, *Wan Hai 266*, *ACX Crystal*, and *Maersk Evora*. BACKGROUND SOURCE: GOOGLE EARTH.

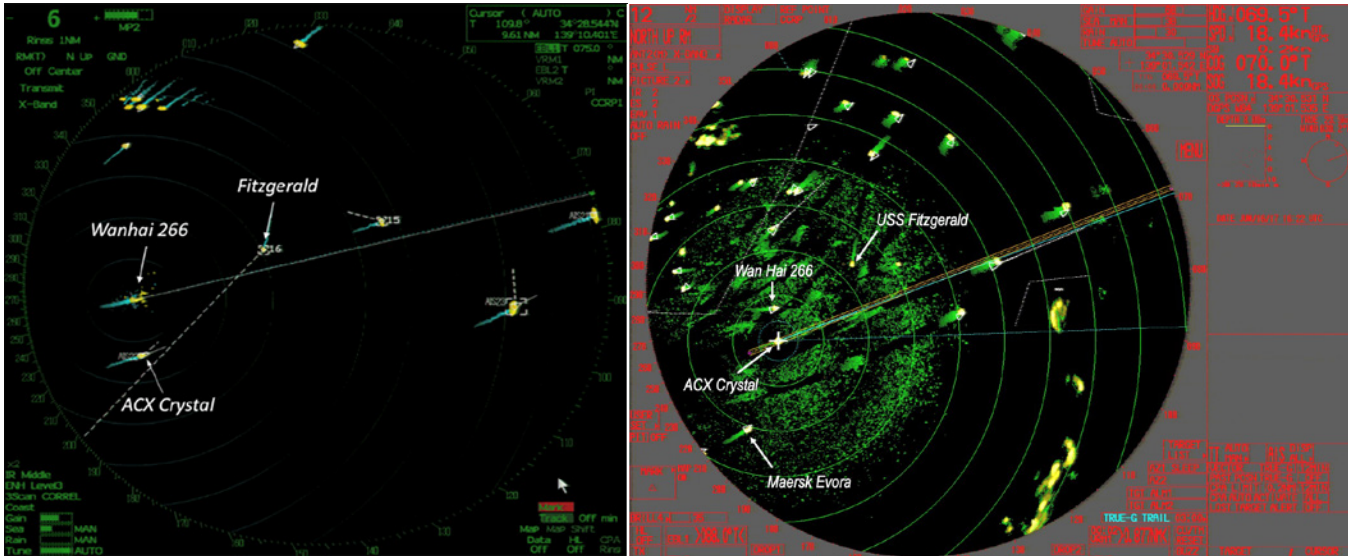
Figure 32. A comparison of radar screens from different vessels before the collision. **Left:** Screen capture from the *Wan Hai 266* electronic navigation software, about 6 minutes before the collision. **Right:** Screen capture from the *ACX Crystal* electronic navigation software (radar and ARPA), at the same time. (Vessel names have been added to screen images.)

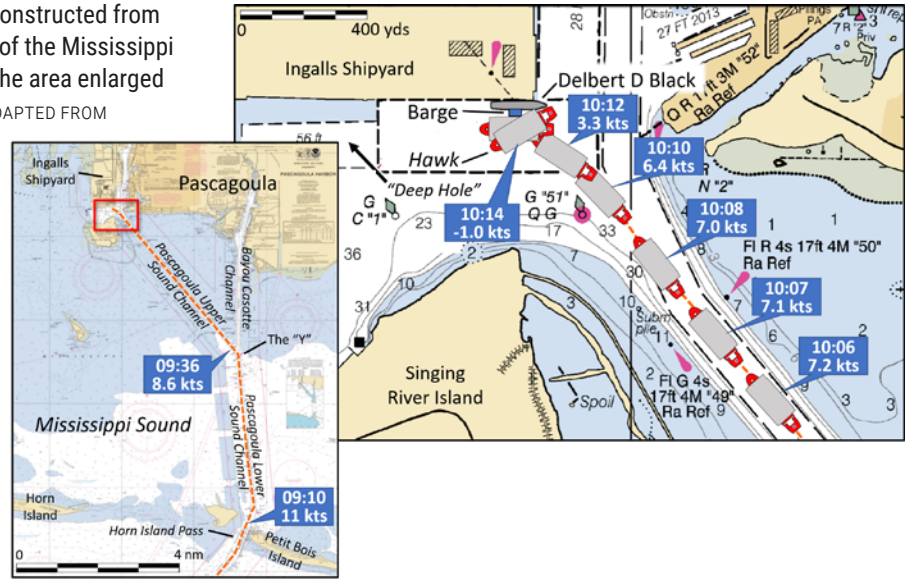
As the ship approached the barge, pilot 1 ordered the tugboats to sound their whistles and ordered the *Hawk*'s crew to drop the port anchor in an attempt to arrest the forward motion of the vessel. At 1012, the starboard side of the drydock on the *Hawk* struck the electrical testing barge, puncturing the side of the drydock. An electrical fire broke out on the barge and was extinguished by shipyard workers. The force of the impact drove the barge into the side of the destroyer's hull, creating a breach at the waterline that resulted in flooding in berthing and equipment spaces on the ship. A steel beam on the barge driven into the destroyer's weather decks caused damage to a boat davit and superstructure bulkhead.

Figure 35. Right: Accident trackline reconstructed from AIS data. The lower left is a broad view of the Mississippi Sound, with the red rectangle showing the area enlarged in the upper right. BACKGROUND SOURCE: ADAPTED FROM NOAA CHART 81054.

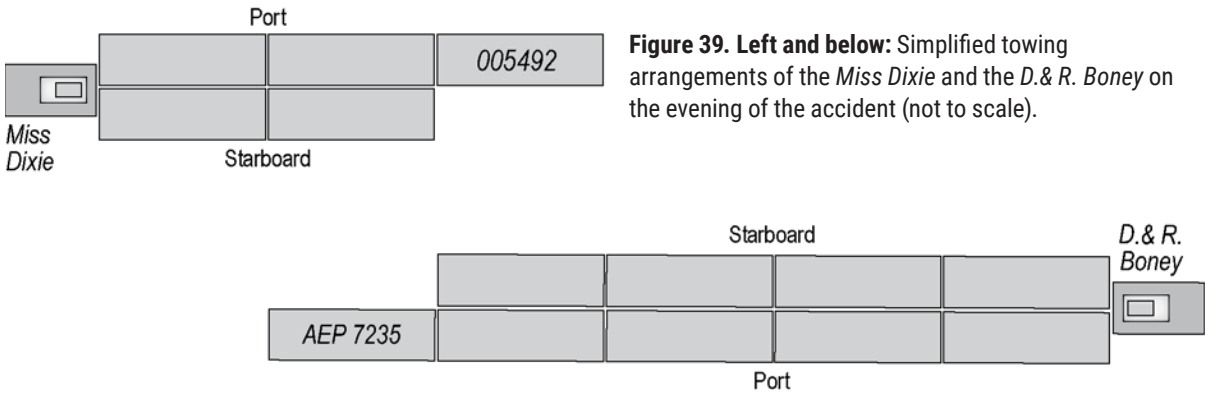
Figure 39. Left and below: Simplified towing arrangements of the *Miss Dixie* and the *D.& R. Boney* on the evening of the accident (not to scale).

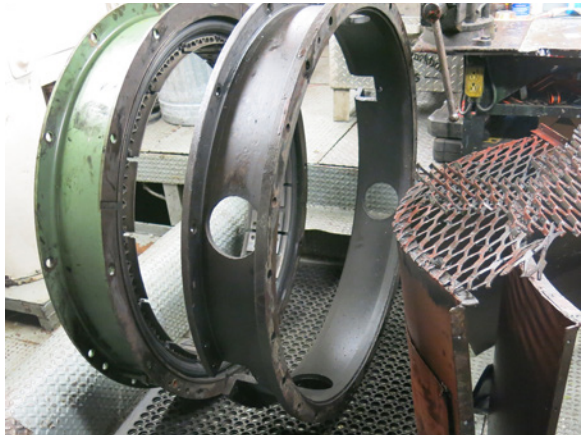
Figure 41. Above: Port clutch assembly steel rings removed from the *Miss Dixie* during postaccident inspection. **Below:** Condition of the port engine clutch friction pads aboard the *Miss Dixie* after the accident.

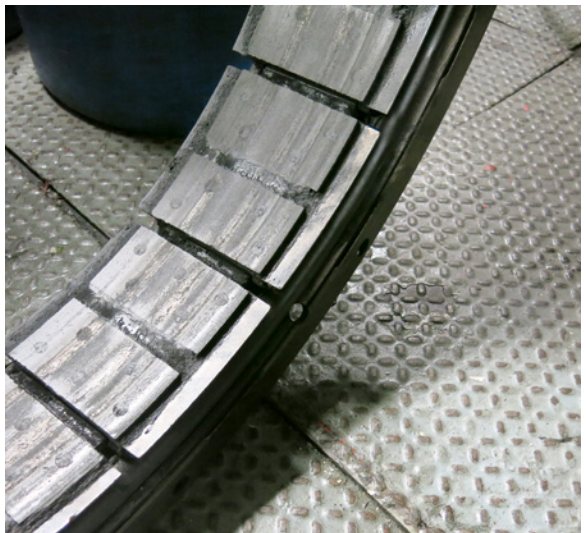
A postaccident inspection by a service representative found that the port clutch had excessive wear, would slip, and was only 40% operational. The air-actuated clutch was designed to transfer torque from the engine to the propeller by inflating a rubber air tube within a steel ring, forcing friction shoes onto the rotating assemblies, which would rotate the propeller at a proportional speed to the engine. Heat is generated by a slipping clutch, producing smoke from the overheating of components in the clutch system, such as the rubber tube, and results in a reduction of power being transferred to the propeller.

Without records to show any previous maintenance or inspections of the port and starboard clutches aboard the ***Miss Dixie***, the condition of the units at the time of the accident was unknown. The clutches were not inspected over the 6 months of ownership, and the owner had not developed periodic inspection or maintenance procedures per manufacturer's guidance associated with the clutches, which are critical components of the propulsion system.

Owners and operators should ensure that all critical equipment associated with propulsion systems, such as clutches, are included in preventative maintenance systems and that they follow the manufacturer's maintenance and inspection interval recommendations.

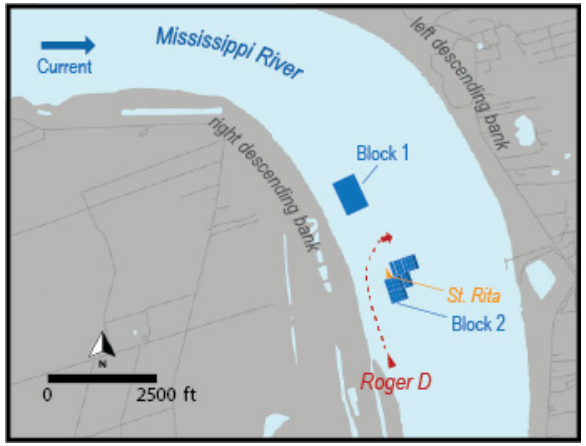
Figure 45. Approximate trackline of the towing vessel *Roger D* as it approached the *St. Rita* and Block 2.
BACKGROUND SOURCE: GOOGLE MAPS.

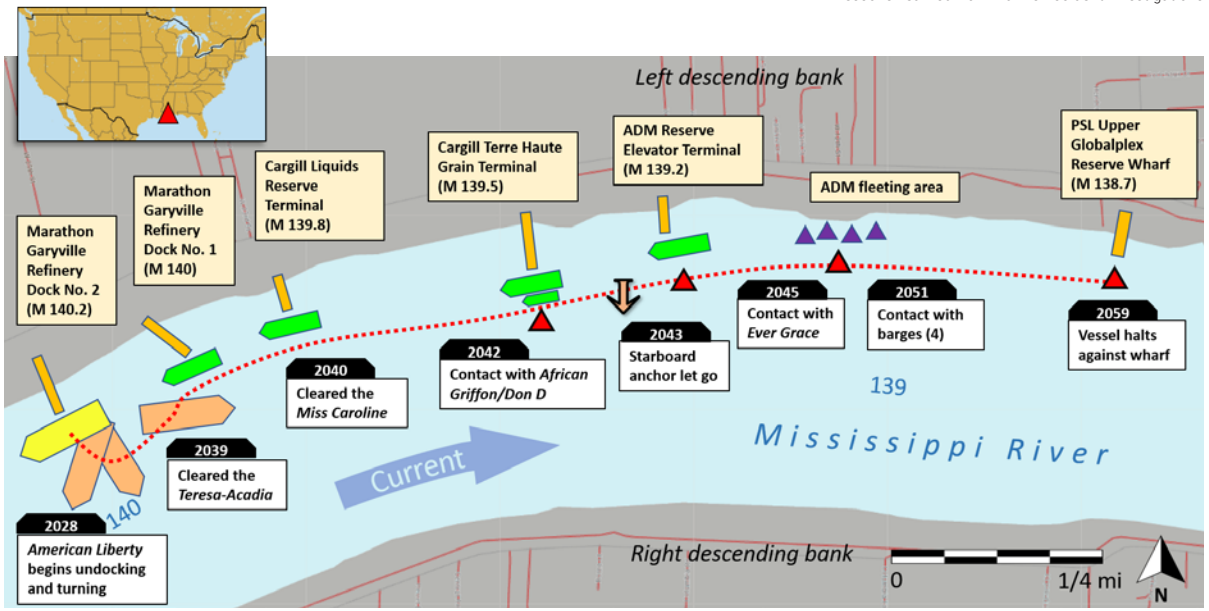
Figure 48. From where the *American Liberty* was moored, there were five wharfs on the left descending bank down river. All vessels were moored starboard-side-to, bow pointed upriver. Shown is the vessel's AIS track (red dots) getting under way, turning counterclockwise, moving bow first down river, and contacting vessels and wharfs along the left descending bank, as indicated by the red triangles. Not to scale. BACKGROUND SOURCE: GOOGLE MAPS.

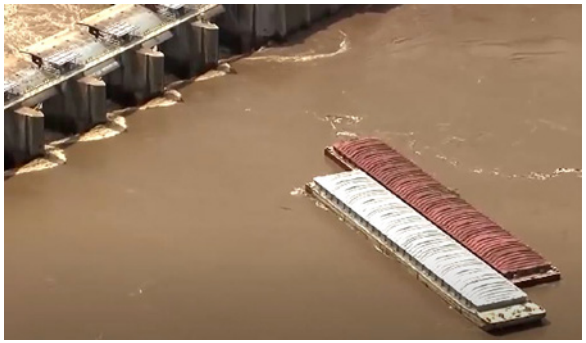
Figure 52. Barges *MTC 7256* and *LTD 11140* shortly before striking Webbers Falls Dam. SOURCE: KJRH-TV.

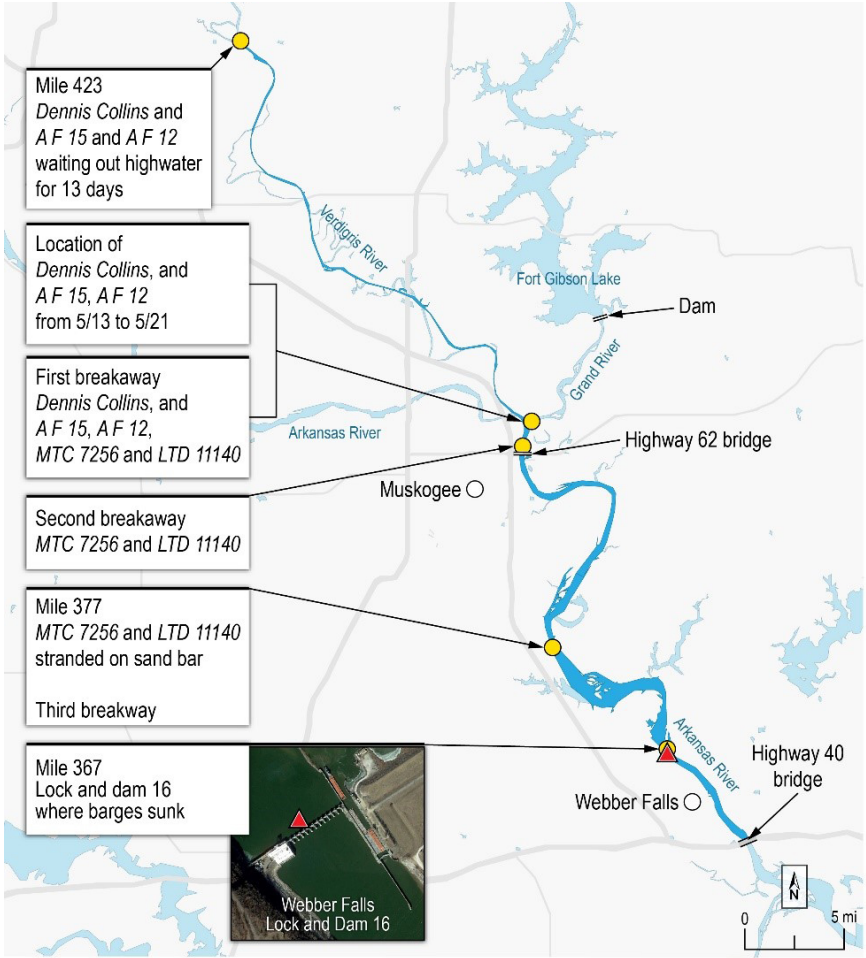
Figure 53. Map of area of the McClellan-Kerr Arkansas River Navigation System. Inset: Where the *MTC 7256* and *LTD 11140* struck the Webbers Falls Dam, as indicated by the red triangle.

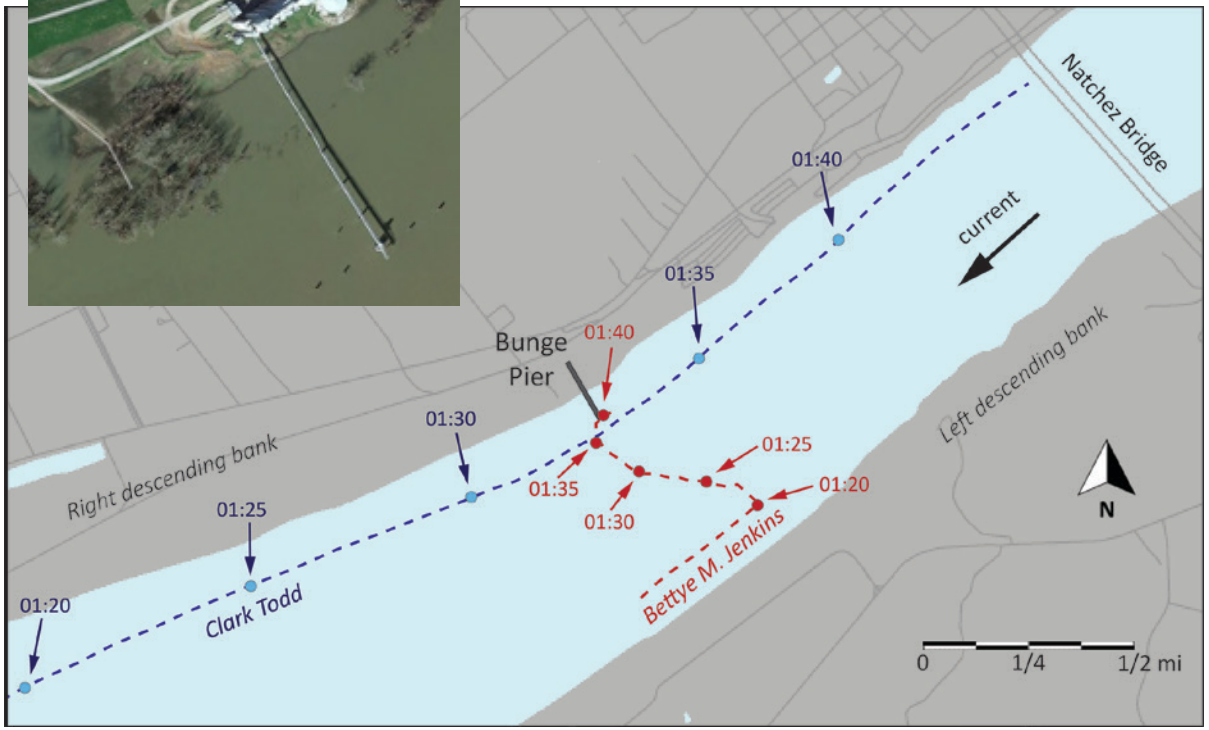
Figure 57. Select positions of the *Clark Todd* and the *Bettye M. Jenkins*.
DATA SOURCE: US COAST GUARD NAVIGATION CENTER; BACKGROUND SOURCE: GOOGLE MAPS.

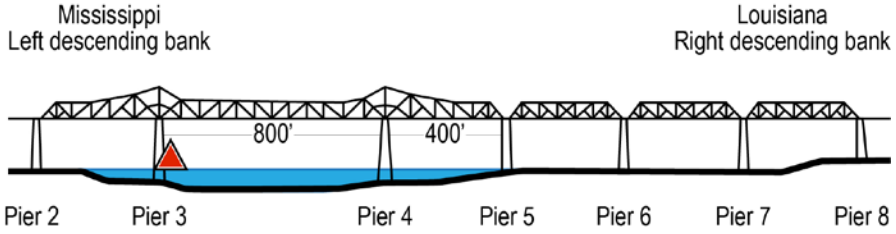
Figure 60. A drawing of the Old Highway 80 Bridge looking down river. The red triangle indicates the location of the bridge strike.

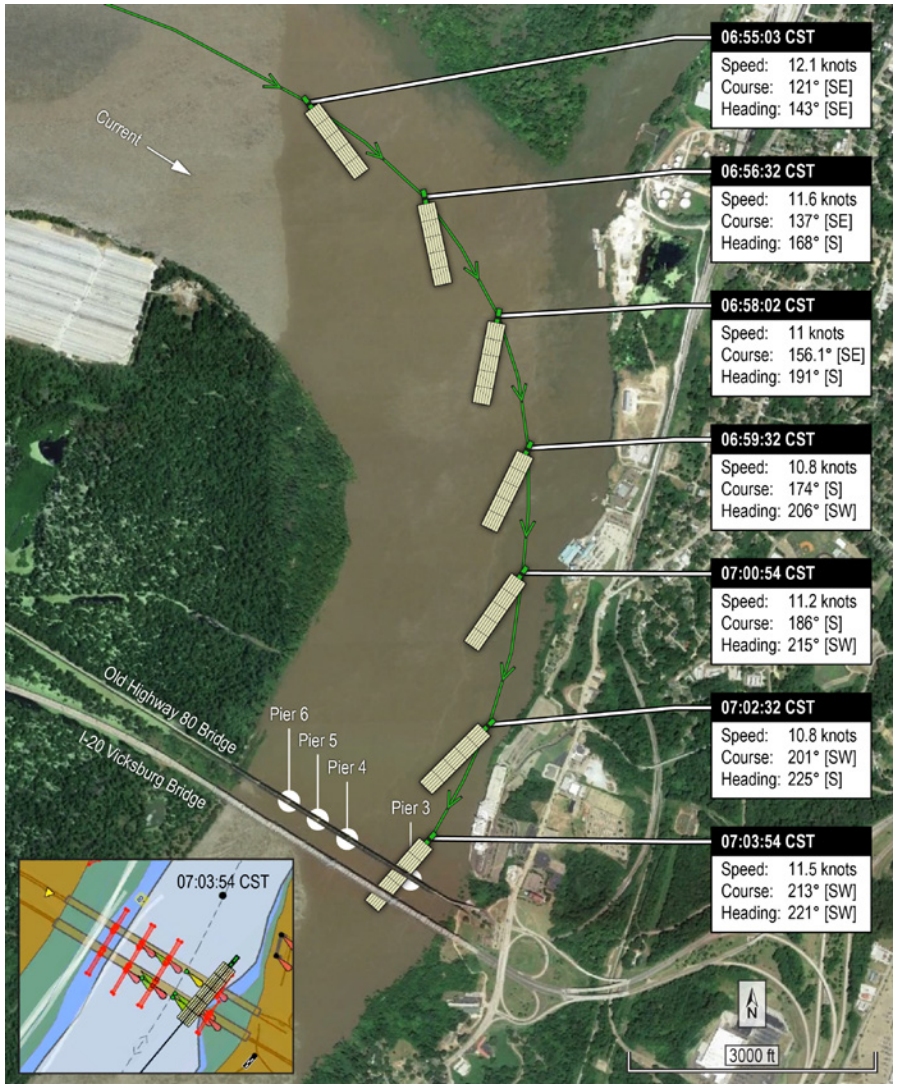
Figure 61. Right: Trackline of the *Chad Pregracke* and its 30 barges over the last 9 minutes leading up to the bridge strike. BACKGROUND SOURCE: GOOGLE EARTH.
Inset: *Chad Pregracke* as recorded on Rose Point at 07:03:54 CST.

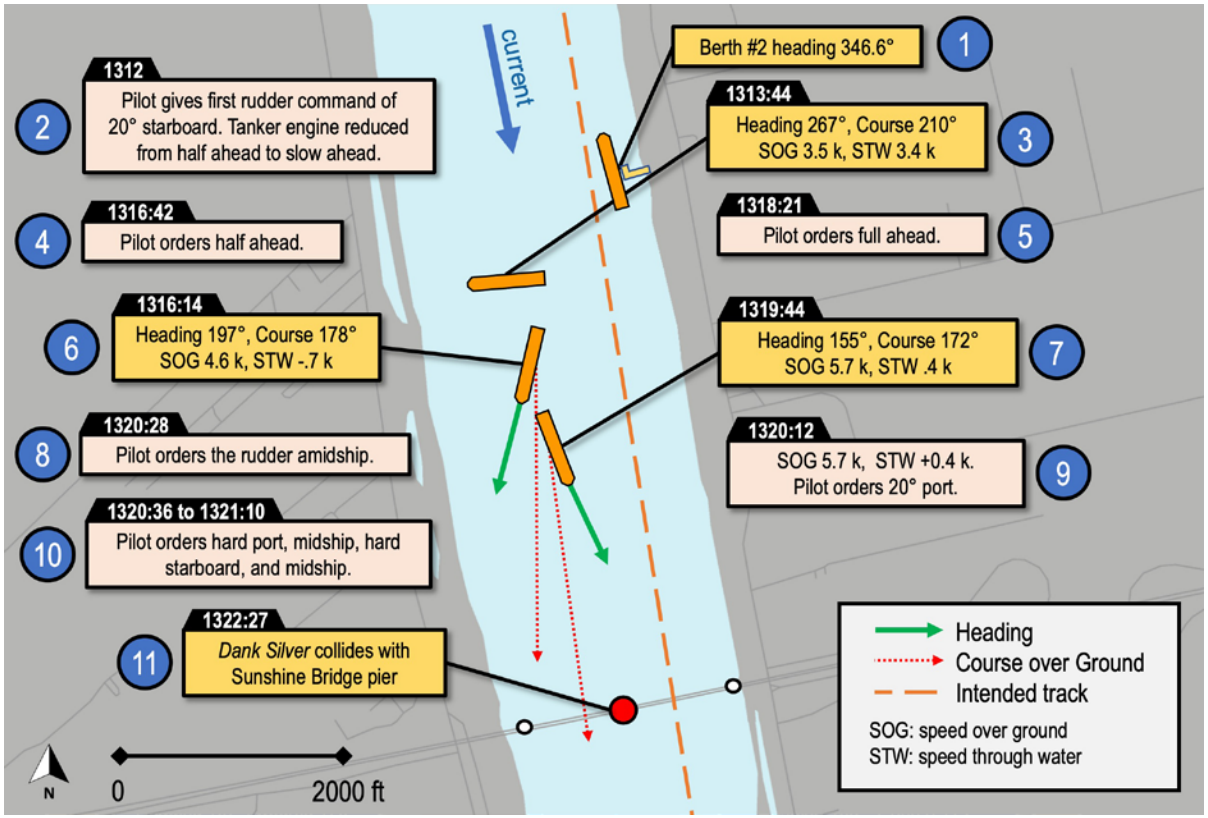
Figure 64. Course of the *Dank Silver* from ECDIS data. BACKGROUND SOURCE: GOOGLE MAPS.

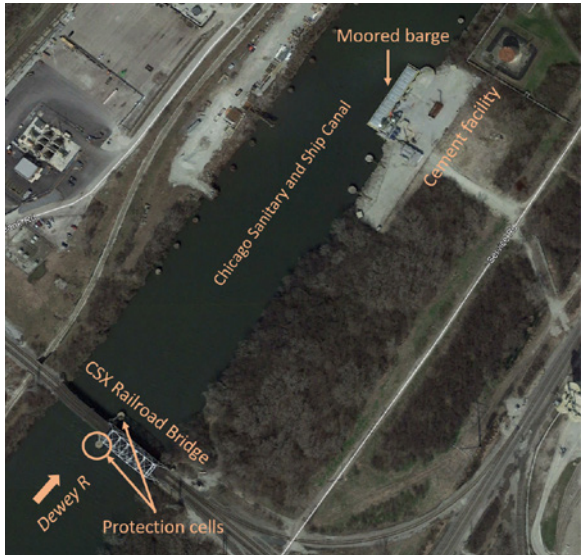
Figure 70. Location of the Chicago Sanitary and Ship Canal where the *Dewey R* and tow attempted to pass through the CSX Railroad Bridge, and location of a barge moored at the cement facility, similar to the barge that was moored at the time of the accident. The protection cell that was struck is circled. BACKGROUND SOURCE: GOOGLE MAPS.

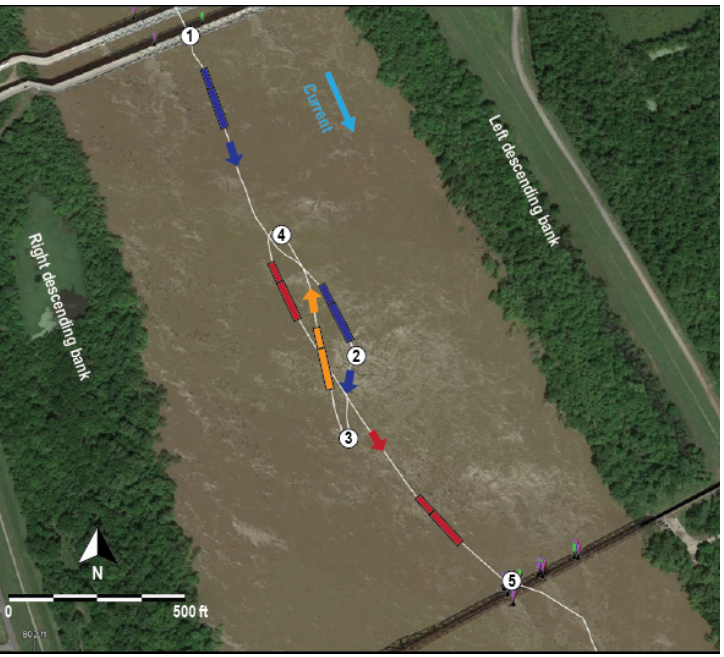
Figure 75. Left: The *Edna T. Gattle*'s approach to the Union Pacific Railway Bridge. The track is shown as a white line. **1.** At 2328, the *Edna T. Gattle* and tow passed under the US 190 Bridge, with a speed over ground of 7.5 mph. **2.** At 2336, the vessel was set to starboard while backing down, with a speed over ground of 1.8 mph. **3.** At 2339, the vessel began backing up river. **4.** At 2345, with the bridge fully open, the captain started his second approach. **5.** At 2348, the tow contacted the Union Pacific Railway Bridge, with a speed over ground of 13.7 mph.

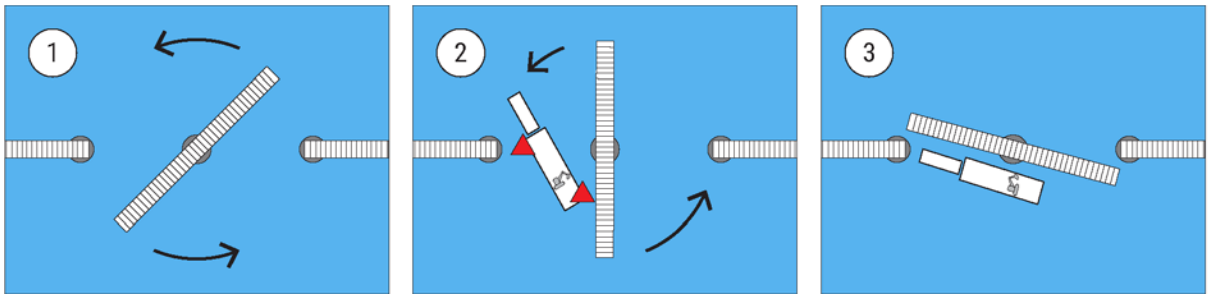
Figure 77. Depiction (not to scale) of the *Edna T. Gattle* and tow as the vessel approached and struck the Union Pacific Railway Bridge, forcing the bridge to swing counterclockwise to an almost-closed position. **1.** The *Edna T. Gattle* and its tow approached the swing span and called the bridge tender at 2307 to request an opening. The bridge was fully open at 2337, and the *Edna T. Gattle* began its second approach at 2345. **2.** The *Edna T. Gattle* and its tow were not lined up on the openings of the bridge, so at 2348, the barge hit the bridge pier, then bounced to port. The port bow of the vessel hit the swing span pedestal. As the barge was swept under the bridge, the spud and excavator struck the swing span. **3.** After being struck, the swing span of the bridge rotated counterclockwise to an almost-closed position. The barge being pushed by the *Edna T. Gattle* took on water through multiple holes and fractures to the port bow corner and starboard aft bulkheads.

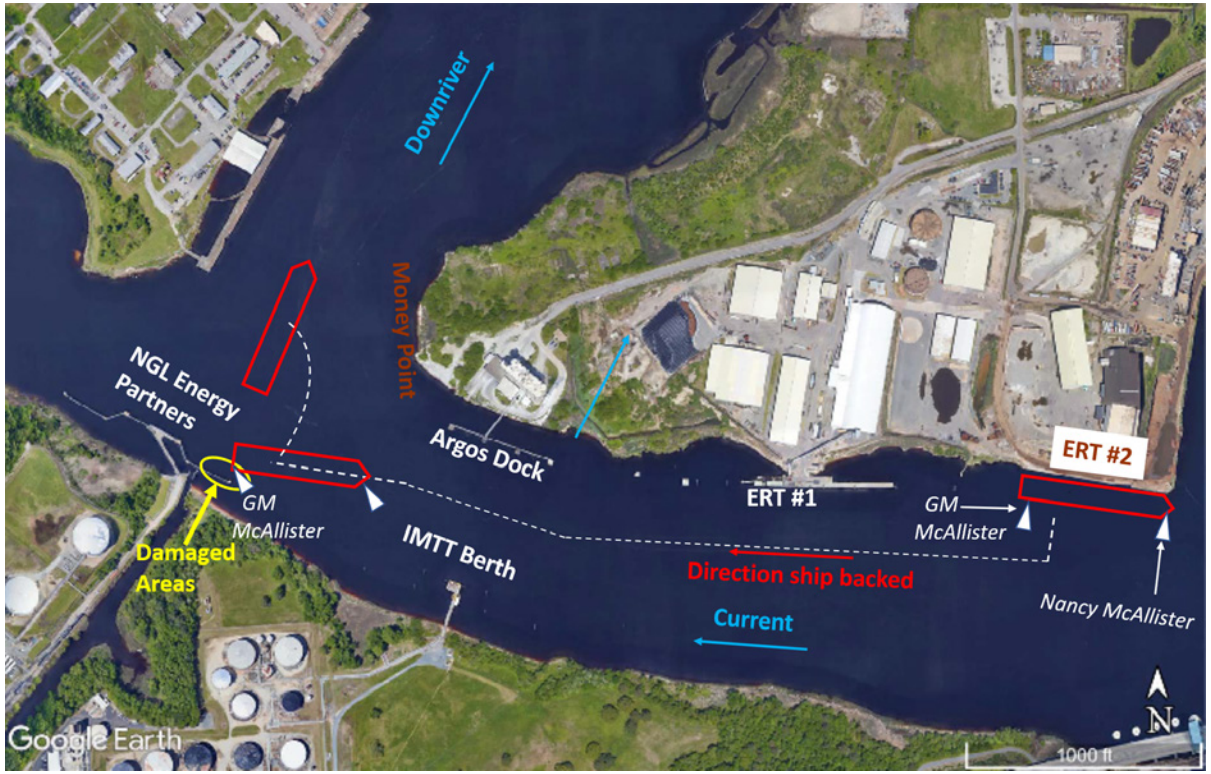
Figure 83. Right: Detailed satellite image of the area where the *G.M. McAllister* contacted the NGL Energy Partners wharf.
BACKGROUND SOURCE: GOOGLE EARTH.

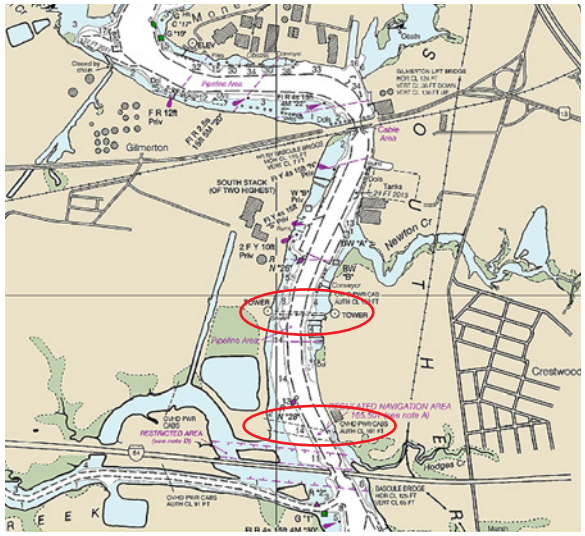
Figure 84. NOAA chart 12253, which the crew used to navigate on board the *Goose Creek*. The powerlines are circled in red. ANNOTATED BY NTSB.

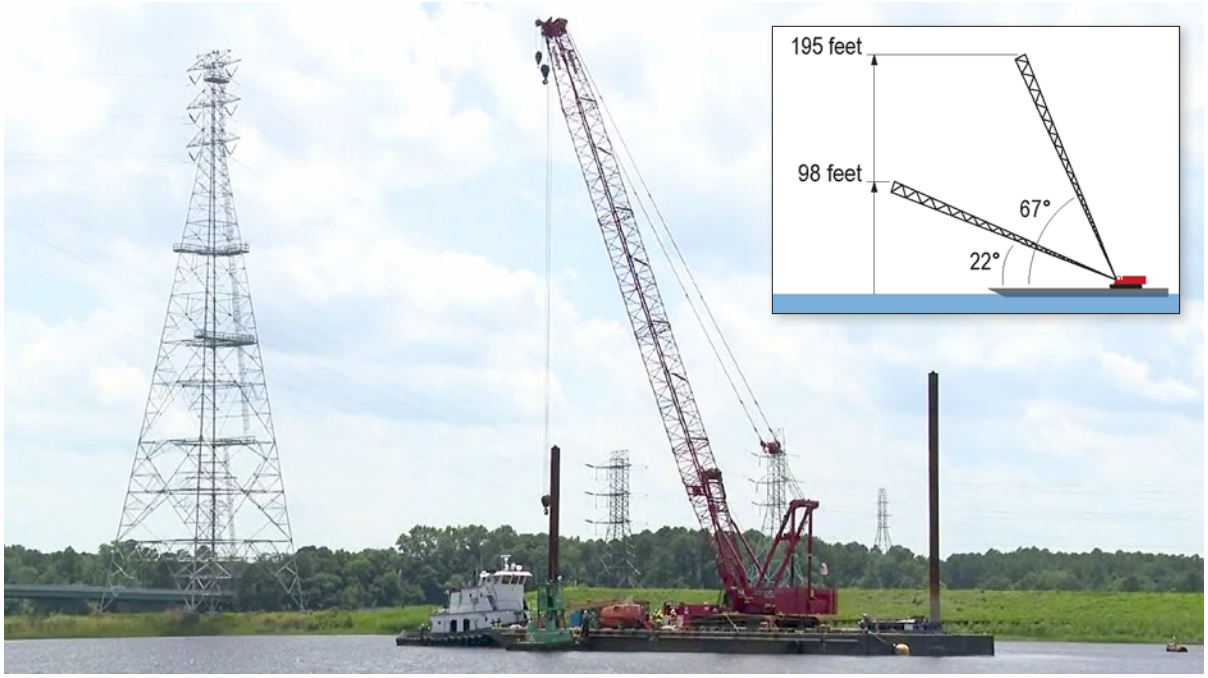
The crane operator announced over the radio that he had "200 feet of stick out." The crane boom's angle indicator read 67 degrees postaccident, indicating the air draft was approximately 195 feet at the time of the accident, which exceeded the charted 152-foot vertical clearance of lines no. 120 by 43 feet. Although aware that the construction workers intended to raise a spud and warned of the nearby powerlines, the captain allowed the workers to raise the crane boom. About 1134, the crane's boom contacted lines no. 120, and arc flashes and "cannon like-booms" were observed. All three transmission lines subsequently parted and fell into the river. There were no reported injuries, and the tow safely moored outside of the channel.

Figure 86. Towing vessel *Goose Creek* and crane barge *U1510* spudded down in Chesapeake, Virginia, after the accident. Inset (not to scale) depicts the crane boom elevation when stowed at 22° and as determined after the accident with an angle of 67°. SOURCE: COAST GUARD; ILLUSTRATION BY NTSB.

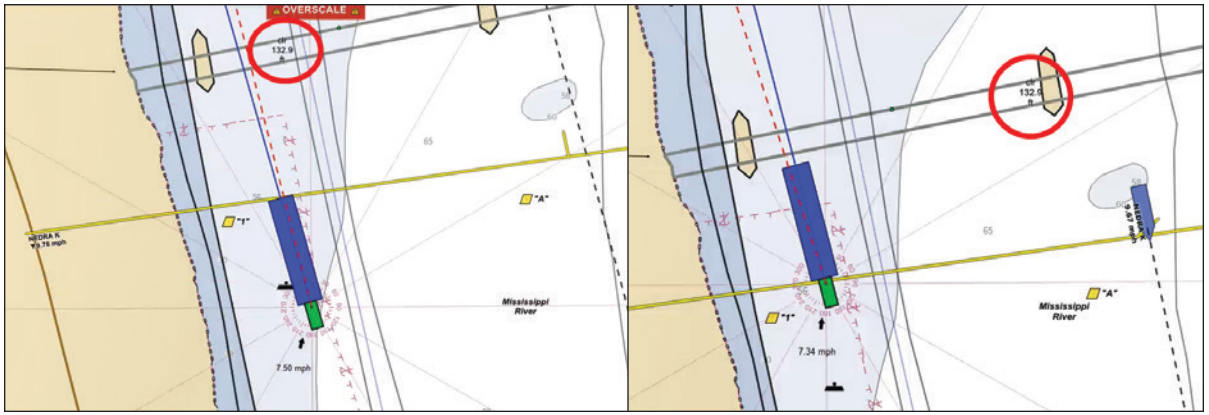
Figure 88. Screenshots of the *Kristin Alexis*' Rose Point at 0139 (left) and at 0140 (right). The vertical clearance for the Sunshine Bridge is circled in red.

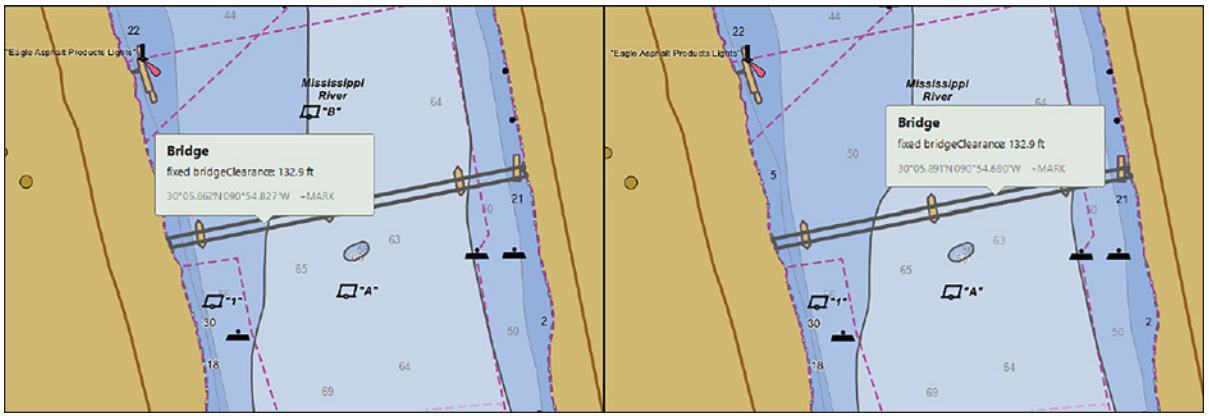
Figure 89. Vertical clearance of the Sunshine Bridge's west (left) and channel (right) spans, as indicated postaccident by the Rose Point display on board the *Kristin Alexis*, which showed the same clearance for each span (132.9 feet).

The *Kristin Alexis* was equipped with GPS, an AIS, a radar, and a Rose Point electronic charting system. Since the crane's pedestal caused radar echo and blocked the radar view, the pilot used the vessel's Rose Point, which inaccurately indicated that both the channel and west spans of the Sunshine Bridge had a vertical clearance of 132.9 feet (only the channel span was 132.9 feet). The crew also occasionally consulted NOAA chart 11370, which listed only one vertical clearance for the bridge (133 feet). The pilot erroneously assumed that the air draft of the crane barge was 130 feet and he would therefore have 2–2.9 feet of overhead clearance to safely transit under the west span. However, a postaccident survey of the bridge showed that the minimum vertical clearance was 128.8 feet for the west span (about 7 feet lower than the reported crane barge's 136-foot air draft). The vessel's electronic chart system, which pulled data from NOAA charts, did not reflect the actual minimum vertical clearance for that span of the Sunshine Bridge.

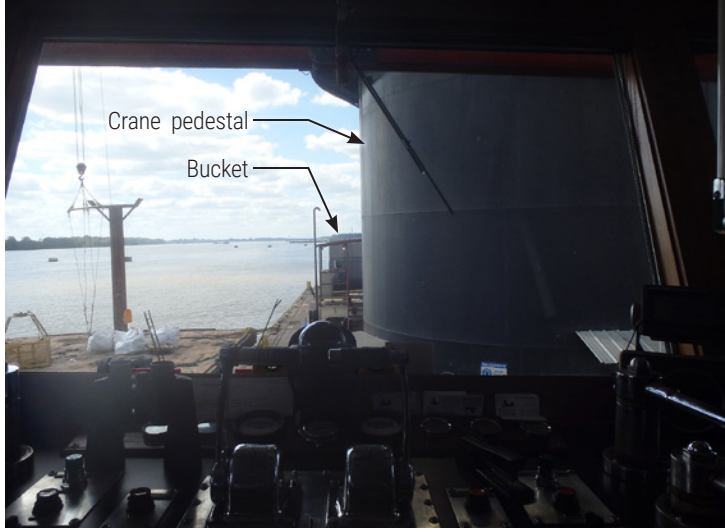
Figure 92. Forward view from the *Kristin Alexis*' wheelhouse. The crane's pedestal blocks most of the starboard view, while the crane bucket blocks a portion of the forward view ahead.
SOURCE: COAST GUARD.

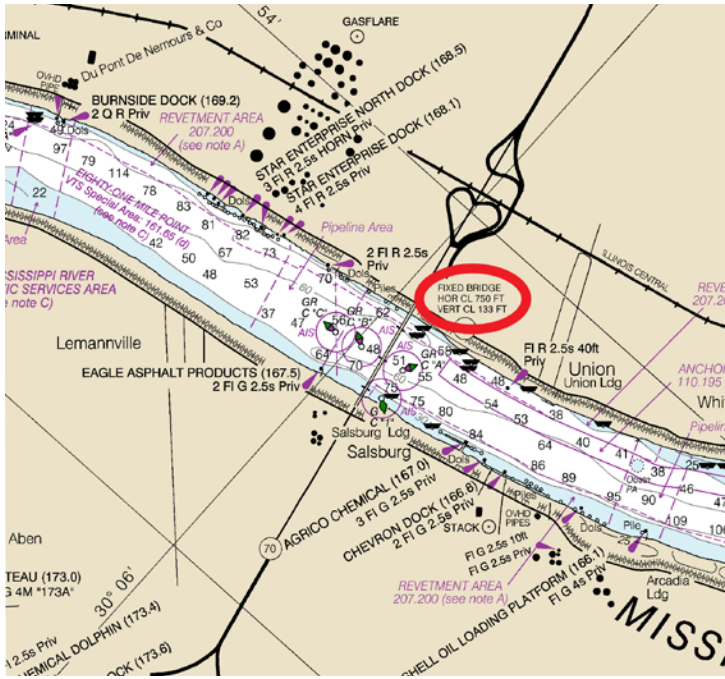
Figure 93. Excerpt of NOAA chart 11370 used by the crew. The vertical (133 feet) and horizontal clearances (750 feet) of the Sunshine Bridge are shown circled in red.
SOURCE: NOAA; ANNOTATED BY NTSB.

Further, the NTSB found that contrary to NOAA guidance, when there are multiple navigable spans for a bridge, NOAA navigational charts do not consistently list vertical clearances for each span. Navigational aids should provide mariners with a simple and precise way to navigate and not increase workload or cause confusion. Therefore, the NTSB issued one new recommendation to NOAA to review and update bridge data and charts to include vertical clearance information for all navigable bridge spans.

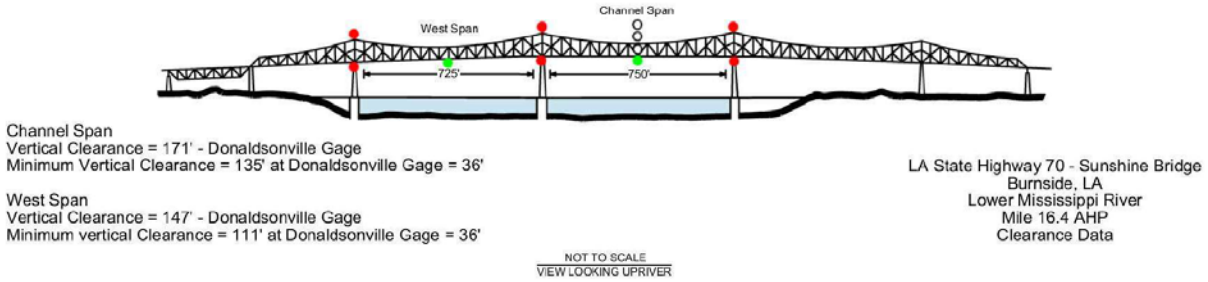
Figure 94. Sunshine Bridge span vertical clearances. The right descending bank is the west bank, and the left descending bank is the east bank.

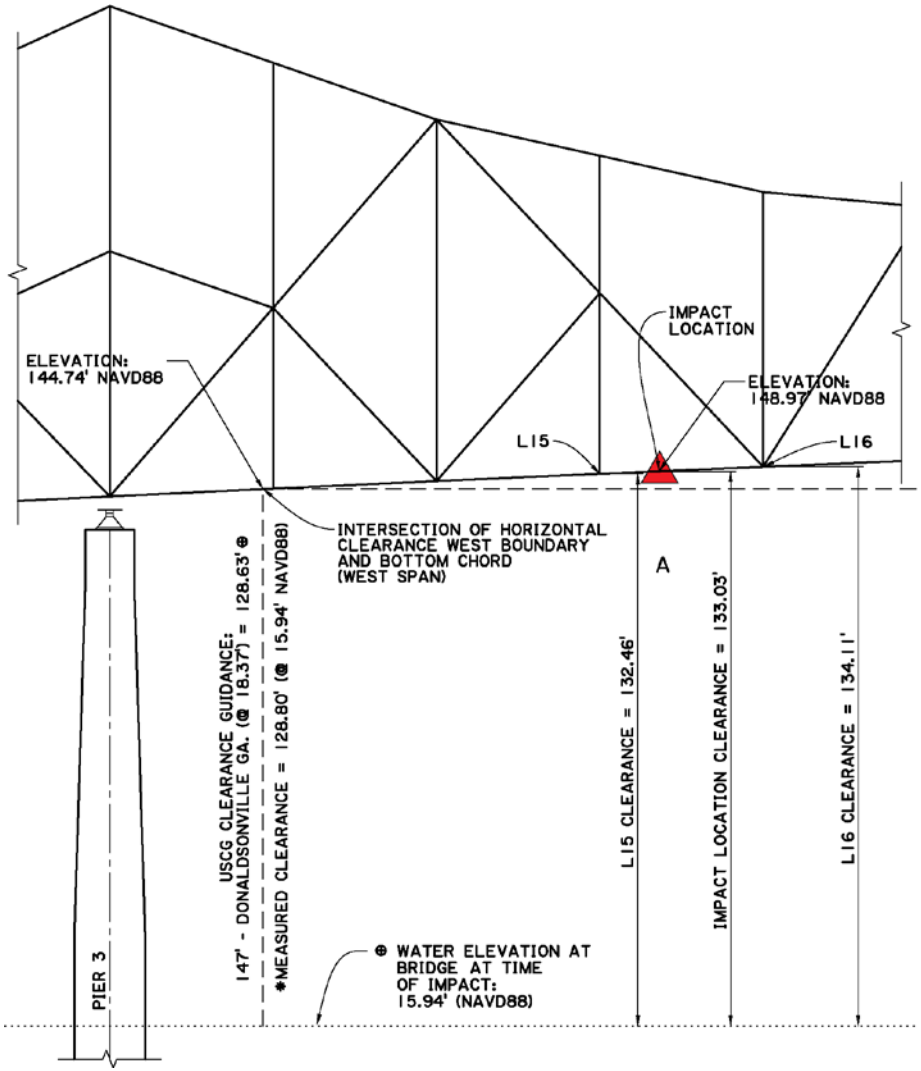
Figure 95. Vertical clearances of the Sunshine Bridge's west span measured shortly after the accident. The impact location is marked with a red triangle.

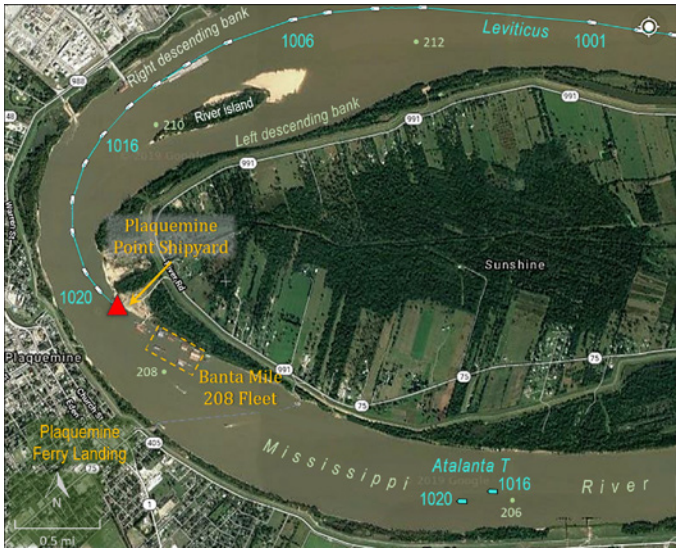
Figure 96. Trackline of *Leviticus* leading up to the contact with the barges moored at the Plaquemine Point Shipyard, based on the vessel's AIS data. According to the passing arrangement, Plaquemine Ferry Landing is where the tow would have met the *Atalanta T*.
SOURCE: MARINE TRAFFIC; GOOGLE EARTH; ANNOTATED BY NTSB.
