SAFER SEAS Digest 2020

Lessons Learned from Marine Accident Investigations

NTSB National Transportation Safety Board

NTSB/SPC-21-01

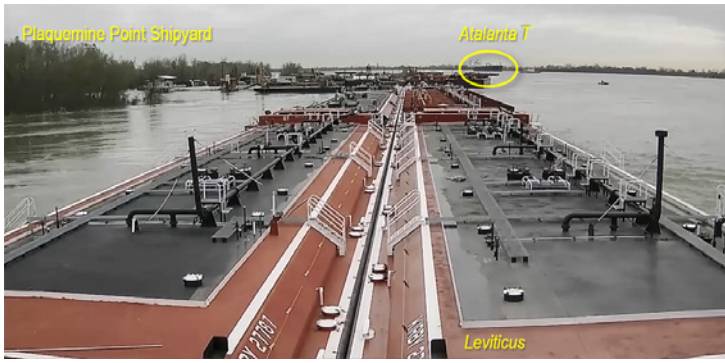
Figure 99. Screen capture from the *Leviticus*' video recorder at 1020 looking forward shows initial impact with the moored barges at the shipyard's cleaning plant.
SOURCE: KIRBY INLAND MARINE.

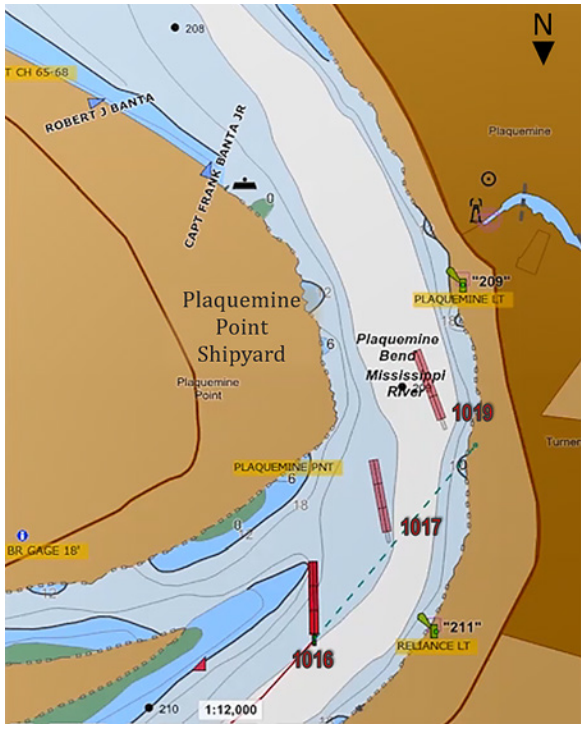
Figure 100. Screen capture from playback of *Leviticus*' navigation system at 1016 shows tow length and predicted positions as the vessel rounds the bend. Position times have been superimposed.
SOURCE: KIRBY INLAND MARINE.

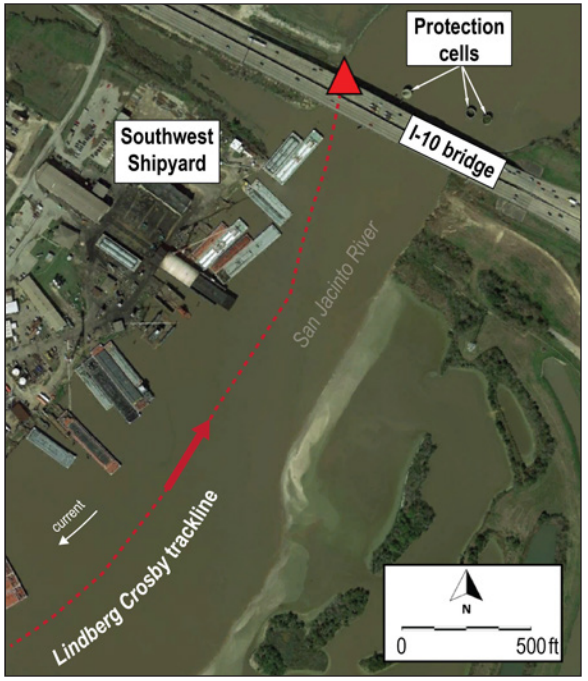
Figure 104. Trackline and location of the *Lindberg Crosby* when the tow struck the I-10 bridge (marked with red triangle). BACKGROUND SOURCE: GOOGLE EARTH.

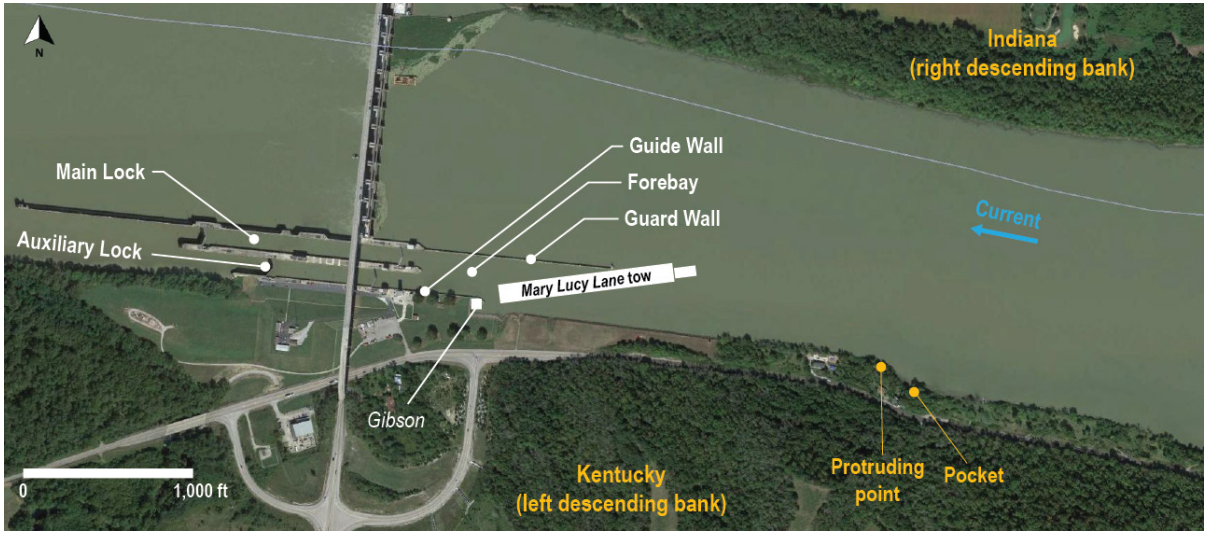
Figure 109. Below: Approximate positions of the *Mary Lucy Lane* tow and the workboat *Gibson* about 1555, when the tow contacted the guard wall. BACKGROUND SOURCE: GOOGLE EARTH.

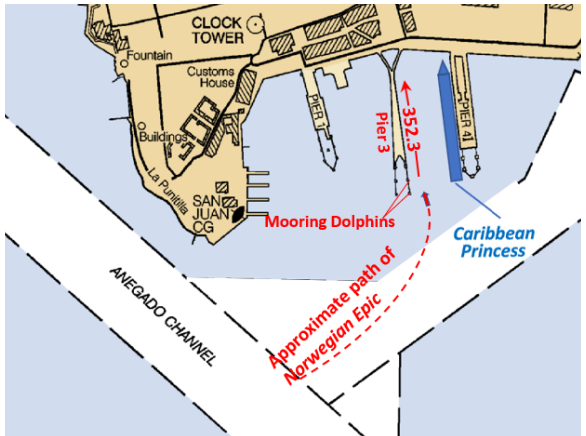
Figure 113. Below: Berthing area and approximate path of the *Norwegian Epic*. The *Caribbean Princess* is not to scale. BACKGROUND SOURCE: NOAA CHART 25670.

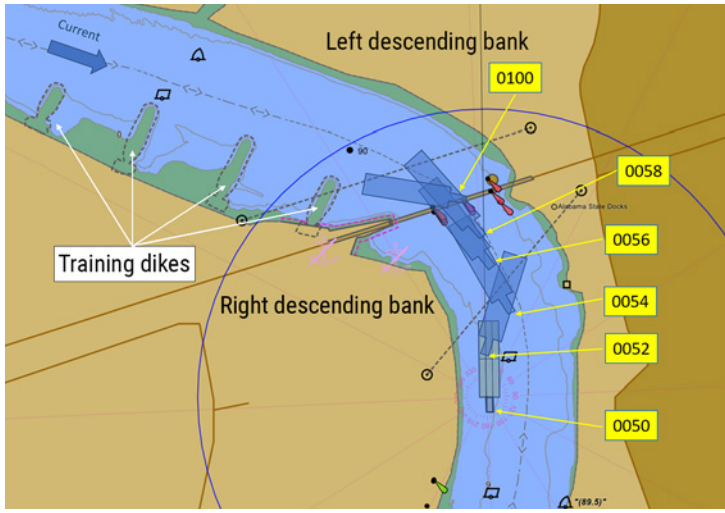
Figure 116. Select positions of the *Rivers Wilson* and barges on the Tombigbee River near mile 90 before the accident. Note the training dikes up river of the bridge on the right descending bank. BACKGROUND SOURCE: CORPS OF ENGINEERS; VESSEL DATA: GRAESTONE.

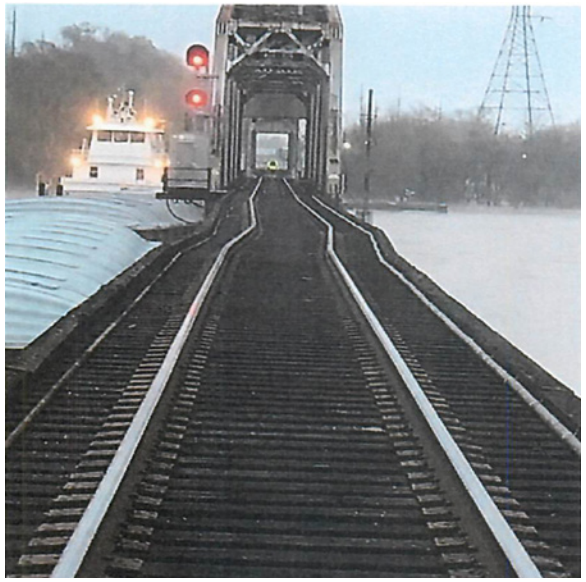
Figure 117. Rail displacement of the Norfolk Southern railway bridge, looking east, with the *Rivers Wilson* and two barges alongside. SOURCE: COAST GUARD.

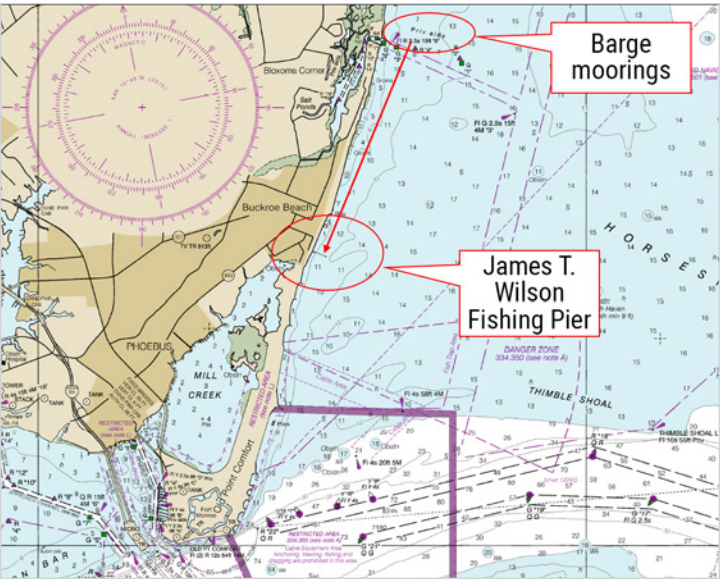
Figure 125. Extract of NOAA Chart 12222, with red arrow showing the assumed path barge *YD 71* took from its mooring to the James T. Wilson Fishing Pier.
BACKGROUND SOURCE: NOAA.

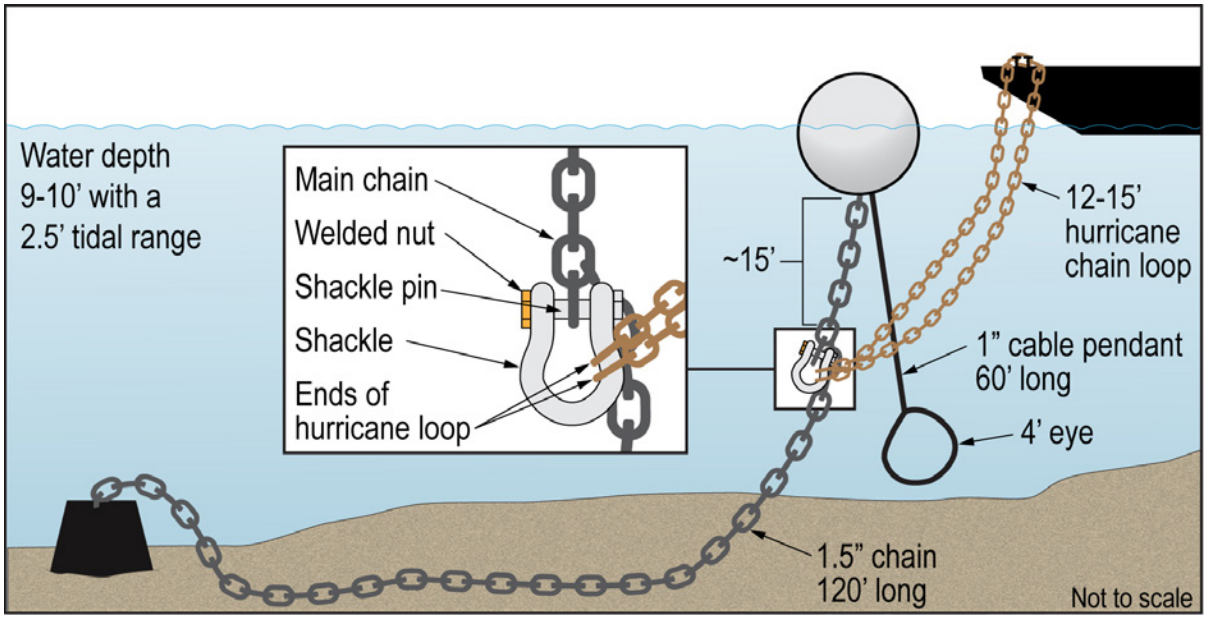
The mooring's chain and hurricane loop were found intact. Neither the shackle nor its pin connecting the hurricane loop to the chain were found. Therefore, the barge could only slip its mooring if the shackle failed, or if the pin backed out after the weld attaching the nut to the pin failed. It is more likely the weld failed than material failure of the shackle bow or pin occurred. This likely would have occurred over a period of time, with the strain of the 4-foot storm wave action, near gale winds, and/or high tide breaking it free.

Figure 126. A representation of the arrangement of the *YD 71*'s mooring at the time of the accident.

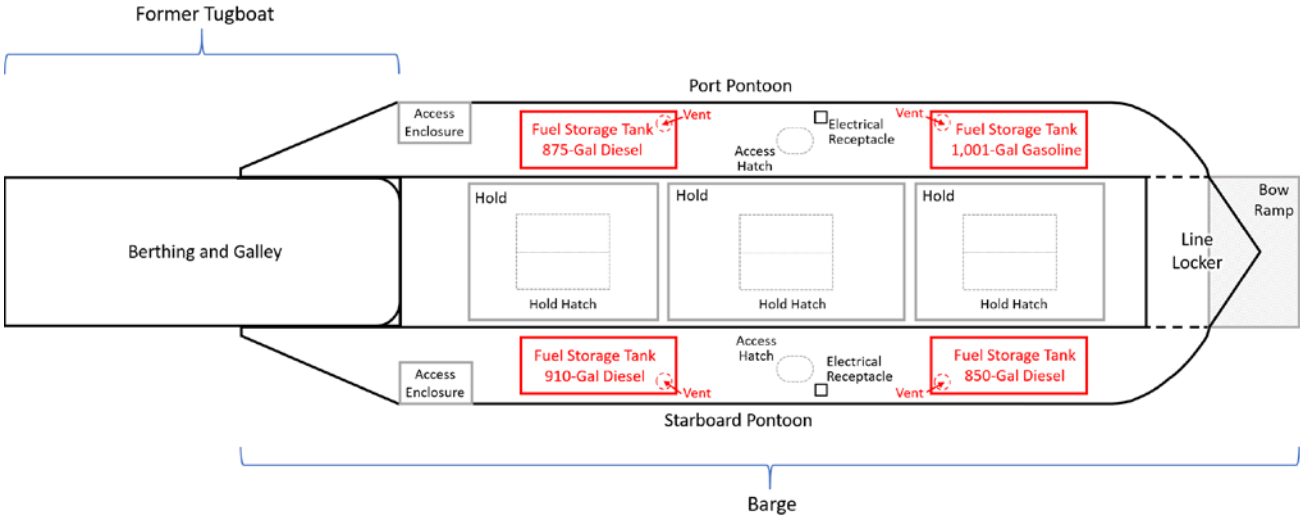
Figure 130. Simplified general arrangement of the *Alaganik*, with fuel amounts in each fuel cargo tank at the time of the accident. Vessel hull dimensions are drawn approximately to scale.

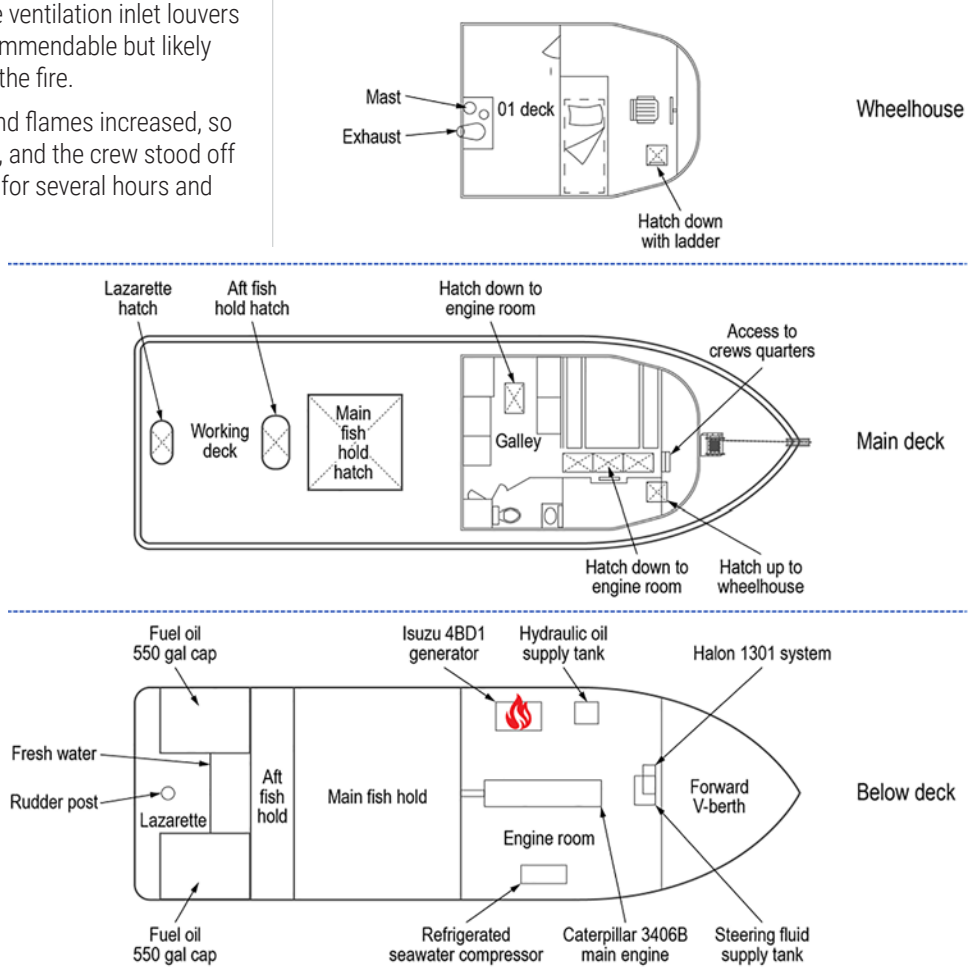
The probable cause of the fire aboard the fishing vessel *Ariel* was the ignition of fuel leaking from the generator fuel supply line in the engine room. Contributing to the severity of the fire and the eventual loss of the vessel were the fixed-open inlets for the engine room ventilation, which allowed fire-extinguishing agent to escape and air to enter the space.

Figure 133. Below: General arrangement of the *Ariel*, with the area where the fire was first reported indicated by the red flame icon.

Fixed fire-extinguishing systems in engineering and other hazardous spaces require a minimum concentration of extinguishing agent to either halt the chemical reaction producing the fire, displace the oxygen feeding the fire, or effect a combination of both. To ensure the effectiveness of the system and prevent the reintroduction of oxygen to the space, ventilation inlets should be designed or modified to be closed remotely or covered.

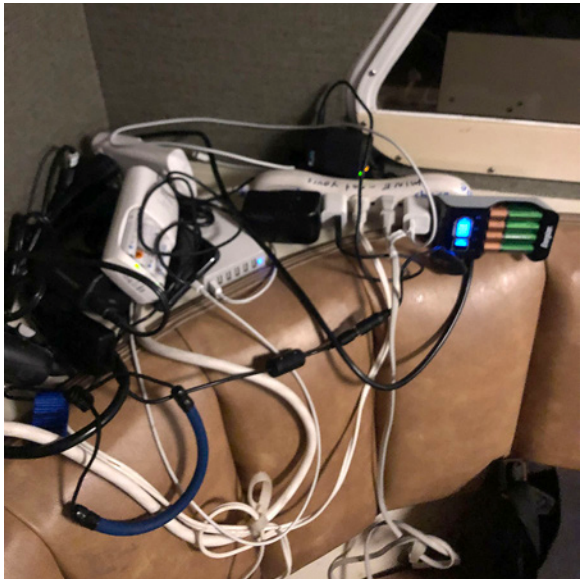
Figure 137. Photo taken August 31, 2019, of devices plugged in to charge at the port side aft corner of the salon on the *Conception*. SOURCE: J. DIGNAM.

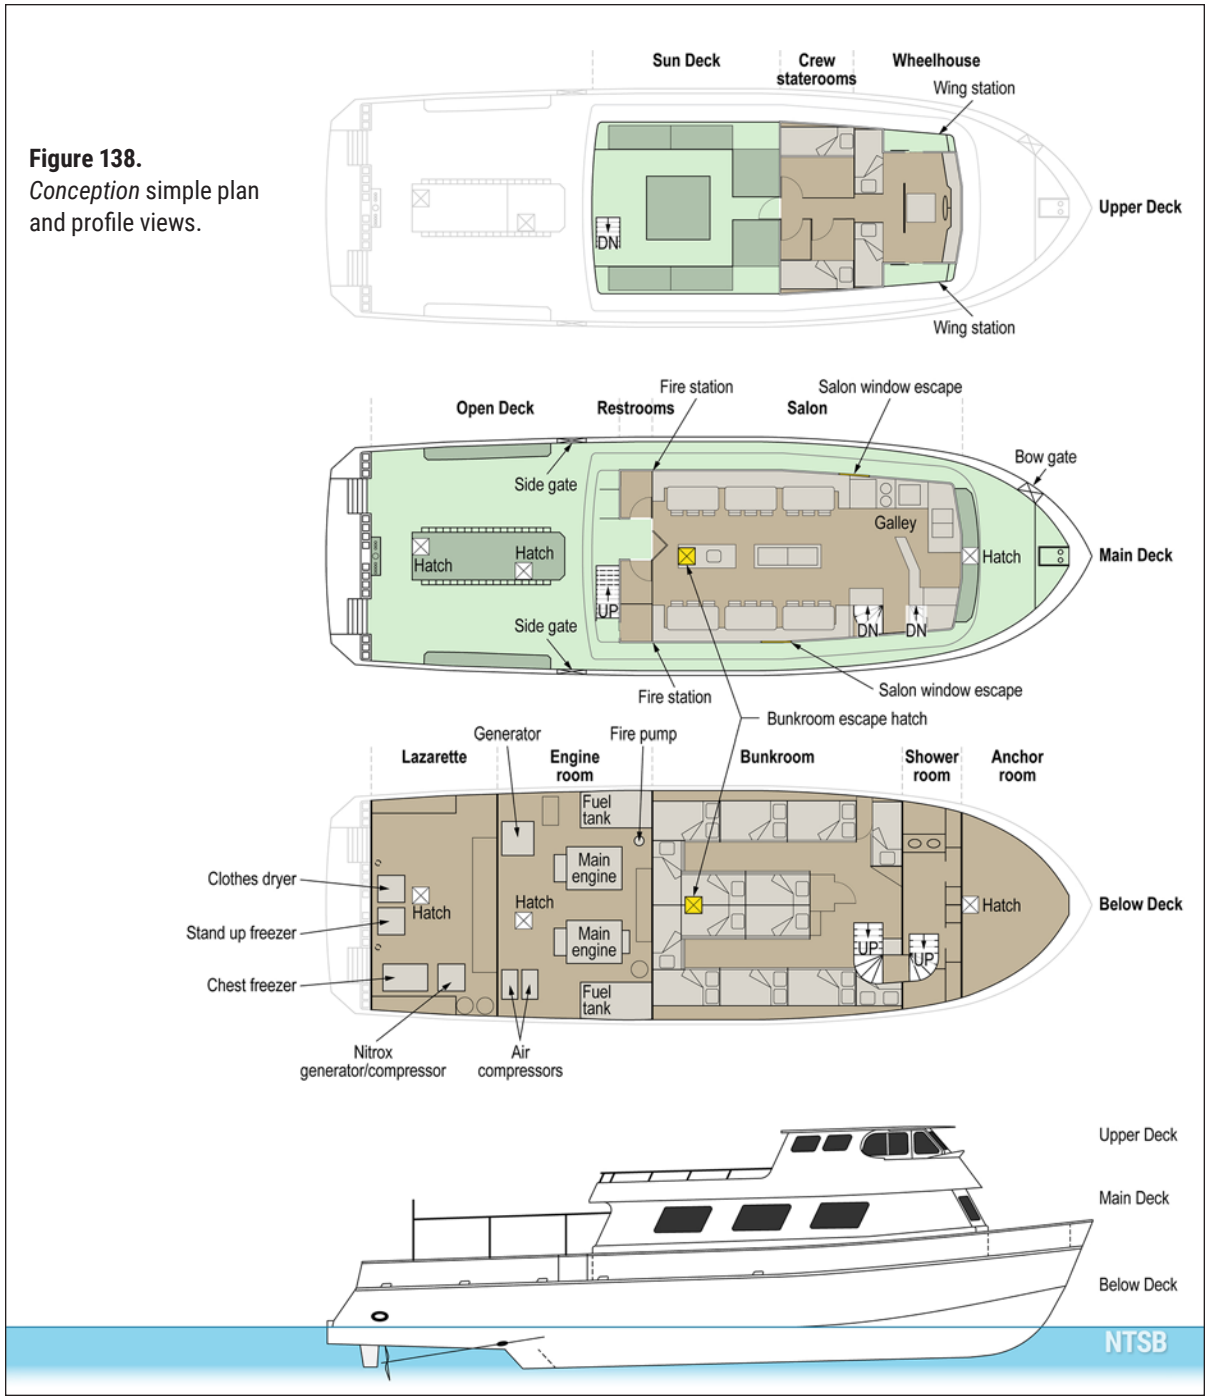
Figure 138.
Conception simple plan and profile views.

The probable cause of the accident on board the small passenger vessel *Conception* was the failure of Truth Aquatics, Inc., to provide effective oversight of its vessel and crewmember operations, including requirements to ensure that a roving patrol was maintained, which allowed a fire of unknown cause to grow, undetected, in the vicinity of the aft salon on the main deck. Contributing to the undetected growth of the fire was the lack of a United States Coast Guard regulatory requirement for smoke detection in all accommodation spaces. Contributing to the high loss of life were the inadequate emergency escape arrangements from the vessel's bunkroom, as both exited into a compartment that was engulfed in fire, thereby preventing escape.

As a result of its investigation into this accident, the NTSB issued seven new safety recommendations to the Coast Guard that focused on improving regulations regarding smoke detection, verification of roving patrols, and means of escape aboard all small passenger vessels, including existing vessels. The NTSB also issued two recommendations to industry organizations to share with their members the circumstances of the *Conception* accident in order to encourage members to voluntarily make changes to improve the safety of their vessels.

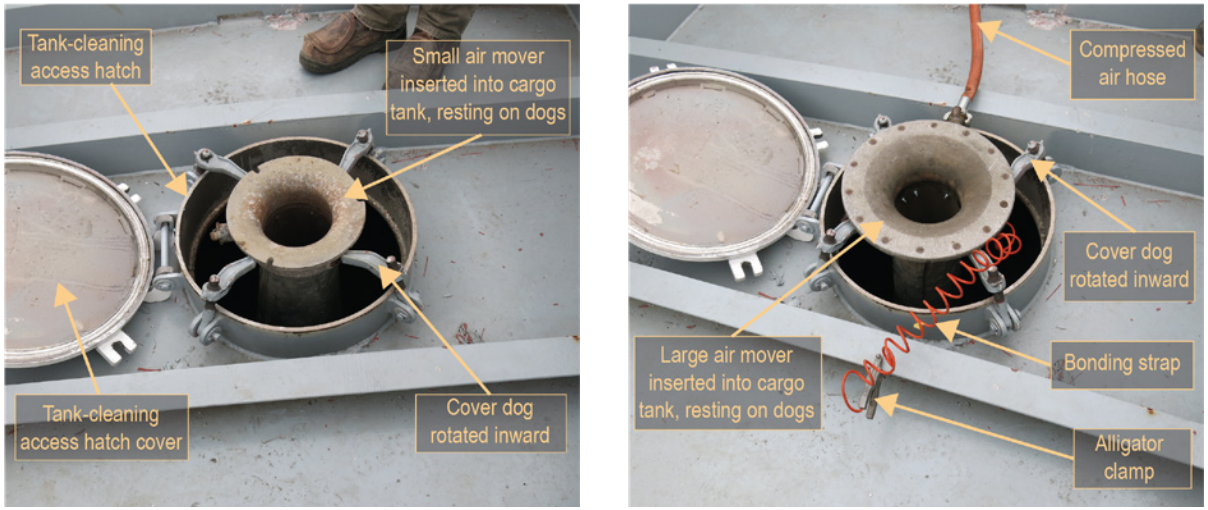
Figure 151. Demonstration of air-mover-installation methods reconstructed after the accident. **Left:** Smaller (6-inch diameter) air mover without compressed air hose and bonding wire. **Right:** Larger (11-inch-diameter) air mover connected with compressed air hose and bonding wire with clamp.

At 0929, within minutes of the compressed air supply to the air movers being applied, an explosion occurred. Cargo tank 2 was the likely location of the initial explosion. The source of ignition was most likely a static electrical discharge from the air mover that was resting on the painted dogs of cargo tank 2's tank-cleaning access hatch. Postaccident testing indicated that resting the air mover on the dogs did not provide a good electrical bond between the air mover housing and the barge. An inadequately bonded air mover would have allowed the accumulation of electrostatic charge generated by the flow of the compressed air stream with water droplets and rust particles. Without a proper bonding connection, a static electrical charge would likely not safely dissipate to the grounded barge, but could instead accumulate, causing a potential spark hazard.

Hazardous cargos with flammable vapors are subject to the risk of explosion. Shipboard and shoreside personnel working aboard vessels and barges carrying such cargos should establish and follow procedures for the bonding of all air-moving equipment when venting tanks.

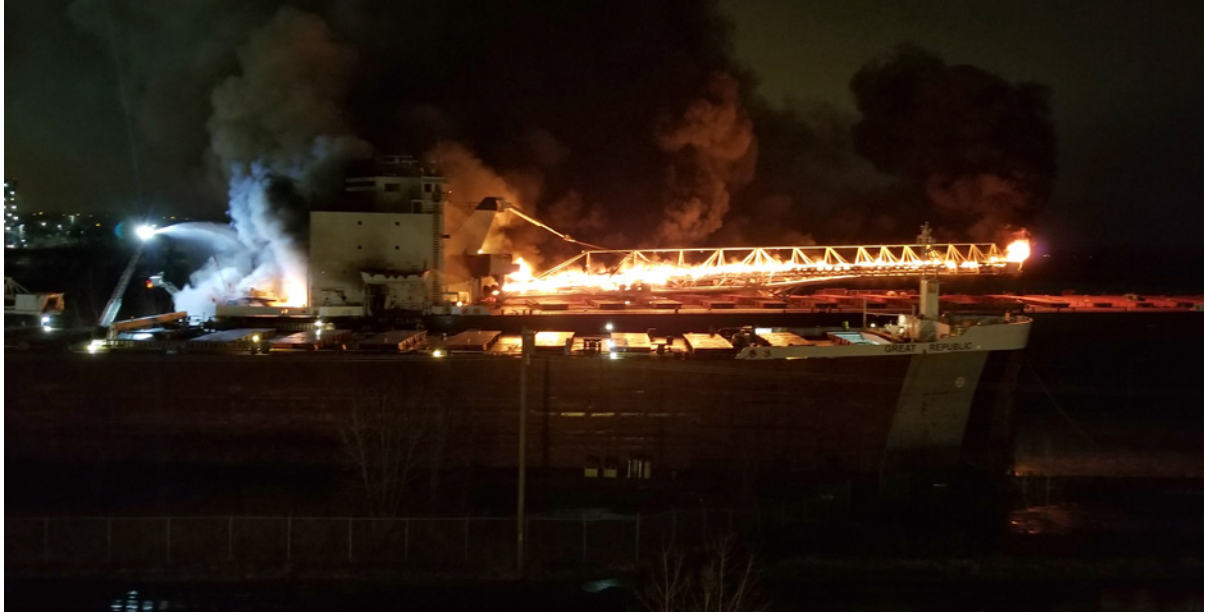
Figure 154. Vessel fire at 2220. Billowing smoke pours from the vessel and the cargo conveyor boom is completely engulfed in flames. SOURCE: GREAT LAKES TRADER CHIEF ENGINEER.

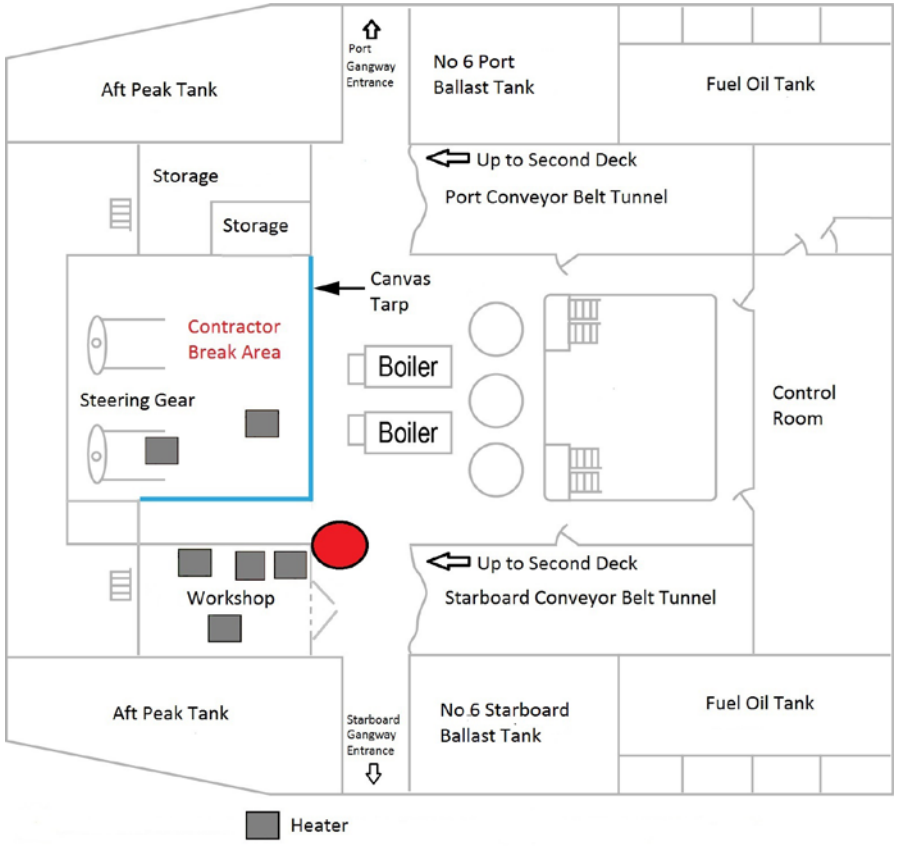
Figure 156. Drawing (not to scale) of third deck, showing location of heaters and tarp in the engine room. A red circle identifies the structural fire damage on the third deck.

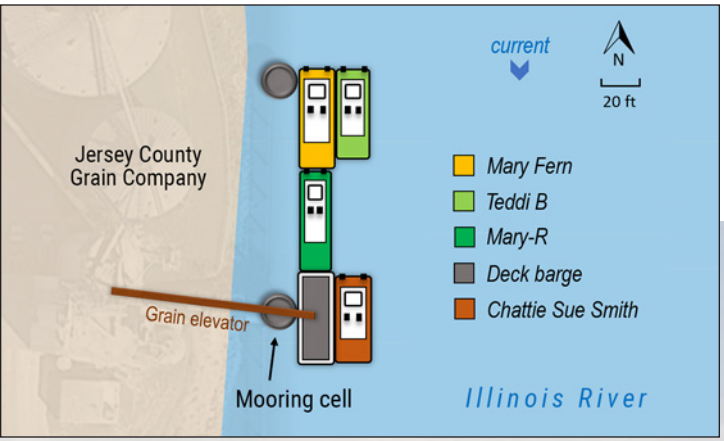
A post-salvage inspection of the deck barge revealed that there were several small holes on the deck that could have allowed rainwater to collect and enter the interior compartments. Additionally, holes found on the sides and bottom of the hull could have allowed continuous flooding. Based on a review of its condition, the holes likely had been present for a significant amount of time and were the source of the barge flooding.

The probable cause of the sinking of the towing vessels *Chattie Sue Smith, Mary Fern*, and *Mary-R*, along with a deck barge, was the deteriorated condition of the barge and the infrequent monitoring of the vessels, which allowed the barge to flood and sink, ultimately pulling down the moored towing vessels.

Figure 160. Left: The mooring arrangement of the three towing vessels at the time of the accident is depicted with approximate positions. BACKGROUND SOURCE: GOOGLE MAPS.

Figure 161. Below: *Mary Fern* (capsized on left), *Chattie Sue Smith* (sunken in center), and *Teddi B* (upright on right) about 0800 on the morning of the sinking. SOURCE: HARDIN FIRE PROTECTION DISTRICT.

To protect vessels and the environment, it is good marine practice for owners and operators to conduct regular oversight and maintenance of vessel and barges, even during lay-up periods. Oversight should include periodic testing and maintenance of dewatering equipment.

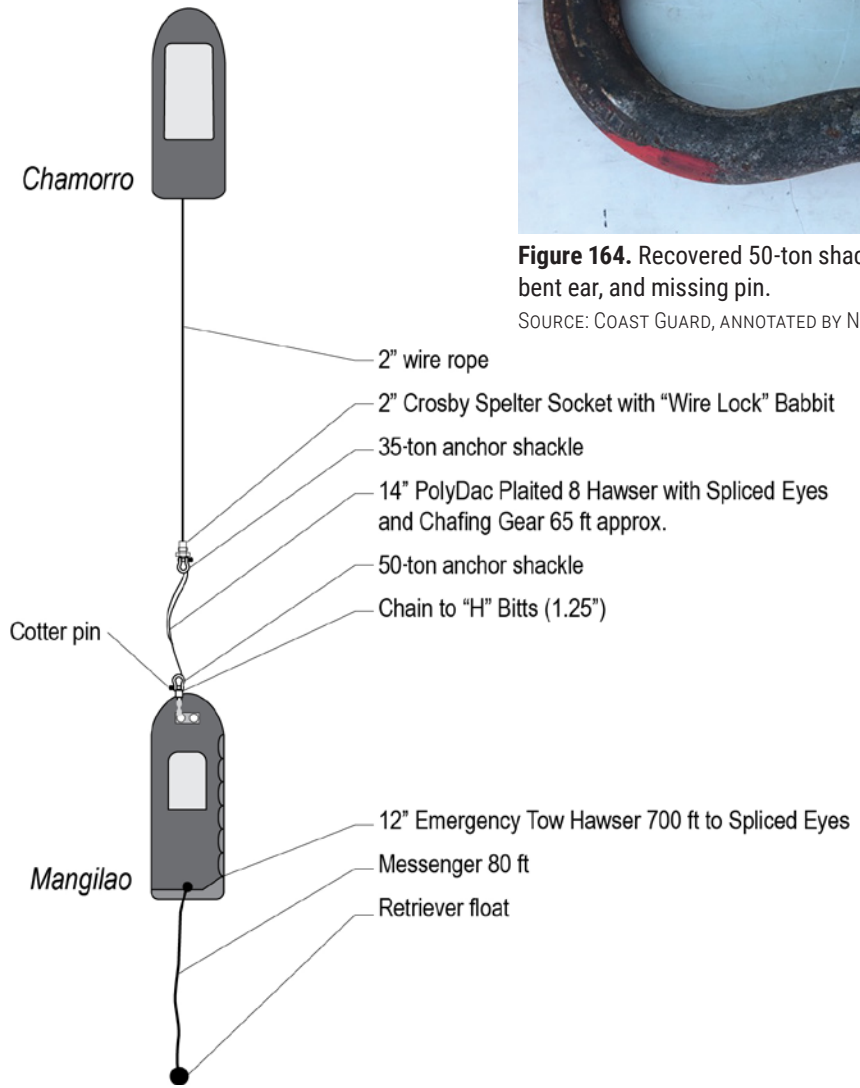
The probable cause of the sinking of the *Mangilao* was the failure of the *Chamorro*'s towing arrangement due to the loss of a towline shackle pin, which left the *Mangilao* adrift and resulted in the ingress of water from boarding seas in a developing typhoon.

Figure 164. Recovered 50-ton shackle with nylon rope, bent ear, and missing pin.
SOURCE: COAST GUARD, ANNOTATED BY NTSB.

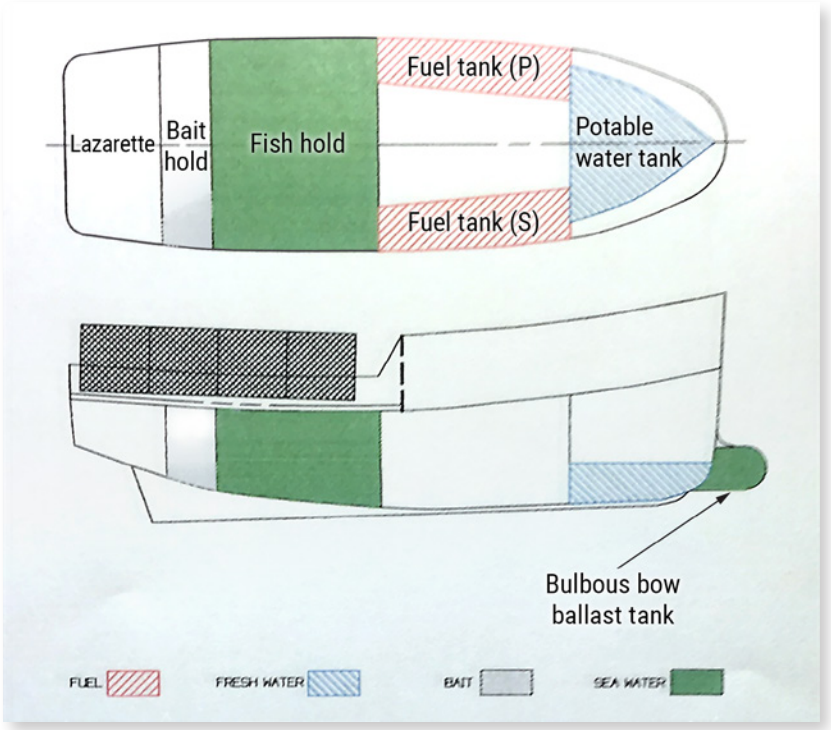
Figure 166. Below: The *Pacific 1* top and starboard-side profile view of compartments and tank locations. Although the stability booklet shows the bulbous bow ballast tank filled with sea water, at the time of the accident, this tank was pressed with fresh water.
BACKGROUND SOURCE: *PACIFIC 1* STABILITY BOOKLET.

The engineer aligned the bilge and emergency pumps to de-water the lazarette but could not keep up with the flooding. After about 20 minutes, he noticed water entering the engine room via a 2-inch electrical conduit pipe that ran through the top of the bulkhead separating the engine room from the lazarette.

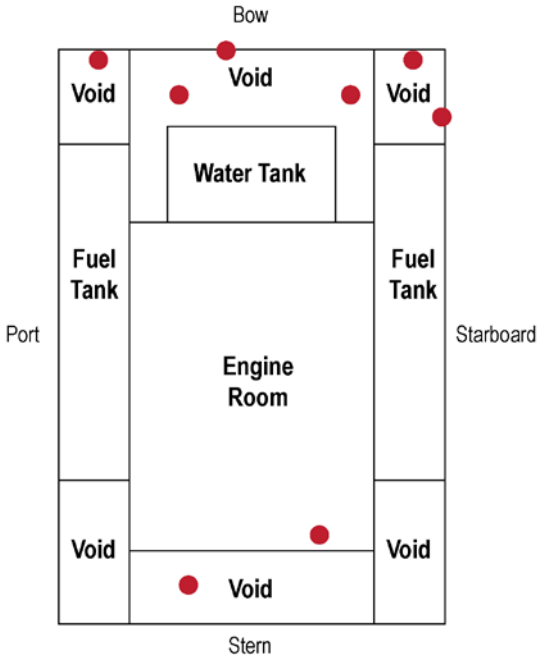
Figure 167. Below: Simplified layout of the *Tom Bussler*'s voids and fuel tanks. Pre-existing damage is marked with red circles.

To protect vessels and the environment, it is good marine practice for owners to conduct regular oversight and maintenance of hulls, including between drydock periods. Regardless of inspection requirements, owners are obligated to ensure vessels are properly maintained, equipped, and operated in a safe condition. Issues with watertight integrity and wastage should be addressed immediately.

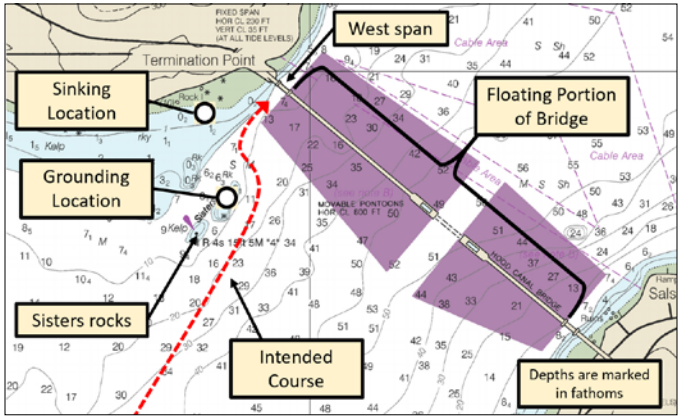
Shortly after the vessel started to turn, it grounded on the Sisters. The vessel had a listed draft of 5.5 feet, which was the maximum estimated depth of the area it grounded in at the time, accounting for the tide. It is most likely that the vessel's starboard propeller first contacted the northern Sister rocks, which shut down the starboard engine. As the vessel proceeded, the keel from midships to the stern contacted the rocks at least three times, causing the vessel to rapidly slow and the damaged hull to take on water. At the same moment, the port propeller also contacted the rocks, causing additional damage and shutting down the port engine. The owner sent his family to shore on the dinghy, and then contacted the Coast Guard.

Figure 179. Below: Damage to the keel of the *Silver Lining* postaccident.

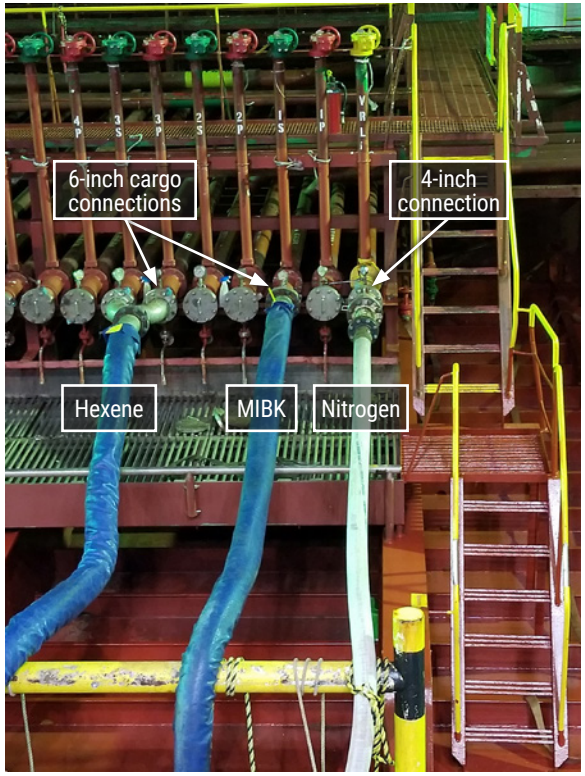
Figure 182. Cargo manifold configuration on board the *Fairchem Filly* at the time of the accident. SOURCE: VOPAK.
