Indoor Air Quality Assessment Report

Sky Valley Educational Center
351 Short Columbia Street
Monroe, Washington

PBS Project Number 41373.000
April 2016

Prepared by
PBS Engineering & Environmental
2517 Eastlake Avenue East
Seattle, Washington
(206) 233-9639

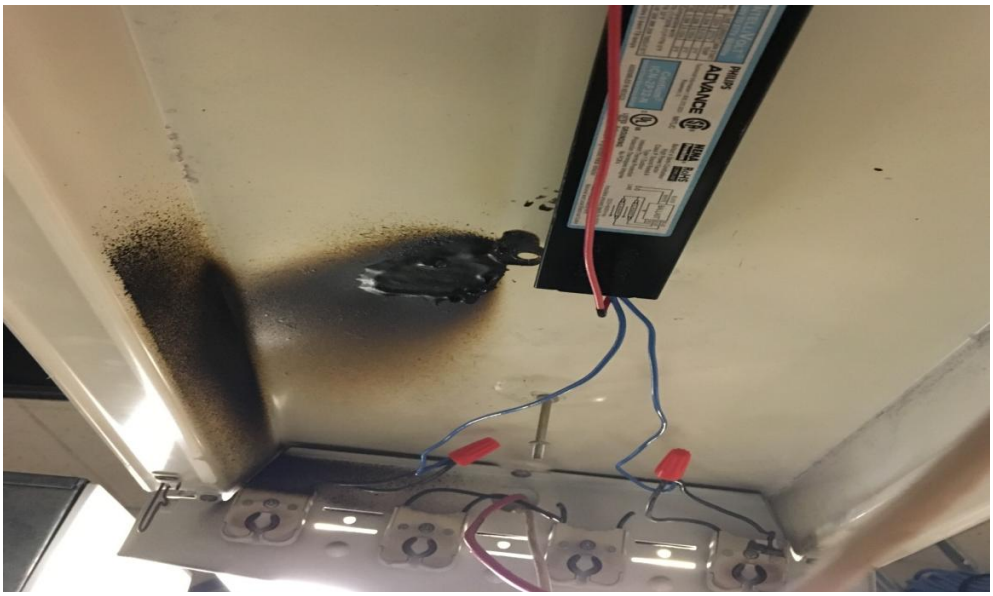
1. Administration Server Room - Suspect PCB residue in fluorescent light fixture.

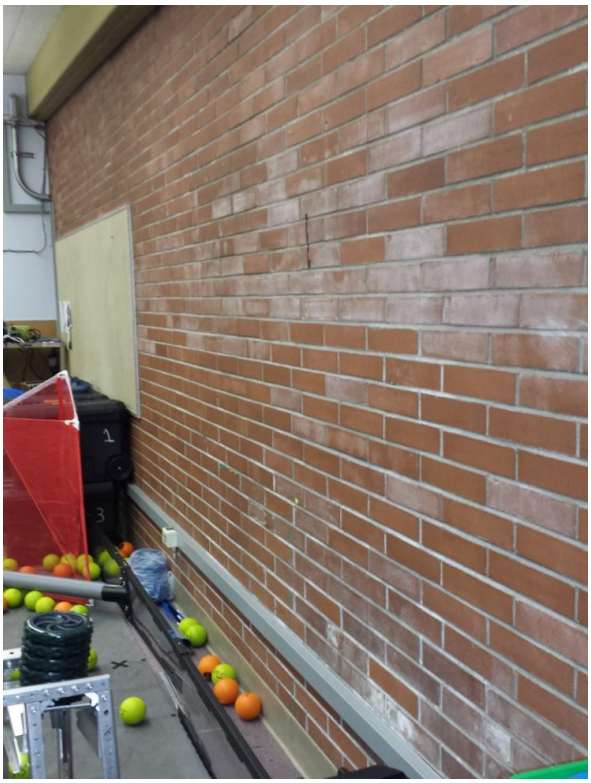
6. Annex Room B – Water intrusion east perimeter wall

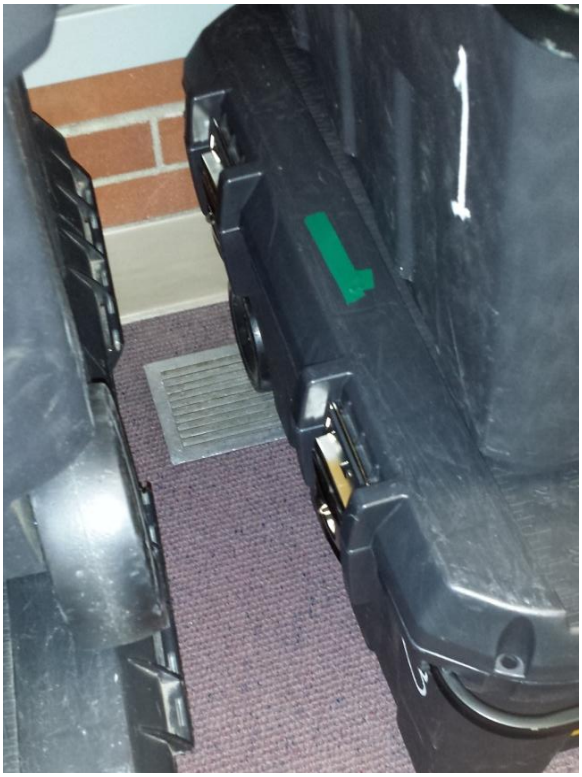
7. Annex Room B – Blocked in-floor air supply grill.

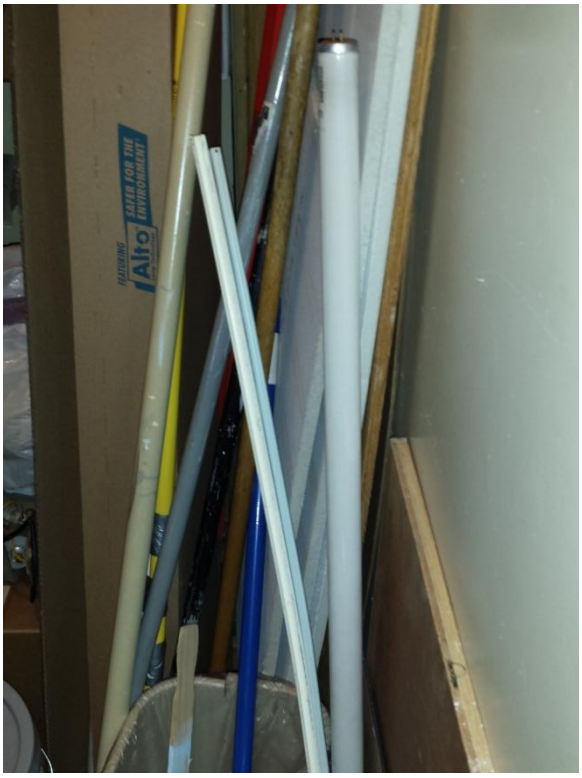
28. Annex Paint Storage Room – Improperly stored fluorescent light tube.

Fluorescent light tubes were observed to be improperly stored in numerous areas throughout campus. All fluorescent light tubes contain mercury and if broken, have the potential to contaminate surrounding areas. PBS recommends the tubes be placed in proper storage containers to prevent accidental breakage.

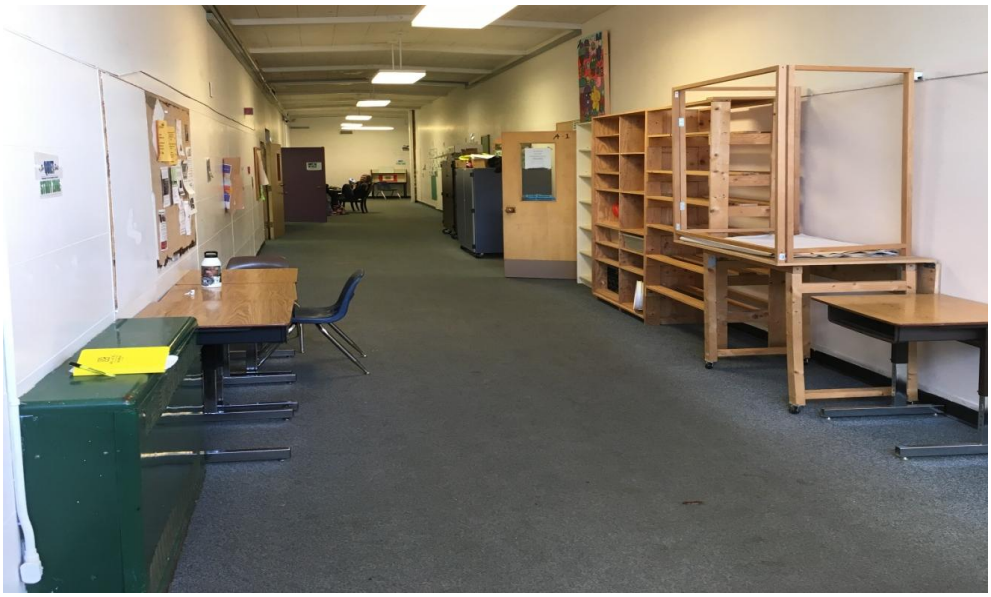
31. Annex Main Corridor – Discolored carpet.

The carpet in the Annex corridor is visibly discolored from heavy foot traffic. Carpets accumulate heavy dust and debris and impact air quality when disturbed. Carpets are not recommended in corridors because of the heavy traffic they endure. PBS recommends removing carpets from all corridors and replacing with a smooth surface such as wood, terrazzo or vinyl. If the carpet is to remain, PBS recommends cleaning frequency be evaluated.

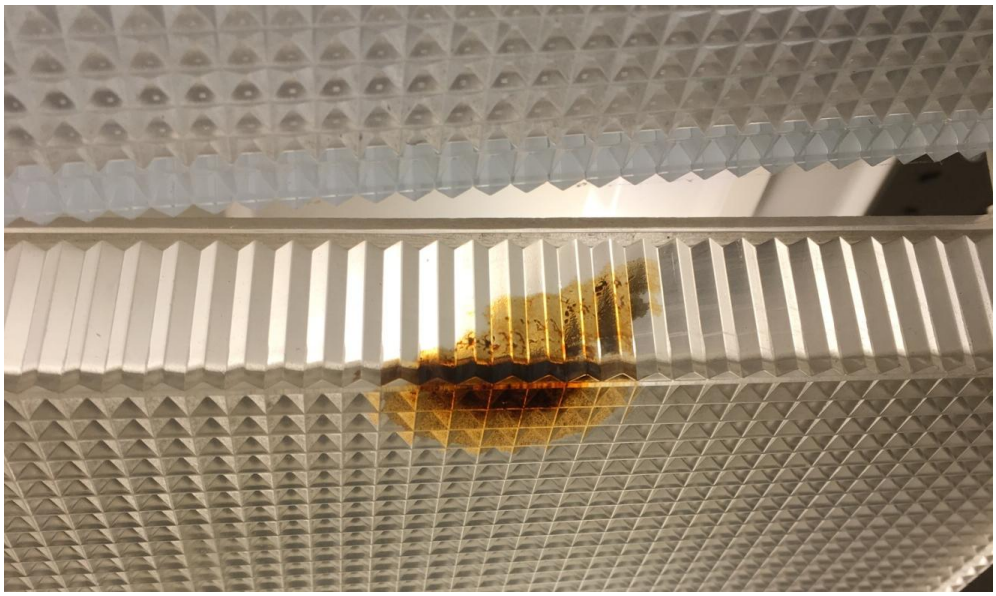
35. Music Room SPA Storage – Suspect PCB residue in light fixture lense.

Suspect PCB residue was observed inside fluorescent light fixtures. PBS recommends all fluorescent light fixtures throughout campus be evaluated for suspect PCB-containing ballasts and suspect PCB residue. All work associated with PCB ballast residue cleaning and handling must be performed in accordance with WAC 173-303 and 40 CFR Part 761). It is our understanding that the Monroe School District has trained personnel currently going through each light fixture in each space throughout campus.

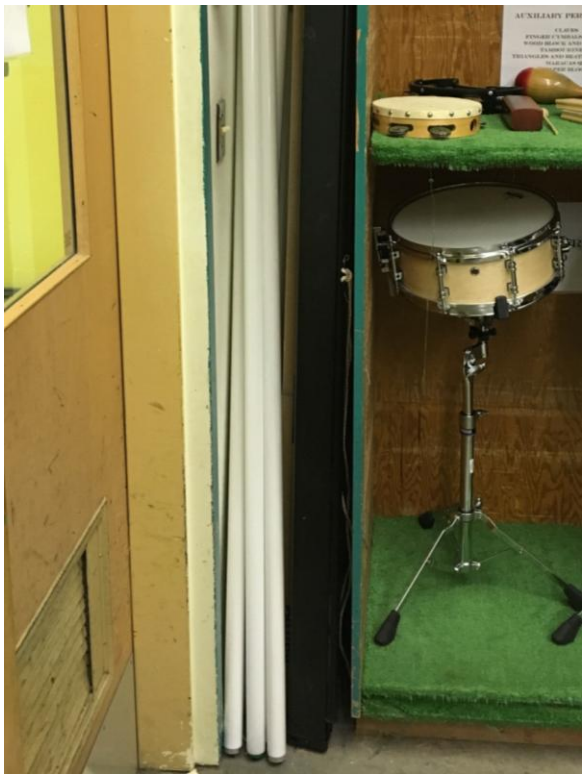
36. Music Instrument Storage – Improperly stored fluorescent light tubes.

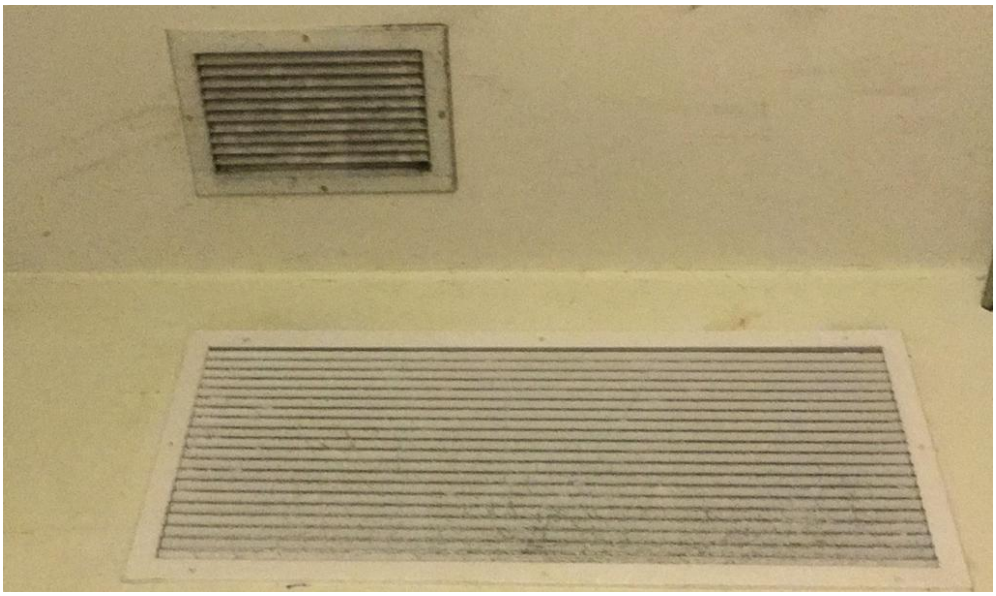
37. Music Percussion Storage – Dust/debris impeding air flow through exhaust grill.

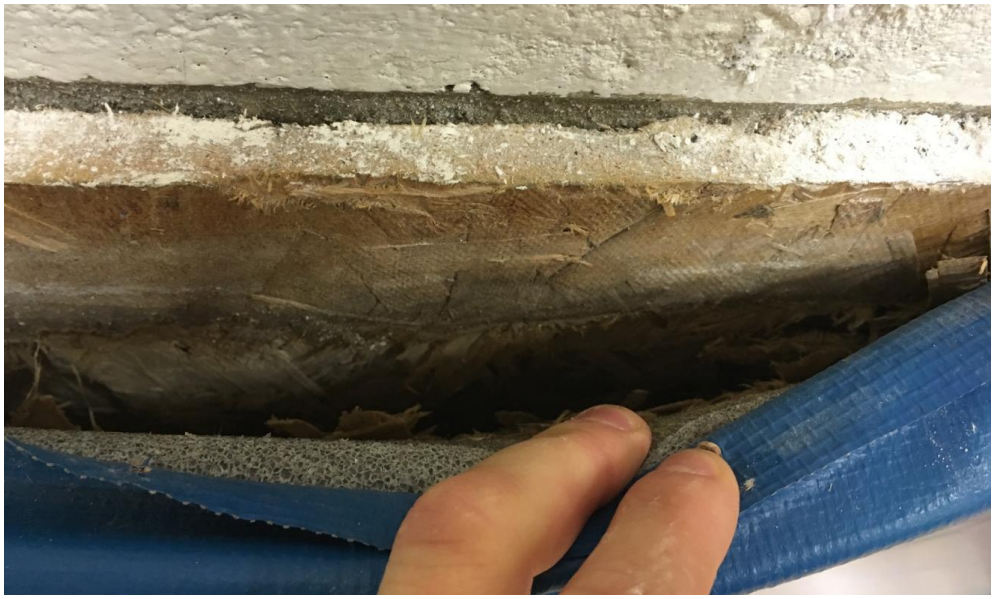
42. Small Gym East Perimeter Wall –
Fungal growth on the OSB behind the athletic safety pads on the lower wall.

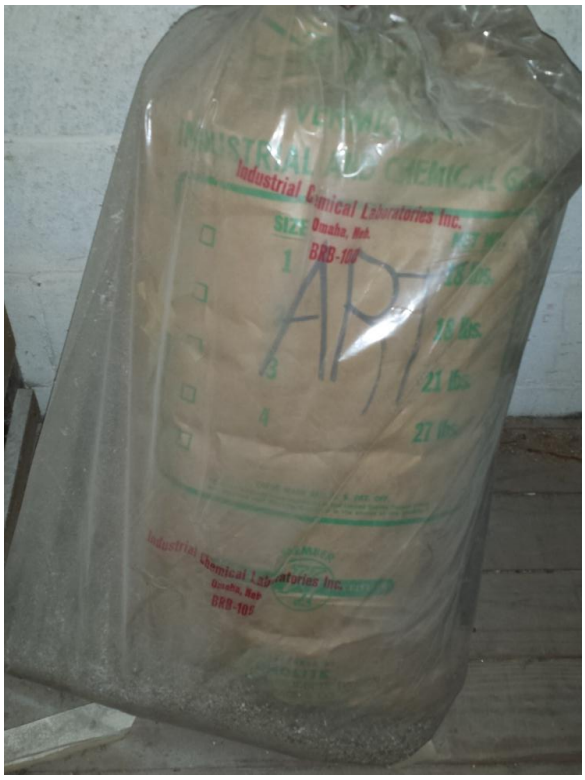
51. Technology Building – Bag of asbestos-containing vermiculite in mechanical attic.

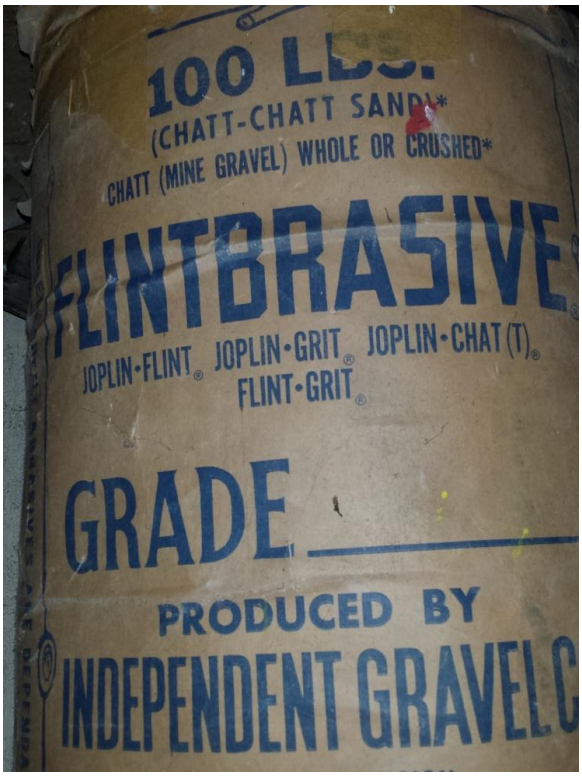
52. Technology Building – Bag of asbestos-containing abrasive in mechanical attic.

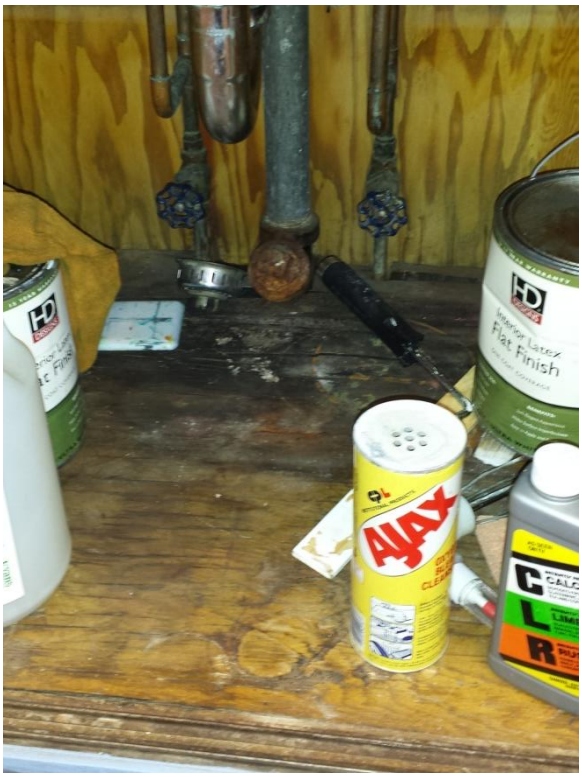
58. Technology Building Room 23 – Water damaged sink cabinet with fungal growth.

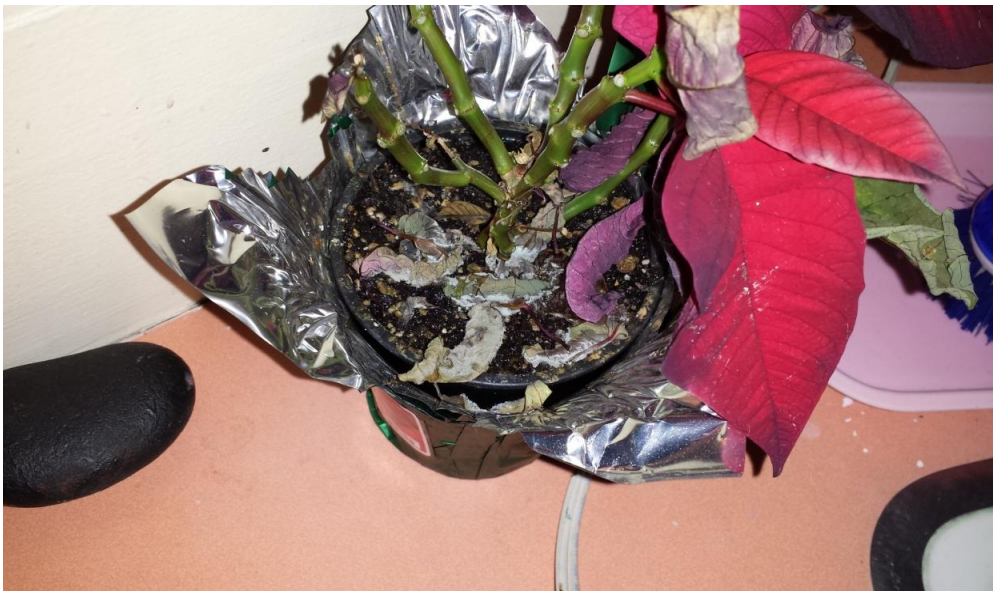
69. South Pod Central Common Area – Moldy plant on countertop.

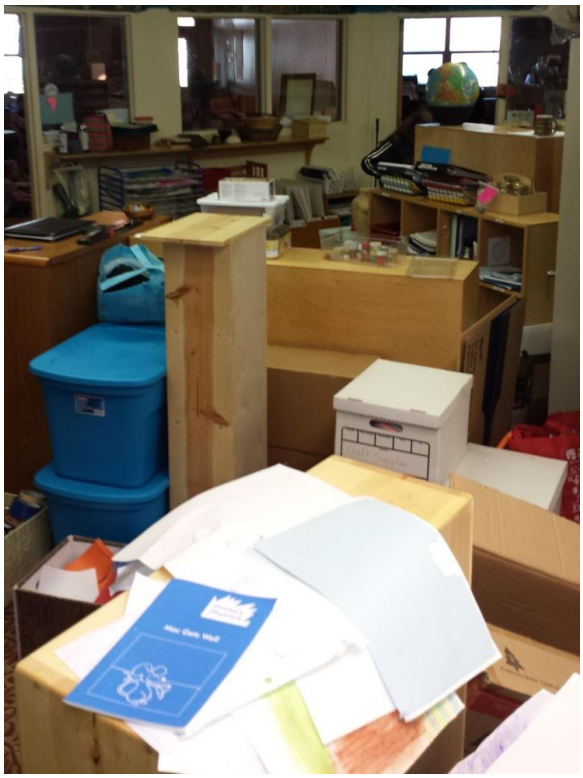
70. South Pod Central Common Area –
Difficult area to adequately clean due to the amount of stored items.

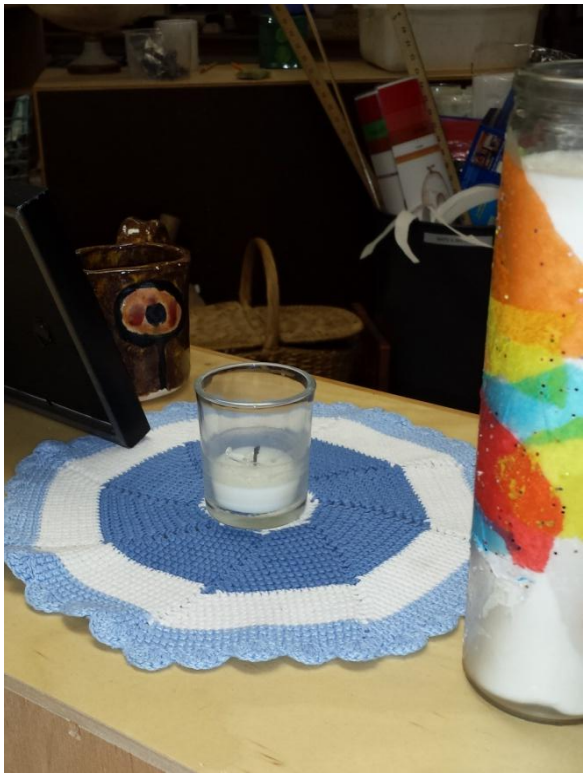
71. South Pod Central Common Area – Candle burning creates airborne particulate.

Evidence of cooking and candle burning was observed in classrooms. These activities generate airborne particulate, chemicals and odors. Candle burning and cooking are not recommended in classrooms.

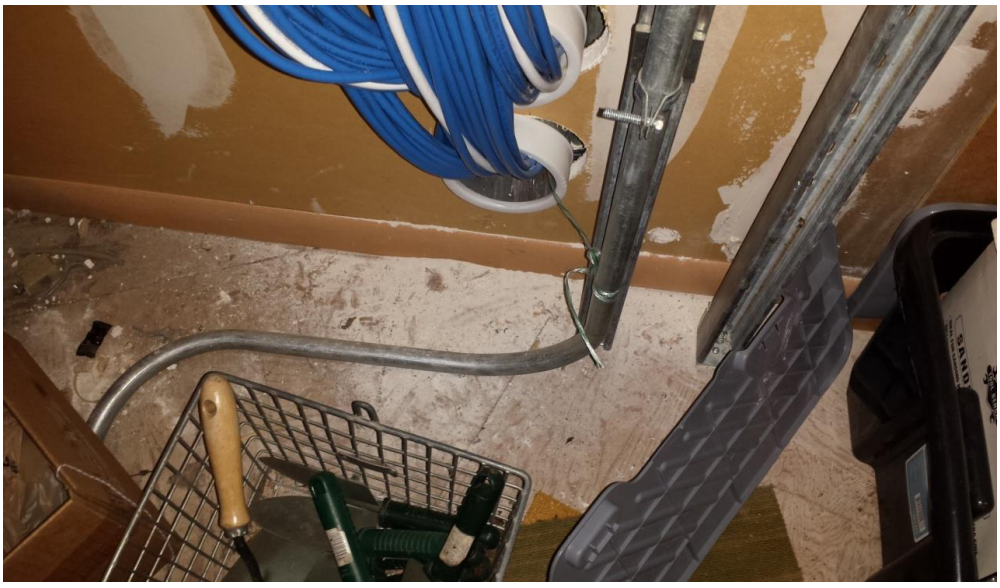
72. South Pod Attic – Gypsum wallboard debris from cabling upgrade project.

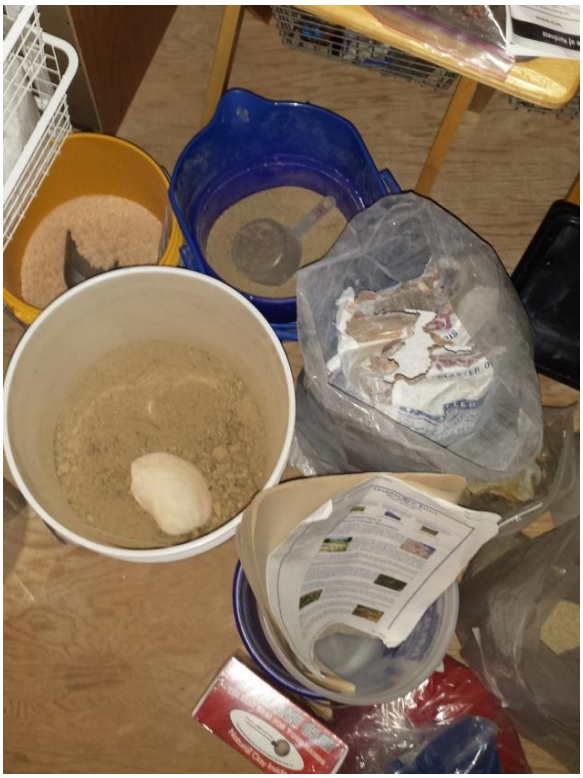
74. South Pod Attic – Buckets of dirt and sand.
