**REPORT
OF THE
AMERICAN PUBLIC TRANSPORTATION ASSOCIATION
PEER REVIEW PANEL
FOR
MEMPHIS AREA TRANSIT AUTHORITY
Memphis, TN**

REPORT
OF THE
AMERICAN PUBLIC TRANSPORTATION ASSOCIATION
PEER REVIEW PANEL
ON
TROLLEY FIRES
AT THE
MEMPHIS AREA TRANSIT AUTHORITY

Executive Summary

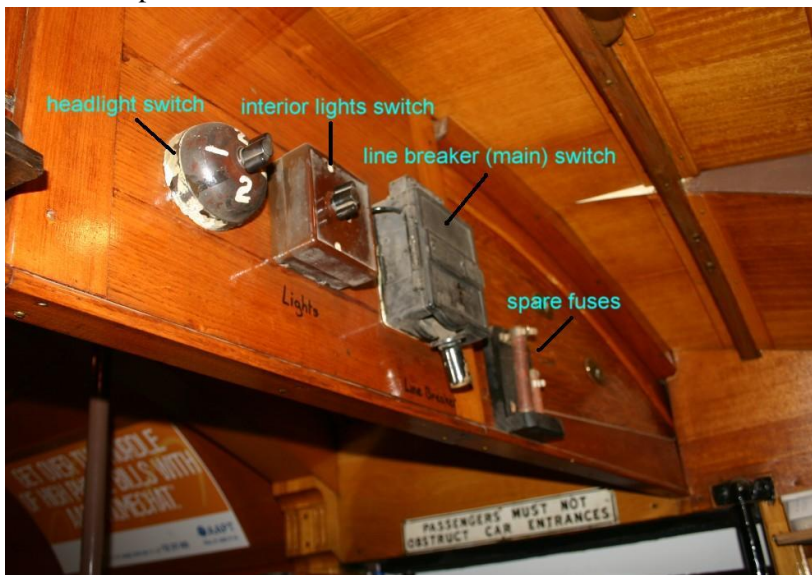
Figure 8 – Series of switches in a typical cab. They are located at ceiling level and behind the trolley operator.

Note the line breaker switch can be

manually operated by the operator.

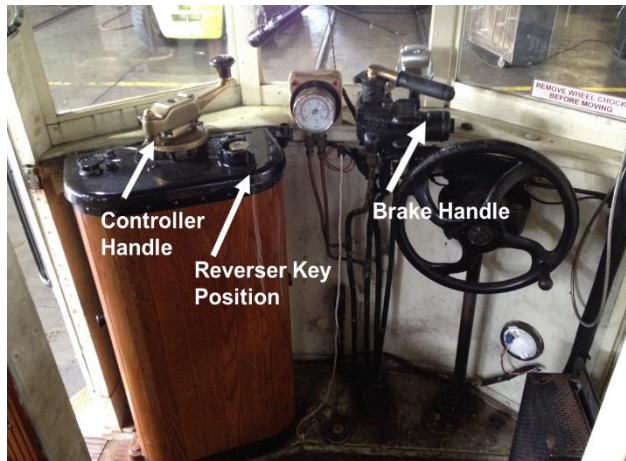
Figure 9 – Typical cab showing position of controller handle, brake handle and reverser key switch position

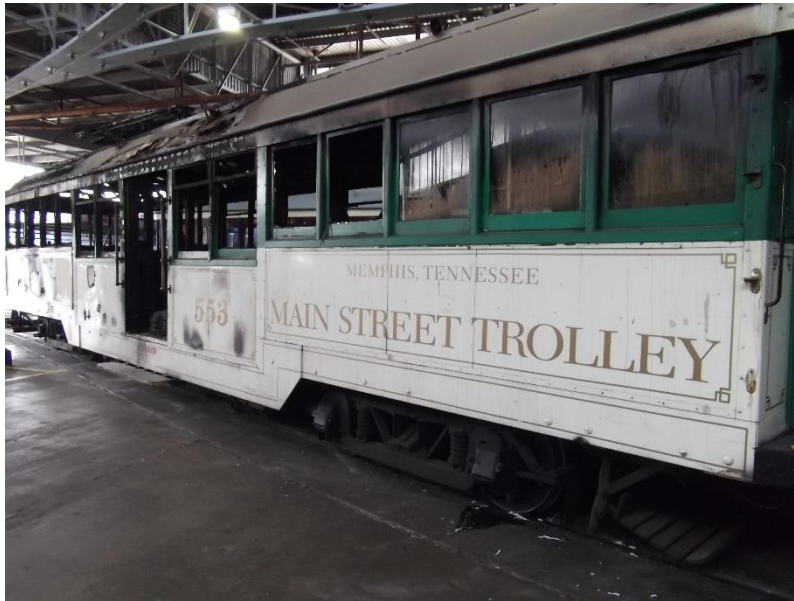
Trolley #553 is a Melbourne type car. Believed it was manufactured about 1920 in Melbourne, Australia. Refurbished by MATA contractors between 1997 and 2002.

The fire occurred on the Madison Avenue Line on the Danny Thomas overpass bridge.

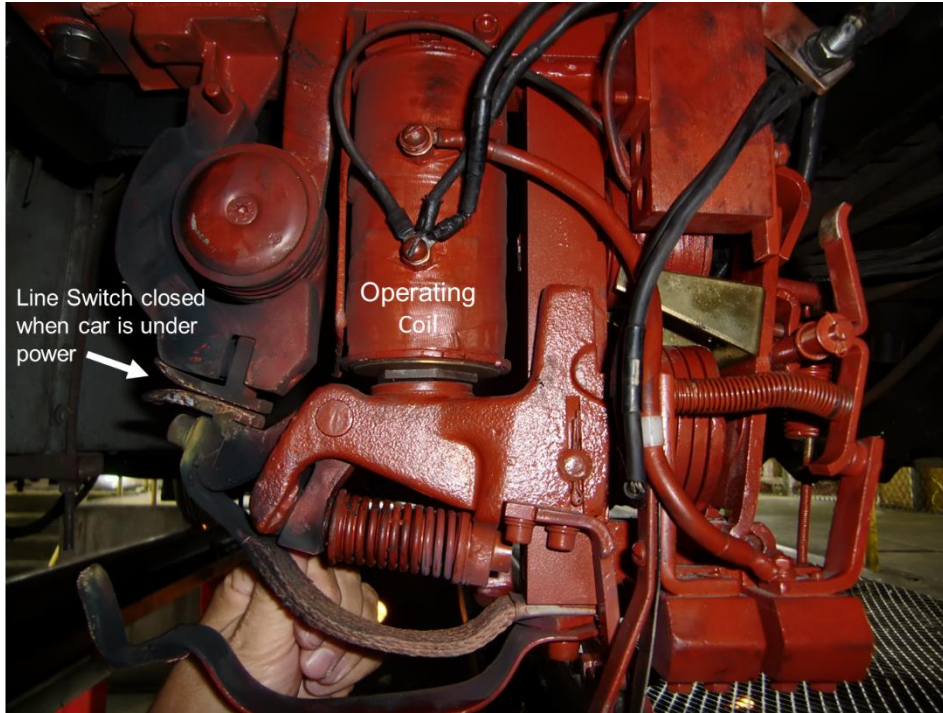
The line breaker overload is being pushed by hand to simulate the 600 Volts dc overload.

Figure 19 - The line breaker with the main operating contacts closed and the operating coil actuated. This is the normal state when the car is under power.

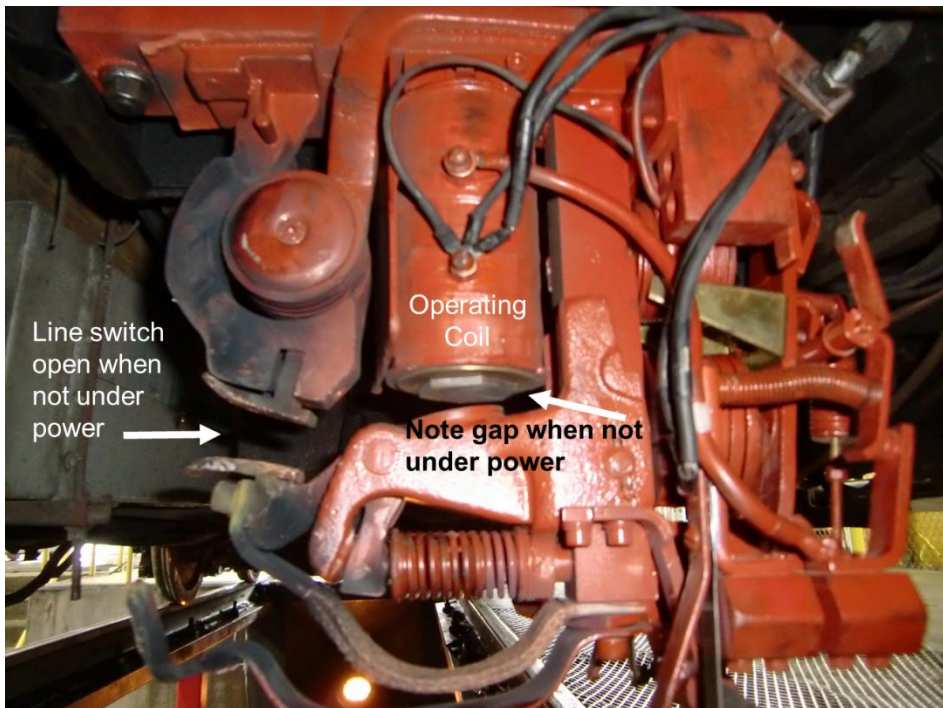
Figure 20 – When no power is present, the operating coil is disengaged and the line breaker switch tips are open.

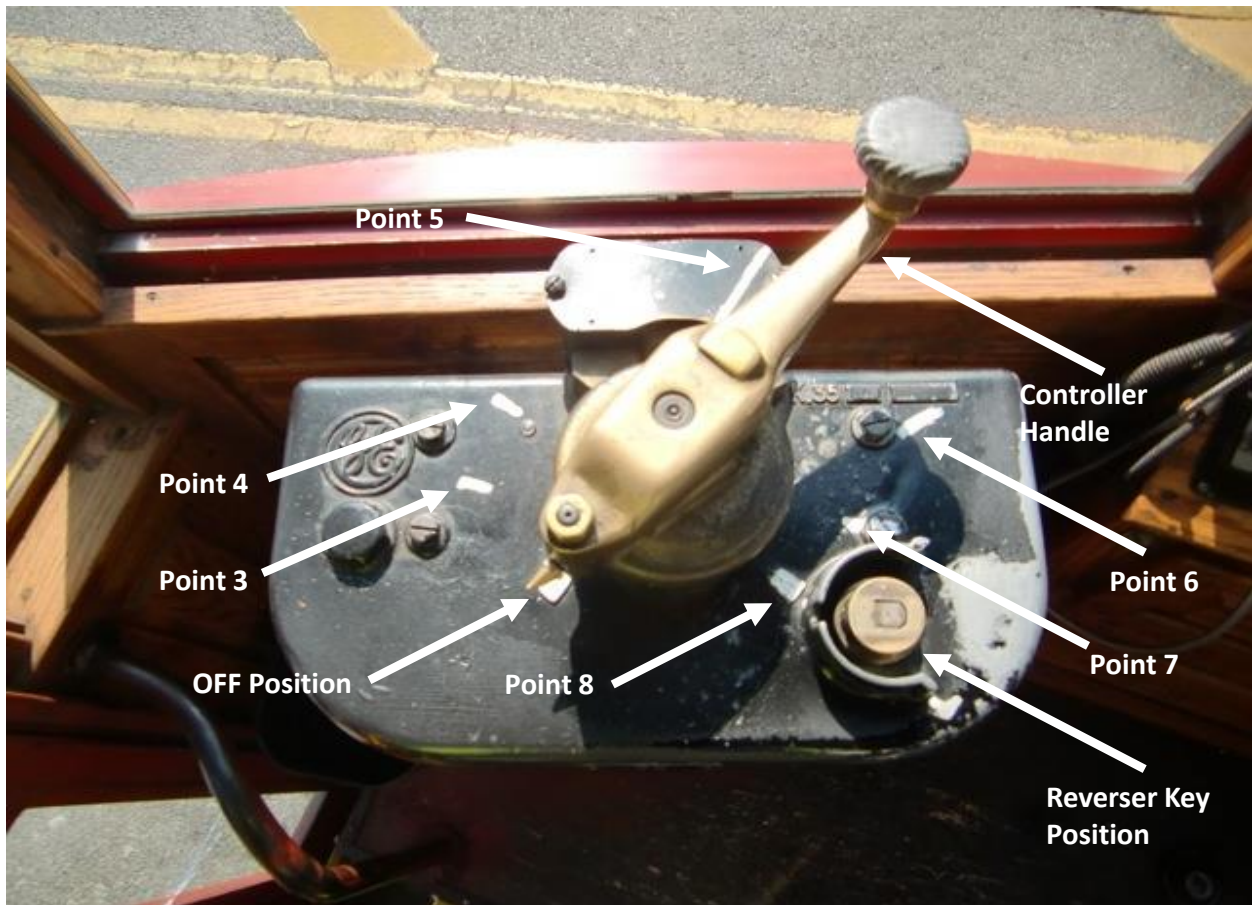
Typical controller layout showing various points and the reverser key switch location

Figure 21 – Typical cab controller/reverser key position set up
