# Town of Carolina Beach Canal Drive Flooding & Vulnerability Assessment Study

Submitted by: Aptim Coastal Planning & Engineering of North Carolina, Inc.

Project No. 636236194 February 2019 Town of Carolina Beach

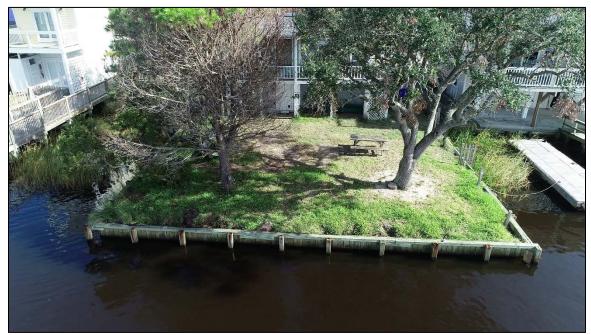
Figure 15. Screenshots from the Drone Video showing a portion of the marina bulkhead along Canal Drive and the bulkhead at 1313 Canal Drive.

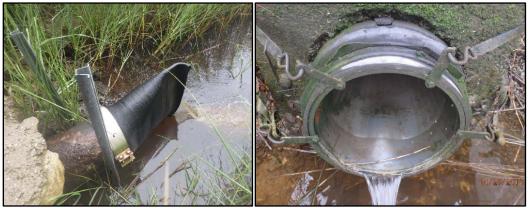
Figure 22. Examples of Functioning Backflow Prevention Devices Currently Installed. (left: recurved duckbill valve, right: WaStop® Inline Check Valve)

Several of the existing subtidal duckbill backflow prevention devices were observed to be encrusted with oysters and barnacles that inhibit proper sealing of the valves. It has also been observed that debris or trash can get caught in the opening and prevent the duckbill valve from sealing properly. Regular maintenance to remove any obstructions may improve the function of these backflow prevention devices. The WaStop® inline check valves that were observed appeared to be unobstructed with marine growth or debris and functioning properly at the time of the observations. Several residents that live along Canal Drive have reported that inlets along Canal Drive no longer back up with water during high tides in the locations where the duckbill valves were replaced by the WaStop® valves. Table 12 provides a summary of the elevation, pipe material, size and locations where the duckbill valves and WaStop® valves were observed. Included in the table are the approximate locations of that outfalls included in the Town's GIS database, but were not observed during the study.
