EPA Level 4 Investigation

**Gopher Resource
Tampa Plant**

June 30, 2021

**Prepared By:
EPC Air Division Staff**

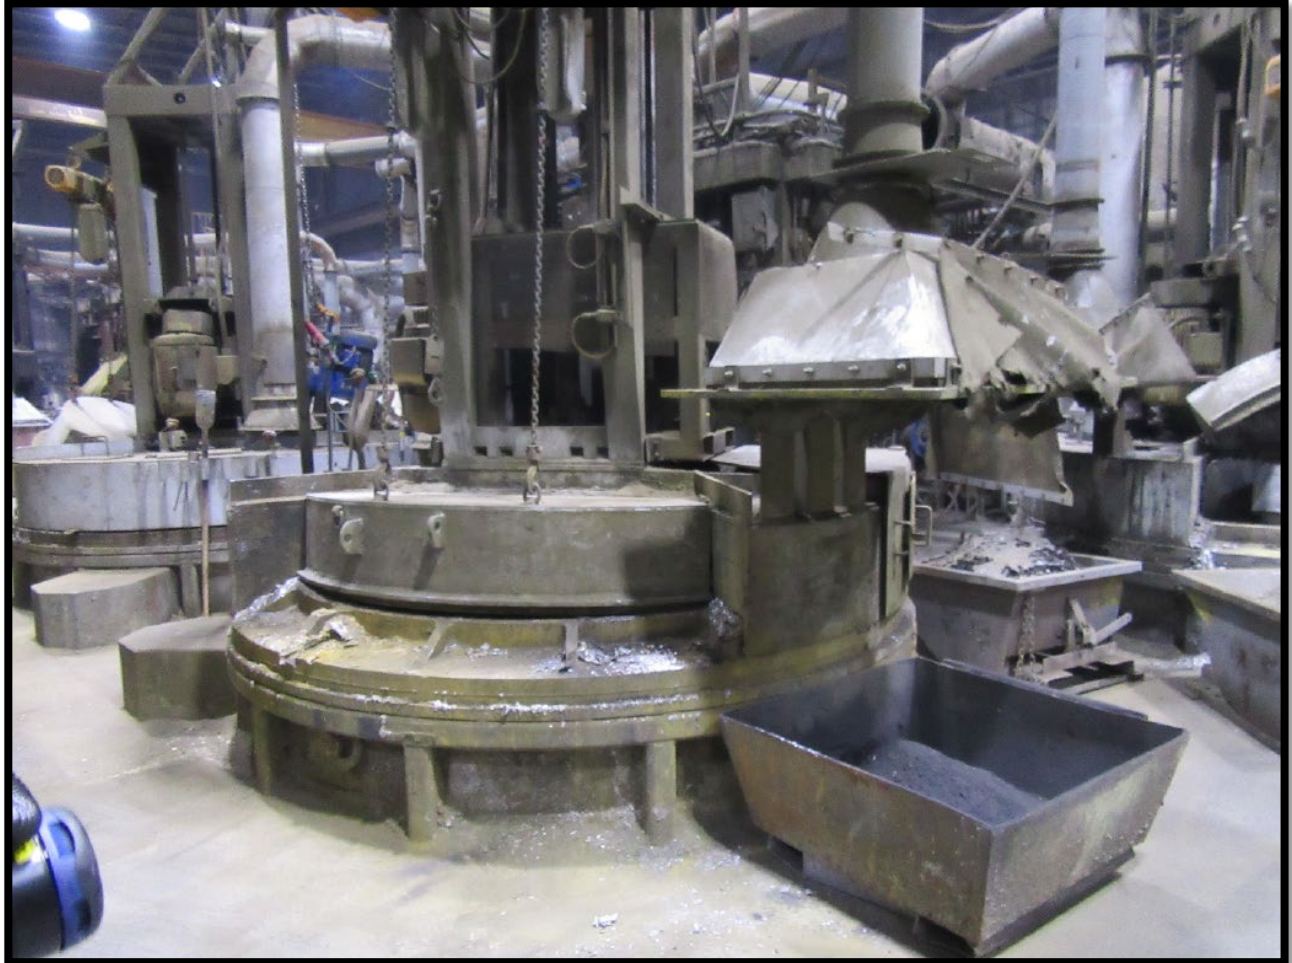
Photo #4 - Refining Kettle

We began our inspection with a walkthrough of the Refining Area where we noted the 10 Refining Kettles. Each appeared to have a direct evacuation to a ventilation system but included an additional hood pickup point for Manual Drossing. We didn't observe any active refining for Refining Kettles Nos. 1-8. So, we took several hood velocity readings on Refining Kettle No. 4. The duct velocity of the Main Duct ranged from 132 - 141 fpm near the middle of the duct. The face velocity of the Manual

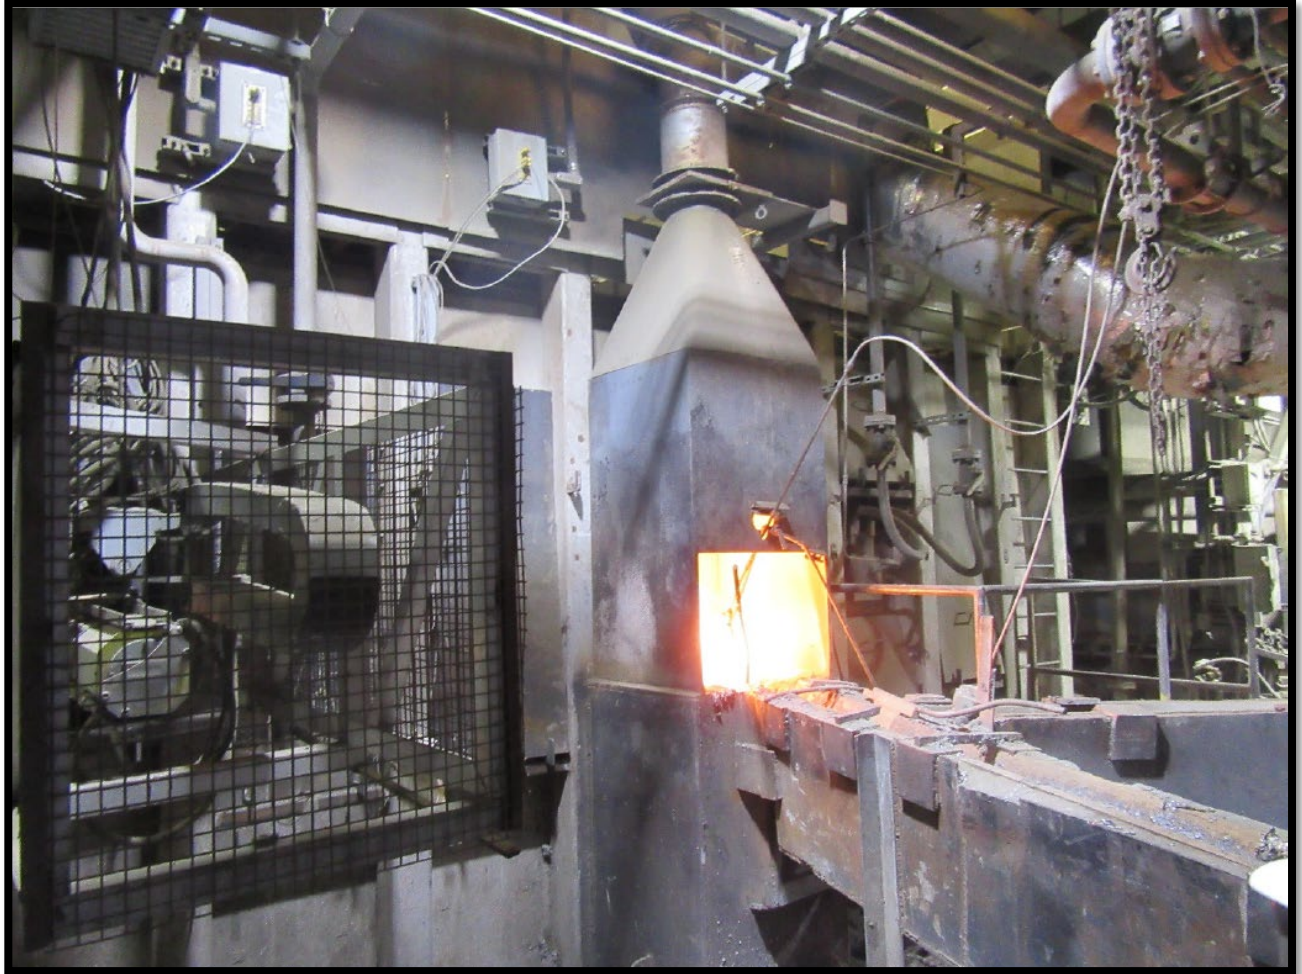
Photo #8 - Reverberatory Furnace Lead Tapping

As we walked over to the Reverberatory Furnace Lead Tapping Area, we noted that there were no Launder duct hoods, and each slide gate for the ducts were in the closed position, which appeared to partially confirm TBT Allegation No. 6. We then proceeded to the Reverberatory Furnace Lead Tapping and noted a hood enclosure ventilating the Lead Tapping. The furnace was operating, and there didn't appear to be any visible fugitive emissions escaping from the hood. We didn't detect any CO or SO₂ concentrations. Launder No. 1 was directing lead from the Reverberatory Furnace to Launder Nos. 2 and 3. Launder No. 2 was directing lead to Refining Kettle Nos. 10 with Launder No. 3 directing lead to Refining Kettle No. 9.
