Subj: COMMAND INVESTIGATION INTO THE FACTS AND CIRCUMSTANCES  
SURROUNDING THE FIRE ONBOARD USS BONHOMME RICHARD (LHD 6) ON  
OR ABOUT 12 JULY 2020

# COMMAND INVESTIGATION

On 12 July 2020, a fire set USS BONHOMME RICHARD (LHD-6) ablaze for more than four days, and left the ship damaged beyond economical repair. Although the fire was started by an act of arson, the ship was lost due to an inability to extinguish the fire. In the 19 months executing the ship's maintenance availability, repeated failures allowed for the accumulation of significant risk and an inadequately prepared crew, which led to an ineffective fire response. There were four key focus areas to this final outcome:

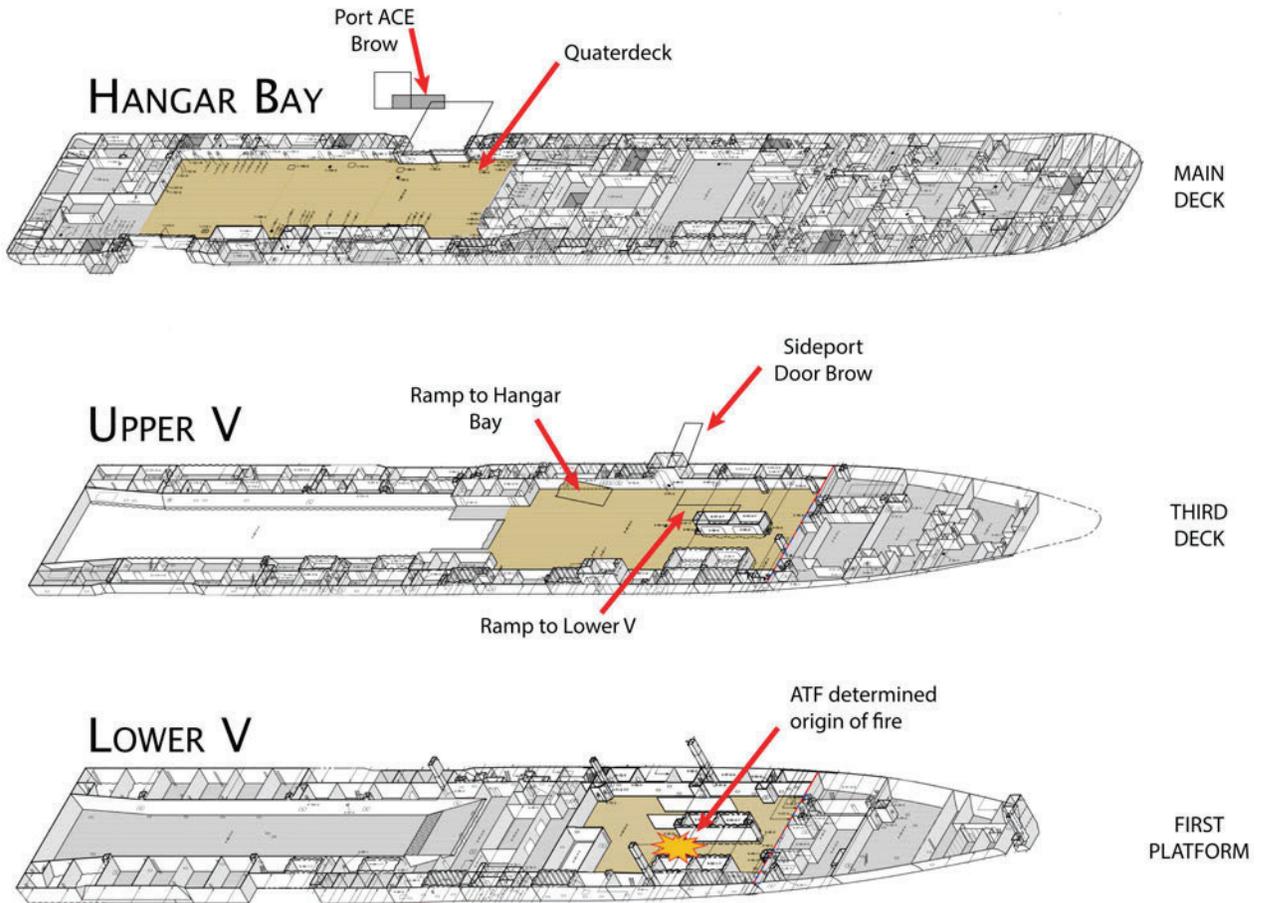
Figure 2 depicts various BONHOMME RICHARD decks and compartments.

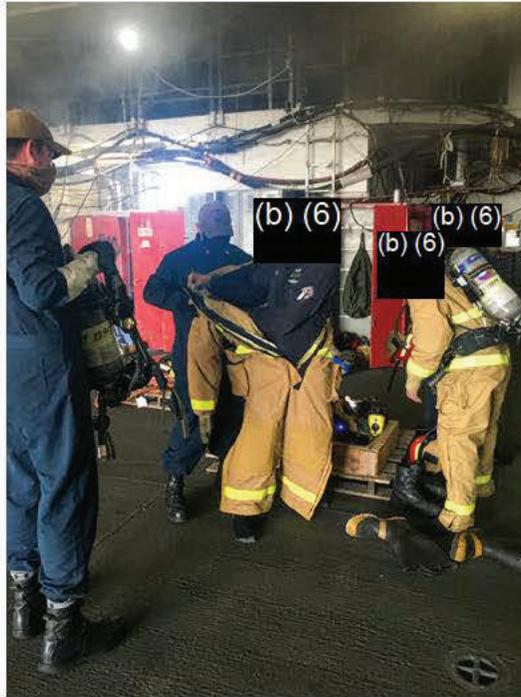
25. Following the IMC announcement from the Quarterdeck, BONHOMME RICHARD Sailors began assembling in the Hangar and dressing out in SCBAs and Firefighting Ensembles (FFEs). Multiple Sailors, including several Chief Petty Officers (CPO), reported they did not dress out in FFEs because they were wearing the Type III Navy Working Uniform (NWU), rather than coveralls. The choice not to dress out was at least partially based on an assumption that it is not

Figure 3 captures BONHOMME RICHARD Sailors dressing out in the Hangar.

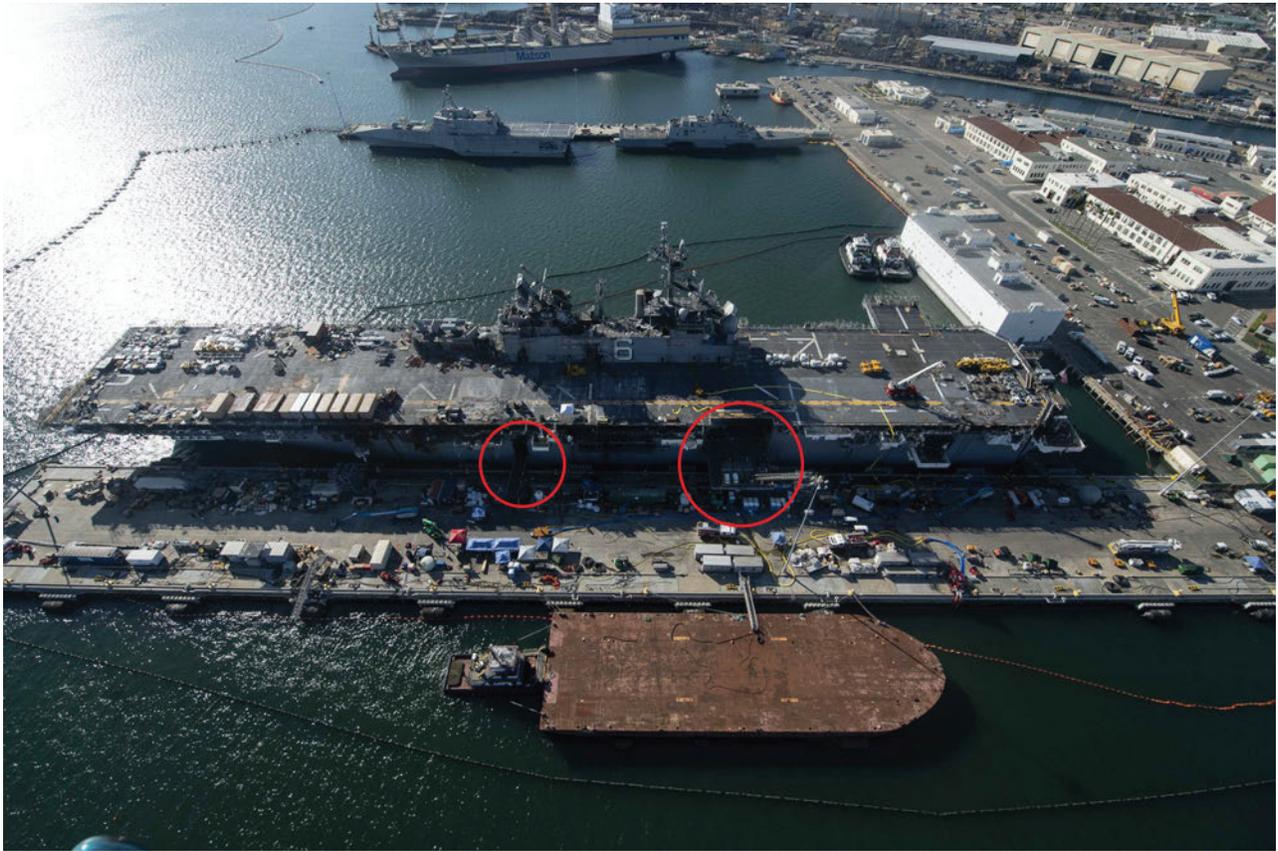
Figure 5 is a photograph of BONHOMME RICHARD with the sideport door/port ACE identified.

49. FEDFIRE proceeded to establish its attack via the port ACE (See Figure 5 above) and commenced running hoses from its engines on the pier up to the port ACE. With no installed firemain system on Pier 2 (or any other NBSD pier), FEDFIRE Engine 161 connected to the potable water riser, which was supplying water to FITZGERALD located on Pier 2. Once established in the Hangar, FEDFIRE ran hoses through the forward portion of the Hangar, down the Upper V ramp, through Upper V, and down the ramp to Lower V. Engine 161, led by FEDFIRE (b) (6), was the first team to lay a hose line down to Lower V. His team consisted of four FEDFIRE firefighters and (b) (6). FEDFIRE Engine 161 laid 200 feet of hose from the Quarterdeck, across the Hangar, down the Upper V ramp, and across Lower V. They then had to attach an additional 100 feet down the ramp. After laying this hose, FEDFIRE Engine 161 was not able to combat the fire because a team member received a “low air” alarm on his SCBA. FEDFIRE (b) (6)’s team egressed at approximately 0904. [Encl 44, 126, 140, 148, 149, 151, 152, 153, 154, 155]

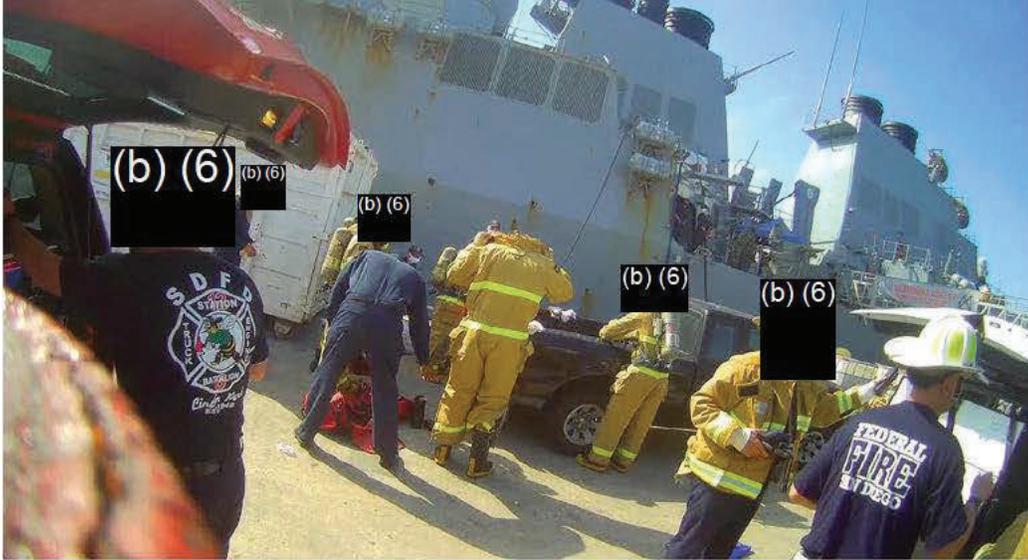
58. On arrival, SDFD met with FEDFIRE (b) (6), who had assumed the role of FEDFIRE Incident Commander (IC). (b) (6) directed SDFD to support FEDFIRE's attack via the port ACE. At this time, FEDFIRE did not provide SDFD any information about the fire other than they had not determined its location. By this time (0900), several BONHOMME RICHARD Sailors were aware of the fire's location. [Encl 126, 156, 166, 178, 179]

Figure 6 is a screen capture from SDFD (b) (6)'s helmet-mounted camera footage. The image shows the ICP (FEDFIRE and SDFD command vehicles with tailgates up) at approximately 0910.

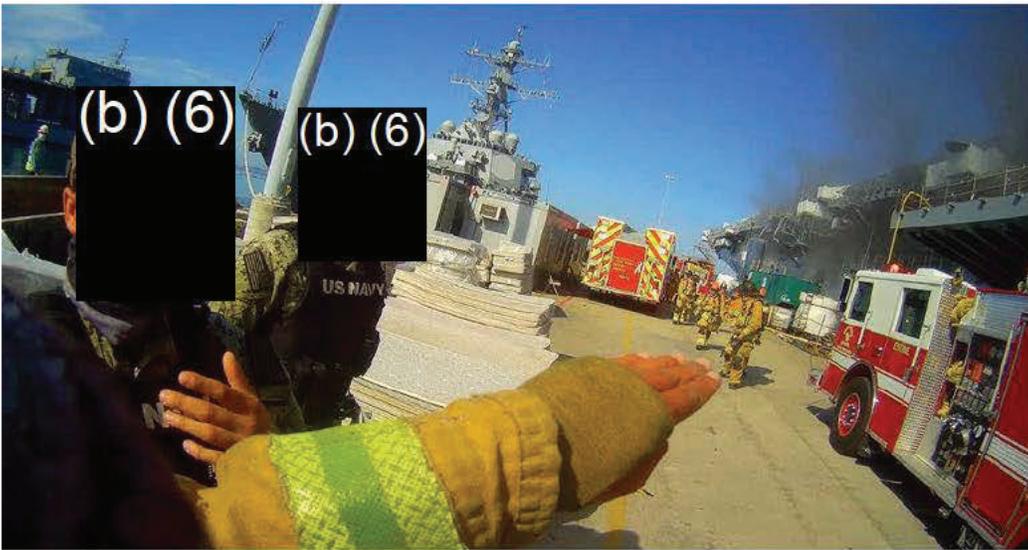
59. After arriving at 0900 and checking in with FEDFIRE (b) (6) near the entrance to Pier 2, SDFD (b) (6) walked down the pier and asked a Navy Sailor whether he knew where the fire was located. The Sailor replied that the fire was located either in Upper V or Lower V while pointing past the port ACE toward the sideport ramp. SDFD (b) (6) asked several personnel for a “map” of the ship but was unable to acquire one. [Encl 126, 166, 180]

Figure 7 is a screen capture from SDFD (b) (6)'s helmet-mounted camera footage. At approximately 0908, SDFD (b) (6) stopped Sailors to seek information about the fire.

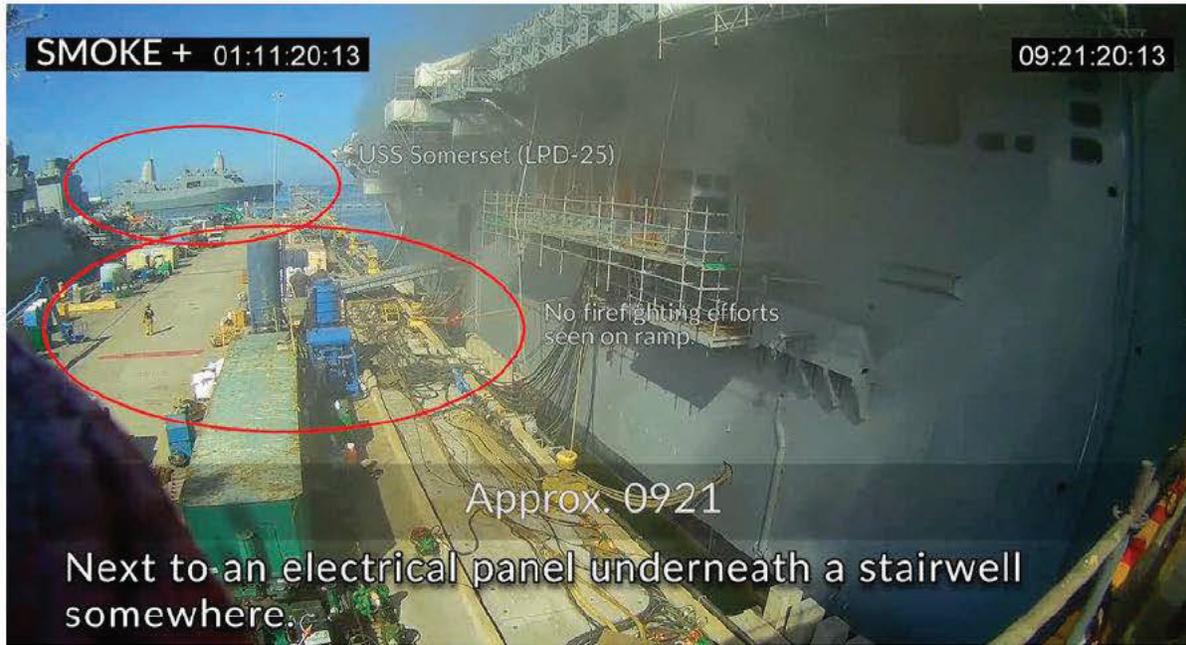
64. Despite evidence that suggests the Duty Fire Marshal was carrying DC plates as he departed the ship, both FEDFIRE and SDFD Chiefs stated that DC plates were not available at the ICP. When BONHOMME RICHARD Amphibious Air Traffic Control Officer (AATCO), (b) (6) arrived at the ICP at approximately 1100, he observed multiple personnel attempting to locate DC plates. The BONHOMME RICHARD XO stated in his interview that BONHOMME RICHARD’s crew did not take DC plates with them when they evacuated the

Figure 8 is a screen capture from SDFD (b) (6)'s helmet-mounted camera footage (subtitles and other text added by the investigation team). SDFD (b) (6) was speaking about the location of the fire. No personnel are visible by the sideport door.

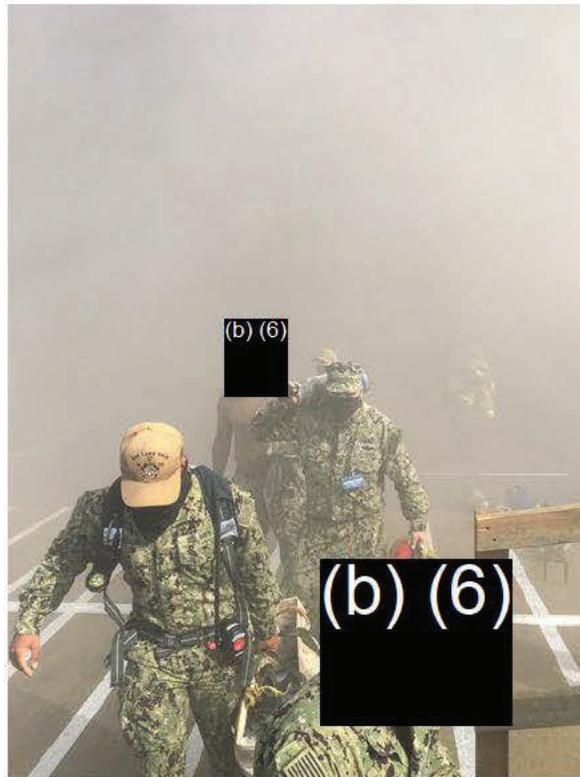
65. At approximately 0900, (b) (6) and RUSSELL's R&A team were directed to evacuate the Hangar due to smoke. They debarked and staged on the pier next to the sideport ramp. RUSSELL's team observed numerous BONHOMME RICHARD Sailors departing the ship. At approximately 0915, due to deteriorating smoke conditions in the Hangar, the CDO ordered all personnel not wearing SCBAs to evacuate the ship. Prior to issuing this order, the CDO spoke to BONHOMME RICHARD CO via phone and informed him that he (the CDO) was ordering the evacuation of non-SCBA wearing personnel. The CO concurred with this action and ordered the evacuation. There are varying reports on whether this evacuation order was communicated over the IMC. [Encl 27, 41, 70, 98, 99, 142, 185, 195]

Figure 9 shows Sailors evacuating the BONHOMME RICHARD Hangar.

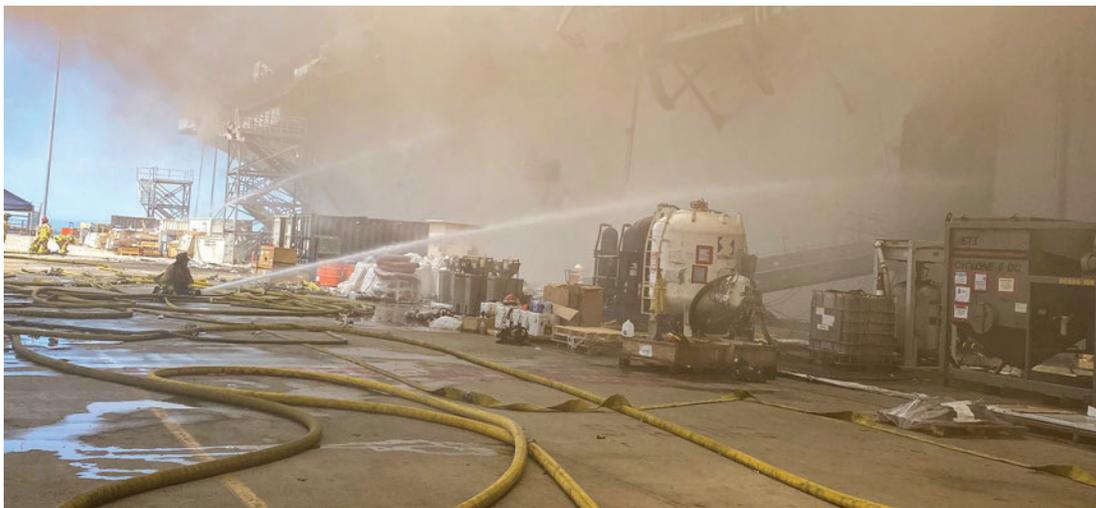
101. At approximately 1124, FEDFIRE personnel and several BONHOMME RICHARD Sailors, including the DCA, returned to Pier 2 to establish an unmanned monitor (fire nozzle) at the sideport door, which sprayed water directly into Upper V from the sideport door. FEDFIRE (b) (6) and FEDFIRE (b) (6) were the first FEDFIRE firefighters to return to the pier after the explosion. FEDFIRE (b) (6)'s team was tasked with leading a firefighting effort up to the Hangar (Division 1) while FEDFIRE (b) (6)'s team was tasked with leading a firefighting effort into Lower V (Division 2). Due to the intensity of the fire, Divisions 1 and 2 were re-tasked with evaluating the state of the fire and determining the feasibility of recommencing firefighting efforts. The fire's intensity, heat, and a significant amount of debris forced the divisions to use a “round robin” approach to combatting the casualty. The teams departed just outside the ship and swapped out bottles before reentering and continuing to fight. [Encl 149, 189, 203, 257, 258, 259]

Figure 13 shows firefighting monitors spraying water from the pier on 12 July 2020.

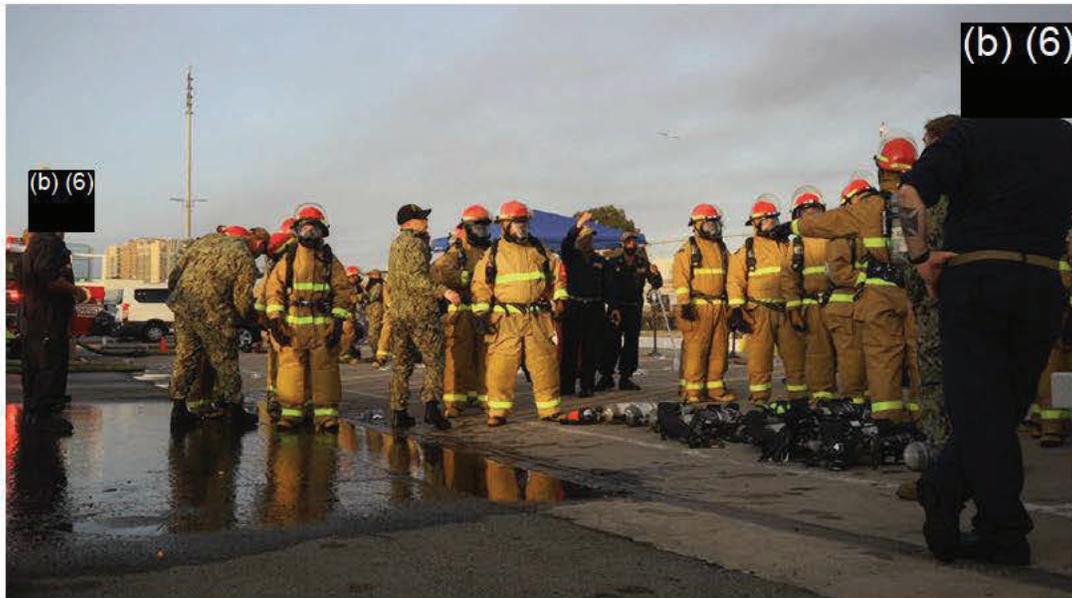
152. Expanding beyond the initial early efforts of a few Sailors, over the remainder of the afternoon, teams of BONHOMME RICHARD Sailors began joining FEDFIRE in firefighting efforts. Initially, BONHOMME RICHARD teams were not integrated with FEDFIRE teams; while both organizations contributed teams, the teams themselves were not integrated. A team of BONHOMME RICHARD Sailors entered via the sideport door at approximately 1530. By this time, two unmanned monitors, each capable of deploying 300 gallons-per-minute (GPM), were placed in Upper V with one pointing in Upper V itself and the second pointing down the Lower V ramp. Despite issues with water volume, these monitors continued pumping water into Upper and Lower V. [Encl 149, 172, 197, 249, 313, 380, 381]

Figure 14 shows BONHOMME RICHARD Sailors organizing into fire teams.

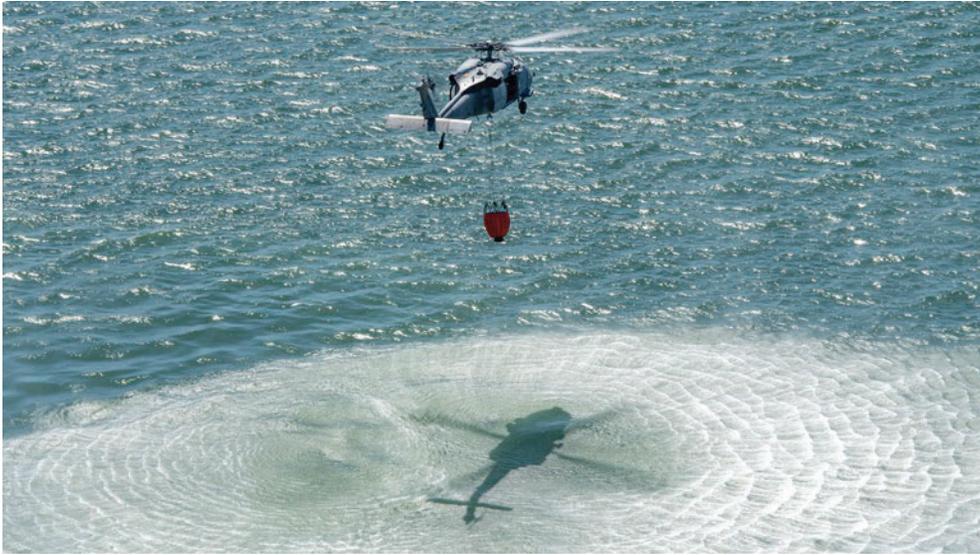
172. From 12 July 2020 until 15 July 2020, 1,649 water drops were conducted, deploying 545,076 gallons of water. (See Figures 16 and 17). After 12 July 2020, the SCORE detachment was augmented by additional aircrews from HSC-3. Various Navy, FEDFIRE, and contract firefighting personnel disagreed about the overall effectiveness of the water drops. [Encl 188, 308, 391, 393, 394, 395]

Figure 16 shows a SH-60 helicopter picking up water to conduct water drops on BONHOMME RICHARD.

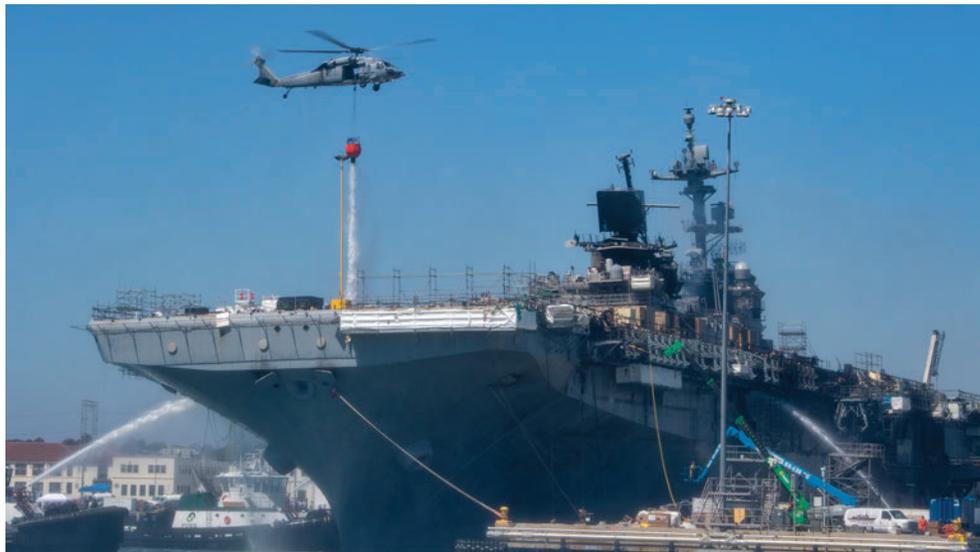
Figure 17 shows a helicopter conducting a water drop on BONHOMME RICHARD.

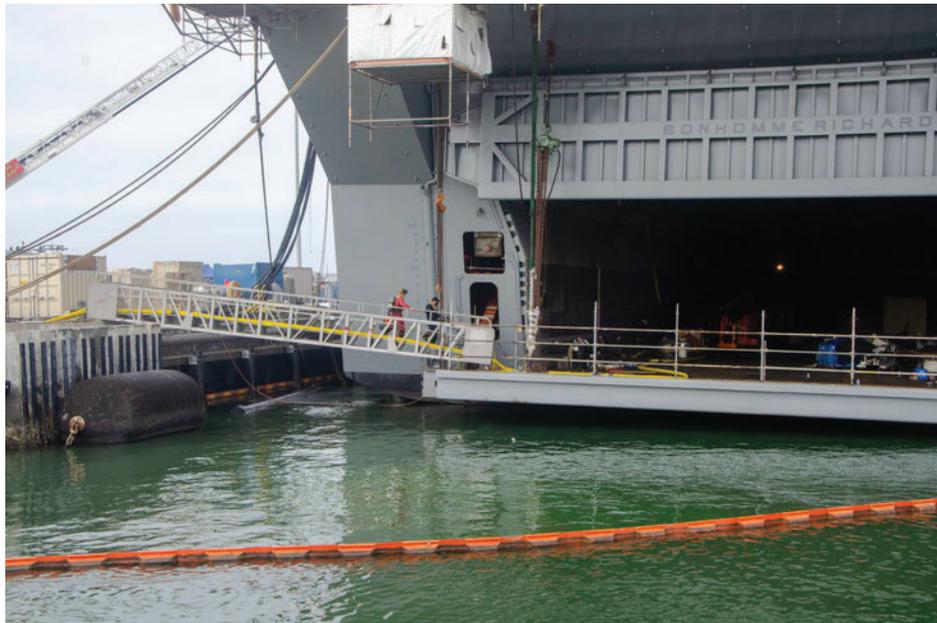
175. At approximately 0211, 13 July 2020 a NAVFAC crane, organized by (b) (6), landed a brow on the stern gate, enabling a 20-man hose team to enter and relieve the 5-man team. (See Figure 18). This team continued the fire attack by advancing forward through the Well Deck toward Upper V. [Encl 72, 179, 187, 249, 313, 385, 396, 397, 398]

Figure 18 shows the stern gate brow, which was landed at approximately 0211 on 13 July 2020.

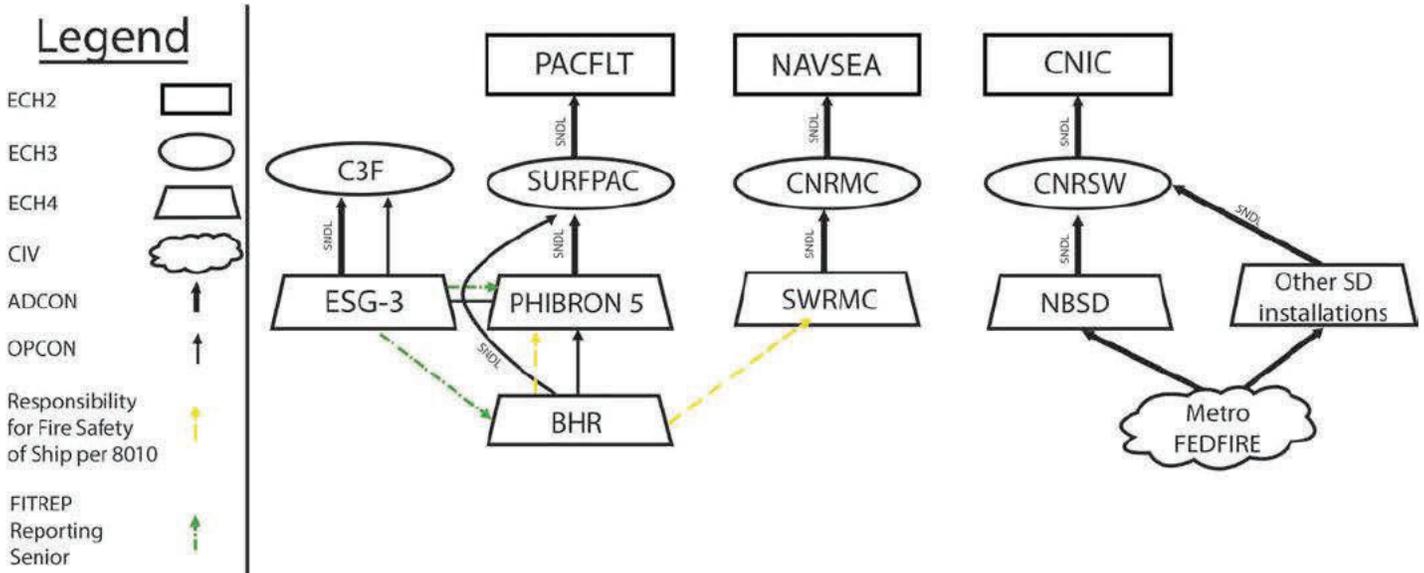
Figure 20 depicts the various command and supporting relationships related to BONHOMME RICHARD fire safety during its availability.

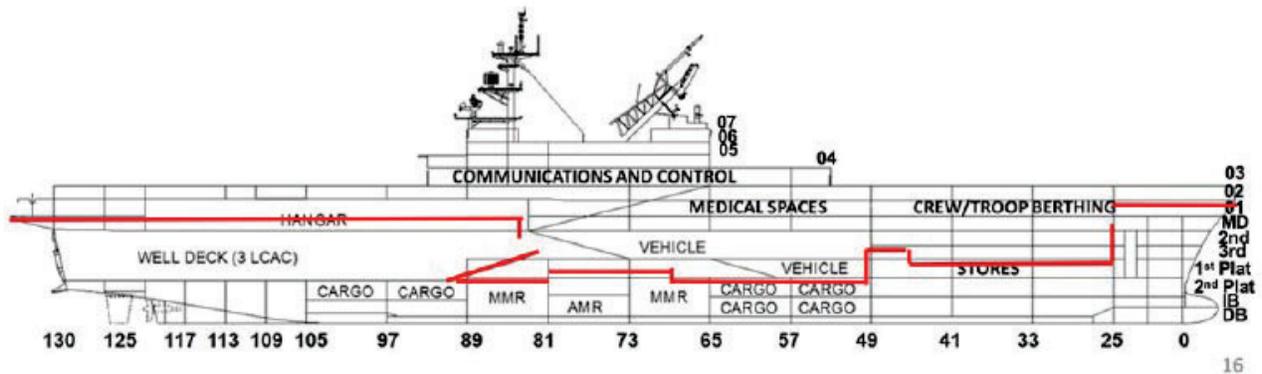
Figure 46 shows the NAVSEA “cut-line.”

1046. To aid in repair calculations, the MA established an approximate “cut-line,” above which virtually no compartment is salvageable. The MA concluded that restoration above the cut-line would entail the removal and replacement of entire decks, compartments, and all associated contents and equipment. Major spaces above the cut-line include: the island structure, all 02-level compartments for the entire length of the ship, all 01-level compartments from Frame 25 to the stern, all compartments on the Main Deck from Frames 25 to 89. Key spaces below the cut-line that still require total replacement include Damage Control (DC) Central (5-79-0-C, Ship’s Laundry (4-73-0-Q), Upper Vehicle Stowage Area (Upper V) (3-49-0-A) and Lower V (4-49-0-A). [Encl 731]

1047. Below the cut-line, the MA concluded that most compartments are either intact or could be repaired via standard ship repair processes. Major spaces below the cut-line include: 1 Main Machinery Room (MMR) (6-65-0-E), 2 MMR (6-81-0-E), Auxiliary Machinery Room (AMR) (6-73-0-E), Lower Cargo Ammunition Magazines (6-49-0-M, 6-57-0-M), Aft Steering (7-121-2-
