INDIANA UTILITY REGULATORY COMMISSION

APPLICANT'S SUBMISSION OF DIRECT TESTIMONY OF
JOHN BIGALBAL

STG1 Failure on Start-Up

Analysis Title: STG1 Startup Failure
Principle Analyst: Holcombe Baird
Analysis Sponsor: Kevin Cook
Analysis Dates: May 2, 2021 - July 8, 2021
Report Date: August 20, 2021

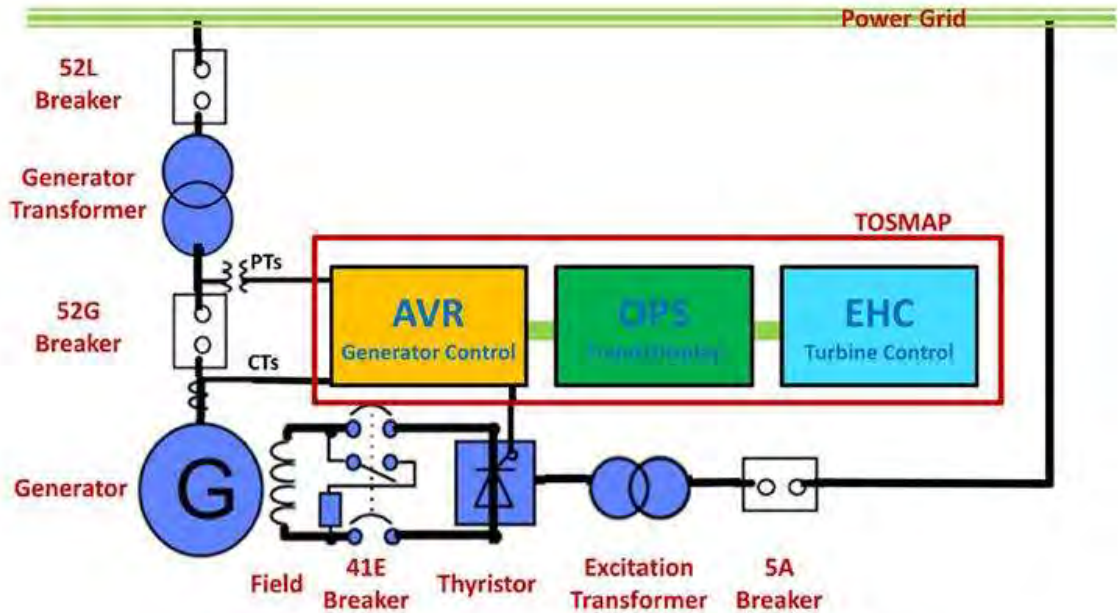
Figure 1, Simplistic diagram of generator protection and control components

9 A12. On April 25, 2021, the unit was returning from its planned maintenance outage and began
10 start up. During start up, the steam turbine unit experienced an issue with the generator
11 breaker (52G Breaker as shown in Figure 1 above) that prohibited it from synchronizing
12 with the grid. The generator breaker (52G Breaker) should have closed to allow the unit

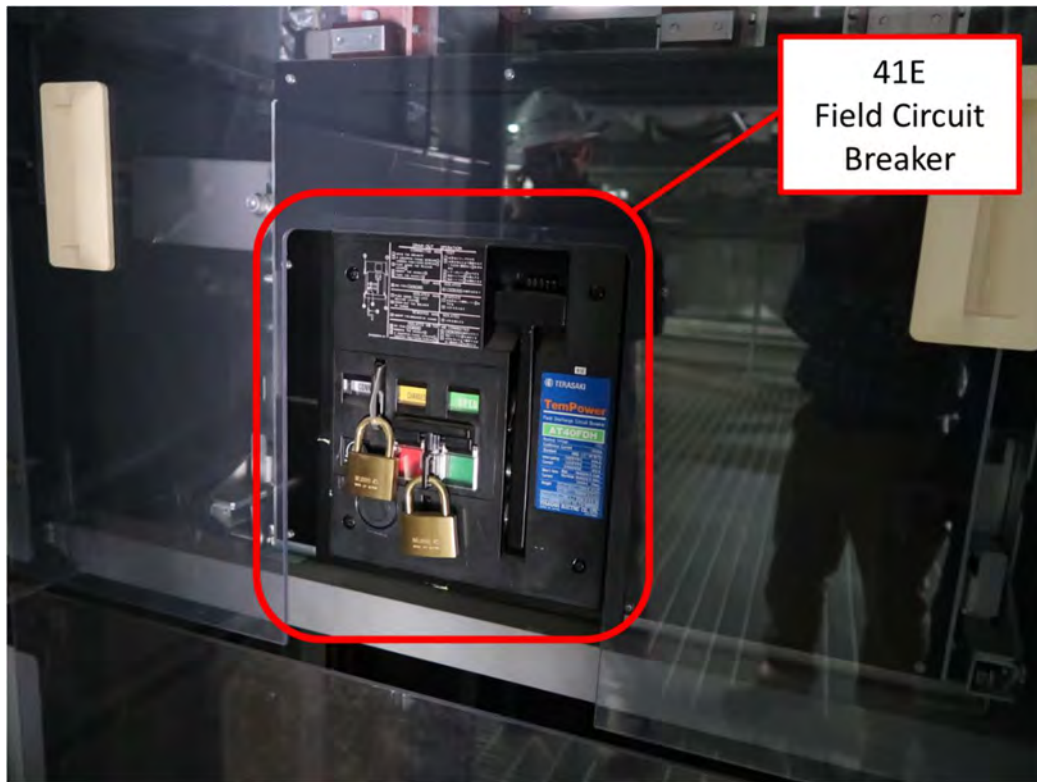
41E Breaker: also called the FCB, Field Circuit Breaker, is a device that functions to apply or interrupt the field excitation to the generator. (Refer to Photograph 2)

The RCA investigation also investigated the causes for the 41E Breaker failure to open when the manual Turbine trip was initiated. There are three sources for signals to open the 41E Breaker: 1) The hardwired 86 Series Lockouts, 2) the Turbine Trip from processor logic monitoring process related conditions, including the Manual Trip push button, and 3) a 41E Open Demand signal initiated by the AVR. (Refer to Figure 14) All three of these signals are interlocked through a N/C contact of the 52GX1 Relay. When the 52GX1 Relay is latched in the SET position (52G Breaker closed status) the N/C contact is open, preventing the signals to open the 41E Breaker from reaching the 41TP coil which opens the 41E Breaker. As a result of the 52GX1 Relay not receiving a RESET signal, the AVR did not send a 41E Open Demand signal. In addition, the hardwired signals to open the 41E Breaker from the 86G1, 86G2 and 86ET Lockouts as well as the Turbine Trip were all blocked from activating the 41TP coil. (Refer to Figure 14 and Figure 15) There was no way for the 41E Breaker to receive a signal to open. The RCA investigation determined the 41E Breaker Open signal from the 86 Series Lockouts and the Turbine Trip signals to open the 41E Breaker utilize 52G Breaker status indications using Direct Contacts on the 52G Breaker. The AVR, on the other hand, uses the Indirect Contact signals from the 52GX1 Relay in its logic to initiate the signal to open the 41E Breaker.

Photograph 2, STG 41E Breaker Location

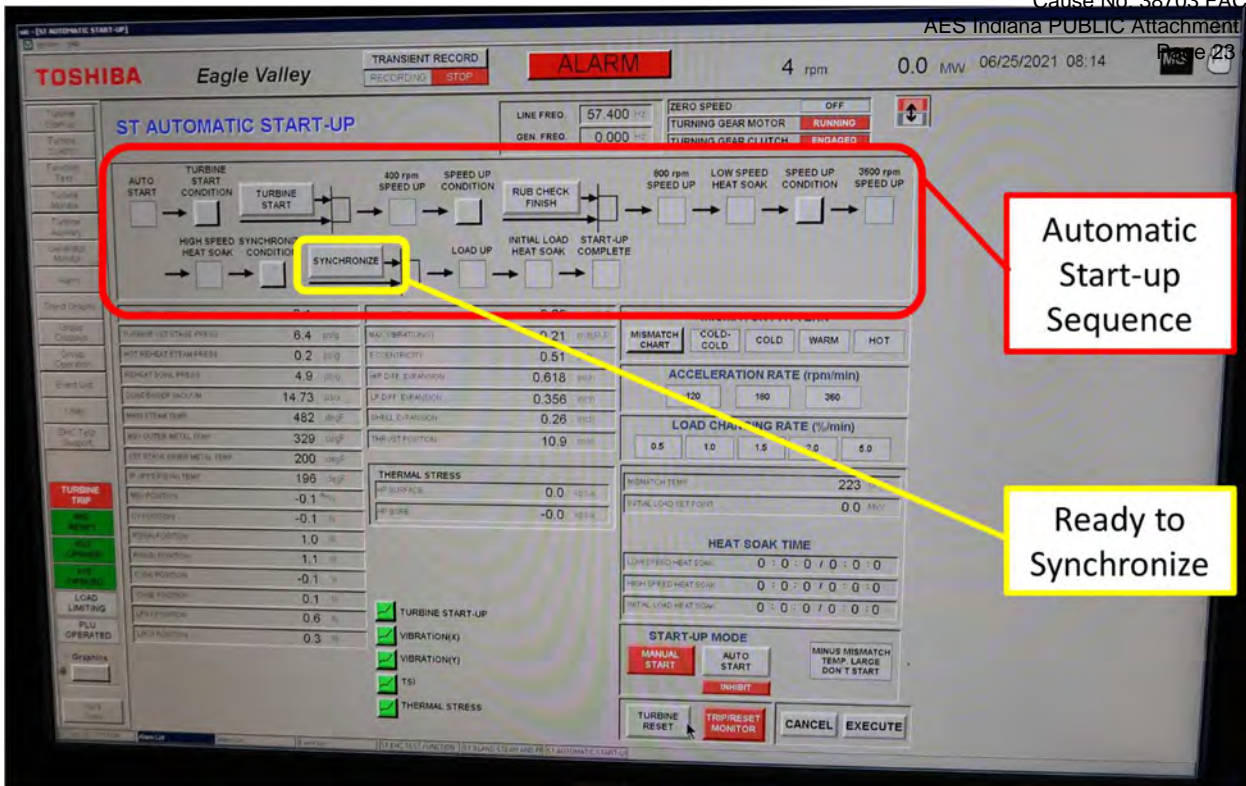
Photograph 9, STG Turbine Automatic Start operator display

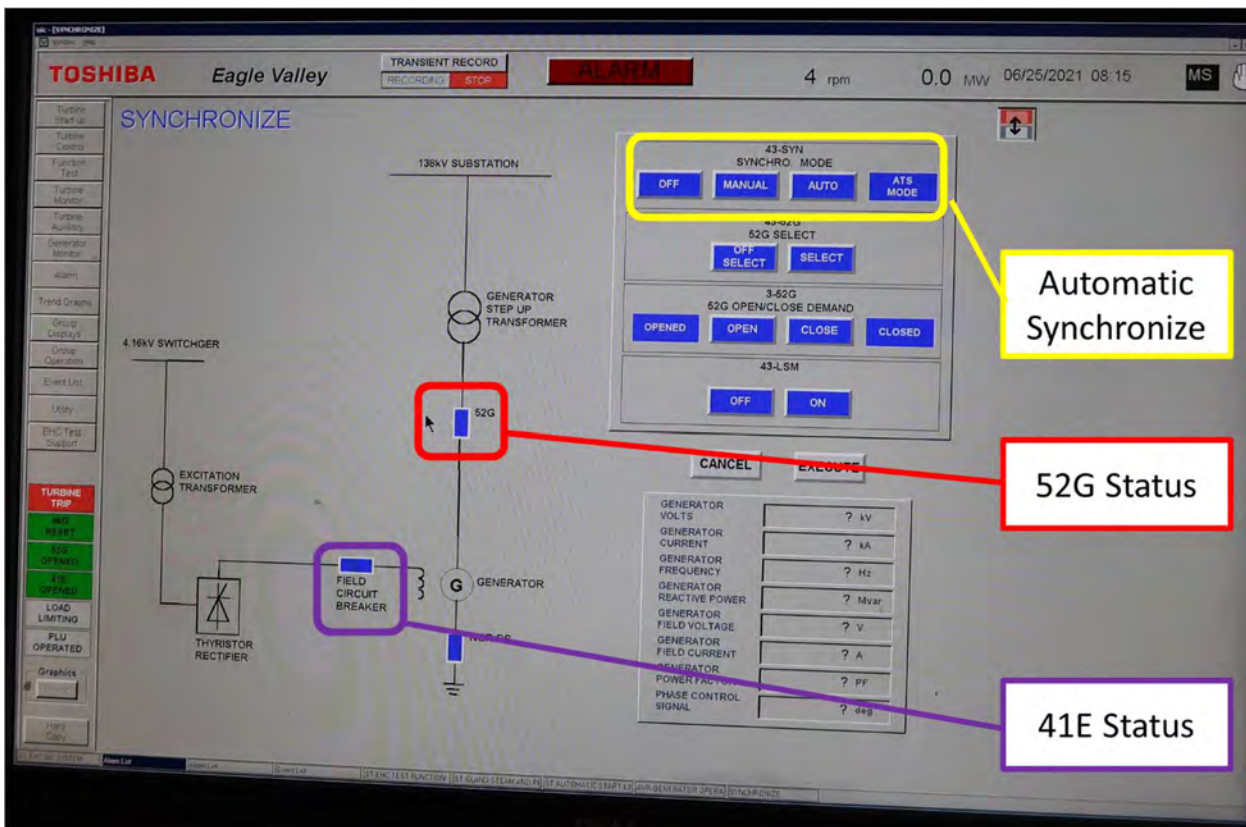
The RCA investigation reviewed the findings from the AES onsite technicians' troubleshooting efforts of April 25th. Their efforts involved tracing the source of the Input for the operator display output of the 52G Breaker status through the Toshiba logic, and back to the 52GX1 Relay. The 52GX1 Relay was not activating the RESET Coil to send the 52G Breaker Open status signal. They traced the activation source for the 52GX1 Relay RESET coil to terminal B10 in the Generator Circuit Breaker cabinet. It was then the technicians found a yellow wire hanging loose and attached to terminal B10. (Refer to Photograph 3) The construction wiring connection drawings showed a jumper wire connection between B10 and B4. (Refer to Figure 10) The loose end of the yellow wire was test landed to terminal B4 but there was no change in the display status on the SYNCHRONIZE Operation screen. The troubleshooting effort continued but made no further progress.

Photograph 10, STG Generator Synchronize operator display.

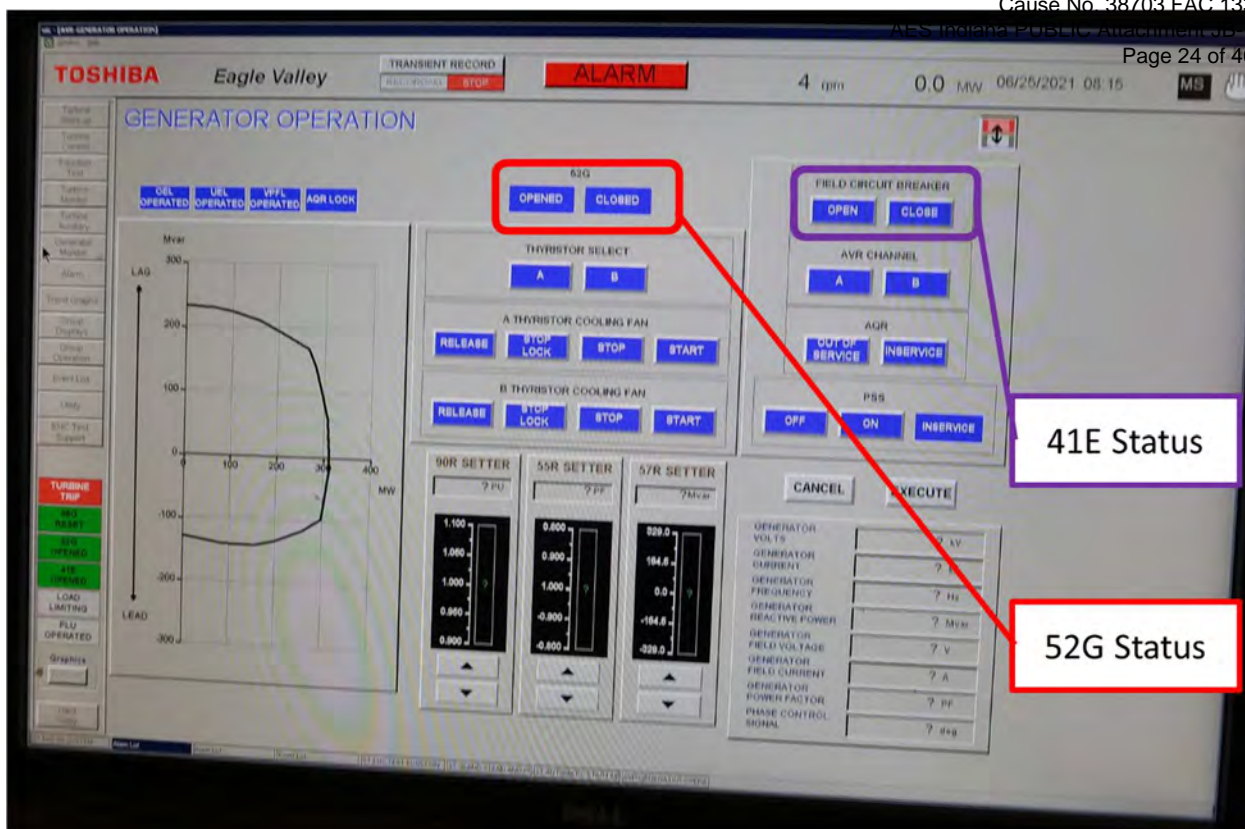
the GENERATOR OPERATION screen which is provided to monitor the generator control (Refer to Photograph 11)

Photograph 11, STG Generator Operation operator display

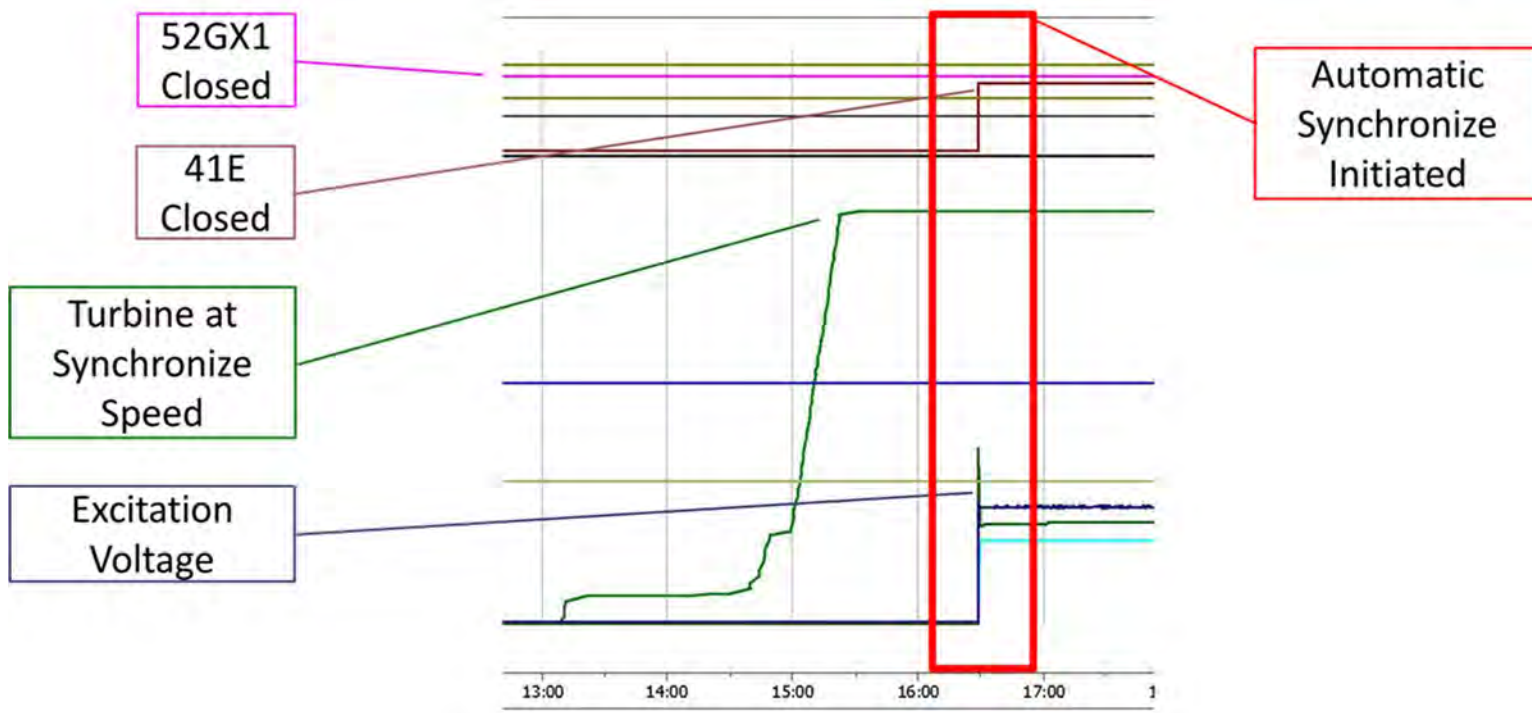
The trends showed a normal startup of the steam turbine, progressing through pre-programmed heat soak cycles until it reached a speed of 3,600 rpm. At that time, the Auto- Synchronize sequence was initiated. The 41E Breaker changed status from Open to Closed. (Refer to Figure 4) The operator's SYNCHRONIZE display screen indicated the 52G Breaker status as closed while showing 52G Breaker as open on the status menu at the lower left of the screen. (Refer to Figure 3) When the manual Turbine Trip was initiated, the operator display screen indicated a turbine trip on the lower left status menu while 41E Breaker indicated as remaining closed. (Refer to Figure 5) When the second manual Turbine Trip was initiated the same results as previous trip were recorded; however, the 86G1 and 86G2 Lockouts tripped. (Refer to Figure 7) The review of the trend data also noticed the indication signal on the SYNCHRONIZE display screen was indicating the 52G Breaker was Closed when the startup sequence was initiated. Using earlier data trend, it was determined the signal had been showing a 52G Breaker Open status before the 52G Breaker testing during the outage. The signal was lost when the outage LOTO isolated the power to the AVR cabinet. When the power was restored, the signal was indicating the 52G Breaker was Closed. The 52G Breaker status signal remained showing Closed until a test wire was connected between terminals 7 and 9 in the Field Circuit Breaker cabinet for the 52GX1 Relay. (Refer to Figure 9)

Figure 4, Trend data at Auto Synchronize start

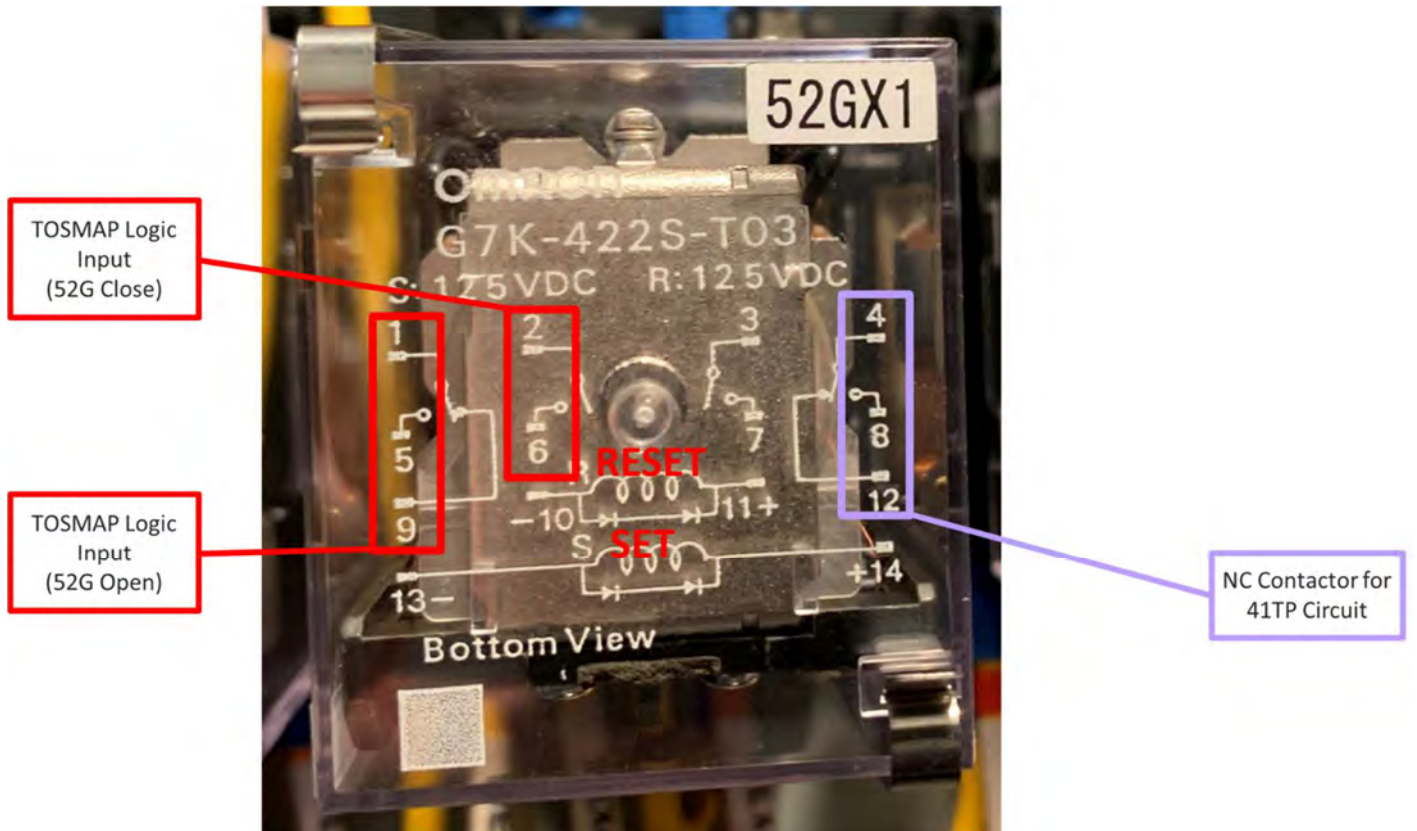
The AVR receives its 52G Breaker status indication through contacts on the 52GX1 Relay. (Refer to Figure 12) The TOSMAP I/O input KI0004 receives a signal from the N/O contact of the 52GX1 Relay for an indication the 52G Breaker is Closed. The TOSMAP I/O input KI0005 receives a signal from the N/C contact of the 52GX1 Relay for an indication the 52G Breaker is Opened. (Refer to Figure 13) The 52GX1 Relay is a latching relay. It receives SET and RESET signals from mechanically actuated contacts on the 52G Breaker. (Refer to Figure 11) The SET signal is through N/O contact to indicate the 52G Breaker Closed and the RESET signal is through N/C contact to indicate 52G Breaker is Open. (Refer to Figure 9) The jumper wire between Terminals B10 and B3 is there to provide the positive source connection to the N/C contacts of the 52G Breaker. (Highlighted in Yellow on Figure 9) The yellow jumper wire was incorrectly shown connecting terminals B10 to B4 on the CB&I interconnecting cable drawings. (Refer to Figure 10) The drawing is incorrect as proven through understanding the wiring circuitry as this connection would not complete the circuit from the positive to negative sources.

Figure 12, 52GX1 Relay diagram.
