Supplemental Report

REFERENCE: US Steel – No. 2 Control Room Deluge Piping Evaluation
Insured: US Steel
Location of Incident: Clairton, Pennsylvania
Date of Incident: December 24, 2018
Sedgwick File Number: PGH19110240
EDT File Number: HFD6062-85199

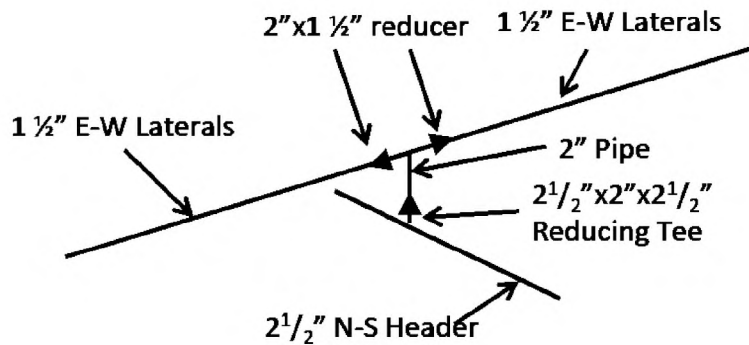
5. The transition from the 2½ inch header at Pipe Section “C” to the laterals is provided by a 2 inch by 2½ inch by 2 inch reducing tee fitting (2”x2½”x2” reducing tee), with the 2 inch portion of the tee feeding the laterals (refer to sketch on the next page).

6. A 4"x2"x4" reducing tee that had experienced severe thinning, due to corrosion, (identified as corroded 4"x2"x4" reducing tee on the drawing) was found near C-521. Given the configuration of the deluge piping shown on the installation drawing, all indications are that the 4"x2"x4" reducing tee was attached to the north end of Pipe Section "E".
7. A portion of the roof for No. 2 Control Room had experienced a collapse between support Truss 9 and 10 (identified on the drawing as Hole in Roof).

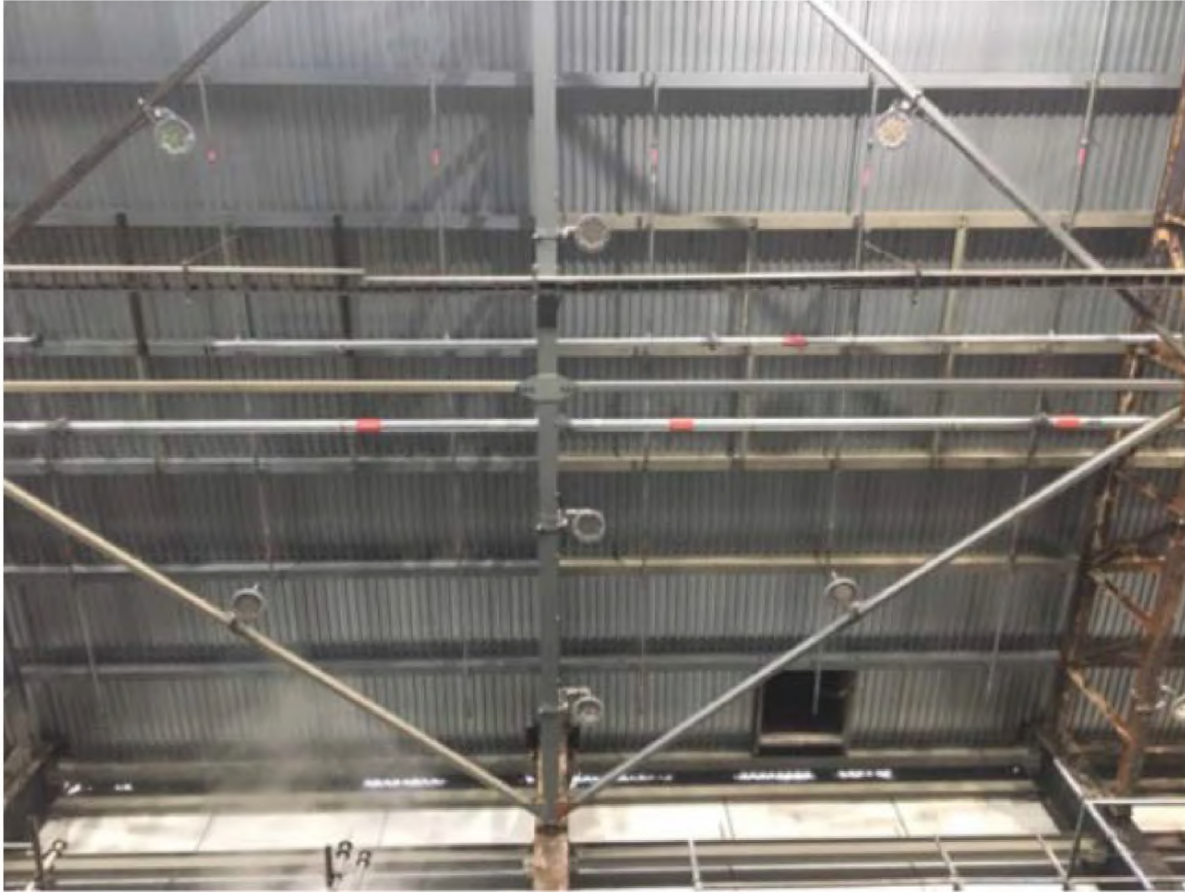
intended to support/suspend the piping. To provide further context with regard to evaluation of the deluge system above the vacuum machines, reference here is to a photograph of the replacement deluge system (installed in 2019), as viewed from the floor:
