Root Cause Analysis of the Uncontrolled Hydrocarbon Release from Aliso Canyon SS-25

May 16, 2019

MAIN REPORT

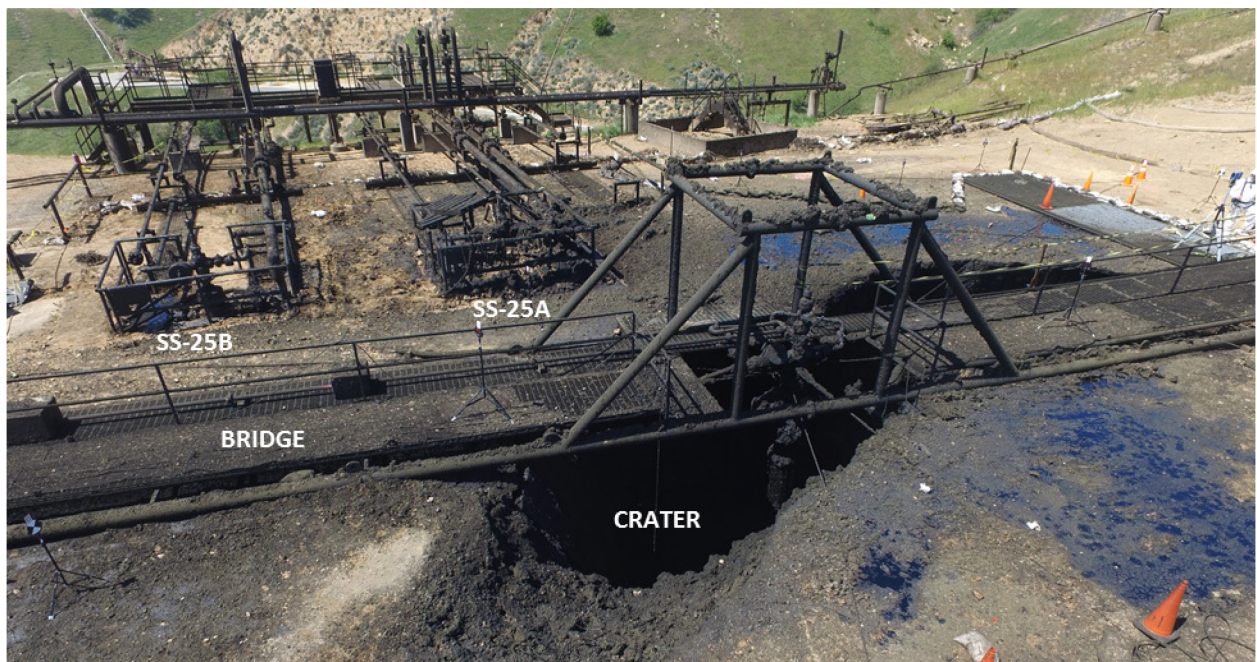
Figure 17: SS-25 Well Site West View Aerial Photograph Post Blowout Taken on April 01, 2016

Formation of the crater occurred during various periods of the blowout. Figure 16 and Figure 17 show aerial photographs of the crater looking down and west, respectively. The images also show the SS-25A and SS-25B wellheads after removing the heat shields. The bridge and concrete beam were installed during the kill operations to provide access to the wellhead. The bridge provided a platform for personnel to connect lines and operate valves. The concrete beam was used to anchor a steel cable handrail.

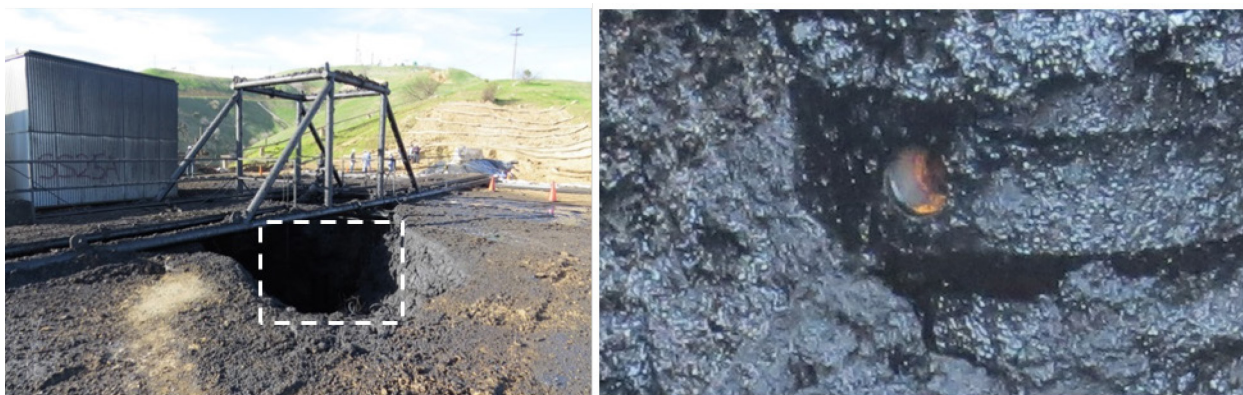
Figure 18: Photos of Missing 11 3/4 in. Casing Valve Taken on February 25, 2016

Figure 18 shows an image of the location of the missing 11 3/4 in. casing annulus valve. The valve backed off during the kill attempts and was not located during the Phase 1 evidence search. The valve most likely ended up at the bottom of the crater with the SS-25 cellar. The cellar collapsed to the bottom of the crater during its formation. A portion of the concrete pad that was attached to the cellar was hanging

from the south side of the crater. The details of the Phase I activities are described in the *Phase I summary* report [9].

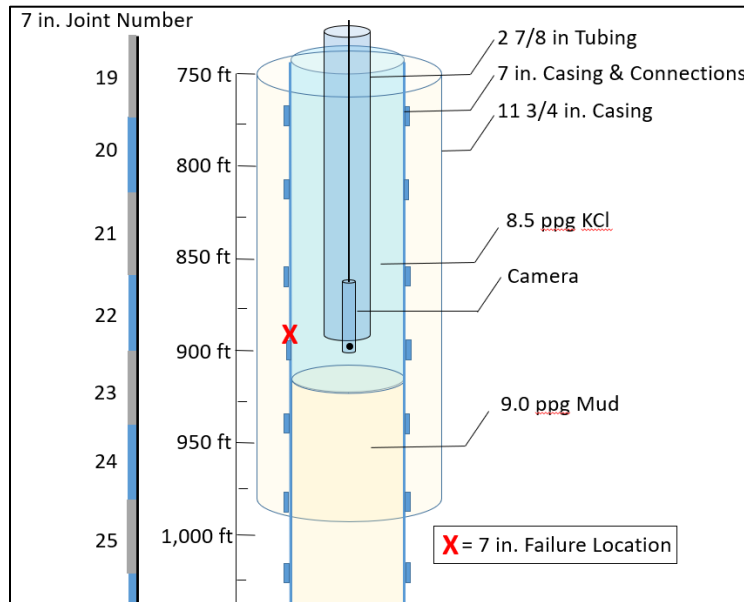
Figure 23: Well Configuration for Through-Tubing Camera Run to View 7 in. Failure Area

A Baker Hughes wireline was rigged up and used to run the EV downhole video camera through the tubing and into the 7 in. casing. Figure 23 shows a schematic of the well configuration for the video camera work. With the video camera positioned at the end of tubing, the tubing was slowly raised while simultaneously pumping clear 8.5 ppg KCl fluid. Pumping continued while the ID of the 7 in. casing was observed with the camera.

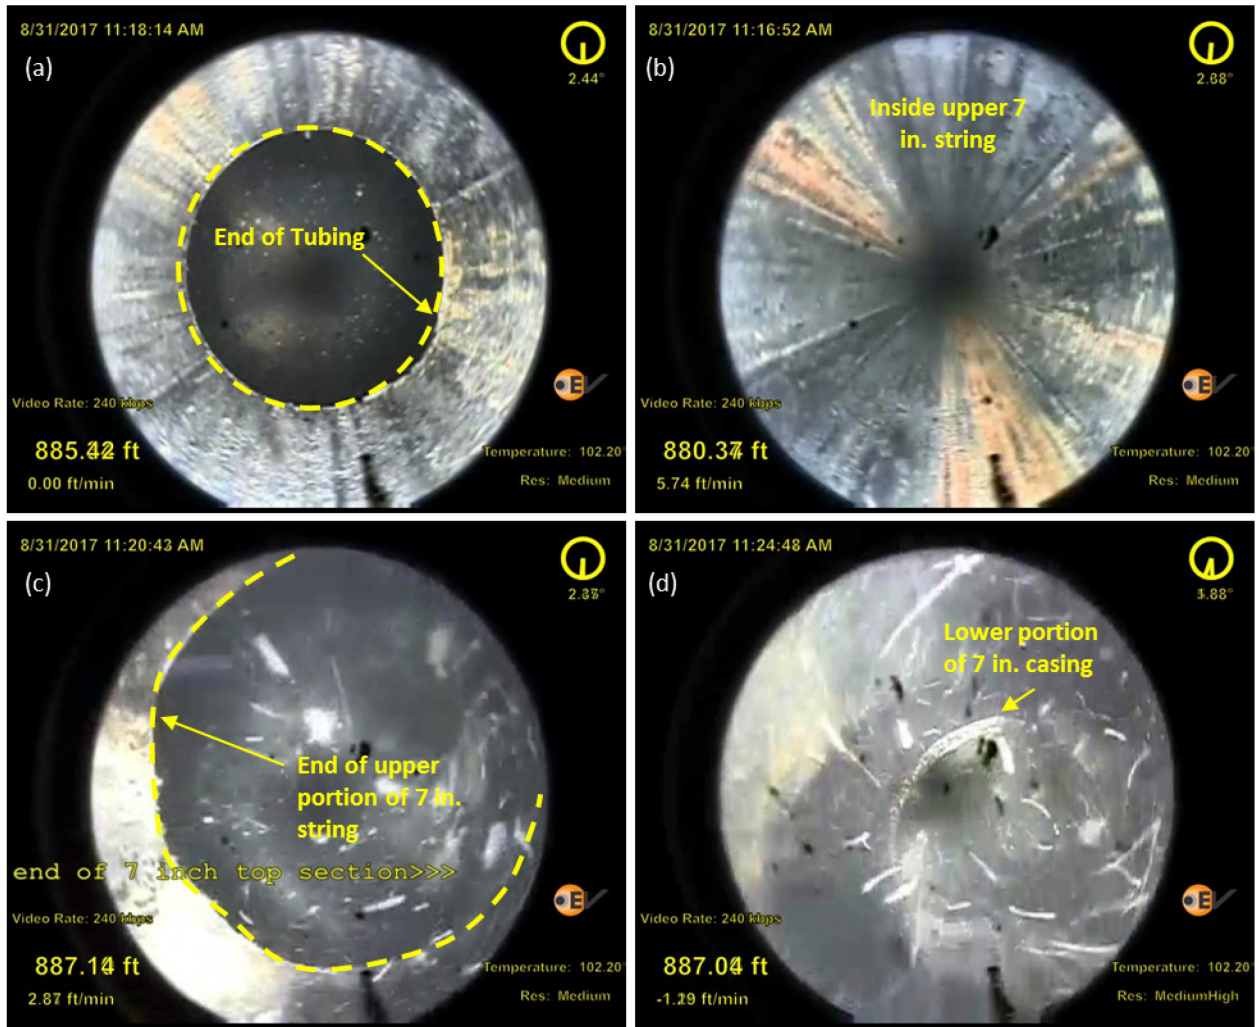
Figure 24: EV Lower Camera Snapshots from August 31, 2017 Showing the Parted 7 in. Casing

Figure 24 shows images extracted during the camera run. Figure 24 (a) shows the end of the tubing, which was set at approximately 885 ft. Figure 24 (b) shows the camera inside the upper 7 in. casing string after exiting the tubing. Figure 24 (c) shows the end of the upper 7 in. casing string. This was the location of the parted 7 in. casing. The camera exited the upper string and looked down at the lower string. Figure 24 (d) shows the lower 7 in. casing string offset from the camera. The lower string was sitting approximately 5 in. below the upper string. The camera runs confirmed that the 7 in. casing was parted and that the lower fish was offset from the upper string.

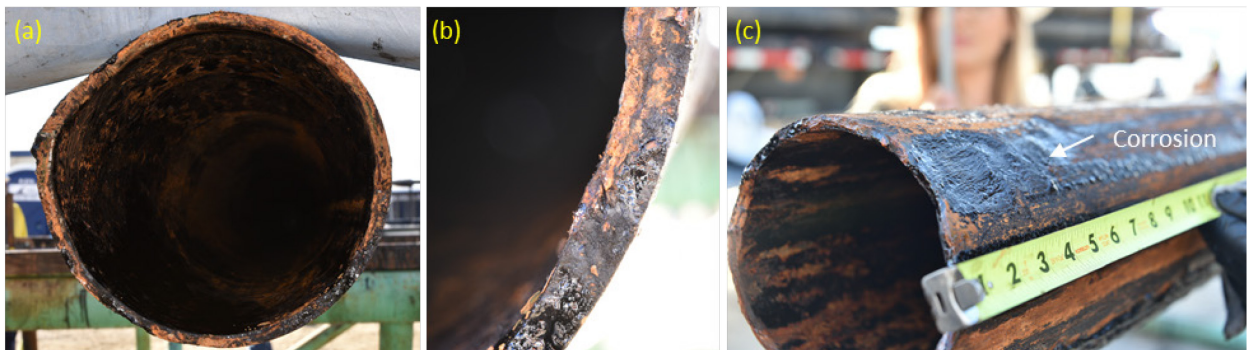
Figure 27: Parted Casing (C022) on the SS-25 Pipe Rack

The upper circumferential fracture surface was examined on the SS-25 pipe rack. Figure 27 shows an (a) overall and (b) close-up image of the fracture surface. The images show that the fracture surface was obscured by the presence of oil and scale. The circumferential fracture surface appeared mostly flat with a pointed section that faced the south side of the rig floor. Figure 27 (c) shows corrosion features adjacent to the fracture surface.

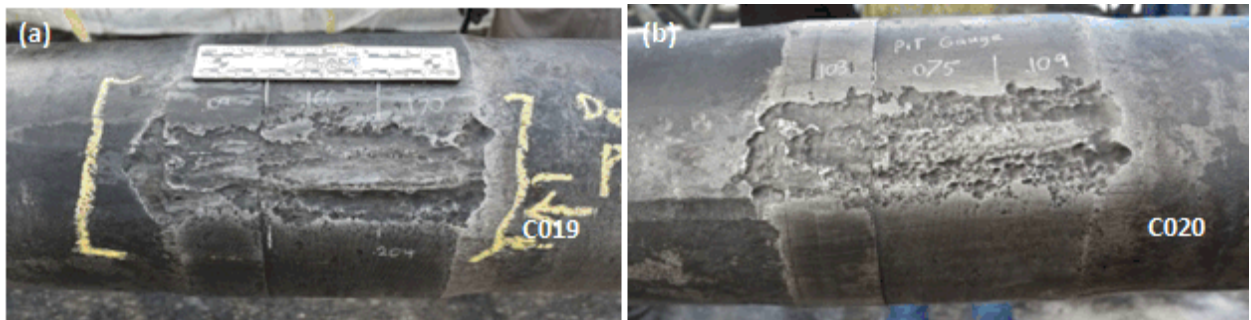
Figure 29: Connection Corrosion on (a) C019 and (b) C020

Shallow metal loss was first identified on the C014 connection and was present on the remainder of the extracted casing pipe bodies and connections. Corrosion was identified on many of the connections below C014 with increasing severity. Figure 28 shows the shallow corrosion on the C014 connection. Figure 29 shows corrosion on the connections for (a) C019 and (b) C020. The corrosion is similar to C014's but more severe.

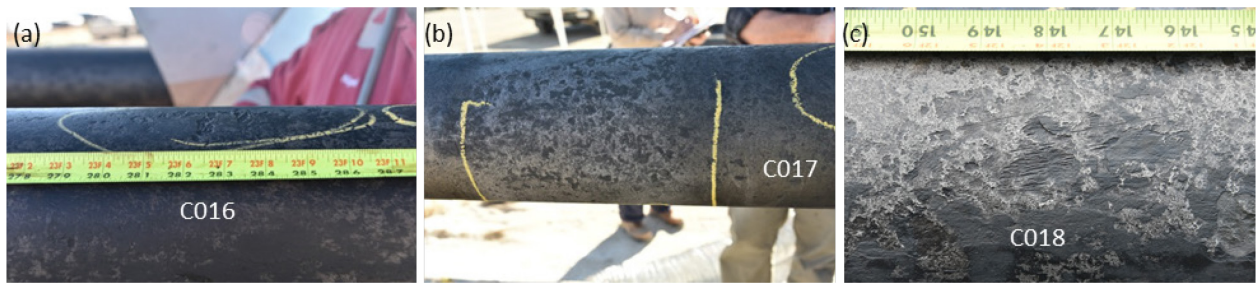
Figure 30: Pipe Body Corrosion on (a) C016, (b) C017, and (c) C018

Corrosion was also identified on the pipe bodies, beginning with C014. Figure 30 shows examples of pipe body corrosion from (a) C016, (b) C017, and (c) C018. Figure 30 (c) shows corrosion with striated grooves slightly angled from the longitudinal axis of the pipe. This type of feature was identified at many locations along the casing below C014. Figure 31 shows examples of corrosion with striated grooves from (a) C018 and (b) C022. Figure 32 shows the largest corrosion feature identified during the PS-20 inspection. The shape and morphology appeared to be consistent with the features found on the connections (Figure 29).

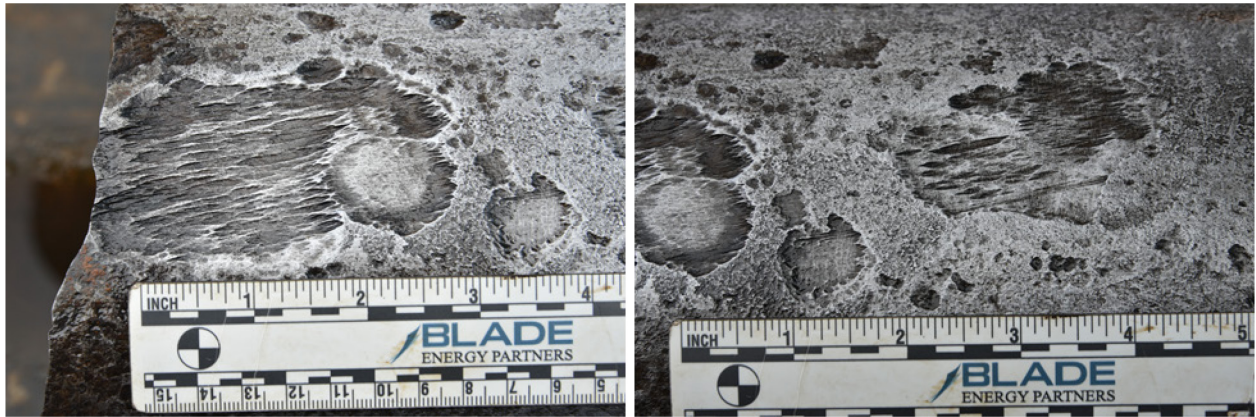
Figure 35: Corrosion with Striated Grooves Adjacent to Fracture Surface

The fracture surface was removed from C022 prior to cleaning and inspection. A cut location approximately 1 ft from the fracture surface was selected, cleaned, and inspected with MPI and UT. An additional cut was made on C022 to remove the connection. Figure 33 shows a diagram of the C022 cut locations. The diagram shows that the section containing the fracture surface was designated C022B after the cuts were executed. Cuts were made using the cold cutter as it had been done on the rig floor. Figure 34 (a) shows cutting joint C022. Figure 34 (b) shows the cutoff piece after cleaning with Sentinel 909. Figure 35 shows the C022B corrosion features adjacent to the fracture surface.

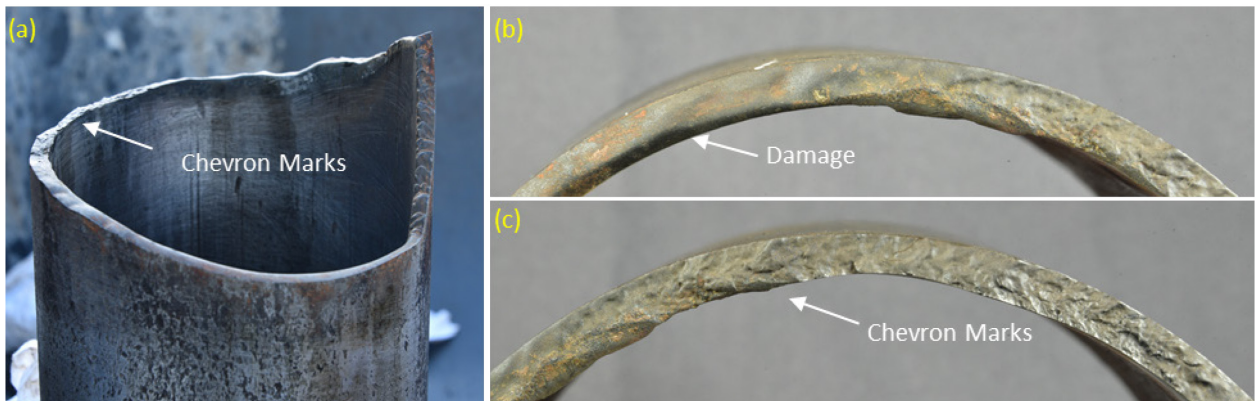
Figure 36: (a) Circumferential Fracture Surface after Cleaning Showing (b) Erosion and (c) Chevron Marks

The fracture surface was examined after being cleaned with Sentinel 909. Most of the fracture surface had been eroded, but chevron marks were visible in some areas. Figure 36 (a) shows the circumferential fracture surface after cleaning with Sentinel 909. Figure 36 (b) and (c) shows close-up images of the fracture surface taken in the field lab after undergoing ultrasonic cleaning.

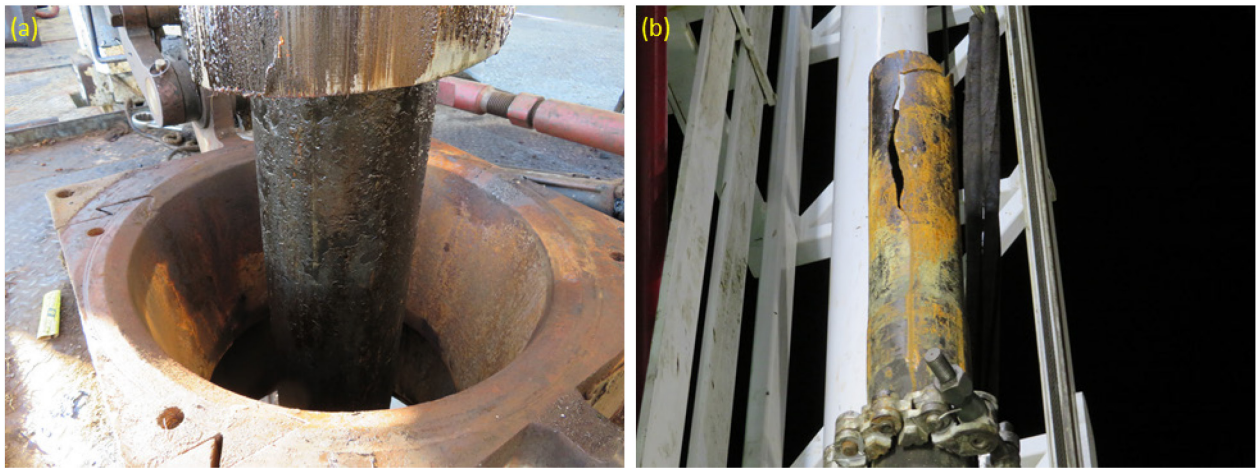
Figure 39: Lower Section of the Parted 7 in. Casing (a) In and (b) Out of the Pawl Tool

Figure 39 shows the fish on the rig floor with the tool (a) engaged and (b) removed. This was the first opportunity to visually examine the fish. The first major observation was that there was an axial rupture below the circumferential parting. C023 was moved from the rig floor to the pipe racks using the crane and a nylon sling. The pipe handler was not used to eliminate damage due to handling. The fracture surfaces were wrapped with VCI and covered for the night. C024 was extracted on November 15, 2017. A 13 ft section (C023A) of C023 was cut on the SS-25 pipe rack using the cold cutter to remove the axial rupture and circumferential parting. The pipe sections (C023A, C023B, and C024) were transported to PS-20 for further inspection. These pipe sections were inspected at PS-20 and preserved in the as-recovered condition for further analysis in Houston, TX. No onsite cleaning was done for these samples.

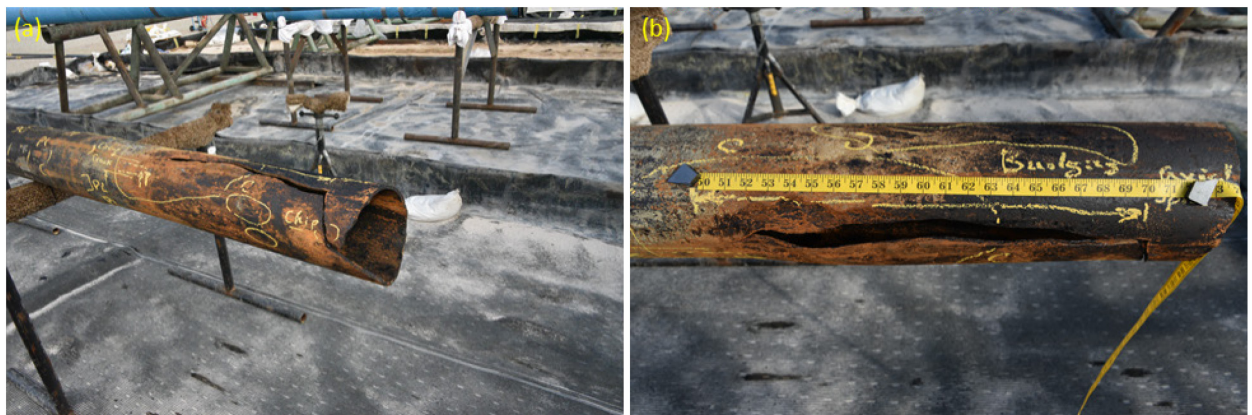
Figure 40: Axial Rupture and Circumferential Parting (C023A)

Figure 40 (a) and (b) show the axial rupture and circumferential parting on the 7 in. casing. The axial rupture was surrounded by a corrosion feature and was located below the circumferential parting. Wall thinning, along with bulging was observed near the middle of the axial rupture. The axial rupture had one lower arrest point away from the circumferential fracture, adjacent to the connection. The upper portion of the axial rupture turns similar to the lower arrest point, but was connected to the circumferential parting by an inclined fracture surface.

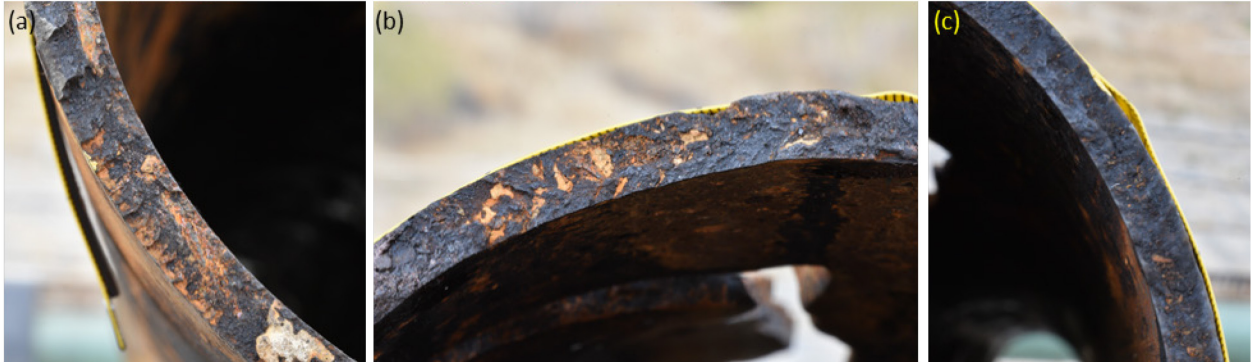
Figure 41: Circumferential Parting Fracture Surface (a) Features, (b) Chevron Marks, and (c) Surface Erosion

The fracture surface was covered with oil deposits and scale products but features were identifiable. Figure 41 (a), (b), and (c) show surface features, chevron marks, and other features, respectively.

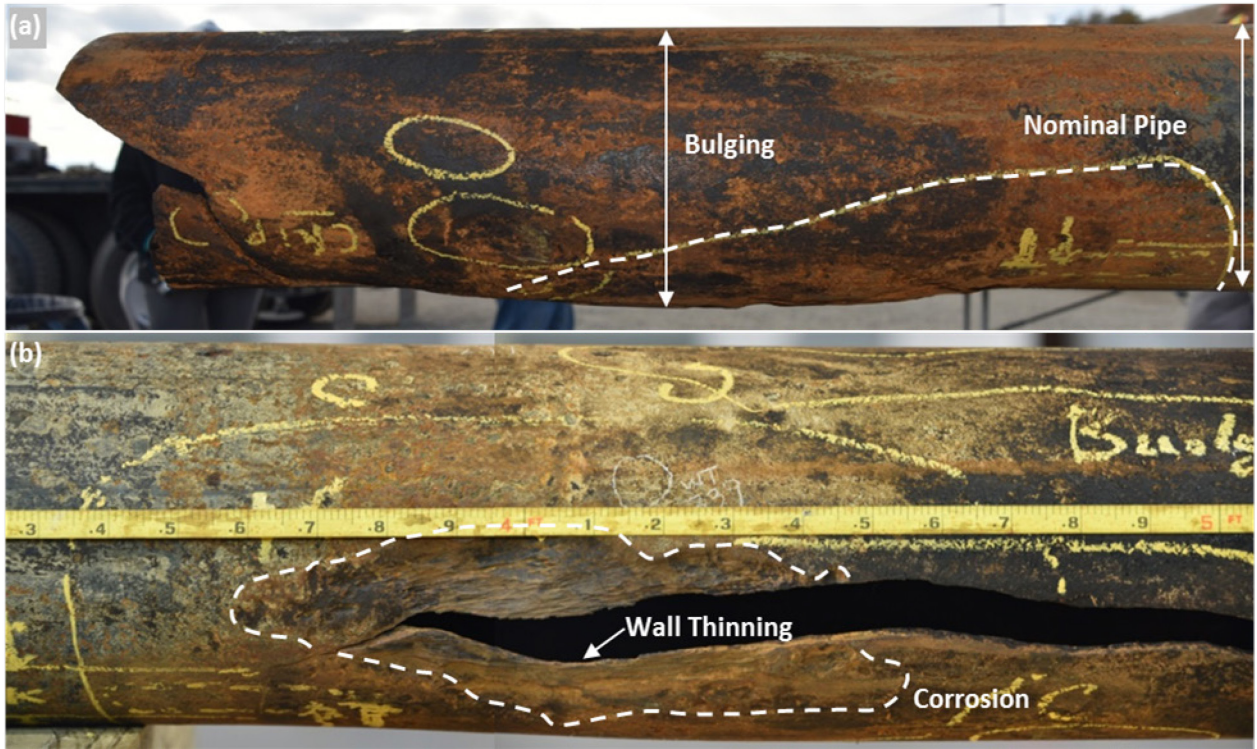
Figure 45: Images of Axial Rupture Showing (a) Bulging and (b) Corrosion Associated with the Axial Rupture

The laboratory examination showed that the 7 in. casing failure originated from an 85% wall loss area due to corrosion. The corroded casing failed, resulting in a 2 ft long axial rupture. Figure 45 (a) and (b) show the bulging and corrosion associated with the axial rupture.

The visual examination showed that during the axial rupture, plastic bulging occurred first, along with slow ductile tearing due to the internal pressure. Tearing instability occurred once the axial flaw reached the critical size, followed by rapid crack propagation in the axial direction. The crack changed direction (upper and lower turning points) and finally arrested due to dynamic energy consumption [14] [15] [16]. There were two turning points on both the upper and lower side of the rupture.

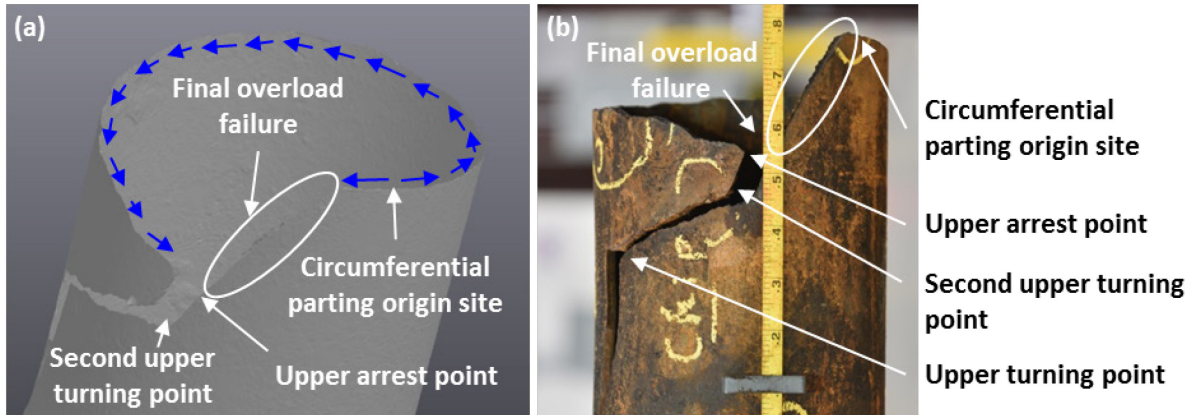
Figure 47: (a) Laser Scan and (b) Photo Indicating Circumferential Parting Initiation Site and Final Failure

Visual and stereoscopic examination of the circumferential parting showed that the failure was not a continuation of the axial rupture, but rather re-initiated near the corner on one side of the parted casing. The origin site was determined based on chevron marks identified on the fracture surface. Figure 47 is a (a) laser scan and (b) image which identifies the upper arrest point, circumferential parting initiation site, and the final overload failure. Figure 48 is stitched stereo images showing the chevron marks and propagation direction of the circumferential parting. These observations indicate that the axial rupture and circumferential parting were two separate events despite their close proximity, and that they are most likely related to each other. This is discussed in more detail later within this section.

The circumferential parting was brittle, which was different from the axial rupture. No evidence of local plastic deformation or overload necking was observed near the fracture surfaces on either side of the circumferential parting.

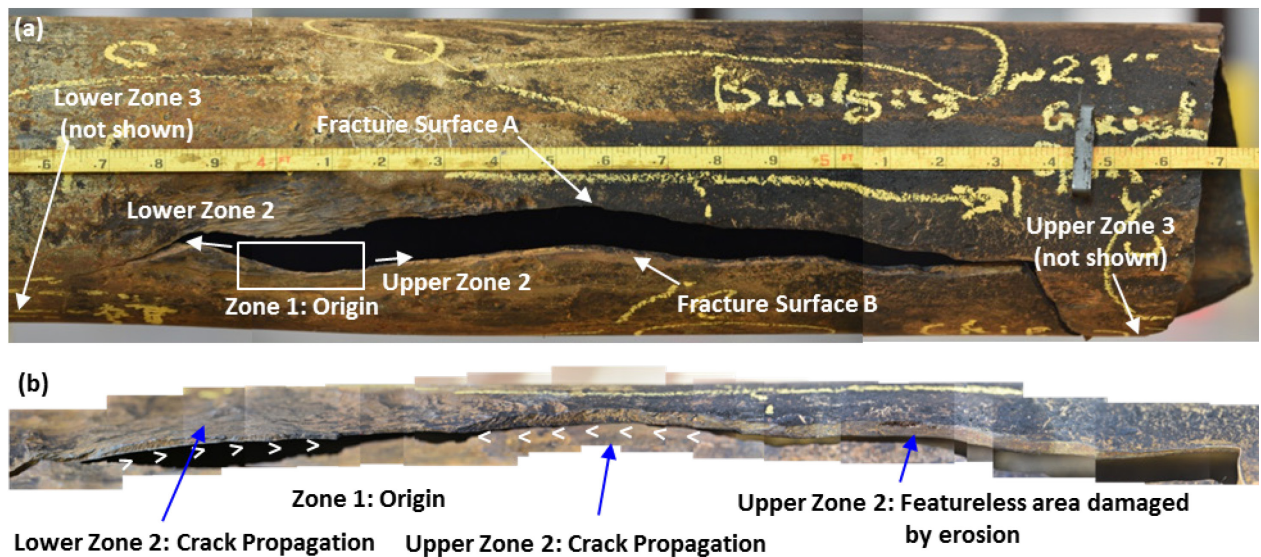
Figure 50: (a) Front and (b) Top Views of Fracture Surface B Identifying the Three Zones

Figure 50 illustrates the three zones of the axial rupture. Zone 1 is a short section of the axial rupture, which was identified by severe wall thinning due to corrosion. Zone 2 extends from the lower and upper boundaries of Zone 1 to the boundary of the lower and upper arrest region. Lower and upper Zone 2 contained chevron marks. However, upper Zone 2 contained a featureless segment created by erosion. Zone 3 contained the lower and upper arrest region. The arrest points in Zone 3 cannot be seen in Figure 50 (a) or (b).

Zone 1 was determined based on the chevron marks in Zone 2. The apexes of the chevron marks generally point towards the origin of a failure. The chevron marks in Zone 2 pointed towards the area with the maximum metal loss. Both observations suggested that this area was the origin of the axial rupture, and it was denoted as Zone 1.

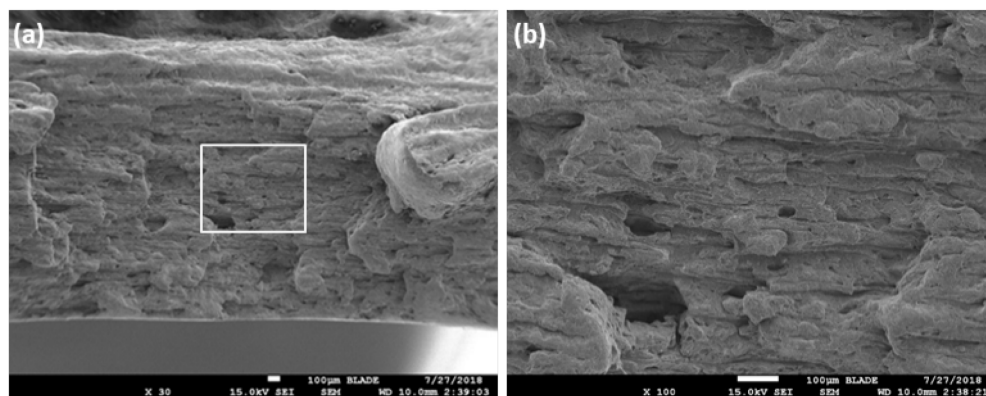
Figure 54: SEM Images of Area 8 Taken at (a) 30x and (b) 100x

C023A1B2C and C023A1B2D were examined with the SEM at several locations and magnifications to identify the fracture mode of the origin (Zone 1). Figure 53 shows the areas of interest (AOI) chosen during the SEM examination. C023A1B2C contained most of the origin and was selected for detailed examination. Figure 54 and Figure 55 are SEM images of two AOIs (A8 and A17) that represent the typical features identified in the origin during the examination. The images show woody-type morphology, deformation markings, possible dimples, and pearlite-like features. Cleavage and grain boundary facets were not observed in any of the AOIs in the origin.

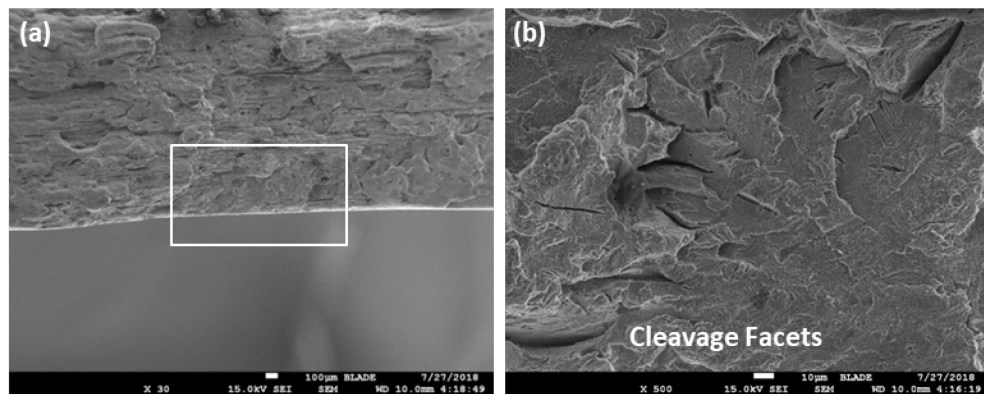
Figure 56: SEM Images of Area 19 Taken at (a) 30× and (b) 500×

A transition from ductile to a ductile–brittle mix was observed beginning at A19 (Figure 53). The transition showed a shift from a woody-type morphology to a mix of woody-type morphology and cleavage. The amount of cleavage facets appeared to increase from location A19 to A27. The observations implied that the speed of the axial rupture was increasing through the transition zone until the crack became fully unstable. Figure 56 is a SEM image from A19 showing the ductile–brittle mixed fracture mode. The images show areas of cleavage facets and deformation markings.

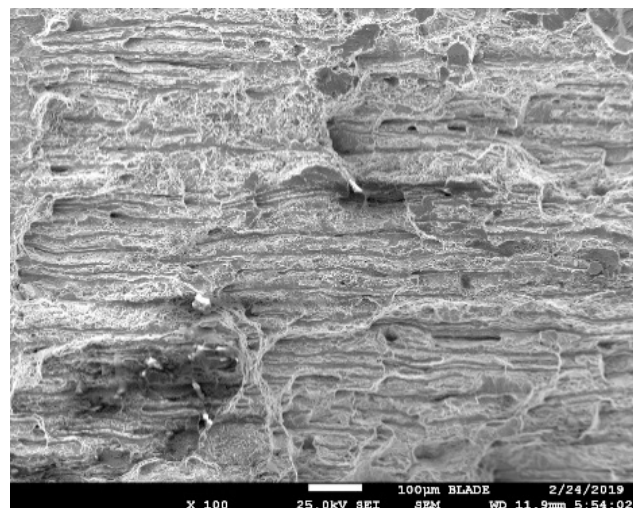
Figure 57: SEM Images of J-R Specimen L4-000 Taken at 100×

The initial examination of the axial rupture suggested that the origin experienced ductile tearing based on the woody-type morphology and deformation markings. The fracture surface produced by J-R ductile tearing tests were used to confirm the ductile tearing observed in the origin. Specimen L4-000 was tested at room temperature, which was comparable to the downhole temperature at the time of the axial rupture. Figure 57 shows SEM images taken at 100× showing the woody-type morphology. Higher magnification images showed the dimpled nature of the surface.

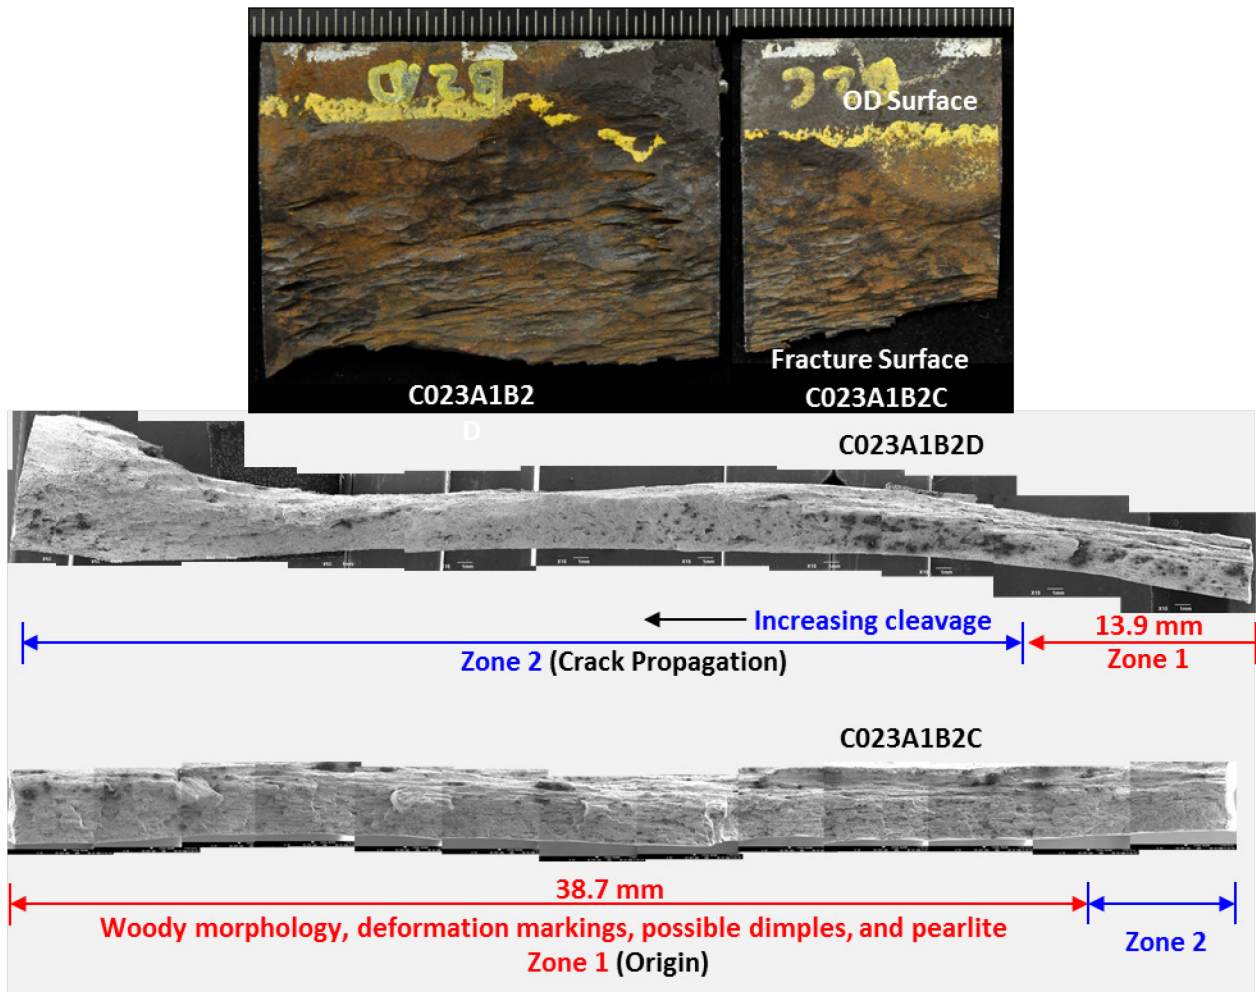
Figure 58: Origin Measurements Based on Micro Definition for C023A1B2C and C023A1B2D

The origin was originally defined based on metal loss measurements and chevron marks identified on the fracture surface. The origin length based on this criterion was measured at 4.8 in. (123 mm). The origin was redefined based on micro-scale features identified on the fracture surface. The micro-scale-based measurement was defined as the length of fracture surface that exhibits fully ductile tearing with no cleavage facets. The origin length based on the new micro-scale definition was 2.13 in. (54 mm). Figure 58 shows the Zone 1 measurements for C023A1B2C and C023A1B2D based on the new origin definition. The origin was measured as 0.55 in. (13.9 mm) and 1.52 in. (38.7 mm) for C023A1B2C and C023A1B2D, respectively. The kerf from the saw cut was approximately 0.06 in. (1.4 mm). The measurements result in a total Zone 1 length of 2.13 in. (54.0 mm). The initial origin length was reduced by more than a factor of two.

The length difference of the origin based on the micro (SEM) and macro (visual) definitions reflects the difference in the role they played for the axial rupture. The micro definition measurement of 2.13 in. represents the initial size of the crack origin. The macro definition measurement of 4.8 in. represents the rapid propagation of the crack as indicated by chevron marks.

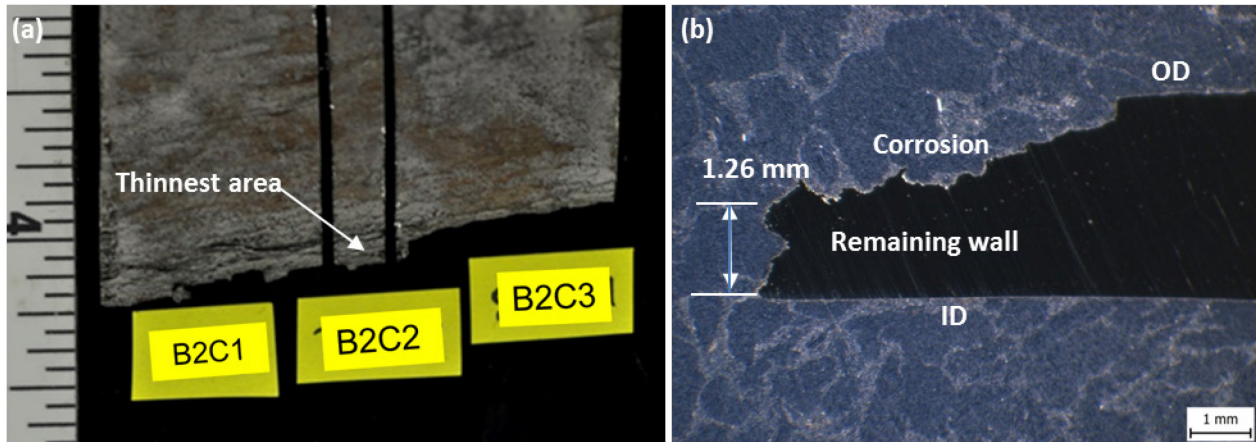
Figure 59: (a) Macro and (b) Metallographic Image of C023A1B2C2 Showing the Remaining Wall

A metallographic cross section was made to accurately measure the minimum remaining wall. The origin specimens (C023A1B2C and C023A1B2D) were visually examined to identify the thinnest area. The selected area was cross-sectioned, mounted, and polished for examination with a microscope. Figure 59 shows the location of the (a) metallographic section of C023A1B2C and the (b) measured remaining wall thickness on the polished specimen. The measured remaining wall was 0.0496 in. (1.26 mm), and the measured wall thickness of the unaffected area was 0.321 in. (8.15 mm). The calculated maximum metal loss, or maximum corrosion depth, was 85% actual wall thickness. The refined measurement of 0.0496 in. was accurate and was used as an input parameter for failure pressure calculations.

Ductile tearing and bulging could have contributed to the remaining wall measurement by ductile deformation. The measured remaining wall would then have been a combination of the original metal loss due to corrosion and thinning caused by the axial rupture. Cross-sections adjacent to the fracture surface were examined to determine if bulging and ductile tearing contributed to the remaining wall thickness measurement. Detailed metallographic examination confirmed that the grains appeared equiaxed and not elongated. Therefore, the remaining wall loss of 85% was caused by metal loss due to corrosion.

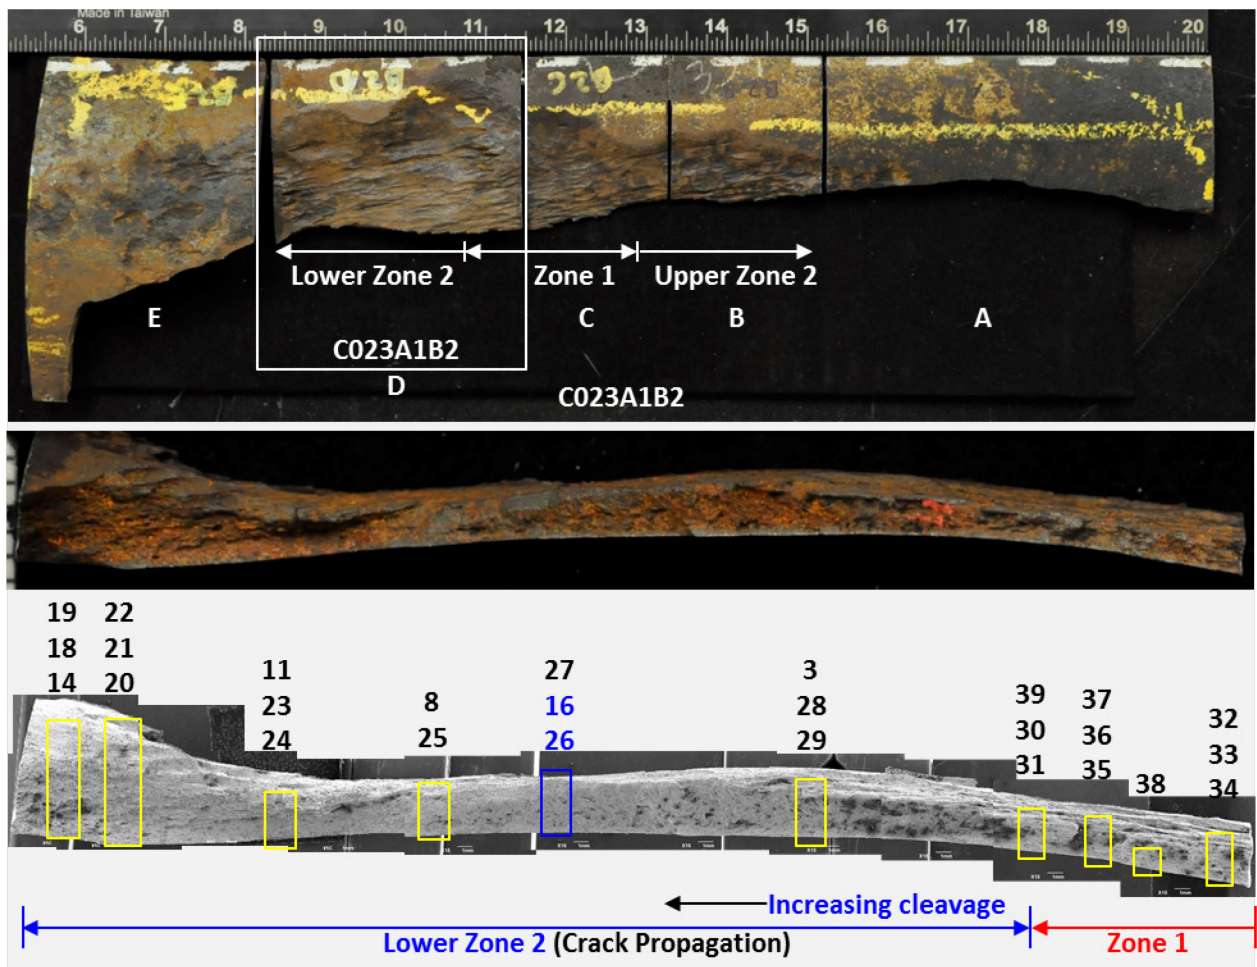
Figure 60: Images Showing Division Between Zone 1 and Lower and Upper Zone 2

Zone 2 was separated into two sections by Zone 1. The two sections are referred to as Upper and Lower Zone 2 in reference to the zones’ relative position in the SS-25 well (Figure 60). Lower Zone 2 was examined first with a detailed SEM examination of specimen C023A1B2D. Figure 60 also shows the C023A1B2D fracture surface before (middle) and after (lower) cleaning.

The SEM examination showed a mixed fracture mode that consisted of cleavage (brittle) and micro-void-coalescence and dimples (ductile). The amount of cleavage increased with distance from the origin, but decreased as the crack approached the lower turning point. Figure 61 shows typical SEM images taken from locations in Zone 2.

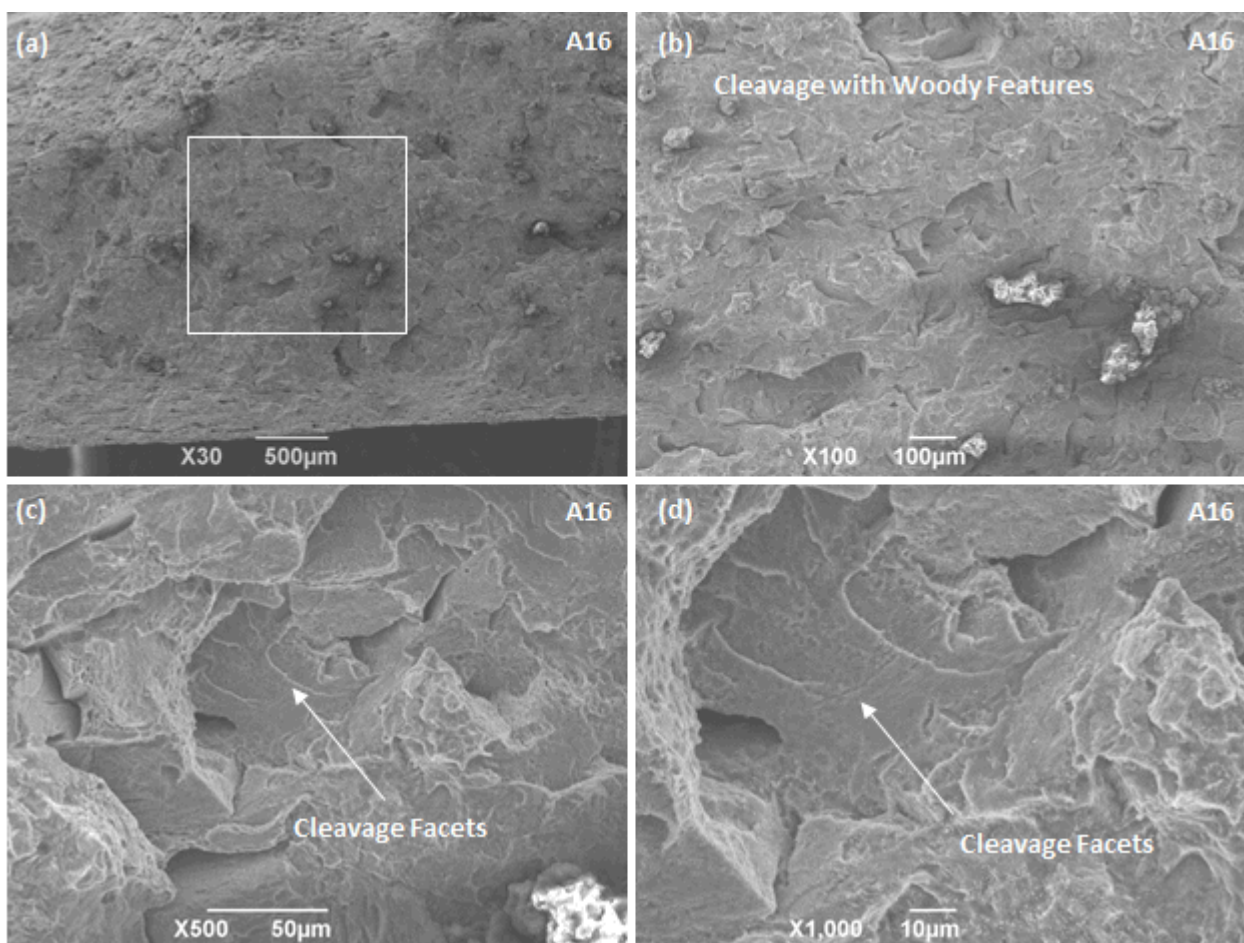
Figure 61: SEM Images from Locations A16 and A26 Showing Mixed Fracture Mode

The occurrence of cleavage in Zone 2 is understandable. In body-centered cubic metals, such as mild steels, cleavage is promoted by low service temperature, high strain rate, presence of stress concentrators (stress state), specimen size, material (composition and microstructure), and certain environments. The 7 in. casing axial rupture failure occurred at an approximate temperature of 80°F, which would not have caused cleavage during slow loading. Based on this observation, the main contributing factors for promoting cleavage were related to strain rate.

Half-size CVN tests were conducted at various temperatures for material extracted from the SS-25 7 in. casing joints. The measured average ductile-to-brittle transition temperature (DBTT) based on impact energy is 87°F (30.8°C), indicating that the material was susceptible to brittle failure. On the other hand, the strain rate in Zone 2 was high due to the high speed of crack propagation after the critical crack size was reached, and tearing instability occurred. The evidence suggests that the high strain rate and a DBTT value of 87°F contributed to the cleavage observed in Lower Zone 2.

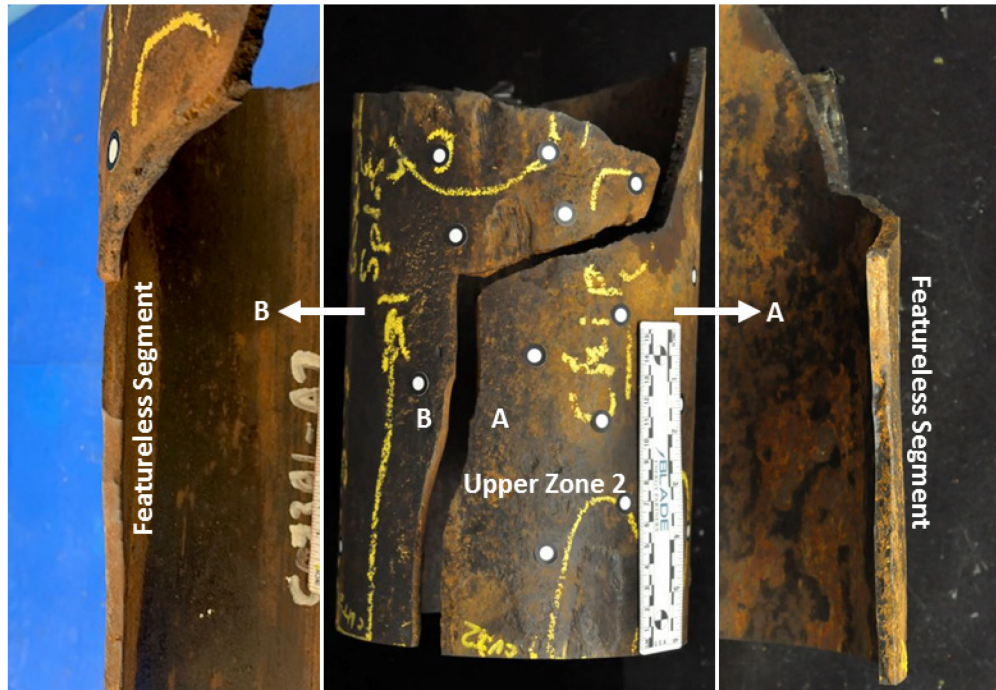
Figure 62: Overview of Upper Featureless Zone

Upper Zone 2 contained a 9 in. long featureless region in addition to a region with chevron marks. The 9 in. featureless region appeared relatively smooth with no visible chevron marks. Visual examination of the featureless region suggested that the fracture surface had been eroded due to escaping gas caused by the axial rupture. Figure 62 shows an overview of Upper Zone 2. Fracture surfaces A and B are mating surfaces of the rupture, which show the Upper Zone 2 featureless segment. Fracture surface A was used to characterize the fracture surface, while B was preserved for future investigations.

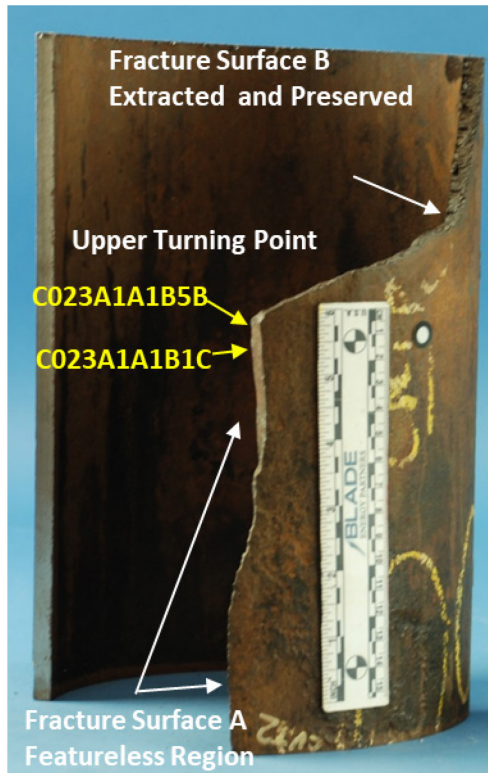
Figure 63: Fracture Surface A Featureless Region of Upper Zone 2

Two specimens were investigated to characterize the Upper Zone 2 featureless region. Figure 63 is a macro photograph of the featureless region. Specimen C023A1A1B5B contained a small section of the featureless zone and the upper turning point. Specimen C023A1A1B1C contained a portion of the featureless zone directly below specimen C023A1A1B5B. Both specimens were examined in detail with the SEM.

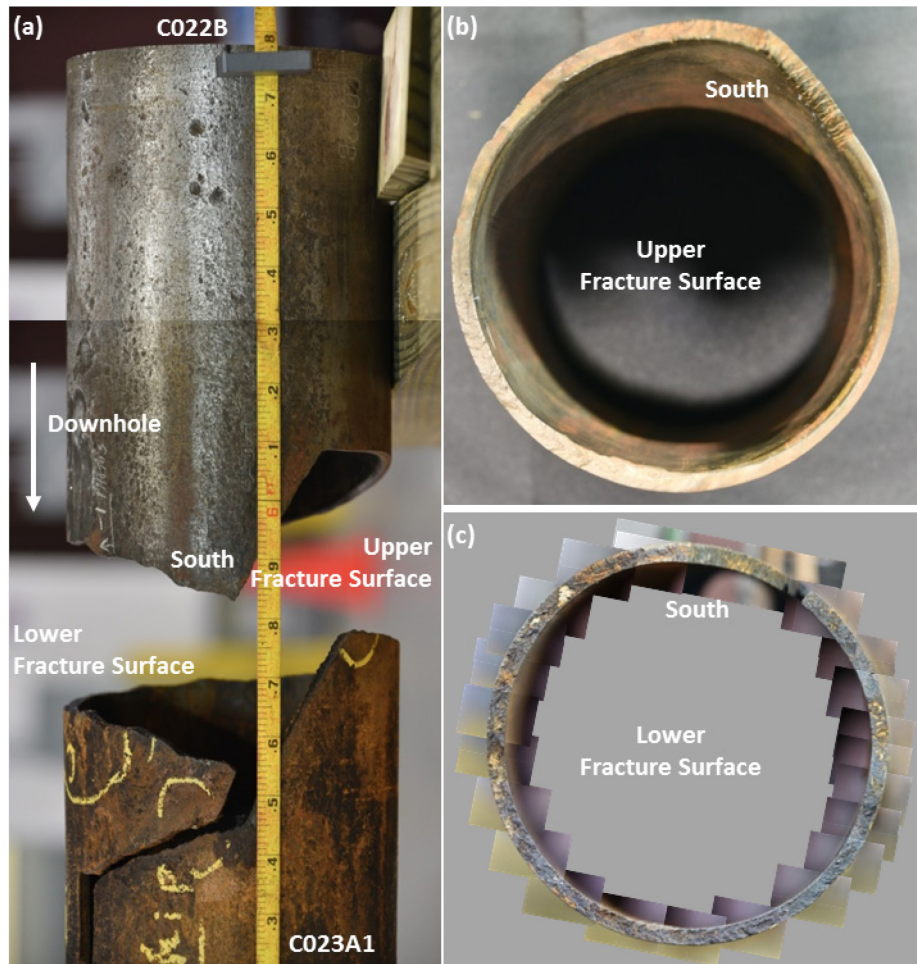
Figure 66: (a) Circumferential Parting Showing the (b) Upper and (c) Lower Fracture Surfaces

The upper fracture surface was facing down after the parting and was severely eroded by the high-pressure gas escaping from the reservoir. The lower fracture surface was facing up during the blowout and appeared well preserved. Figure 66 (a) shows the lower and upper fracture surfaces during the visual examination. The specimens are oriented in the same position as they were in the well. The pointed section of C022B was identified as the south-facing side of the pipe on the rig floor. Figure 66 (b) shows the erosion to the upper fracture surface. Remnants of chevron marks were visible in some areas of the fracture surface. However, most of the surface appeared smooth and featureless. Figure 66 (c) shows the condition of the lower fracture surface during the examination. Chevron marks were visible and were well defined as compared to the upper fracture surface. The lower fracture surface had no indications of erosion and was later confirmed by stereo and SEM examinations.

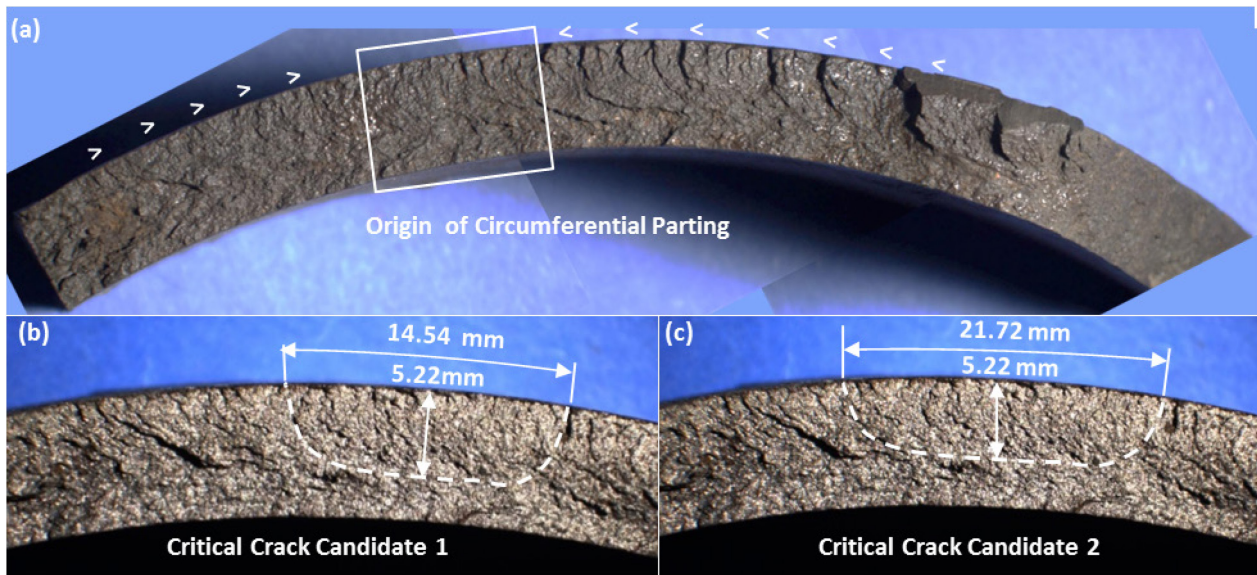
Figure 68: Circumferential Parting (a) Origin, (b) and (c) Critical Crack Candidates

Zone 1 was identified based on the chevron marks observed on the fracture surface. An initial area was identified as a possible origin site based on visual and stereoscopic examinations. The proposed origin site was thoroughly examined with the stereo microscope and SEM to determine the origin size. Two semi-elliptical areas were identified as possible critical crack sizes (origin) for the circumferential parting. The first critical crack candidate was 14.55 mm long and 5.2 mm deep. There was uncertainty in identifying the fine chevron marks adjacent to the origin. A second critical crack candidate was identified, which extended just beyond the first critical crack candidate. The second critical crack candidate was 21.72 mm long and 5.22 mm deep. Figure 68 (a) shows the origin area for the circumferential parting. Figure 68 (b) and (c) show the location and sizes of the critical crack candidates.
